**Flood Control Project Maintenance
Levee Inspections**

Fall 2008 Levee Maintenance Deficiency Summary Report

San Joaquin River Basin

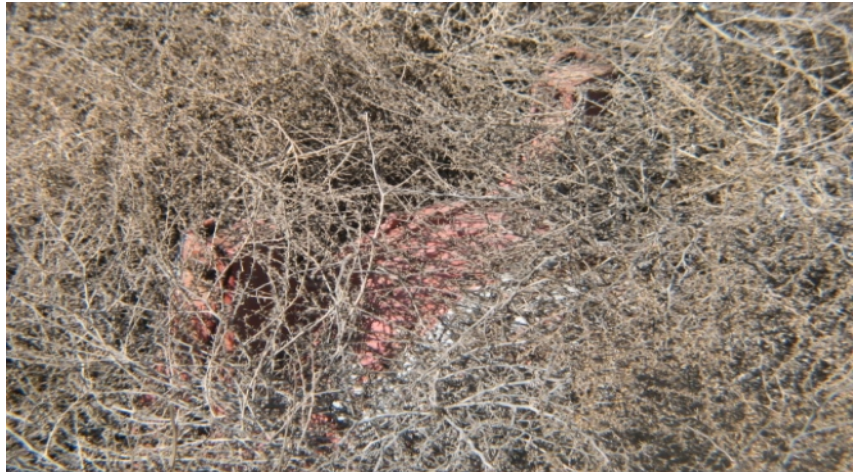
Levee Mile Report Line	4
Start Levee Mile	0.87
End Levee Mile	0.87
Location	
Category	Interior Drainage & Piping Systems
Item	Vegetation & Obstructions
Vegetation (Tumbleweeds) blocking flap gate at LM 0.87

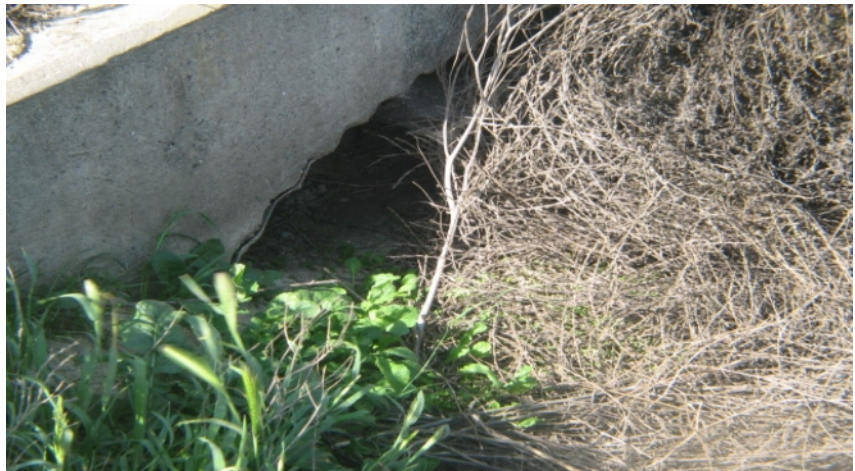
Levee Mile Report Line	5
Start Levee Mile	3.95
End Levee Mile	3.95
Location	
Category	Interior Drainage & Piping Systems
Item	Vegetation & Obstructions
Inlet of pipe over 50 % blockage at LM 3.95

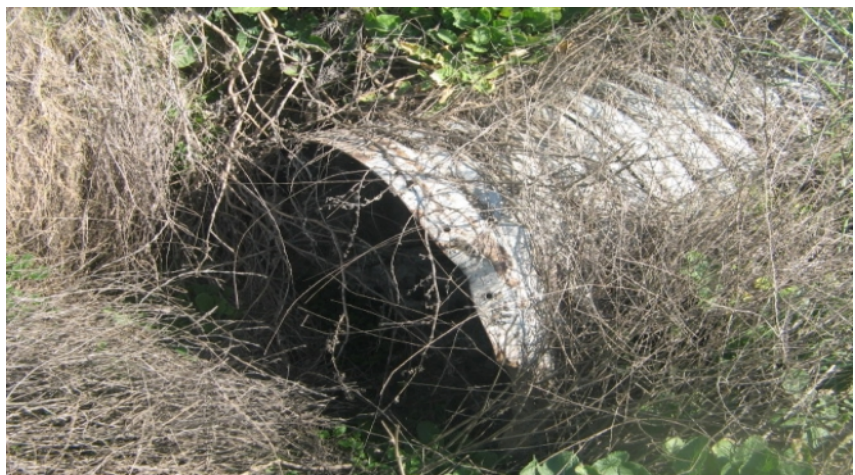
Levee Mile Report Line	6
Start Levee Mile	3.95
End Levee Mile	3.95
Location	
Category	Interior Drainage & Piping Systems
Item	Flap Gates
Flap gate missing at LM 3.95

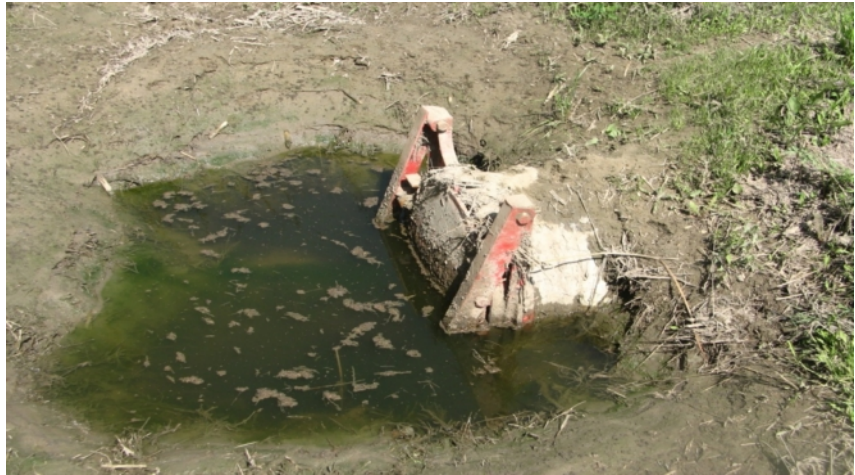
Levee Mile Report Line	10
Start Levee Mile	6.63
End Levee Mile	6.63
Location	
Category	Interior Drainage & Piping Systems
Item	Vegetation & Obstructions
Flap gate blockage at LM 6.63

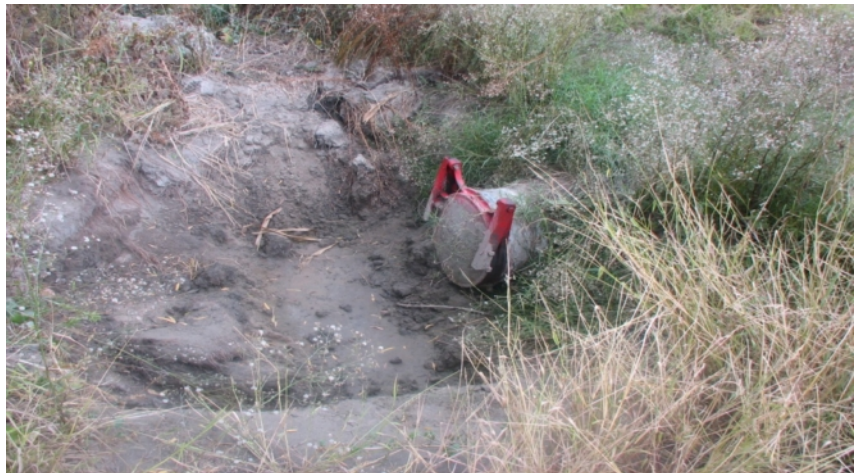
Levee Mile Report Line	10
Start Levee Mile	6.63
End Levee Mile	6.63
Location	
Category	Interior Drainage & Piping Systems
Item	Vegetation & Obstructions
Looking at acceptable condition of flap gate.

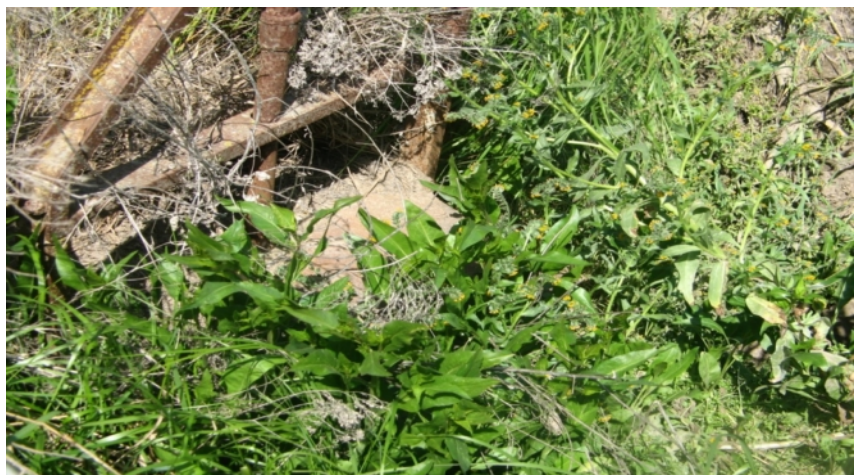
Levee Mile Report Line	11
Start Levee Mile	9.36
End Levee Mile	9.36
Location	
Category	Interior Drainage & Piping Systems
Item	Vegetation & Obstructions
Srew gate block and not operating properly at LM 9.36

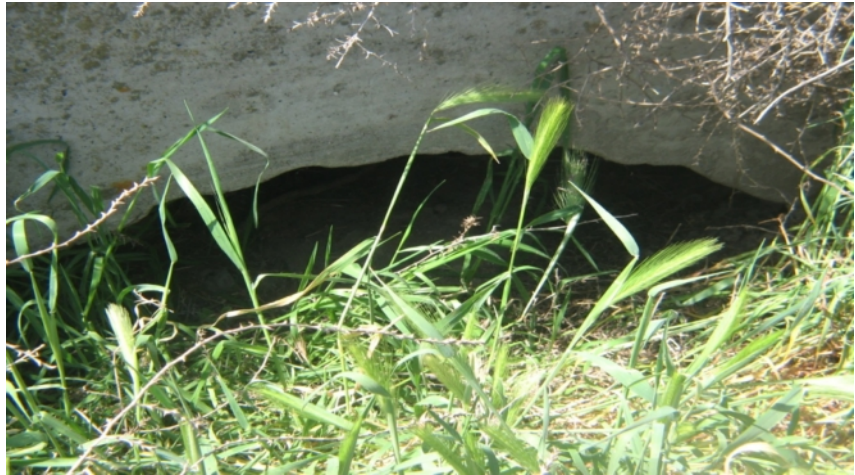
Levee Mile Report Line	12
Start Levee Mile	9.66
End Levee Mile	9.66
Location	
Category	Interior Drainage & Piping Systems
Item	Vegetation & Obstructions

Inlet of pipe blockage over 50 % at LM 9.66

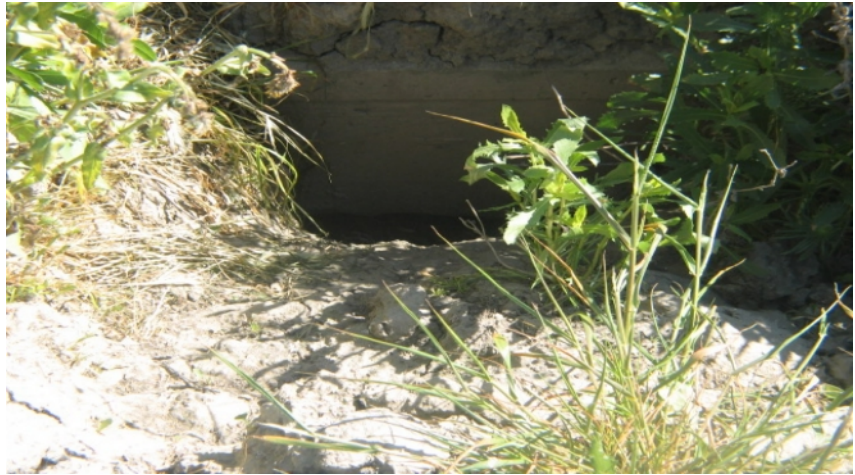
Levee Mile Report Line	1
Start Levee Mile	4.14
End Levee Mile	4.14
Location	
Category	Interior Drainage & Piping Systems
Item	Vegetation & Obstructions
Inlet of pipe over 50% blockage at LM 4.14

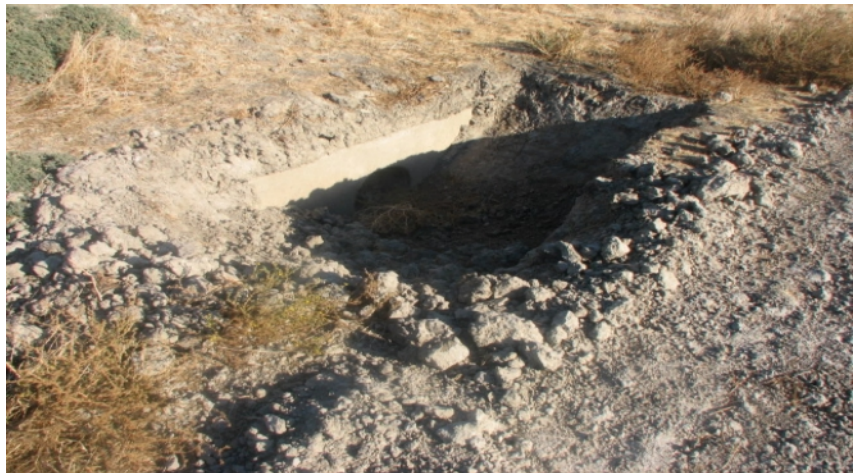
Levee Mile Report Line	1
Start Levee Mile	4.14
End Levee Mile	4.14
Location	
Category	Interior Drainage & Piping Systems
Item	Vegetation & Obstructions
Looking at inlet of pipe at acceptable condition.

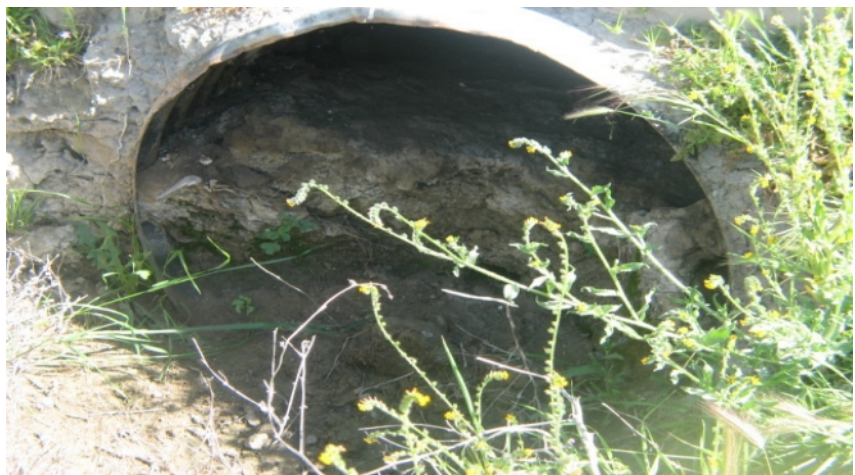
Levee Mile Report Line	2
Start Levee Mile	4.67
End Levee Mile	4.67
Location	
Category	Interior Drainage & Piping Systems
Item	Vegetation & Obstructions
Inlet of pipe over 50% blockage at LM 4.67

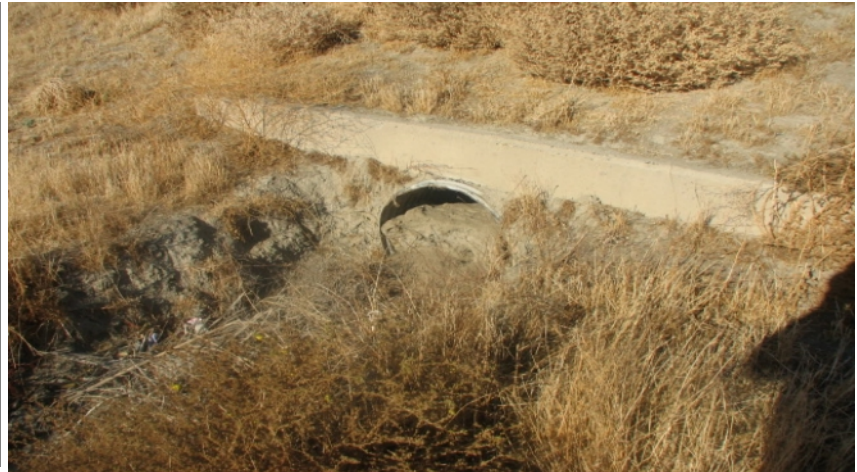
Levee Mile Report Line	2
Start Levee Mile	4.67
End Levee Mile	4.67
Location	
Category	Interior Drainage & Piping Systems
Item	Vegetation & Obstructions
Looking at inlet of pipe at minimally acceptable condition.

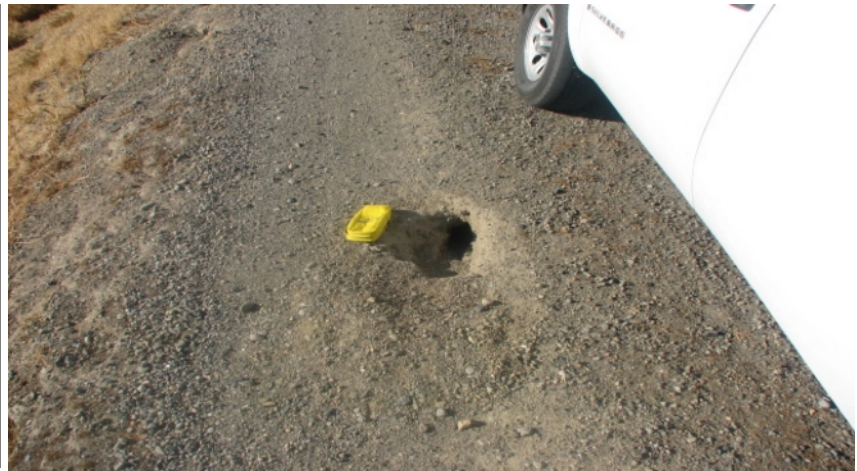
Levee Mile Report Line	3
Start Levee Mile	4.67
End Levee Mile	4.67
Location	
Category	Earthen Levee
Item	Animal Control
Looking at squirrel hole at crown of levee.

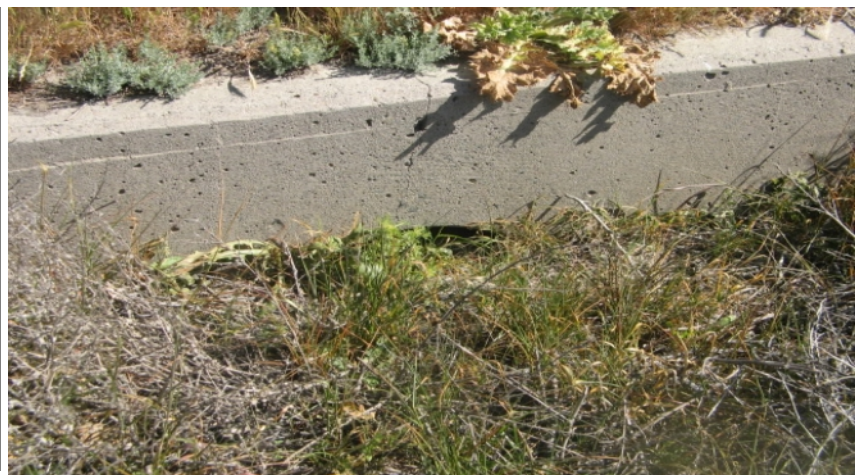
Levee Mile Report Line	4
Start Levee Mile	5.32
End Levee Mile	5.32
Location	
Category	Interior Drainage & Piping Systems
Item	Vegetation & Obstructions
Inlet of pipe over 50% blockage at LM 5.32

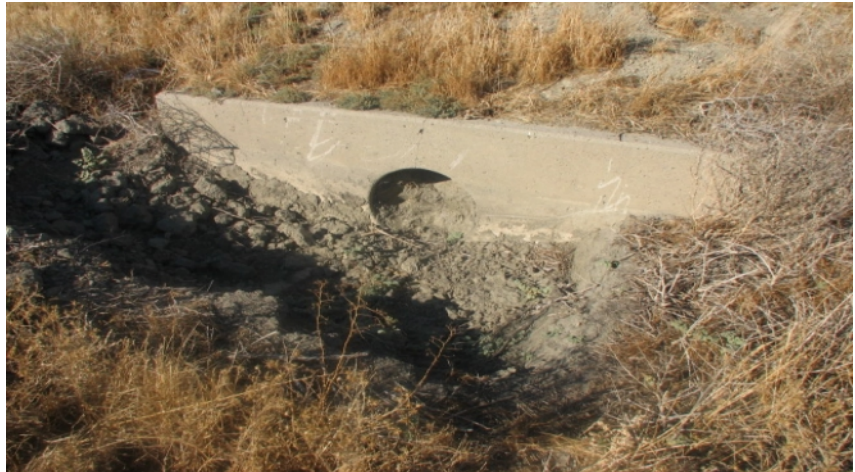
Levee Mile Report Line	4
Start Levee Mile	5.32
End Levee Mile	5.32
Location	
Category	Interior Drainage & Piping Systems
Item	Vegetation & Obstructions
Looking at inlet of pipe at an minimally acceptable condition

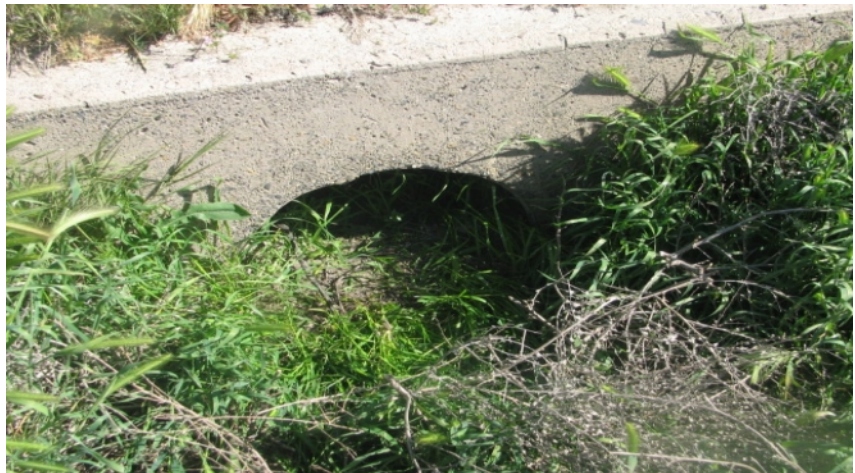
Levee Mile Report Line	5
Start Levee Mile	5.60
End Levee Mile	5.60
Location	
Category	Interior Drainage & Piping Systems
Item	Vegetation & Obstructions
Inlet of pipe over 25% blockage at LM 5.60

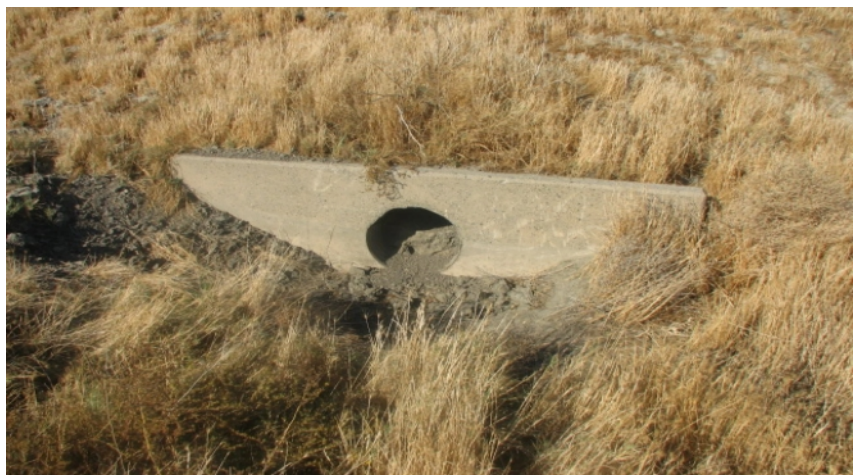
Levee Mile Report Line	5
Start Levee Mile	5.60
End Levee Mile	5.60
Location	
Category	Interior Drainage & Piping Systems
Item	Vegetation & Obstructions
Looking at inlet of pipe at an acceptable condition.

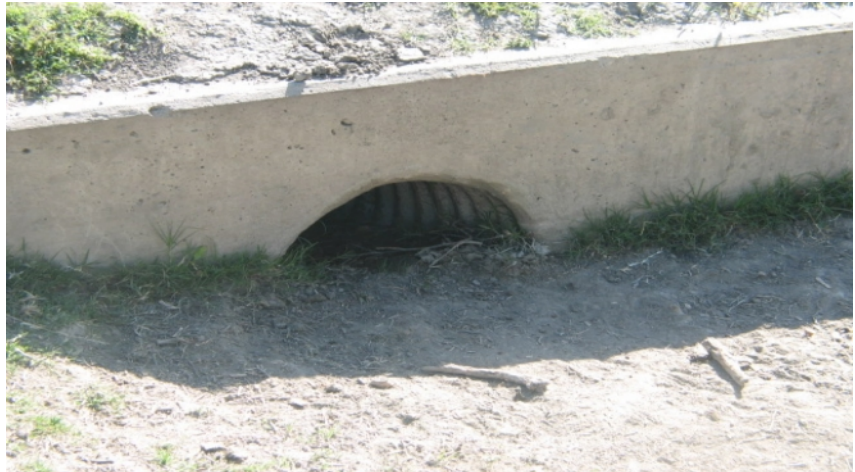
Levee Mile Report Line	6
Start Levee Mile	8.20
End Levee Mile	8.20
Location	
Category	Interior Drainage & Piping Systems
Item	Vegetation & Obstructions
Inlet of pipe over 50 % blockage at LM 8.20

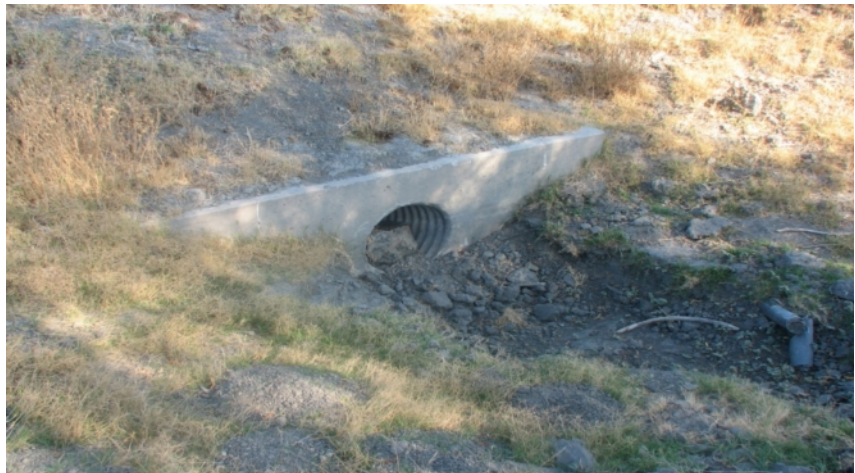
Levee Mile Report Line	6
Start Levee Mile	8.20
End Levee Mile	8.20
Location	
Category	Interior Drainage & Piping Systems
Item	Vegetation & Obstructions
Looking at inlet of pipe at an acceptable condition.

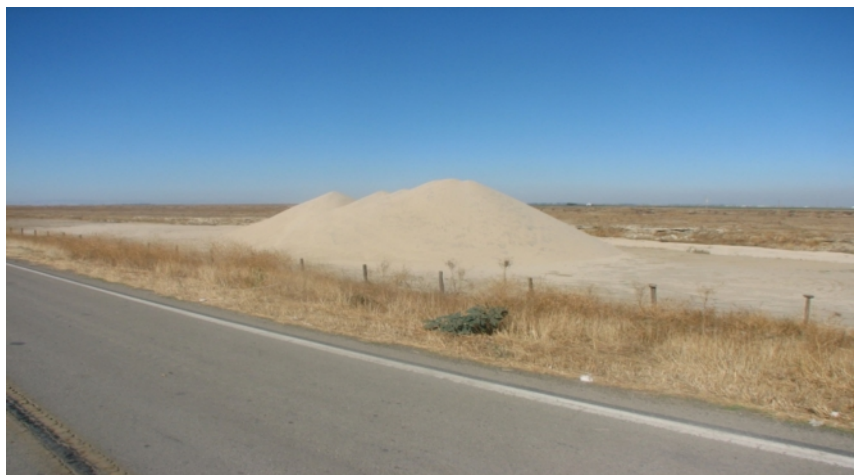
Levee Mile Report Line	7
Start Levee Mile	20.67
End Levee Mile	20.67
Location	
Category	Earthen Levee
Item	Encroachments
Looking north at sand pipe over three feet high in channel.

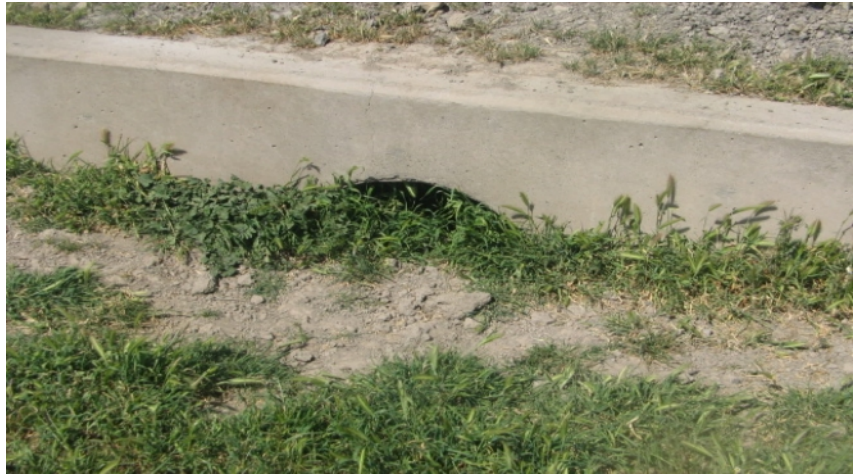
Levee Mile Report Line	1
Start Levee Mile	2.12
End Levee Mile	2.12
Location	
Category	Interior Drainage & Piping Systems
Item	Vegetation & Obstructions
Inlet of pipe blockage over 50 % at LM 2.12

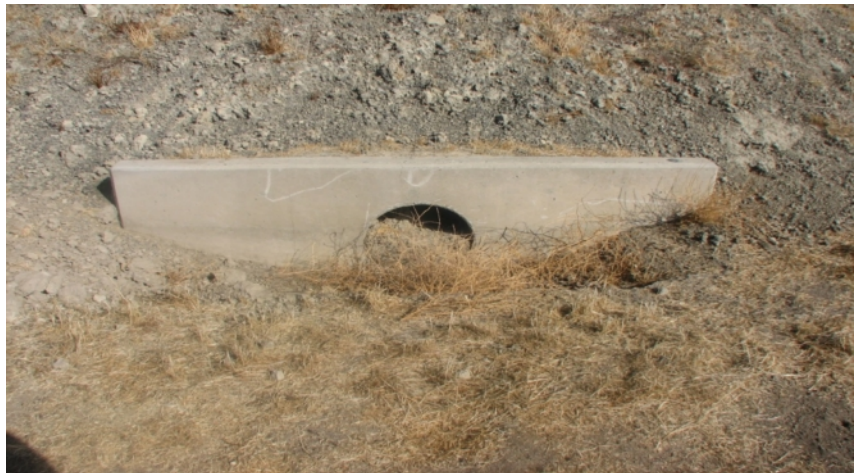
Levee Mile Report Line	1
Start Levee Mile	2.12
End Levee Mile	2.12
Location	
Category	Interior Drainage & Piping Systems
Item	Vegetation & Obstructions
Looking at inlet of pipe at an minimally acceptable condition.

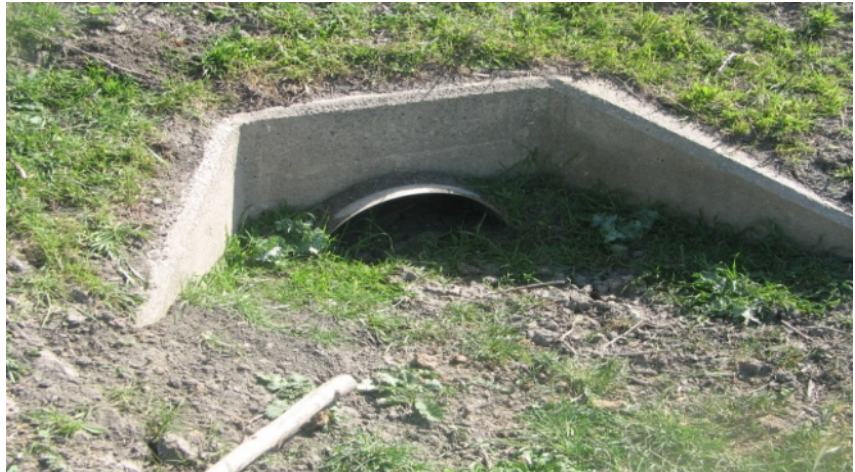
Levee Mile Report Line	1
Start Levee Mile	0.87
End Levee Mile	0.87
Location	
Category	Interior Drainage & Piping Systems
Item	Vegetation & Obstructions
Inlet of pipe over 50 % blockage at LM 0.87

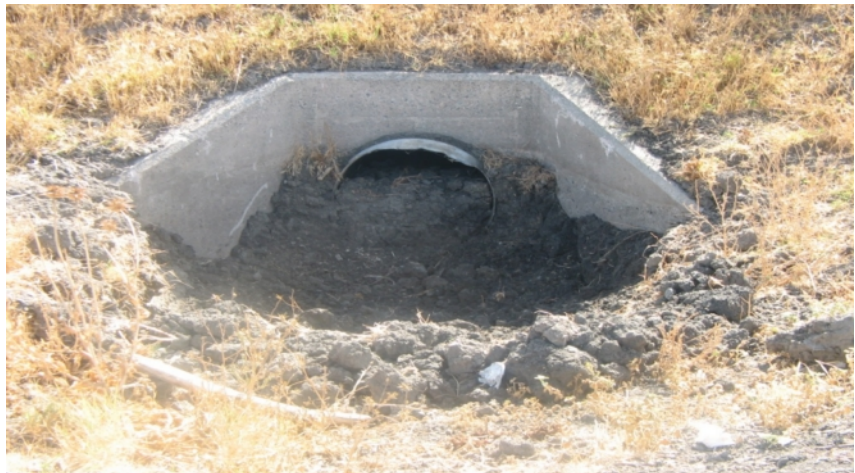
LMR Line	Levee Mile		Category	Item	Location *	Rating **	Action/Comment	GPS Latitude/Longitude		Photo	Issue
	Start	End						Start	End		
1	0.87	0.87	Interior Drainage & Piping Systems	Vegetation & Obstructions	LS	M	Inspector Comments: Inlet of pipe is at minimally acceptable condition.	37.219993 ° -120.698355 °	37.219993 ° -120.698355 °	Y	3

Levee Mile Report Line	1
Start Levee Mile	0.87
End Levee Mile	0.87
Location	
Category	Interior Drainage & Piping Systems
Item	Vegetation & Obstructions
Looking at inlet of pipe at a minimally acceptable condition.

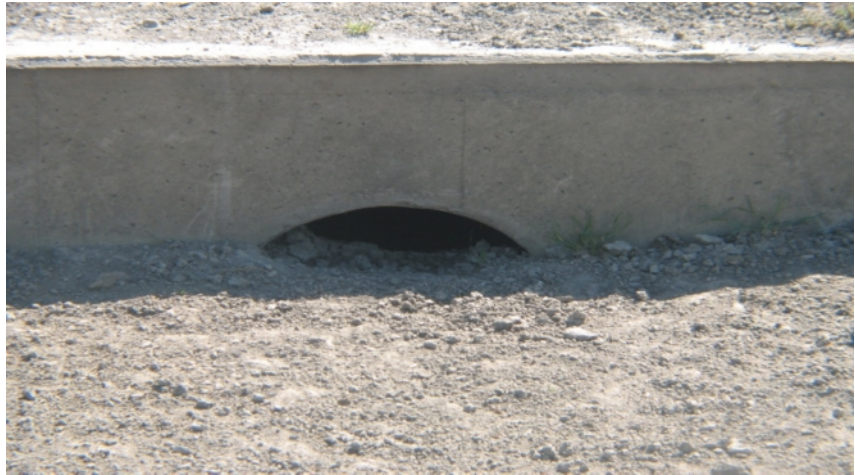
Levee Mile Report Line	1
Start Levee Mile	0.41
End Levee Mile	0.41
Location	
Category	Interior Drainage & Piping Systems
Item	Vegetation & Obstructions
Inlet of pipe over 50% blockage at LM 0.41

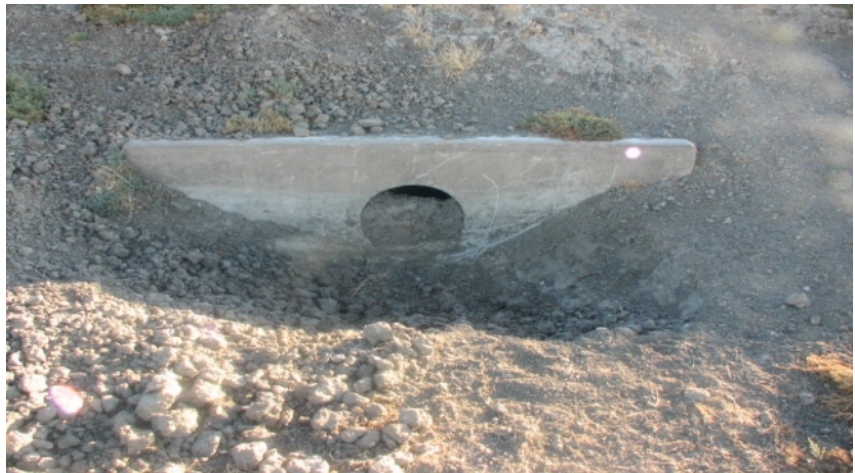
LMR Line	Levee Mile		Category	Item	Location *	Rating **	Action/Comment	GPS Latitude/Longitude		Photo	Issue
	Start	End						Start	End		
1	0.41	0.41	Interior Drainage & Piping Systems	Vegetation & Obstructions	LS	M	Inspector Comments: Inlet of pipe is at minimally acceptable condition 25% blockage.	37.202785 ° -120.747603 °	37.202785 ° -120.747603 °	Y	3

Levee Mile Report Line	1
Start Levee Mile	0.41
End Levee Mile	0.41
Location	
Category	Interior Drainage & Piping Systems
Item	Vegetation & Obstructions
Looking at inlet of pipe at aa minimally acceptable condition
