**Flood Control Project Maintenance  
Levee Inspections**

**Fall 2011 Levee Maintenance Deficiency Summary Report**

**Overall LMA & Unit Ratings, including DWR Erosion Survey**

**San Joaquin River Basin**

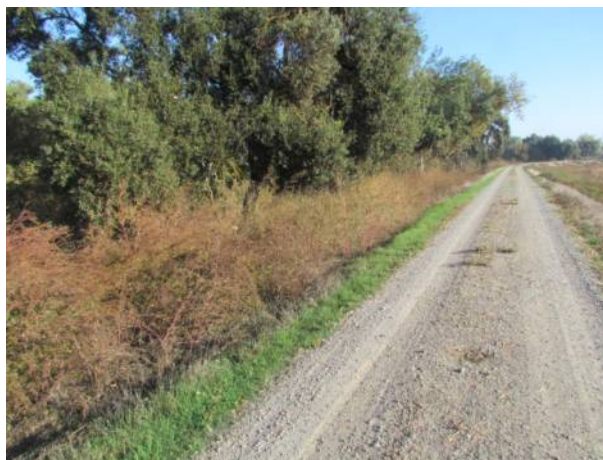
Levee Mile Report Line	3
Start Levee Mile	0.16
End Levee Mile	0.16
Location	Water Side
Category	Earthen Levee
Item	Trim / Thin Trees

Looking south at tree limbs over roadway.

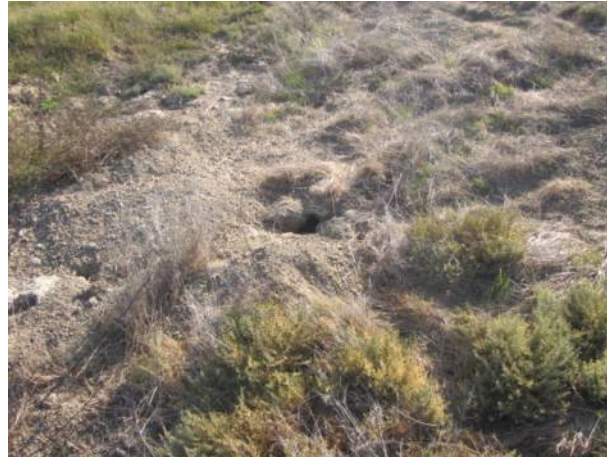
Levee Mile Report Line	7
Start Levee Mile	3.72
End Levee Mile	3.74
Location	Land Side
Category	Earthen Levee
Item	Animal Control

Looking at typical view of squirrel burrows on landside slope in this section of levee.

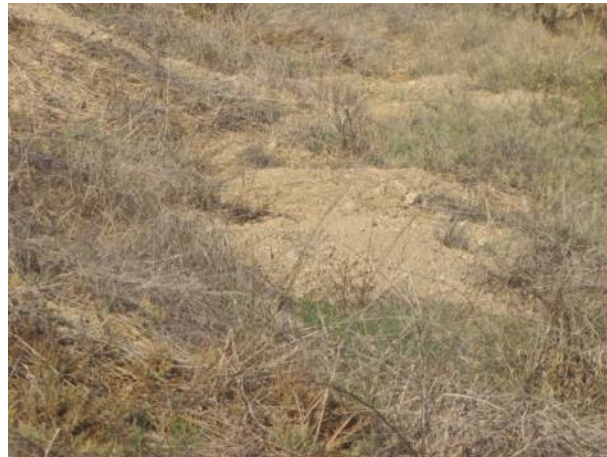
Levee Mile Report Line	8
Start Levee Mile	4.00
End Levee Mile	4.08
Location	Land Side
Category	Earthen Levee
Item	Encroachments

Looking south at irrigation ditch along landside toe.

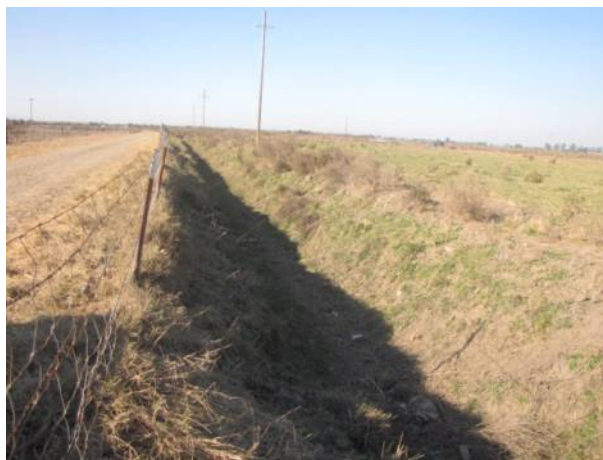
Levee Mile Report Line	11
Start Levee Mile	6.04
End Levee Mile	6.64
Location	Water Side
Category	Earthen Levee
Item	Vegetation

Looking south at dense vegetation on waterside and landside slopes.

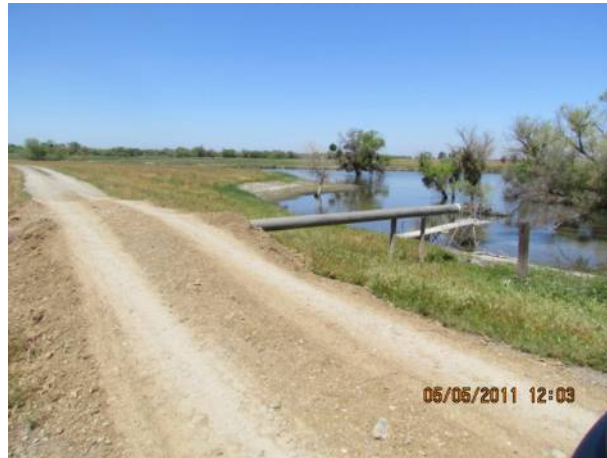
Levee Mile Report Line	16
Start Levee Mile	19.33
End Levee Mile	19.33
Location	Crown
Category	Earthen Levee
Item	Encroachments

Looking northeast at pipe on landside slope.

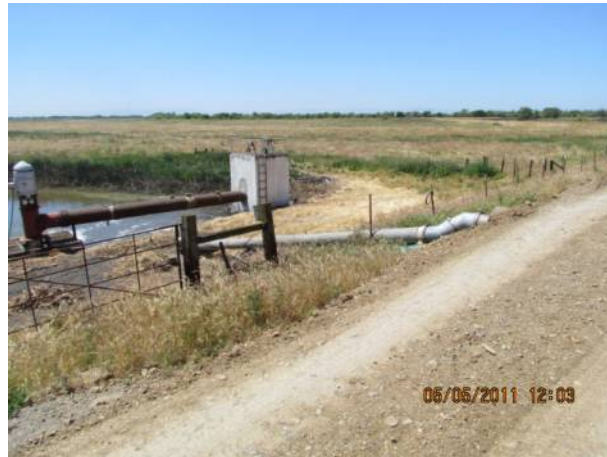
Levee Mile Report Line	16
Start Levee Mile	19.33
End Levee Mile	19.33
Location	Crown
Category	Earthen Levee
Item	Encroachments

Looking south at unauthorized pipe across levee and ramp.

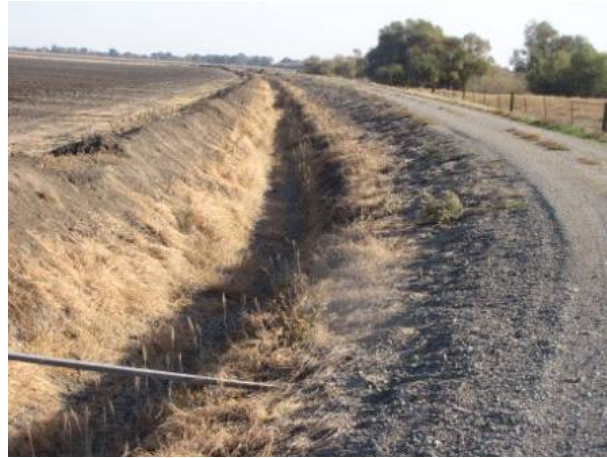
Levee Mile Report Line	17
Start Levee Mile	22.09
End Levee Mile	22.56
Location	Land Side
Category	Earthen Levee
Item	Encroachments

Looking southeast at ditch along landside toe.

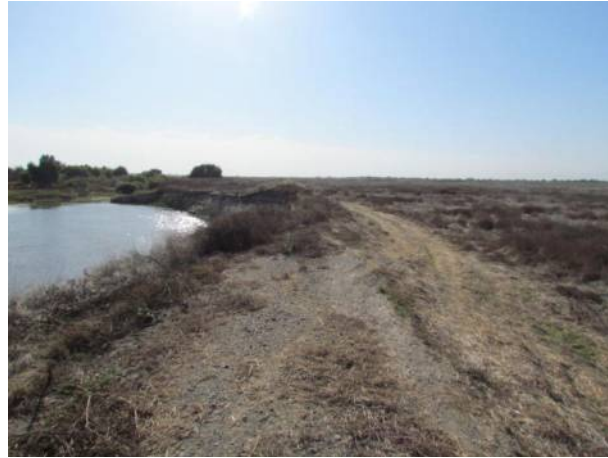
Levee Mile Report Line	1
Start Levee Mile	0.77
End Levee Mile	0.77
Location	Water Side
Category	Earthen Levee
Item	Erosion / Bank Caving

Looking southeast at erosion along waterside slope.

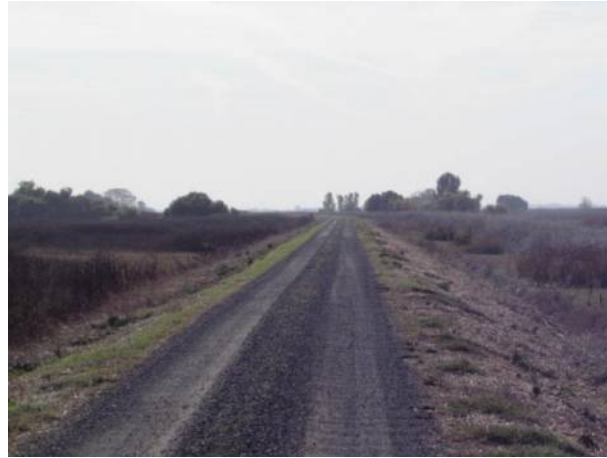
Levee Mile Report Line	1
Start Levee Mile	7.88
End Levee Mile	13.79
Location	Land Side
Category	Earthen Levee
Item	Vegetation
Looking north at a typical view of levee slopes.	
richard_f_20111114_441.jpg

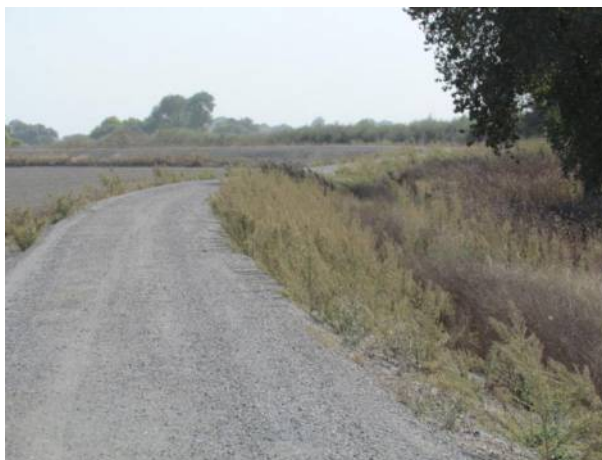
Levee Mile Report Line	2
Start Levee Mile	0.44
End Levee Mile	0.44
Location	Land Side
Category	Earthen Levee
Item	Slope Stability

Looking southwest at levee damage cause by vehicle traffic on landside slope.

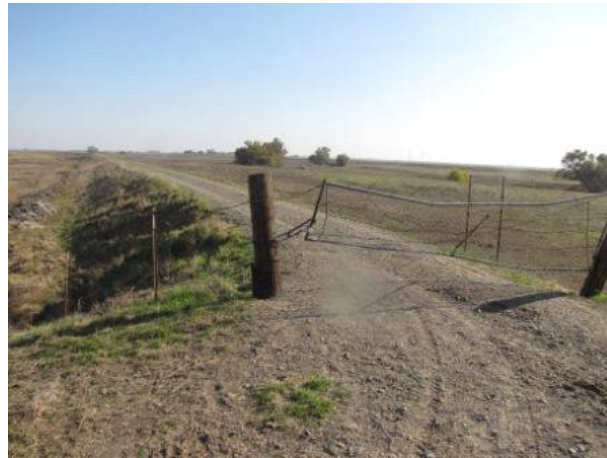
Levee Mile Report Line	5
Start Levee Mile	6.58
End Levee Mile	6.58
Location	Crown
Category	Earthen Levee
Item	Repair Gates

Looking south at damaged gate.

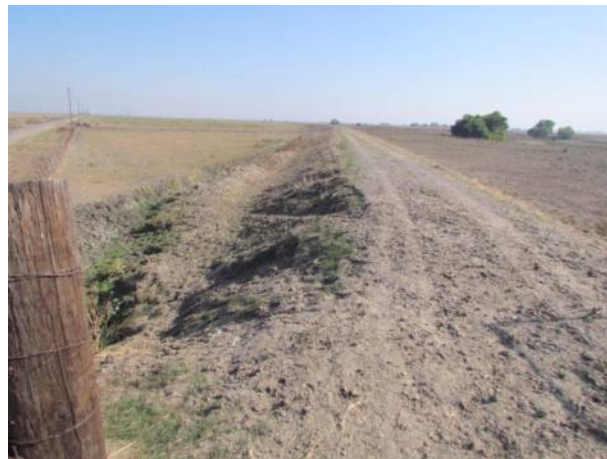
Levee Mile Report Line	6
Start Levee Mile	6.58
End Levee Mile	6.58
Location	Land Side
Category	Earthen Levee
Item	Animal Control

Looking east at levee slope damage by livestock on landside slope.

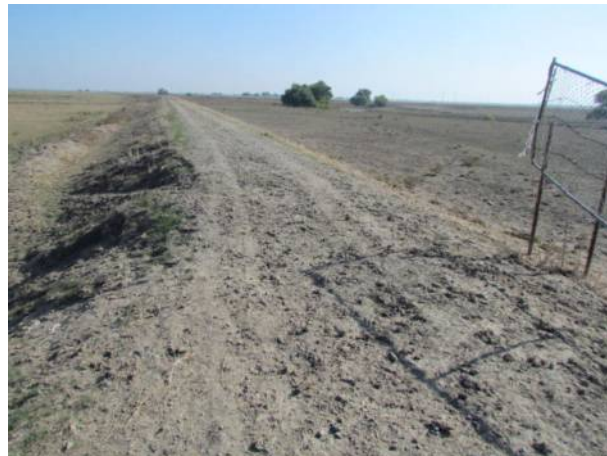
Levee Mile Report Line	7
Start Levee Mile	6.58
End Levee Mile	8.09
Location	Crown
Category	Earthen Levee
Item	Crown Surface / Depressions / Rutting

Looking east at rutting cause by livestock traffic on levee crown.

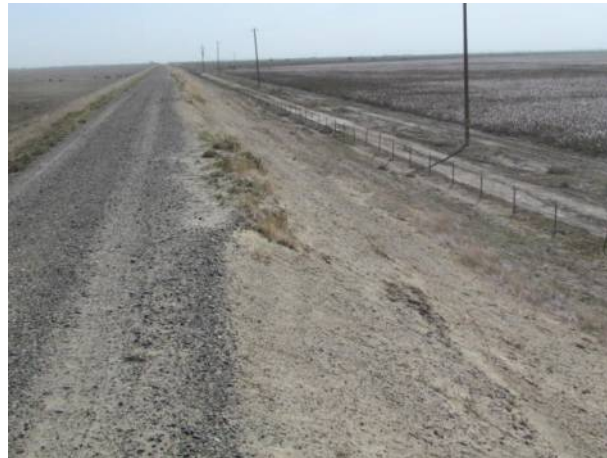
Levee Mile Report Line	10
Start Levee Mile	24.50
End Levee Mile	24.93
Location	Land Side
Category	Earthen Levee
Item	Slope Stability
Looking south at livestock traffic along landside slope.	
richard_f_20111114_431.jpg

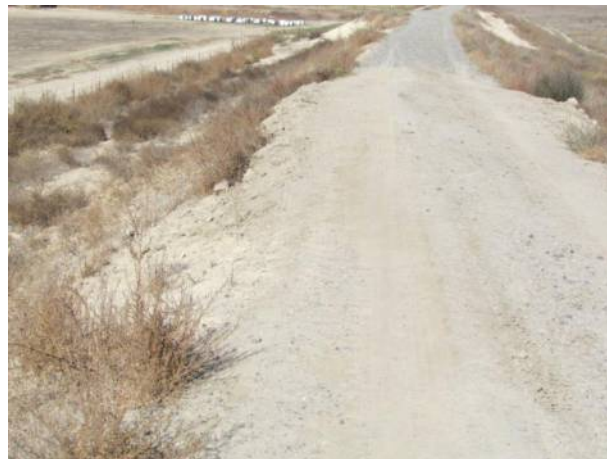
Levee Mile Report Line	11
Start Levee Mile	27.56
End Levee Mile	27.87
Location	Land Side
Category	Earthen Levee
Item	Slope Stability
Looking north at heavy livestock traffic on landside shoulder and slope.	
richard_f_20111114_428.jpg

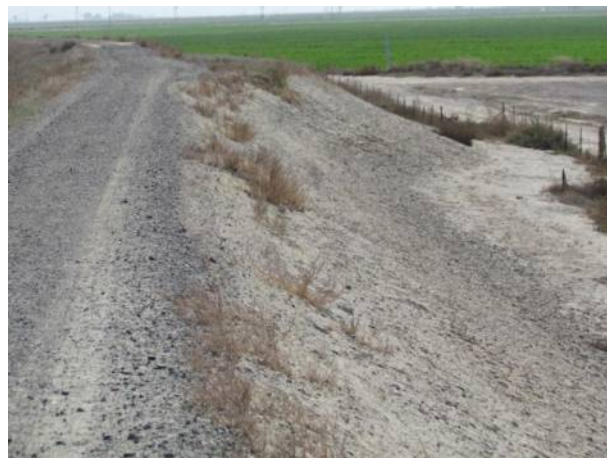
Levee Mile Report Line	11
Start Levee Mile	27.56
End Levee Mile	27.87
Location	Land Side
Category	Earthen Levee
Item	Slope Stability
Looking south at livestock traffic along landside slope.	
richard_f_20111114_429.jpg

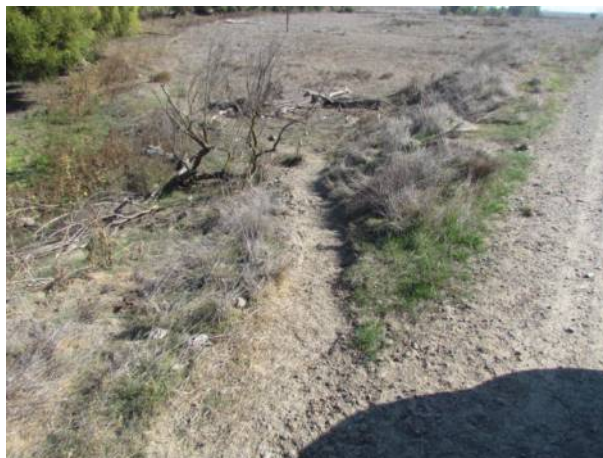
Levee Mile Report Line	3
Start Levee Mile	1.51
End Levee Mile	1.51
Location	Land Side
Category	Earthen Levee
Item	Animal Control

Looking south at damaged by livestock on landside slope.

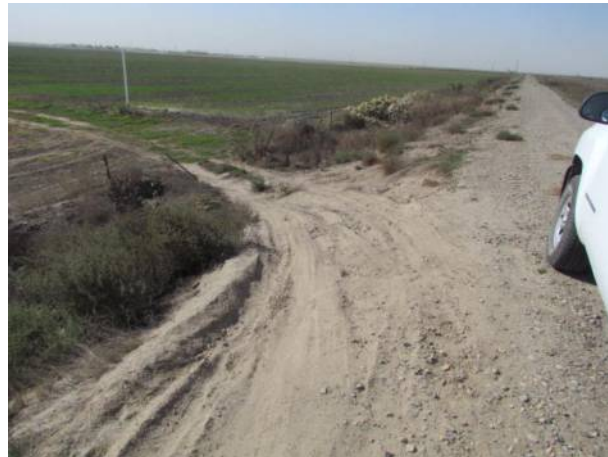
Levee Mile Report Line	3
Start Levee Mile	1.77
End Levee Mile	1.77
Location	Land Side
Category	Earthen Levee
Item	Slope Stability

Looking at landside damage cause by vehicle traffic.

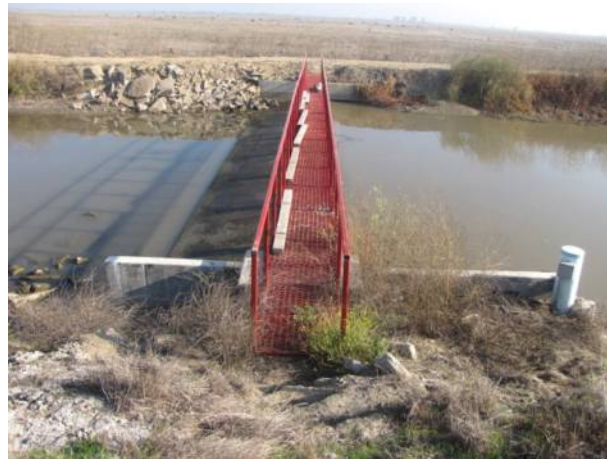
Levee Mile Report Line	5
Start Levee Mile	3.85
End Levee Mile	3.85
Location	Water Side
Category	Channels
Item	Encroachments

Looking north at weir.
