**Flood Control Project Maintenance
Levee Inspections**

Fall 2012 Levee Maintenance Deficiency Summary Report

San Joaquin River Basin

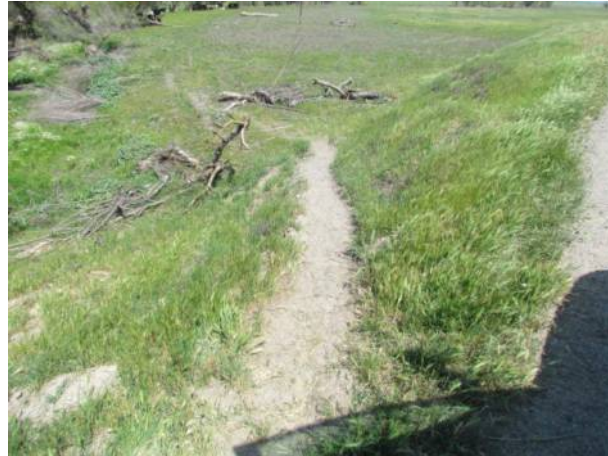
Levee Mile Report Line	4
Start Levee Mile	1.51
End Levee Mile	1.51
Location	Land Side
Category	Earthen Levee
Item	Animal Control
Looking northeast at landside slope damaged by livestock.	
richard_f_20121101_084.jpg

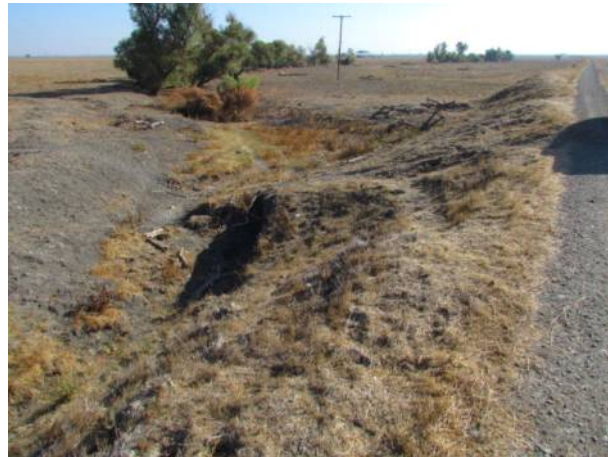
Levee Mile Report Line	4
Start Levee Mile	1.51
End Levee Mile	1.51
Location	Land Side
Category	Earthen Levee
Item	Animal Control
Looking southeast at landside slope and toe damage by livestock.	
richard_f_20121115_871.JPG

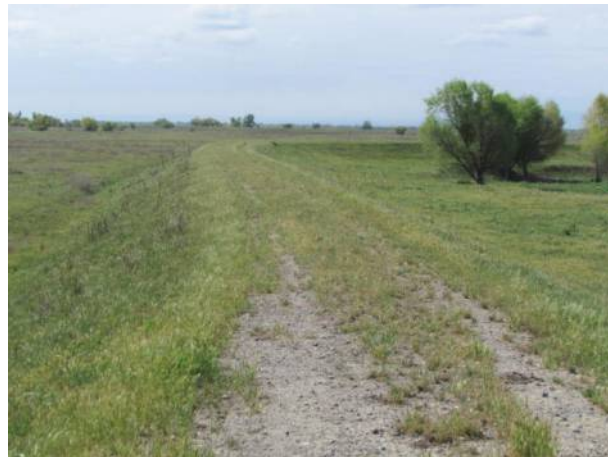
Levee Mile Report Line	1
Start Levee Mile	0.00
End Levee Mile	2.22
Location	Crown
Category	Earthen Levee
Item	Crown Surface / Depressions / Rutting
Looking east at vegetation on levee crown.	
richard_f_20121101_091.jpg

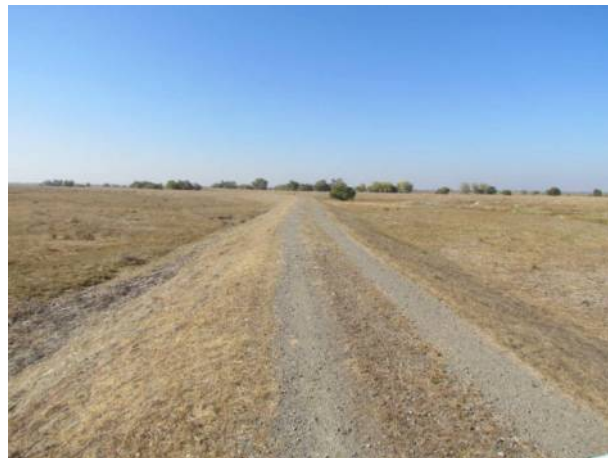
Levee Mile Report Line	1
Start Levee Mile	0.00
End Levee Mile	2.22
Location	Crown
Category	Earthen Levee
Item	Crown Surface / Depressions / Rutting
Looking east at un-graded levee crown.(Fall 2012)	
richard_f_20121115_875.JPG

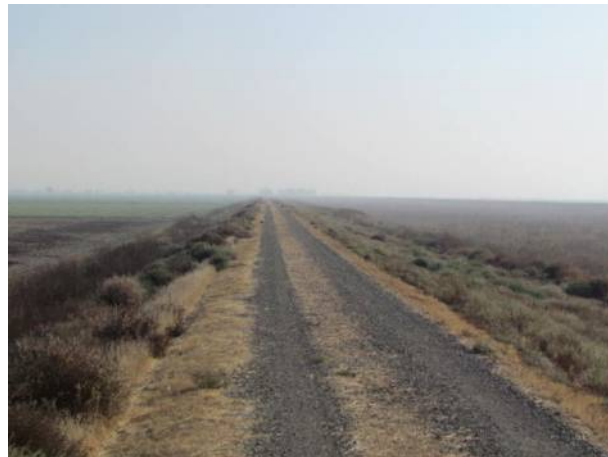
Levee Mile Report Line	3
Start Levee Mile	0.00
End Levee Mile	1.99
Location	Water Side
Category	Earthen Levee
Item	Vegetation
Looking east at unwanted vegetation on levee crown and slope.	
richard_f_20121101_092.jpg
