**Flood Control Project Maintenance
Levee Inspections**

Fall 2013 Levee Maintenance Deficiency Summary Report

San Joaquin River Basin

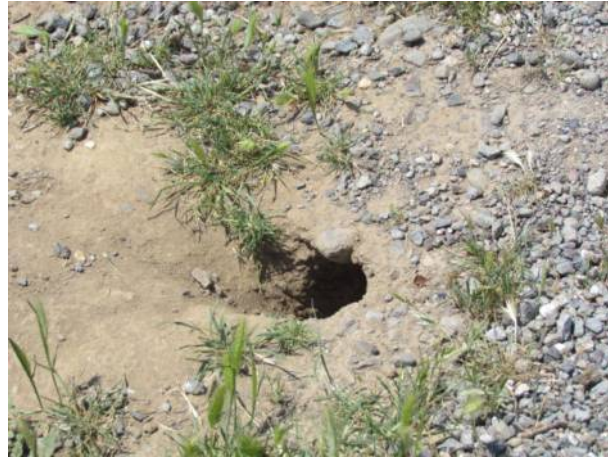
Levee Mile Report Line	4
Start Levee Mile	0.03
End Levee Mile	0.07
Location	Land Side
Category	Earthen Levee
Item	Animal Control

Looking south at repaired site on landward slope.
(Spring 2013)

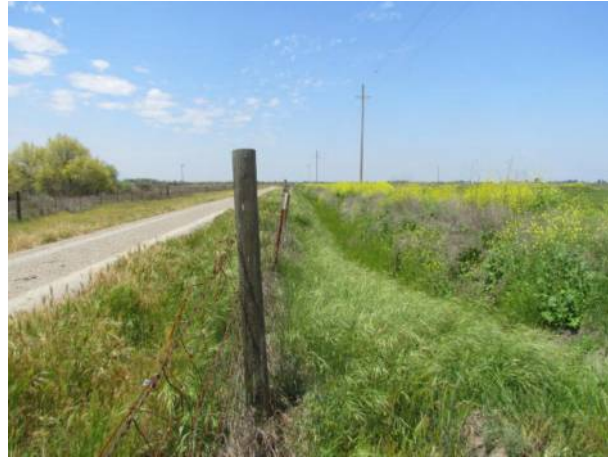
Levee Mile Report Line	14
Start Levee Mile	4.72
End Levee Mile	4.72
Location	Land Side
Category	Earthen Levee
Item	Animal Control

LMR No.	Levee Mile		Category	Item	Location	Rating	Action/Comment	GPS Latitude/Longitude		Issue No.
	Start	End						Start	End	
14	4.72	4.72	Earthen Levee	Animal Control	LS	M Ma	A2 : Repair the levee slope damaged by livestock and prevent large animal access. Inspector Comments: Levee landward toe damaged by live stock.	37.302398 ° -120.920920 °	37.302398 ° -120.920920 °	9 Y
DWR ID: DWR_NA0010_01_s_2013_9										
15	5.75	5.75	Earthen Levee	Animal Control	LS A/W	Ma	A3 : No rodents visible, but rodent burrows visible; need to backfill and compact or grout burrows. Inspector Comments: Large rodent holes on landside slope near fence pole.	37.304057 ° -120.907200 °	37.304057 ° -120.907200 °	116 Y
DWR ID: DWR_NA0010_01_s_2012_116										
16	6.04	6.46	Earthen Levee	Vegetation	WSA/W	Ma	V9 : Keep the crown roadway free of vegetation.	37.303715 ° -120.902115 °	37.303838 ° -120.891912 °	13
DWR ID: DWR_NA0010_01_s_2012_13

Looking south at damage slope by livestock on landward slope.

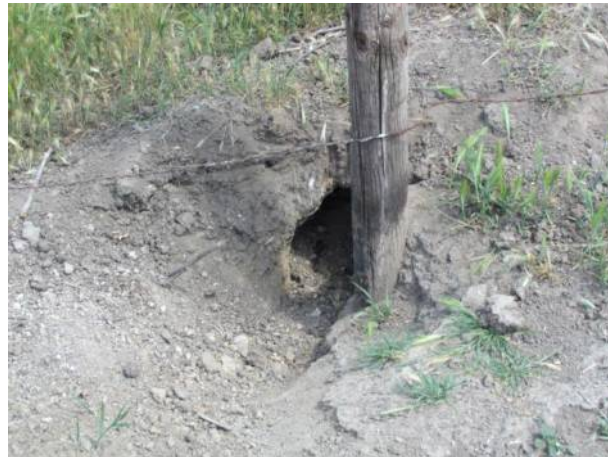
Levee Mile Report Line	15
Start Levee Mile	5.75
End Levee Mile	5.75
Location	Land Side
Category	Earthen Levee
Item	Animal Control

Looking south at repaired rodent site on landside slope. (Fall 2012)

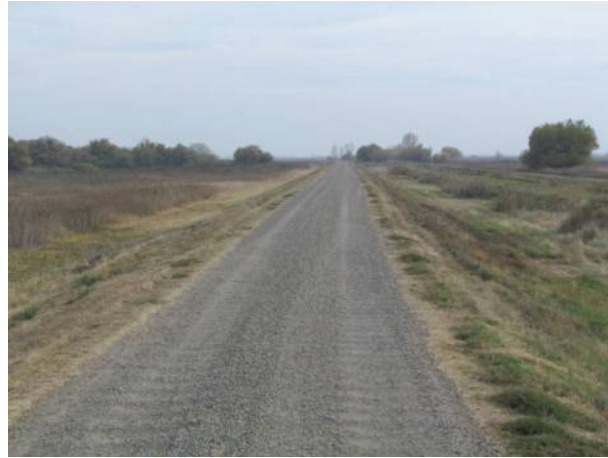
Levee Mile Report Line	3
Start Levee Mile	9.46
End Levee Mile	9.46
Location	Land Side
Category	Earthen Levee
Item	Encroachments

Looking north at broken tree limb on landside slope.

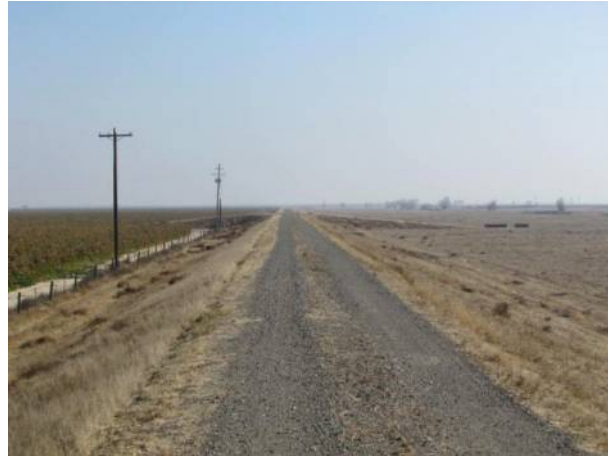
Levee Mile Report Line	20
Start Levee Mile	29.58
End Levee Mile	29.70
Location	Land Side
Category	Earthen Levee
Item	Erosion / Bank Caving
Looking south at erosion caused by livestock on landside slope.	
richard_f_20131112_210.jpg

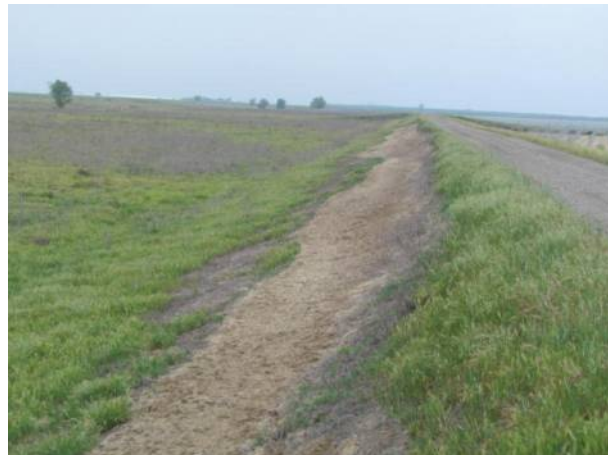
Levee Mile Report Line	20
Start Levee Mile	29.58
End Levee Mile	29.70
Location	Land Side
Category	Earthen Levee
Item	Erosion / Bank Caving
Looking east at livestock erosion on landward slope.	
richard_f_20131127_298.JPG

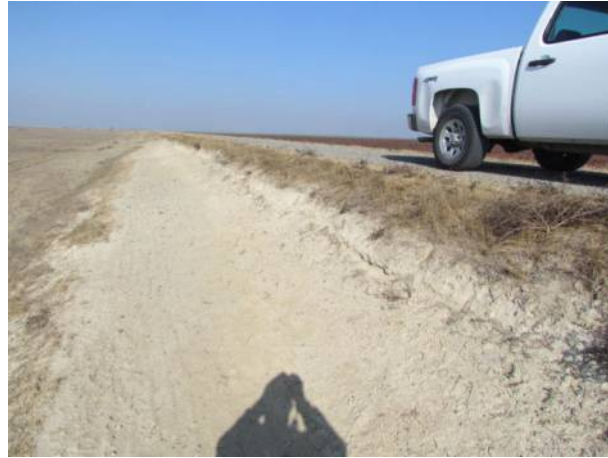
Levee Mile Report Line	24
Start Levee Mile	34.50
End Levee Mile	34.50
Location	Water Side
Category	Earthen Levee
Item	Encroachments
Looking west at unauthorized ramp on waterward slope.	
richard_f_20131127_300.JPG

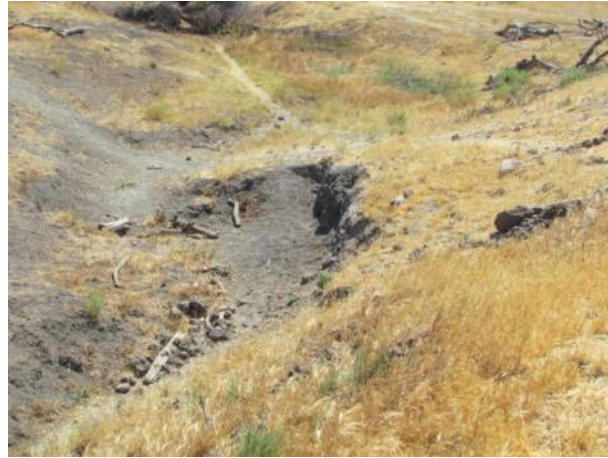
Levee Mile Report Line	4
Start Levee Mile	1.51
End Levee Mile	1.51
Location	Land Side
Category	Earthen Levee
Item	Animal Control
Looking south at landward slope.	
richard_f_20131112_227.JPG

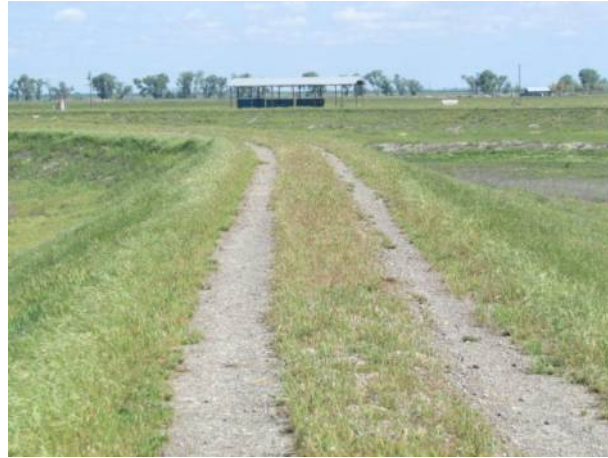
Levee Mile Report Line	1
Start Levee Mile	0.00
End Levee Mile	2.22
Location	Crown
Category	Earthen Levee
Item	Crown Surface / Depressions / Rutting
Looking east at vegetation on levee crown.	
richard_f_20131112_238.jpg
