**Flood Control Project Maintenance  
Levee Inspections**

**Fall 2014 Levee Maintenance Deficiency Summary Report**

**San Joaquin River Basin**

<b>NA0010</b>	Overall LMA Rating	Total LMA Miles						
<b>Lower San Joaquin Levee District</b>	<b>U</b>	<b>191.11</b>						
Rated Item	Maintenance Deficiency				Enforcement		Design & System Obsolescence	
	M Miles	U Miles	M + 4U Miles	Threshold %	M Miles	U Miles	M Miles	U Miles
<i>Earthen Levee</i>								
Vegetation	58.64	1.91	66.28	34.68%				
Trim / Thin Trees	0.03		0.03	0.02%				
Encroachments	1.83		1.83	0.96%	1.82			
Animal Control	2.70		2.70	1.41%				
Slope Stability	1.08		1.08	0.57%				
Erosion / Bank Caving	0.13	0.01	0.17	0.09%				
Crown Surface / Depressions / Rutting	10.46		10.46	5.47%				
<i>Interior Drainage &amp; Piping Systems</i>								
Erosion Areas		0.01	0.04	0.02%				
<i>Rivers, Channels &amp; Designated Floodways</i>								
Encroachments						0.01		
<i>Supplemental</i>								
DWR UCIP Field Study					2.78	0.17		
<b>LMA Totals:</b>	<b>74.87</b>	<b>1.93</b>	<b>82.59</b>	<b>43.21%</b>	<b>4.60</b>	<b>0.18</b>	<b>0.00</b>	<b>0.00</b>

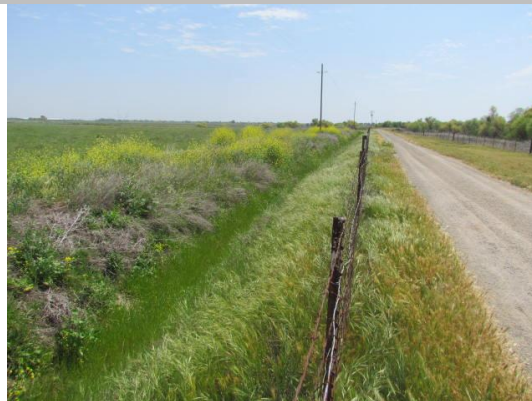
Photo 2 of 2 : FA\_2014\_NA0010\_118\_5\_20141103\_00003.jpg

Looking south at irrigation ditch at landside toe.

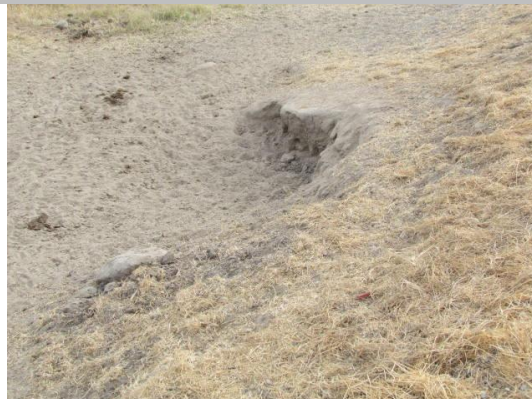
Photo 1 of 2 : FA\_2014\_NA0010\_118\_9\_20141103\_00005.jpg

Looking southeast at erosion on landward toe.

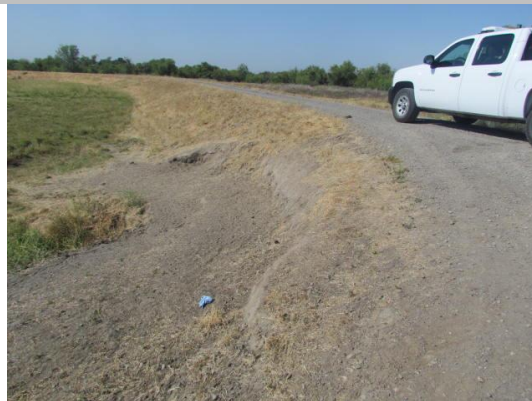
Photo 2 of 2 : FA\_2014\_NA0010\_118\_9\_20141103\_00006.jpg

Looking south at damage slope by livestock on landward slope.

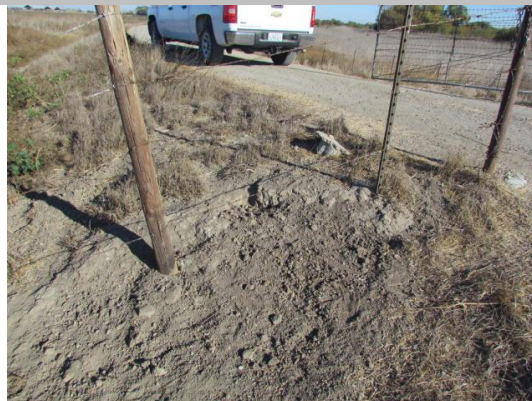
Photo 2 of 3 : FA\_2014\_NA0010\_118\_116\_20141103\_00016.jpg

Looking south at repaired rodent site on landside slope. (Fall 2012)

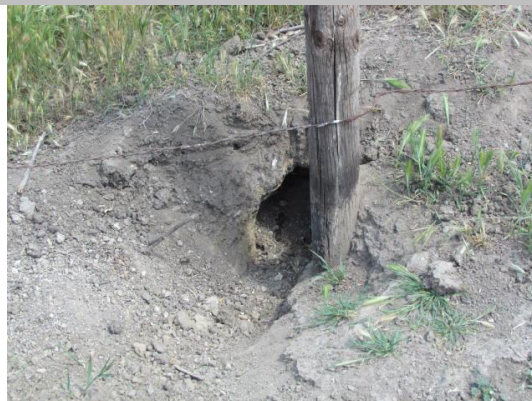
Photo 3 of 3 : FA\_2014\_NA0010\_118\_116\_20141103\_00017.jpg

Looking northeast at one of several holes on landside shoulder and slope.

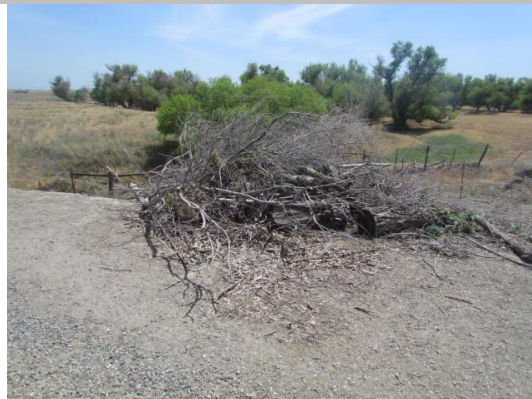
Photo 1 of 1 : FA\_2014\_NA0010\_118\_27\_20141103\_00011.jpg

Looking at prunings on waterward shoulder and slope.

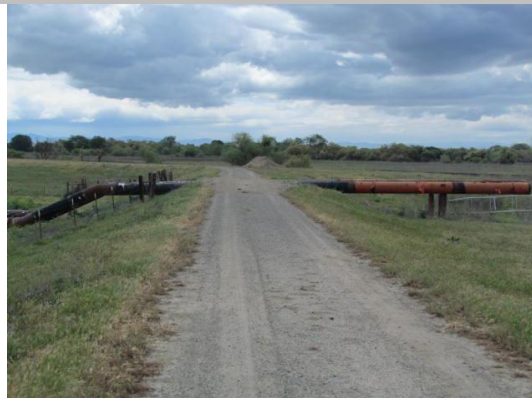
Photo 1 of 1 : FA\_2014\_NA0010\_118\_8\_20141103\_00004.jpg

Looking south at pipe across levee crown.

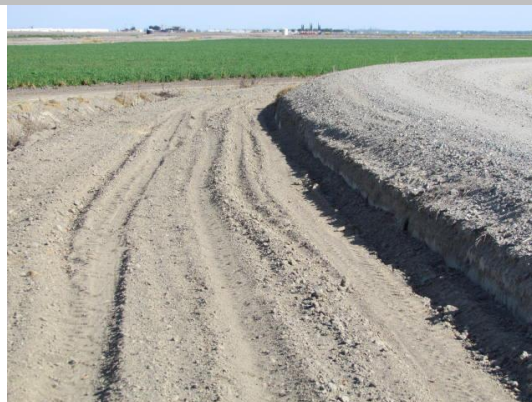
Photo 2 of 2 : FA\_2014\_NA0010\_118\_20\_20141103\_00008.jpg

Looking west at farmer discing landside slope.

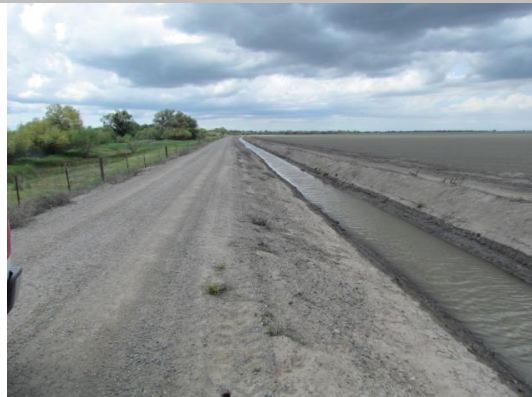
Photo 1 of 2 : FA\_2014\_NA0010\_118\_22\_20141103\_00009.jpg

Looking downstream at irrigation ditch at landside toe.

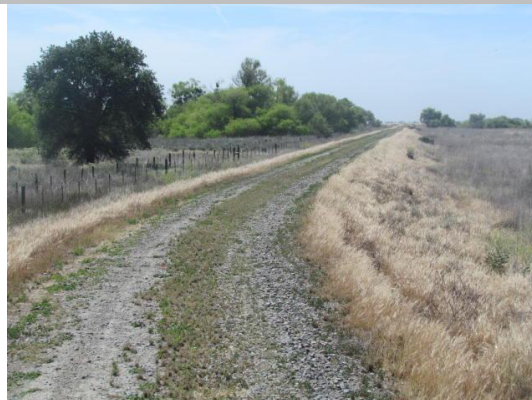
Photo 2 of 2 : FA\_2014\_NA0010\_119\_9\_20141103\_00006.jpg

Looking north at vegetation on levee crown.

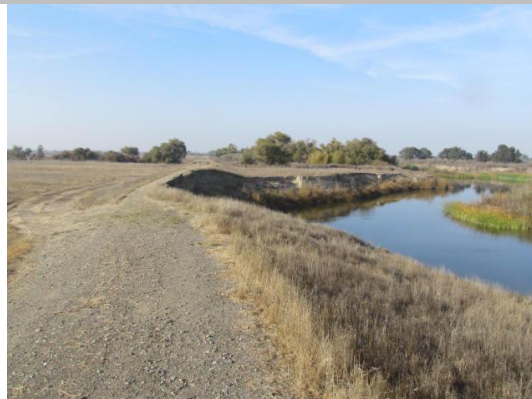
Photo 1 of 3 : FA\_2014\_NA0010\_119\_5\_20141110\_00008.jpg

Looking north at erosion on waterward slope. (Fall 2014)

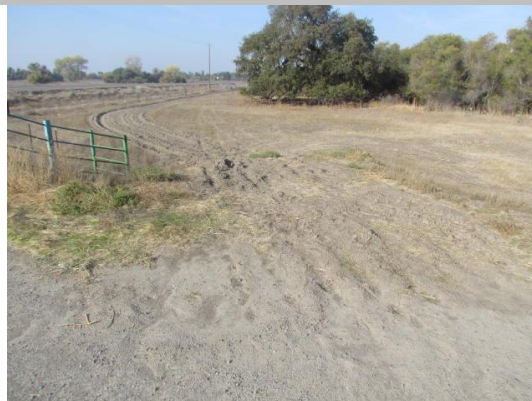
Photo 1 of 2 : FA\_2014\_NA0010\_119\_2\_20141110\_00009.jpg

Looking northeast at unauthorized ramp on landward slope.

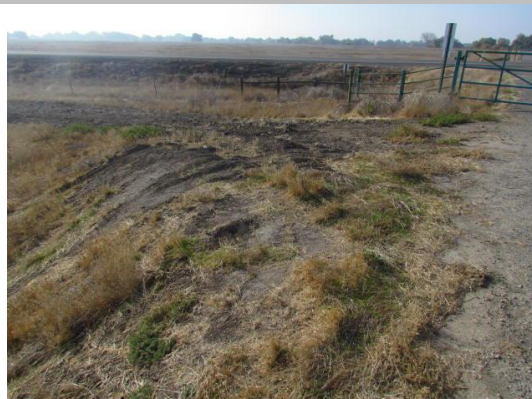
Photo 2 of 2 : FA\_2014\_NA0010\_119\_2\_20141110\_00010.jpg

Looking northwest at unauthorized ramp on waterward slope.

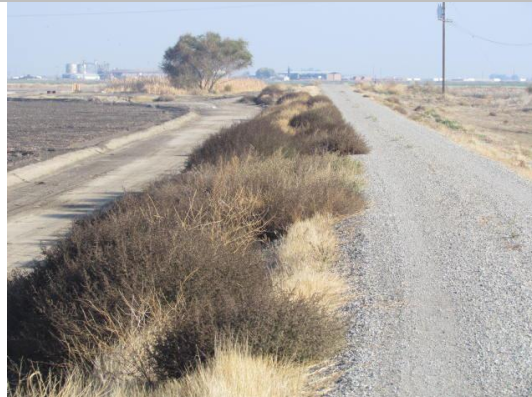
Photo 1 of 1 : FA\_2014\_NA0010\_121\_4\_20141110\_00001.jpg

Looking north at tumble weeds on landward slope.

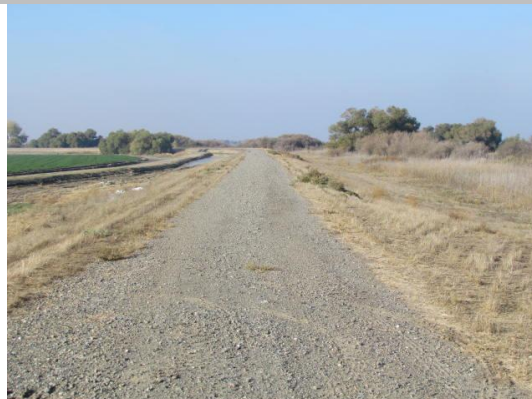
Photo 1 of 1 : FA\_2014\_NA0010\_122\_9\_20141110\_00005.jpg

Looking north at levee in compliance with standards.

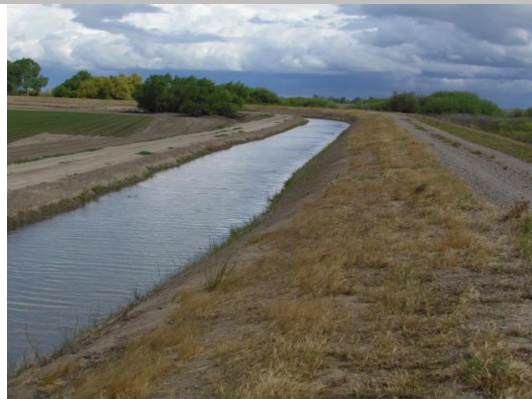
Photo 3 of 3 : FA\_2014\_NA0010\_122\_3\_20141103\_00003.jpg

Looking north at irrigation ditch at landside toe.

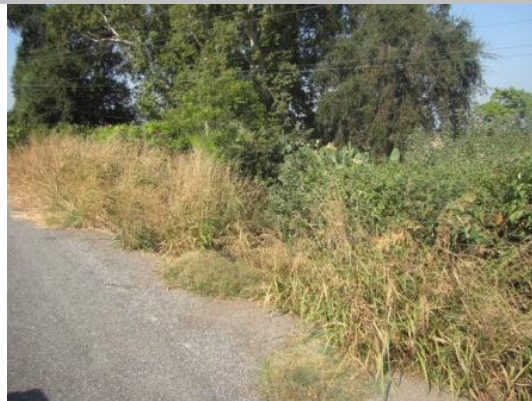
Photo 2 of 2 : FA\_2014\_NA0010\_123\_3\_20141103\_00003.jpg

Looking south at dense trees on landside slope.

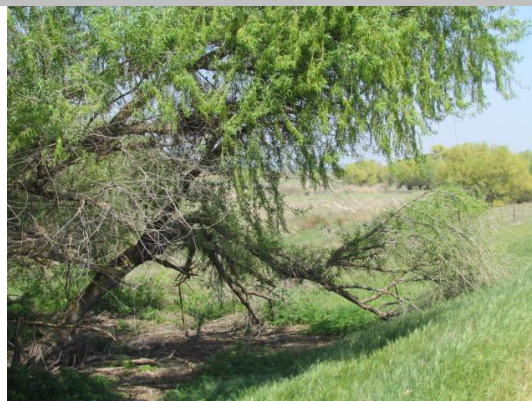
Photo 1 of 1 : FA\_2014\_NA0010\_123\_2\_20141103\_00001.jpg

Looking south at down tree limb on landside slope and toe.

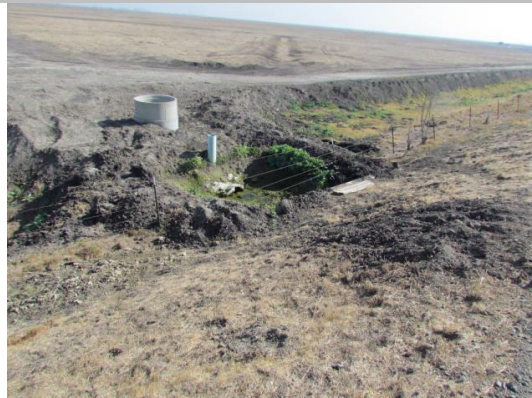
Photo 1 of 2 : FA\_2014\_NA0010\_123\_8\_20141110\_00016.jpg

Looking west at drain structure on landward toe.

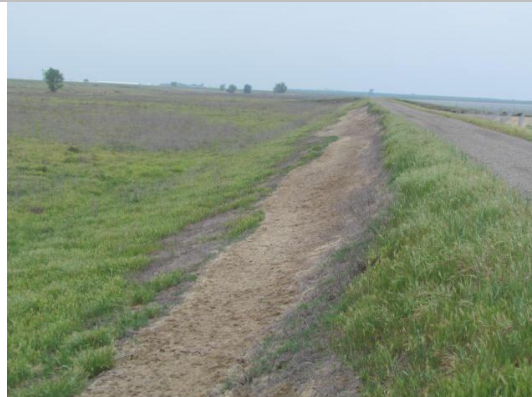
Photo 1 of 3 : FA\_2014\_NA0010\_123\_171\_20141103\_00012.jpg

Looking south at erosion caused by livestock on landside slope.

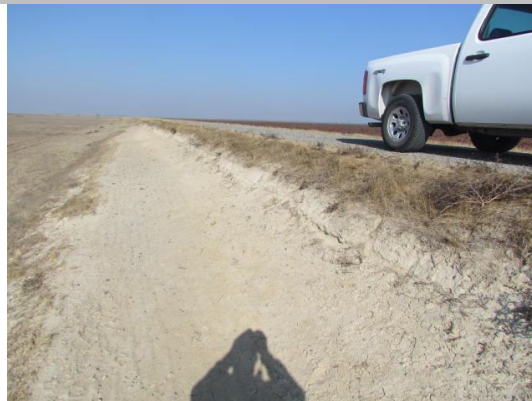
Photo 2 of 3 : FA\_2014\_NA0010\_123\_171\_20141103\_00013.jpg

Looking south at livestock erosion on landward slope.

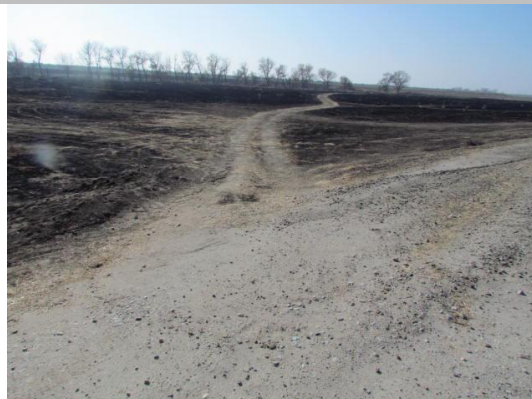
Photo 1 of 1 : FA\_2014\_NA0010\_123\_11\_20141103\_00007.jpg

Looking west at unauthorized ramp on waterward slope.

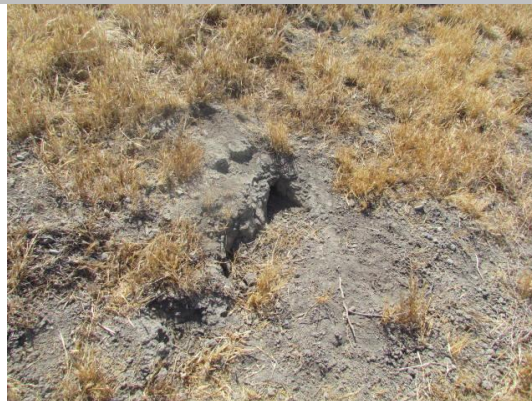
Photo 2 of 2 : FA\_2014\_NA0010\_124\_10\_20141103\_00011.jpg

Looking at typical rodent holes on landward slope.

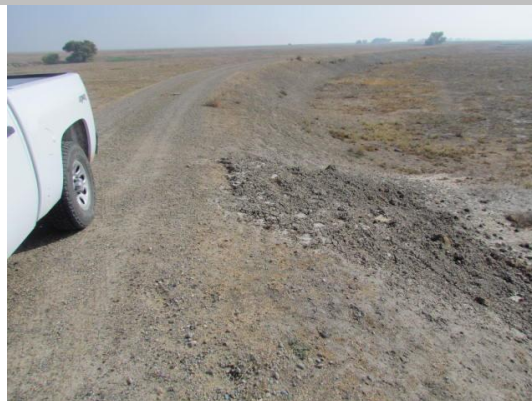
Photo 1 of 2 : FA\_2014\_NA0010\_124\_9\_20141110\_00014.jpg

Looking northwest damage slope corrected.

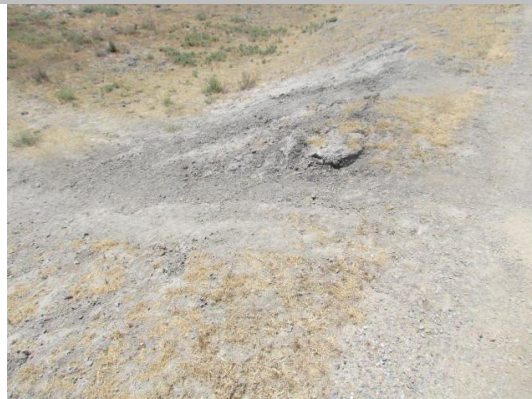
Photo 2 of 2 : FA\_2014\_NA0010\_124\_9\_20141103\_00009.jpg

Looking at slope damage cause by vehicle traffic on landward slope.

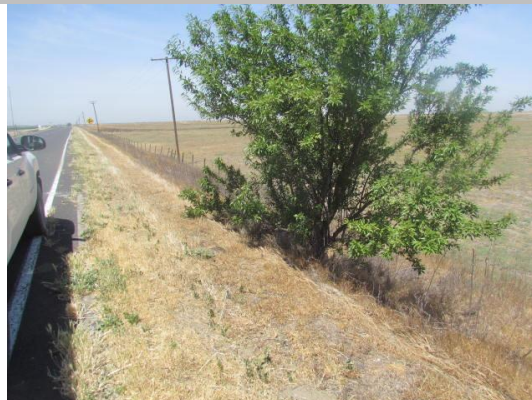
Photo 1 of 1 : FA\_2014\_NA0010\_124\_14\_20141103\_00012.jpg

Looking east at tree on waterward slope.

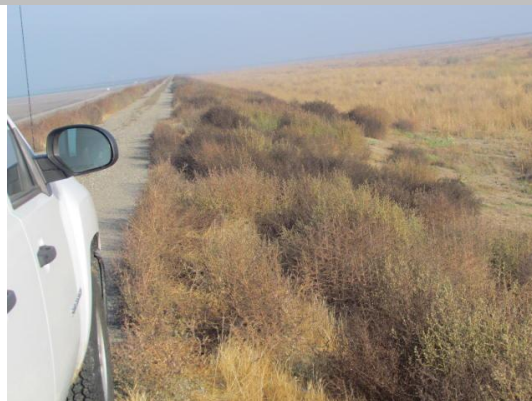
Photo 1 of 1 : FA\_2014\_NA0010\_124\_64\_20141110\_00017.jpg

Looking northeast at dense tumble weeds on waterward slope.

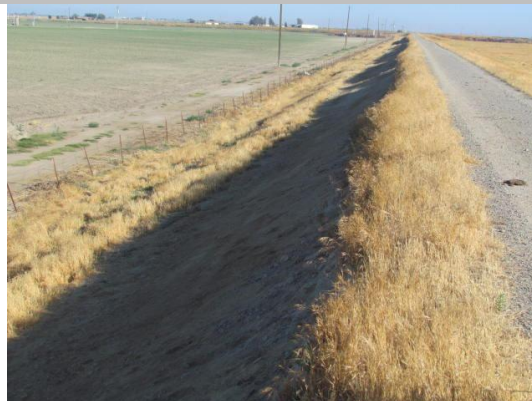
Photo 1 of 2 : FA\_2014\_NA0010\_124\_5\_20141103\_00007.jpg

Looking north at livestock erosion on landward slope.

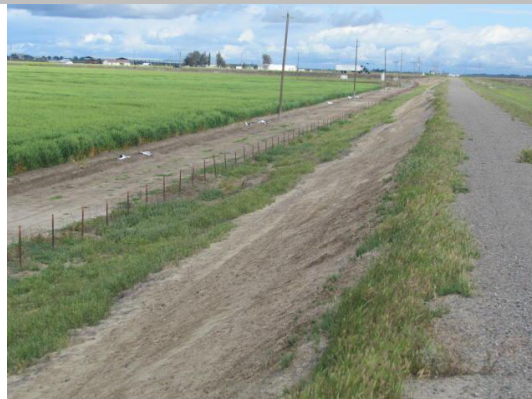
Photo 2 of 2 : FA\_2014\_NA0010\_124\_5\_20141103\_00008.jpg

Looking north at livestock erosion on landside slope.

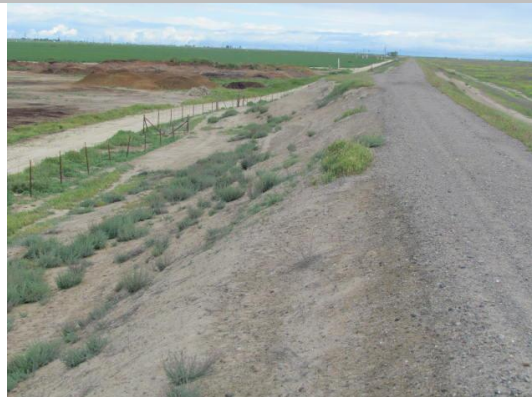
Photo 1 of 4 : FA\_2014\_NA0010\_124\_3\_20141103\_00003.jpg

Looking north at livestock erosion on landside shoulder and slope.

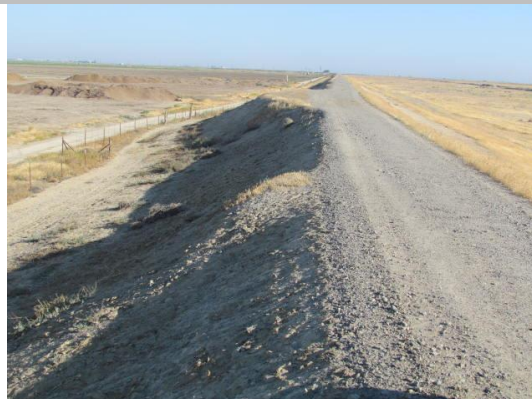
Photo 3 of 4 : FA\_2014\_NA0010\_124\_3\_20141103\_00005.jpg

Looking north at livestock erosion on landward slope. (Spring 2013)

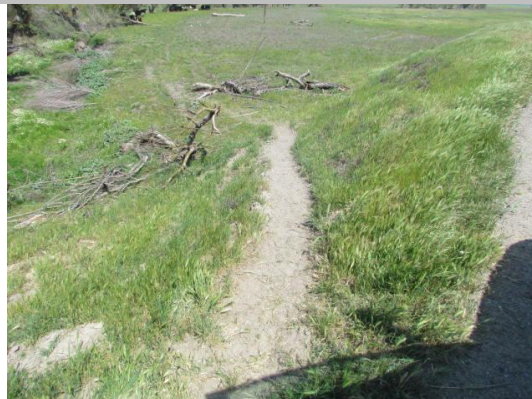
Photo 1 of 4 : FA\_2014\_NA0010\_125\_3\_20141103\_00003.jpg

Looking northeast at landside slope damaged by livestock.

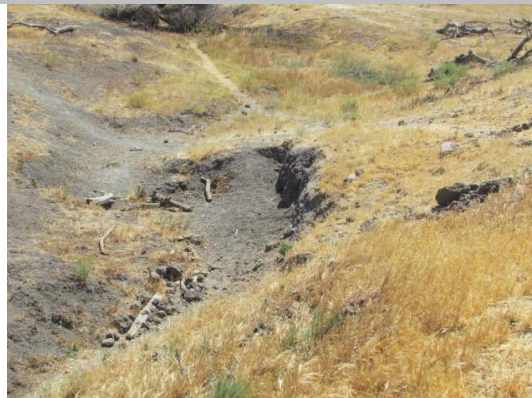
Photo 3 of 4 : FA\_2014\_NA0010\_125\_3\_20141103\_00005.jpg

Looking southeast at damage on landward toe.(Spring 2013)

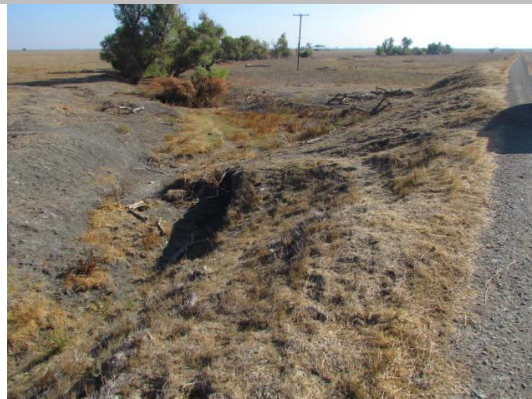
Photo 4 of 4 : FA\_2014\_NA0010\_125\_3\_20141103\_00006.jpg

Looking southeast at landside slope and toe damage by livestock.

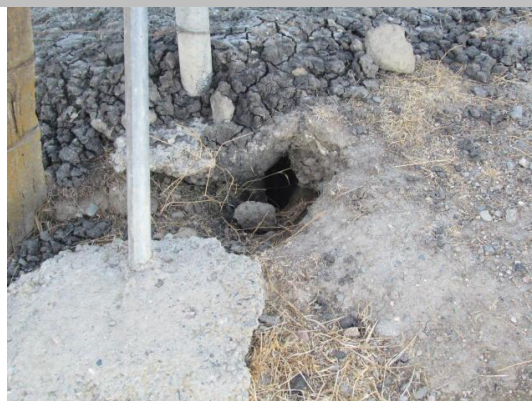
Photo 1 of 1 : FA\_2014\_NA0010\_125\_12\_20141110\_00017.jpg

Looking east at rodent hole next to fence post on landward shoulder.

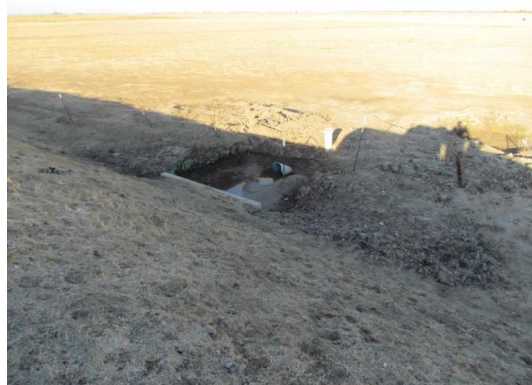
Photo 1 of 1 : FA\_2014\_NA0010\_125\_8\_20141110\_00019.jpg

Looking west at site corrected according to Board standards.

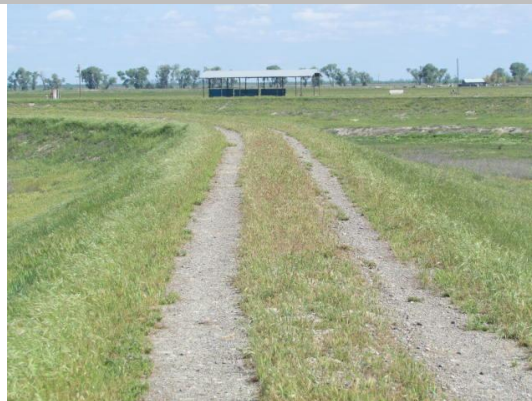
Photo 2 of 2 : FA\_2014\_NA0010\_126\_28\_20141103\_00008.jpg

Looking west at vegetation on levee crown.

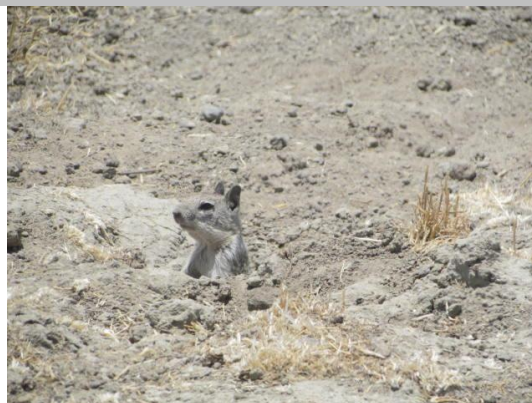
Photo 1 of 1 : FA\_2014\_NA0010\_126\_8\_20141103\_00007.jpg

Looking west at rodent holes on landward slope.

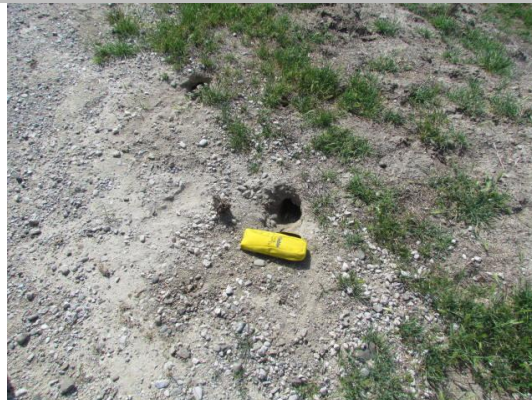
Photo 1 of 3 : FA\_2014\_NA0010\_126\_7\_20141103\_00004.jpg

Looking at typical rodent hole along the section.

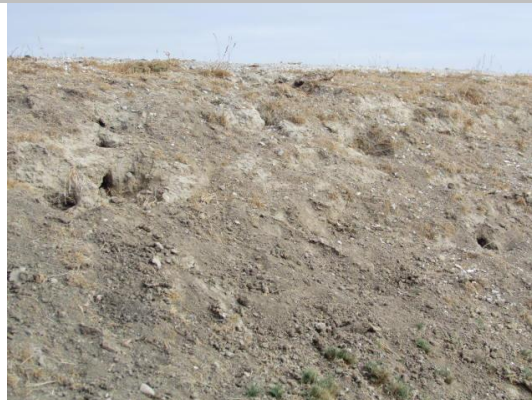
Photo 2 of 3 : FA\_2014\_NA0010\_126\_7\_20141103\_00005.jpg

Looking south at several rodent holes on landward slope.

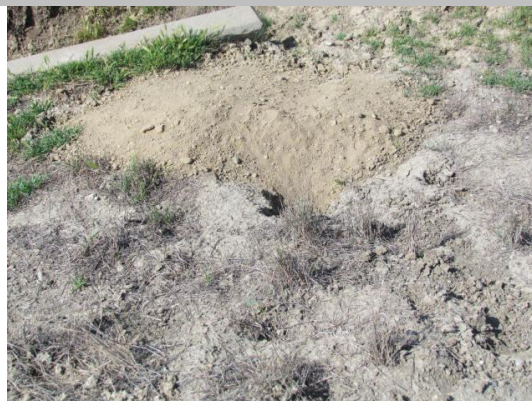
Photo 3 of 3 : FA\_2014\_NA0010\_126\_7\_20141103\_00006.jpg

Looking at typical rodent hole on landside slope near headwall.

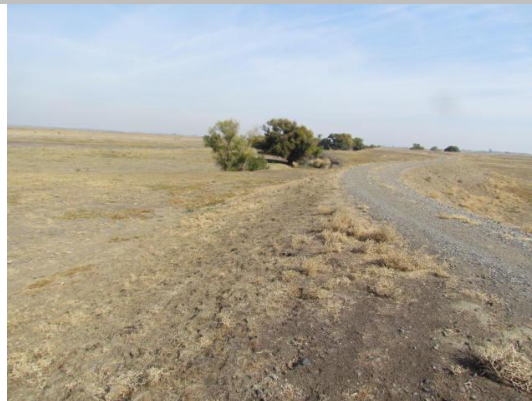
Photo 2 of 2 : FA\_2014\_NA0010\_128\_2\_20141110\_00002.jpg

Looking at landward slope in compliance with standards.

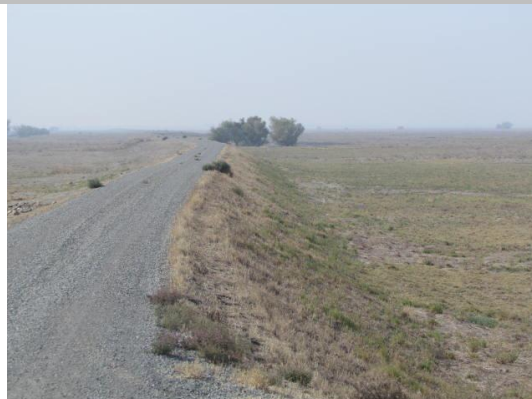
Photo 1 of 2 : FA\_2014\_NA0010\_129\_10\_20141110\_00002.jpg

Looking at landward slope in compliance with standards.

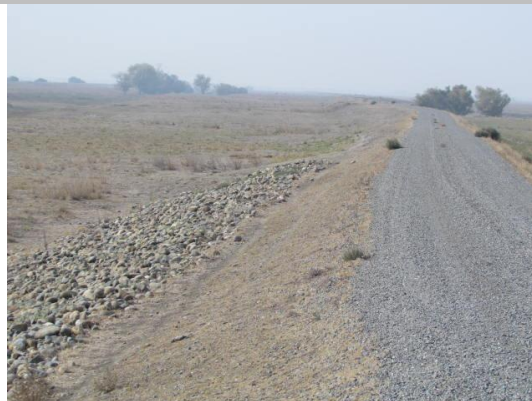
Photo 2 of 2 : FA\_2014\_NA0010\_129\_10\_20141110\_00004.jpg

Looking at waterward slope in compliance with standards.

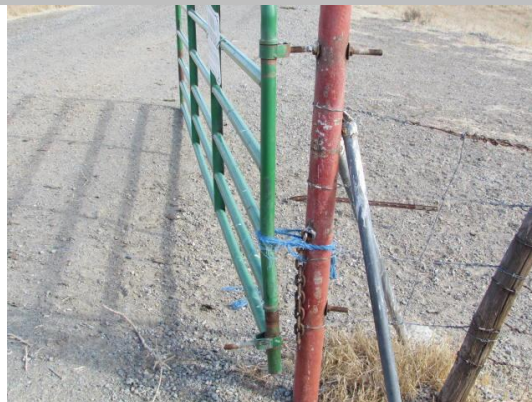
Photo 1 of 2 : FA\_2014\_NA0010\_129\_2\_20141103\_00001.jpg

Looking at bottom hinge broken on gate across levee crown.

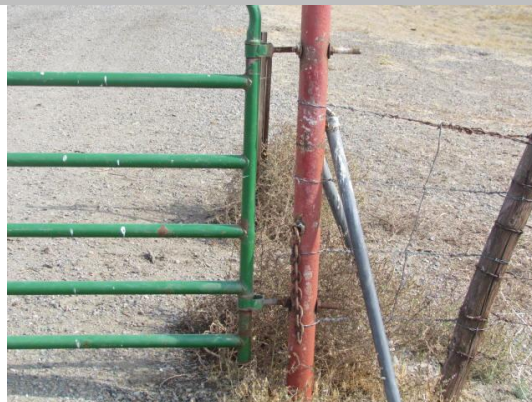
Photo 2 of 2 : FA\_2014\_NA0010\_129\_2\_20141110\_00005.jpg

Looking at gate in compliance with standards. (Fall 2014)

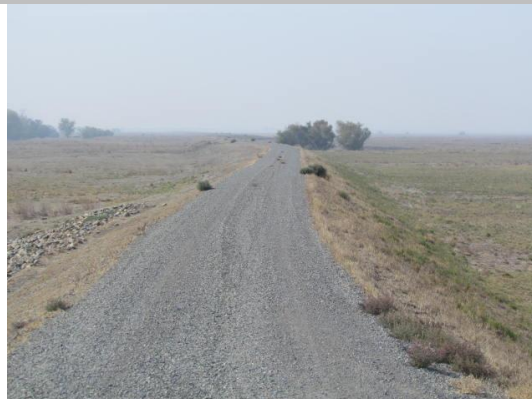
Photo 1 of 1 : FA\_2014\_NA0010\_130\_10\_20141110\_00001.jpg

Looking at typical of levee in compliance with standards.

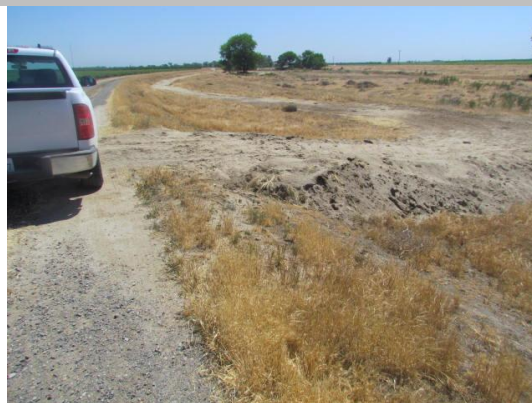
Photo 3 of 3 : FA\_2014\_NA0010\_131\_5\_20141103\_00002.jpg

Looking east at unauthorized ramp on waterward slope.

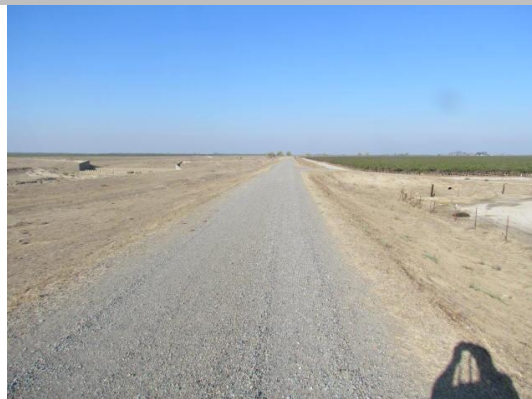
Photo 1 of 1 : FA\_2014\_NA0010\_132\_3\_20141110\_00001.jpg

Looking at type view of levee in complies with standards.

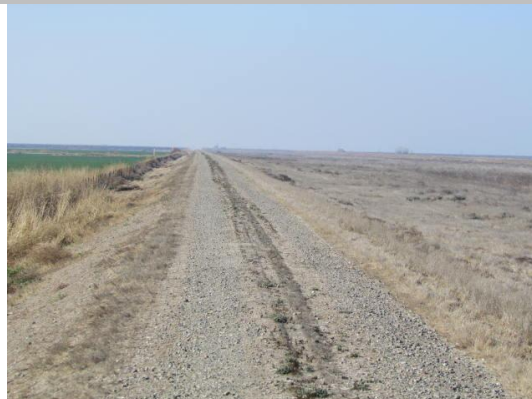
Photo 1 of 1 : FA\_2014\_NA0010\_134\_14\_20141103\_00001.jpg

Looking west at the properly maintained levee crown.

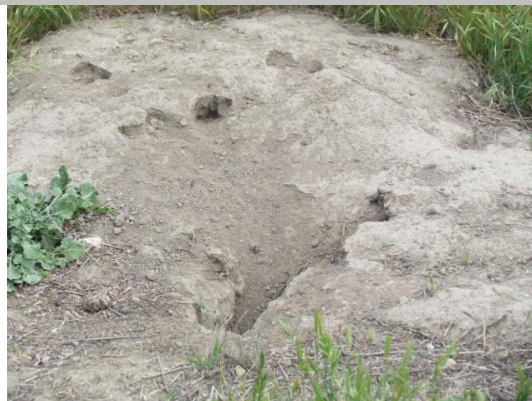
Photo 1 of 1 : FA\_2014\_NA0010\_135\_8\_20141103\_00002.jpg

Looking at several rodent holes on landside slope.

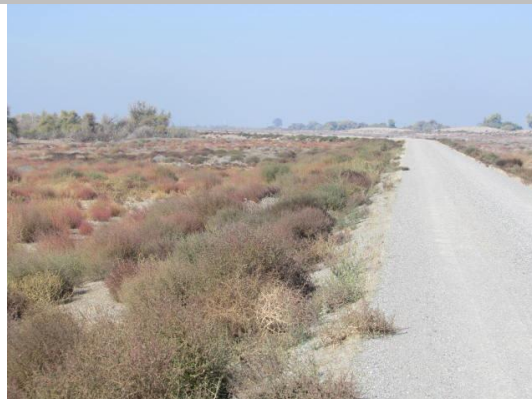
Photo 1 of 1 : FA\_2014\_NA0010\_137\_1\_20141110\_00003.jpg

Looking at typical view of tumble weeds on levee slopes.

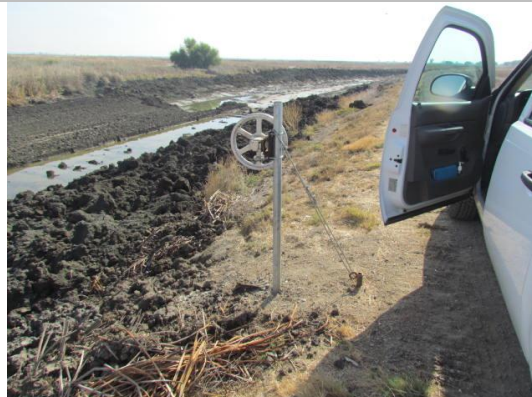
Photo 1 of 1 : FA\_2014\_NA0010\_138\_23\_20141110\_00015.jpg

Looking south at pulley on waterward shoulder.

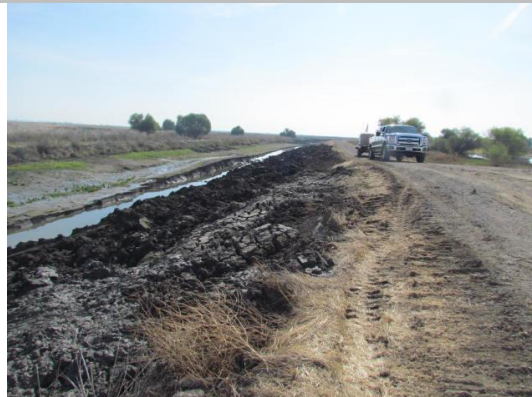
Photo 1 of 3 : FA\_2014\_NA0010\_138\_22\_20141110\_00016.jpg

Looking south at excavated waterward slope.

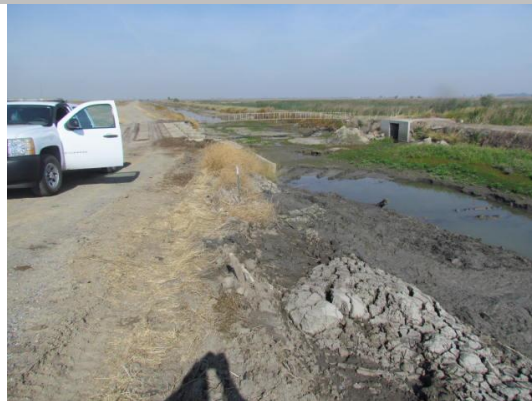
Photo 3 of 3 : FA\_2014\_NA0010\_138\_22\_20141110\_00018.jpg

Looking north at excavated waterward slope.

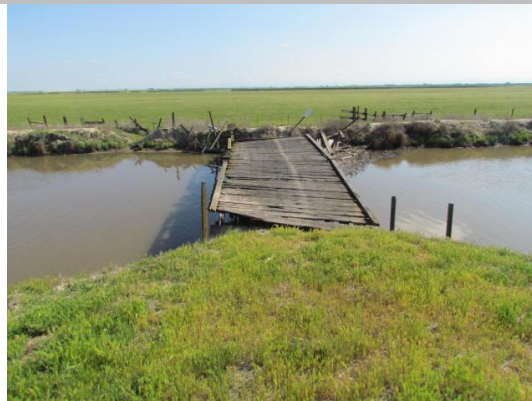
Photo 4 of 4 : FA\_2014\_NA0010\_138\_3\_20141103\_00004.jpg

Looking east at dilapidated bridge across canal.

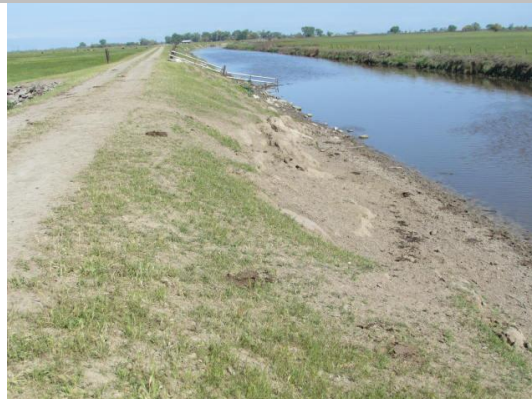
Photo 1 of 1 : FA\_2014\_NA0010\_138\_5\_20141103\_00007.jpg

Looking north at waterside erosion from livestock.

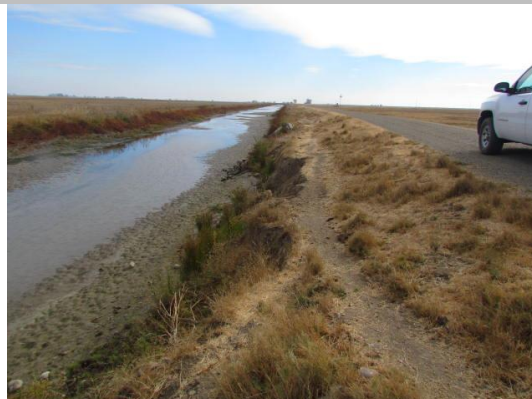
Photo 2 of 2 : FA\_2014\_NA0010\_138\_4\_20141103\_00006.jpg

Looking south livestock erosion on waterward toe.

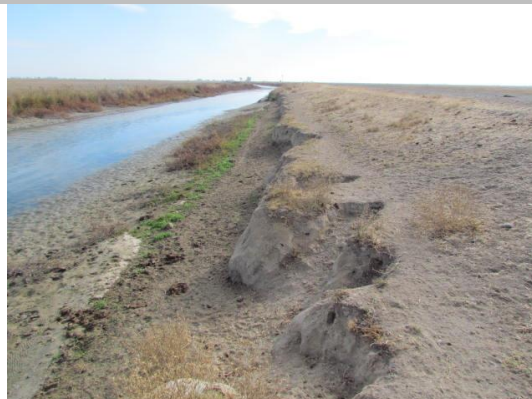
Photo 1 of 2 : FA\_2014\_NA0010\_138\_6\_20141103\_00008.jpg

Looking south at livestock erosion on waterward toe.

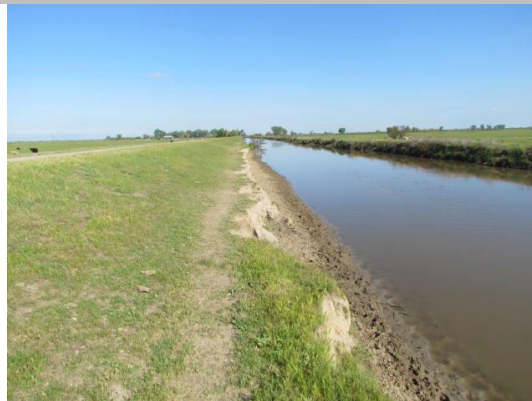
Photo 2 of 2 : FA\_2014\_NA0010\_138\_6\_20141103\_00009.jpg

Looking north at livestock erosion along waterside slope and toe.

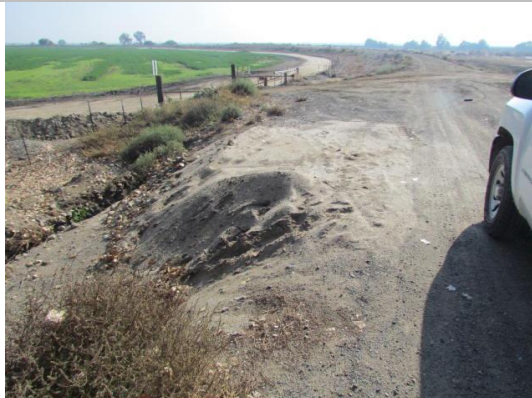
Photo 1 of 3 : FA\_2014\_NA0010\_139\_14\_20141110\_00017.jpg

Looking south at repaired site on landward slope.

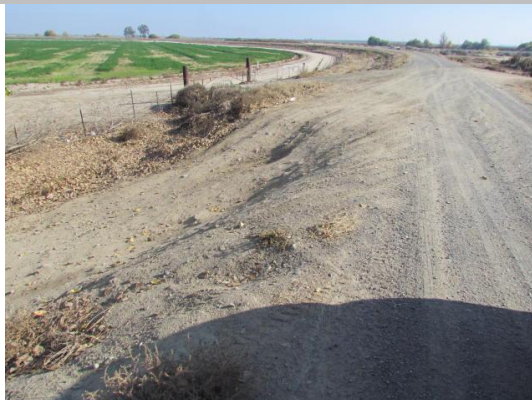
Photo 2 of 3 : FA\_2014\_NA0010\_139\_14\_20141103\_00012.jpg

Looking south at slope damaged by vehicle traffic. (Fall 2013)

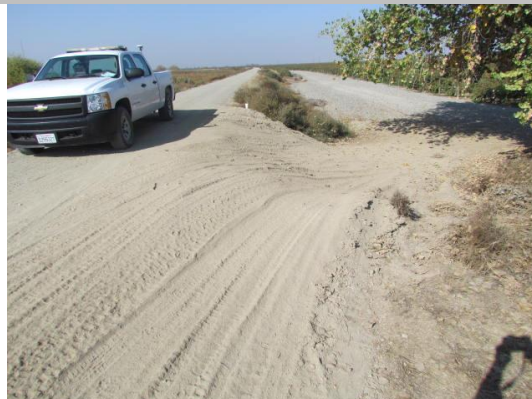
Photo 3 of 3 : FA\_2014\_NA0010\_139\_14\_20141103\_00013.jpg

Looking north at slope damaged by vehicle traffic.

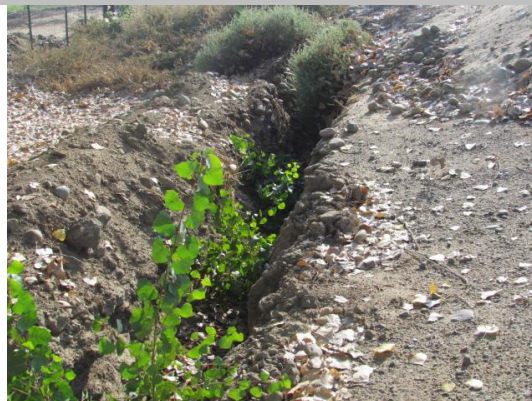
Photo 1 of 2 : FA\_2014\_NA0010\_139\_29\_20141110\_00018.jpg

Looking south at trench at landward toe.

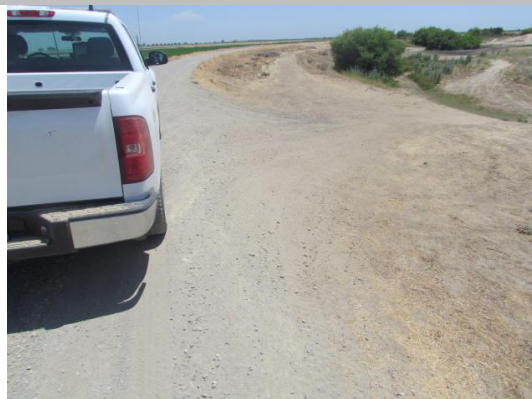
Photo 1 of 1 : FA\_2014\_NA0010\_139\_16\_20141103\_00015.jpg

Looking south at waterward slope damaged by vehicle traffic

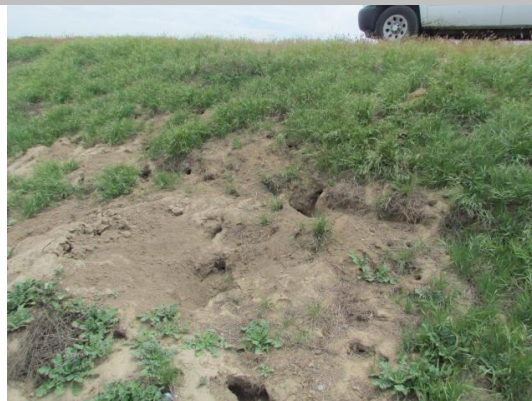
Photo 1 of 1 : FA\_2014\_NA0010\_139\_5\_20141103\_00005.jpg

Looking at several rodent holes on landside slope.

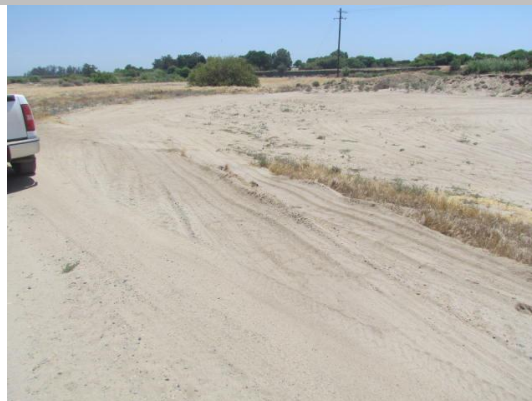
Photo 1 of 1 : FA\_2014\_NA0010\_139\_17\_20141103\_00016.jpg

Looking southwest at waterward slope damaged due to vehicle traffic.

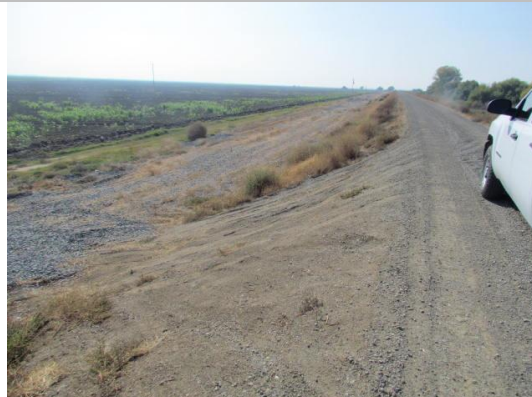
Photo 1 of 1 : FA\_2014\_NA0010\_140\_13\_20141110\_00005.jpg

Looking north at slope damage by vehicle traffic on landward slope.

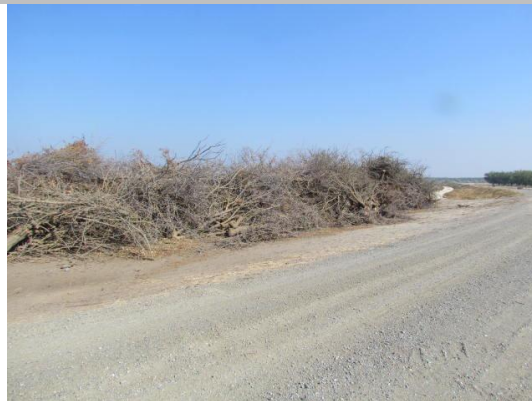
Photo 2 of 2 : FA\_2014\_NA0010\_140\_3\_20141110\_00007.jpg

Looking south at large pruning pile in channel.

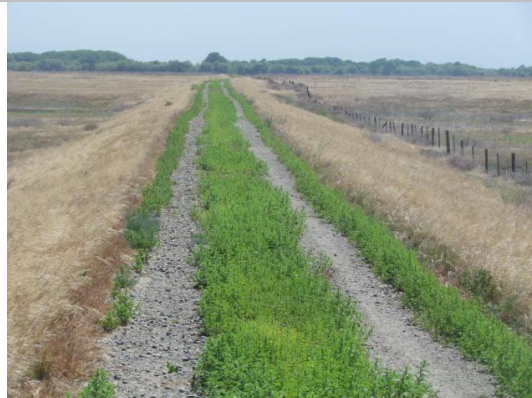
Photo 2 of 2 : FA\_2014\_NA0010\_141\_8\_20141103\_00001.jpg

Looking north at typical view of vegetation on levee crown.
