**Flood Control Project Maintenance
Levee Inspections**

Fall 2015 Levee Maintenance Deficiency Summary Report

San Joaquin River Basin

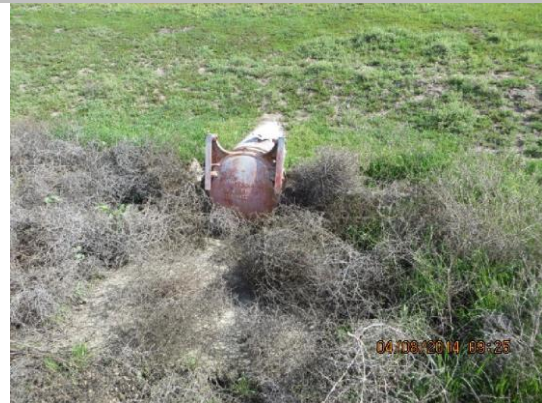
Photo 3 of 3 : UCIP_FA_2015_4214.jpg

Flapgate, pipe, and headwall on WS toe.

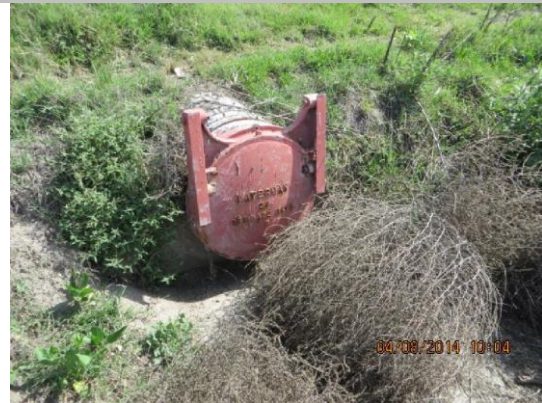
Photo 3 of 3 : UCIP_FA_2015_4250.jpg

Pipe and flapgate visible on WS toe.

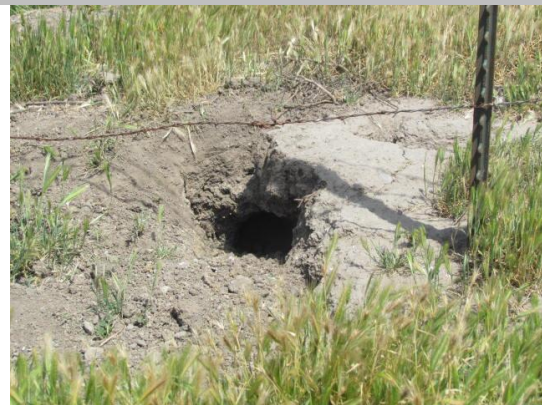
Photo 1 of 3 : FA_2015_NA0010_118_116_20150914_00022.jpg

Looking east at one of several rodent holes on landside shoulder and slope.

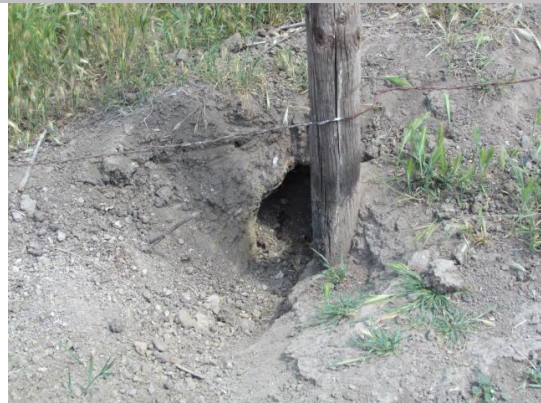
Photo 3 of 3 : FA_2015_NA0010_118_116_20150914_00024.jpg

Looking northeast at one of several holes on landside shoulder and slope.

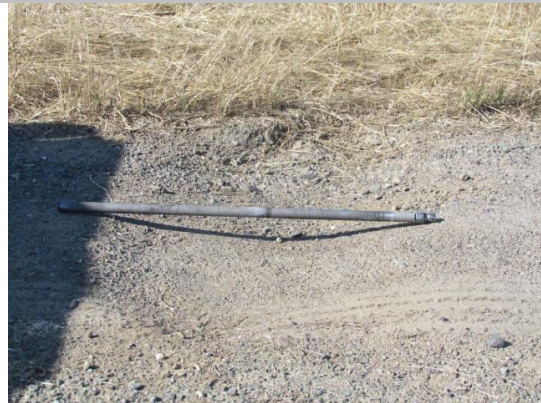
Photo 3 of 3 : FA_2015_NA0010_118_14_20150914_00012.jpg

Looking west at depression on levee crown.

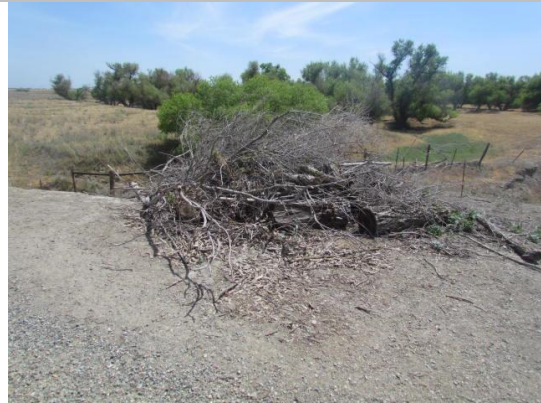
Photo 1 of 1 : FA_2015_NA0010_118_27_20150914_00017.jpg

LM Start	18.77	Rating **	M	Issue No.	27
LM End	18.77	Issue Type +	En	Location *	WS
Category	Earthen Levee			GPS Latitude/Longitude	
				Start	End
Item	Encroachments			37.205080 °	37.205080 °
				-120.762655 °	-120.762655 °
DWR ID	DWR_NA0010_01_s_2014_27				
Action/Comments					
Prunings

Looking at prunings on waterward shoulder and slope.

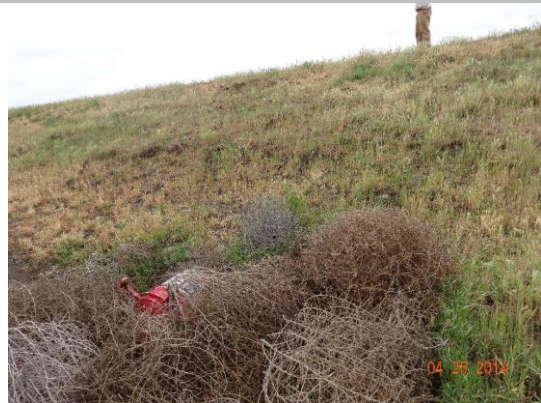
Photo 2 of 3 : UCIP_FA_2015_5436.jpg

Flap gate visible on waterward side--potential erosion present on slope.

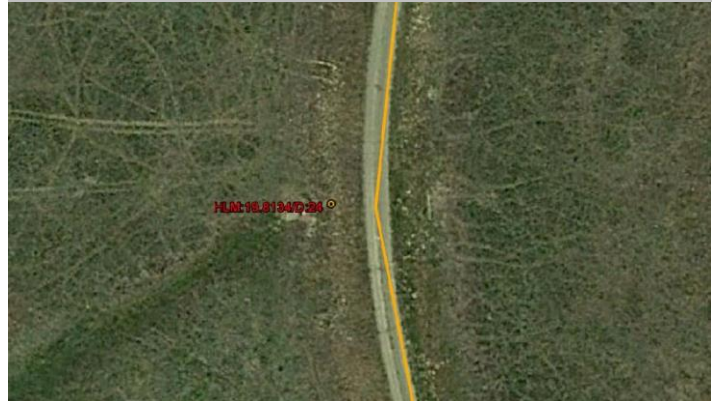
Photo 1 of 1 : UCIP_FA_2015_5454.jpg

Indicators that a crossing is still present through the levee. Flap gate should be in waterward side.

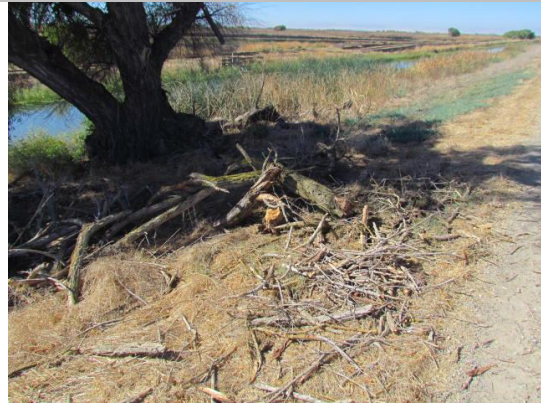
Photo 1 of 1 : FA_2015_NA0010_120_14_20151012_00004.jpg

Looking at prunings on landward slope.

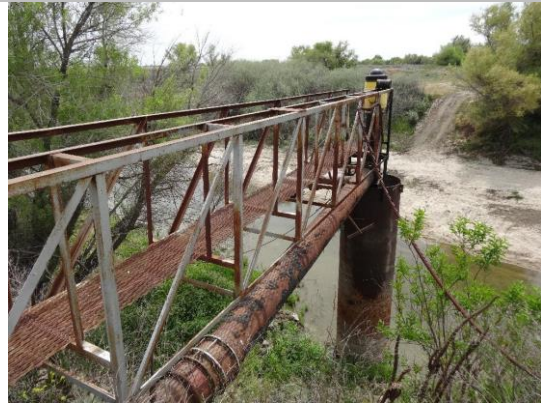
Photo 1 of 3 : UCIP_FA_2015_4798.jpg

Pump and damage walkway located on waterward side.

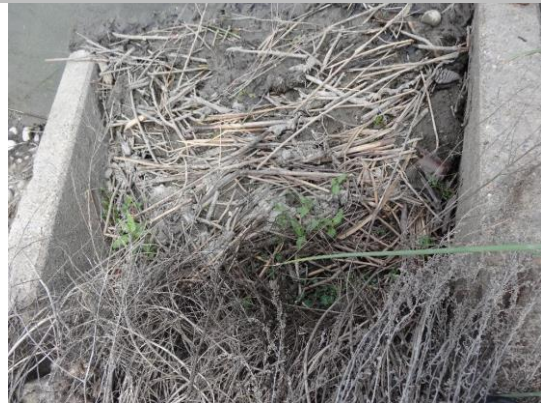
Photo 2 of 3 : UCIP_FA_2015_3572.jpg

Sediment blocking flap gate located on waterward side.

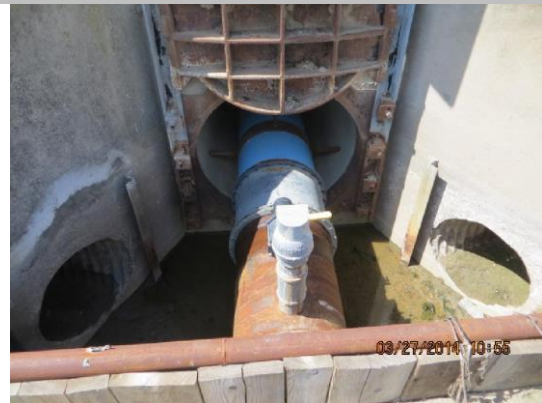
Photo 1 of 3 : UCIP_FA_2015_4454.jpg

24-inch PVC pipe sleeved through 48-inch concrete pipe. Rails on Slide gate rusted beyond use.

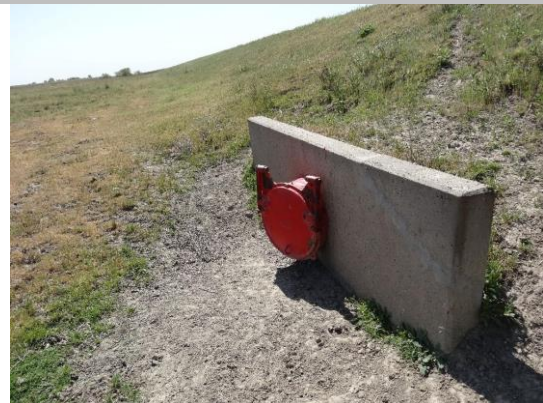
Photo 1 of 3 : UCIP_FA_2015_5700.jpg

Pipe crosses levee at an angle.

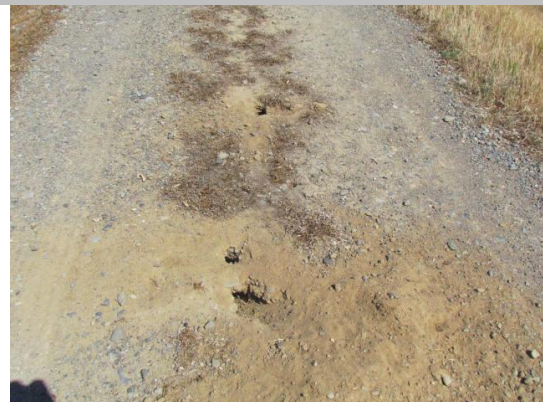
Photo 1 of 1 : FA_2015_NA0010_125_187_20150914_00012.jpg

Looking at several rodent holes on levee crown.

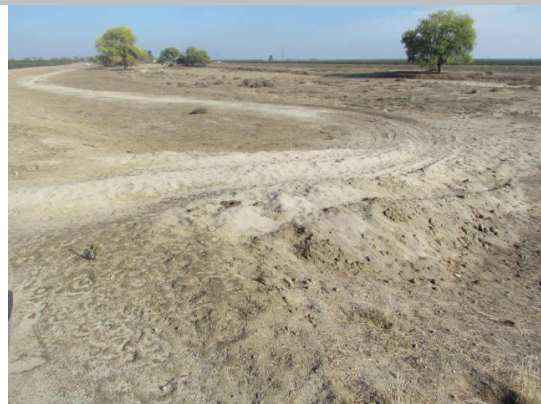
Photo 1 of 3 : FA_2015_NA0010_131_5_20150914_00001.jpg

Looking at unauthorized ramp on waterward slope. (Fall 2014)

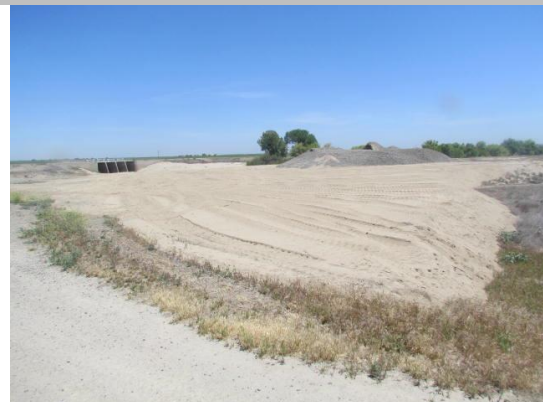
Photo 1 of 2 : FA_2015_NA0010_140_47_20150914_00007.jpg

Looking south at berm on waterward slope.
