**Flood Control Project Maintenance
Levee Inspections**

Fall 2016 Levee Maintenance Deficiency Summary Report

San Joaquin River Basin

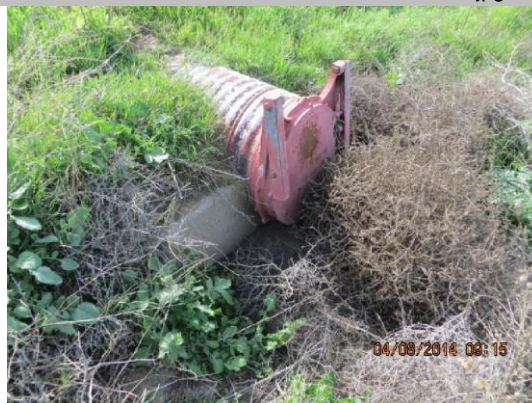
Photo 2 of 2 : UCIP_FA_2016_39095_60623.jpg

Flapgate and headwall visible on WS toe.

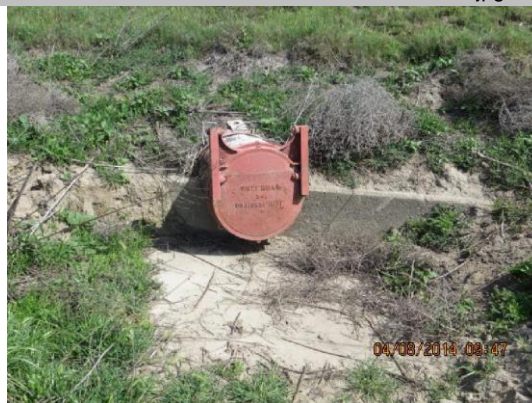
Photo 2 of 2 : UCIP_FA_2016_33563_60663.jpg

Pipe, headwall, and flapgate visible on WS toe.

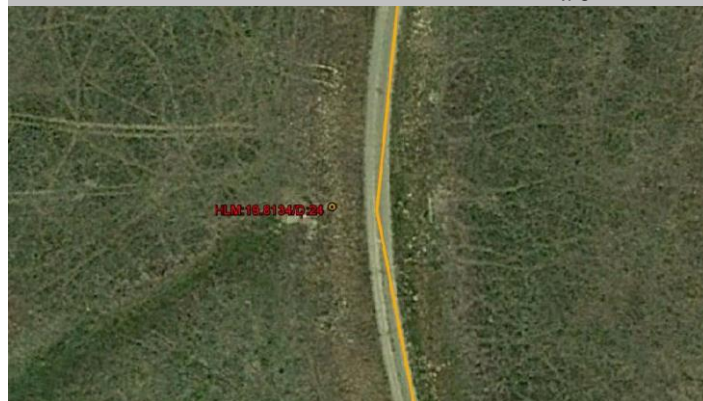
Photo 1 of 1 : UCIP_FA_2016_36253_65645.jpg

Indicators that a crossing is still present through the levee. Flap gate should be in waterward side.

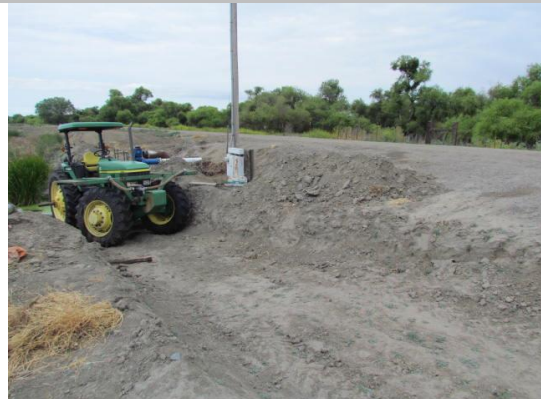
Photo 2 of 2 : FA_2016_NA0010_118_1184_20161007_00026.jpg

Looking east at ramp cut into landward slope.

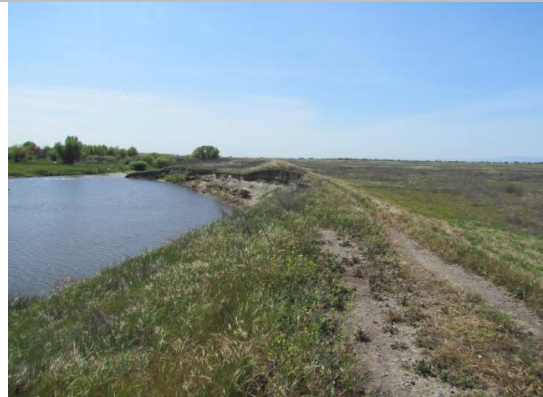
Photo 3 of 3 : FA_2016_NA0010_119_5_20161007_00005.jpg

Looking south at large erosion on waterside slope. (Spring 2012)

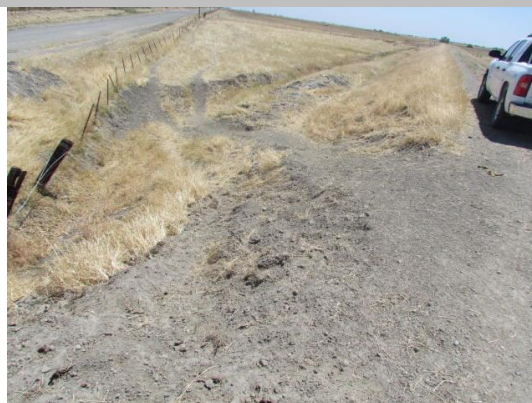
Photo 2 of 2 : FA_2016_NA0010_123_1309_20161007_00016.jpg

Looking east at damaged landward slope.

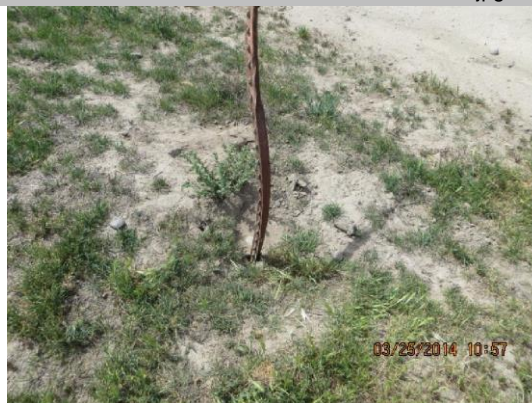
Photo 2 of 2 : UCIP_FA_2016_41716_59307.jpg

Buried Siphon breaker on WS shoulder.

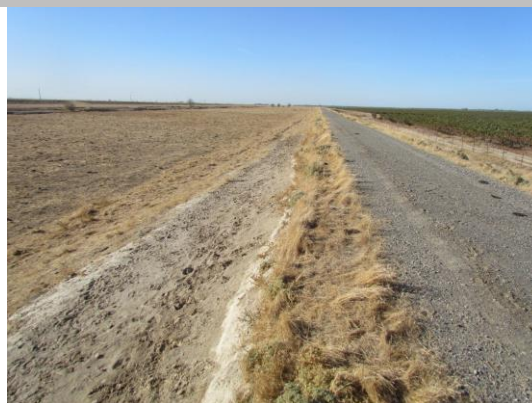
Photo 2 of 2 : FA_2016_NA0010_123_171_20161024_00209.jpg

Looking north at animal erosion on waterward slope.

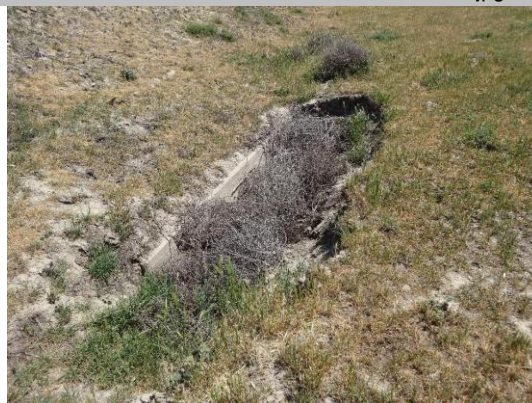
Photo 2 of 2 : UCIP_FA_2016_36607_66421.jpg

View of landward side--concrete headwall visible through dense vegetation.

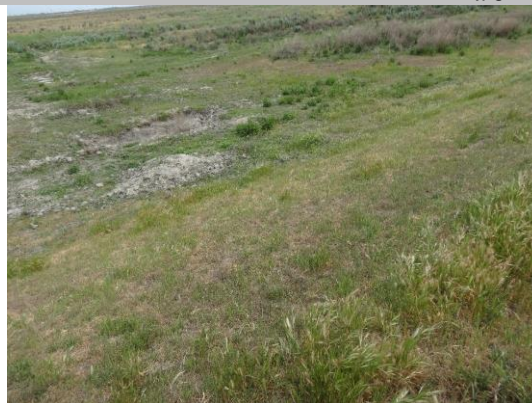
Photo 1 of 2 : UCIP_FA_2016_49974_66562.jpg

View of WS. Channel section exposed near waterward toe.

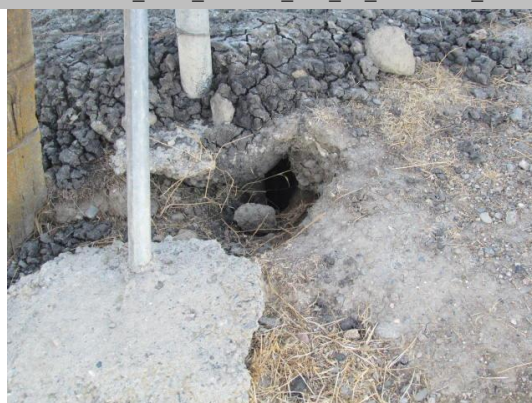
Photo 1 of 2 : FA_2016_NA0010_125_12_20161007_00003.jpg

Looking east at rodent hole next to fence post on landward shoulder.

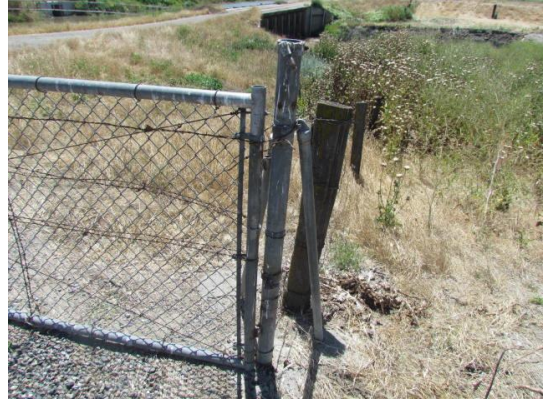
Photo 1 of 1 : FA_2016_NA0010_127_5_20161007_00001.jpg

Looking at missing hingers on fence post.

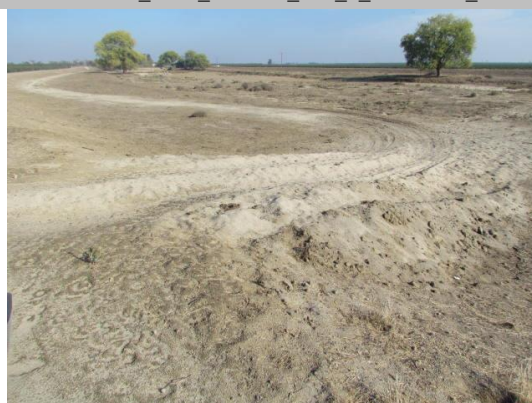
Photo 1 of 3 : FA_2016_NA0010_131_5_20161007_00001.jpg

Looking at unauthorized ramp on waterward slope. (Fall 2014)

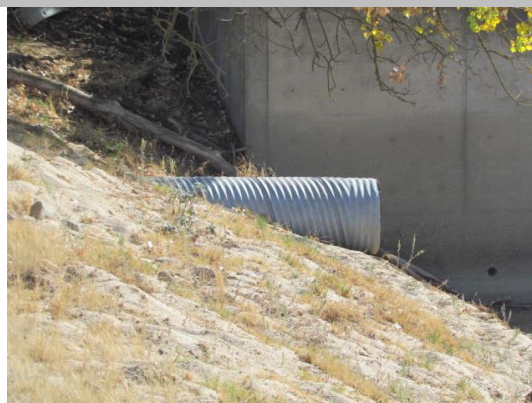
Photo 6 of 6 : FA_2016_NA0010_131_6_20161007_00008.jpg

Looking at corrugated pipe on south end on downstream side of structure.
