**Flood Control Project Maintenance
Levee Inspections**

Fall 2018 Levee Maintenance Deficiency Summary Report

San Joaquin River Basin

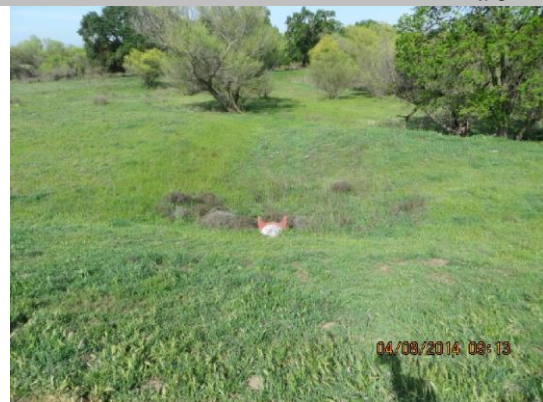
Photo 1 of 3 : UCIP_FA_2018_39095_60622.jpg

Flapgate and headwall visible on WS toe.

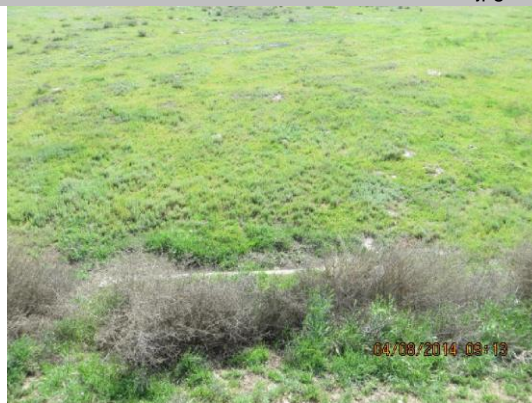
Photo 3 of 3 : UCIP_FA_2018_39095_60621.jpg

Pipe and headwall visible on LS toe.

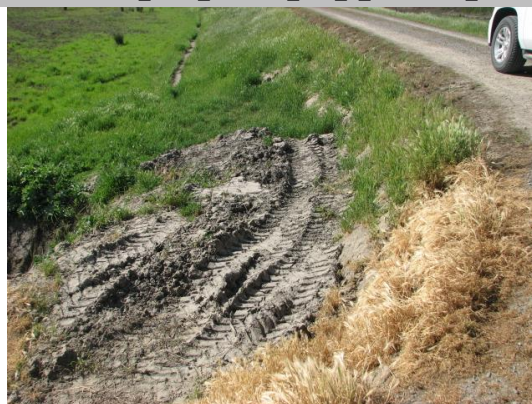
Photo 1 of 3 : FA_2018_NA0010_118_9_20180911_00006.jpg

Looking south at fill poorly placed on landward slope and toe. (Spring 2018)

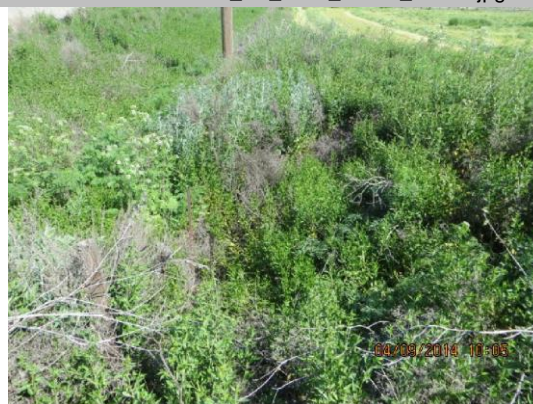
Photo 1 of 2 : UCIP_FA_2018_39250_60872.jpg

Heavy vegetation on LS toe.

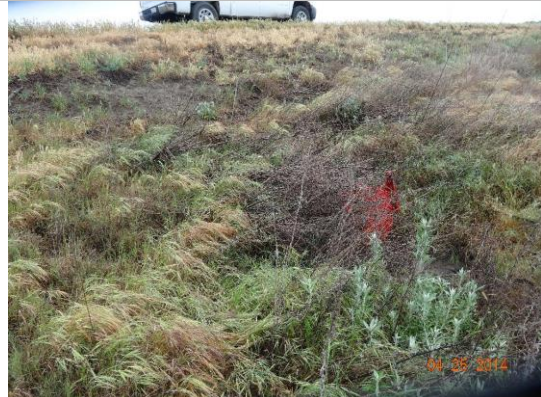
Photo 2 of 3 : UCIP_FA_2018_36169_65463.jpg

View of waterward slope covered by dense vegetation.

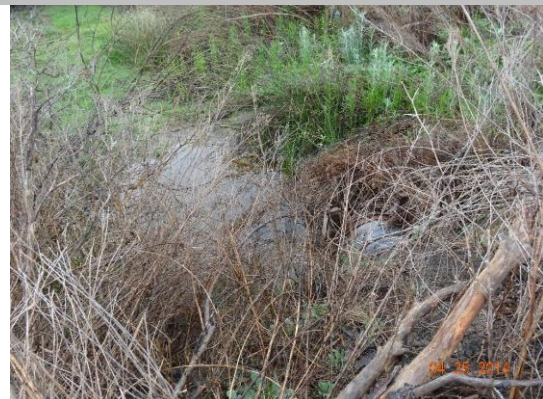
Photo 2 of 3 : UCIP_FA_2018_39257_65479.jpg

Crossing visible on waterward side under dense vegetation.

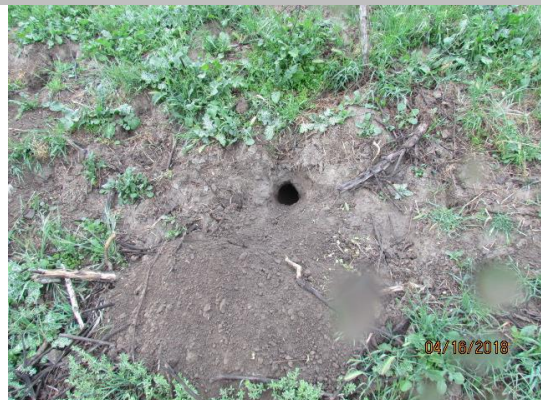
Photo 2 of 2 : FA_2018_NA0010_118_94_20180911_00020.jpg

Looking at typical view of rodent holes with this section. (Spring 2018)

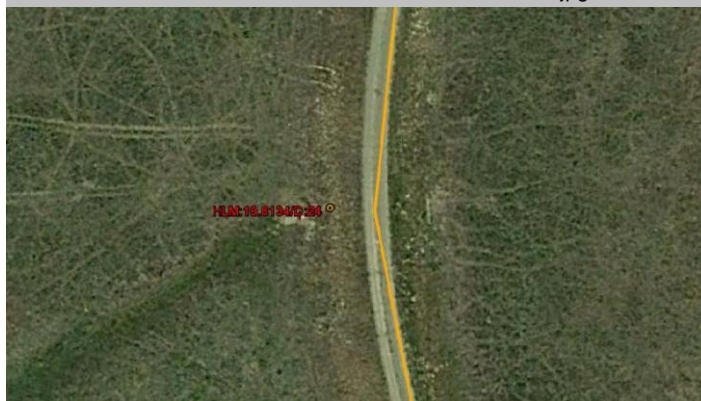
Photo 1 of 1 : UCIP_FA_2018_36253_65645.jpg

Indicators that a crossing is still present through the levee. Flap gate should be in waterward side.

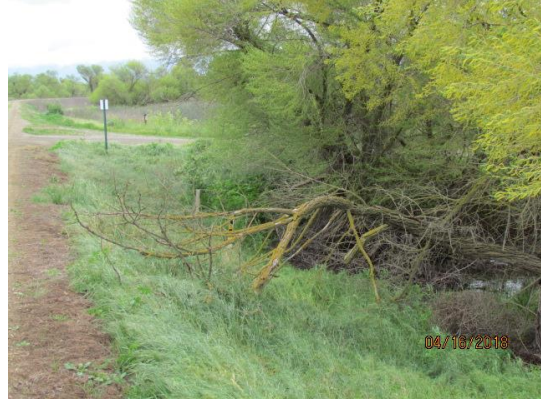
Photo 1 of 2 : FA_2018_NA0010_120_17_20180911_00005.jpg

Looking north at broken tree limbs and branches on landward slope.
(Spring 2018)

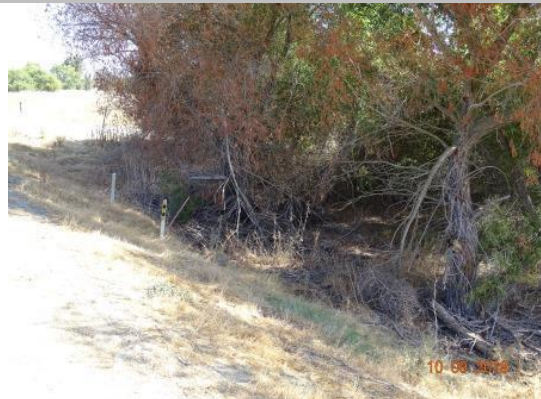
Photo 2 of 2 : FA_2018_NA0010_120_17_20181029_00049.jpg

View of dead branches on landside toe. (Fall 2018)

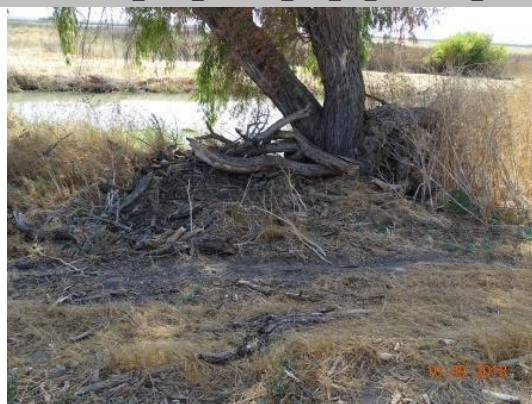
Photo 1 of 2 : FA_2018_NA0010_120_14_20181029_00050.jpg

Pruning at landside toe. (Fall 2018)

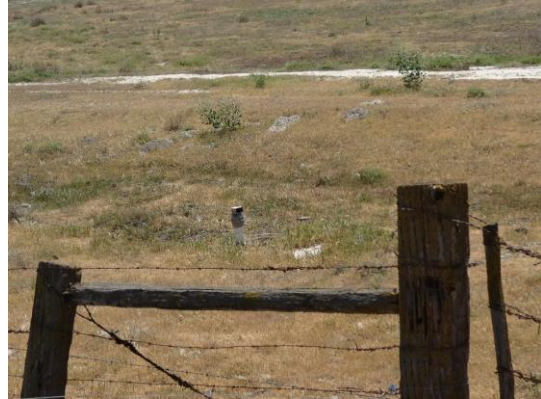
Photo 3 of 3 : UCIP_FA_2018_36585_66391.jpg

View of landward side. No signs of concrete headwall only siphon breaker visible on landward side.

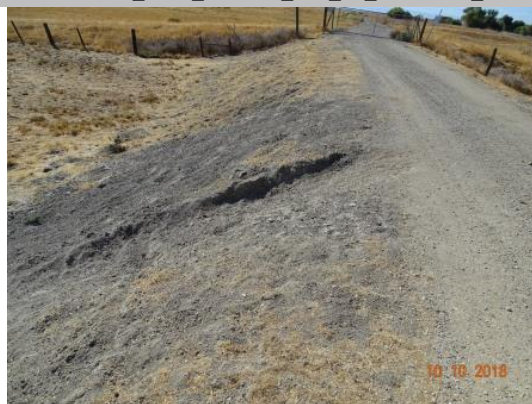
Photo 1 of 1 : FA_2018_NA0010_124_66_20181101_00189.jpg

damage from livestock foot traffic. (Fall 2018)

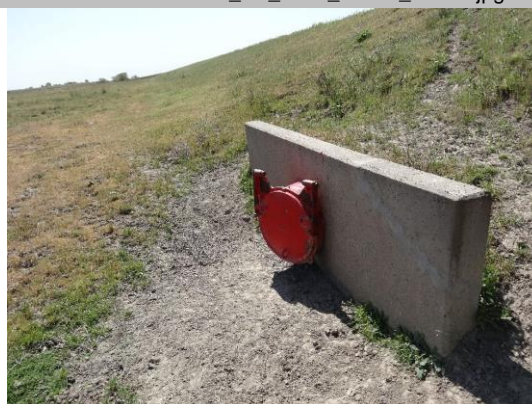
Photo 3 of 3 : UCIP_FA_2018_39474_61683.jpg

Pipe crosses levee at an angle.

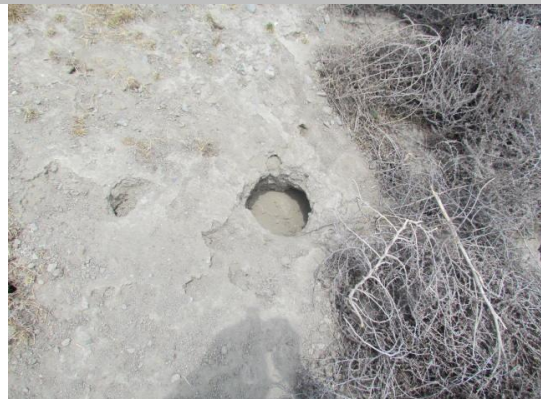
Photo 4 of 5 : FA_2018_NA0010_124_1211_20180911_00047.jpg

Looking at large rodent hole on waterward slope. Spring 2015

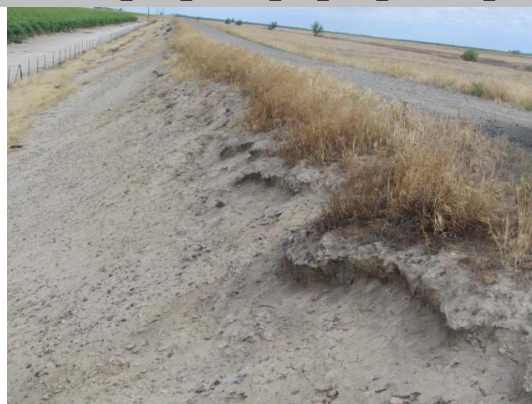
Photo 1 of 2 : FA_2018_NA0010_124_1207_20180911_00039.jpg

Looking northeast at livestock erosion on landward slope.

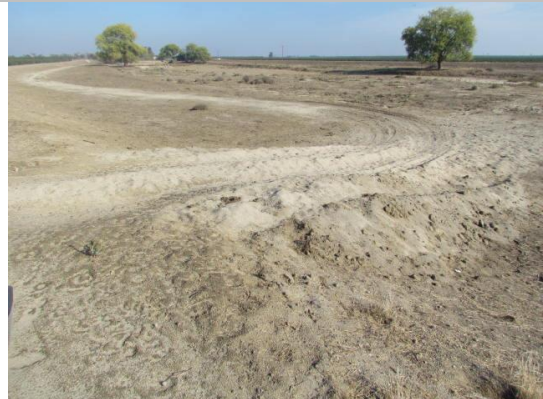
Photo 3 of 3 : FA_2018_NA0010_131_5_20180911_00002.jpg

Looking at unauthorized ramp on waterward slope. (Fall 2014)

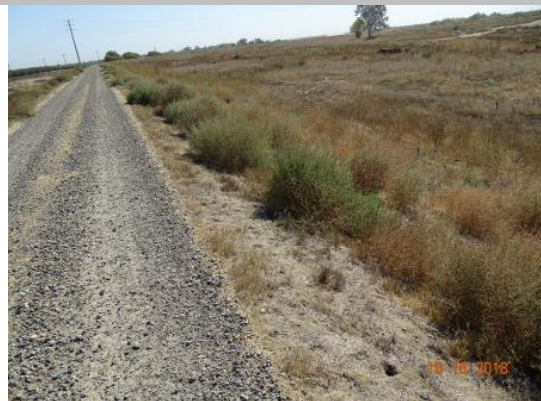
Photo 1 of 1 : FA_2018_NA0010_135_42_20181105_00056.jpg

brush along waterside slope obstructing view. (Fall 2018)

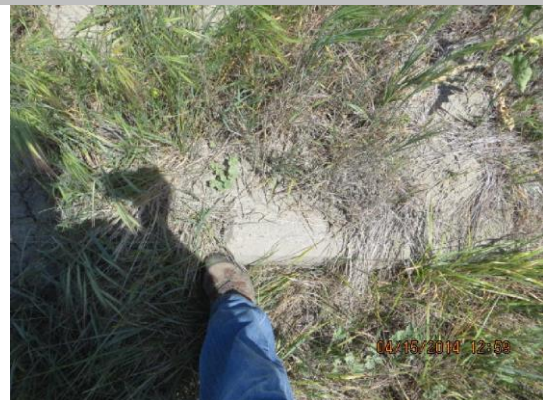
Photo 3 of 3 : UCIP_FA_2018_33733_61028.jpg

Buried concrete headwall on LS toe.

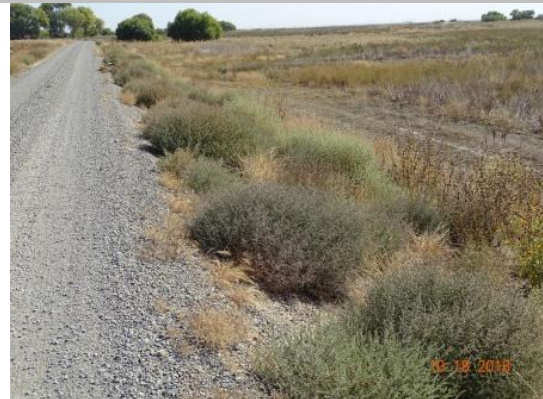
Photo 1 of 1 : FA_2018_NA0010_139_33_20181107_00042.jpg

View of brush along waterside slope. (Fall 2018)

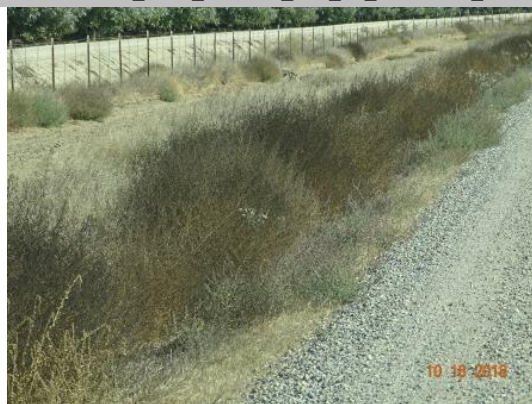
Photo 1 of 1 : FA_2018_NA0010_139_51_20181107_00049.jpg

Large brush along landside slope. (Fall 2018)

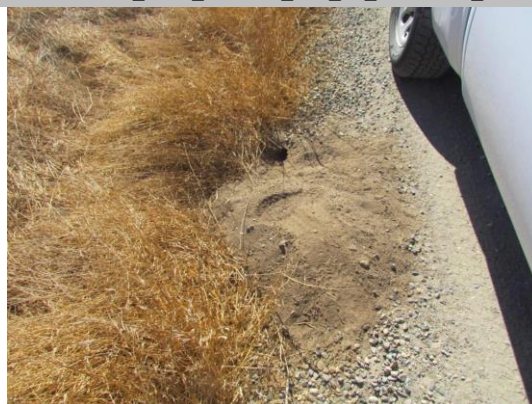
Photo 1 of 1 : FA_2018_NA0010_139_25_20180911_00007.jpg

Looking at typical view of rodent hole on waterward shoulder.
