**Flood Control Project Maintenance
Levee Inspections**

Fall 2019 Levee Maintenance Deficiency Summary Report

San Joaquin River Basin

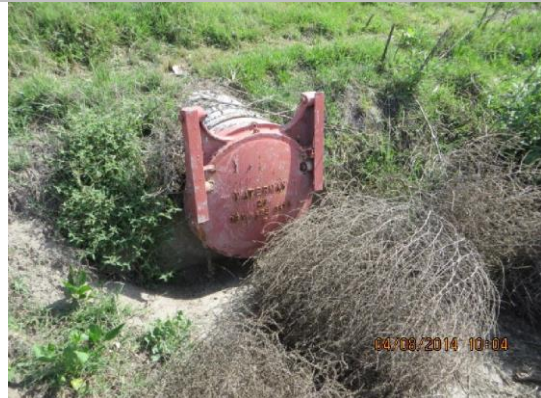
Photo 2 of 3 : UCIP_FA_2019_39123_60676.jpg

Pipe and flapgate visible on WS toe.

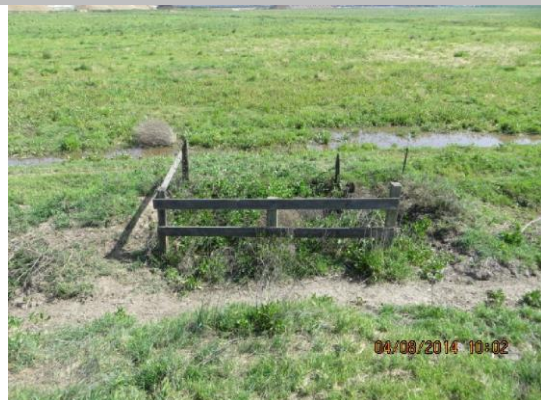
Photo 3 of 3 : UCIP_FA_2019_39123_60674.jpg

Wooded barrier around drop-inlet on LS toe.

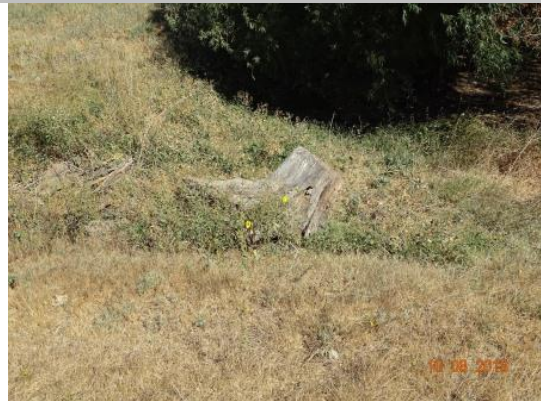
Photo 2 of 2 : FA_2019_NA0010_118_110_20190912_00021.jpg

View of tree stump on landside slope. (Fall 2018)

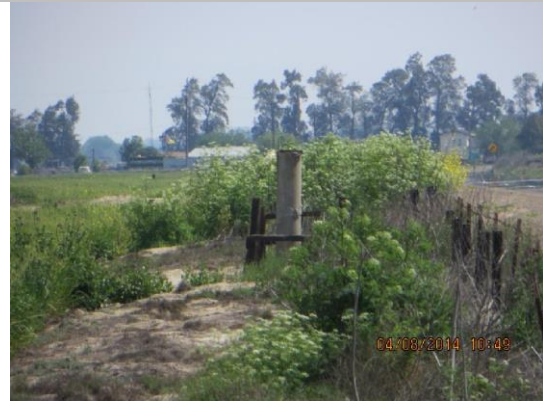
Photo 2 of 2 : UCIP_FA_2019_39133_60724.jpg

12-inch concrete standpipe off LS toe.

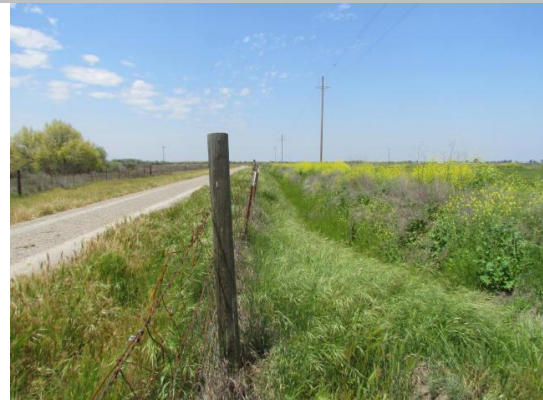
Photo 1 of 2 : FA_2019_NA0010_118_5_20190912_00001.jpg

LM Start	3.98	Rating **	U	Issue No.	5
LM End	4.05	Issue Type +	En	Location *	LS
Category	Earthen Levee			GPS Latitude/Longitude	
				Start	End
Item	Encroachments			37.310837°	37.310003°
				-120.926182°	-120.925313°
DWR ID	DWR_NA0010_01_s_2012_5				
Comment Code					
DT : Ditch					
Inspector Comment					
Irrigation ditch at landside toe.

Looking north at irrigation ditch at landside toe.

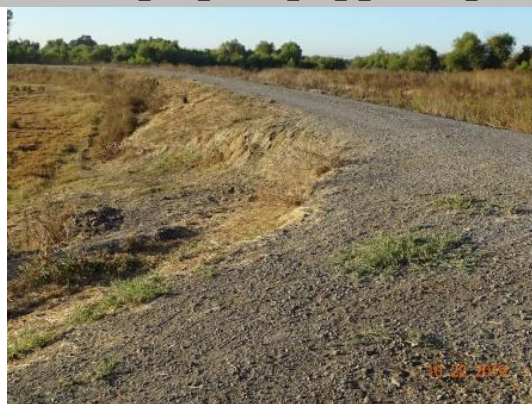
Photo 1 of 3 : FA_2019_NA0010_118_9_20191104_00280.jpg

View of landside slope damage from livestock. (Fall 2019)

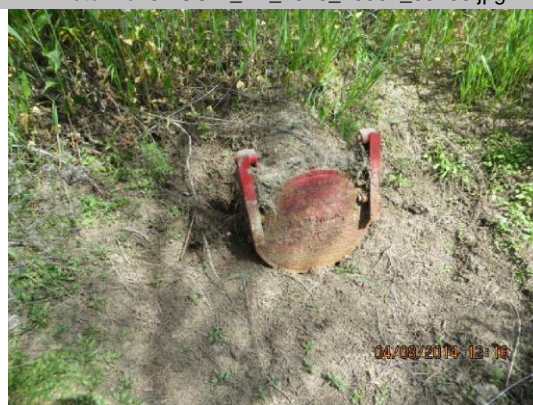
Photo 2 of 3 : UCIP_FA_2019_49962_60766.jpg

Pipe and flapgate visible at WS toe. Flapgate blocked by sedimentation on WS toe.

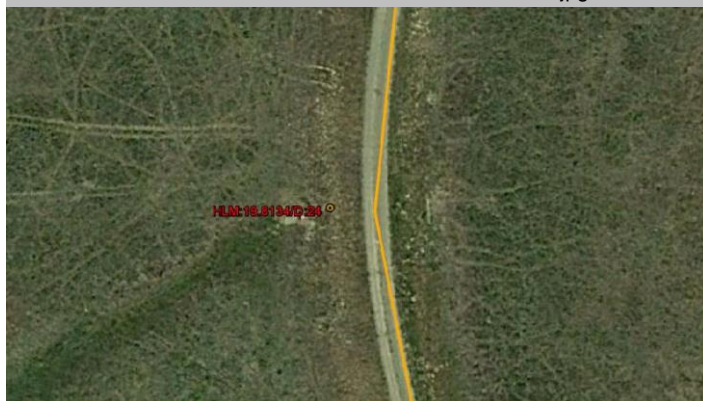
Photo 1 of 1 : UCIP_FA_2019_36253_65645.jpg

Indicators that a crossing is still present through the levee. Flap gate should be in waterward side.

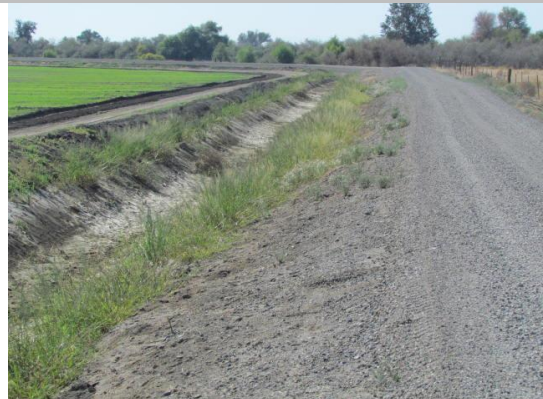
Photo 1 of 3 : FA_2019_NA0010_118_22_20190912_00011.jpg

Looking downstream at irrigation ditch at LM 22.06

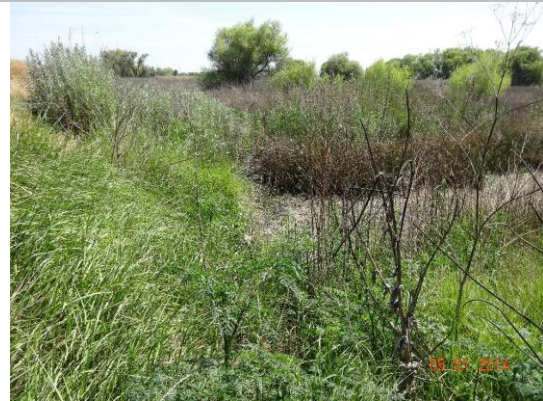
Photo 2 of 3 : UCIP_FA_2019_36508_66123.jpg

Dense vegetation along levee slope and toe.

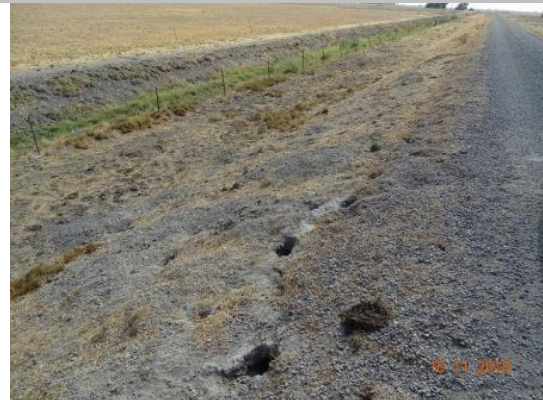
Photo 1 of 2 : FA_2019_NA0010_123_139_20190912_00035.jpg

View of rodent holes on landside shoulder. (Fall 2018)

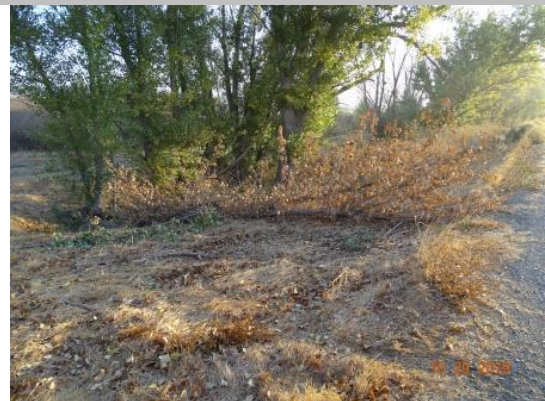
Photo 1 of 1 : FA_2019_NA0010_123_158_20191108_00331.jpg

View of downed tree limb on the landside slope. (Fall 2019)

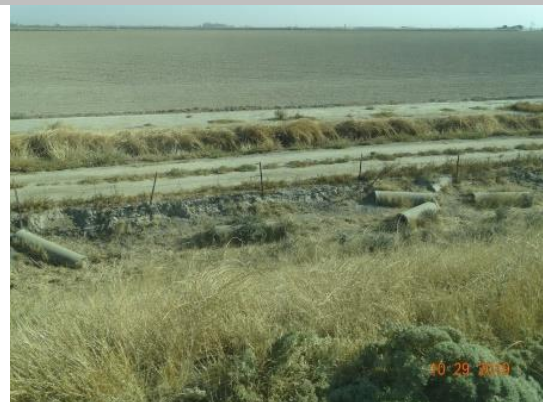
Photo 1 of 1 : FA_2019_NA0010_123_175_20191108_00336.jpg

Sections of concrete pipe left along the landside toe. (Fall 2019)

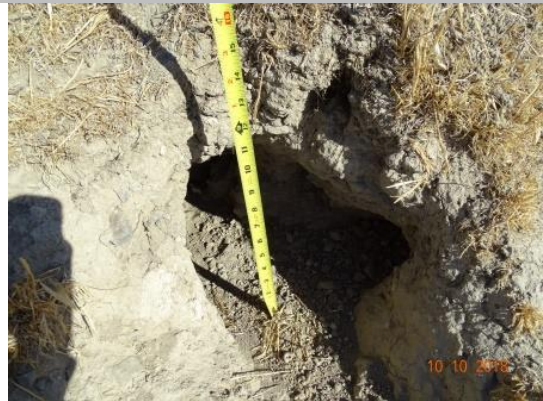
Photo 2 of 2 : FA_2019_NA0010_124_92_20190912_00034.jpg

Measurement of large burrow. (Fall 2018)

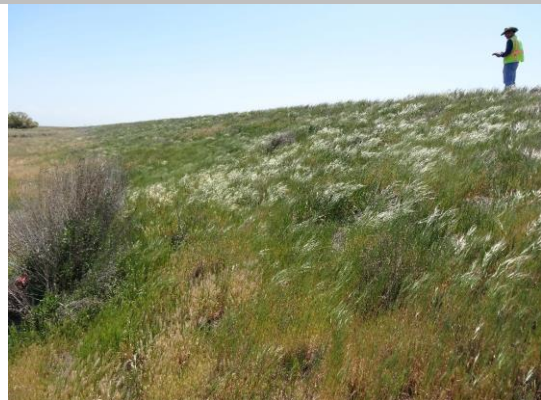
Photo 2 of 3 : UCIP_FA_2019_36611_66440.jpg

View of waterward side--dense vegetation covers slope.

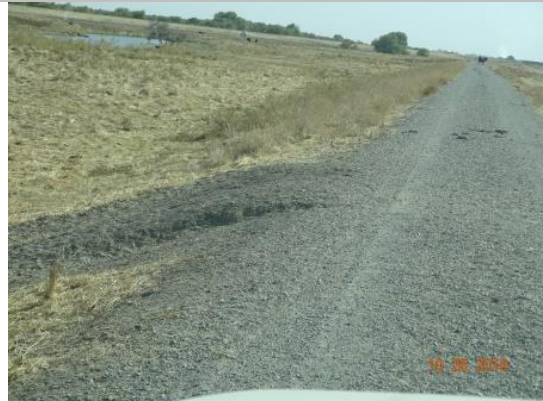
Photo 1 of 1 : FA_2019_NA0010_124_89_20191112_00197.jpg

View of damage to the waterside slope looking upstream. (Fall 2019)

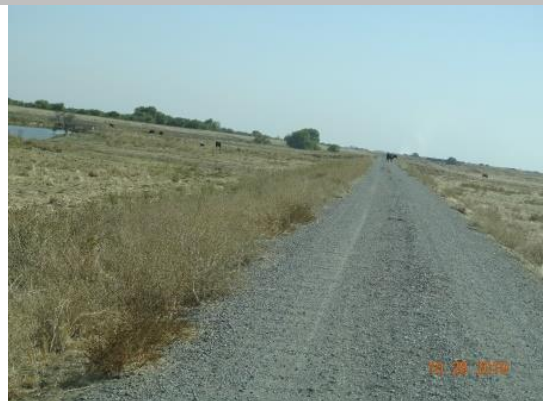
Photo 1 of 1 : FA_2019_NA0010_124_90_20191112_00198.jpg

View of vegetation along the waterside slope looking upstream. (Fall 2019)

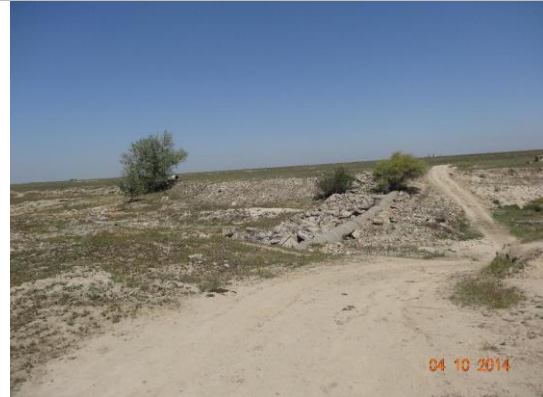
Photo 3 of 3 : UCIP_FA_2019_36693_66609.jpg

Concrete pipe through Eastside Bypass exposed.

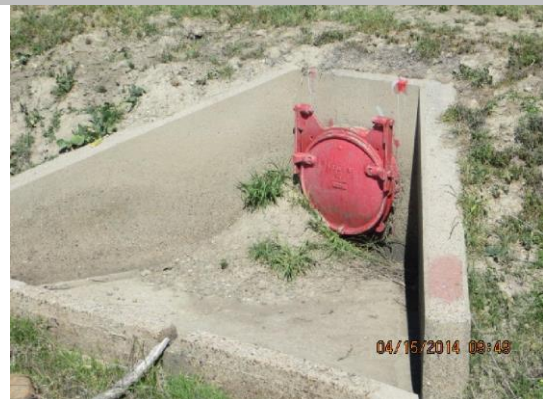
Photo 2 of 3 : UCIP_FA_2019_49966_60955.jpg

Pipe, headwall, and flapgate at WS toe. Soil buildup partially blocking flapgate.

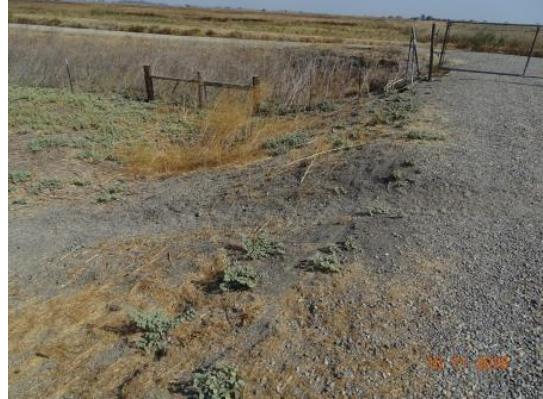
Photo 1 of 2 : FA_2019_NA0010_127_4_20190912_00001.jpg

View of slope erosion due to foot traffic. (Fall 2018)

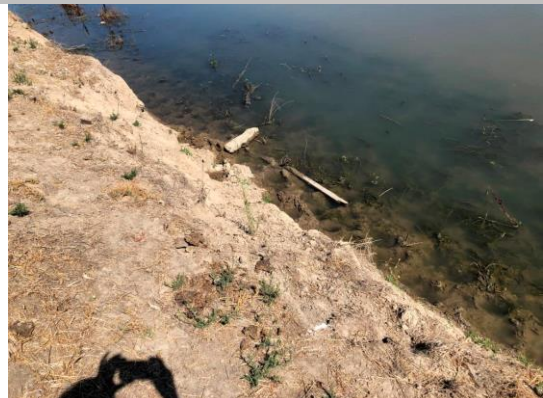
Photo 3 of 3 : SJR2019_DWR_NA0010_22A_f_ 2018_37_4.JPG

Close-up view of the erosion.

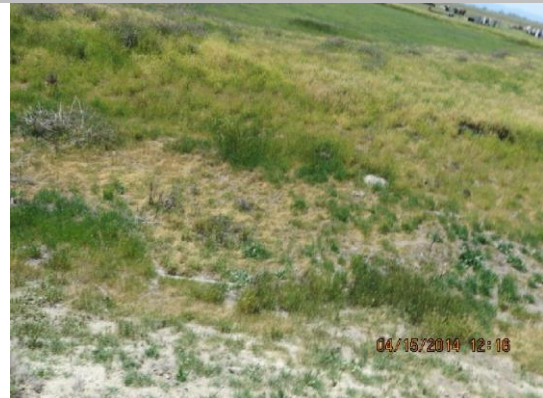
Photo 3 of 3 : UCIP_FA_2019_39536_61020.jpg

Buried headwall on LS toe.

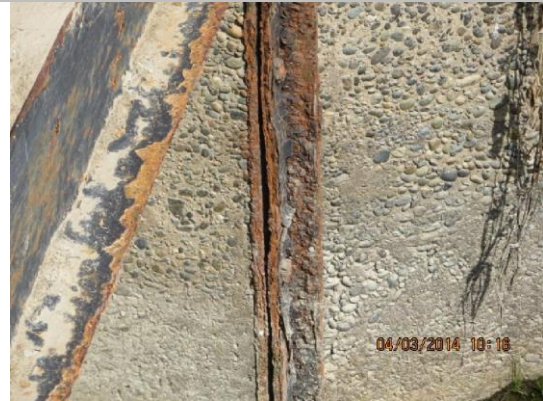
Photo 3 of 3 : UCIP_FA_2019_53192_59808.jpg

Heavy corrosion in slide gate tracks on WS toe.
