Flood Control Project Maintenance Levee Inspections

Fall 2020 Levee Maintenance Deficiency Summary Report

San Joaquin River Basin

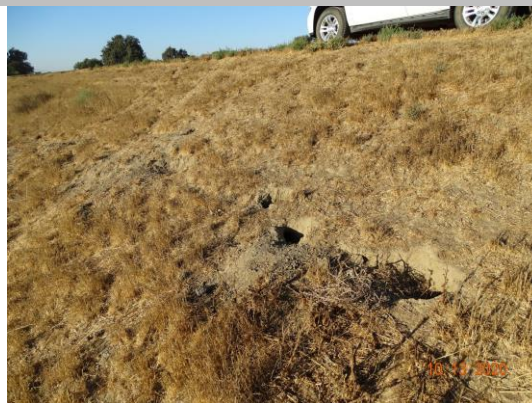
Photo 1 of 1 : FA_2020_NA0010_118_95_20201019_00261.jpg

Several rodent holes observed in the landside slope. (Fall 2020)

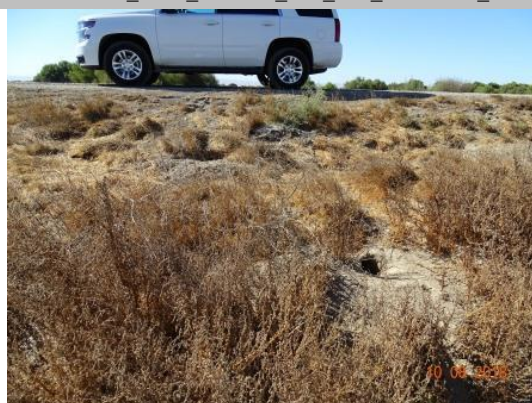
Photo 1 of 1 : FA_2020_NA0010_118_116_20200901_00015.jpg

View of landside slope with rodent holes. (Fall 2018)

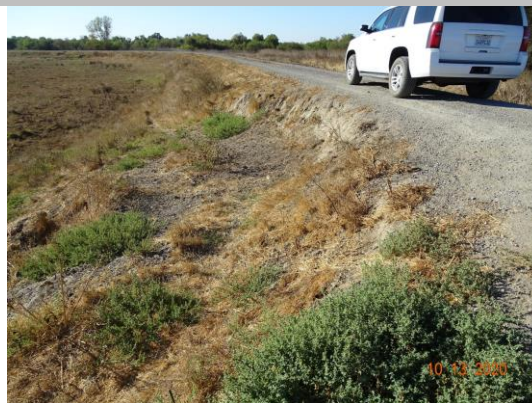
Photo 1 of 1 : FA_2020_NA0010_118_9_20201020_00268.jpg

View of damage to the landside slope. (Fall 2020)

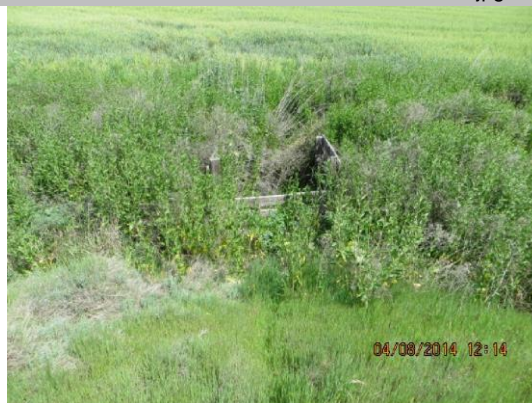
Photo 3 of 3 : UCIP_FA_2020_61846_60765.jpg

Wooden barrier around drop inlet on LS toe. Excess vegetation.

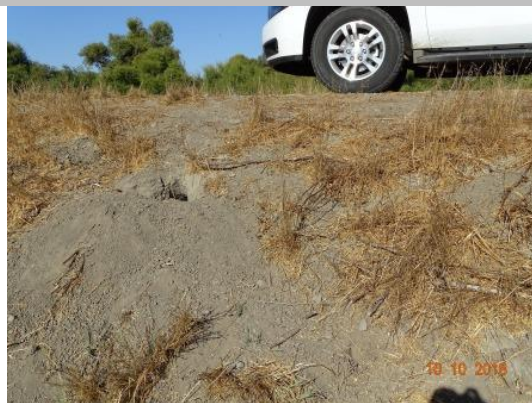
Photo 1 of 1 : FA_2020_NA0010_118_120_20200901_00018.jpg

View of rodent burrow in the landside slope. (Fall 2018)

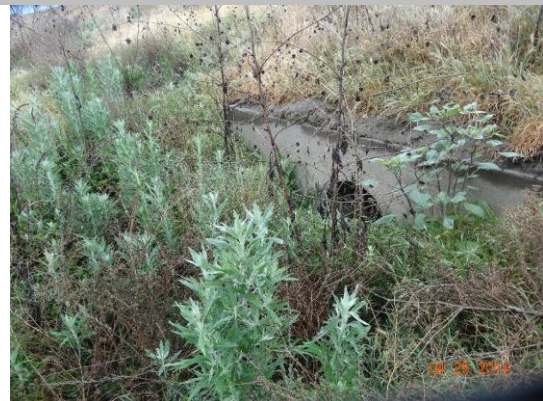
Photo 3 of 3 : UCIP_FA_2020_61881_65462.jpg

Concrete headwall visible on landward toe--dense vegetation blocking inlet.

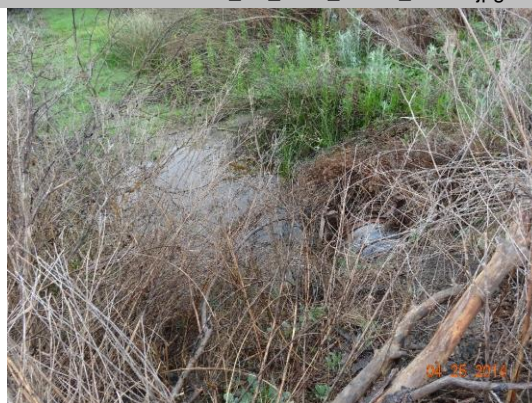
Photo 2 of 3 : UCIP_FA_2020_61884_65479.jpg

Crossing visible on waterward side under dense vegetation.

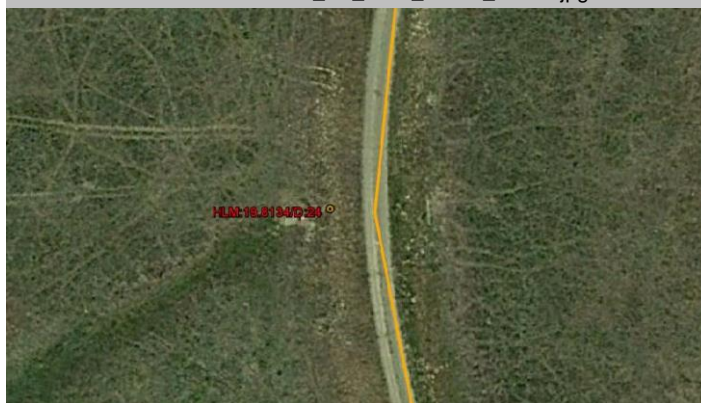
Photo 1 of 1 : UCIP_FA_2020_61902_65645.jpg

Indicators that a crossing is still present through the levee. Flap gate should be in waterward side.

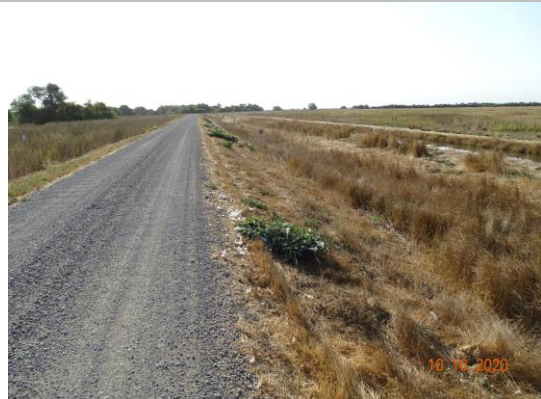
Photo 1 of 1 : FA_2020_NA0010_119_24_20201019_00062.jpg

View of vegetation along the landside slope. (Fall 2020)

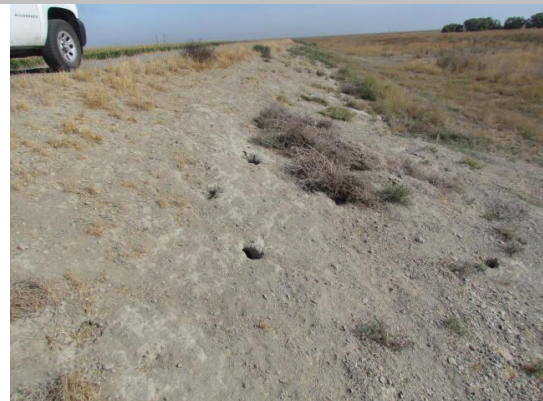
Photo 1 of 1 : FA_2020_NA0010_124_1211_20200901_00045.jpg

Looking at several rodent holes on waterward slope. (Fall 2015)

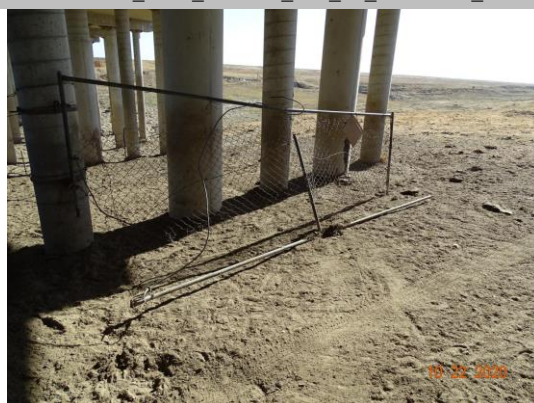
Photo 1 of 1 : FA_2020_NA0010_124_78_20201028_00187.jpg

View of damaged access gate under highway 152. (Fall 2020)

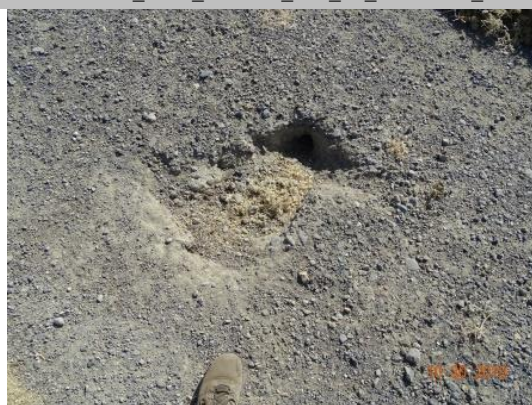
Photo 1 of 1 : FA_2020_NA0010_124_19_20200901_00004.jpg

View of rodent burrow in the levee crown. (Fall 2019)

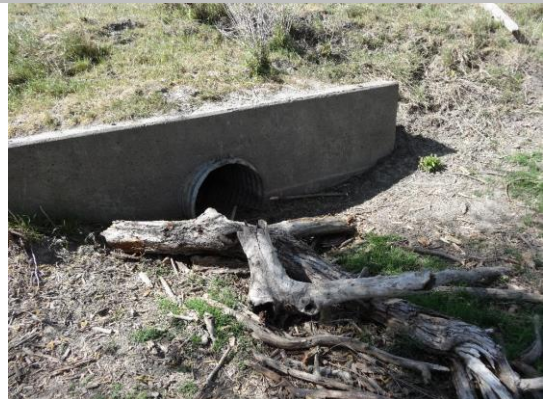
Photo 3 of 3 : UCIP_FA_2020_62069_62030.jpg

Concrete headwall located on landward side--debris in front of headwall.

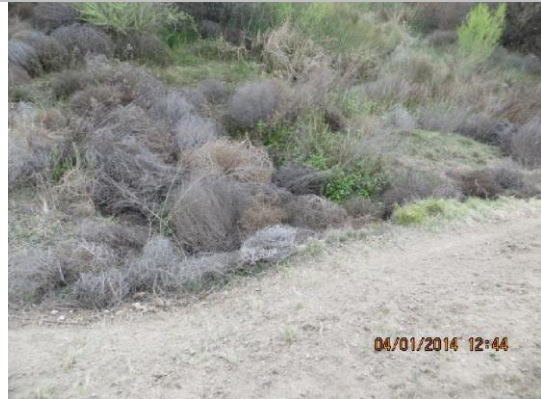
Photo 3 of 3 : UCIP_FA_2020_62098_59746.jpg

Concrete headwall at channel on LS toe. Heavy vegetation buildup.

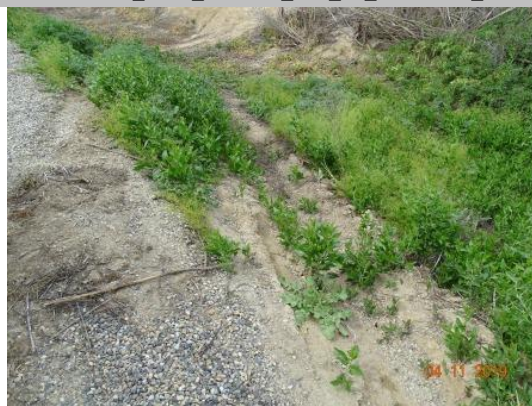
Photo 1 of 1 : FA_2020_NA0010_139_62_20200901_00007.jpg

View of damage to landside slope by vehicle traffic looking downstream.
(Spring 2019)

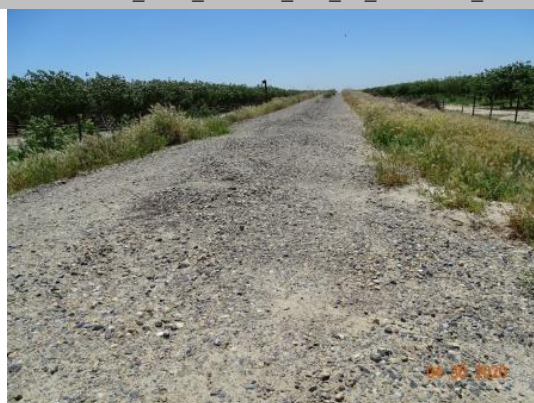
Photo 1 of 1 : FA_2020_NA0010_139_65_20200901_00008.jpg

Depressions forming in the levee crown. (Spring 2020)

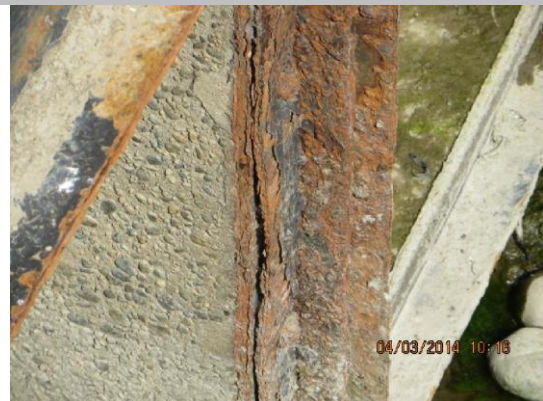
Photo 3 of 3 : UCIP_FA_2020_62206_59800.jpg

Slide gate tracks show heavy corrosion impacting actuation of slide gate.

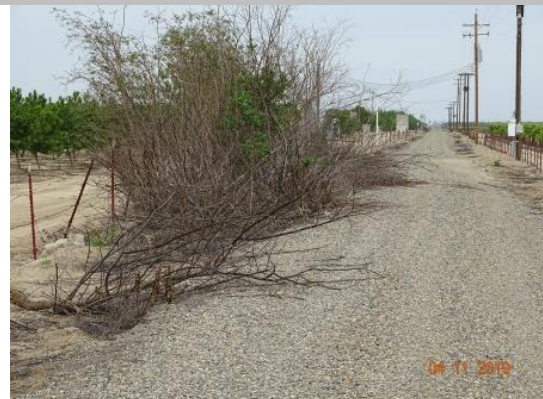
Photo 1 of 1 : FA_2020_NA0010_139_58_20200901_00006.jpg

Woody vegetation on landside toe obstructing landside of crown. (Spring 2019)
