## Flood Control Project Maintenance Levee Inspections

### Fall 2021 Levee Maintenance Deficiency Summary Report

#### San Joaquin River Basin

NA0010 Lower San Joaquin Levee District	Overall LMA Rating	Total LMA Miles							
	U	191.27							
Rated Item	Maintenance Deficiency				Enforcement		Design & System Obsolescence		
	M Miles	U Miles	M + 4U Miles	Threshold %	M Miles	U Miles	M Miles	U Miles	
<i>Earthen Levee</i>									
Vegetation	47.00	9.57	85.28	44.59%					
Trim / Thin Trees	0.10		0.10	0.05%					
Encroachments	0.23	0.02	0.31	0.16%	9.29	0.59			
Animal Control	7.67	2.19	16.43	8.59%					
Slope Stability	0.05	0.01	0.09	0.05%					
Erosion / Bank Caving	0.13	0.81	3.37	1.76%					
Crown Surface / Depressions / Rutting	0.01		0.01	0.01%					
Repair Gates	0.02	0.02	0.10	0.05%					
<i>Rivers, Channels &amp; Designated Floodways</i>									
Encroachments					0.01	0.01			
<i>Supplemental</i>									
DWR Erosion Survey	0.12	0.17	0.80	0.42%					
DWR UCIP Field Study					1.29	0.05			
DWR UCIP LMA Responsibility									
<i>LMA Totals:</i>	55.33	12.79	106.49	55.67%	10.59	0.65	0.00	0.00

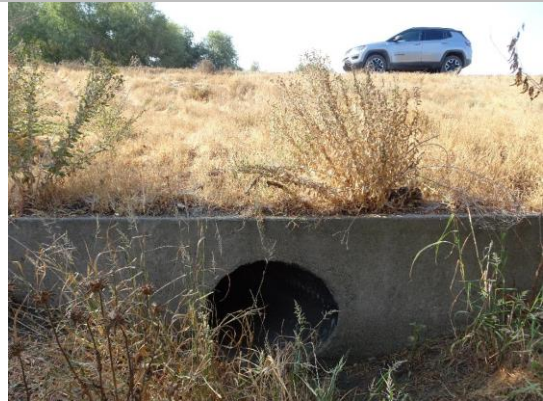
Photo 3 of 3 : UCIP\_FA\_2021\_64700\_90561.jpg

LS view: Concrete headwall and pipe visible at LS toe

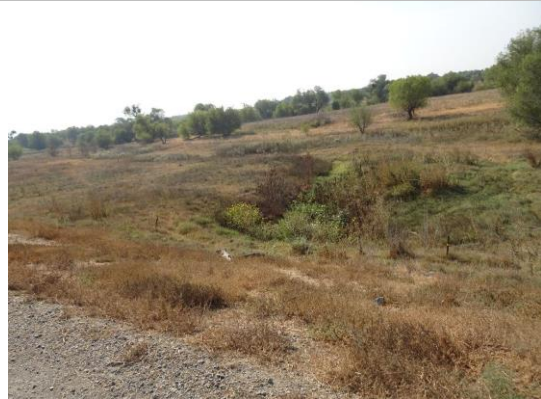
Photo 3 of 3 : UCIP\_FA\_2021\_64844\_90574.jpg

WS view: Flapgate and headwall not visible on WS toe from levee crown

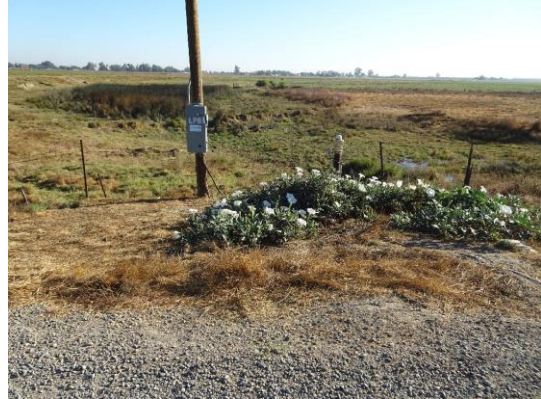
Photo 3 of 3 : UCIP\_FA\_2021\_64849\_92355.jpg

LS view: overview of LS

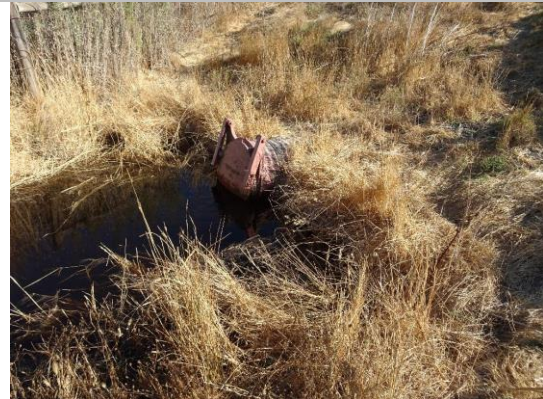
Photo 3 of 3 : UCIP\_FA\_2021\_64720\_90679.jpg

WS view: Pipe and flapgate at WS toe

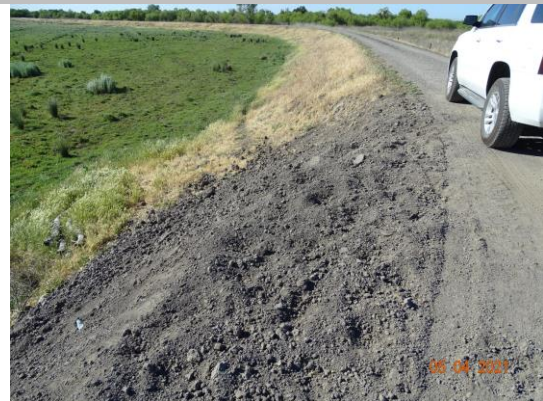
Photo 1 of 1 : FA\_2021\_NA0010\_118\_9\_20210830\_00003.jpg

View of repaired slope damage on the landside. (Spring 2021)

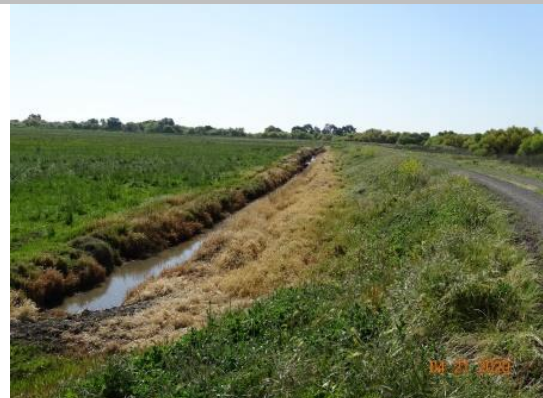
Photo 1 of 1 : FA\_2021\_NA0010\_118\_107\_20210830\_00011.jpg

LM Start	4.77	Rating **	M	Issue No.	107
LM End	5.32	Issue Type +	En	Location *	LS
Category	Earthen Levee			GPS Latitude/Longitude	
				Start	End
Item	Encroachments			37.301269 °	37.300396 °
				-120.920660 °	-120.912625 °
DWR ID	DWR_NA0010_01_s_2019_107				
Comment Code					
DT : Ditch					
Inspector Comment					
Ditch it roughly 8-15 ft away from levee toe.

Looking upstream at an irrigation ditch along the landside toe. (Spring 2020)

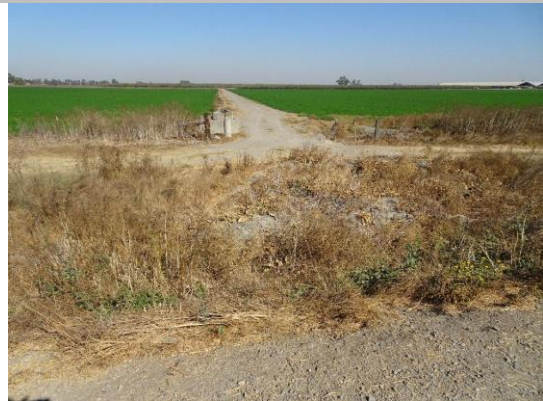
Photo 3 of 3 : UCIP\_FA\_2021\_64852\_90690.jpg

LS view: View of LS toe from levee crown. Pipe and headwall not visible

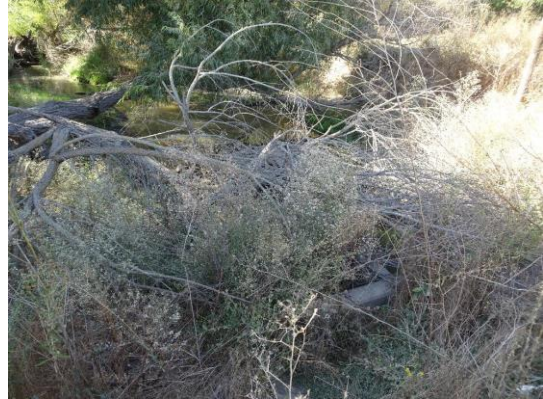
Photo 3 of 3 : UCIP\_FA\_2021\_64729\_90706.jpg

WS view: Inspection of WS headwall, pipe, and flapgate inhibited by dense vegetation

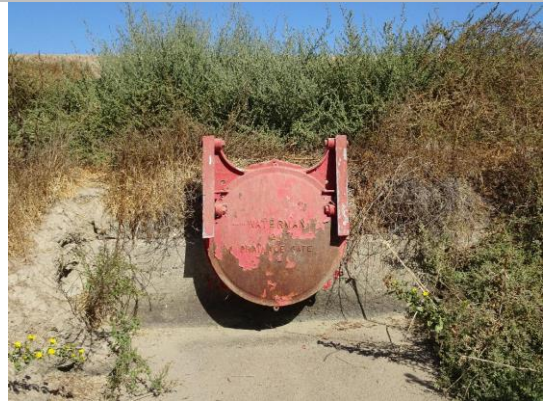
Photo 3 of 3 : UCIP\_FA\_2021\_64733\_90721.jpg

WS view: Pipe, flapgate, and headwall at WS toe.

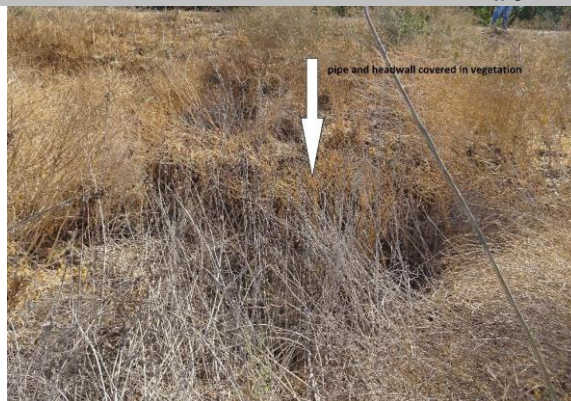
Photo 2 of 3 : UCIP\_FA\_2021\_64742\_90790.jpg

LS view: Headwall not visible due to high vegetation on LS toe and slope

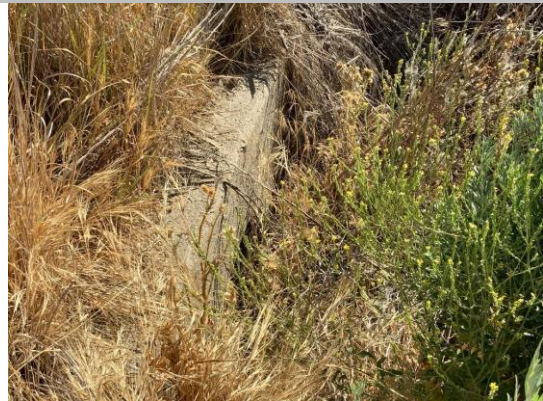
Photo 3 of 3 : UCIP\_FA\_2021\_67490\_100076.jpg

LS view: Close up of pipe inlet and headwall, covered by vegetation.

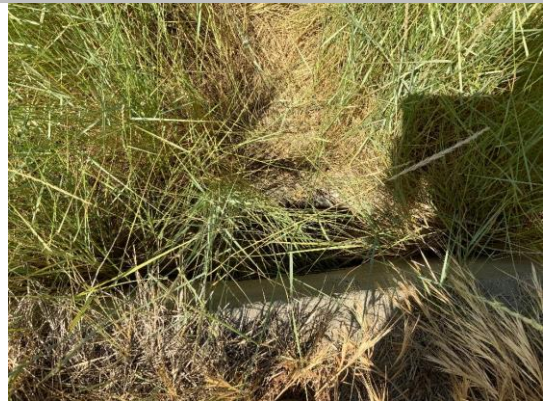
Photo 3 of 3 : UCIP\_FA\_2021\_68227\_100043.jpg

LS view: Headwall barely visible at toe.

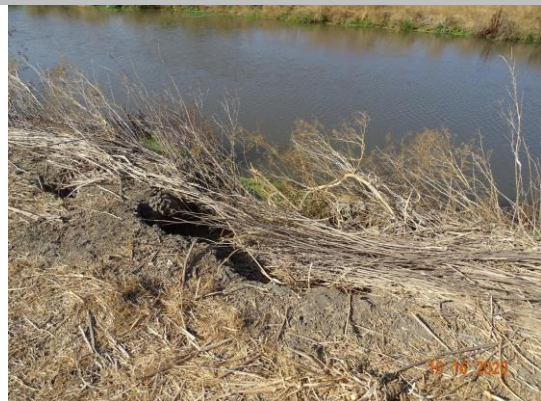
Photo 1 of 1 : FA\_2021\_NA0010\_120\_25\_20210830\_00006.jpg

View of erosion pocket in the landside slope. (Fall 2020)

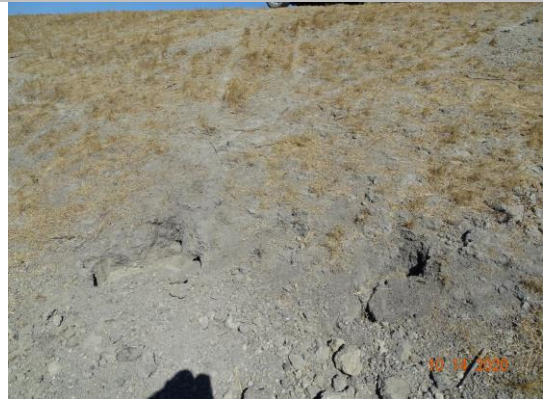
Photo 1 of 1 : FA\_2021\_NA0010\_123\_105\_20210830\_00014.jpg

View of rodent activity in the landside slope. (Fall 2020)

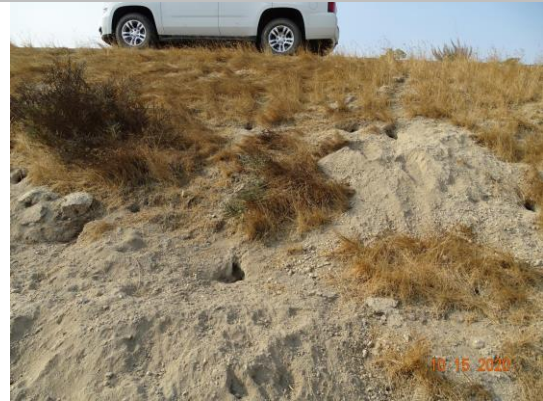
Photo 1 of 1 : FA\_2021\_NA0010\_123\_135\_20210830\_00033.jpg

View of rodent burrow in the landside slope. (Fall 2020)

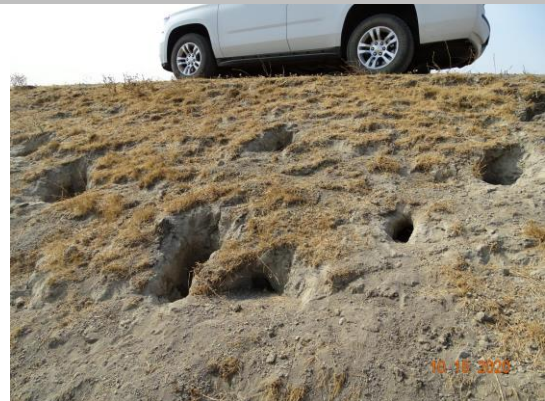
Photo 1 of 1 : FA\_2021\_NA0010\_123\_148\_20210830\_00042.jpg

View of burrows in the landside. (Fall 2020)

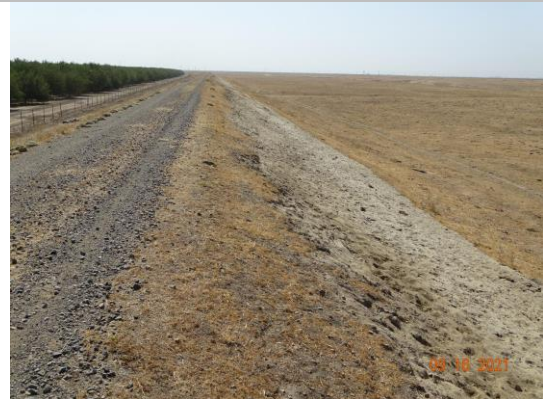
Photo 1 of 1 : FA\_2021\_NA0010\_123\_169\_20210929\_00342.jpg

View of slope damage from cattle traffic. (Fall 2021)

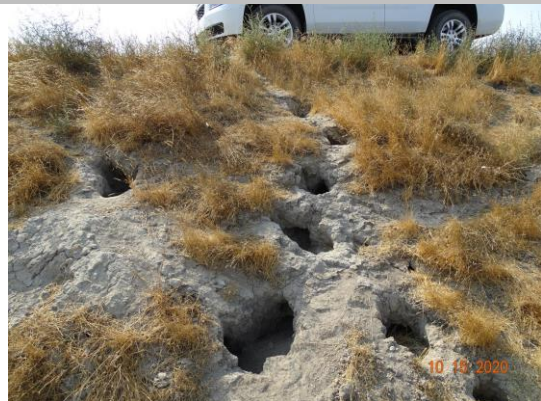
Photo 1 of 1 : FA\_2021\_NA0010\_123\_129\_20210830\_00029.jpg

Several large rodent holes noted at this location. (Fall 2020)

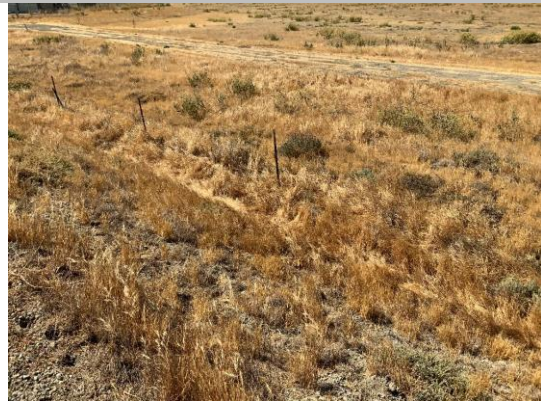
Photo 3 of 3 : UCIP\_FA\_2021\_69951\_102959.jpg

LS view: Slope from the crown, no pipe visible.

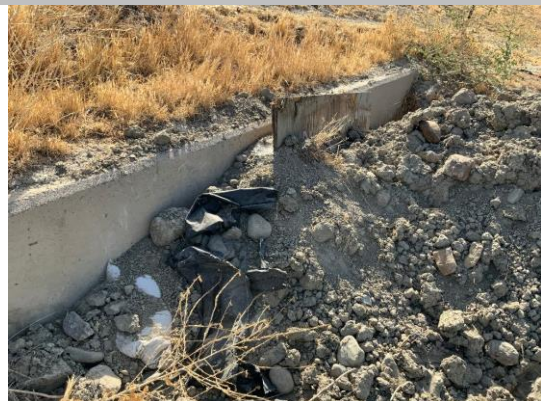
Photo 3 of 3 : UCIP\_FA\_2021\_69955\_103032.jpg

LS view: Pile of dirt completely covering pipe inlet at toe.

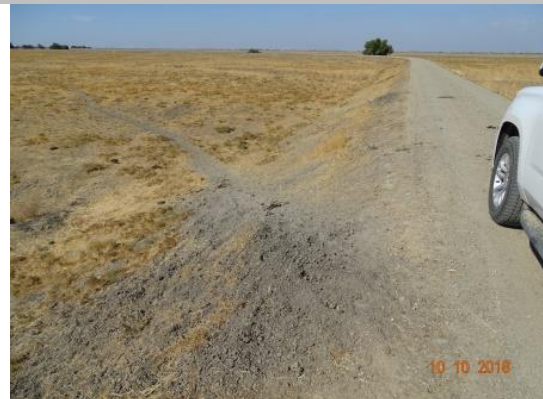
Photo 1 of 1 : FA\_2021\_NA0010\_124\_74\_20210830\_00012.jpg

Slope damage from livestock. (Fall 2018)

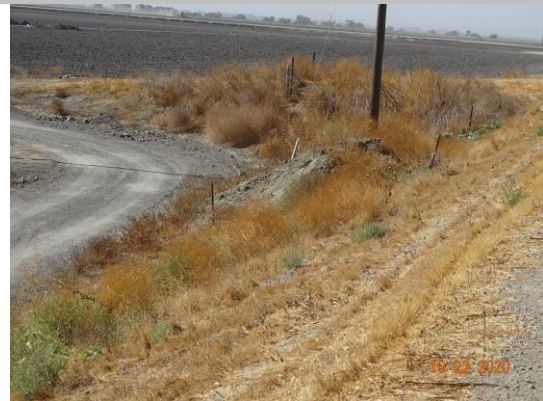
Photo 1 of 1 : FA\_2021\_NA0010\_124\_68\_20210830\_00008.jpg

Looking downstream at dirt stockpile on the landside toe. (Fall 2020)

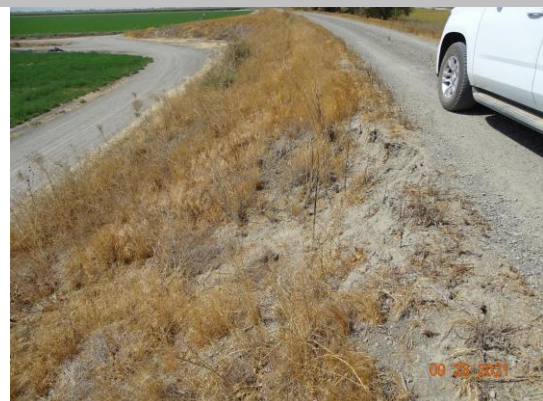
Photo 1 of 1 : FA\_2021\_NA0010\_124\_120\_20210929\_00218.jpg

View of slope stability issue on the landside slope. (Fall 2021)

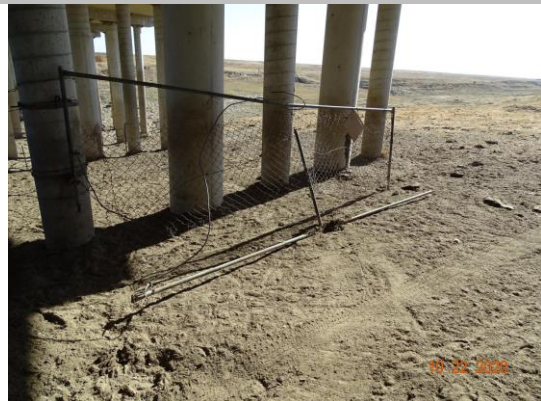
Photo 1 of 1 : FA\_2021\_NA0010\_124\_78\_20210830\_00014.jpg

View of damaged access gate under highway 152. (Fall 2020)

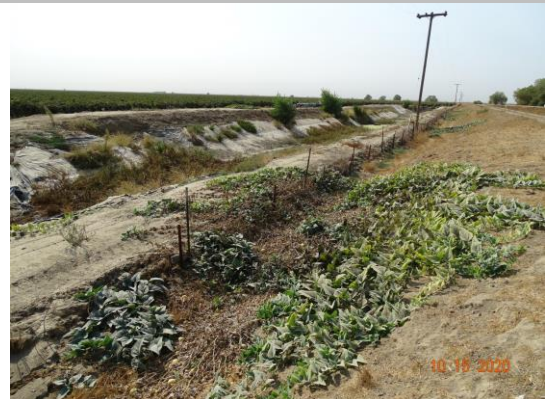
Photo 1 of 1 : FA\_2021\_NA0010\_132\_3\_20210830\_00001.jpg

Retention basin dug approximately 20 ft from the landside toe. (Fall 2020)

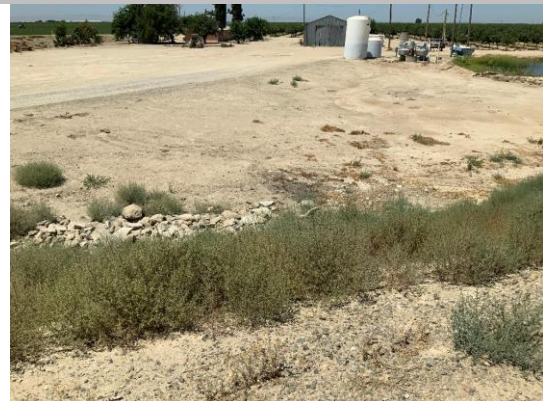
Photo 2 of 3 : UCIP\_FA\_2021\_68244\_102061.jpg

LS view: Toe from crown, no pipe visible.

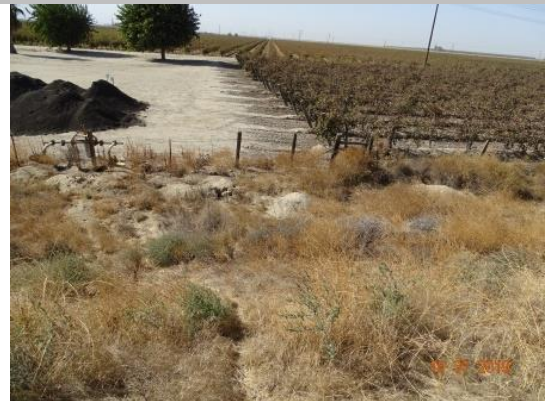
Photo 1 of 1 : FA\_2021\_NA0010\_137\_21\_20210830\_00008.jpg

Several rodent burrows observed at the landside toe. (Fall 2019)

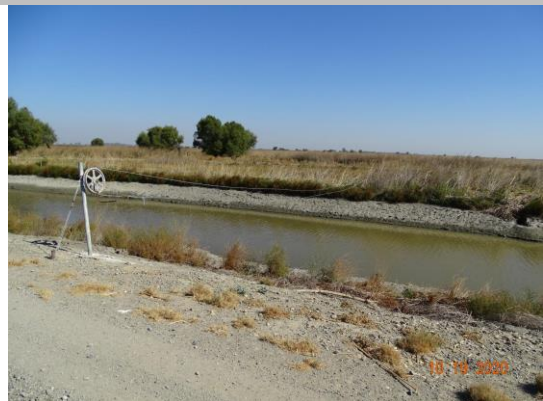
Photo 1 of 1 : FA\_2021\_NA0010\_138\_23\_20210830\_00026.jpg

Pulley on the waterside shoulder. (Fall 2020)

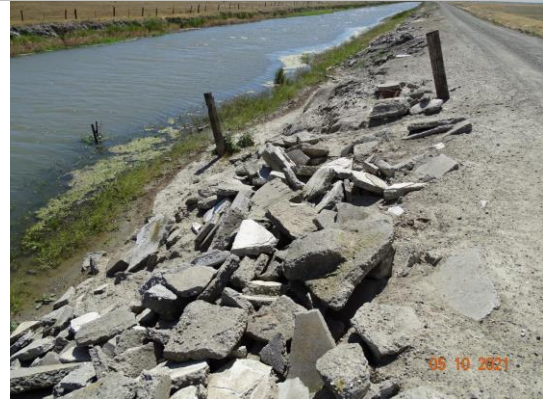
Photo 1 of 1 : FA\_2021\_NA0010\_138\_8\_20210830\_00015.jpg

Slope damage repaired with concrete rubble on the waterside slope and shoulder. (Spring 2021)

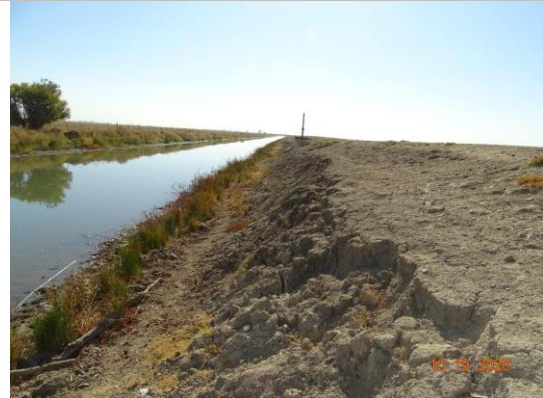
Photo 1 of 1 : FA\_2021\_NA0010\_138\_6\_20210830\_00011.jpg

Looking southeast at livestock erosion on waterward toe. (Fall 2020)

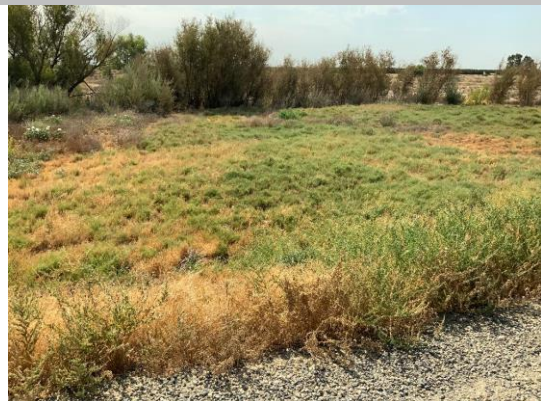
Photo 3 of 3 : UCIP\_FA\_2021\_68783\_102601.jpg

WS view: Toe from crown, no pipe or markers visible.

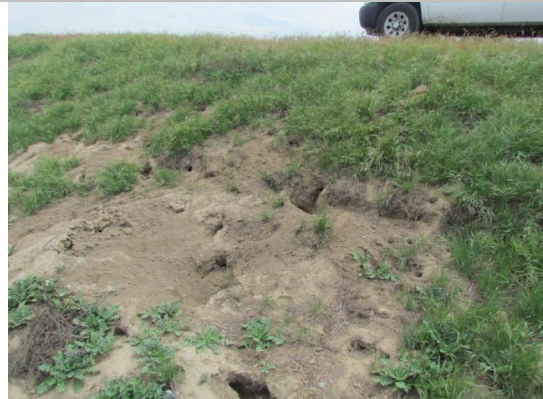
Photo 1 of 1 : FA\_2021\_NA0010\_139\_5\_20210830\_00002.jpg

Looking at several rodent holes on landside slope.

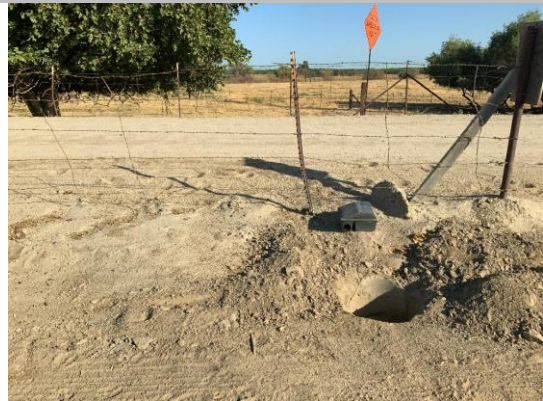
Photo 3 of 3 : UCIP\_FA\_2021\_68925\_102864.jpg

LS view: Slope from toe, no pipe visible.
