Flood Control Project Maintenance Levee Inspections

Fall 2022 Levee Maintenance Deficiency Summary Report

San Joaquin River Basin

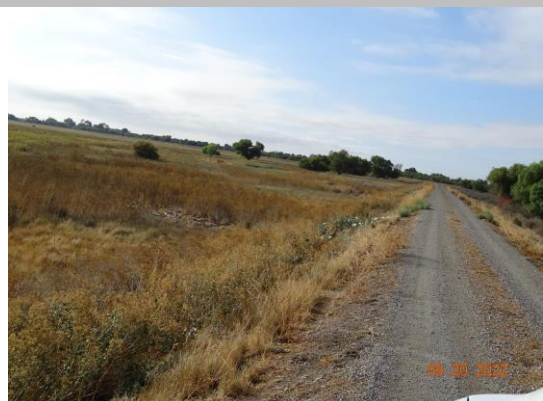
Photo 1 of 1 : FA_2022_NA0010_118_123_20221007_00293.jpg

View of vegetation on the landside slope looking upstream. (Fall 2022)

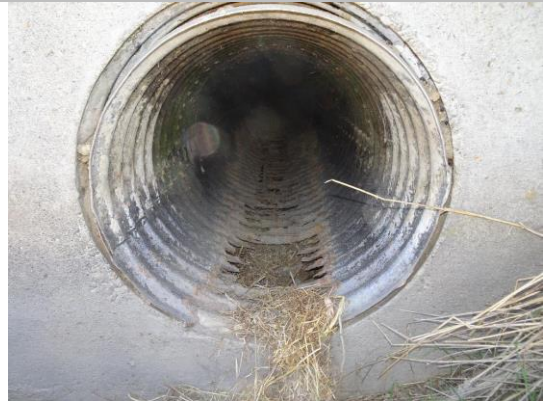
Photo 3 of 3 : UCIP_FA_2022_70665_90720.jpg

LS view: Headwall and deeply corroded pipe at LS toe

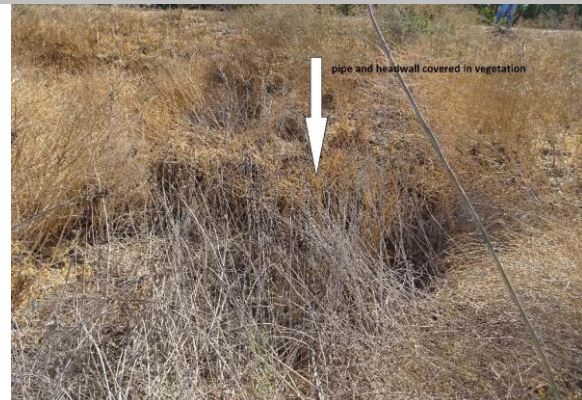
Photo 2 of 3 : UCIP_FA_2022_70675_90790.jpg

LS view: Headwall not visible due to high vegetation on LS toe and slope

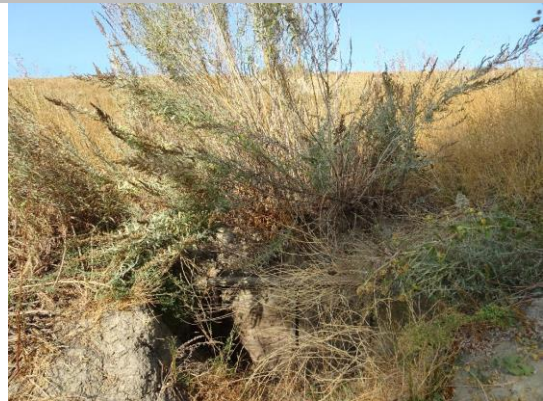
Photo 3 of 3 : UCIP_FA_2022_70688_90955.jpg

LS view: Pipe and headwall blocked by debris at LS toe

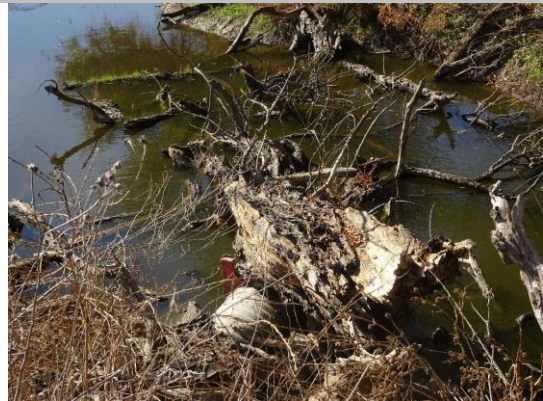
Photo 3 of 3 : UCIP_FA_2022_70706_90837.jpg

WS view: debris blocking pipe flapgate at WS toe.

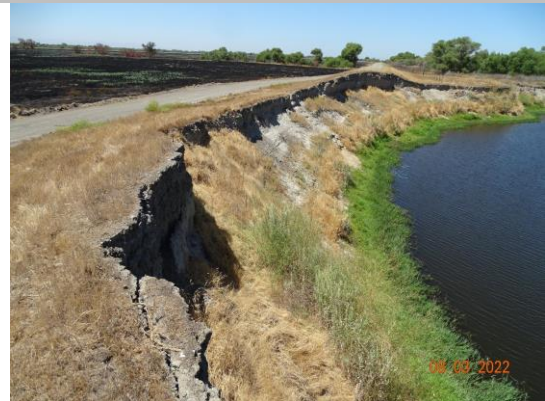
Photo 1 of 3 : SJR2022_NA0010U02RM129.22_4.JPG

8/3/2022: View of the erosion with the missing levee segment looking downstream.

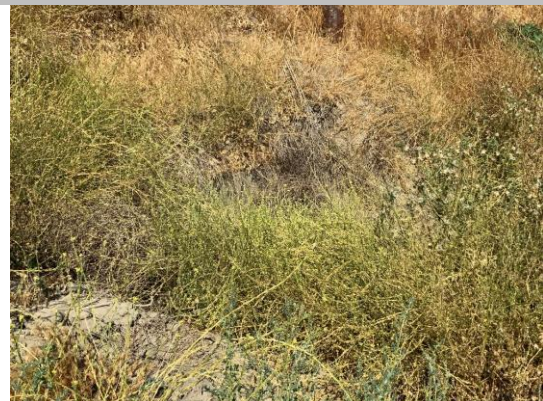
Photo 1 of 1 : UCIP_FA_2022_70965_101342.jpg

LS toe: Headwall buried under vegetation.

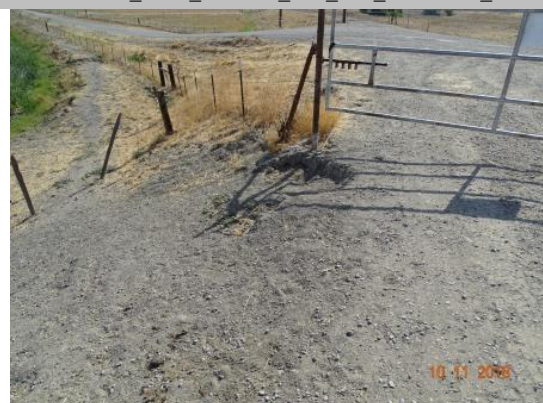
Photo 1 of 1 : FA_2022_NA0010_123_140_20220822_00036.jpg

Erosion on landward slope caused by animal foot traffic. (Fall 2018)

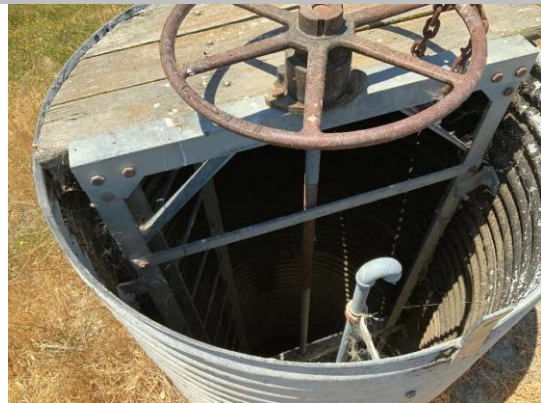
Photo 1 of 2 : UCIP_FA_2022_71009_100872.jpg

WS view: Close up of riser and slidegate, missing partial cover.

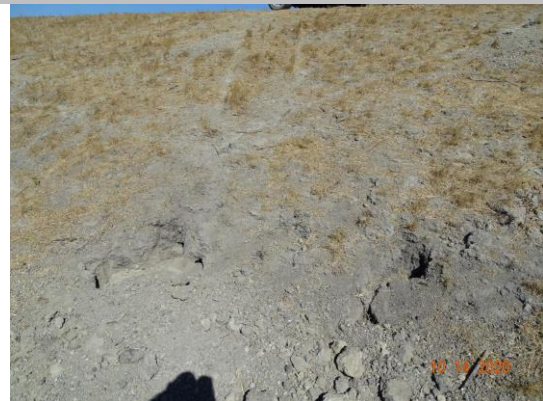
Photo 1 of 1 : FA_2022_NA0010_123_105_20220822_00013.jpg

View of rodent activity in the landside slope. (Fall 2020)

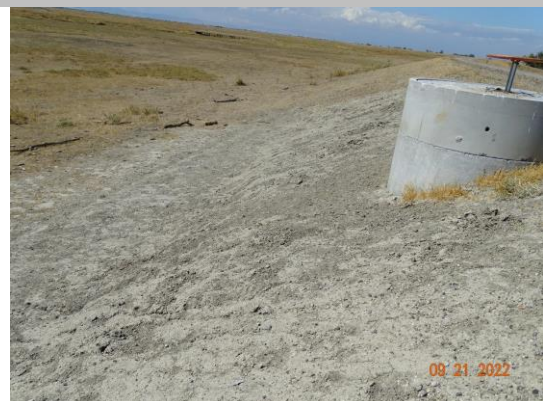
Photo 1 of 1 : FA_2022_NA0010_123_174_20221010_00364.jpg

Erosion on the waterside slope from livestock activity. (Fall 2022)

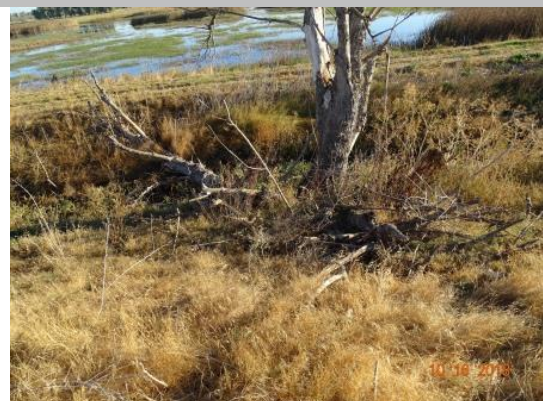
Photo 1 of 1 : FA_2022_NA0010_123_150_20220822_00042.jpg

Tree trimmings on landside slope and toe. (Fall 2018)

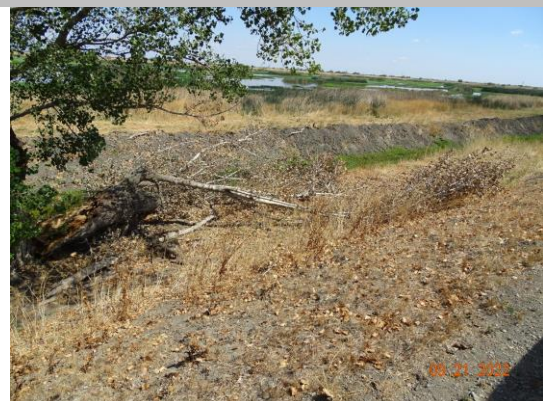
Photo 1 of 1 : FA_2022_NA0010_123_180_20221010_00366.jpg

Fallen trees and broken limbs on the landside slope and toe. (Fall 2022)

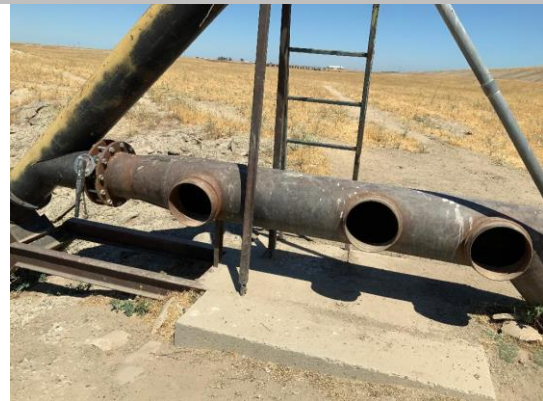
Photo 1 of 2 : UCIP_FA_2022_71055_104368.jpg

WS view: Closeup of pipe with missing valves or covers, 1 of 2 photos.

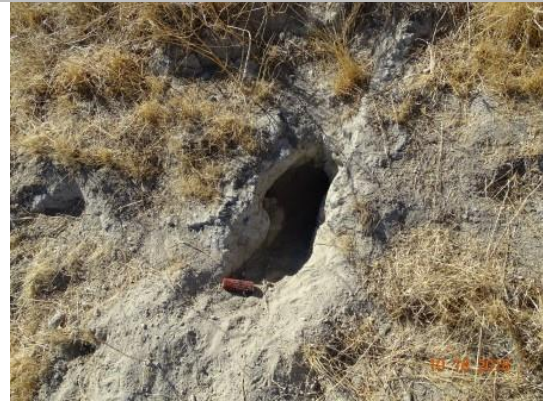
Photo 1 of 1 : FA_2022_NA0010_123_9_20220822_00007.jpg

View of representative rodent burrow. (Fall 2018)

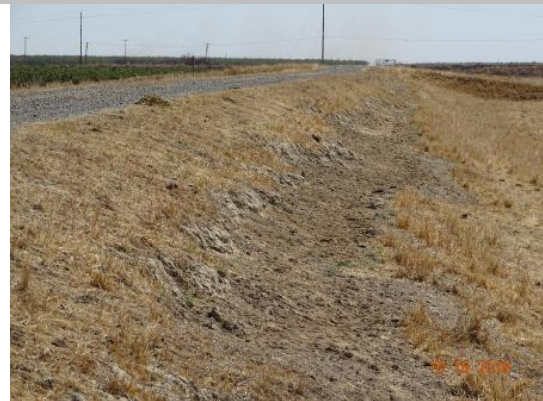
Photo 1 of 1 : FA_2022_NA0010_123_164_20220822_00052.jpg

Slope damage from animal traffic. (Fall 2018)

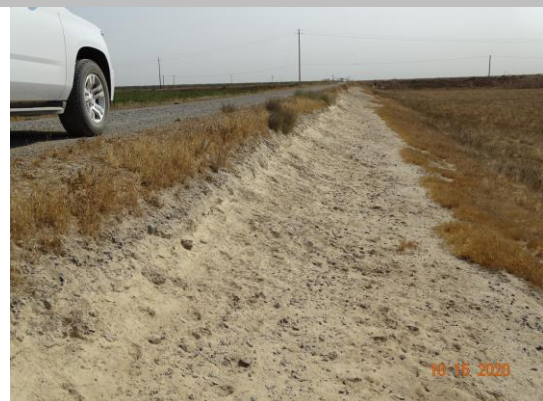
Photo 1 of 1 : FA_2022_NA0010_123_171_20220822_00058.jpg

Looking south at livestock erosion on the waterside slope. (Fall 2020)

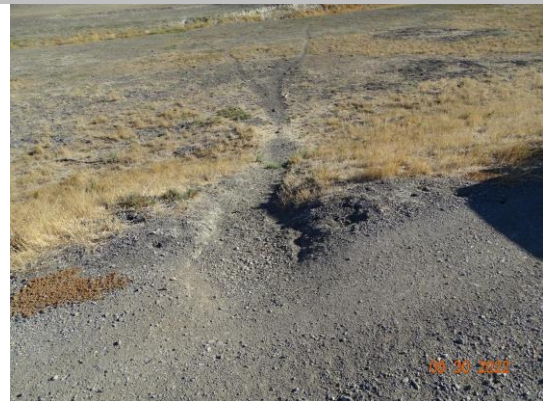
Photo 1 of 1 : FA_2022_NA0010_124_85_20221010_00245.jpg

View of livestock damage on waterside slope. (Fall 2022)

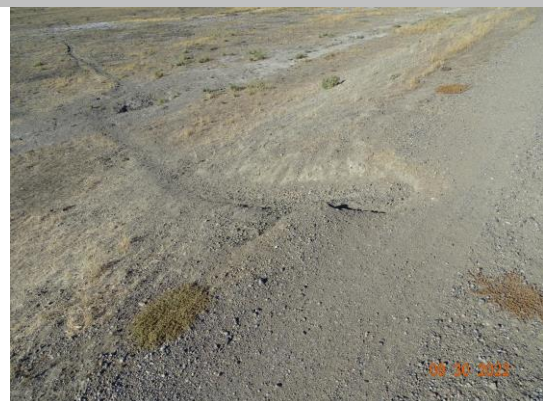
Photo 1 of 1 : FA_2022_NA0010_124_84_20221010_00246.jpg

Erosion to slope and into crown from livestock. (Fall 2022)

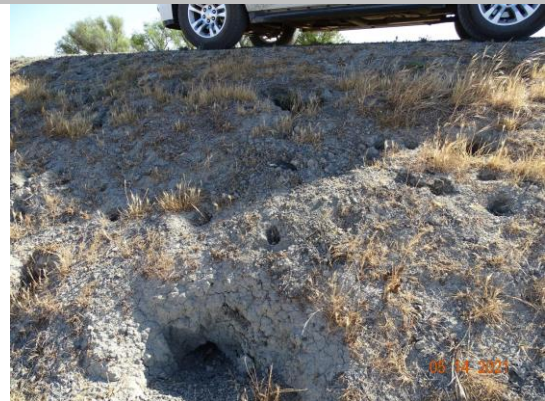
Photo 1 of 1 : FA_2022_NA0010_124_90_20220822_00023.jpg

Looking at multiple rodent holes in the landside slope. (Spring 2021)

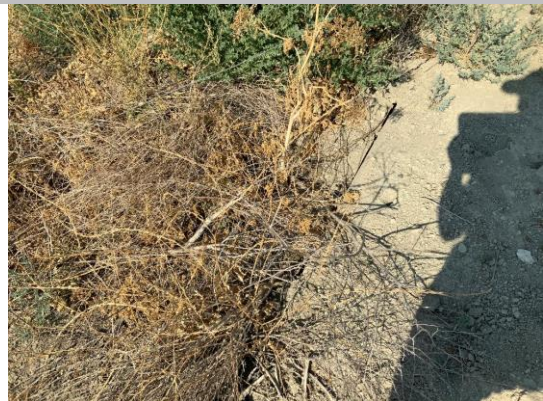
Photo 1 of 3 : UCIP_FA_2022_71152_102340.jpg

LS view: Top of headwall at toe, inlet covered with vegetation.

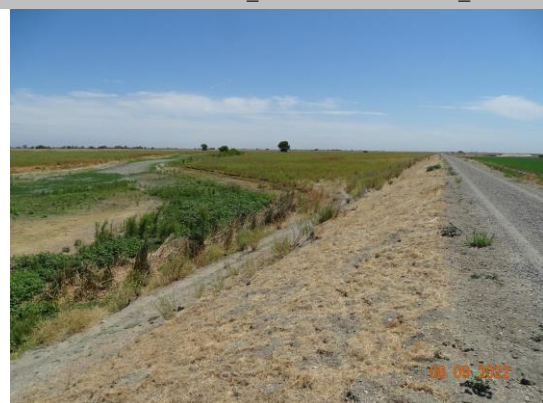
Photo 1 of 3 : SJR2022_NA0010U06LM14.95_2.JPG

8/9/2022: View of the erosion looking upstream.

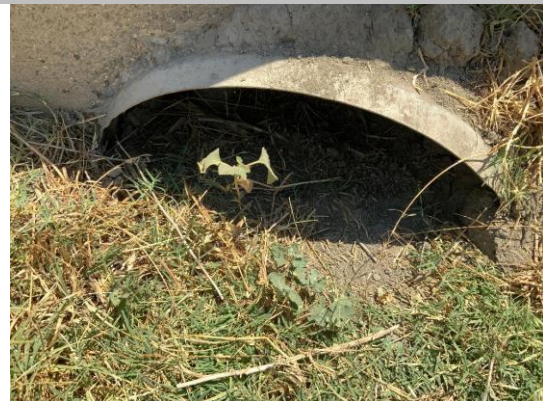
Photo 1 of 2 : UCIP_FA_2022_71137_101421.jpg

LS view: Closeup of pipe inlet at toe filled with sediment.

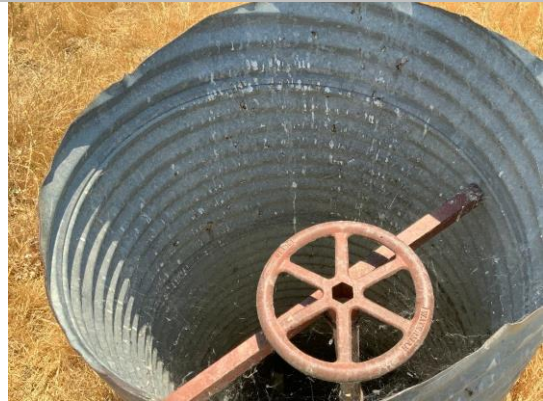
Photo 1 of 2 : UCIP_FA_2022_71139_101555.jpg

WS view: Riser missing cover on slope.

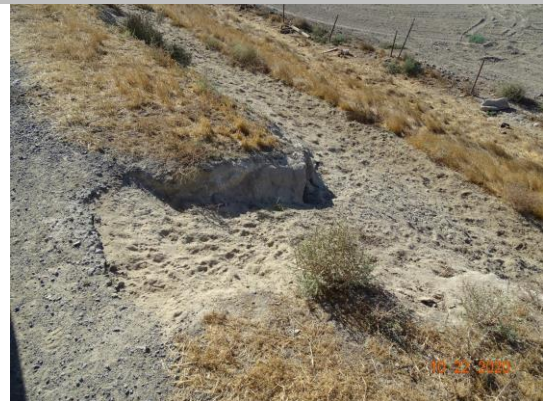
Photo 1 of 1 : FA_2022_NA0010_124_91_20220822_00024.jpg

Cattle trail damage to the landside slope and shoulder. (Fall 2020)

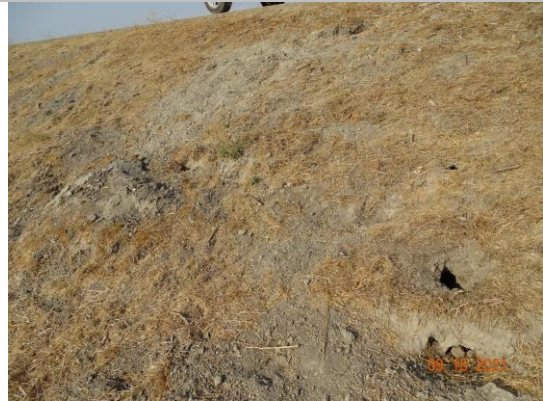
Photo 1 of 1 : FA_2022_NA0010_125_23_20220822_00009.jpg

Looking at rodent burrows along the waterside slope. (Fall 2021)

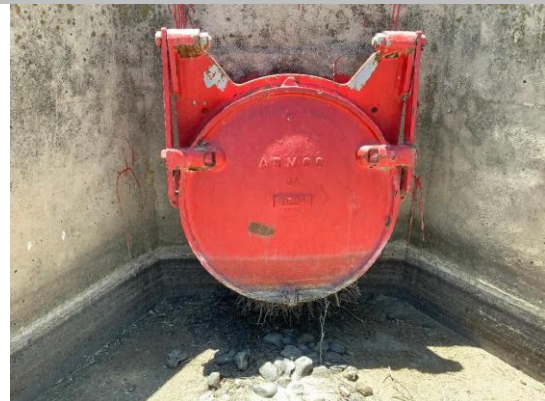
Photo 1 of 1 : UCIP_FA_2022_71182_99580.jpg

WS view: Close up of flapgate, vegetation coming out of it.

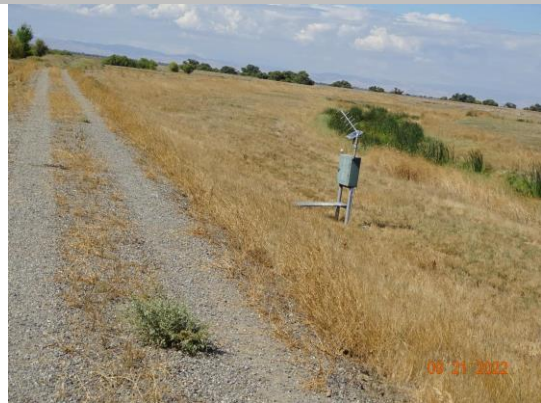
Photo 1 of 1 : FA_2022_NA0010_128_3_20221012_00002.jpg

View of vegetation on the waterside slope looking downstream. (Fall 2022)

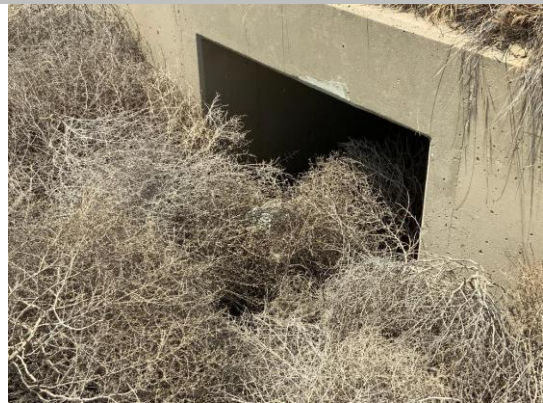
Photo 1 of 1 : UCIP_FA_2022_73439_102427.jpg

LS view: Closeup of inlet at toe covered by tumbleweeds.

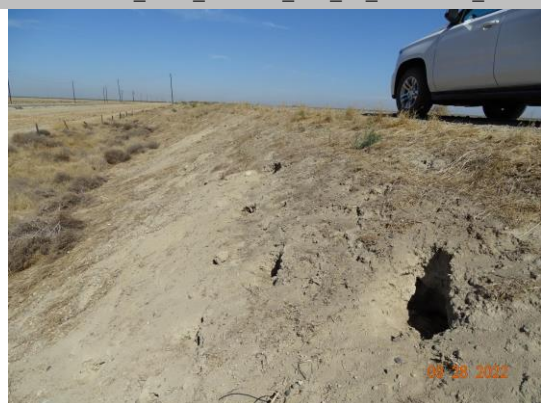
Photo 1 of 1 : FA_2022_NA0010_137_38_20221014_00018.jpg

Several rodent holes observed in this section. (Fall 2022)

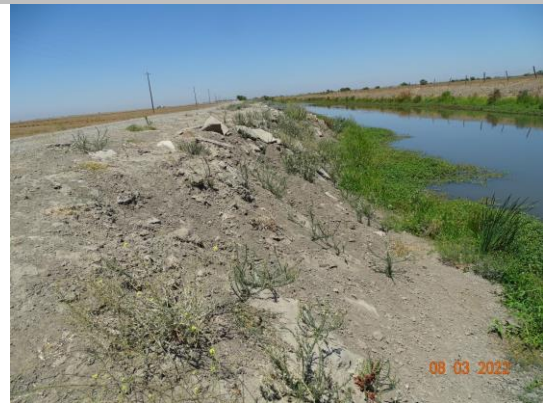
Photo 1 of 1 : SJR2022_NA0010U22RM3.70_2.JPG

8/3/2022: View of the erosion looking downstream.

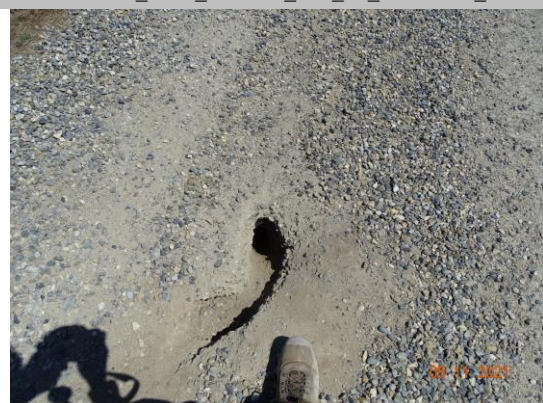
Photo 1 of 1 : FA_2022_NA0010_139_31_20220822_00009.jpg

View of rodent burrow in the levee crown. (Spring 2021)

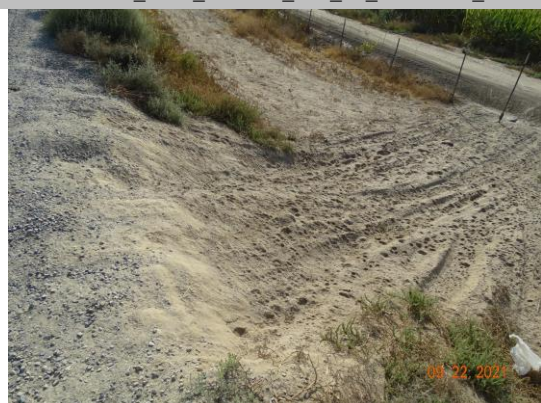
Photo 1 of 1 : FA_2022_NA0010_140_39_20220822_00012.jpg

Damage to the landside slope from vehicle traffic. (Fall 2021)

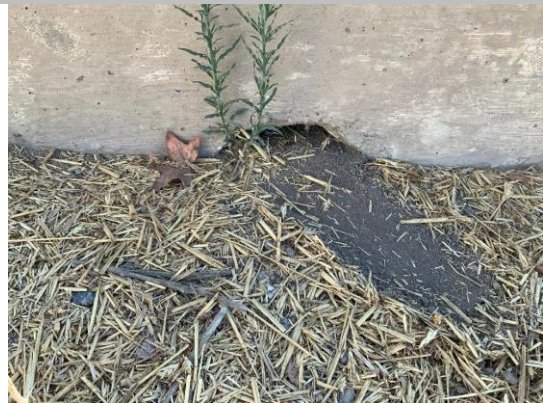
Photo 1 of 2 : UCIP_FA_2022_73636_102830.jpg

LS view: Closeup of pipe inlet buried with sediment.
