Flood Control Project Maintenance Levee Inspections

Fall 2024 Levee Maintenance Deficiency Summary Report

San Joaquin River Basin

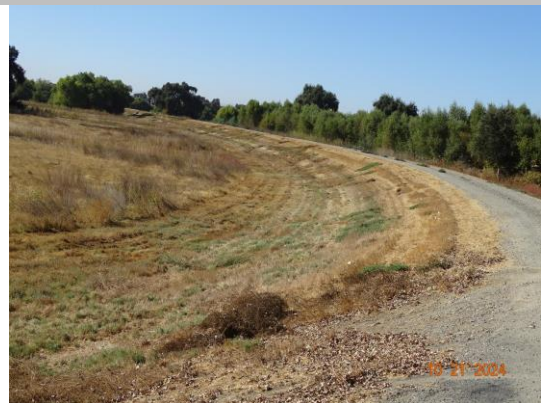
Photo 1 of 1 : FA_2024_NA0010_118_88_20241105_00251.jpg

View of vegetation management on the landside slope. (Fall 2024)

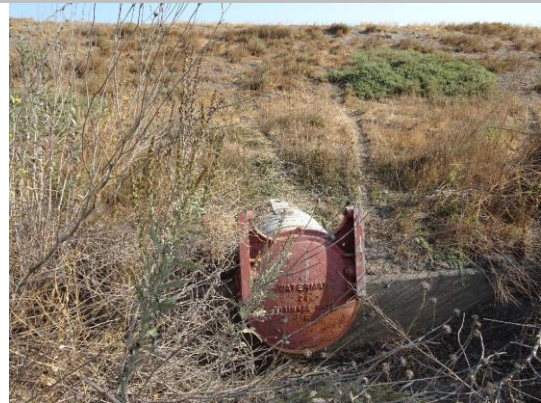
Photo 2 of 3 : UCIP_FA_2024_70639_90546.jpg

WS view: Pipe, flapgate, and headwall at WS toe

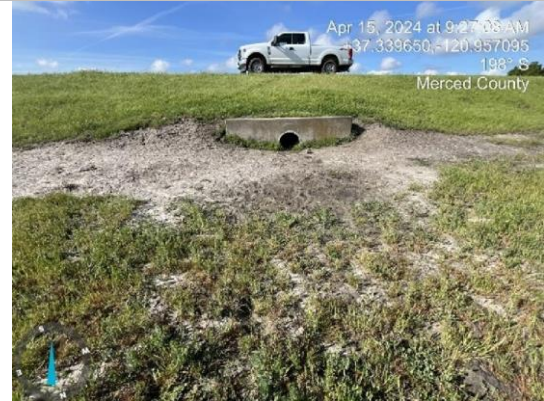
Photo 1 of 3 : UCIP_FA_2024_83233_121598.jpg

LS view: Headwall and pipe on LS toe. Scour surrounding headwall has been addressed (photo sent by LMA).

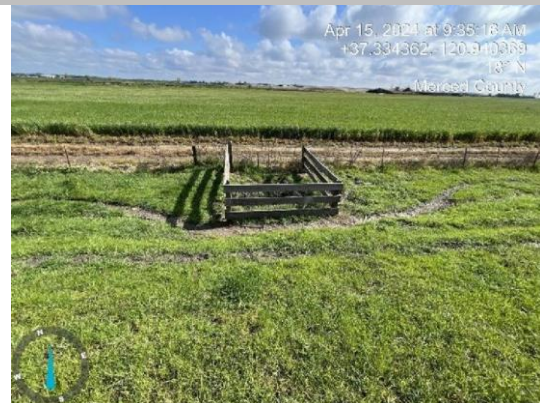
Photo 1 of 3 : UCIP_FA_2024_83239_121609.jpg

LS view: Rodent activity near crossing noted in 10/06/2020 inspection has been corrected (photo sent by LMA).

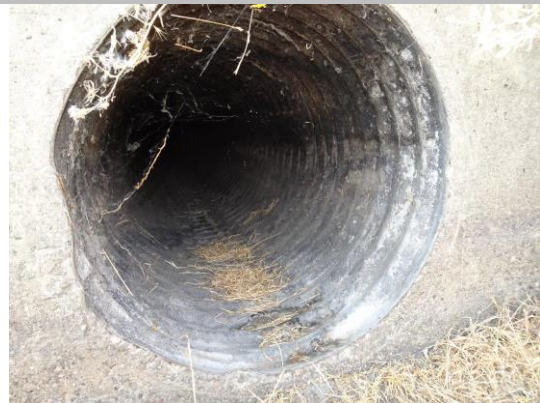
Photo 3 of 3 : UCIP_FA_2024_70649_90636.jpg

LS view: close up view inside pipe inlet

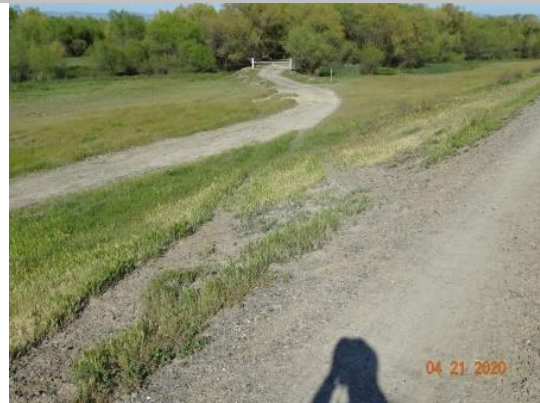
Photo 1 of 1 : FA_2024_NA0010_118_113_20240828_00014.jpg

LM Start	2.58	Rating **	A/W	Issue No.	113
LM End	2.58	Issue Type +	Ma	Location *	WS
Category	Earthen Levee			GPS Latitude/Longitude	
				Start	End
Item	Erosion / Vehicle Traffic			37.327936 °	37.327936 °
				-120.933013 °	-120.933013 °
DWR ID	DWR_NA0010_01_f_2018_113				
Comment Code					
E6 : Repair the levee slope damaged by vehicle traffic and prevent access where possible.					
Inspector Comment					
There is damage caused by vehicle traffic over the levee but the integrity of the levee is not compromised. Continue to monitor.

Slope damage by vehicle traffic. (Spring 2020)

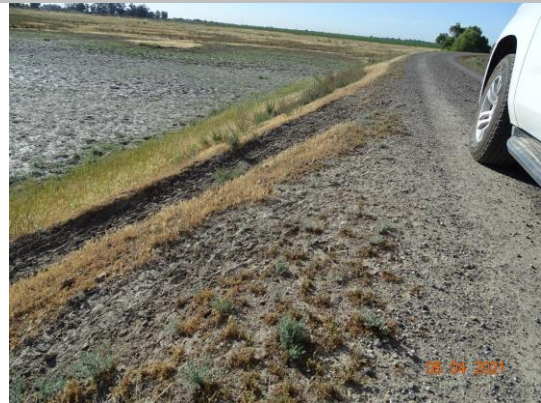
Photo 1 of 1 : FA_2024_NA0010_118_104_20240828_00008.jpg

Slope damage on the landside slope from livestock traffic. (Spring 2021)

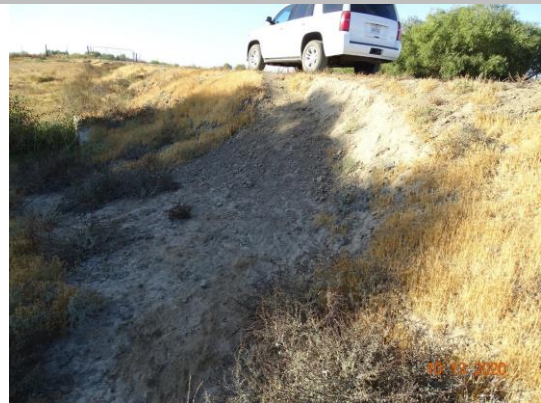
Photo 1 of 1 : FA_2024_NA0010_118_108_20240828_00011.jpg

LM Start	3.13	Rating **	M	Issue No.	108
LM End	3.13	Issue Type +	Ma	Location *	LS
Category	Earthen Levee			GPS Latitude/Longitude	
				Start	End
Item	Erosion / Livestock			37.321488 °	37.321488 °
				-120.928758 °	-120.928758 °
DWR ID	DWR_NA0010_01_s_2017_108				
Comment Code					
E4 : Repair the levee slope damaged by livestock and prevent large animal access.					
Inspector Comment					
Slope damage caused by animal traffic on landside toe.

View of landside slope damage by animal traffic. (Fall 2020)

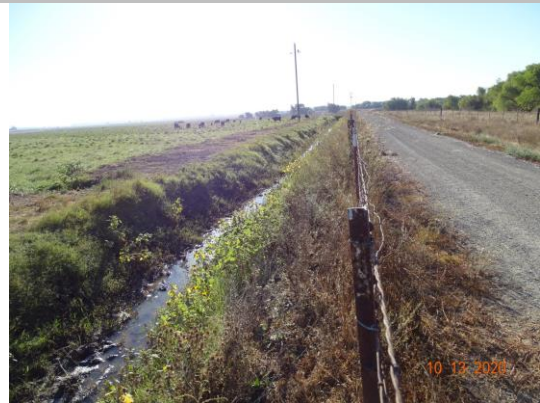
Photo 1 of 1 : FA_2024_NA0010_118_5_20240828_00002.jpg

Looking south at irrigation ditch at the landside toe. (Fall 2020)

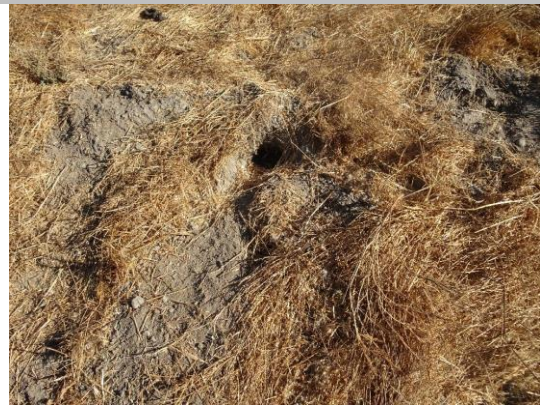
Photo 3 of 3 : UCIP_FA_2024_77849_90673.jpg

Observed burrowing on limited view of LS and WS slopes

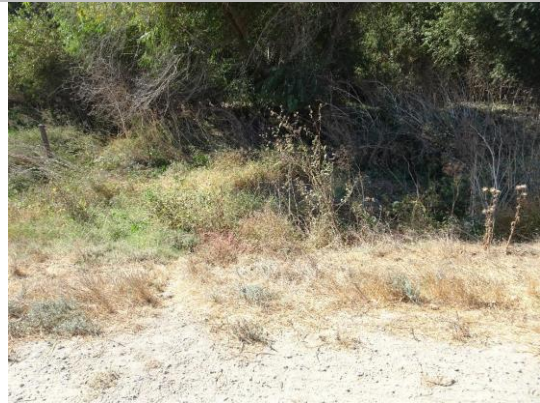
Photo 3 of 3 : UCIP_FA_2024_70663_90708.jpg

WS view: Pipe and flapgate at WS toe not visible from levee crown due to dense vegetation

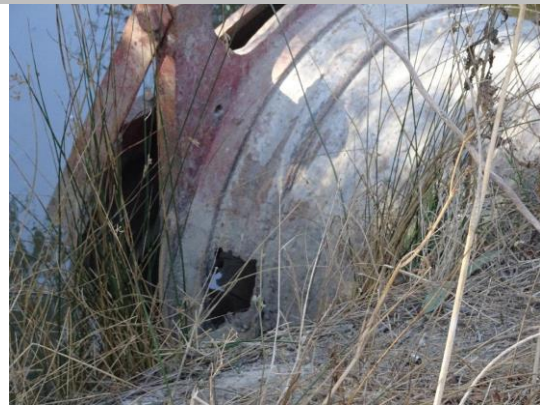
Photo 3 of 3 : UCIP_FA_2024_70664_90723.jpg

WS view: Extensive corrosion visible at WS invert

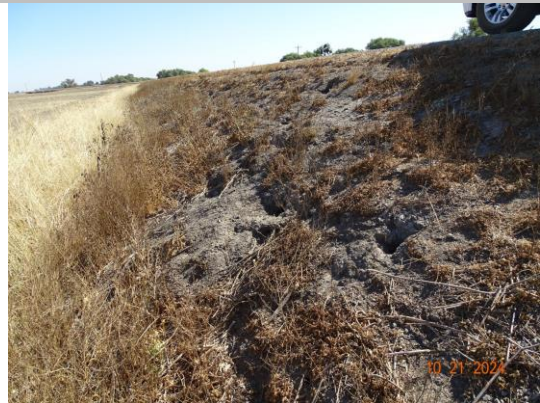
Photo 1 of 1 : FA_2024_NA0010_118_90_20241105_00253.jpg

View of rodent burrows on the landside slope. (Fall 2024)

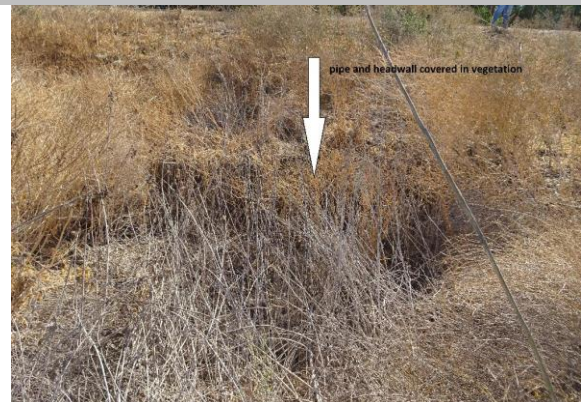
Photo 2 of 3 : UCIP_FA_2024_84500_90790.jpg

LS view: Headwall not visible due to high vegetation on LS toe and slope

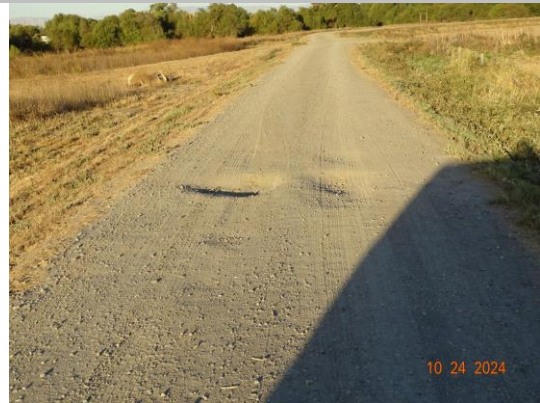
Photo 1 of 1 : FA_2024_NA0010_118_91_20241105_00255.jpg

View of depressions in the levee crown. (Fall 2024)

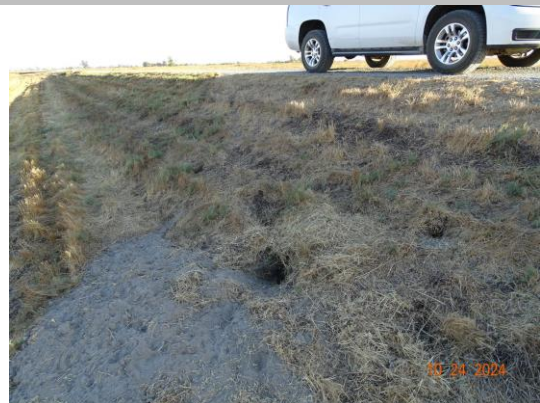
Photo 1 of 1 : FA_2024_NA0010_118_92_20241105_00256.jpg

View of rodent burrows in the waterside slope. (Fall 2024)

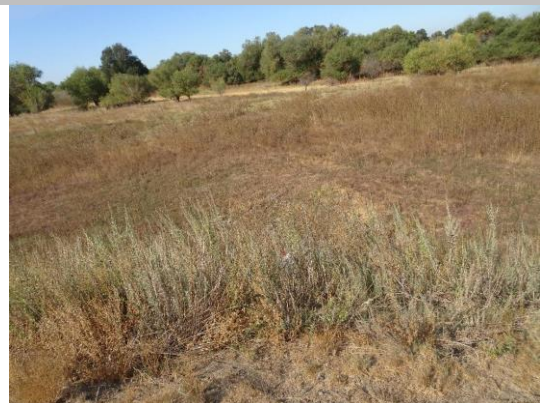
Photo 2 of 3 : UCIP_FA_2024_83274_90960.jpg

WS view: dense vegetation near WS toe.

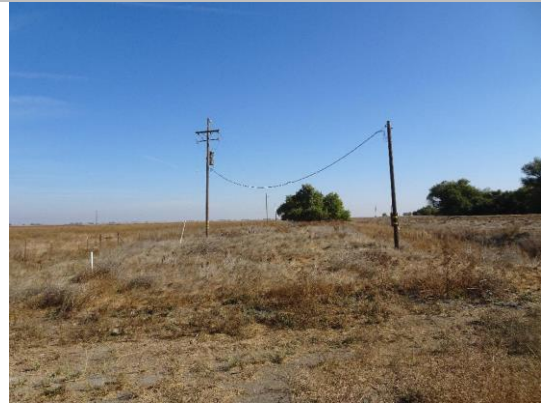
Photo 3 of 3 : UCIP_FA_2024_81165_90823.jpg

LS view: view from LS toe, looking US. Pipe and headwall not found on LS toe.

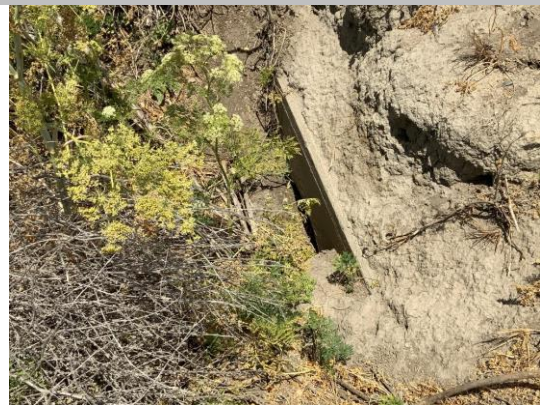
Photo 1 of 1 : UCIP_FA_2024_70943_100135.jpg

LS view: Headwall barely visible at toe, covered in sediment.

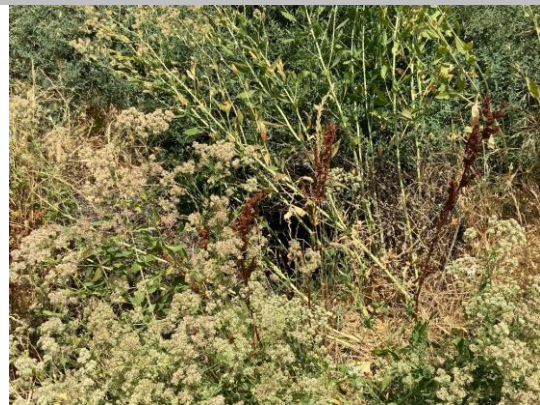
Photo 1 of 1 : UCIP_FA_2024_70946_100157.jpg

LS view: Close up of pipe inlet at toe covered in vegetation.

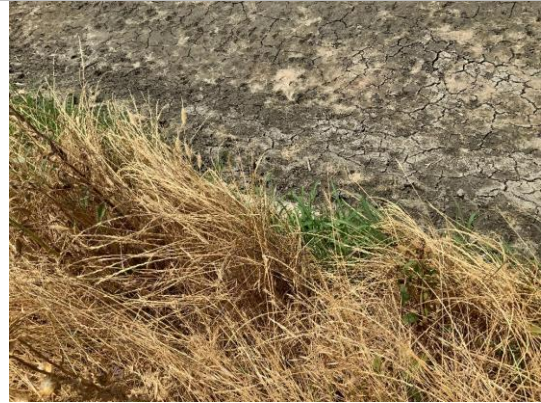
Photo 1 of 1 : UCIP_FA_2024_77861_100170.jpg

LS view: Headwall barely visible at toe, buried under sediment.

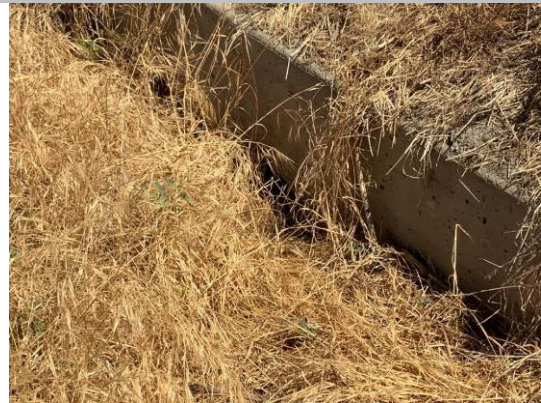
Photo 1 of 2 : UCIP_FA_2024_70954_100343.jpg

LS view: Close up of pipe inlet, covered in vegetation.

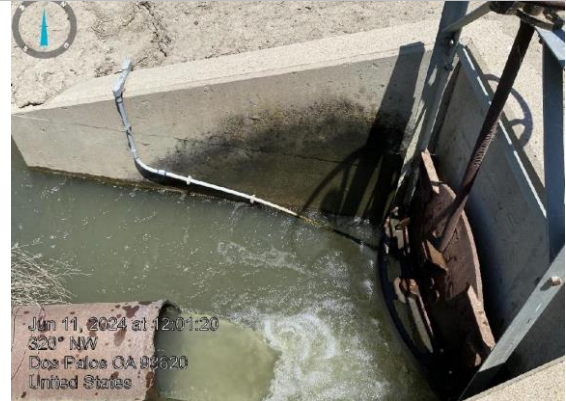
Photo 1 of 3 : UCIP_FA_2024_84570_124937.jpg

Water-Side: 16-inch steel irrigation pipe discharging outside 36-inch CMP pipe, standing water around headwall. Photo courtesy by CVFPB

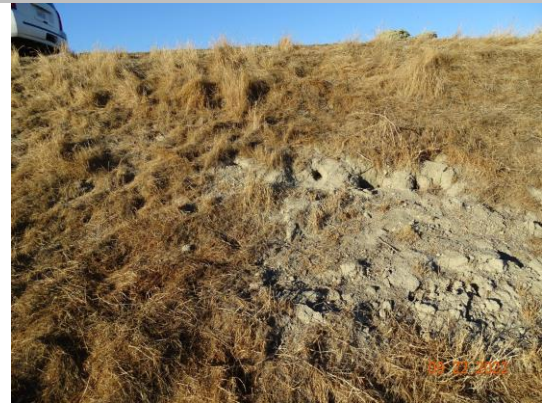
Photo 1 of 1 : FA_2024_NA0010_123_185_20240828_00056.jpg

View of rodent burrows in the landside slope. (Fall 2022)

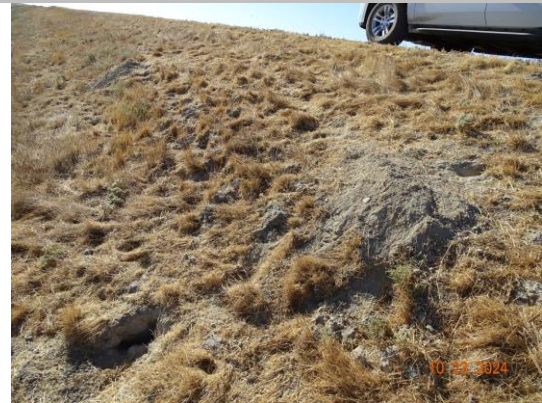
Photo 1 of 1 : FA_2024_NA0010_123_108_20241105_00292.jpg

Multiple rodent holes observed in the landside slope. (Fall 2024)

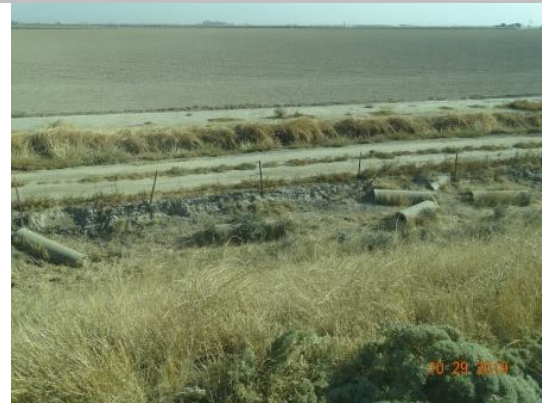
Photo 1 of 1 : FA_2024_NA0010_123_175_20240828_00051.jpg

Sections of concrete pipe left along the landside toe. (Fall 2019)

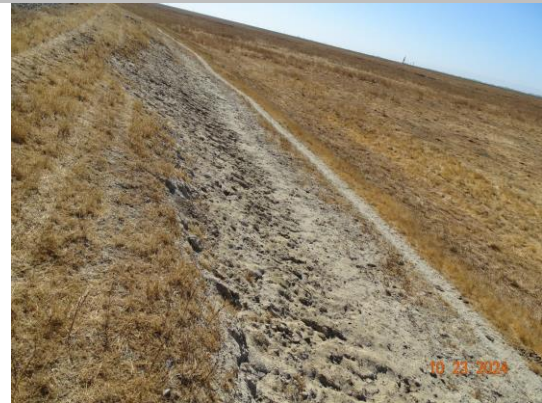
Photo 1 of 1 : FA_2024_NA0010_123_169_20241105_00296.jpg

Damage to the waterside slope and shoulder from livestock traffic. (Fall 2024)

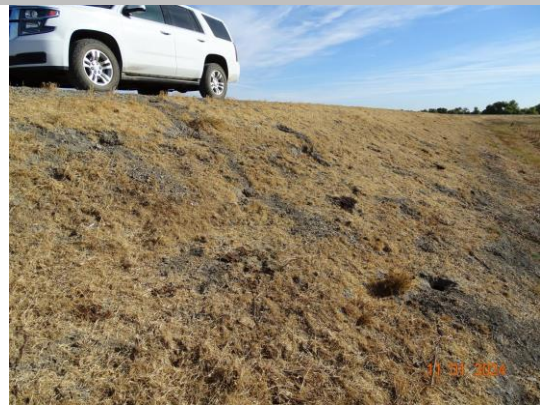
Photo 1 of 1 : FA_2024_NA0010_124_126_20241105_00146.jpg

View of rodent burrows on the landside slope. (Fall 2024)

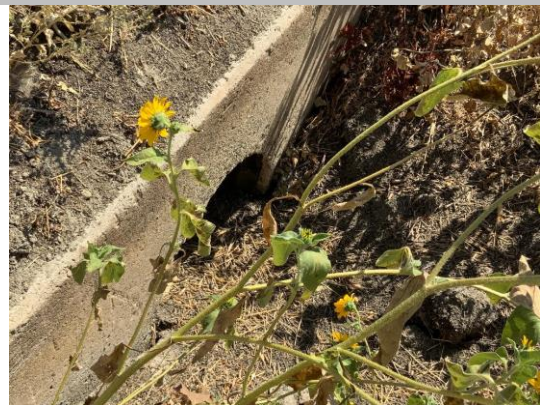
Photo 1 of 2 : UCIP_FA_2024_71097_102947.jpg

LS view: Closeup of pipe inlet at toe with dense sediment and debris inside.

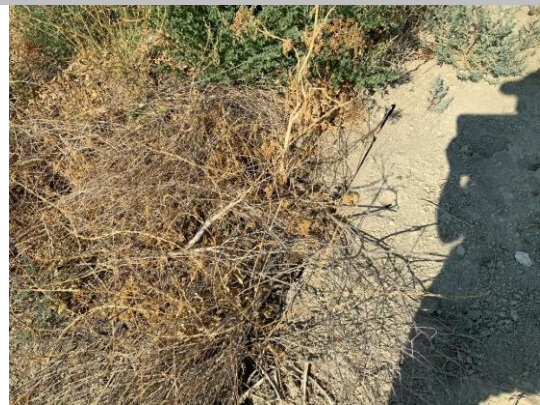
Photo 1 of 3 : UCIP_FA_2024_71152_102340.jpg

LS view: Top of headwall at toe, inlet covered with vegetation.

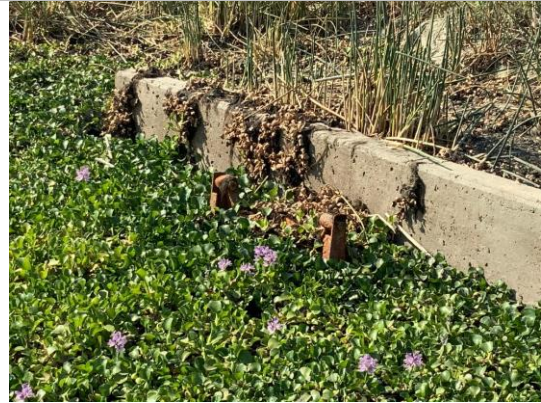
Photo 1 of 1 : UCIP_FA_2024_71134_102360.jpg

WS view: Closeup of headwall and flapgate covered by dirt at toe.

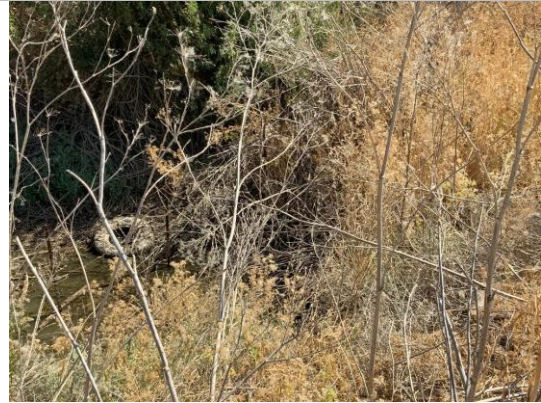
Photo 2 of 2 : UCIP_FA_2024_71141_101584.jpg

WS view: Close up of pipe outlet area covered with vegetation.

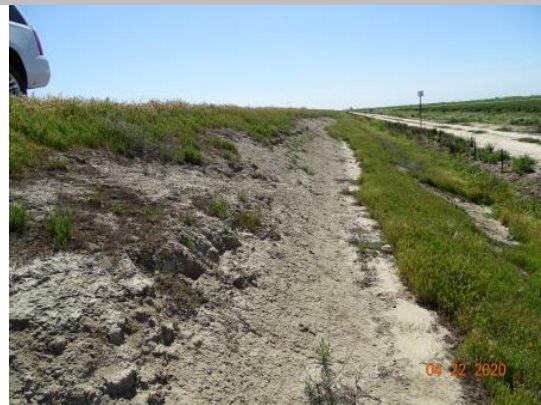
Photo 1 of 1 : FA_2024_NA0010_124_1209_20240828_00073.jpg

Erosion on the landside slope from livestock activity. (Spring 2020)

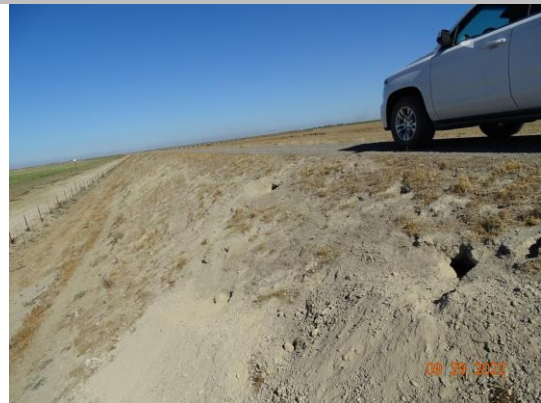
Photo 1 of 1 : FA_2024_NA0010_124_149_20240828_00067.jpg

View of multiple rodent holes on the landside slope. (Fall 2022)

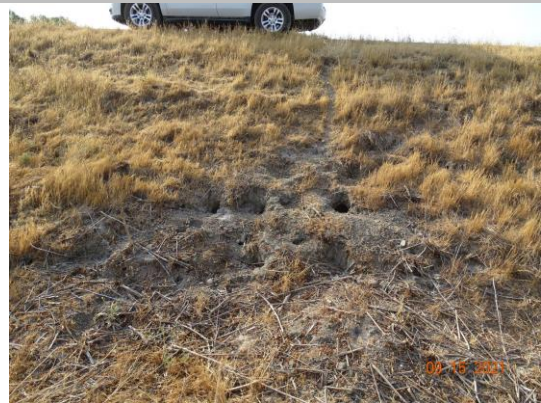
Photo 1 of 1 : FA_2024_NA0010_125_17_20240828_00005.jpg

View of rodent holes in the landside slope. (Fall 2021)

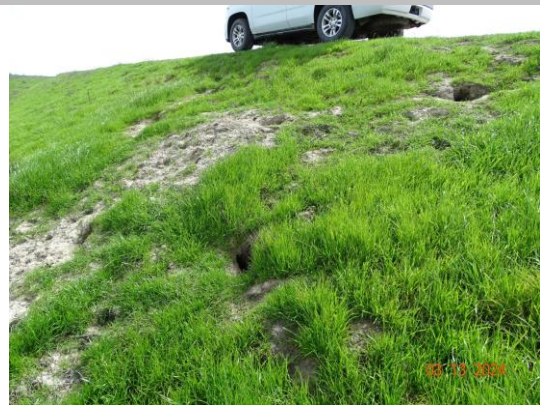
Photo 1 of 1 : FA_2024_NA0010_127_5_20240828_00001.jpg

View of multiple rodent holes on the landside slope. (Spring 2024)

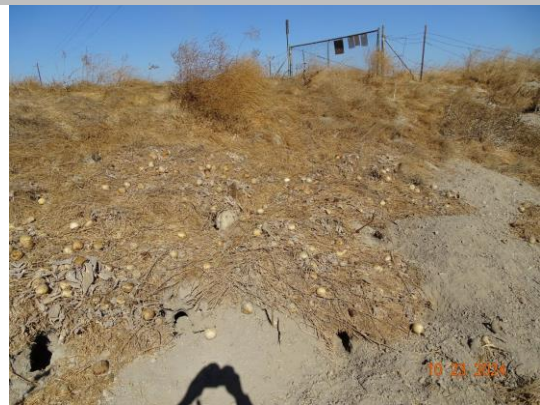
Photo 1 of 1 : FA_2024_NA0010_134_12_20241106_00010.jpg

Large rodent holes in the landside slope. (Fall 2024)
