**Flood Control Project Maintenance
Levee Inspections**
LMA District Cover Sheet
Spring 2008 Levee Inspection Results

Lower San Joaquin Levee District

Levee Inspection Report By Mile - Spring 2008

Waterway	Bank	Unit Miles	Inspection Date	Inspector
Unit No. 01 San Joaquin River	Right	22.56	04/07/2008	Richard Willoughby

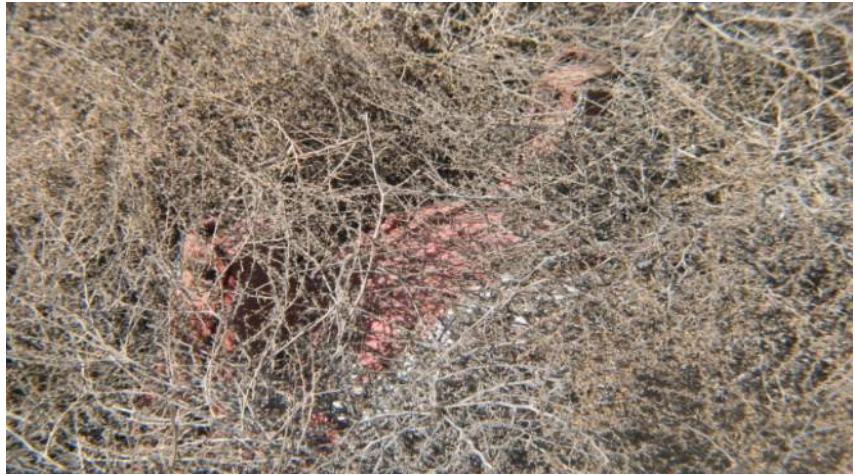
Levee Mile Report Line	4
Start Levee Mile	0.87
End Levee Mile	0.87
Location	
Category	Interior Drainage & Piping Systems
Item	Vegetation & Obstructions
Vegetation (Tumbleweeds) blocking flap gate at LM 0.87

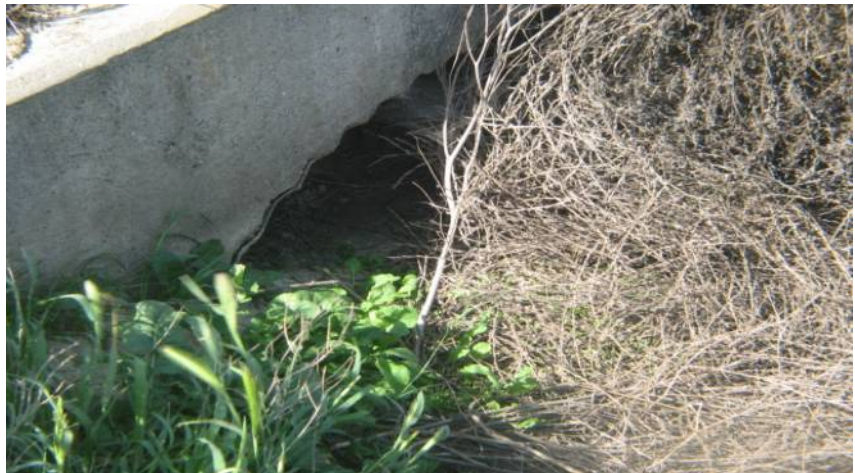
Levee Mile Report Line	5
Start Levee Mile	3.95
End Levee Mile	3.95
Location	
Category	Interior Drainage & Piping Systems
Item	Vegetation & Obstructions
Inlet of pipe over 50 % blockage at LM 3.95

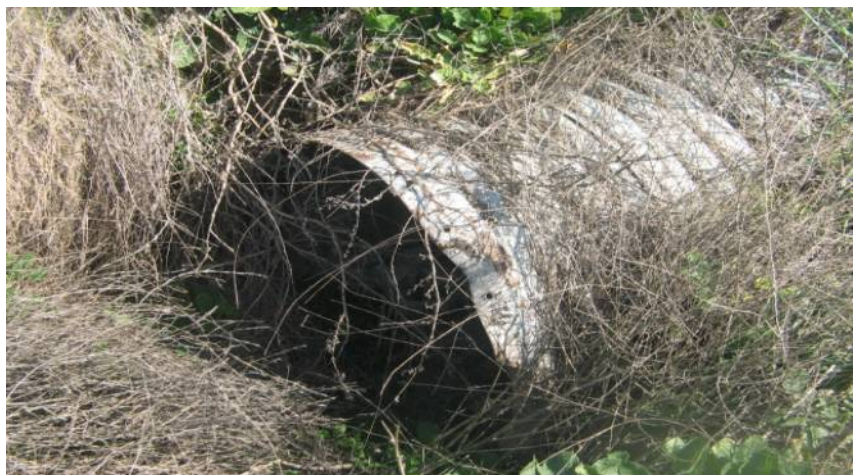
Levee Mile Report Line	6
Start Levee Mile	3.95
End Levee Mile	3.95
Location	
Category	Interior Drainage & Piping Systems
Item	Flap Gates
Flap gate missing at LM 3.95

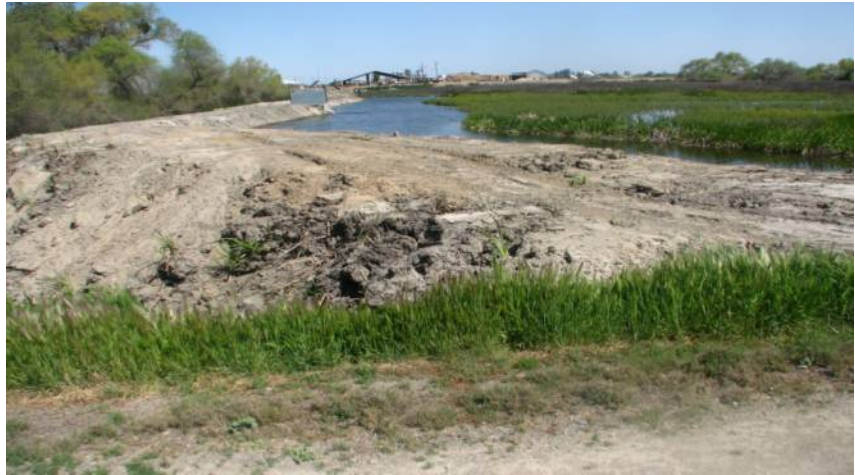
Levee Mile Report Line	7
Start Levee Mile	6.33
End Levee Mile	6.33
Location	
Category	Earthen Levee
Item	Encroachments
Landowner build private levee into project levee at LM 6.33

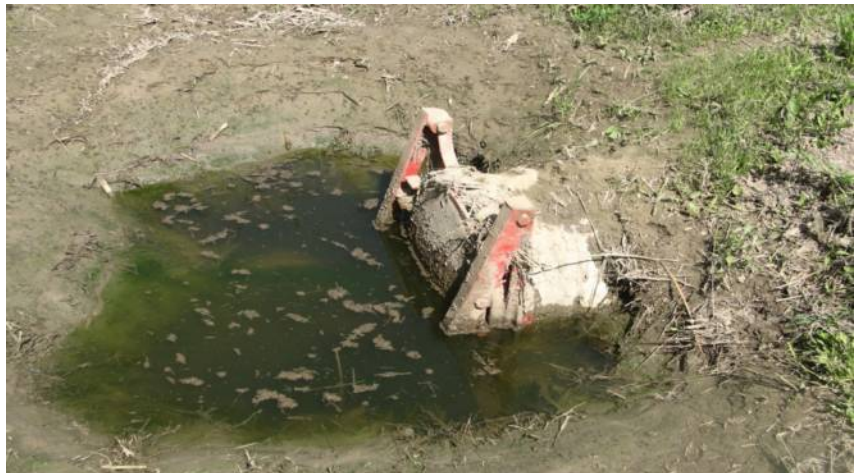
Levee Mile Report Line	8
Start Levee Mile	6.63
End Levee Mile	6.63
Location	
Category	Interior Drainage & Piping Systems
Item	Vegetation & Obstructions
Flap gate blockage at LM 6.63

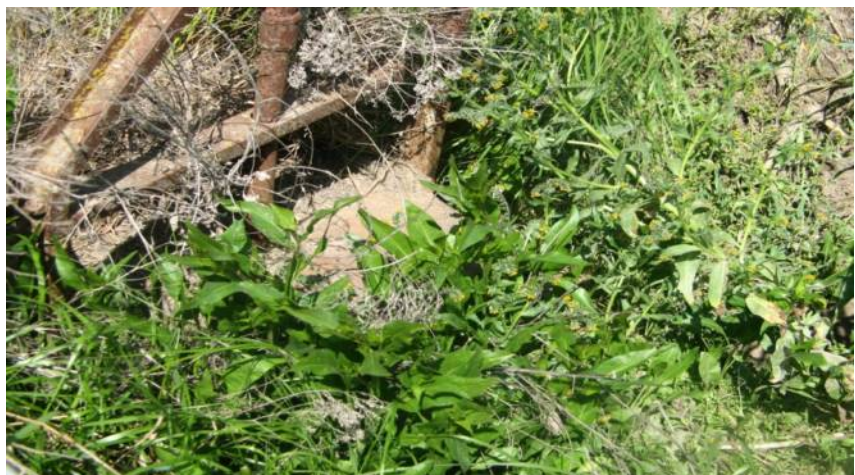
Levee Mile Report Line	9
Start Levee Mile	9.36
End Levee Mile	9.36
Location	
Category	Interior Drainage & Piping Systems
Item	Vegetation & Obstructions
Sewer gate block and not operating properly at LM 9.36

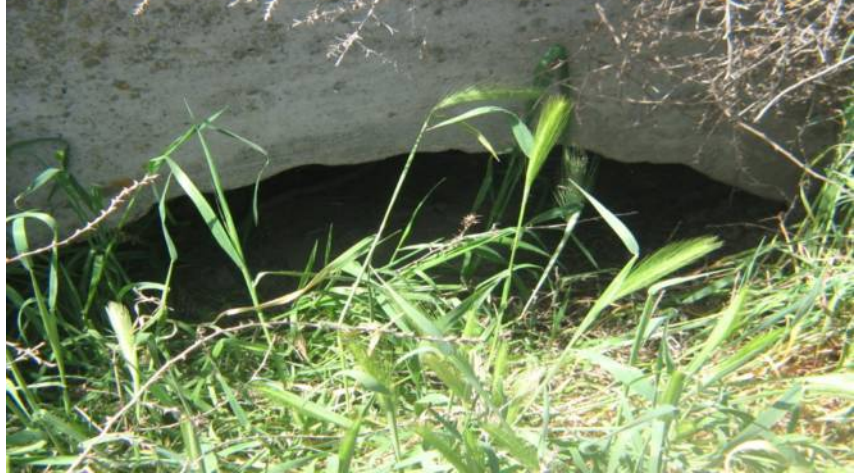
Levee Mile Report Line	10
Start Levee Mile	9.66
End Levee Mile	9.66
Location	
Category	Interior Drainage & Piping Systems
Item	Vegetation & Obstructions
Inlet of pipe blockage over 50 % at LM 9.66

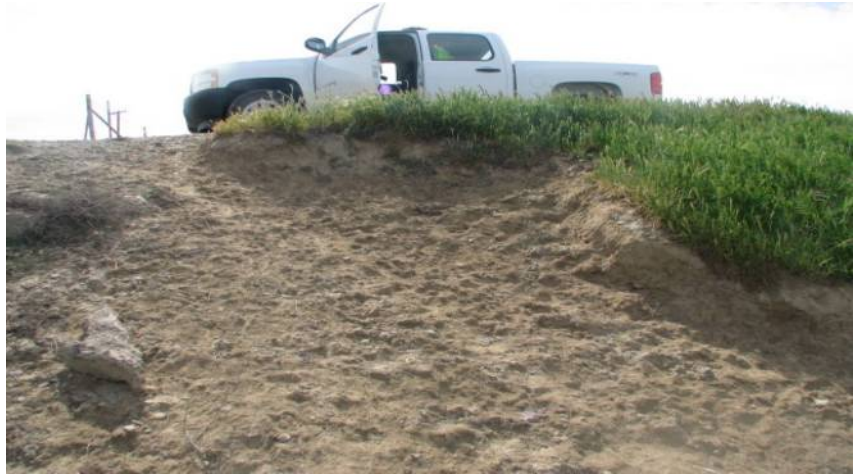
Levee Mile Report Line	10
Start Levee Mile	29.74
End Levee Mile	29.74
Location	
Category	Earthen Levee
Item	Slope Stability
Landward slope damage by animal traffic at LM 29.74

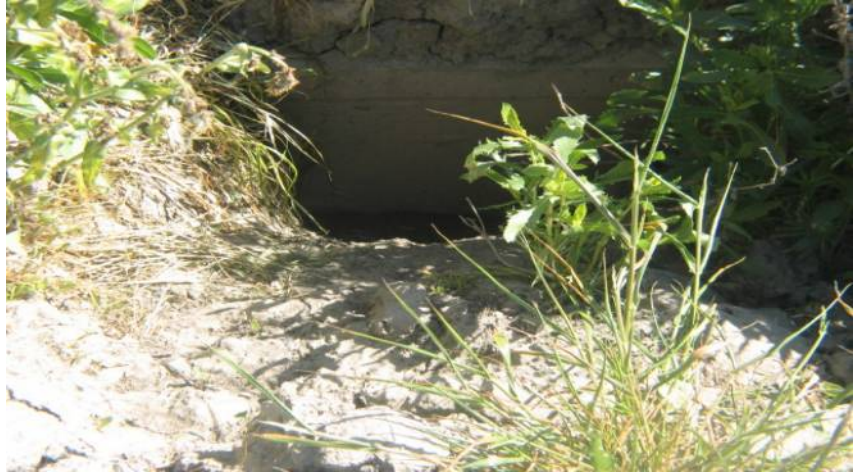
Levee Mile Report Line	3
Start Levee Mile	4.14
End Levee Mile	4.14
Location	
Category	Interior Drainage & Piping Systems
Item	Vegetation & Obstructions
Inlet of pipe over 50% blockage at LM 4.14

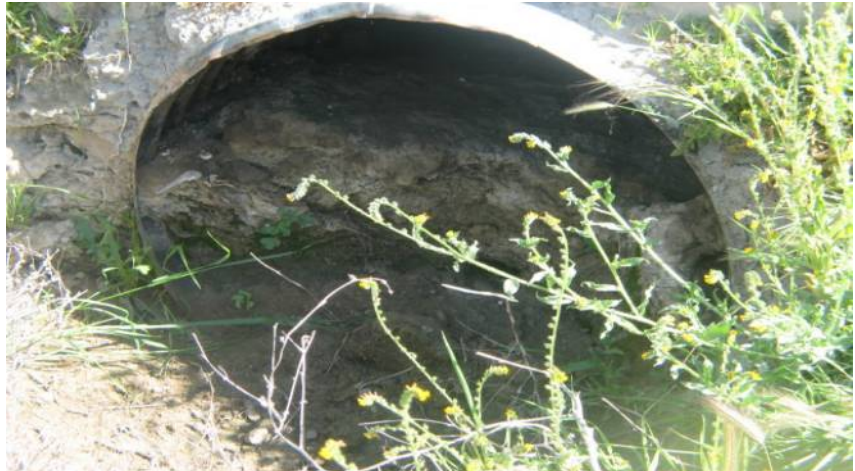
Levee Mile Report Line	4
Start Levee Mile	4.67
End Levee Mile	4.67
Location	
Category	Interior Drainage & Piping Systems
Item	Vegetation & Obstructions
Inlet of pipe over 50% blockage at LM 4.67

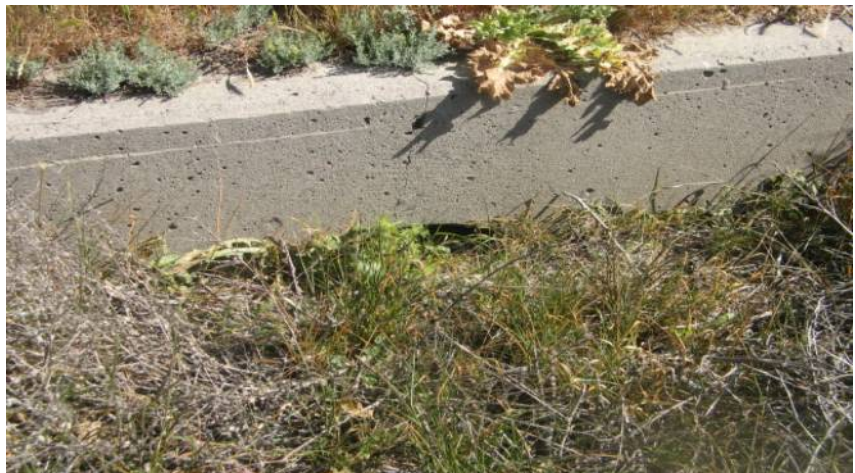
Levee Mile Report Line	5
Start Levee Mile	5.32
End Levee Mile	5.32
Location	
Category	Interior Drainage & Piping Systems
Item	Vegetation & Obstructions
Inlet of pipe over 50% blockage at LM 5.32

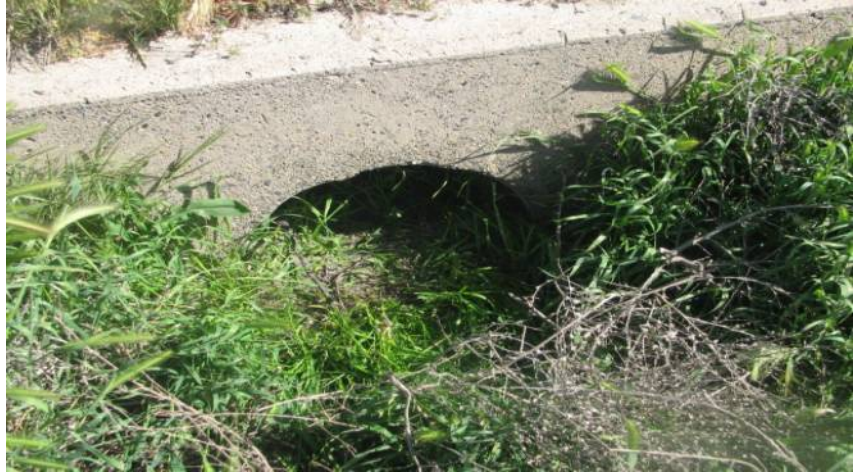
Levee Mile Report Line	6
Start Levee Mile	5.60
End Levee Mile	5.60
Location	
Category	Interior Drainage & Piping Systems
Item	Vegetation & Obstructions
Inlet of pipe over 25% blockage at LM 5.60

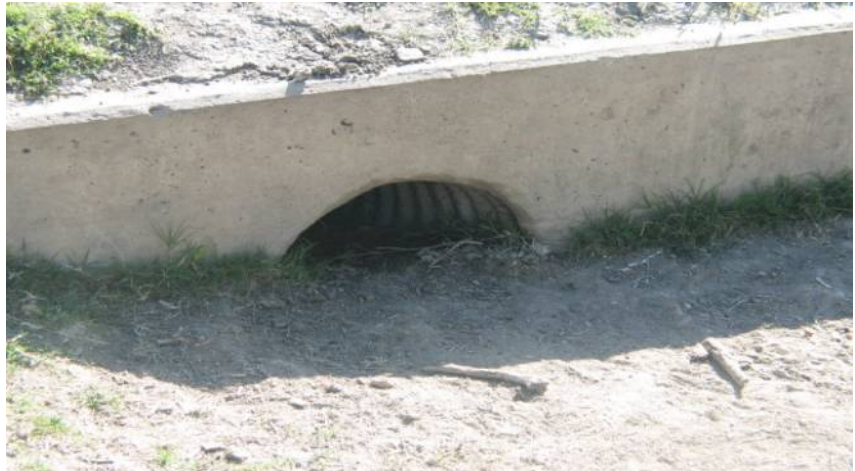
Levee Mile Report Line	7
Start Levee Mile	8.20
End Levee Mile	8.20
Location	
Category	Interior Drainage & Piping Systems
Item	Vegetation & Obstructions
Inlet of pipe over 50 % blockage at LM 8.20

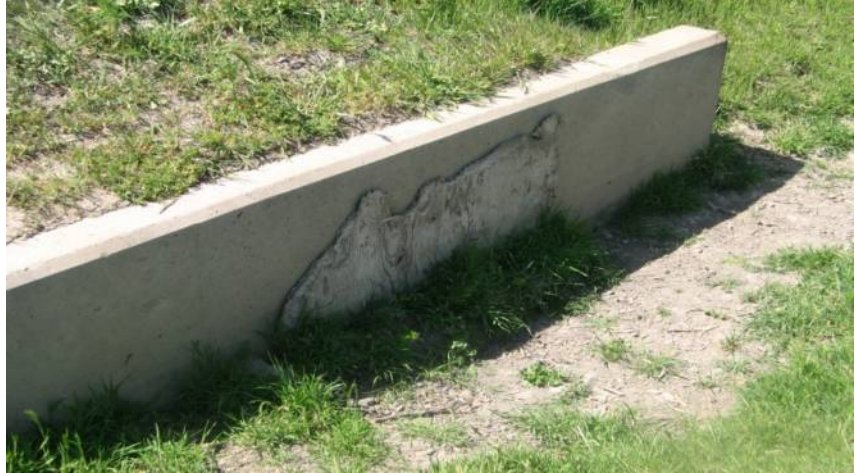
Levee Mile Report Line	4
Start Levee Mile	2.63
End Levee Mile	2.63
Location	
Category	Interior Drainage & Piping Systems
Item	Vegetation & Obstructions
Ply board blocking inlet of pipe at LM 2.63

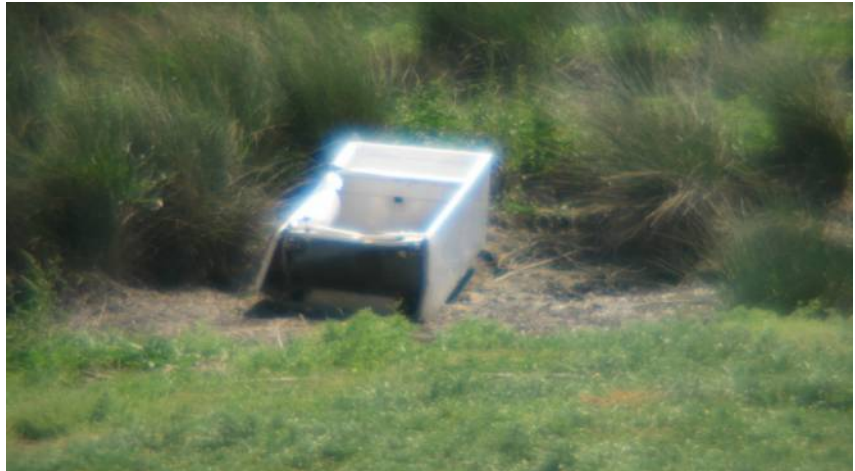
Levee Mile Report Line	5
Start Levee Mile	3.07
End Levee Mile	3.07
Location	
Category	Rivers, Channels & Designated Floodways
Item	Encroachments
Garbage in channel at LM 3.07

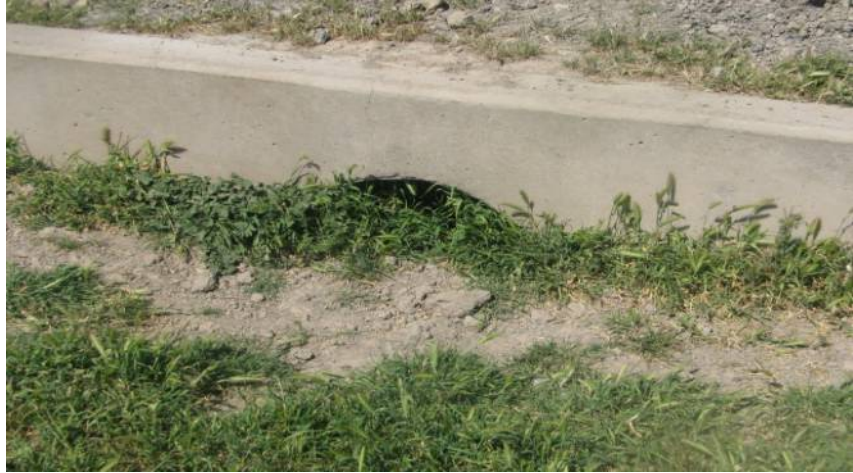
Levee Mile Report Line	3
Start Levee Mile	2.12
End Levee Mile	2.12
Location	
Category	Interior Drainage & Piping Systems
Item	Vegetation & Obstructions

Inlet of pipe blockage over 50 % at LM 2.12

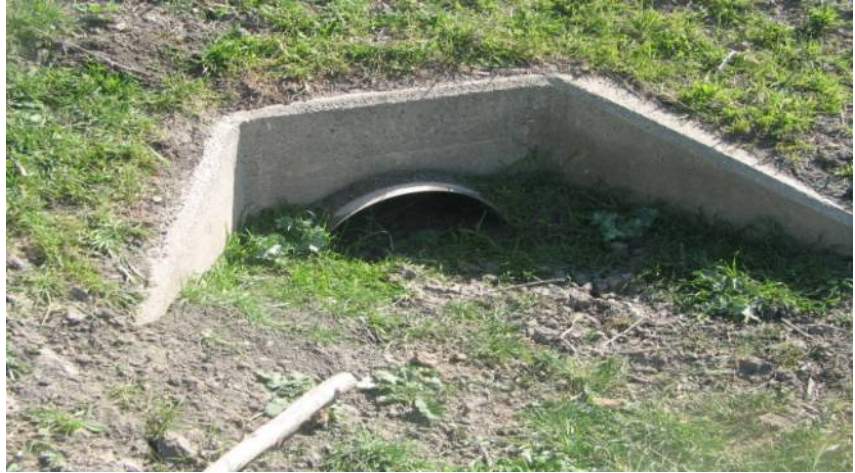
Levee Mile Report Line	3
Start Levee Mile	0.87
End Levee Mile	0.87
Location	
Category	Interior Drainage & Piping Systems
Item	Vegetation & Obstructions

Inlet of pipe over 50 % blockage at LM 0.87

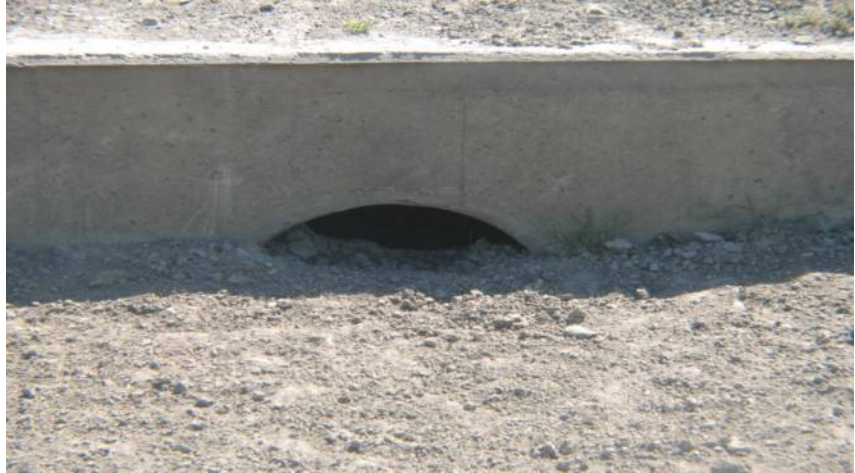
Levee Mile Report Line	3
Start Levee Mile	0.41
End Levee Mile	0.41
Location	
Category	Interior Drainage & Piping Systems
Item	Vegetation & Obstructions
Inlet of pipe over 50% blockage at LM 0.41

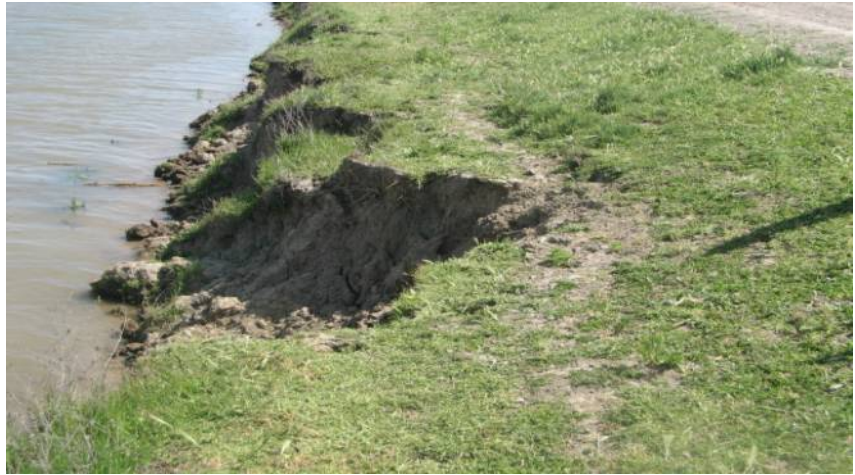
5	4.98	5.05	Earthen Levee	Erosion / Bank Caving	WS	M	Schedule repair of erosion site prior to the next inspection. Inspector Comments: Erosion cause by cattle.	37.266743 ° -120.735293 °	37.267472 ° -120.736335 °	Y	2

Levee Mile Report Line	5
Start Levee Mile	4.98
End Levee Mile	5.05
Location	
Category	Earthen Levee
Item	Erosion / Bank Caving
Erosion on waterward slope from LM 4.98 to 5.05
