**Flood Control Project Maintenance
Levee Inspections**
LMA District Cover Sheet
Spring 2009 Levee Inspection Results

Lower San Joaquin Levee District

Spring 2009 Levee Inspection Results

Levee Inspection Report By Mile - Spring 2009

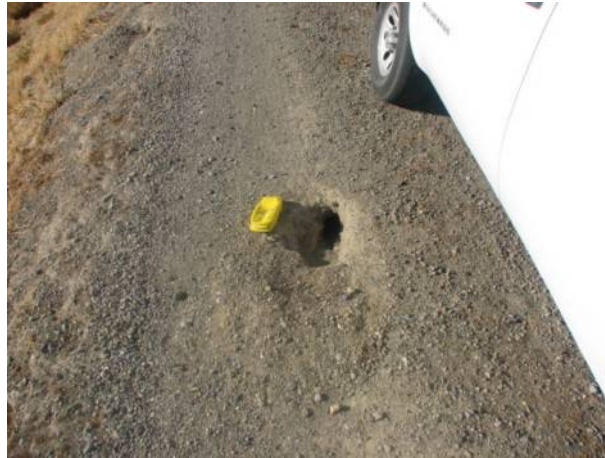
Levee Mile Report Line	3
Start Levee Mile	4.67
End Levee Mile	4.67
Location	Crown
Category	Earthen Levee
Item	Animal Control

Looking at squirrel hole at crown of levee.

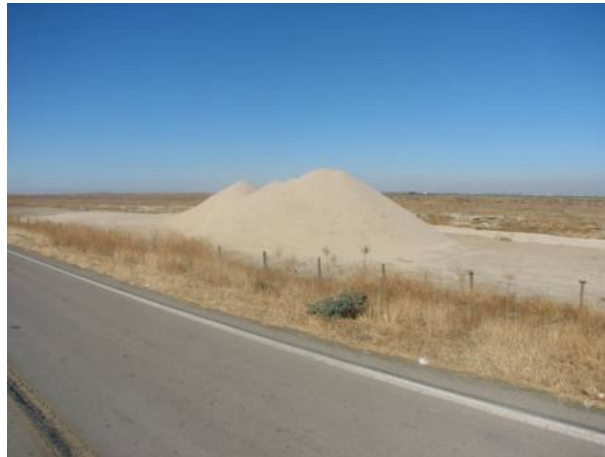
Levee Mile Report Line	8
Start Levee Mile	20.38
End Levee Mile	20.67
Location	Water Side
Category	Earthen Levee
Item	Encroachments

Looking north at sand pipe over three feet high in channel.
