**Flood Control Project Maintenance  
Levee Inspections****LMA District Cover Sheet****Spring 2012 Levee Inspection Results****Lower San Joaquin Levee District**

Waterway			Bank	Unit Miles
Unit No. 01 San Joaquin River			Right	22.56
	Spring (March - May)	Summer (June - August)	(September - November) Fall	Winter (December - February)
Unit Maintenance Rating (Fall Only)				
Date of Inspection	4/23/2012 - 4/26/2012			
DWR Inspector	Richard Willoughby			
Accompanied By

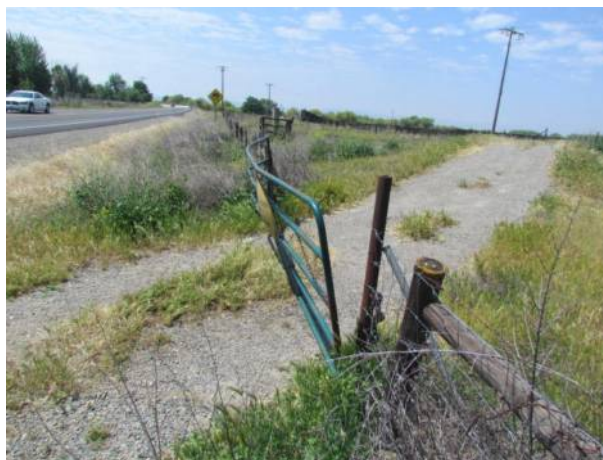
Levee Mile Report Line	14
Start Levee Mile	3.96
End Levee Mile	3.96
Location	Crown
Category	Earthen Levee
Item	Repair Gates

Looking west at damaged gate near Hwy 140.

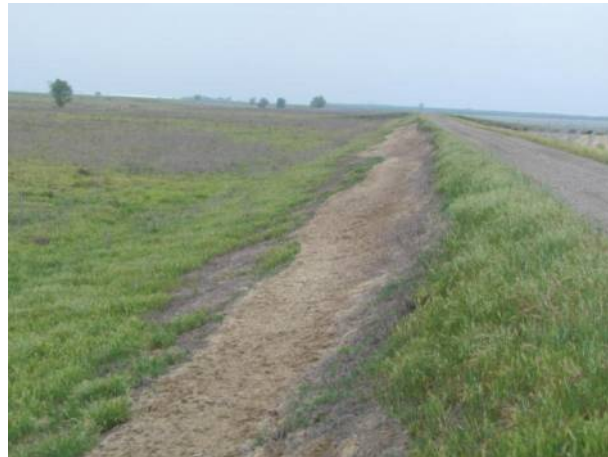
Levee Mile Report Line	17
Start Levee Mile	29.58
End Levee Mile	29.70
Location	Water Side
Category	Earthen Levee
Item	Erosion / Bank Caving

Looking south at erosion caused by livestock on landside slope.

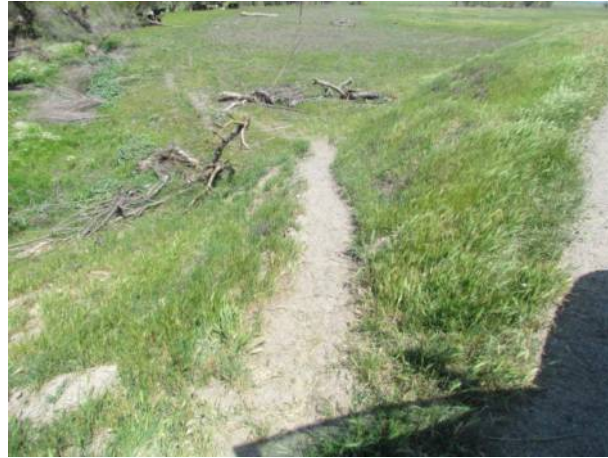
Looking northeast at landside slope damaged by livestock.

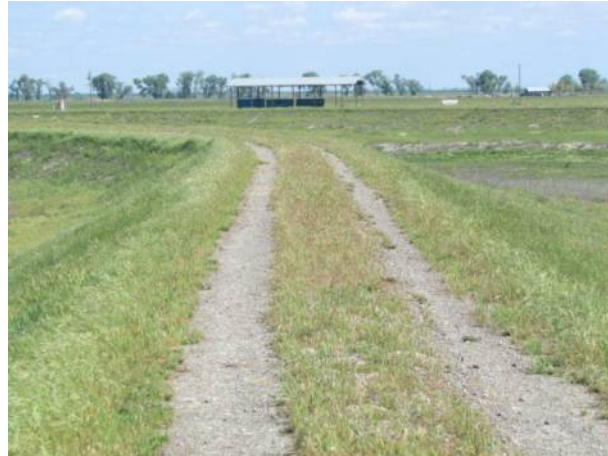
Levee Mile Report Line	1
Start Levee Mile	0.00
End Levee Mile	2.22
Location	Crown
Category	Earthen Levee
Item	Crown Surface / Depressions / Rutting
Looking west at vegetation on levee crown.	
richard_s_20120430_303.jpg

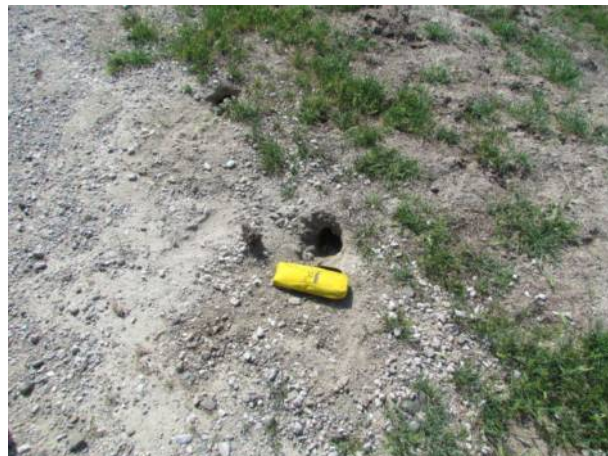
Levee Mile Report Line	6
Start Levee Mile	2.07
End Levee Mile	2.12
Location	Land Side
Category	Earthen Levee
Item	Animal Control
Looking at typical rodent hole along the section.	
richard_s_20120430_301.jpg

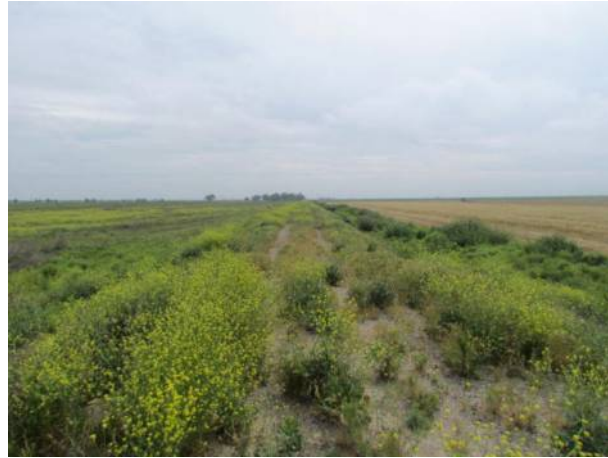
Levee Mile Report Line	4
Start Levee Mile	1.42
End Levee Mile	1.97
Location	Water Side
Category	Earthen Levee
Item	Vegetation
Looking east (upstream) at unwanted vegetation on both levee slope and levee crown.	
richard_s_20120501_323.jpg
