**Flood Control Project Maintenance
Levee Inspections**
LMA District Cover Sheet
Spring 2013 Levee Inspection Results

Lower San Joaquin Levee District

**Flood Control Project Maintenance
Levee Inspections**

Waterway			Bank	Unit Miles
Unit No. 01 San Joaquin River			Right	22.56
	Spring (March - May)	Summer (June - August)	(September - November) Fall	Winter (December - February)
Unit Maintenance Rating (Fall Only)				
Date of Inspection	06/04/2013 - 06/06/2013			
DWR Inspector	Richard Willoughby			
Accompanied By

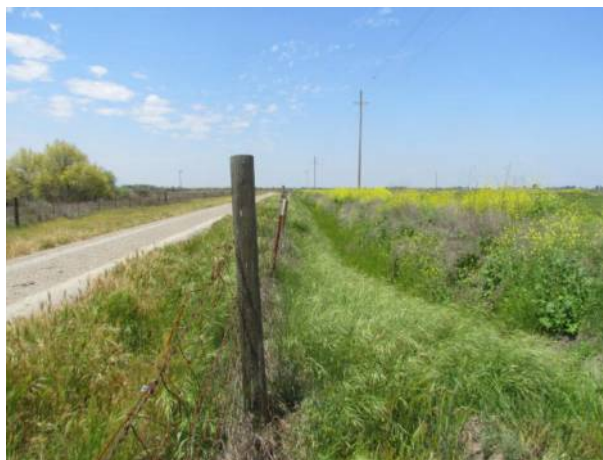
Levee Mile Report Line	16
Start Levee Mile	4.72
End Levee Mile	4.72
Location	Land Side
Category	
Item	Animal Control

Looking south at damage slope by livestock on landward slope.

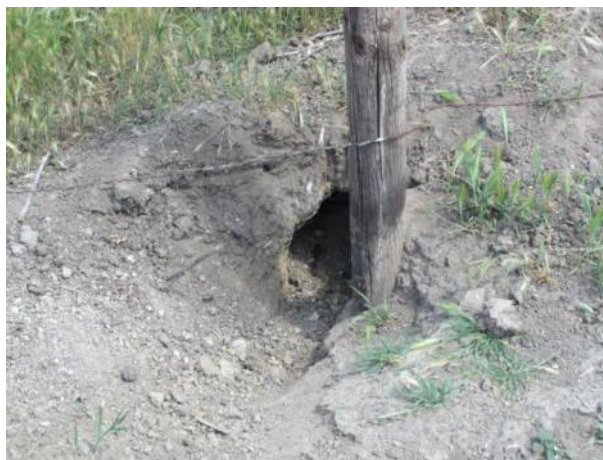
Levee Mile Report Line	17
Start Levee Mile	5.75
End Levee Mile	5.75
Location	Land Side
Category	
Item	Animal Control

Looking south at repaired rodent site on landside slope. (Fall 2012)

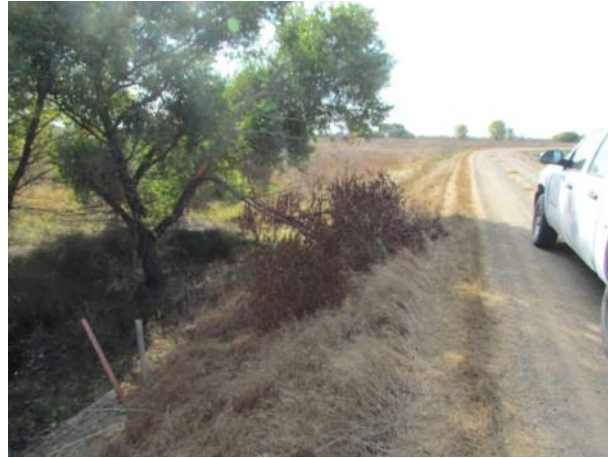
Levee Mile Report Line	4
Start Levee Mile	9.46
End Levee Mile	9.46
Location	Land Side
Category	
Item	Encroachments
Looking north at broken tree limb on landside slope.	
richard_s_20130304_079.JPG

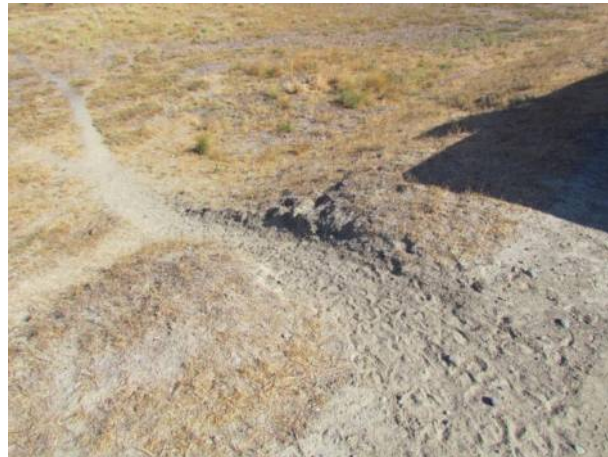
Levee Mile Report Line	11
Start Levee Mile	4.99
End Levee Mile	4.99
Location	Land Side
Category	
Item	Animal Control
Looking east at levee damage by livestock on landside slope.	
richard_s_20130304_091.JPG

DWR ID: DWR_NA0010_05_s_2012_170									
11	4.99	4.99		Animal Control	LS M Ma	A2 : Repair the levee slope damaged by livestock and prevent large animal access.	37.240732 ° -120.749512 °	37.240732 ° -120.749512 °	12 Y
DWR ID: DWR_NA0010_05_f_2012_12									
12	6.50	6.50		Animal Control	WS M Ma	A3 : No rodents visible, but rodent burrows visible; need to backfill and compact or grout burrows.	37.230497 ° -120.727263 °	37.230497 ° -120.727263 °	15
DWR ID: DWR_NA0010_05_s_2012_15									
13	6.58	8.09		Crown Surface / Depressions / Rutting	CR C Ma	C3 : Add appropriate gravel or road base. Grade and compact.	37.229733 ° -120.726450 °	37.213520 ° -120.706475 °	6
DWR ID: DWR_NA0010_05_s_2012_6									
14	6.59	6.59		Animal Control	CR M Ma	Inspector Comments: Rodent hole on top of levee crown.	37.229672 ° -120.726358 °	37.229672 ° -120.726358 °	25
DWR ID: DWR_NA0010_05_s_2013_25

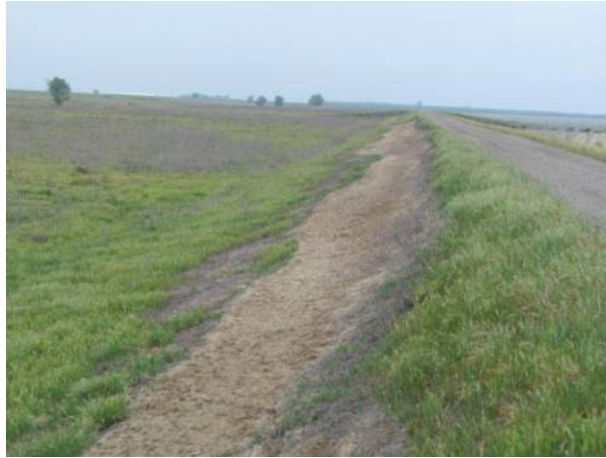
Levee Mile Report Line	26
Start Levee Mile	29.58
End Levee Mile	29.70
Location	Water Side
Category	
Item	Erosion / Bank Caving
Looking south at erosion caused by livestock on landside slope.	
richard_s_20130304_095.jpg

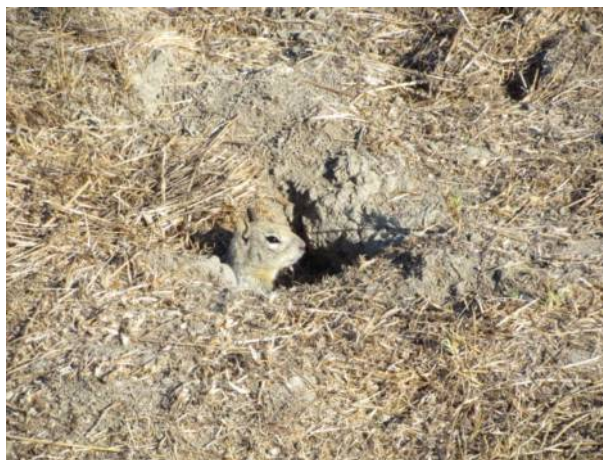
Levee Mile Report Line	6
Start Levee Mile	1.51
End Levee Mile	1.51
Location	Land Side
Category	
Item	Animal Control

Looking northeast at landside slope damaged by livestock.

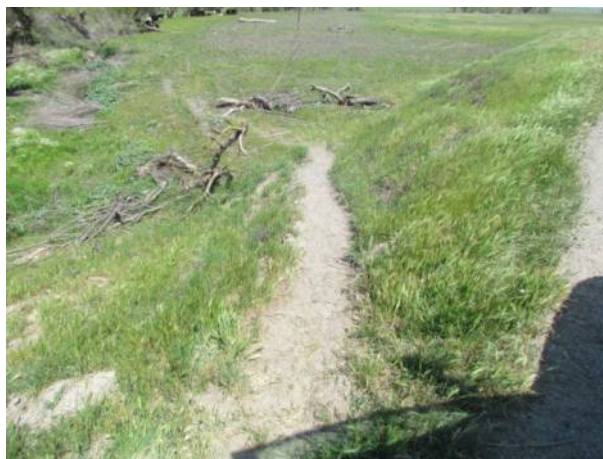
Levee Mile Report Line	6
Start Levee Mile	1.51
End Levee Mile	1.51
Location	Land Side
Category	
Item	Animal Control

Looking southeast at landside slope and toe damage by livestock.

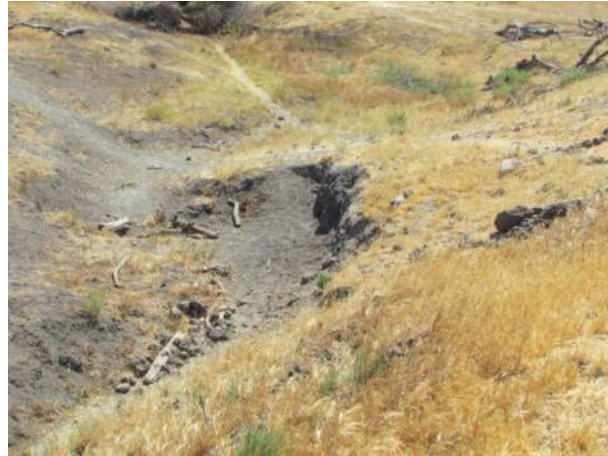
Levee Mile Report Line	6
Start Levee Mile	1.51
End Levee Mile	1.51
Location	Land Side
Category	
Item	Animal Control
Looking southeast at damage on landward toe.(Spring 2013)	
richard_s_20130610_157.JPG

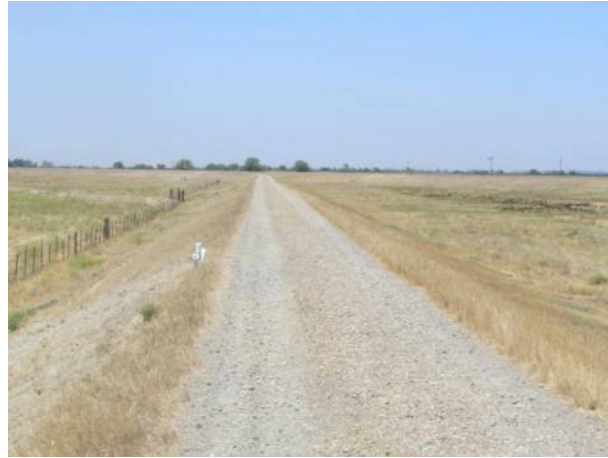
Levee Mile Report Line	5
Start Levee Mile	1.38
End Levee Mile	1.38
Location	Land Side
Category	
Item	Animal Control
Looking west at rodent holes on landward slope.	
richard_s_20130610_163.JPG

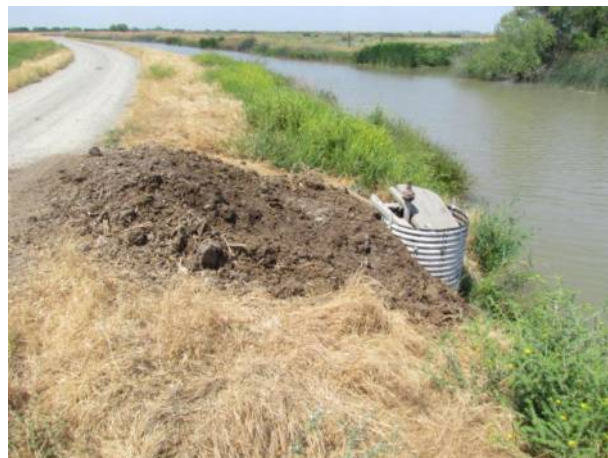
Levee Mile Report Line	3
Start Levee Mile	0.10
End Levee Mile	0.10
Location	Water Side
Category	
Item	Erosion / Bank Caving
Looking south at repaired erosion near screw gate on waterward slope.	
richard_s_20130610_168.JPG

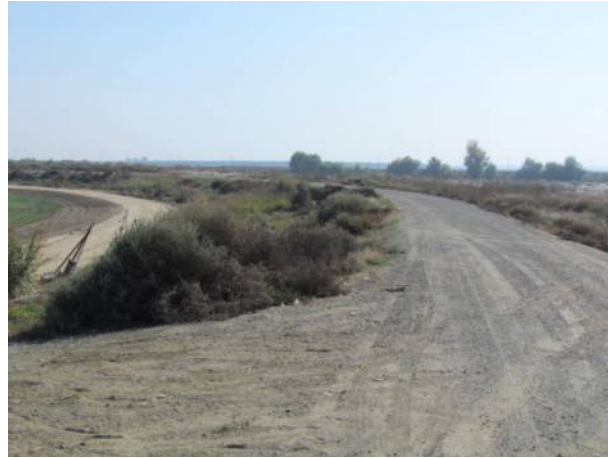
Levee Mile Report Line	5
Start Levee Mile	1.53
End Levee Mile	1.53
Location	Land Side
Category	
Item	Slope Stability

Looking north at slope damage by vehicle traffic.
