**Flood Control Project Maintenance  
Levee Inspections**  
**LMA District Cover Sheet**  
**Spring 2014 Levee Inspection Results**

**Lower San Joaquin Levee District**

**Spring 2014 Levee Inspection Results**

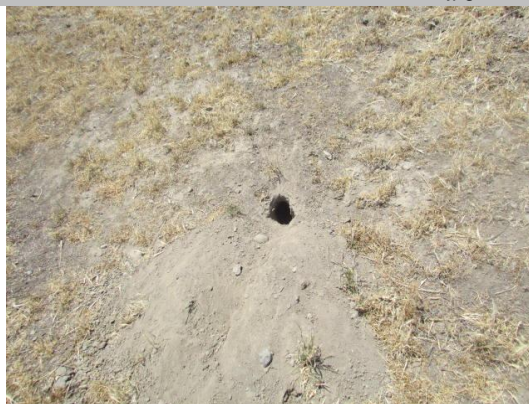
Photo 1 of 1 : richard\_s\_20140520\_846.jpg

Looking at typical rodent holes on landward slope.

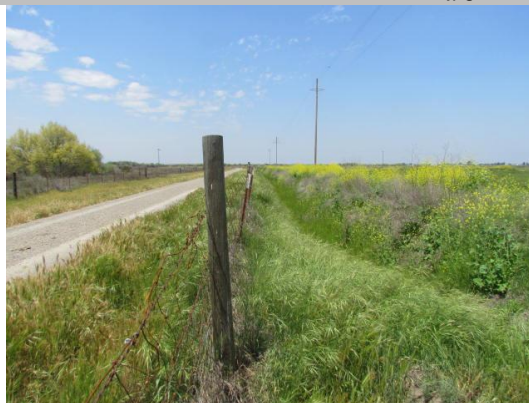
Photo 2 of 2 : richard\_s\_20140417\_542.jpg

Looking north at irrigation ditch at landside toe.

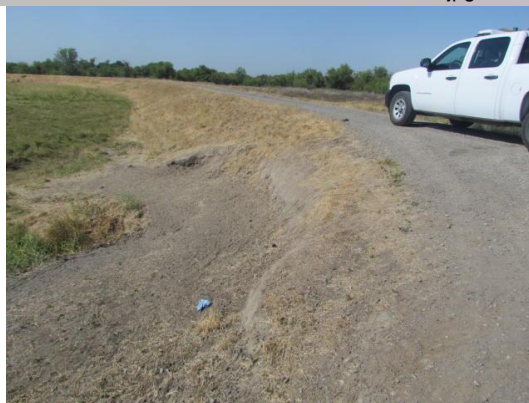
Photo 1 of 2 : richard\_s\_20140417\_544.jpg

LM Start	4.72	Rating **	M	Issue No.	9
LM End	4.72	Issue Type +	Ma	Location *	LS
Category	Earthen Levee			GPS Latitude/Longitude	
				Start	End
Item	Animal Control			37.302398 °	37.302398 °
				-120.920920 °	-120.920920 °
DWR ID	DWR_NA0010_01_s _ 2013_9				
Action/Comments					
Repair the levee slope damaged by livestock and prevent large animal access.					
Inspector Comments: Levee landward toe damaged by livestock.

Looking south at damage slope by livestock on landward slope.

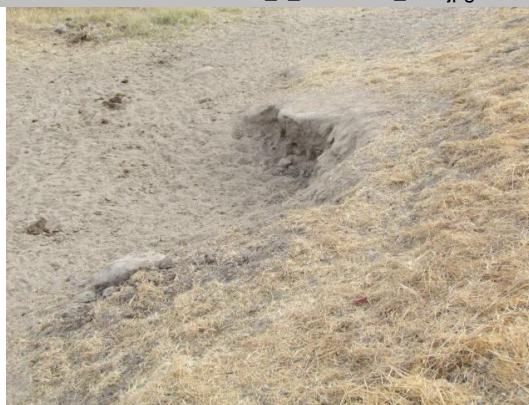
Photo 2 of 2 : richard\_s\_20140417\_545.jpg

Looking southeast at erosion on landward toe.

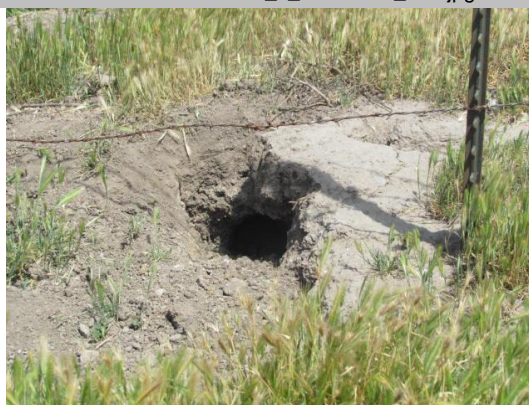
Photo 1 of 3 : richard\_s\_20140417\_555.jpg

LM Start	5.75	Rating **	A/W	Issue No.	116
LM End	5.75	Issue Type +	Ma	Location *	LS
Category	Earthen Levee			GPS Latitude/Longitude	
				Start	End
Item	Animal Control			37.304057 °	37.304057 °
				-120.907200 °	-120.907200 °
DWR ID	DWR_NA0010_01_s _ 2012_116				
Action/Comments					
No rodents visible, but rodent burrows visible; need to backfill and

Looking east at one of several rodent holes on landside shoulder and slope.

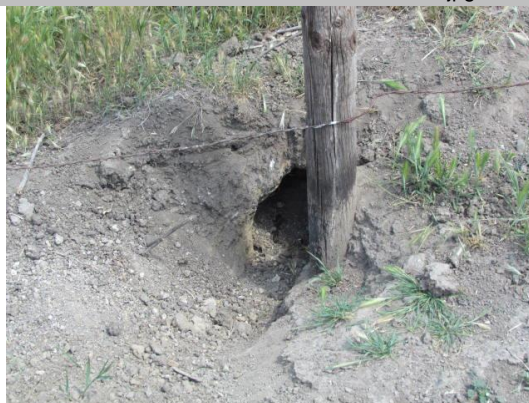
Photo 2 of 3 : richard\_s\_20140417\_556.jpg

Looking northeast at one of several holes on landside shoulder and slope.

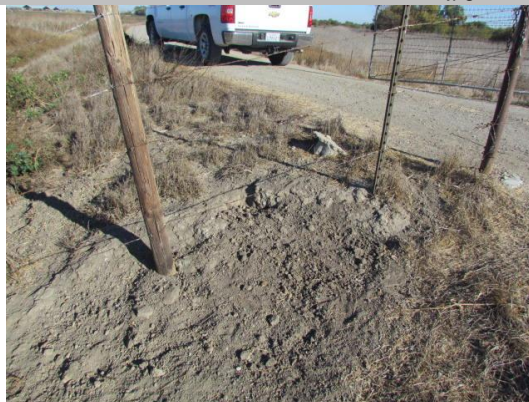
Photo 3 of 3 : richard\_s\_20140417\_557.jpg

Looking south at repaired rodent site on landside slope. (Fall 2012)

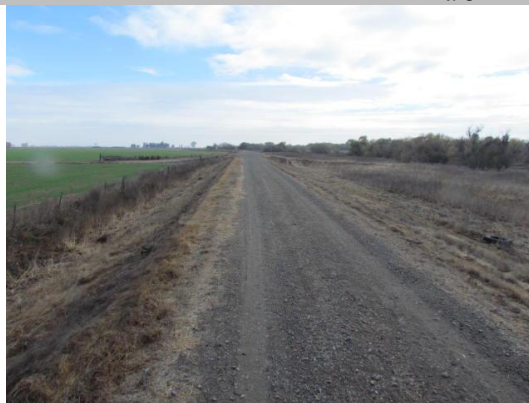
Photo 3 of 3 : richard\_s\_20140417\_560.jpg

Looking south at levee crown. (Fall 2013)

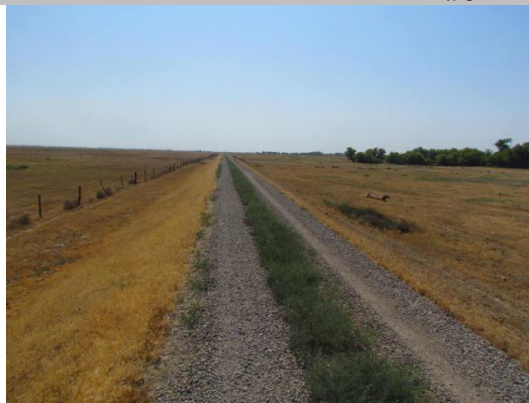
Photo 1 of 2 : richard\_s\_20140417\_551.jpg

Looking south at vegetation on levee crown.

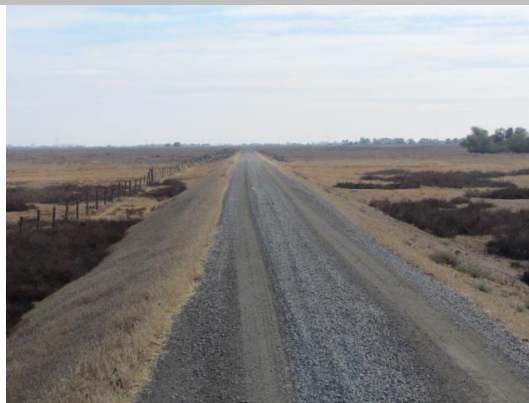
Photo 2 of 2 : richard\_s\_20140417\_552.jpg

Looking south at re-graded levee and added road base on levee crown.

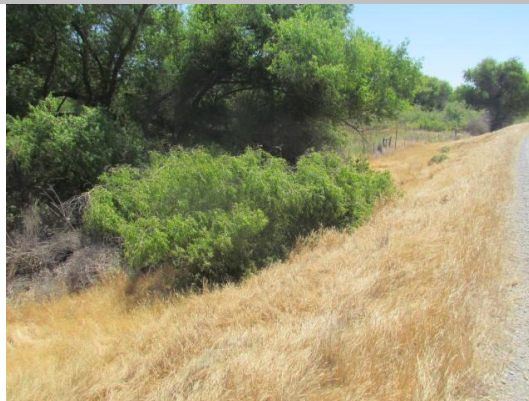
Photo 1 of 1 : richard\_s\_20140417\_553.jpg

LM Start	15.79	Rating **	A/W	Issue No.	30
LM End	15.79	Issue Type +	Ma	Location *	LS
Category	Earthen Levee			GPS Latitude/Longitude	
				Start	End
Item	Encroachments			37.226470 °	37.226470 °
				-120.799622 °	-120.799622 °
DWR ID	DWR_NA0010_01_s _ 2013_30				
Action/Comments					
Tree or limb					
Inspector Comments: Broken tree limb on landward toe.

Looking north at a downed tree limb on landward slope and toe.

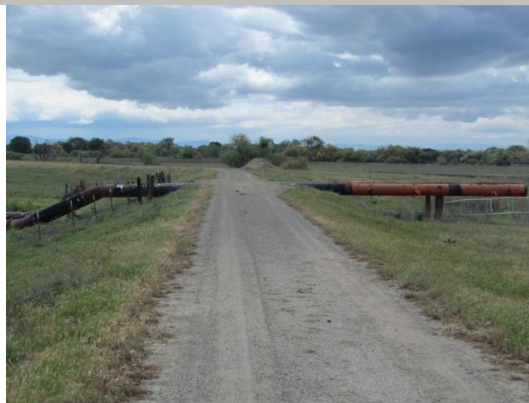
Photo 1 of 1 : richard\_s\_20140417\_543.jpg

Looking south at pipe across levee crown.

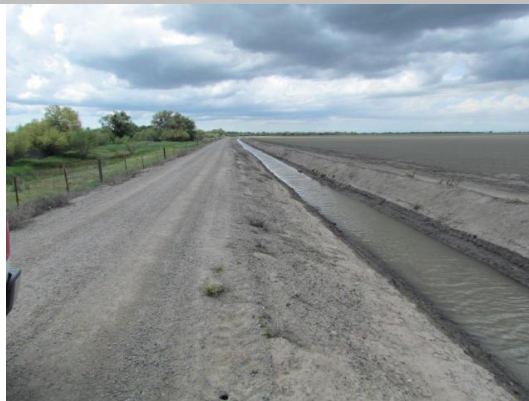
Photo 2 of 2 : richard\_s\_20140417\_550.jpg

Looking downstream at irrigation ditch at landside toe.

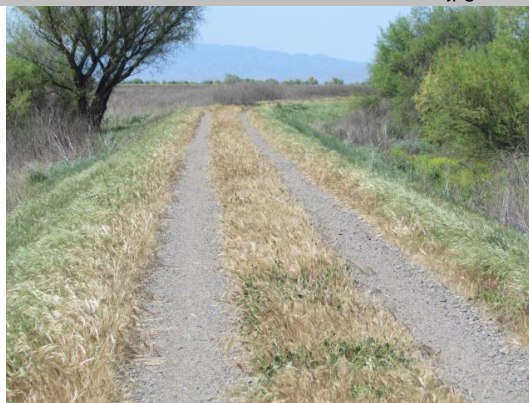
Photo 1 of 1 : richard\_s\_20140417\_733.jpg

Looking north at vegetation on levee crown.

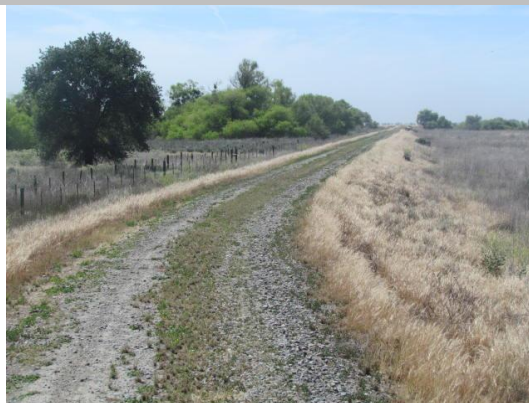
Photo 1 of 1 : richard\_s\_20140520\_844.jpg

LM Start	0.00	Rating **	M	Issue No.	9
LM End	5.30	Issue Type +	Ma	Location *	CR
Category	Earthen Levee			GPS Latitude/Longitude	
				Start	End
Item	Vegetation			37.296229 °	37.261893 °
				-120.880732 °	-120.832390 °
DWR ID	DWR_NA0010_02A_s_2014_9				
Action/Comments					
Remove the wild growth other than native grasses from the levee slopes.					
Inspector Comments: Control vegetation on levee crown.

Looking north at vegetation on levee crown.

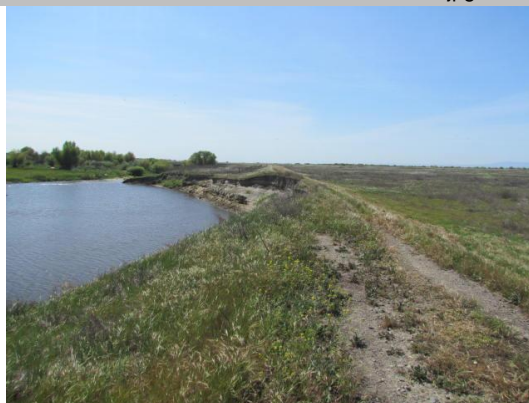
Photo 1 of 2 : richard\_s\_20140417\_734.jpg

LM Start	0.77	Rating **	U	Issue No.	5
LM End	0.77	Issue Type +	Ma	Location *	WS
Category	Earthen Levee			GPS Latitude/Longitude	
				Start	End
Item	Erosion / Bank Caving			37.286877 °	37.286877 °
				-120.874222 °	-120.874222 °
DWR ID	DWR_NA0010_02A_s_2012_5				
Action/Comments					
Schedule repair of erosion site prior to the next inspection. Inspector Comments: A field investigation report in on file. For more information and pictures see field investigation report #4301.

Looking south at large erosion on waterside slope. (Spring 2012)

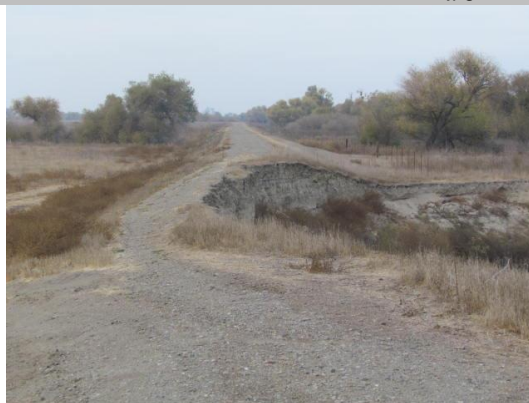
Photo 2 of 2 : richard\_s\_20140417\_735.jpg

Looking north at large erosion on waterward slope. (Fall 2013)

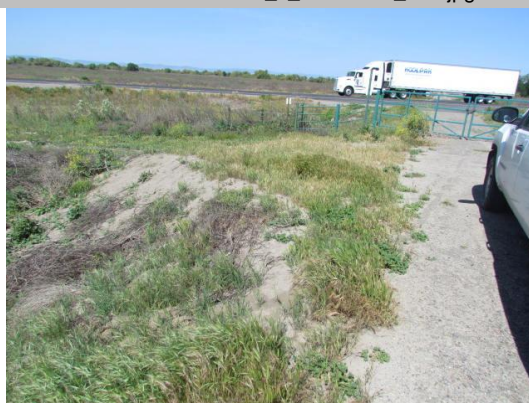
Photo 1 of 2 : richard\_s\_20140417\_731.jpg

LM Start	2.33	Rating **	M	Issue No.	2
LM End	2.33	Issue Type +	En	Location *	LS
Category	Earthen Levee			GPS Latitude/Longitude	
				Start	End
Item	Encroachments			37.291433 °	37.291433 °
				-120.850917 °	-120.850917 °
DWR ID	DWR_NA0010_02A_s_2012_2				
Action/Comments					
Ramp

Looking northwest at ramp on landside slope near Hwy 140.

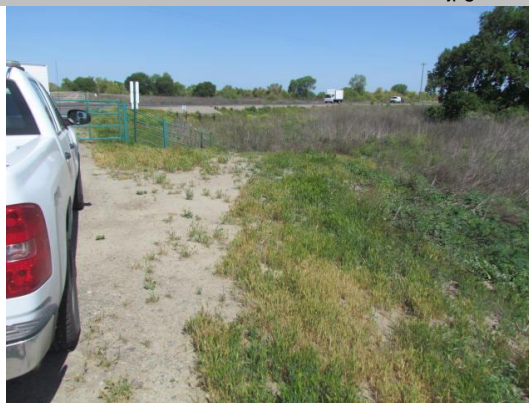
Photo 2 of 2 : richard\_s\_20140417\_732.jpg

Looking northeast at ramp on waterside slope near Hwy 140.

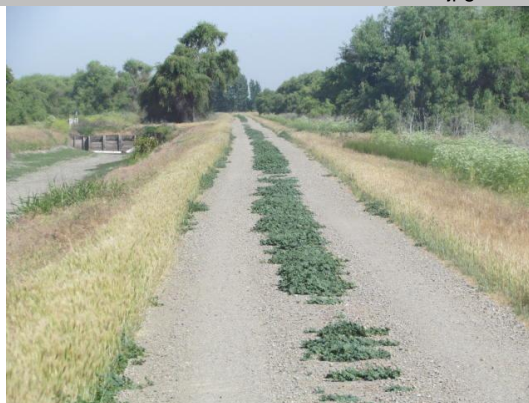
Photo 1 of 1 : richard\_s\_20140520\_838.jpg

Looking north at vegetation on levee crown.

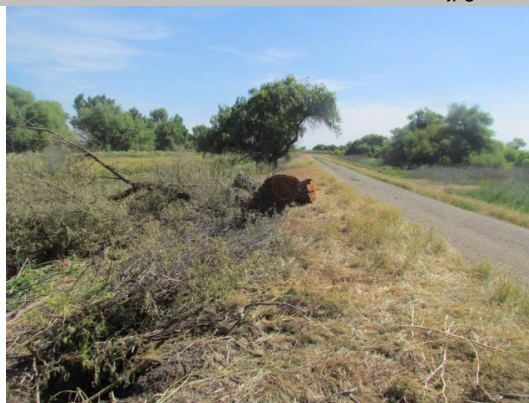
Photo 1 of 2 : richard\_s\_20140520\_840.jpg

Looking north at tree branch on landward slope.

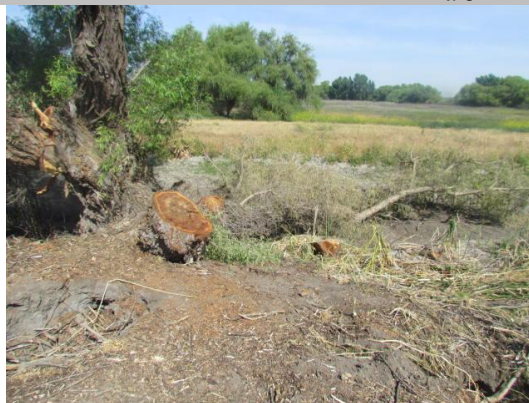
Photo 2 of 2 : richard\_s\_20140520\_841.jpg

Looking southwest at down tree on landward slope.

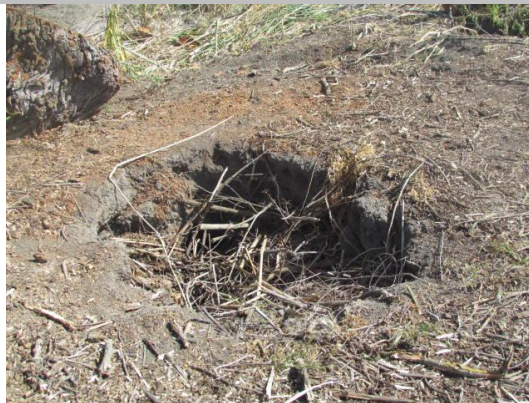
Photo 1 of 2 : richard\_s\_20140520\_842.jpg

LM Start	12.73	Rating **	U	Issue No.	11
LM End	12.73	Issue Type +	Ma	Location *	LS
Category	Earthen Levee			GPS Latitude/Longitude	
				Start	End
Item	Slope Stability			37.185467 °	37.185467 °
				-120.768506 °	-120.768506 °
DWR ID	DWR_NA0010_02B_s_2014_11				
Action/Comments					
Repair slope instability.

Looking at hole on landward shoulder and slope.

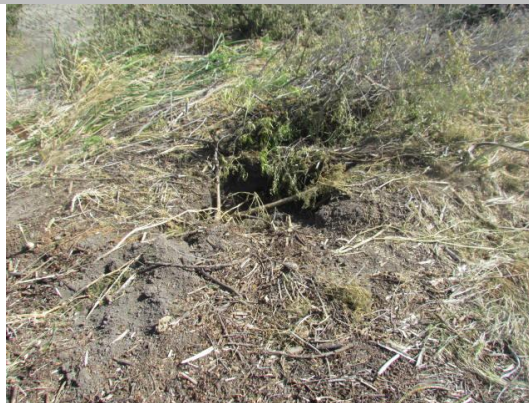
Photo 2 of 2 : richard\_s\_20140520\_843.jpg

LM Start	12.73	Rating **	U	Issue No.	11 (cont)
LM End	12.73	Issue Type +	Ma	Location *	LS
Category	Earthen Levee			GPS Latitude/Longitude	
				Start	End
Item	Slope Stability			37.185467 °	37.185467 °
				-120.768506 °	-120.768506 °
DWR ID	DWR_NA0010_02B_s_2014_11				
Action/Comments					
Repair slope instability. Inspector Comments: Large hole on landward slope from fallen tree. Hole is approx. 3-4' in diameter.

Looking north at second hole on landward shoulder and slope.

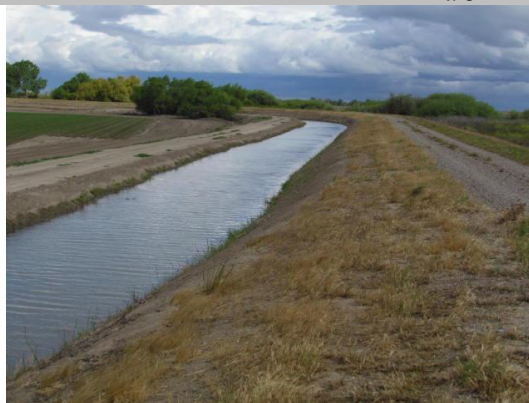
Photo 2 of 3 : richard\_s\_20140417\_749.jpg

Looking north at irrigation ditch at landside toe.

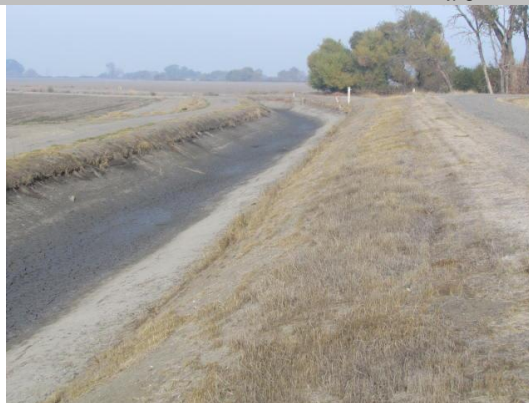
Photo 3 of 3 : richard\_s\_20140417\_750.jpg

Looking north at irrigation ditch at landward toe. (Fall 2013)

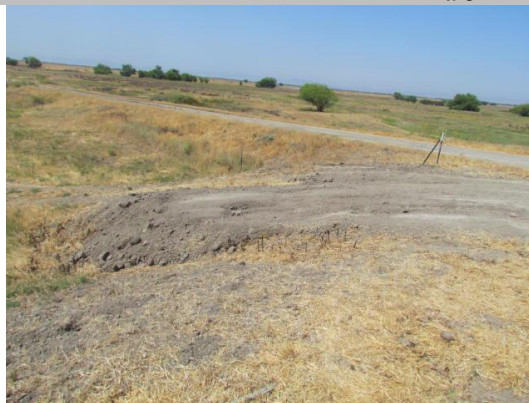
Photo 3 of 3 : richard\_s\_20140417\_756.jpg

Looking northwest at unauthorized ramp on waterward slope.

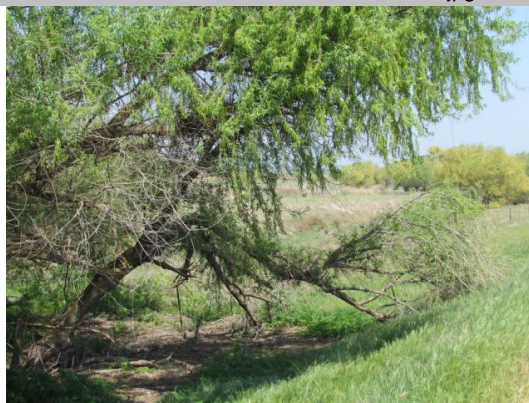
Photo 1 of 1 : richard\_s\_20140417\_751.jpg

Looking south at down tree limb on landside slope and toe.

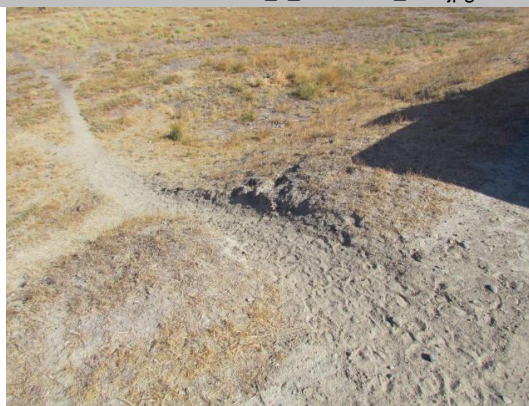
Photo 1 of 2 : richard\_s\_20140417\_758.jpg

LM Start	4.99	Rating **	A/W	Issue No.	12
LM End	4.99	Issue Type +	Ma	Location *	LS
Category	Earthen Levee			GPS Latitude/Longitude	
				Start	End
Item	Animal Control			37.240732 °	37.240732 °
				-120.749512 °	-120.749512 °
DWR ID	DWR_NA0010_05_f _ 2012_12				
Action/Comments					
Repair the levee slope damaged by livestock and prevent large animal access.

Looking east at levee damage by livestock on landside slope.

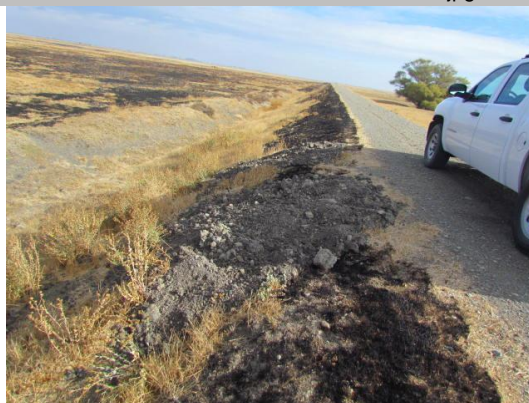
Photo 2 of 2 : richard\_s\_20140417\_759.jpg

Looking south at repaired livestock erosion on landward slope.

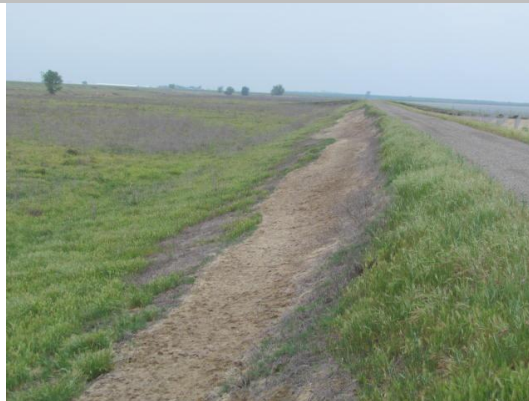
Photo 1 of 3 : richard\_s\_20140417\_763.jpg

Looking south at erosion caused by livestock on landside slope.

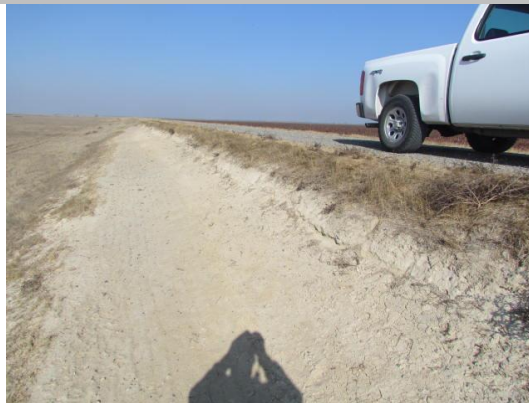
Photo 3 of 3 : richard\_s\_20140417\_765.jpg

Looking south at livestock erosion on landward slope.

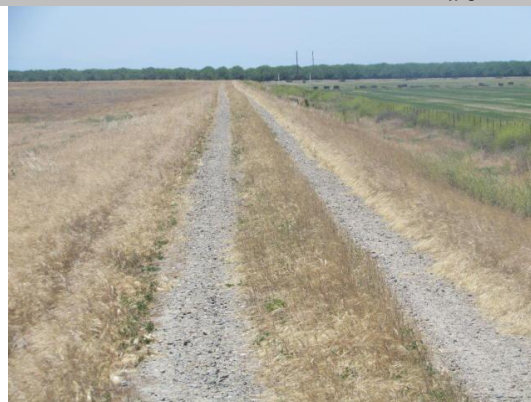
Photo 1 of 1 : richard\_s\_20140520\_825.jpg

Looking at vegetation on levee crown.

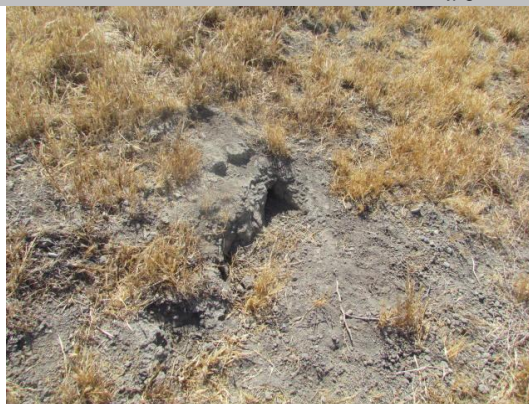
Photo 1 of 2 : richard\_s\_20140417\_774.jpg

Looking at typical rodent holes on landward slope.

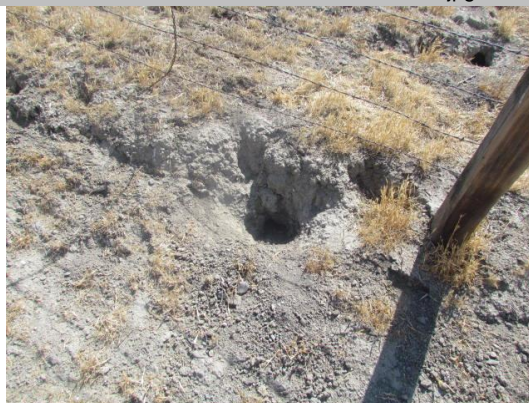
Photo 2 of 2 : richard\_s\_20140417\_775.jpg

Looking at rodent hole along fence line on landward slope.

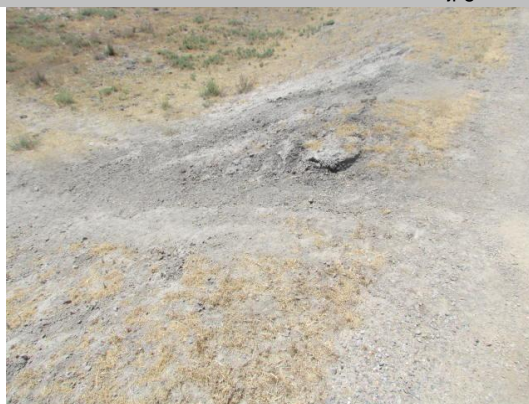
Photo 1 of 1 : richard\_s\_20140520\_836.jpg

Looking at slope damage cause by vehicle traffic on landward slope.

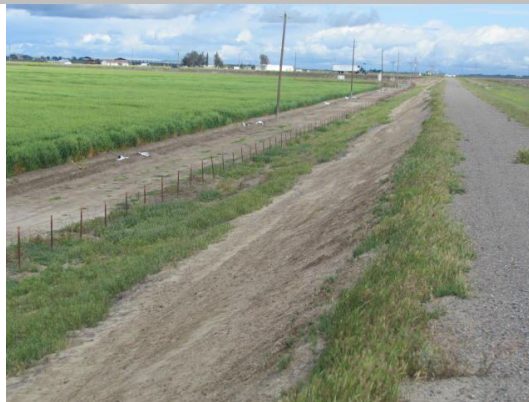
Photo 1 of 2 : richard\_s\_20140417\_772.jpg

Looking north at livestock erosion on landside slope.

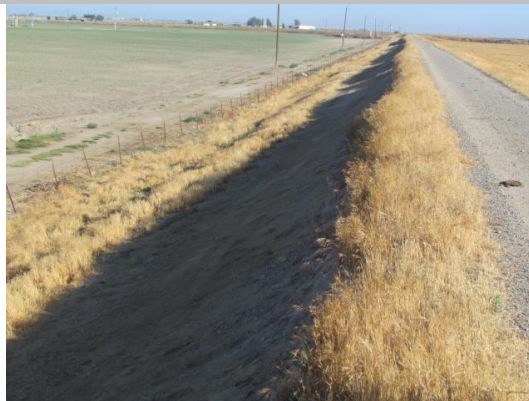
Photo 2 of 2 : richard\_s\_20140417\_773.jpg

Looking north at livestock erosion on landward slope.

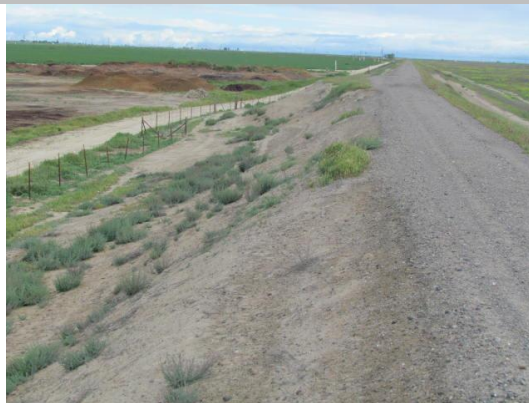
Photo 1 of 4 : richard\_s\_20140417\_768.jpg

Looking north at livestock erosion on landside shoulder and slope.

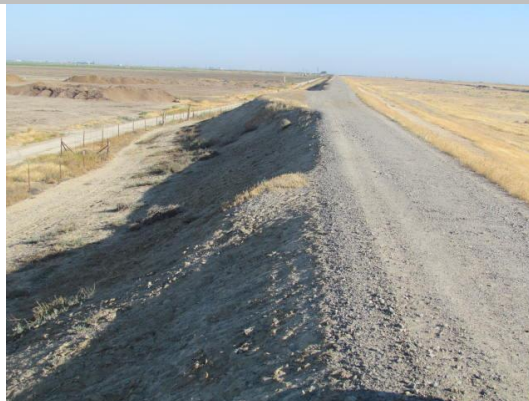
Photo 3 of 4 : richard\_s\_20140417\_770.jpg

Looking north at livestock erosion on landward slope. (Spring 2013)

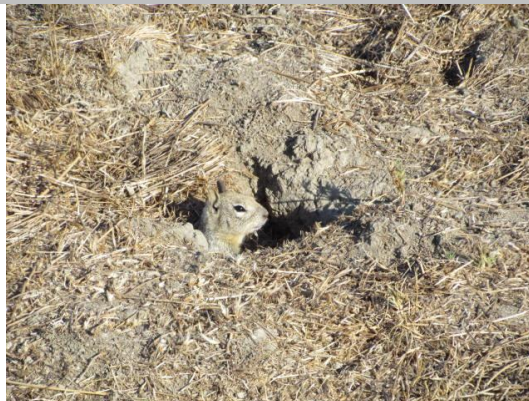
Photo 2 of 2 : richard\_s\_20140417\_780.jpg

Looking at east at active rodent holes on landside berm.

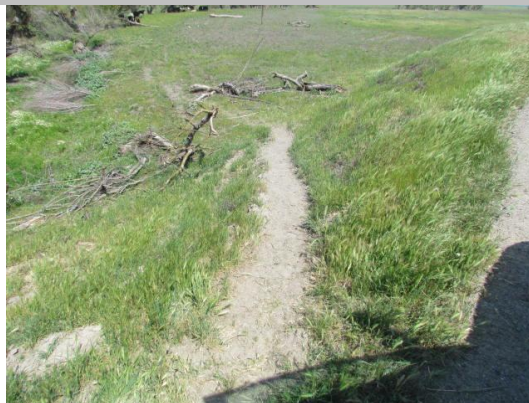
Photo 1 of 4 : richard\_s\_20140417\_782.jpg

Looking northeast at landside slope damaged by livestock.

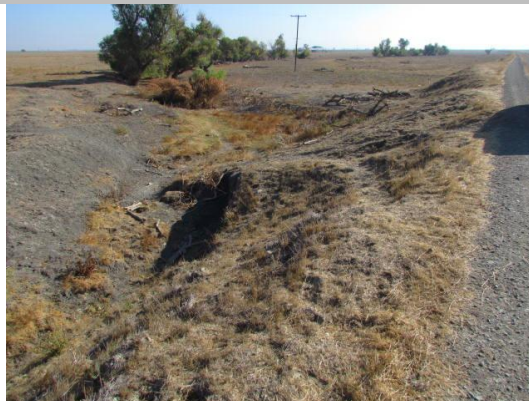
Photo 2 of 4 : richard\_s\_20140417\_783.jpg

Looking southeast at landside slope and toe damage by livestock.

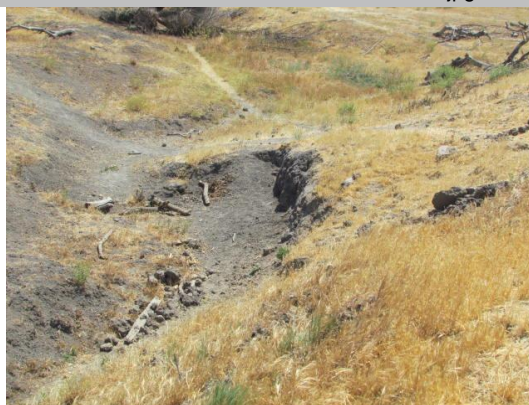
Photo 3 of 4 : richard\_s\_20140417\_784.jpg

Looking southeast at damage on landward toe.(Spring 2013)

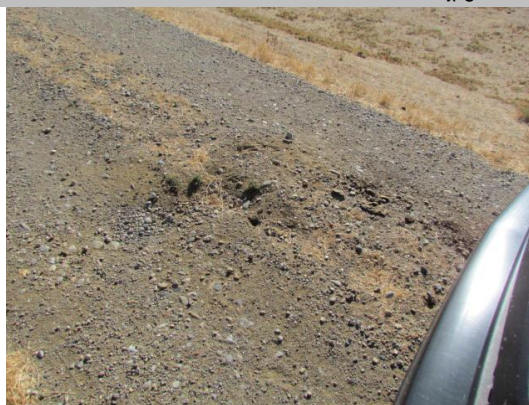
Photo 3 of 3 : richard\_s\_20140417\_790.jpg

Looking north a repaired rodent hole on levee crown.

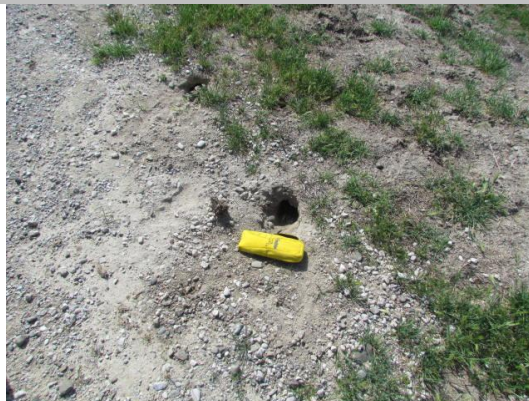
Photo 1 of 3 : richard\_s\_20140417\_791.jpg

Looking at typical rodent hole along the section.

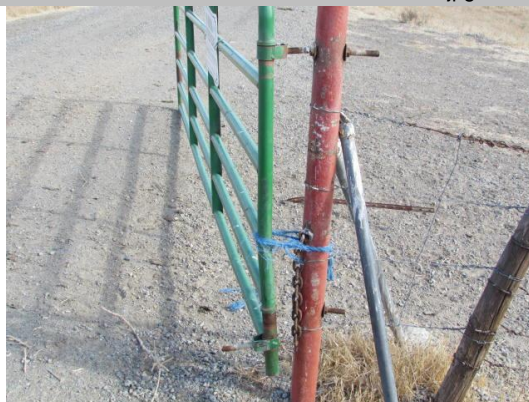
Photo 1 of 1 : richard\_s\_20140417\_629.jpg

Looking at bottom hinge broken on gate across levee crown.

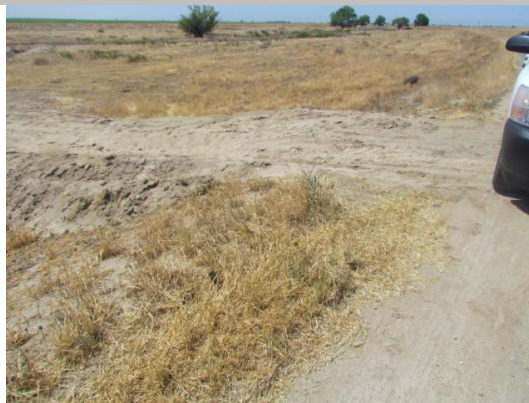
Photo 2 of 2 : richard\_s\_20140520\_819.jpg

Looking west at unauthorized ramp on waterward slope.

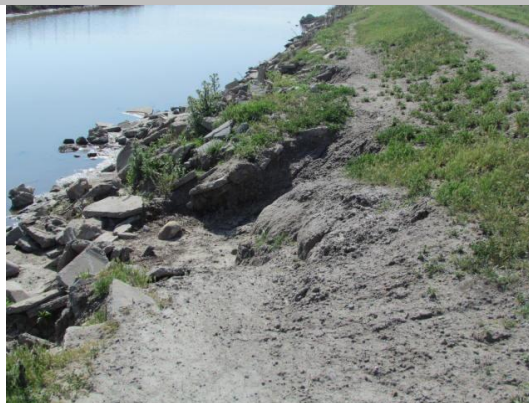
Photo 1 of 2 : richard\_s\_20140417\_636.jpg

Looking northeast at erosion caused by animals on waterside slope.

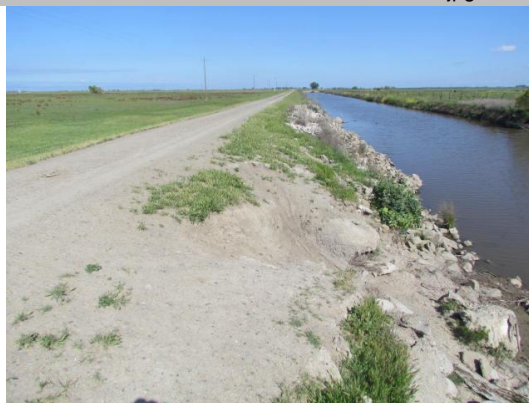
Photo 2 of 2 : richard\_s\_20140417\_637.jpg

Looking south at erosion caused by animals on waterside slope.

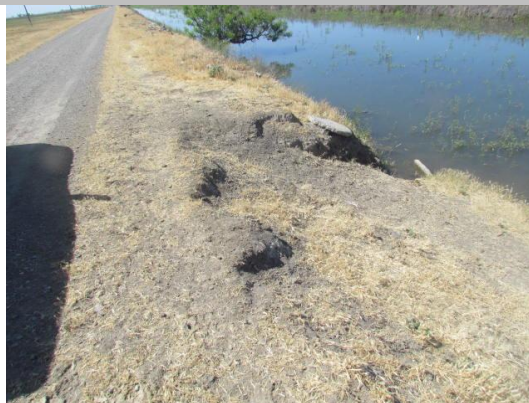
Photo 1 of 1 : richard\_s\_20140519\_812.jpg

Looking south at slope damage cause by animal traffic on waterside slope.

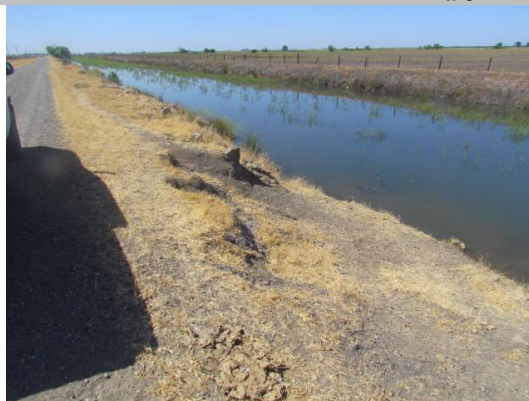
Photo 1 of 1 : richard\_s\_20140519\_813.jpg

Looking south at slope damage caused by animal traffic on waterside slope.

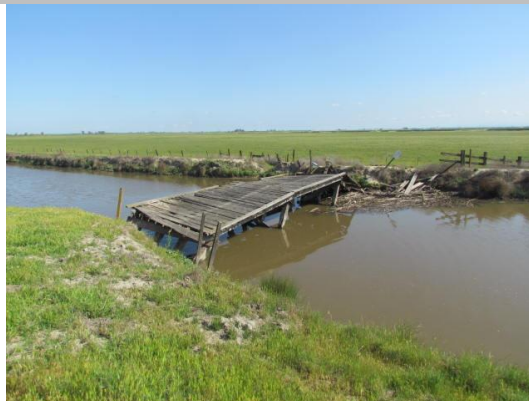
Photo 2 of 2 : richard\_s\_20140417\_639.jpg

Looking northeast at dilapidated bridge across canal.

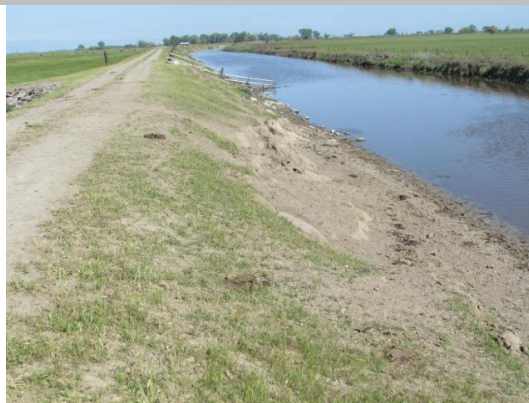
Photo 1 of 1 : richard\_s\_20140417\_642.jpg

Looking north at waterside erosion from livestock.

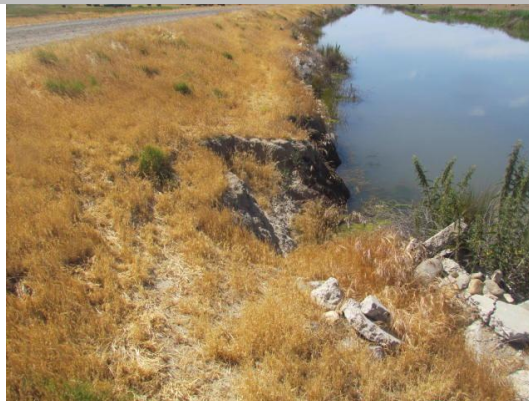
Photo 1 of 1 : richard\_s\_20140519\_814.jpg

Looking south at slope damage cause by animal traffic on waterside slope.

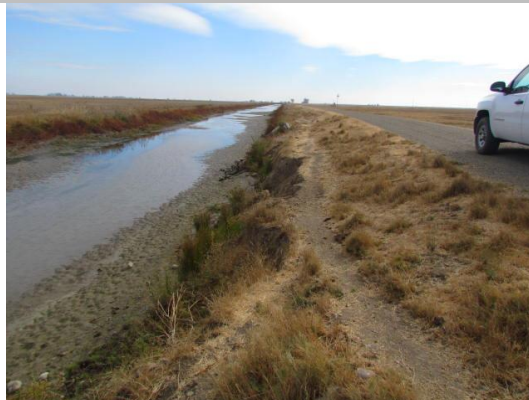
Photo 1 of 2 : richard\_s\_20140417\_640.jpg

Looking south livestock erosion on waterward toe.

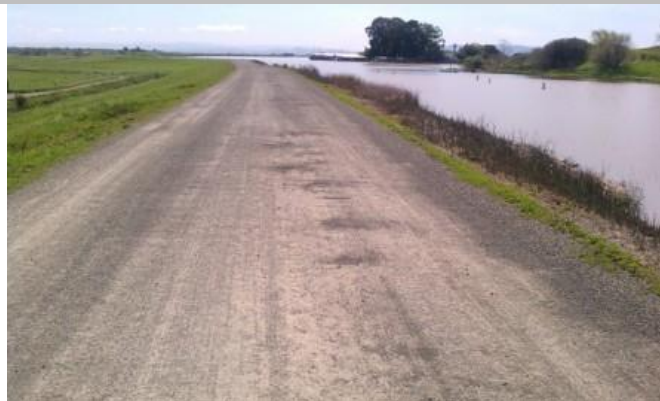
Photo 1 of 1 : richard\_s\_20140417\_648.jpg

Looking south at rutting on levee crown.

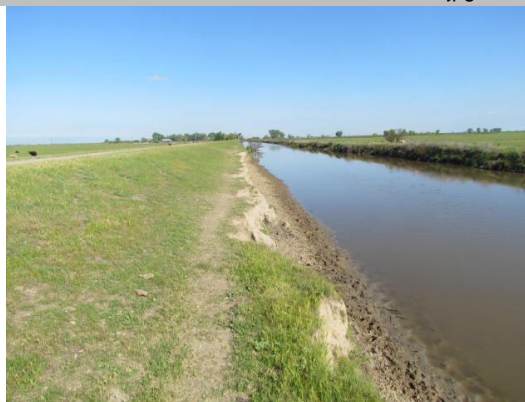
Photo 1 of 2 : richard\_s\_20140417\_643.jpg

Looking north at livestock erosion along waterside slope and toe.

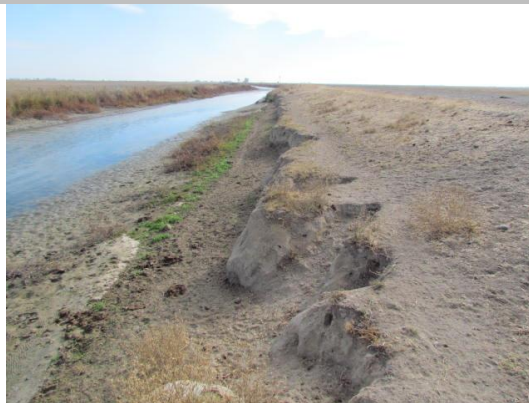
Photo 2 of 2 : richard\_s\_20140417\_644.jpg

Looking south at livestock erosion on waterward toe.

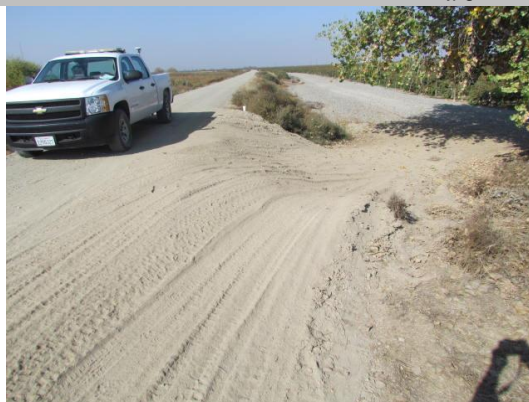
Photo 1 of 2 : richard\_s\_20140417\_660.jpg

Looking north at slope damaged by vehicle traffic.

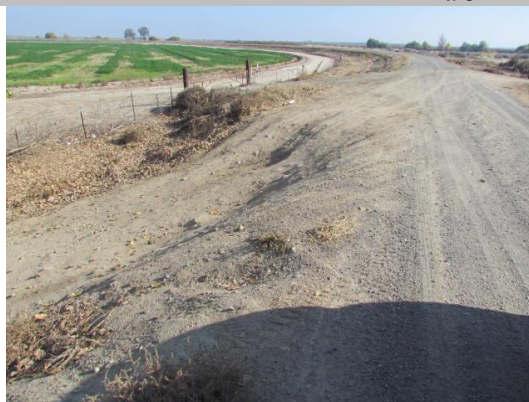
Photo 2 of 2 : richard\_s\_20140417\_661.jpg

Looking south at slope damaged by vehicle traffic. (Fall 2013)

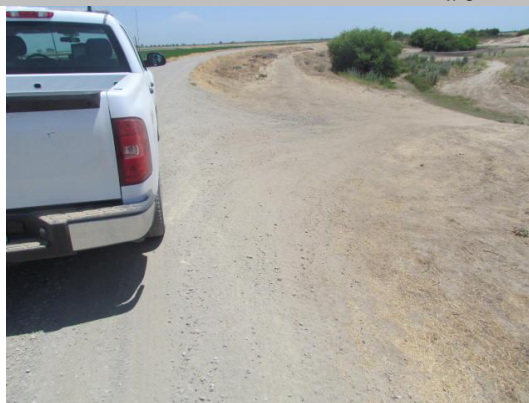
Photo 1 of 1 : richard\_s\_20140417\_663.jpg

Looking south at waterward slope damaged by vehicle traffic

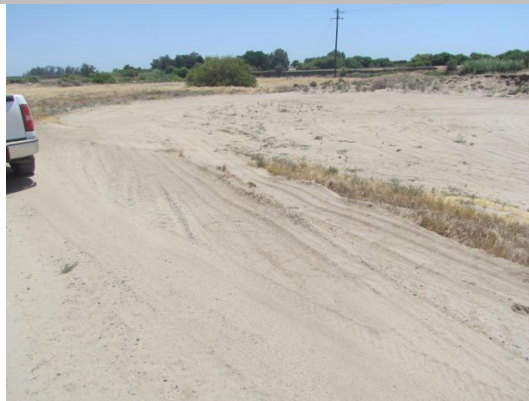
Photo 1 of 1 : richard\_s\_20140417\_664.jpg

Looking southwest at waterward slope damaged due to vehicle traffic.
