**Flood Control Project Maintenance
Levee Inspections****LMA District Cover Sheet****Spring 2015 Levee Inspection Results****Lower San Joaquin Levee District**

Spring 2015 Levee Inspection Results

Lower San Joaquin Levee District

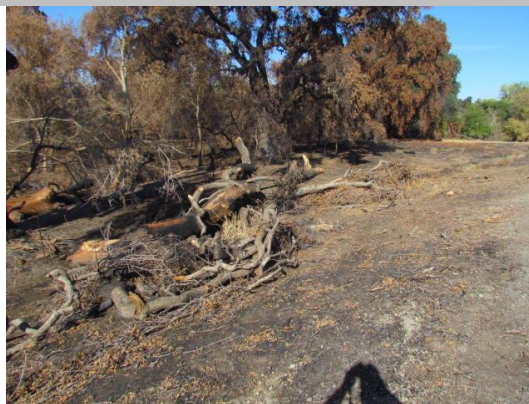
Photo 2 of 2 : SP_2015_NA0010_118_98_20150309_00013.jpg

Looking north at tree limbs on waterward toe.

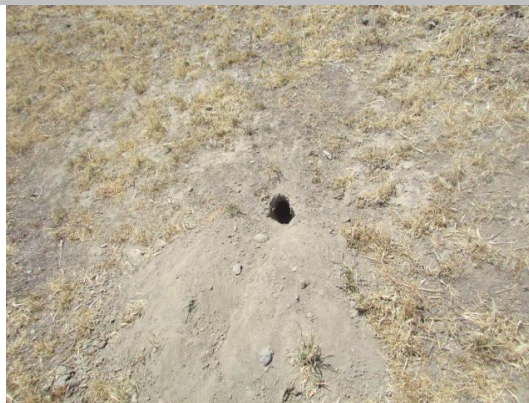
Photo 1 of 1 : SP_2015_NA0010_118_1_20150309_00001.jpg

Looking at typical rodent holes on landward slope.

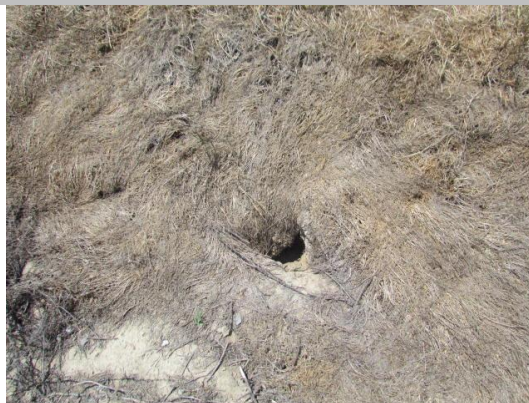
Photo 1 of 1 : SP_2015_NA0010_118_10_20150527_00180.jpg

LM Start	3.16	Rating **	U	Issue No.	10
LM End	3.16	Issue Type +	Ma	Location *	LS
Category	Earthen Levee			GPS Latitude/Longitude	
				Start	End
Item	Animal Control			37.321053 °	37.321053 °
				-120.928785 °	-120.928785 °
DWR ID	DWR_NA0010_01_s_2012_10				
Action/Comments					
No rodents visible, but rodent burrows visible; need to backfill and compact or grout burrows.					
Inspector Comments: Several rodent holes noted in this section.

Looking at typical view of rodent holes on landward slope.

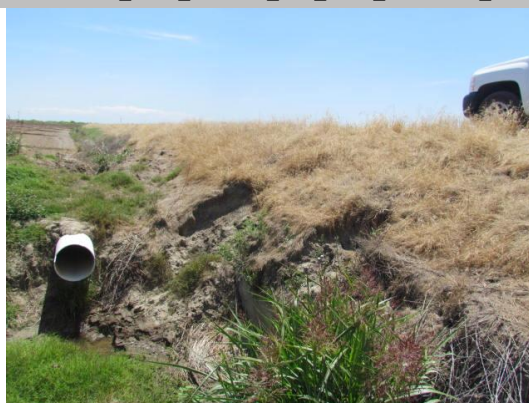
Photo 2 of 3 : SP_2015_NA0010_118_1179_20150527_00182.jpg

LM Start	3.47	Rating **	U	Issue No.	1179
LM End	3.47	Issue Type +	Ma	Location *	LS
Category	Earthen Levee			GPS Latitude/Longitude	
				Start	End
Item	Erosion / Bank Caving			37.317057 °	37.317057 °
				-120.926443 °	-120.926443 °
DWR ID	DWR_NA0010_01_s_2015_1179				
Action/Comments					
Note and monitor erosion site. Inspector Comments: Several erosions greater than three inches on landward slope.

Looking southwest at erosion on landward slope and toe.

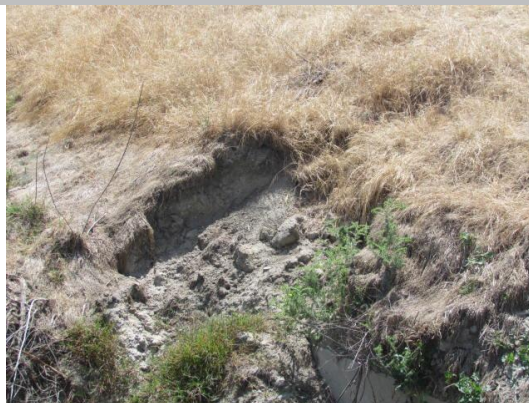
Photo 3 of 3 : SP_2015_NA0010_118_1179_20150527_00183.jpg

Looking west at erosion on landward slope and toe.

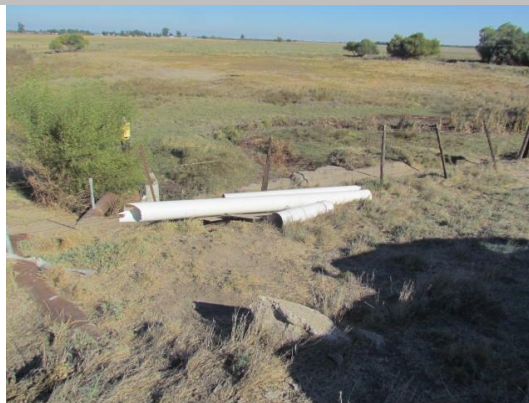
Photo 1 of 1 : SP_2015_NA0010_118_100_20150309_00015.jpg

Looking east at old pvc pipes on landward slope.

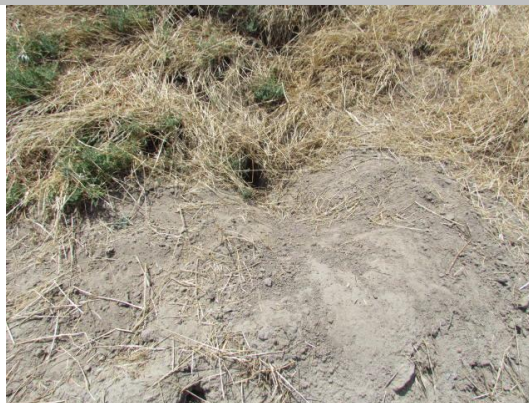
Photo 1 of 1 : SP_2015_NA0010_118_6_20150527_00184.jpg

LM Start	4.18	Rating **	M	Issue No.	6
LM End	4.18	Issue Type +	Ma	Location *	LS
Category	Earthen Levee			GPS Latitude/Longitude	
				Start	End
Item	Animal Control			37.308540 °	37.308540 °
				-120.924003 °	-120.924003 °
DWR ID	DWR_NA0010_01_s _ 2012_6				
Action/Comments					
Exterminate rodents and backfill and compact or grout burrows. Inspector Comments: Several rodent holes noted in this section.

Looking at typical rodent holes within this section.

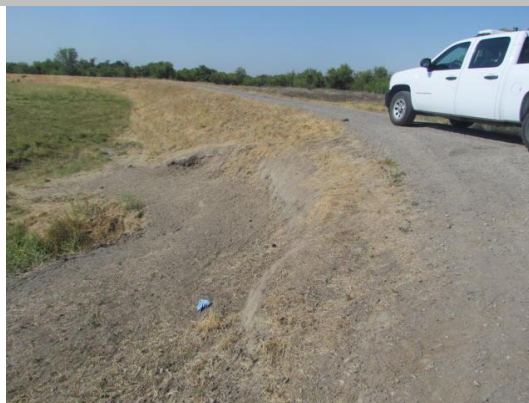
Photo 3 of 3 : SP_2015_NA0010_118_9_20150309_00006.jpg

Looking south at damage slope by livestock on landward slope.

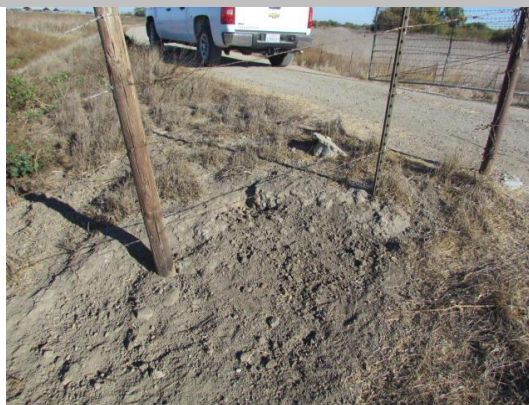
Photo 2 of 3 : SP_2015_NA0010_118_116_20150309_00017.jpg

Looking south at repaired rodent site on landside slope. (Fall 2012)

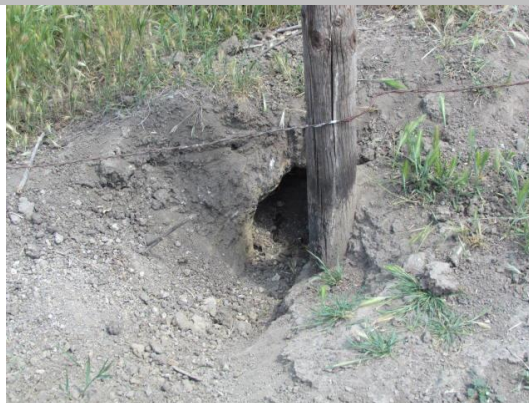
Photo 3 of 3 : SP_2015_NA0010_118_116_20150309_00018.jpg

Looking northeast at one of several holes on landside shoulder and slope.

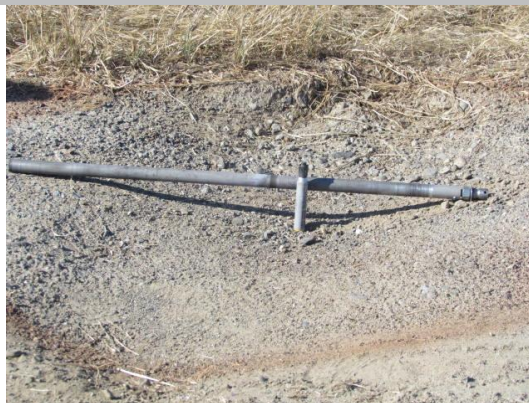
Photo 1 of 2 : SP_2015_NA0010_118_14_20150527_00188.jpg

Looking west at depression greater than three inches on levee crown.

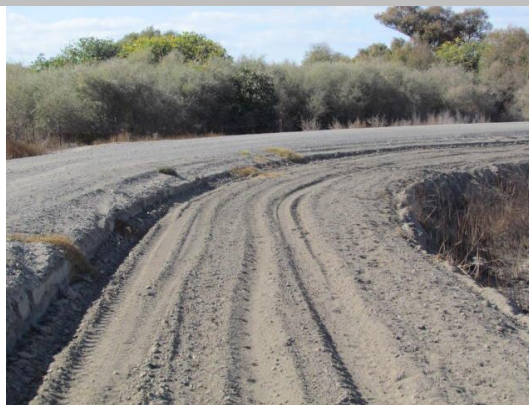
Photo 1 of 2 : SP_2015_NA0010_118_20_20150309_00007.jpg

Looking east at farmer discing into landside slope.

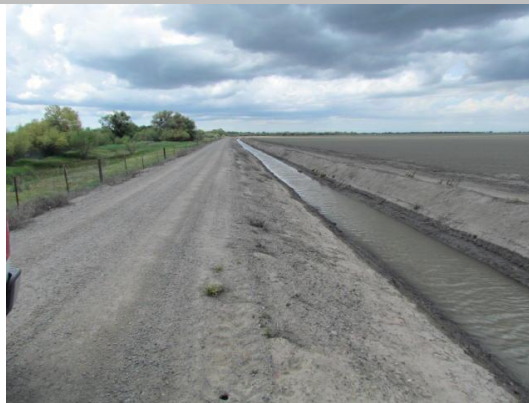
Photo 1 of 2 : SP_2015_NA0010_118_22_20150309_00009.jpg

Looking downstream at irrigation ditch at landside toe.

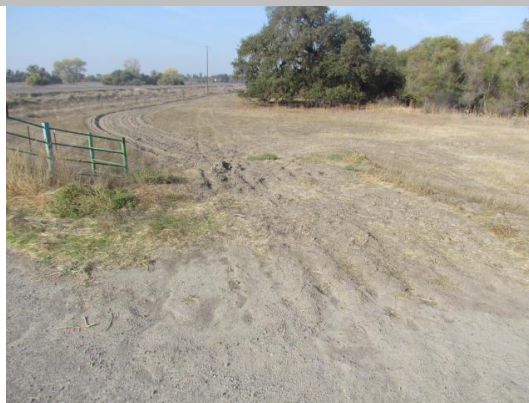
Photo 1 of 2 : SP_2015_NA0010_119_2_20150309_00001.jpg

Looking northeast at unauthorized ramp on landward slope.

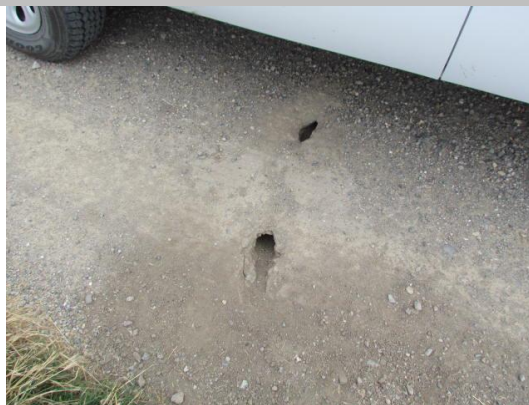
Photo 1 of 1 : SP_2015_NA0010_119_252_20150527_00008.jpg

Looking at rodent holes on levee crown.

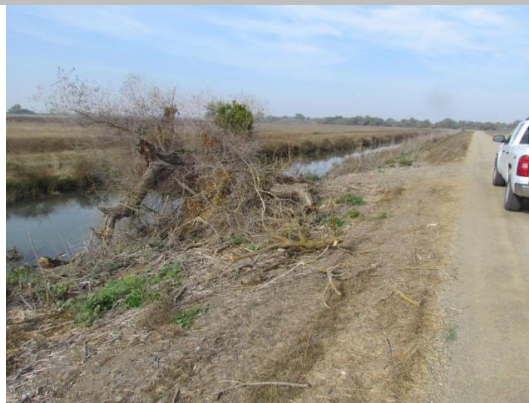
Photo 1 of 2 : SP_2015_NA0010_120_1_20150309_00001.jpg

Looking southwest at tree limb on waterward slope.

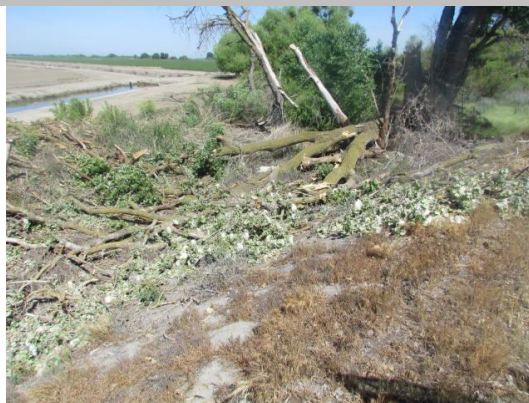
Photo 1 of 1 : SP_2015_NA0010_122_4_20150309_00004.jpg

Looking east at downed tree and prunings on landward slope and toe.

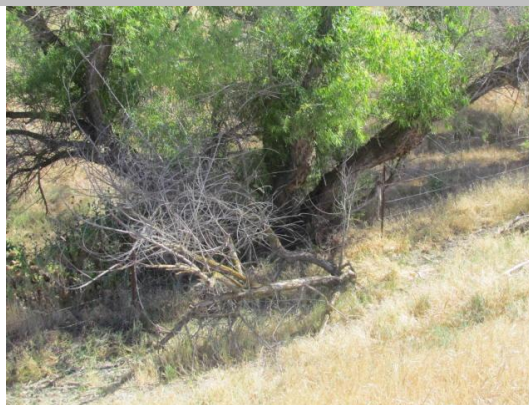
Photo 1 of 2 : SP_2015_NA0010_123_1308_20150527_00459.jpg

Looking southeast at dead tree limbs on landward toe.

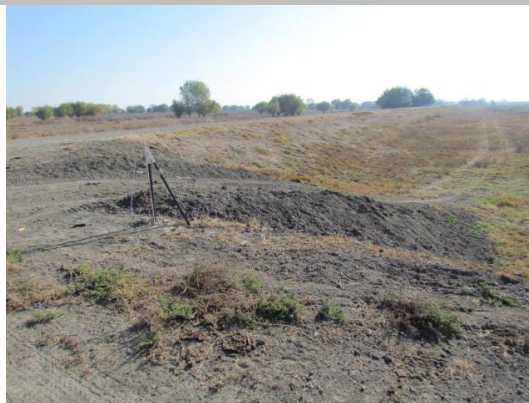
Photo 1 of 3 : SP_2015_NA0010_123_7_20150309_00004.jpg

Looking south at unauthorized ramp on waterside slope.

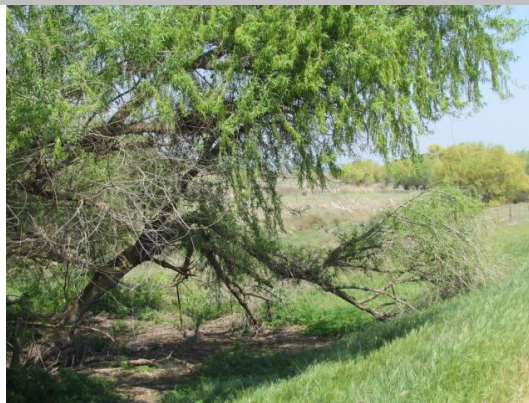
Photo 1 of 1 : SP_2015_NA0010_123_2_20150309_00001.jpg

Looking south at down tree limb on landside slope and toe.

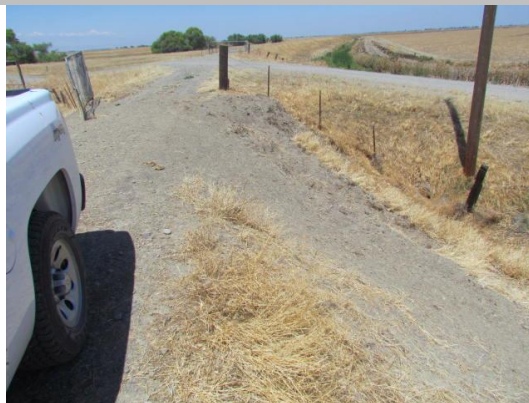
Photo 1 of 2 : SP_2015_NA0010_123_1309_20150527_00462.jpg

Looking north at damaged landward slope.

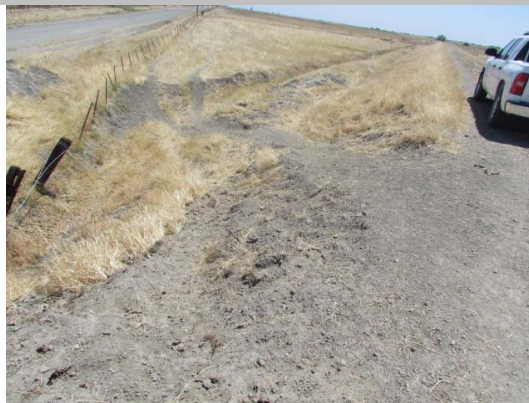
Photo 2 of 2 : SP_2015_NA0010_123_1309_20150527_00463.jpg

Looking south at damaged landward slope.

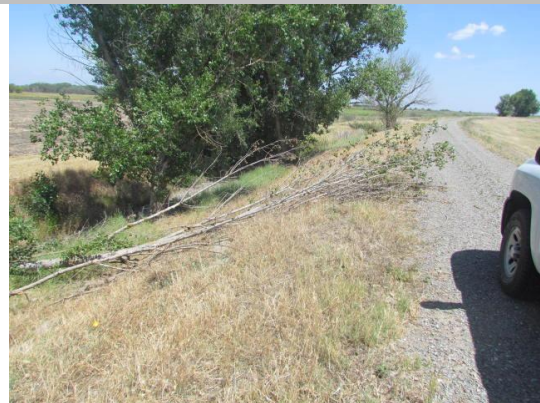
Photo 1 of 1 : SP_2015_NA0010_123_1310_20150527_00464.jpg

Looking south at fallen tree limbs on waterward slope.

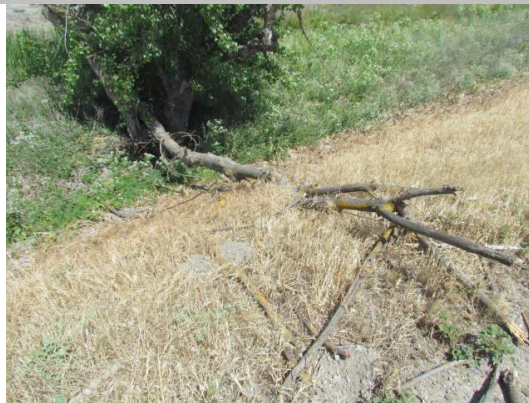
Photo 1 of 1 : SP_2015_NA0010_123_1311_20150527_00465.jpg

Looking east at a fallen tree limbs on waterward slope.

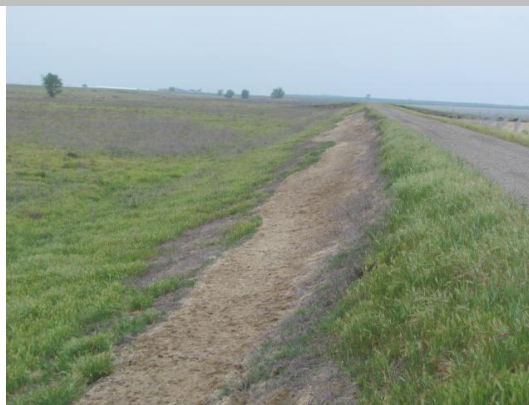
Photo 1 of 3 : SP_2015_NA0010_123_171_20150309_00011.jpg

Looking south at erosion caused by livestock on landside slope.

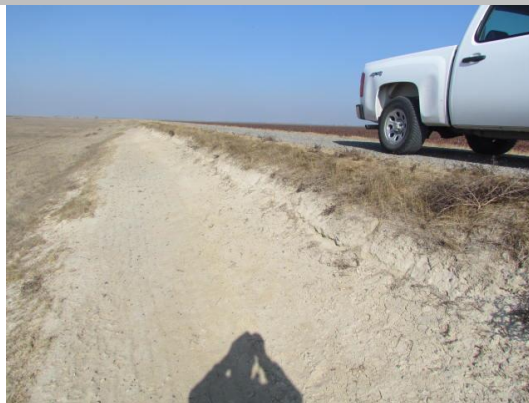
Photo 2 of 3 : SP_2015_NA0010_123_171_20150309_00012.jpg

Looking south at livestock erosion on landward slope.

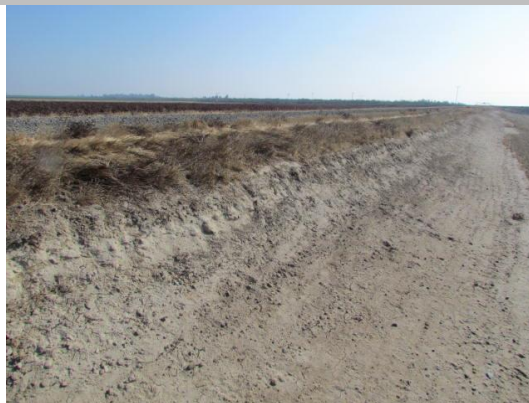
Photo 3 of 3 : SP_2015_NA0010_123_171_20150309_00013.jpg

Looking east at livestock erosion on landward slope.

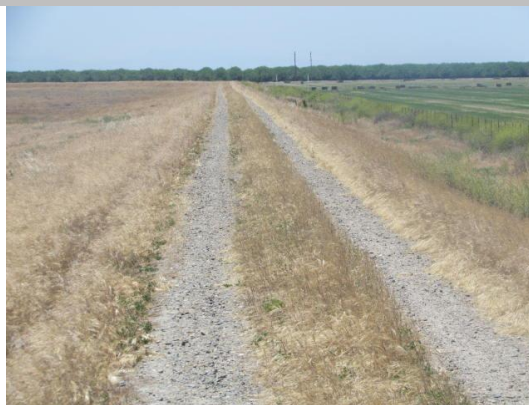
Photo 1 of 1 : SP_2015_NA0010_123_22_20150309_00010.jpg

Looking at vegetation on levee crown.

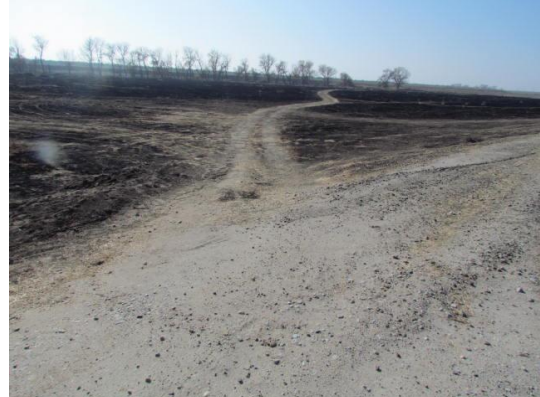
Photo 1 of 1 : SP_2015_NA0010_123_11_20150309_00009.jpg

Looking west at unauthorized ramp on waterward slope.

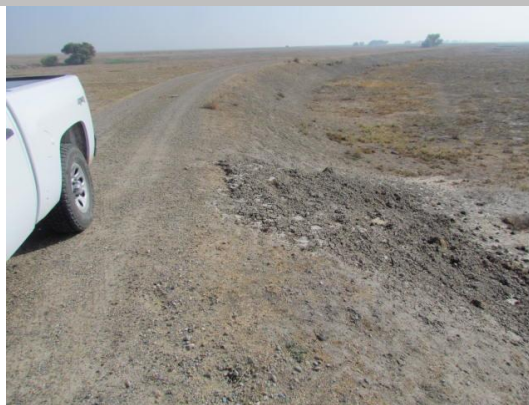
Photo 1 of 2 : SP_2015_NA0010_124_9_20150309_00009.jpg

Looking northwest at damaged slope repaired.

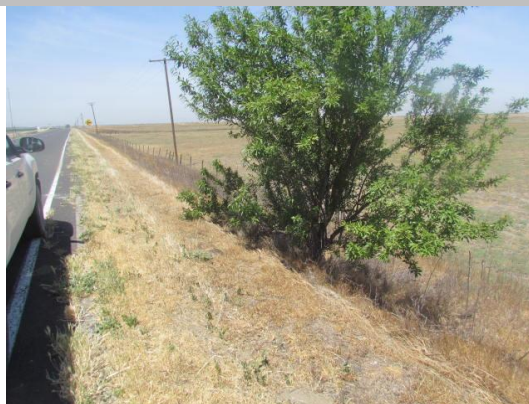
Photo 1 of 1 : SP_2015_NA0010_124_14_20150309_00013.jpg

Looking east at tree on waterward slope.

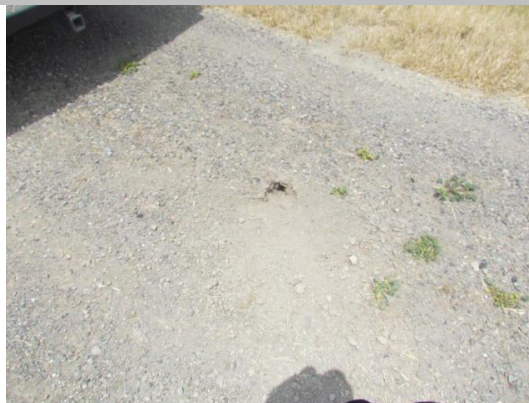
Photo 1 of 1 : SP_2015_NA0010_124_1212_20150528_00399.jpg

Looking at rodent hole on levee crown.

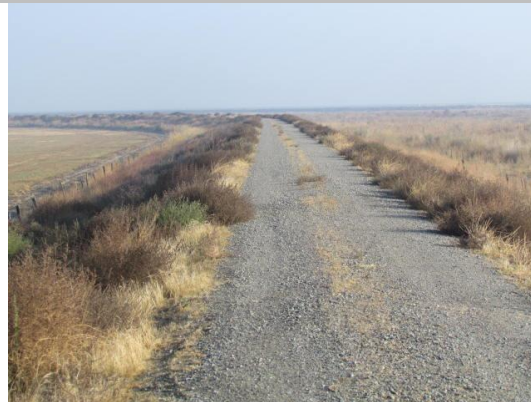
Photo 1 of 1 : SP_2015_NA0010_124_63_20150309_00014.jpg

Looking north at tumble weeds on levee slopes.

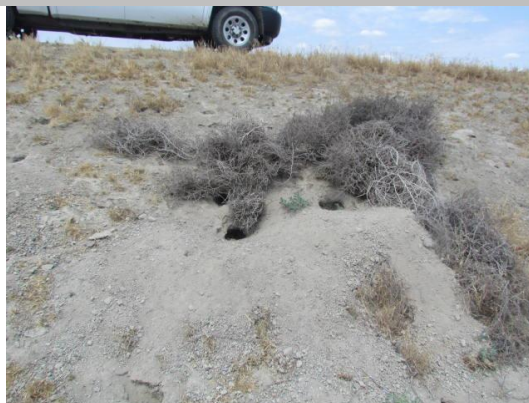
Photo 3 of 3 : SP_2015_NA0010_124_1211_20150528_00401.jpg

Looking east at several rodent holes on waterward slope.

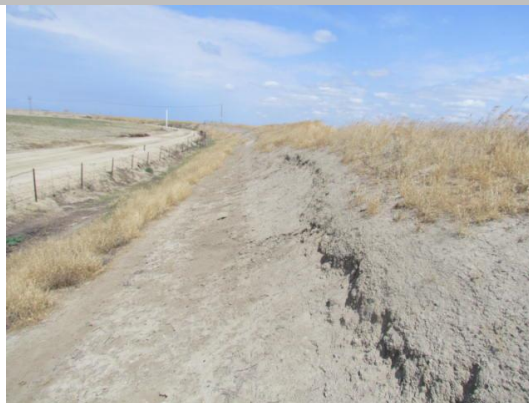
Photo 1 of 2 : SP_2015_NA0010_124_1209_20150528_00403.jpg

Looking north at livestock erosion on landward slope.

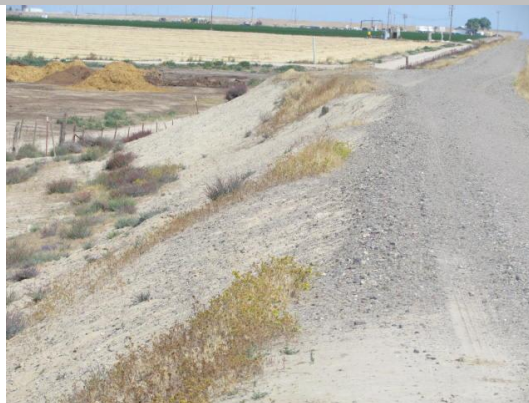
Photo 1 of 5 : SP_2015_NA0010_124_3_20150528_00408.jpg

Looking north at livestock erosion on landward shoulder and slope.(Spring 2015)

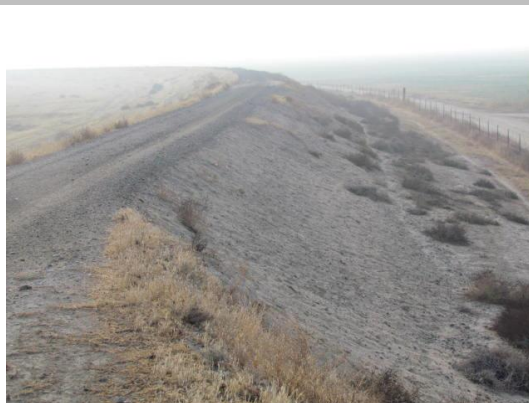
Photo 3 of 5 : SP_2015_NA0010_124_3_20150309_00004.jpg

Looking south at livestock erosion on landward slope. (Fall 2013)

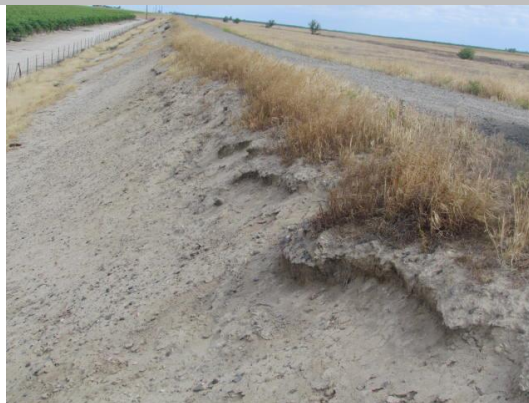
Photo 1 of 2 : SP_2015_NA0010_124_1207_20150528_00409.jpg

Looking northeast at livestock erosion on landward slope.

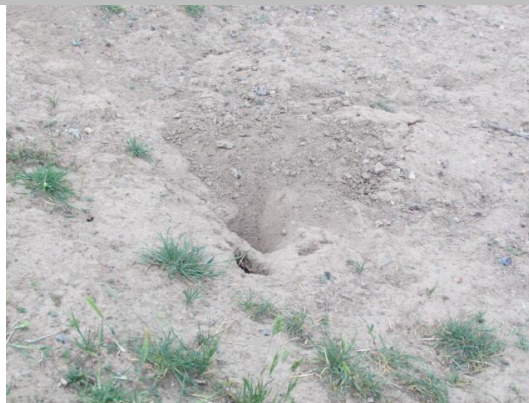
Photo 2 of 2 : SP_2015_NA0010_124_2_20150309_00002.jpg

Looking at typical rodent hole on landside slope.

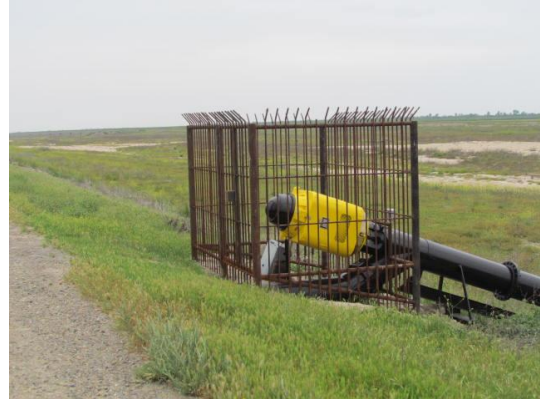
Photo 1 of 1 : SP_2015_NA0010_124_123_20150309_00018.jpg

Looking northeast at new metal fence around slant pump on waterside slope.

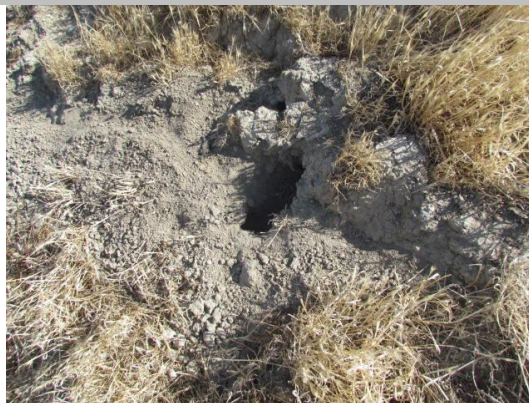
Photo 1 of 1 : SP_2015_NA0010_125_29_20150528_00010.jpg

Looking at typical view of rodent holes on landward slope.

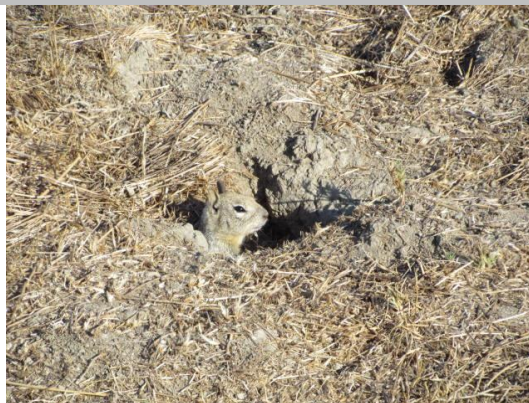
Photo 2 of 2 : SP_2015_NA0010_125_1_20150309_00002.jpg

Looking at east at active rodent holes on landside berm.

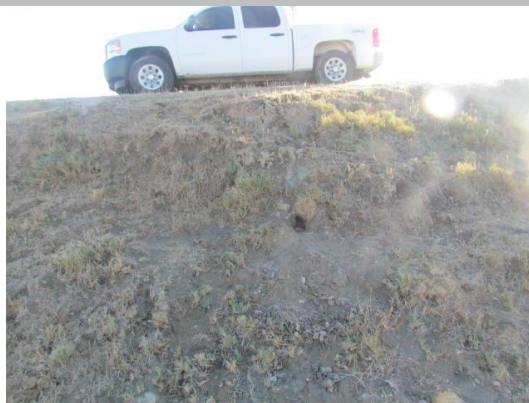
Photo 1 of 1 : SP_2015_NA0010_125_11_20150309_00008.jpg

Looking west at slope damage and rodent activity on landward slope.

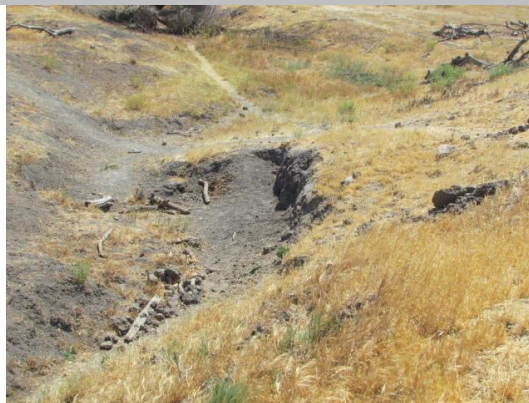
Photo 4 of 5 : SP_2015_NA0010_125_3_20150309_00005.jpg

Looking southeast at damage on landward toe.(Spring 2013)

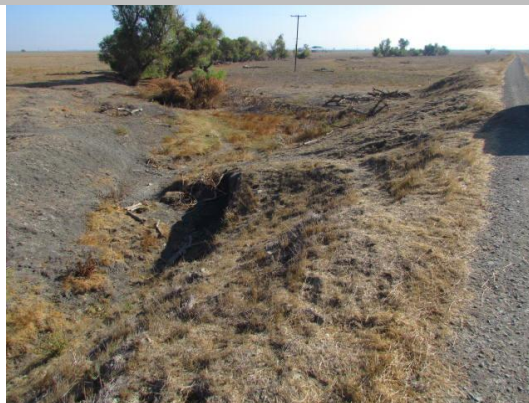
Photo 5 of 5 : SP_2015_NA0010_125_3_20150309_00006.jpg

Looking southeast at landside slope and toe damage by livestock.

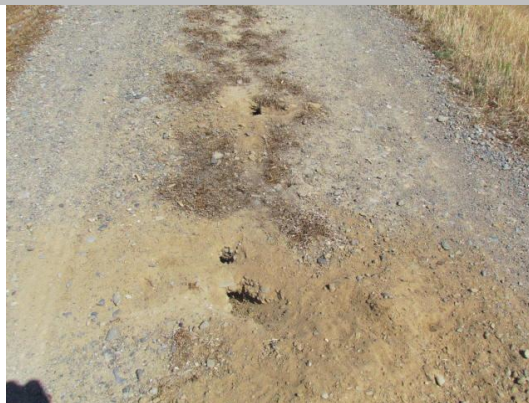
Photo 1 of 1 : SP_2015_NA0010_125_187_20150528_00013.jpg

Looking at several rodent holes on levee crown.

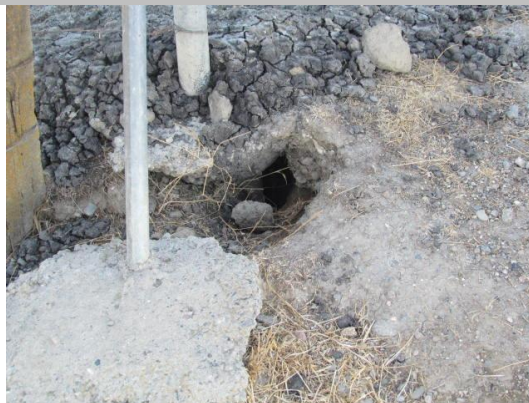
Photo 1 of 1 : SP_2015_NA0010_125_12_20150309_00009.jpg

Looking east at rodent hole next to fence post on landward shoulder.

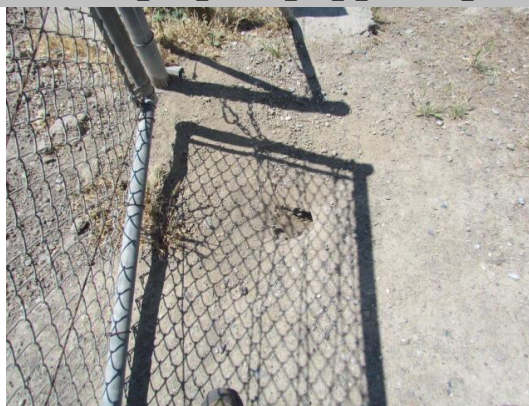
Photo 1 of 4 : SP_2015_NA0010_126_7_20150528_00034.jpg

Looking at several rodent holes near fence line on landward slope.

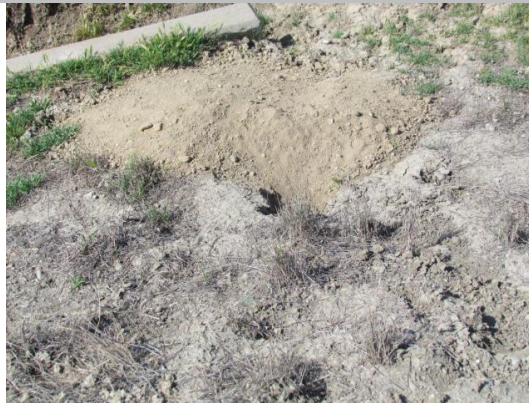
Photo 4 of 4 : SP_2015_NA0010_126_7_20150309_00003.jpg

Looking at typical rodent hole on landside slope near headwall.

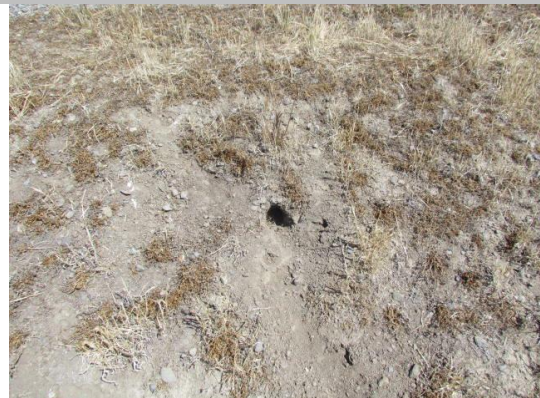
Photo 1 of 1 : SP_2015_NA0010_126_3_20150528_00035.jpg

Looking at typical view of rodent holes on landward slope.

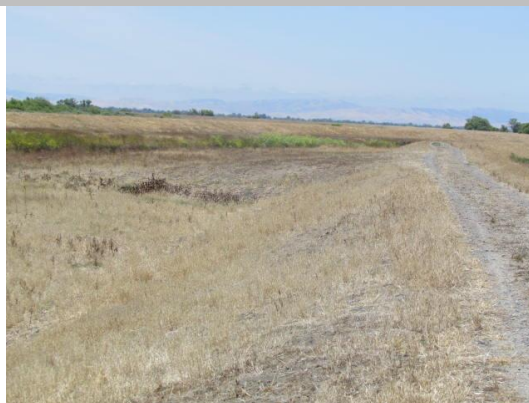
Photo 1 of 1 : SP_2015_NA0010_127_34_20150528_00011.jpg

Looking at typical view of waterward slope.

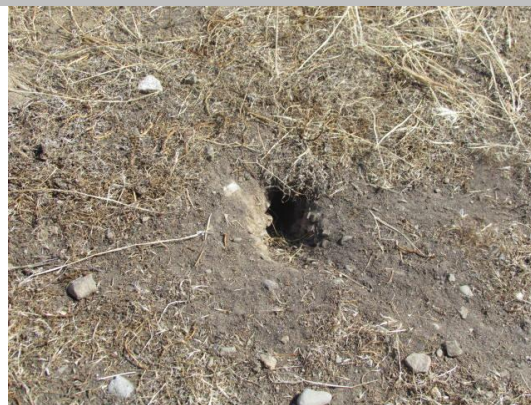
Photo 1 of 1 : SP_2015_NA0010_132_79_20150528_00032.jpg

Looking at typical view of rodent holes on landward slope.

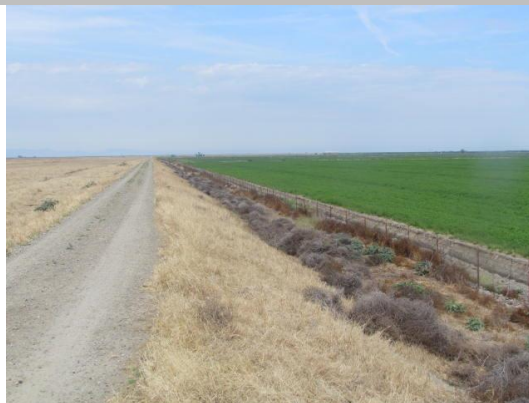
Photo 1 of 1 : SP_2015_NA0010_133_74_20150528_00010.jpg

Looking at typical view of growth on landward slope.

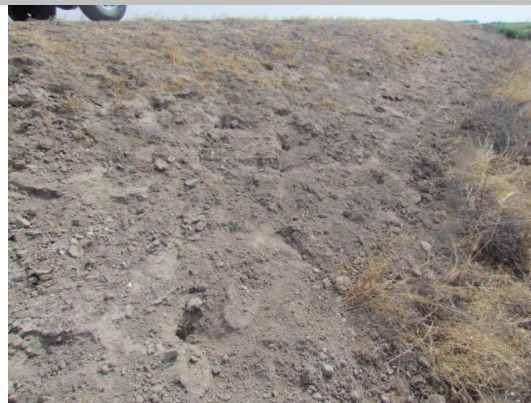
Photo 1 of 1 : SP_2015_NA0010_134_92_20150528_00024.jpg

Looking at several rodent holes on landward slope.

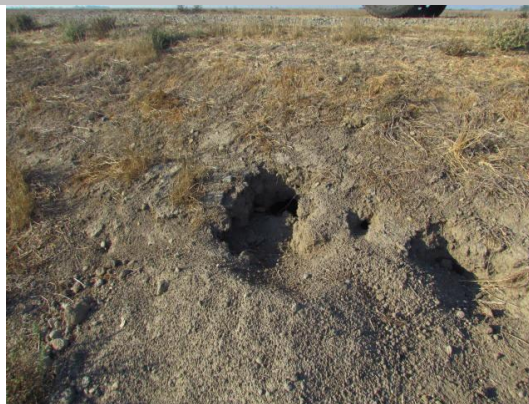
Photo 1 of 2 : SP_2015_NA0010_134_2_20150309_00001.jpg

Looking at large rodent holes on landward slope.

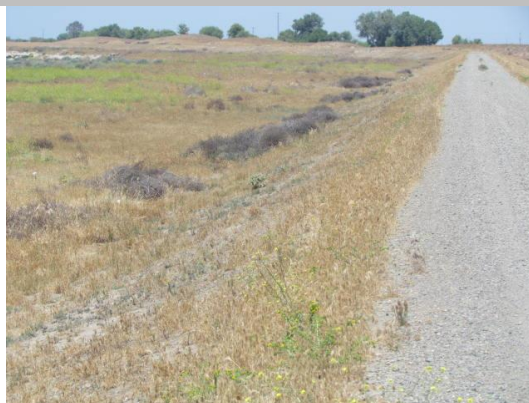
Photo 1 of 1 : SP_2015_NA0010_135_12_20150528_00113.jpg

Looking at typical view of growth on waterward slope.

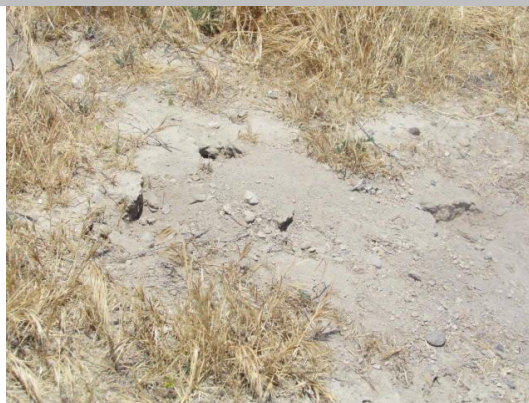
Photo 1 of 2 : SP_2015_NA0010_135_8_20150528_00114.jpg

Looking at several rodent holes on landward slope. (Spring 2015)

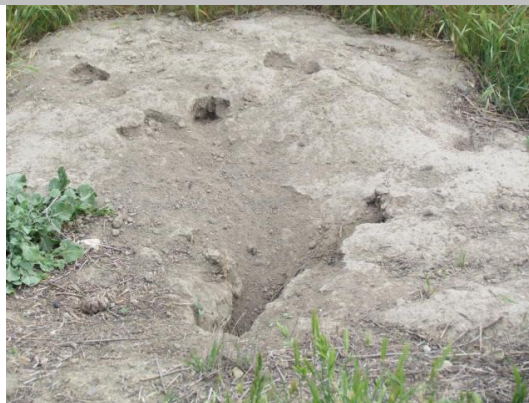
Photo 2 of 2 : SP_2015_NA0010_135_8_20150309_00001.jpg

Looking at several rodent holes on landside slope. (Fall 2014)

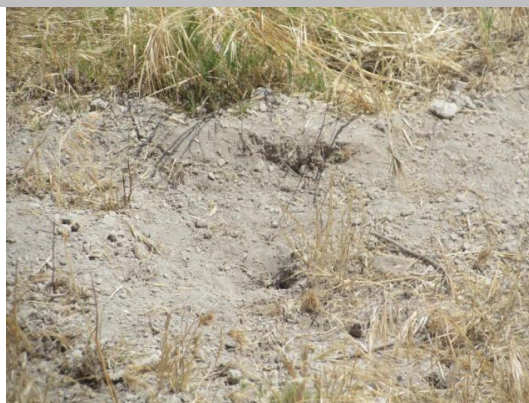
Photo 1 of 1 : SP_2015_NA0010_135_5_20150528_00116.jpg

Looking at typical view of rodent holes on landward slope.

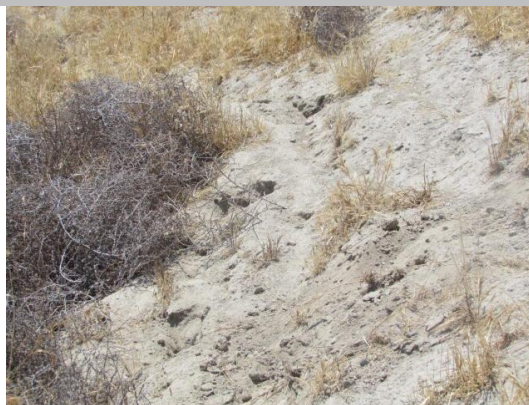
Photo 1 of 1 : SP_2015_NA0010_135_3_20150528_00117.jpg

Looking at several rodent holes on landward slope.

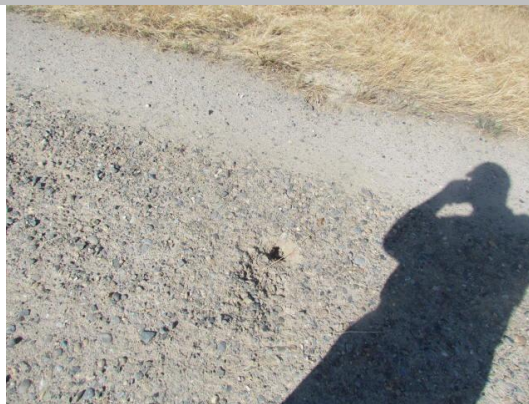
Photo 1 of 1 : SP_2015_NA0010_137_7_20150528_00044.jpg

Looking at typical view of rodent holes within this section on landward slope.

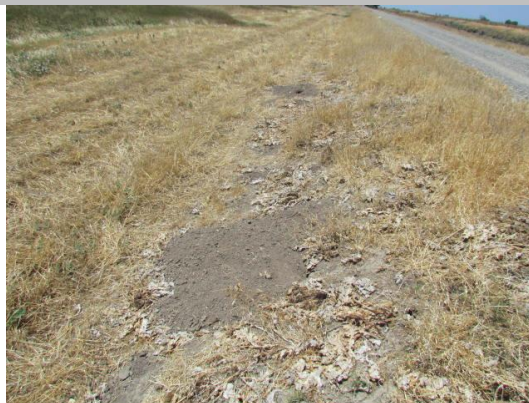
Photo 1 of 1 : SP_2015_NA0010_138_15_20150528_00049.jpg

Looking at several rodent holes on landward slope.

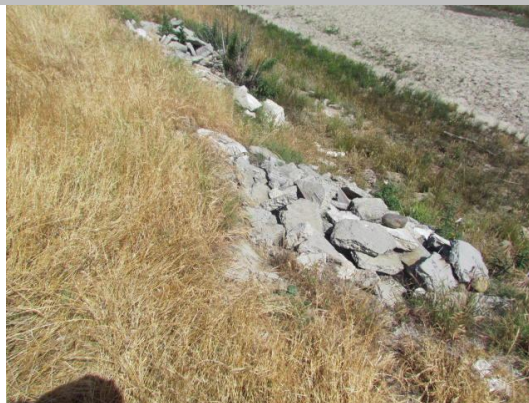
Photo 1 of 2 : SP_2015_NA0010_138_5_20150528_00052.jpg

Looking at erosion sites repaired with rip-rap on waterward slope and toe. (Spring 2015)

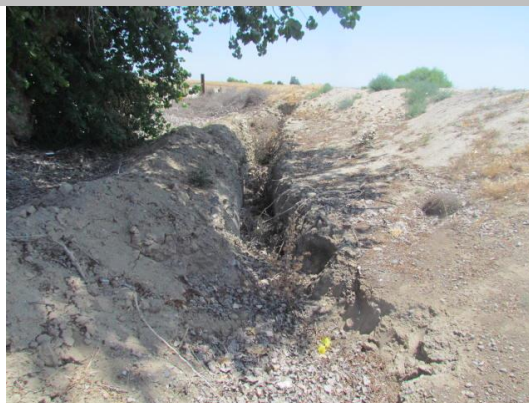
Photo 1 of 3 : SP_2015_NA0010_139_29_20150528_00115.jpg

Looking south at trench at landward toe. (Spring 2015)

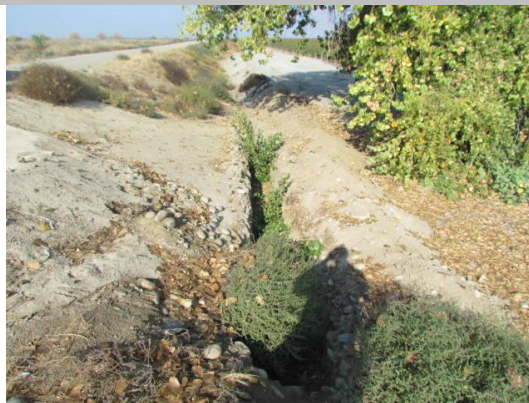
Photo 3 of 3 : SP_2015_NA0010_139_29_20150309_00014.jpg

Looking north at trench at landward toe.

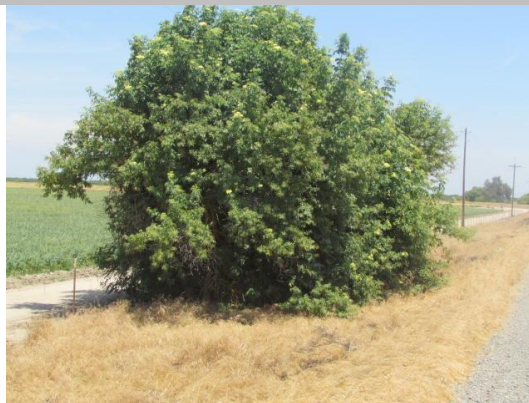
Photo 1 of 2 : SP_2015_NA0010_139_15_20150528_00116.jpg

Looking south at elderberry at landward toe. (Spring 2015)

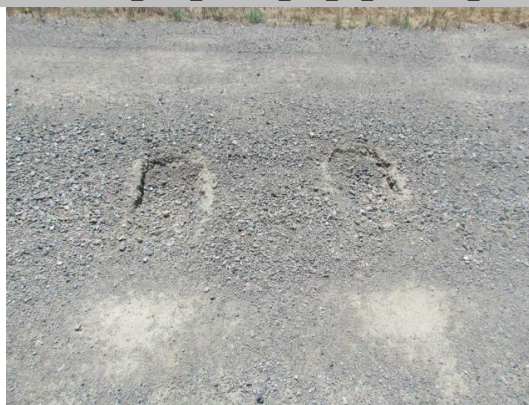
Photo 1 of 2 : SP_2015_NA0010_139_14_20150528_00119.jpg

Looking at two depression on levee crown.

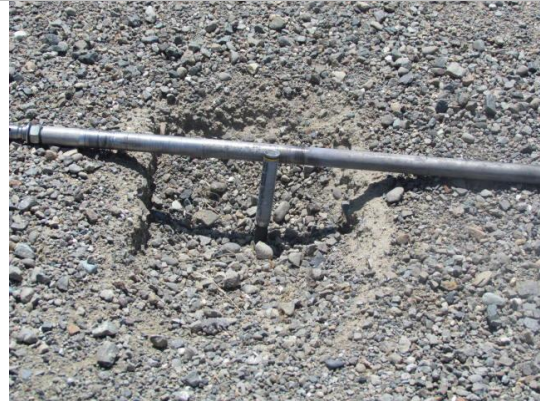
Photo 2 of 2 : SP_2015_NA0010_139_14_20150528_00120.jpg

Looking at one of two depression on levee crown.

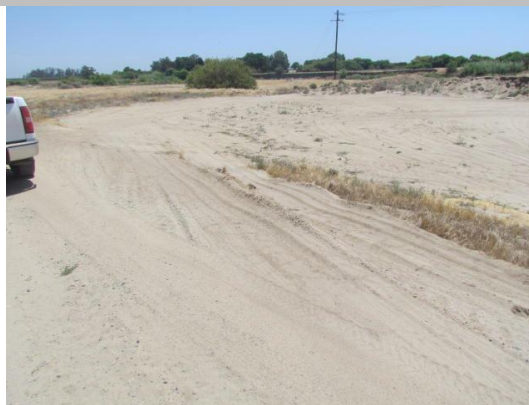
Photo 1 of 1 : SP_2015_NA0010_139_17_20150309_00013.jpg

Looking southwest at waterward slope damaged due to vehicle traffic.

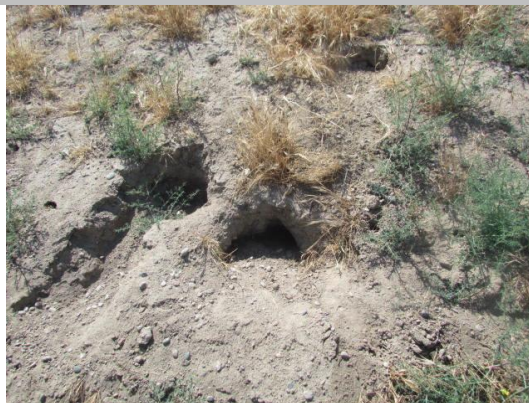
Photo 1 of 1 : SP_2015_NA0010_140_6_20150528_00070.jpg

Looking at several rodent holes on landward slope.
