**Flood Control Project Maintenance
Levee Inspections****LMA District Cover Sheet****Spring 2016 Levee Inspection Results****Lower San Joaquin Levee District**

Spring 2016 Levee Inspection Results

Lower San Joaquin Levee District

Waterway			Bank	Unit Miles
Unit No. 01 San Joaquin River			Right	22.52
	Spring (March - May)	Summer (June - August)	(September - November) Fall	Winter (December - February)
Unit Maintenance Rating (Fall Only)				
Date of Inspection	5/16/2016 - 5/19/2016			
DWR Inspector	Richard Willoughby			
Accompanied By

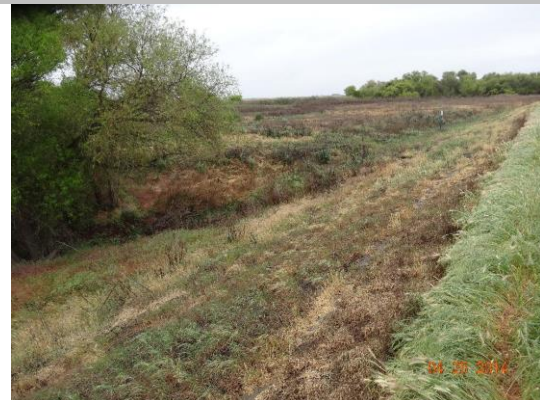
Photo 1 of 2 : UCIP_SP_2016_36166_65449.jpg

View of waterward side.

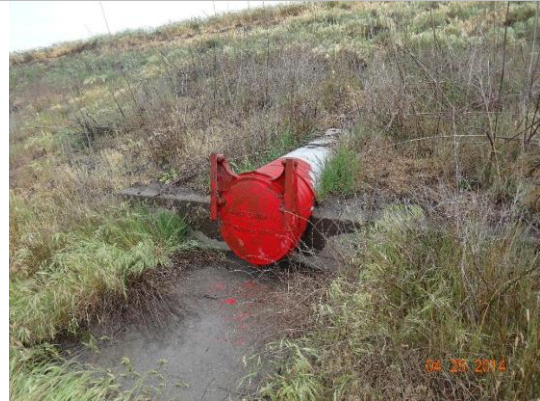
Photo 2 of 2 : UCIP_SP_2016_36168_65457.jpg

Concrete headwall, flap gate, and concrete apron located on waterward side.

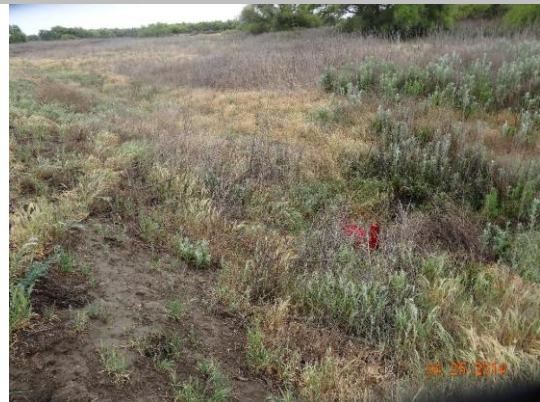
Photo 1 of 2 : UCIP_SP_2016_36169_65464.jpg

View of waterward side--flap gate visible through dense vegetation.

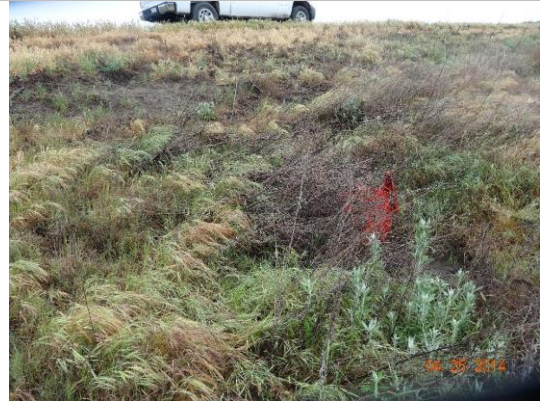
Photo 2 of 2 : UCIP_SP_2016_36169_65463.jpg

View of waterward slope covered by dense vegetation.

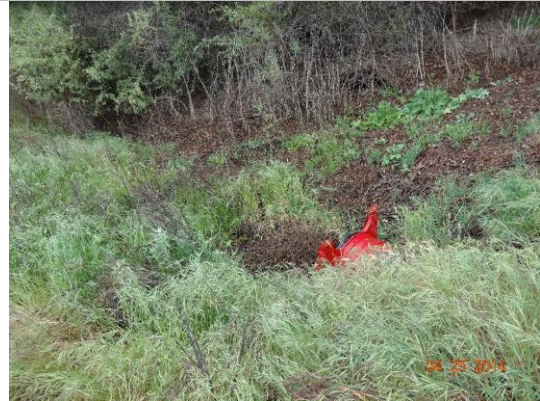
Photo 2 of 2 : UCIP_SP_2016_36171_65470.jpg

Flap gate visible on waterward side.

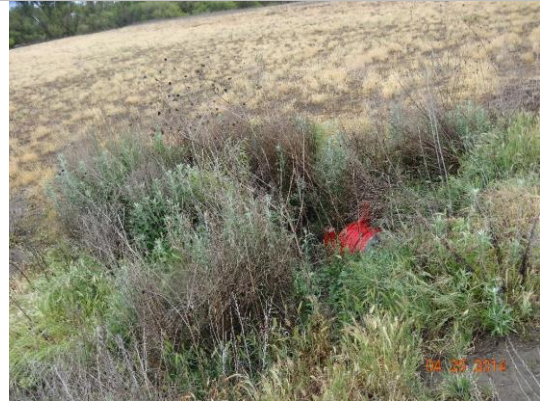
Photo 2 of 2 : UCIP_SP_2016_36172_65475.jpg

Flap gate visible on waterward toe.

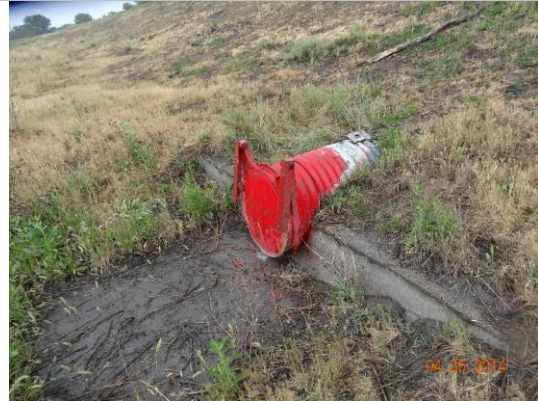
Photo 2 of 2 : UCIP_SP_2016_36204_65546.jpg

Flap gate visible on waterward side.

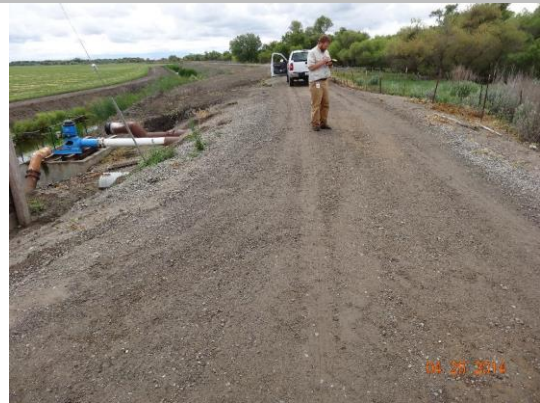
Photo 1 of 2 : UCIP_SP_2016_39878_66308.jpg

Overview of levee crown at crossing--multiple crossings at this location.

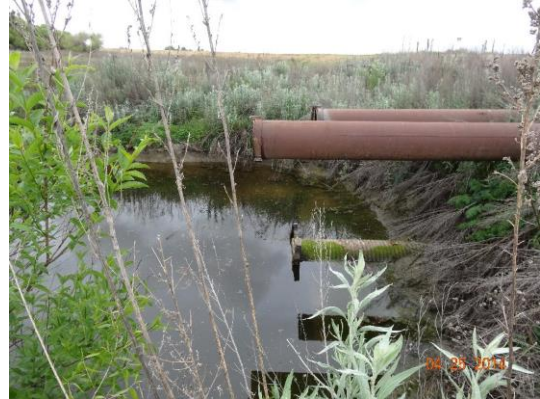
Photo 2 of 2 : UCIP_SP_2016_39878_66309.jpg

Multiple crossings visible on waterward side--36 inch CMP is submersed in water.

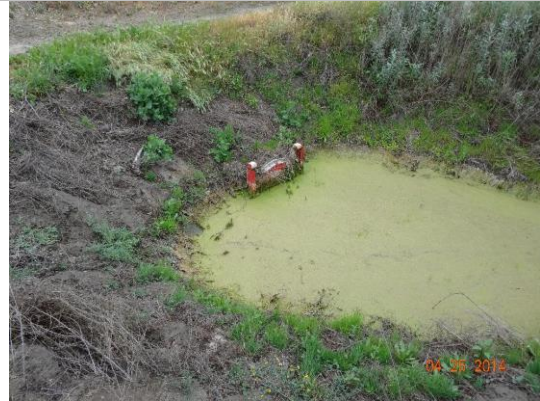
Photo 2 of 2 : UCIP_SP_2016_39271_66313.jpg

Flap gate half way submersed located on waterward side.

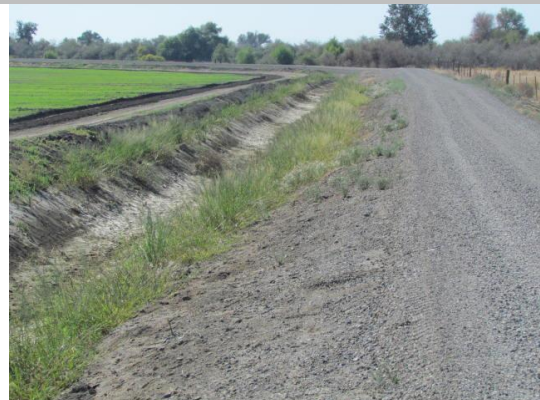
Photo 1 of 3 : SP_2016_NA0010_118_22_20160512_00014.jpg

Looking downstream at irrigation ditch at LM 22.06

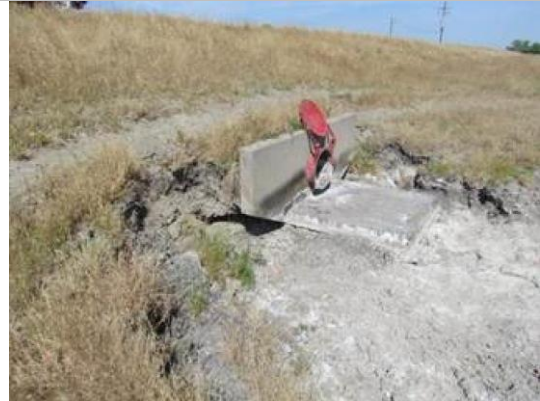
Photo 2 of 2 : UCIP_SP_2016_48510_75114.jpg

View of WS with flap gate open.

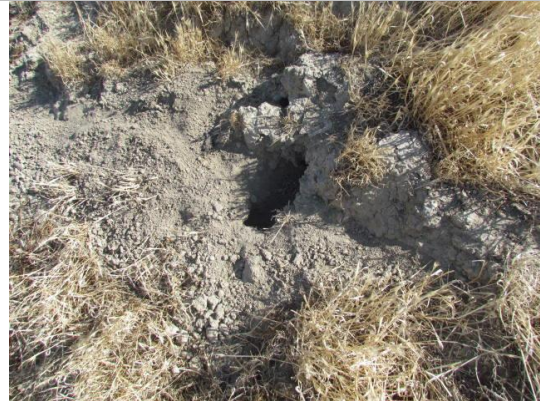
Photo 1 of 1 : SP_2016_NA0010_125_29_20160512_00011.jpg

Looking at typical view of rodent holes on landward slope.

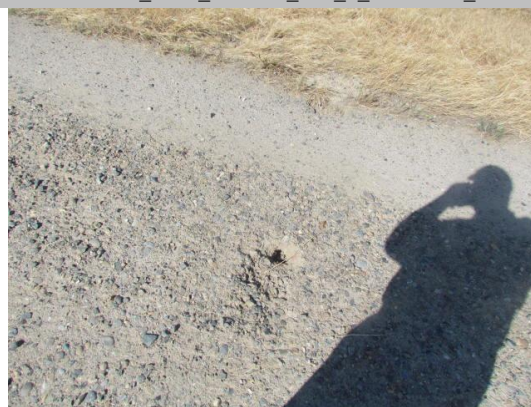
Photo 1 of 1 : SP_2016_NA0010_137_7_20160512_00002.jpg

Looking at typical view of rodent holes within this section on landward slope.

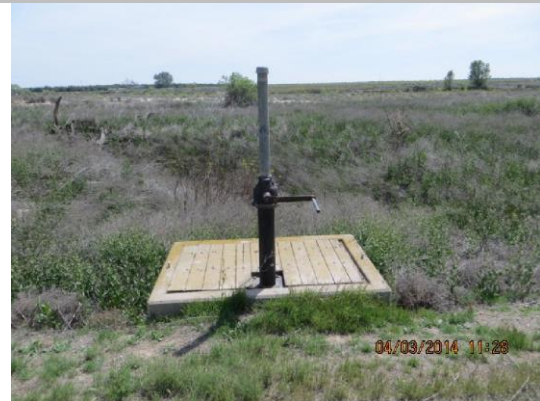
Photo 1 of 2 : UCIP_SP_2016_39540_59848.jpg

Slide gate in concrete riser on WS shoulder.
