**Flood Control Project Maintenance  
Levee Inspections**  
**LMA District Cover Sheet**  
**Spring 2017 Levee Inspection Results**

**Lower San Joaquin Levee District**

Waterway			Bank	Unit Miles
Unit No. 01 San Joaquin River			Right	22.52
	Spring (March - May)	Summer (June - August)	(September - November) Fall	Winter (December - February)
Unit Maintenance Rating (Fall Only)				
Date of Inspection	4/17/2017 - 4/20/2017			
DWR Inspector	Richard Willoughby			
Accompanied By

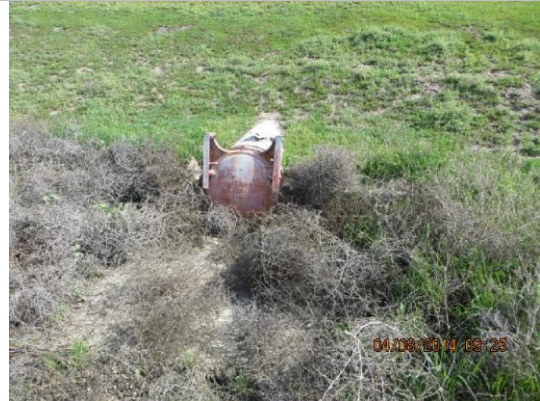
Photo 3 of 3 : UCIP\_SP\_2017\_39096\_60633.jpg

Flapgate, pipe, and headwall on WS toe.

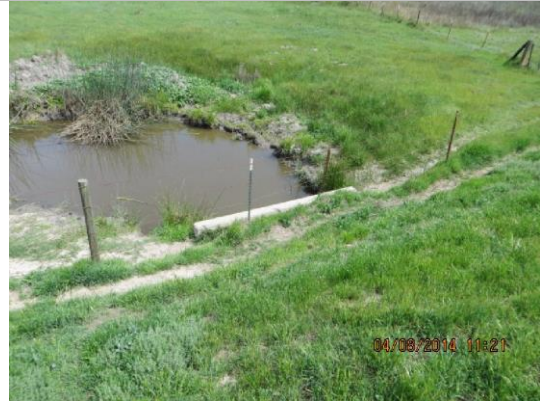
Photo 3 of 3 : UCIP\_SP\_2017\_39140\_60734.jpg

Concrete headwall at LS toe.

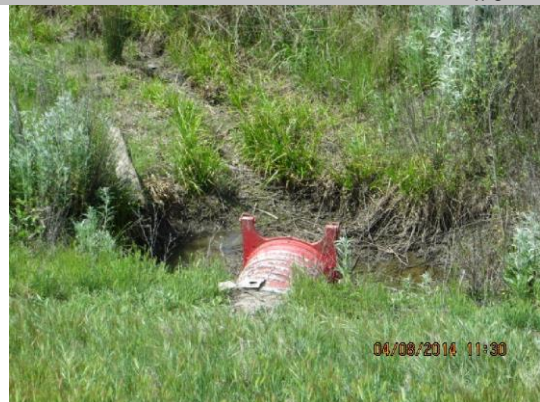
Photo 1 of 3 : UCIP\_SP\_2017\_39141\_60737.jpg

Pipe, flapgate, and headwall on WS toe.

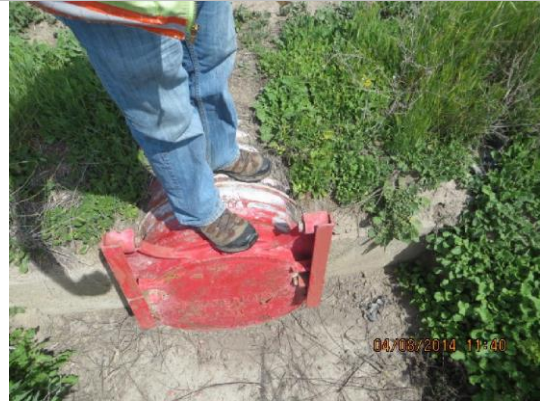
Photo 2 of 2 : UCIP\_SP\_2017\_39143\_60739.jpg

Flapgate and headwall visible at WS toe.

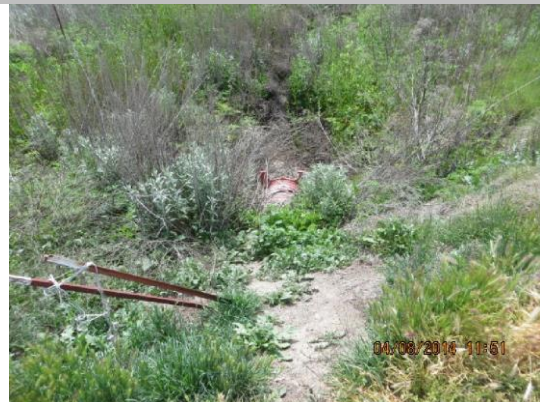
Photo 1 of 2 : UCIP\_SP\_2017\_39151\_60742.jpg

Pipe, concrete headwall, and flapgate visible on WS toe.

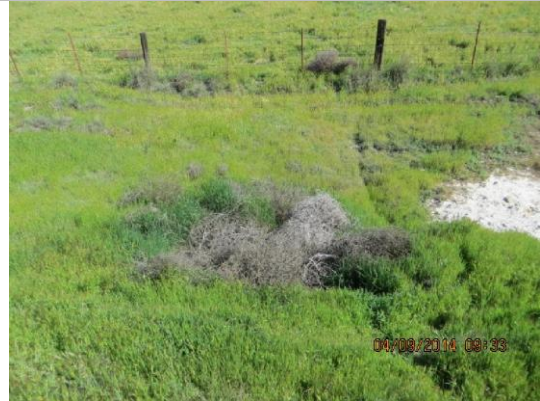
Photo 3 of 3 : UCIP\_SP\_2017\_39245\_60849.jpg

Pipe and concrete headwall at LS toe. Note heavy vegetation.

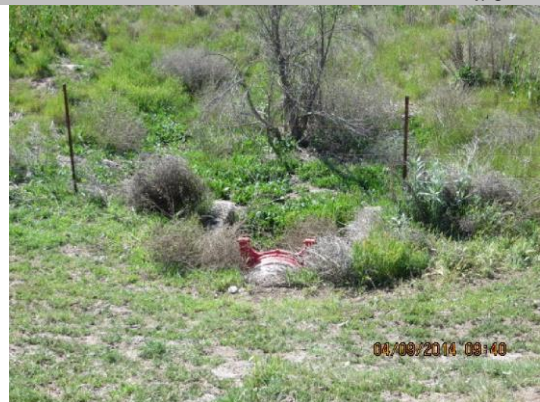
Photo 1 of 3 : UCIP\_SP\_2017\_39246\_60854.jpg

Pipe, Flapgate, and headwall on WS toe.

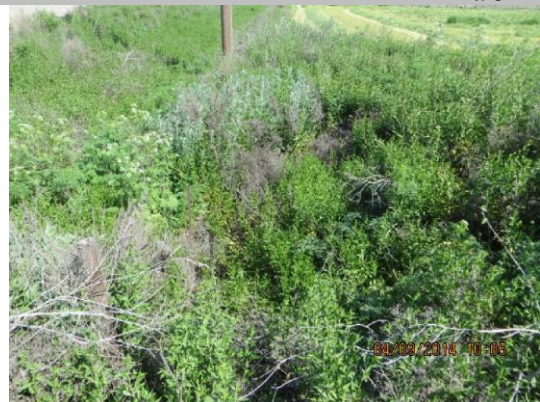
Photo 1 of 2 : UCIP\_SP\_2017\_39250\_60872.jpg

Heavy vegetation on LS toe.

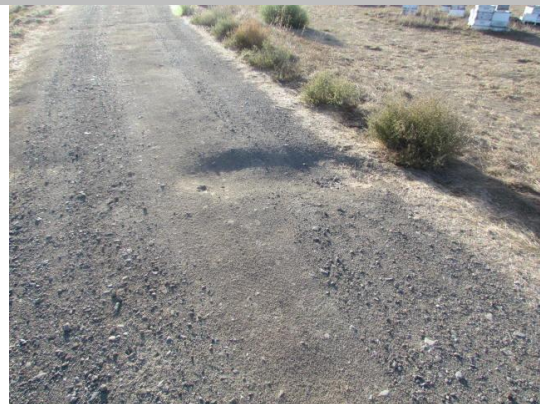
Photo 1 of 3 : SP\_2017\_NA0010\_118\_14\_20170417\_00012.jpg

LM Start	9.57	Rating **	M	Issue No.	14
LM End	9.57	Issue Type +	Ma	Location *	CR
Category	Earthen Levee			GPS Latitude/Longitude	
				Start	End
Item	Crown Surface / Depressions / Rutting			37.295517 °	37.295517 °
				-120.841452 °	-120.841452 °
DWR ID	DWR_NA0010_01_s_2015_14				
Comment Code					
C2 : Repair depressions or ruts in the crown or slope.					
Inspector Comment					
Depression greater than 3" deep by 18" wide by 18" long on levee crown

Looking at depression on levee crown. (Fall 2015)

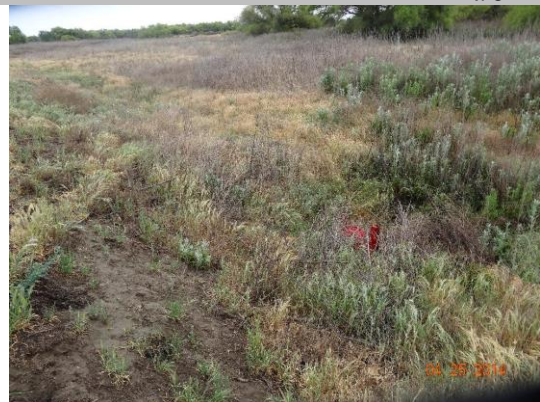
Photo 1 of 3 : UCIP\_SP\_2017\_36169\_65464.jpg

View of waterward side--flap gate visible through dense vegetation.

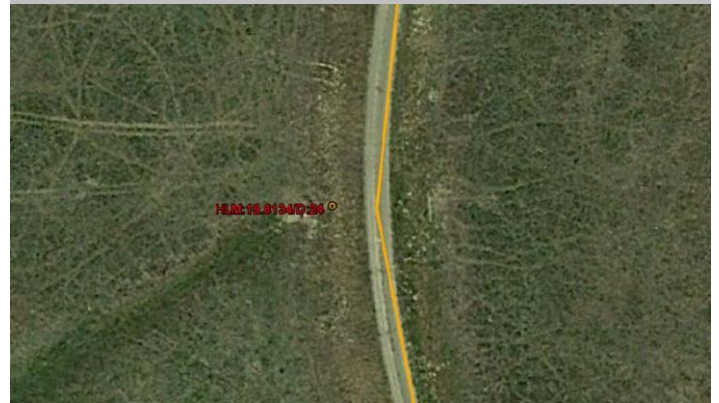
Photo 1 of 1 : UCIP\_SP\_2017\_36253\_65645.jpg

Indicators that a crossing is still present through the levee. Flap gate should be in waterward side.

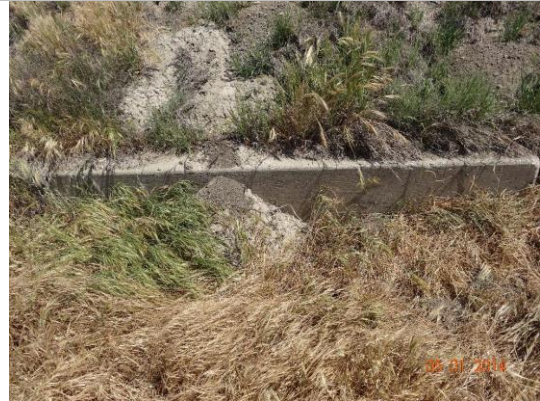
Photo 3 of 3 : UCIP\_SP\_2017\_36512\_66140.jpg

Non-functional crossing concrete headwall and inlet buried on landward side.

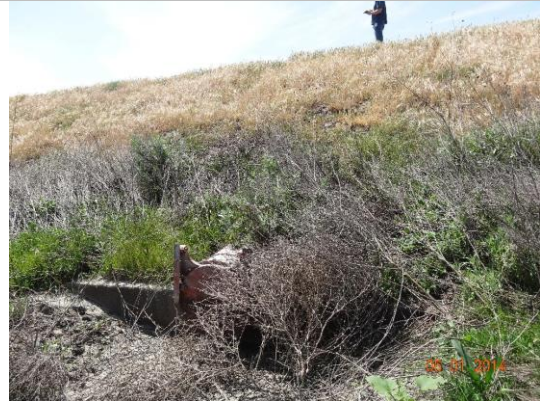
Photo 3 of 3 : UCIP\_SP\_2017\_39364\_66159.jpg

Flap gate and concrete headwall visible through dense vegetation.

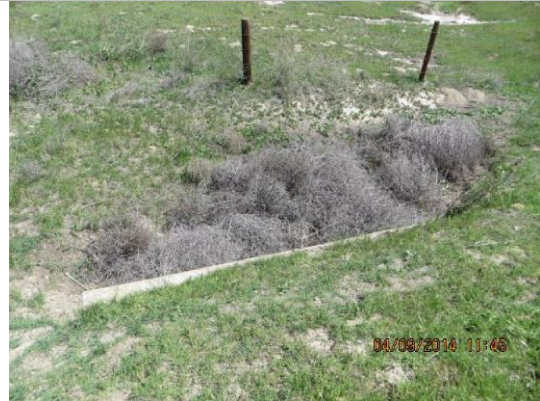
Photo 3 of 3 : UCIP\_SP\_2017\_39584\_60927.jpg

Pipe and concrete headwall on LS toe. Note vegetation buildup.

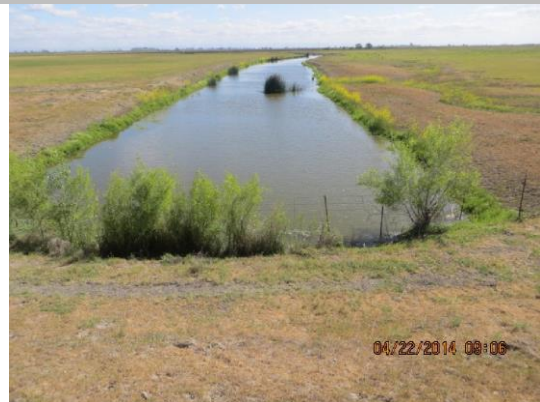
Photo 1 of 2 : UCIP\_SP\_2017\_34170\_62116.jpg

Likely inlet on LS toe. No pipe or headwall can be seen at current water level.

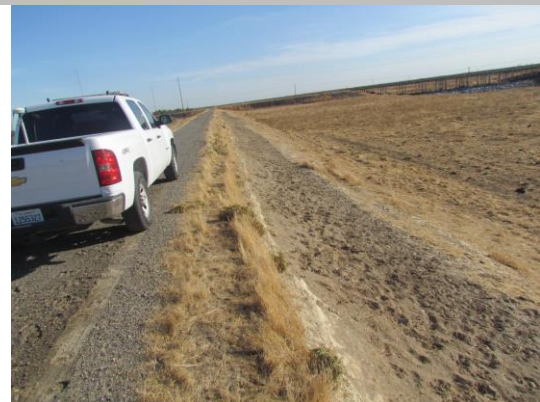
Photo 1 of 2 : SP\_2017\_NA0010\_123\_171\_20170417\_00011.jpg

Looking south at animal erosion on waterward slope.

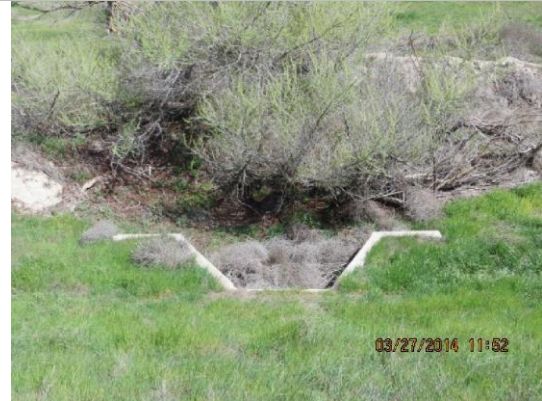
Photo 3 of 3 : UCIP\_SP\_2017\_39644\_59443.jpg

Concrete headwall on LS toe. Note tumbleweeds blocking inlet.

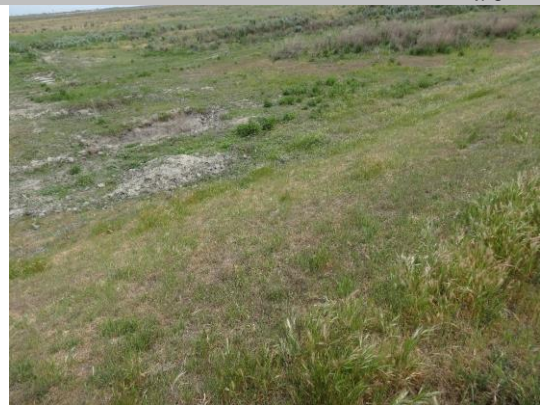
Photo 1 of 3 : UCIP\_SP\_2017\_49974\_66562.jpg

View of WS. Channel section exposed near waterward toe.

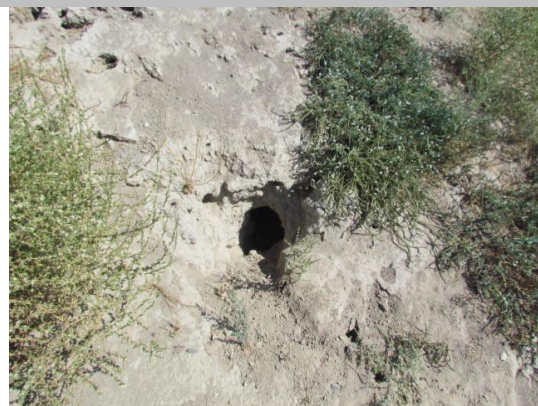
Photo 1 of 2 : SP\_2017\_NA0010\_137\_8\_20170417\_00003.jpg

Looking at large rodent hole on landward slope.

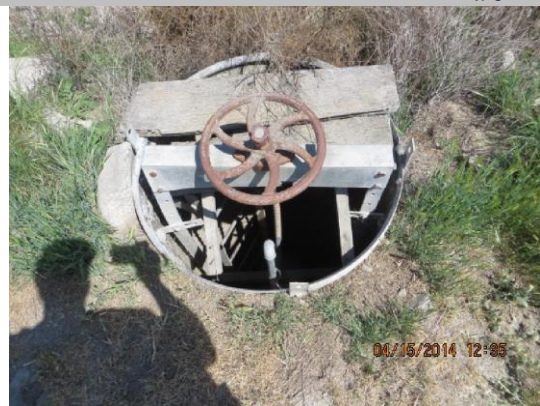
Photo 1 of 3 : UCIP\_SP\_2017\_33732\_61026.jpg

Slidegate in CMP riser on WS shoulder. (Note: actuator does not work).
