**Flood Control Project Maintenance  
Levee Inspections**  
**LMA District Cover Sheet**  
**Spring 2018 Levee Inspection Results**

**Lower San Joaquin Levee District**

**Spring 2018 Levee Inspection Results**

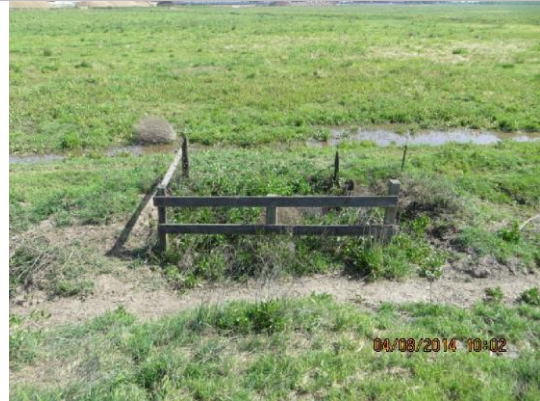
Photo 3 of 3 : UCIP\_SP\_2018\_39123\_60674.jpg

Wooded barrier around drop-inlet on LS toe.

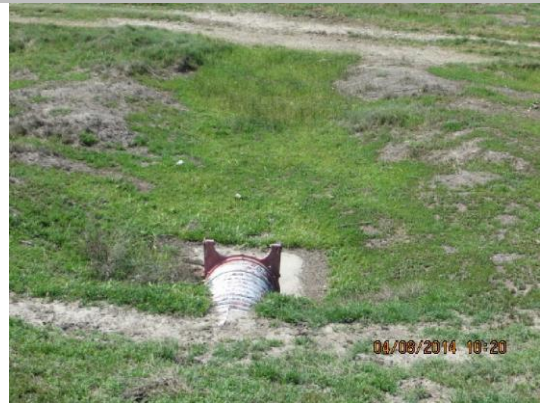
Pipe, flapgate, and headwall on WS toe.

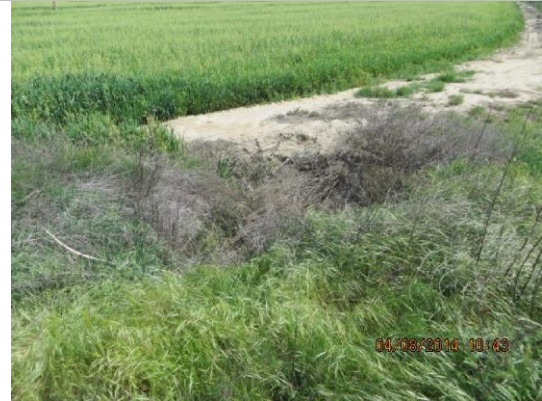
Photo 3 of 3 : UCIP\_SP\_2018\_39132\_60722.jpg

Concrete headwall in heavy vegetation at LS toe.

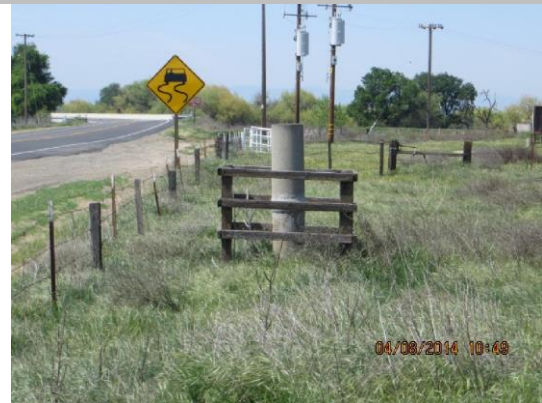
Photo 1 of 2 : UCIP\_SP\_2018\_39133\_60725.jpg

12-inch concrete standpipe off WS toe.

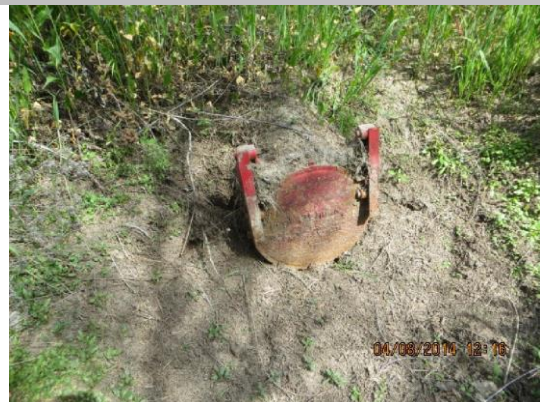
Photo 2 of 3 : UCIP\_SP\_2018\_49962\_60766.jpg

Pipe and flapgate visible at WS toe. Flapgate blocked by sedimentation on WS toe.

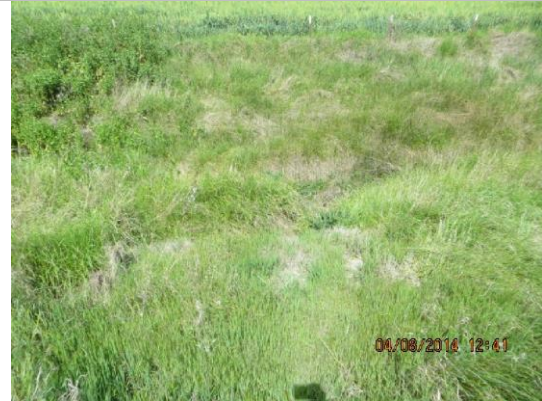
Photo 3 of 3 : UCIP\_SP\_2018\_39161\_60779.jpg

Concrete headwall and pipe visible off LS toe in heavy vegetation.

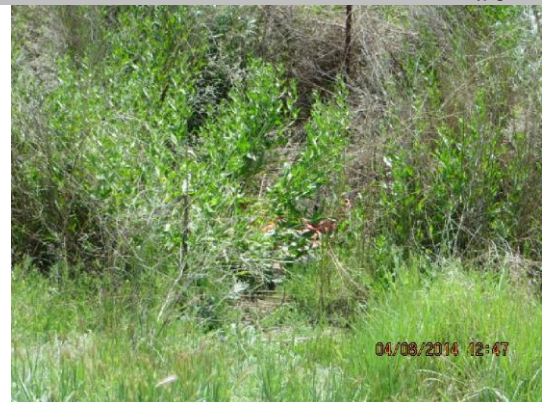
Photo 1 of 3 : UCIP\_SP\_2018\_39243\_60842.jpg

Flapgate and headwall at WS toe. Heavy vegetation on slopes.

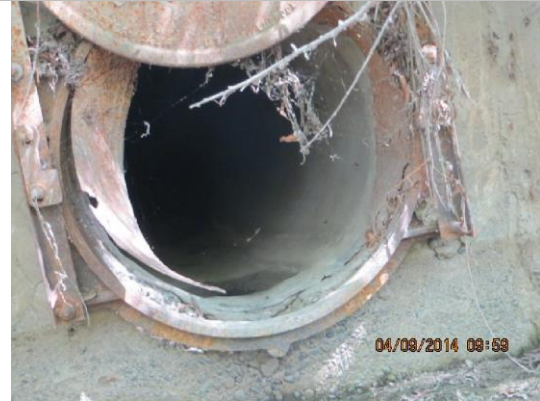
Photo 3 of 3 : UCIP\_SP\_2018\_49964\_60865.jpg

Slidegate rusted through and open on WS toe.

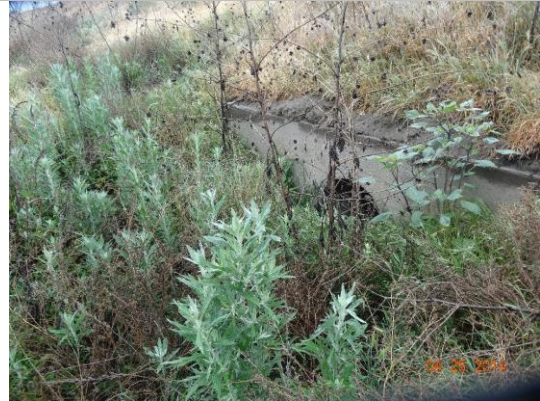
Photo 3 of 3 : UCIP\_SP\_2018\_36169\_65462.jpg

Concrete headwall visible on landward toe--dense vegetation blocking inlet.

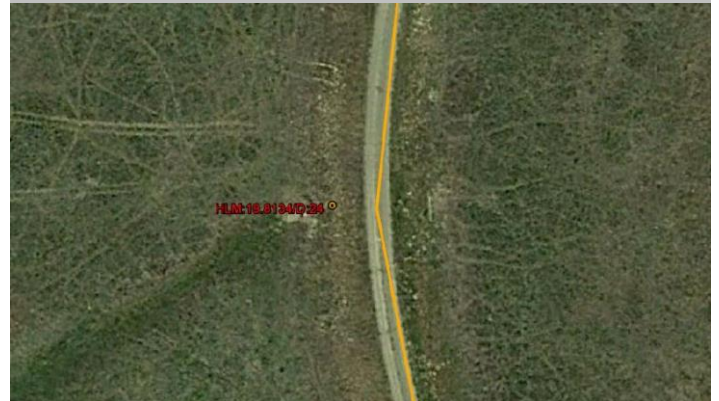
Photo 1 of 1 : UCIP\_SP\_2018\_36253\_65645.jpg

Indicators that a crossing is still present through the levee. Flap gate should be in waterward side.

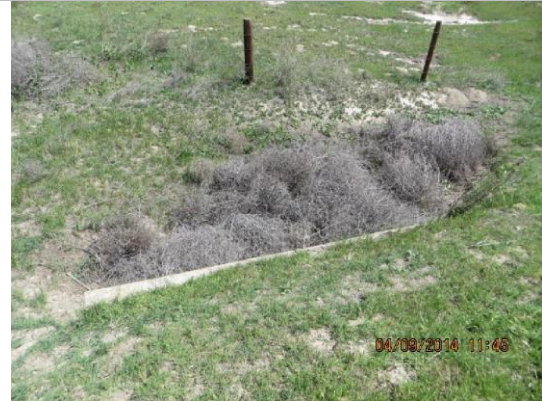
Photo 3 of 3 : UCIP\_SP\_2018\_39584\_60927.jpg

Pipe and concrete headwall on LS toe. Note vegetation buildup.

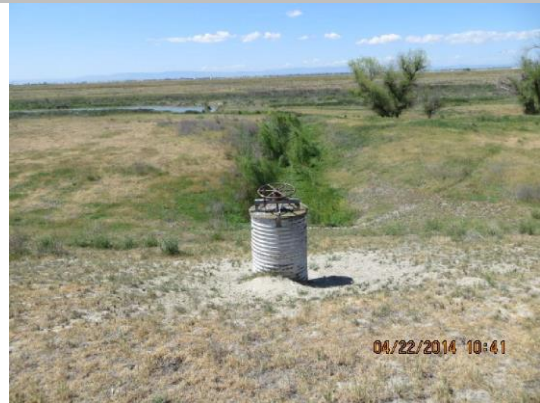
Photo 1 of 3 : UCIP\_SP\_2018\_34273\_62201.jpg

Slidegate in CMP riser on WS slope.

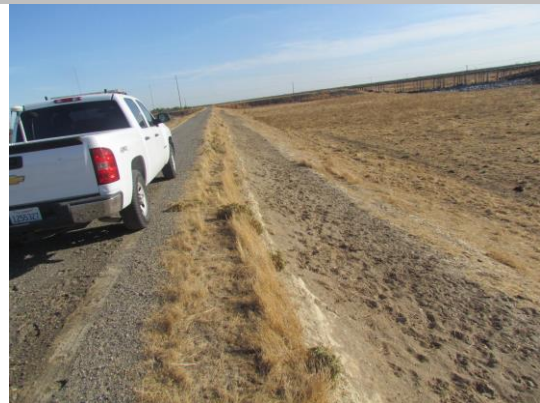
Photo 1 of 2 : SP\_2018\_NA0010\_123\_171\_20180307\_00035.jpg

Looking south at animal erosion on waterward slope.

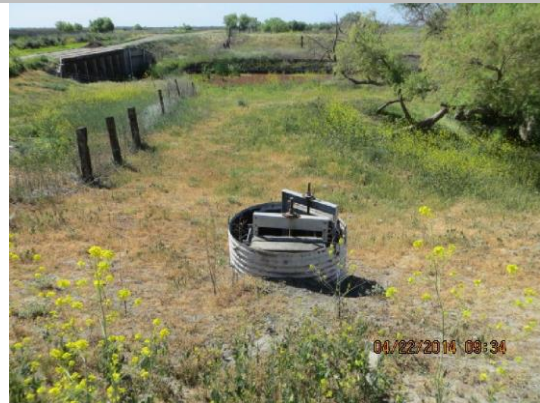
Photo 1 of 3 : UCIP\_SP\_2018\_34186\_62134.jpg

48-inch CMP riser with slide gates on WS slope.

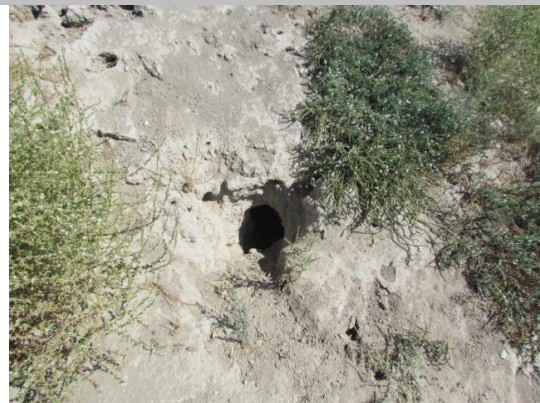
Photo 1 of 2 : SP\_2018\_NA0010\_137\_8\_20180307\_00004.jpg

Looking at large rodent hole on landward slope.

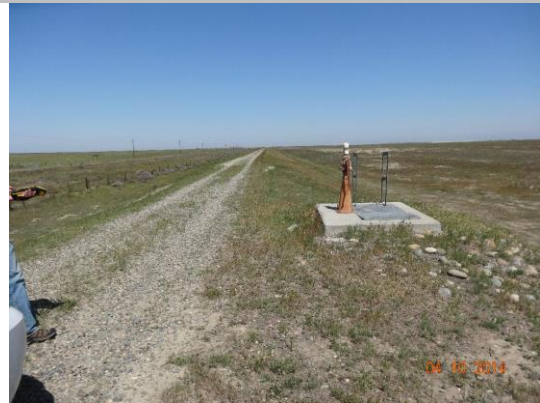
Photo 1 of 3 : UCIP\_SP\_2018\_36843\_67202.jpg

Overview of levee crown at crossing--slide gate inside concrete box located on waterward shoulder.
