**Flood Control Project Maintenance
Levee Inspections**
LMA District Cover Sheet
Spring 2019 Levee Inspection Results

Lower San Joaquin Levee District

Spring 2019 Levee Inspection Results

Waterway			Bank	Unit Miles
Unit No. 01 San Joaquin River			Right	22.52
	Spring (March - May)	Summer (June - August)	(September - November) Fall	Winter (December - February)
Unit Maintenance Rating (Fall Only)				
Date of Inspection	3/26/2019 - 3/26/2019			
DWR Inspector	Corey Fujitani			
Accompanied By

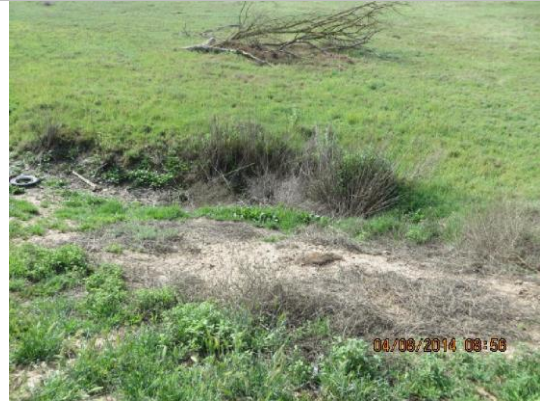
Photo 3 of 3 : UCIP_SP_2019_39091_60602.jpg

Comment Code						
Inspector Comment						
FS_ID:39091 DS_ID:19650 EP_NO: N/A Repair Type: Non-Urgent Crossing Status: Found UCIP Comments: 04/08/2014 Dense vegetation limits the inspector's visibility to identify signs of pipe failure (leaks) along the waterward slope and landward toe. Recommend removing vegetation along pipe alignment and landward toe to conduct proper inspection of structure and appurtenances. (DWR UCIP - W. Wylie) FIELD_STRUCT_DESC: 24-inch corrugated metal gravity drainage pipe through the levee, 10.5 feet below the crown. Flap gate on the waterside (WS) end. Brass cap No. 108 bench mark (BM) on the headwall on the landside (LS), elevation 65.1 feet, USGS Datum. [Additional Reference(s): DWR Levee Log, 2002. USACE San Joaquin O&M Manual 601.1, 1967, (HLM 0.02)]. FS Date: 4/8/2014 7:34:00 AM

Headwall on LS toe.

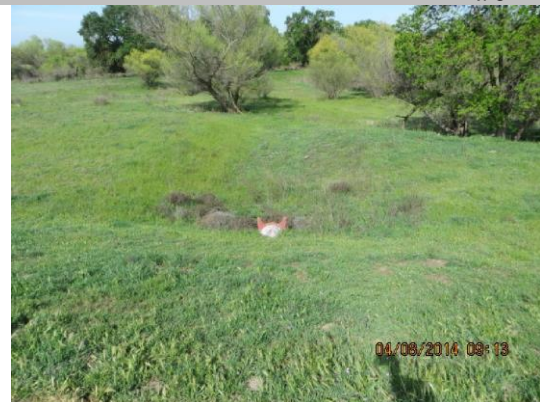
Photo 1 of 3 : UCIP_SP_2019_39095_60622.jpg

LM Start	0.60	Rating **	M	Issue No.	1187
LM End	0.60	Issue Type +	Ma	Location *	
Category	Supplemental			GPS Latitude/Longitude	
				Start	End
Item	DWR UCIP LMA Responsibility			37.341507 °	37.341507 °
				-120.961283 °	-120.961283 °
DWR ID	19583				
Comment Code					
Inspector Comment					
FS_ID:39095 DS_ID:19583 EP_NO: N/A Repair Type: Non-Urgent Crossing Status: Found UCIP Comments: 04/08/2014 Recommend removing vegetation pile through the levee, 8.5 feet below the crown. Flap gate on the waterside (WS) end. Brass cap No. 108 bench mark (BM) on the headwall on the landside (LS). [Additional Reference(s): DWR Levee Log, 2002. USACE San Joaquin O&M Manual 601.1, 1967, (HLM 0.62)]. FS Date: 4/8/2014

Flapgate and headwall visible on WS toe.

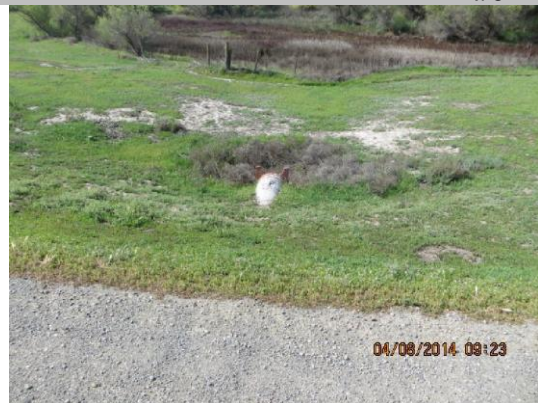
Photo 1 of 3 : UCIP_SP_2019_39096_60632.jpg

Comment Code						
Inspector Comment						
FS_ID:39096						
DS_ID:19585						
EP_NO: N/A						
Repair Type: Non-Urgent						
Crossing Status: Found						
UCIP Comments: 04/08/2014 Moderate erosion around headwall on landward toe. May or may not be an issue. Need to contact owner to determine status of crossing and to address erosion issue on landward side. (DWR UCIP - W. Wylie)						
FIELD_STRUCT_DESC: 24-inch corrugated metal gravity drainage pipe through the levee, 7 feet below the crown. Flap gate on the waterside (WS) end. Brass cap No. 108 bench mark (BM) on the headwall on the landside (LS). [Additional Reference(s): DWR Levee Log, 2002. USACE San Joaquin O&M Manual 601.1, 1967, (HLM 0.95)].						
FS Date: 4/8/2014

Flapgate, pipe, and headwall on WS toe.

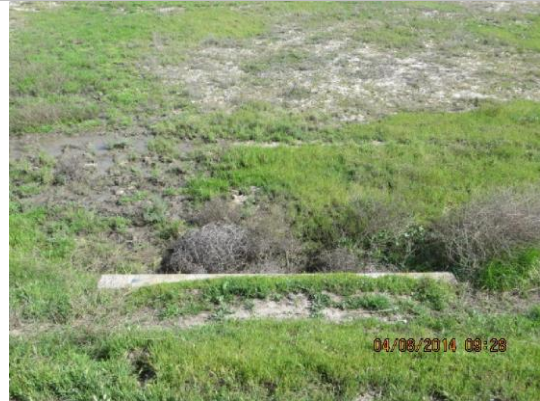
Photo 3 of 3 : UCIP_SP_2019_33543_60641.jpg

Headwall and pipe visible on LS toe.

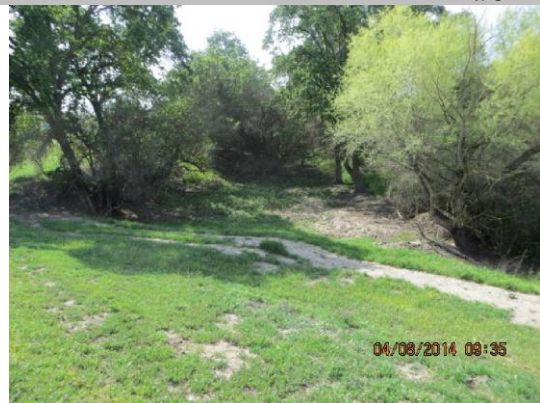
Photo 1 of 3 : UCIP_SP_2019_33544_60649.jpg

LM Start	1.32	Rating **	A/W	Issue No.	1191
LM End	1.32	Issue Type +	Ma	Location *	
Category	Supplemental			GPS Latitude/Longitude	
				Start	End
Item	DWR UCIP LMA Responsibility			37.337361 °	37.337361 °
				-120.950879 °	-120.950879 °
DWR ID	19587				
Comment Code					
Inspector Comment					
FS_ID:33544 DS_ID:19587 EP_NO: N/A Repair Type: No Action Needed Crossing Status: Found UCIP Comments: FIELD_STRUCT_DESC: 36-inch corrugated metal gravity drainage pipe through the levee, 12.8 feet below the crown. Flap gate on the waterside (WS) end. Brass cap No. 108 bench mark (BM) on the headwall on the landside (LS). Pipe crosses through the levee at about a 45 degree angle to the crown. [Additional Reference(s): DWR Levee Log, 2002. USACE San Joaquin O&M Manual 601.1, 1967, (HLM 1.34)]. FS Date: 4/8/2014

Concrete headwall and flapgate visible at WS toe.

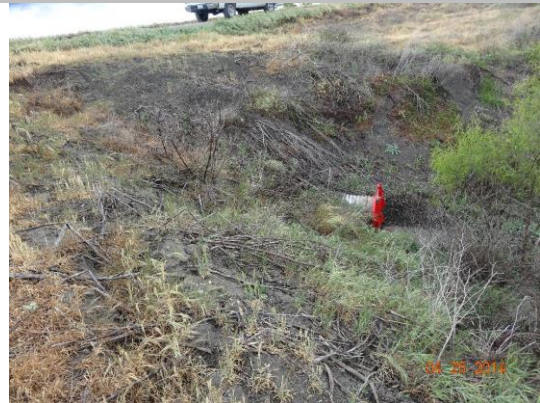
Photo 3 of 3 : UCIP_SP_2019_39258_66287.jpg

View of flap gate visible on waterward side.

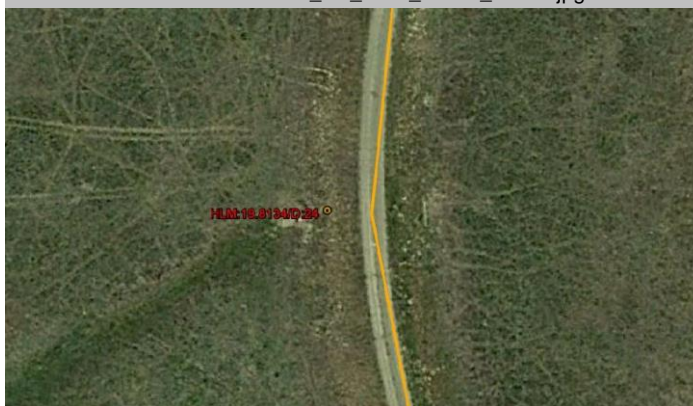
Photo 1 of 1 : UCIP_SP_2019_36253_65645.jpg

Indicators that a crossing is still present through the levee. Flap gate should be in waterward side.

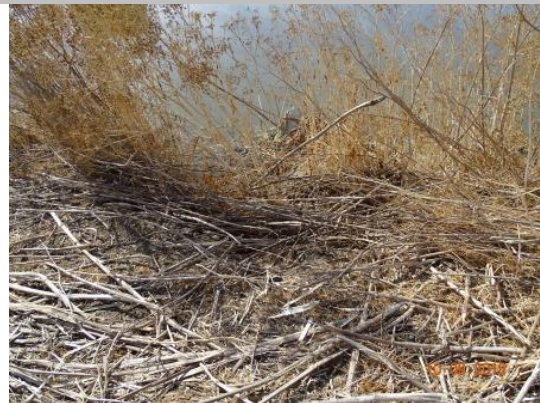
Photo 1 of 2 : SP_2019_NA0010_120_25_20190307_00015.jpg

Looking down landside slope from crown at erosion site. (Fall 2018)

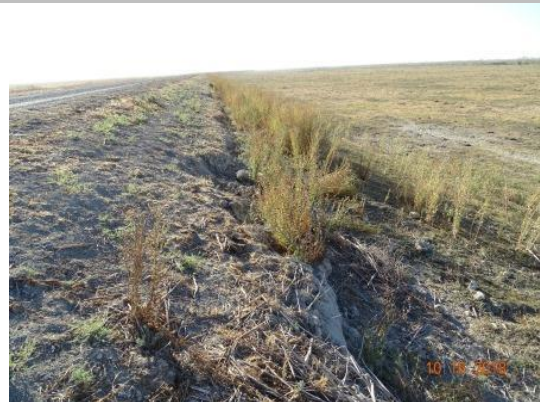
Photo 1 of 1 : SP_2019_NA0010_123_1_20190307_00001.jpg

View of erosion looking upstream. (Fall 2018)

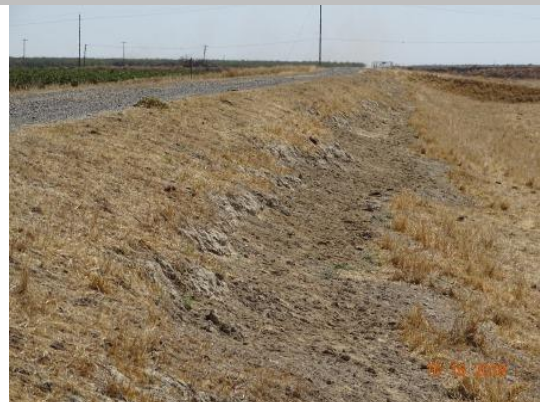
Photo 1 of 1 : SP_2019_NA0010_123_164_20190307_00054.jpg

Slope damage from animal traffic. (Fall 2018)

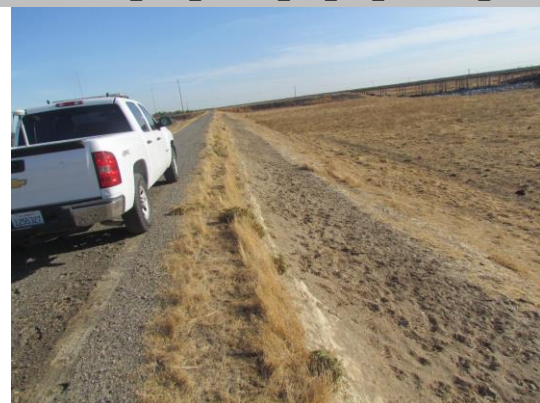
Photo 1 of 2 : SP_2019_NA0010_123_171_20190307_00059.jpg

Looking south at animal erosion on waterward slope.

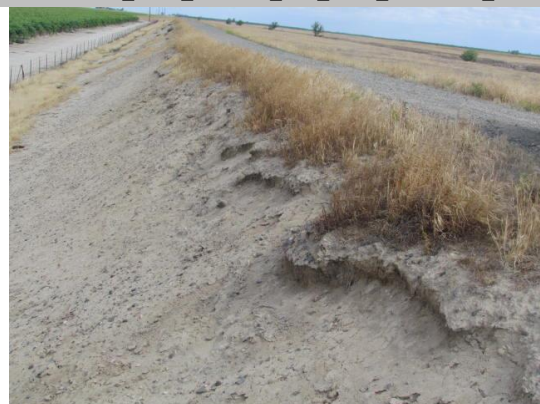
Photo 1 of 2 : SP_2019_NA0010_124_1207_20190307_00048.jpg

Looking northeast at livestock erosion on landward slope.
