# Flood Control Project Maintenance Levee Inspections LMA District Cover Sheet

## Lower San Joaquin Levee District

**Flood Control Project Maintenance  
Levee Inspections  
Unit Cover Sheet**

Waterway			Bank	Unit Miles
Unit No. 01 San Joaquin River			Right	22.52
	Spring (March - May)	Summer (June - August)	(September - November) Fall	Winter (December - February)
Unit Maintenance Rating (Fall Only)				
Date of Inspection	5/4/2021 - 5/4/2021			
DWR Inspector	Corey Fujitani			
Accompanied By

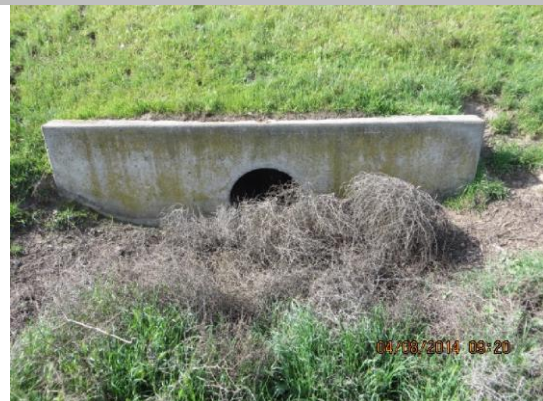
Photo 3 of 3 : UCIP\_SP\_2021\_62646\_60625.jpg

Pipe and headwall visible on LS toe.

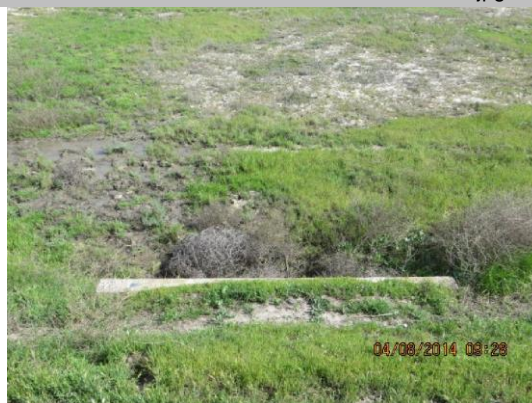
Photo 3 of 3 : UCIP\_SP\_2021\_62615\_60641.jpg

Headwall and pipe visible on LS toe.

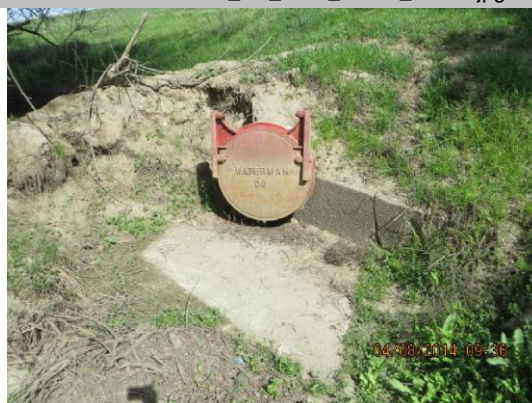
Photo 2 of 3 : UCIP\_SP\_2021\_62617\_60648.jpg

Concrete headwall and flapgate visible at WS toe.

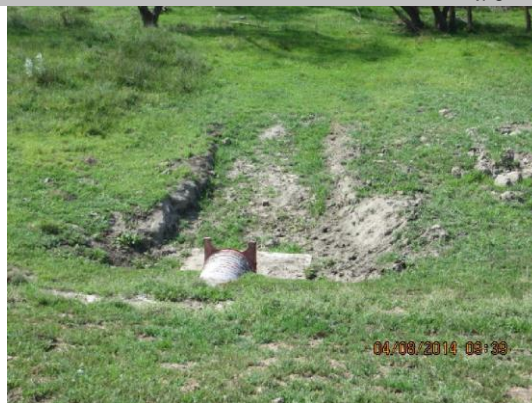
Photo 1 of 3 : UCIP\_SP\_2021\_62618\_60652.jpg

Pipe, flapgate, and concrete headwall visible on WS toe.

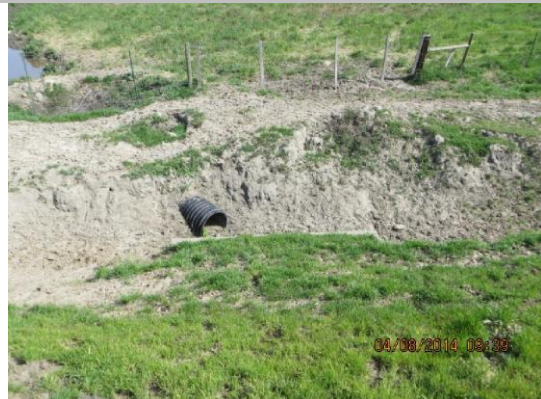
Photo 3 of 3 : UCIP\_SP\_2021\_62618\_60651.jpg

Pipe and concrete headwall visible on LS toe.

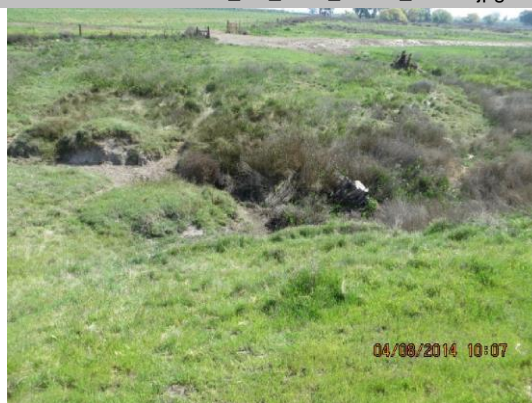
Photo 2 of 3 : UCIP\_SP\_2021\_62637\_71308.jpg

FS\_ID:62637  
DS\_ID:19571  
EP\_NO: N/A  
Repair Type: Non-Urgent  
Crossing Status: Found  
UCIP Comments: 10/06/2020 Pipe status is still Non-Urgent. Pipe angle through the levee. No permit was found authorizing this encroachment. CVFPB will need to review crossing to determine owner. DWR DMP has not completed an internal inspection of the pipe but is scheduled for 2021. (B. Singh - GEI, O. Magana - DWR UCIP)  
FIELD\_STRUCT\_DESC: 36-inch corrugated metal gravity drainage pipe through the levee, 12.6 feet below the crown. Flap gate on the waterside (WS) end. Brass cap No. 100 bench mark (BM) on the headwall on the landside (LS). Wooden barrier around drop inlet on the LS toe. [Additional Reference(s): DWR Levee Log, 2002 (HLM 2.25), listed as a 36-inch corrugated metal pipe (CMP). USACE San Joaquin O&M Manual, Unit 601 Part 1 (SJR601.1), 1967, Revised 25 May 2011, (HLM 2.25), listed as a 36-inch CMP].

Pipe and headwall on LS toe.

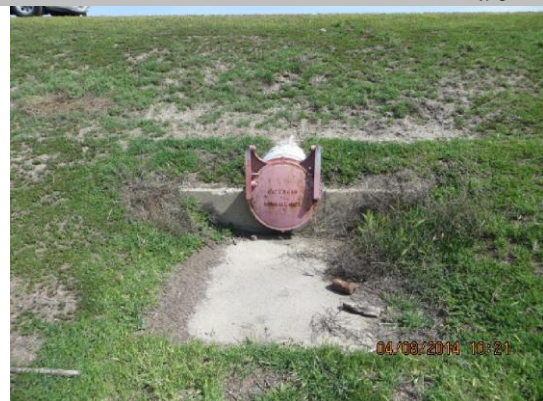
Photo 2 of 3 : UCIP\_SP\_2021\_62626\_60689.jpg

FS\_ID:62626  
DS\_ID:19573  
EP\_NO: N/A  
Repair Type: Non-Urgent  
Crossing Status: Found  
UCIP Comments: 10/06/2020 Pipe status is still Non-Urgent. No permit was found authorizing this encroachment. CVFPB will need to review crossing to determine owner. DWR DMP has not found internal issues, LOF between 1 and 2. Recommend inspection in 5 years. (B. Singh - GEI, O. Magana - DWR UCIP)04/08/2014 Sedimentation in pipe at landward toe. (W. Wylie - DWR UCIP)  
FIELD\_STRUCT\_DESC: 24-inch corrugated metal gravity drainage pipe through the levee, 7.3 feet below the crown. Flap gate on the waterside (WS) end. Brass cap No. 100 bench mark (BM) on the headwall on the landside (LS). [Additional Reference(s): DWR Levee Log, 2002 (HLM 2.71), listed as a 24-inch corrugated metal pipe (CMP). USACE San Joaquin O&M Manual, Unit 601 Part 1 (SJR601.1), 1967, Revised 25 May 2011, (HLM 2.70), listed as a 24-inch CMP].

Pipe, flapgate, and headwall on WS toe.

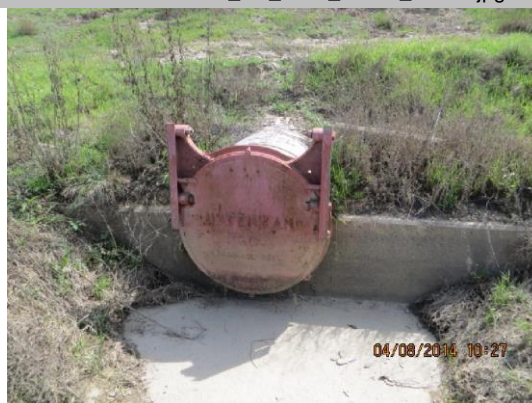
Photo 2 of 3 : UCIP\_SP\_2021\_62627\_60700.jpg

Pipe, Flapgate, and headwall on WS toe.

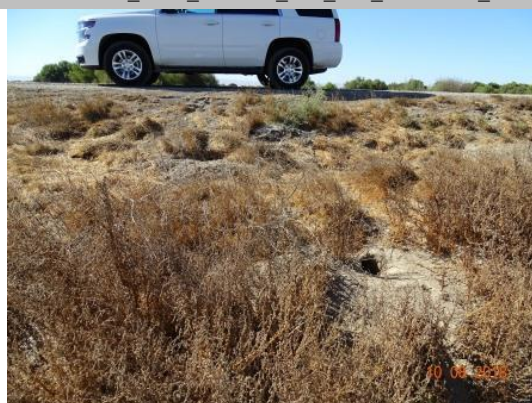
Photo 1 of 1 : SP\_2021\_NA0010\_118\_116\_20210308\_00023.jpg

View of landside slope with rodent holes. (Fall 2018)

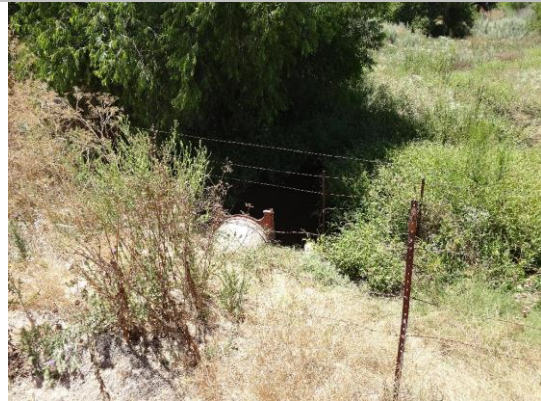
Photo 3 of 3 : UCIP\_SP\_2021\_62642\_75470.jpg

View of WS--fence limits access to flap gate.

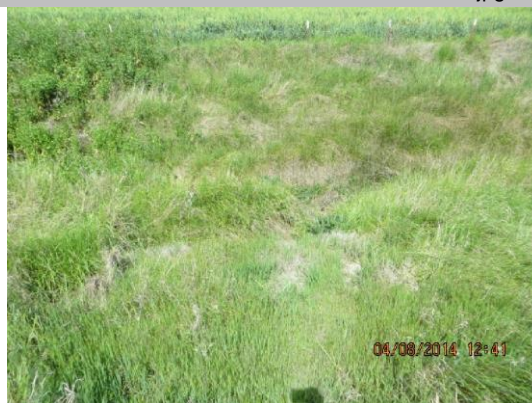
Photo 3 of 3 : UCIP\_SP\_2021\_62644\_60779.jpg

Concrete headwall and pipe visible off LS toe in heavy vegetation.

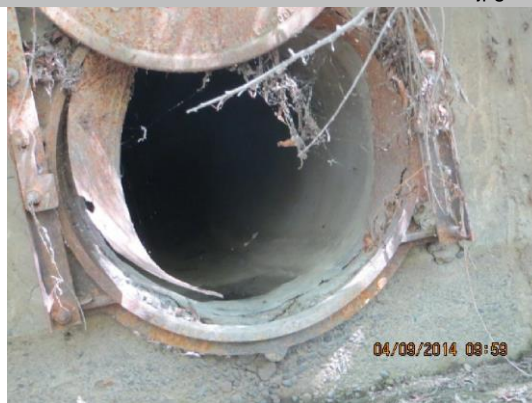
Photo 3 of 3 : UCIP\_SP\_2021\_62666\_60865.jpg

Slidegate rusted through and open on WS toe.

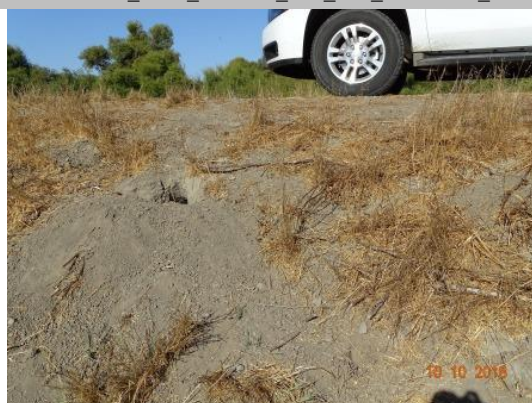
Photo 1 of 1 : SP\_2021\_NA0010\_118\_120\_20210308\_00026.jpg

View of rodent burrow in the landside slope. (Fall 2018)

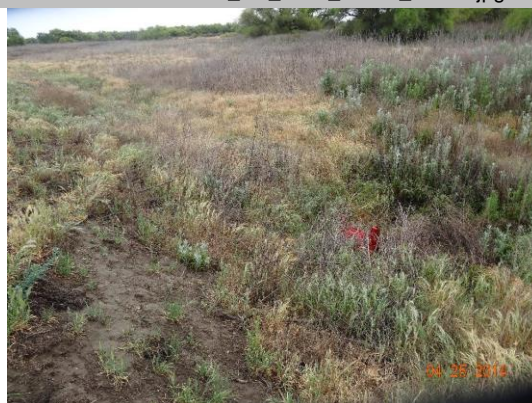
Photo 1 of 3 : UCIP\_SP\_2021\_62673\_65464.jpg

View of waterward side--flap gate visible through dense vegetation.

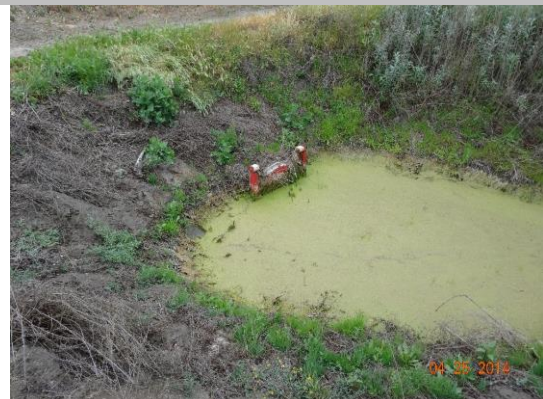
Photo 2 of 3 : UCIP\_SP\_2021\_61910\_66313.jpg

Flap gate half way submersed located on waterward side.

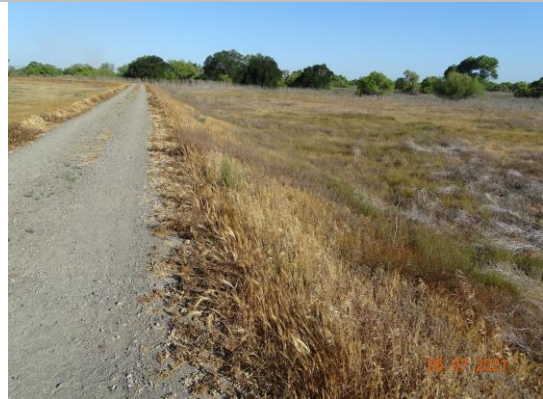
Photo 1 of 1 : SP\_2021\_NA0010\_119\_25\_20210517\_00066.jpg

View of the waterside slope looking downstream. (Spring 2021)

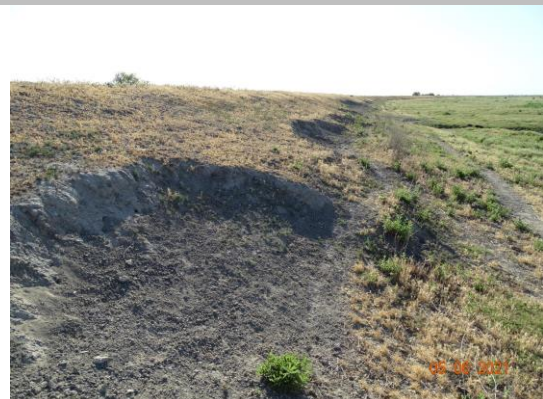
Photo 1 of 1 : SP\_2021\_NA0010\_123\_119\_20210517\_00325.jpg

Looking upstream along the waterside slope at erosion spots. (Spring 2021)

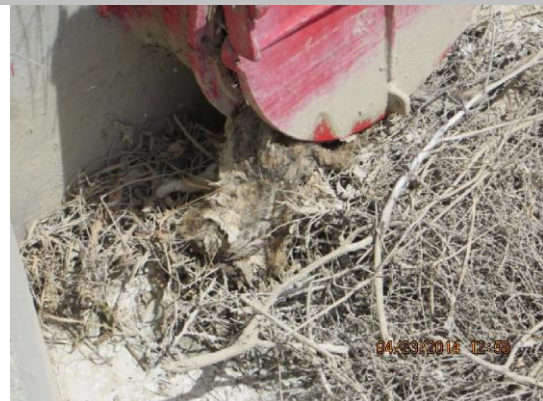
Photo 3 of 3 : UCIP\_SP\_2021\_62484\_62615.jpg

Debris blocking closure of outlet on WS toe.

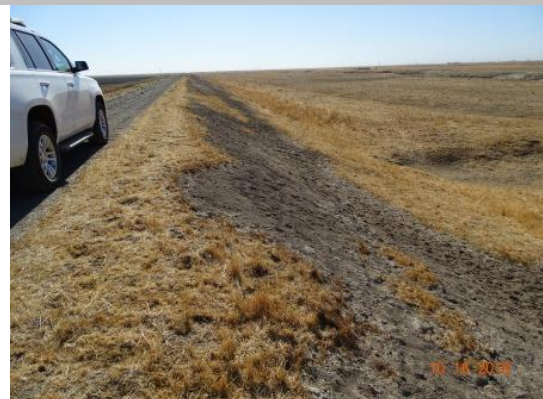
Photo 1 of 1 : SP\_2021\_NA0010\_123\_160\_20210308\_00043.jpg

Slope damage cause by livestock foot traffic. (Fall 2018)

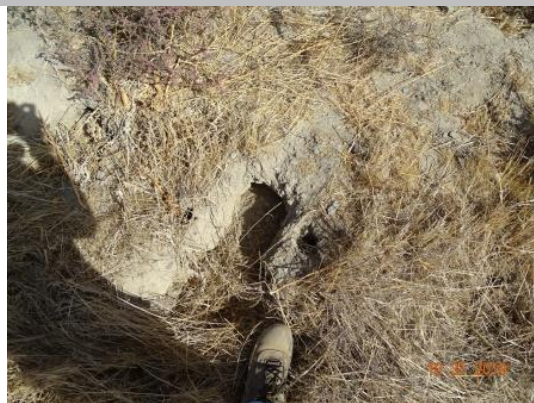
Photo 1 of 1 : SP\_2021\_NA0010\_137\_23\_20210308\_00012.jpg

Representative view of rodent burrows observed at this location. (Fall 2019)

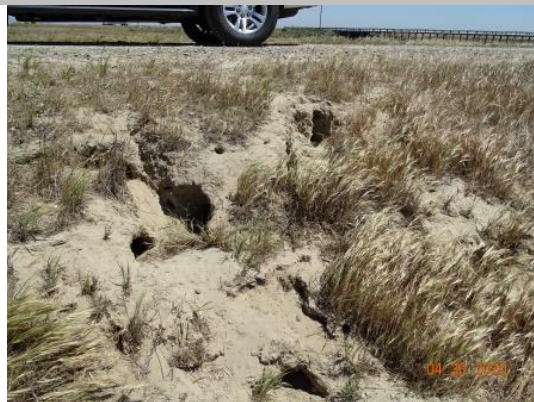
Photo 1 of 1 : SP\_2021\_NA0010\_137\_14\_20210308\_00007.jpg

View of rodent burrows in the landside slope. (Spring 2020)

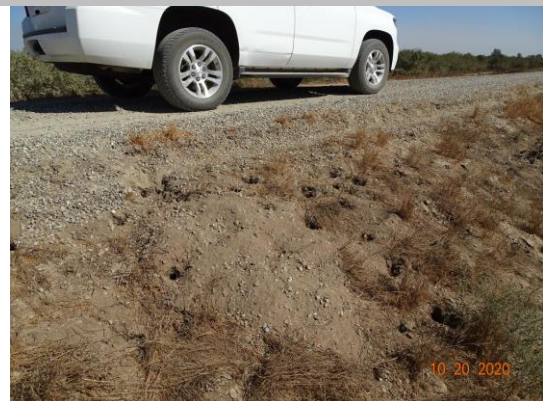
Photo 1 of 1 : SP\_2021\_NA0010\_139\_24\_20210308\_00004.jpg

Several rodent holes noted at this location. (Fall 2020)

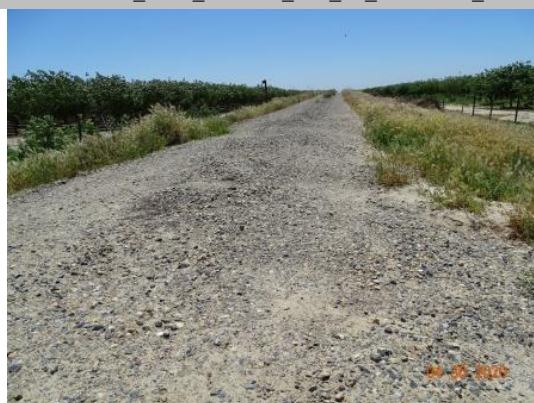
Photo 1 of 1 : SP\_2021\_NA0010\_139\_65\_20210308\_00012.jpg

Depressions forming in the levee crown. (Spring 2020)
