**Flood Control Project Maintenance
Levee Inspections
LMA District Cover Sheet**

Lower San Joaquin Levee District

**Flood Control Project Maintenance
Levee Inspections
Unit Cover Sheet**

Levee Inspection Report By Mile - Spring 2022

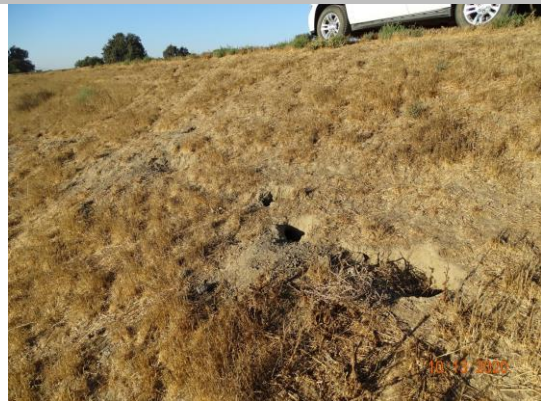
Photo 1 of 1 : SP_2022_NA0010_118_95_20220308_00006.jpg

Several rodent holes observed in the landside slope. (Fall 2020)

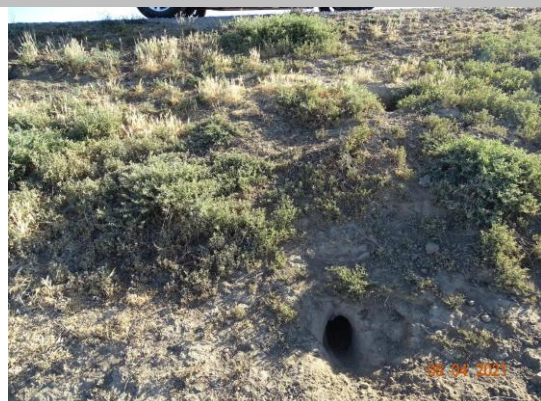
Photo 1 of 1 : SP_2022_NA0010_118_97_20220308_00007.jpg

LM Start	0.45	Rating **	M	Issue No.	97
LM End	0.45	Issue Type +	Ma	Location *	WS
Category	Earthen Levee			GPS Latitude/Longitude	
				Start	End
Item	Animal Control			37.343243 °	37.343243 °
				-120.962159 °	-120.962159 °
DWR ID	DWR_NA0010_01_s_2021_97				
Comment Code					
A1 : Exterminate rodents and backfill and compact or grout burrows.					
Inspector Comment

View of rodent burrows in the waterside slope. (Spring 2021)

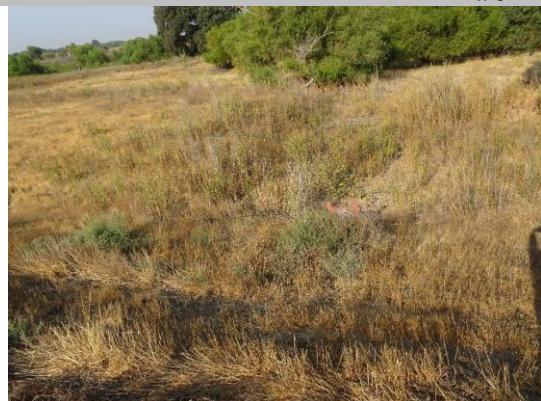
Photo 2 of 3 : UCIP_SP_2022_70638_90538.jpg

FS_ID:70638
DS_ID:19583
EP_NO: N/A
Repair Type: Non-Urgent
Crossing Status: Found
UCIP Comments: 10/06/2020 Record remains Non-Urgent. No permit was found authorizing this encroachment. Rodent activity found near pipe location. CVFPB will need to review crossing to determine owner. DWR DMP has not found internal issues, LOF between 1 and 2. Recommend inspection in 5 years. (B. Singh - GEI, O. Magana - DWR UCIP)04/08/2014 Recommend removing vegetation pile from waterward toe. (W. Wylie - DWR UCIP)
FIELD_STRUCT_DESC: 24-inch corrugated metal (CM) gravity drainage pipe through the levee, 8.5 feet below the crown. Flap gate on the waterside (WS) end. Brass cap No. 108 bench mark (BM) on the headwall on the landside (LS). [Additional Reference(s): DWR Levee Log, 2002, (HLM 0.62). USACE San Joaquin O&M Manual, Unit No. 601, Part No. 1, (SJR601.1), 1967, Revised 25 May 2011, (HLM 0.62)].
FS Date: 10/6/2020

WS view: Flapgate and pipe visible on WS toe

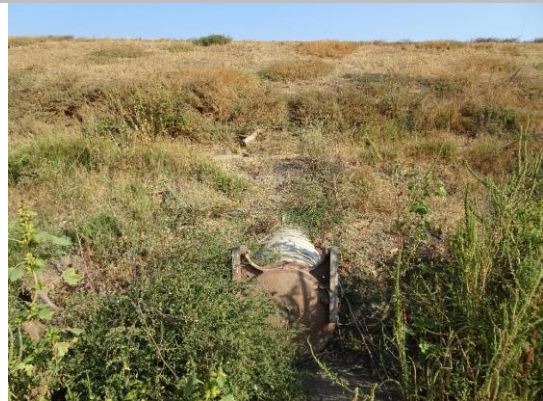
Photo 3 of 3 : UCIP_SP_2022_70643_90570.jpg

FS_ID:70643
DS_ID:19588
EP_NO: N/A
Repair Type: Non-Urgent
Crossing Status: Found
UCIP Comments: 10/06/2020 Record remains Non-Urgent. No permit was found authorizing this encroachment. CVFPB will need to review crossing to determine owner. DWR DMP has not found internal issues, LOF between 1 and 2. Recommend inspection in 5 years. (B. Singh - GEI, O. Magana - DWR UCIP)04/08/2014 Some sediment buildup inside pipe at LS toe. Recommend contacting owner to clear sediment buildup and check wall integrity through pipe section. (W. Wylie - DWR UCIP)
FIELD_STRUCT_DESC: 24-inch corrugated metal (CM) gravity drainage pipe through the levee, 11.0 feet below the crown. Flap gate on the waterside (WS) end. Brass cap No. 108 bench mark (BM) on the headwall on the landside (LS). [Additional Reference(s): DWR Levee Log, 2002, (HLM 1.48). USACE San Joaquin O&M Manual, Unit No. 601, Part No. 1, (SJR601.1), 1967, Revised 25 May 2011, (HLM 1.48)].

Pipe and flapgate visible on WS toe

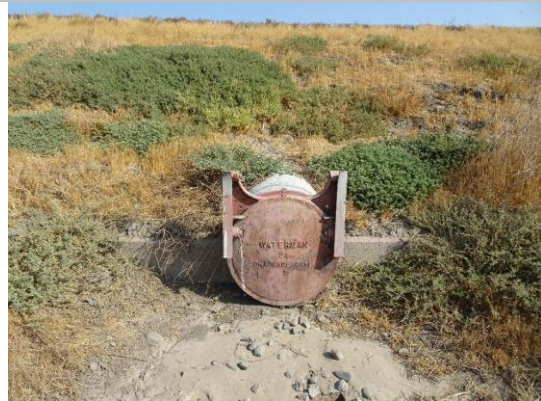
Photo 3 of 3 : UCIP_SP_2022_70650_90640.jpg

WS view: Pipe, flapgate, and headwall at WS toe

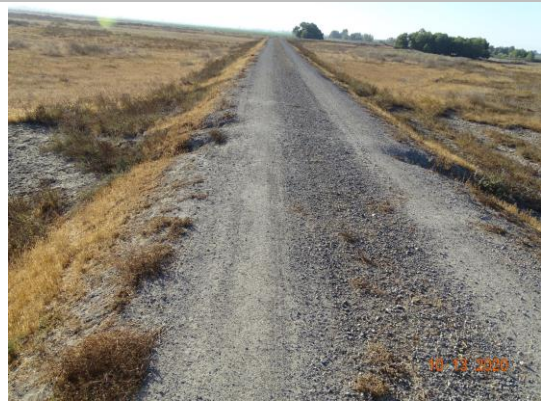
Photo 1 of 1 : SP_2022_NA0010_118_114_20220308_00016.jpg

LM Start	2.99	Rating **	U	Issue No.	114
LM End	2.99	Issue Type +	Ma	Location *	LS
Category	Earthen Levee			GPS Latitude/Longitude	
				Start	End
Item	Erosion / Livestock			37.323328 °	37.323328 °
				-120.929521 °	-120.929521 °
DWR ID	DWR_NA0010_01_f_2018_114				
Comment Code					
E4 : Repair the levee slope damaged by livestock and prevent large animal access.					
Inspector Comment					
Slope damage caused by livestock on both landside and waterside slope has eroded into the levee crown.

View of damage to both slope from livestock activity. (Fall 2020)

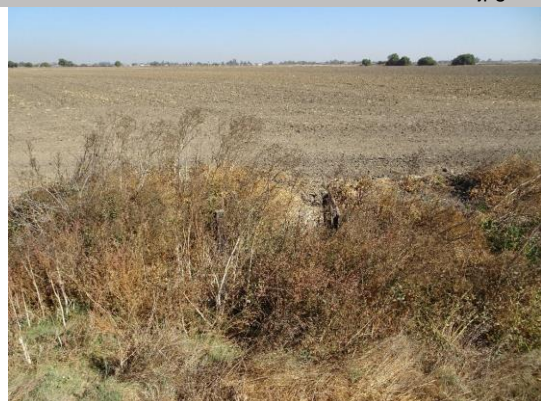
Photo 2 of 3 : UCIP_SP_2022_70663_90713.jpg

LS view: Dense vegetation on LS limiting view of wooden barrier around drop-inlet.

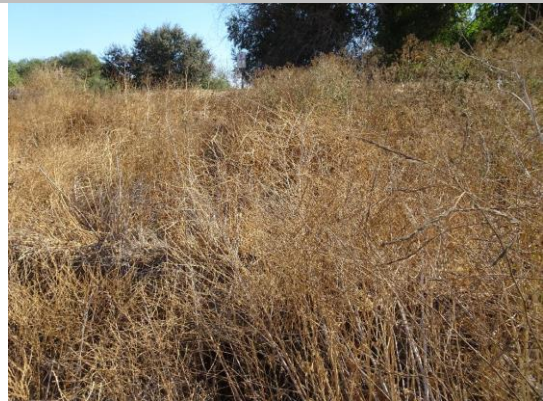
Photo 3 of 3 : UCIP_SP_2022_70674_92419.jpg

LS view: dense vegetation prevented visible evidence of inlets.

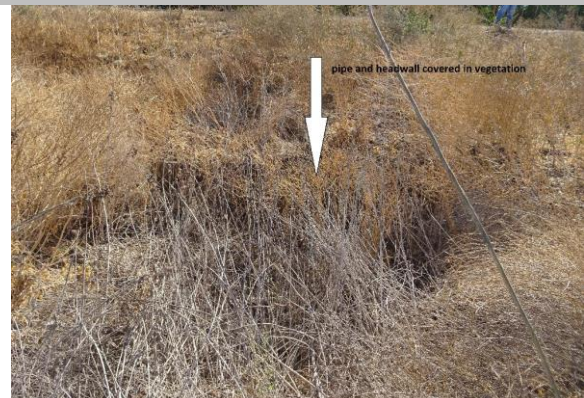
Photo 2 of 3 : UCIP_SP_2022_70675_90790.jpg

LS view: Headwall not visible due to high vegetation on LS toe and slope

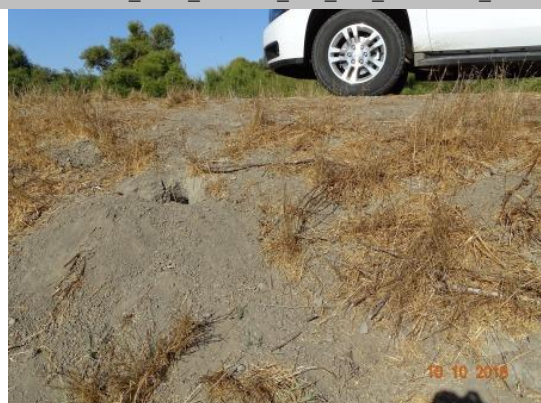
Photo 1 of 1 : SP_2022_NA0010_118_120_20220308_00021.jpg

View of rodent burrow in the landside slope. (Fall 2018)

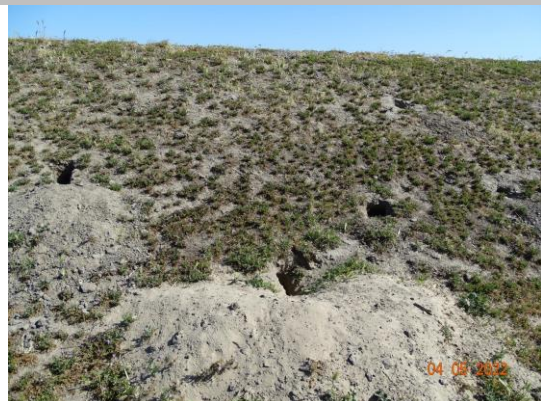
Photo 1 of 1 : SP_2022_NA0010_118_133_20220412_00306.jpg

View of rodent burrows on the waterside slope. (Spring 2022)

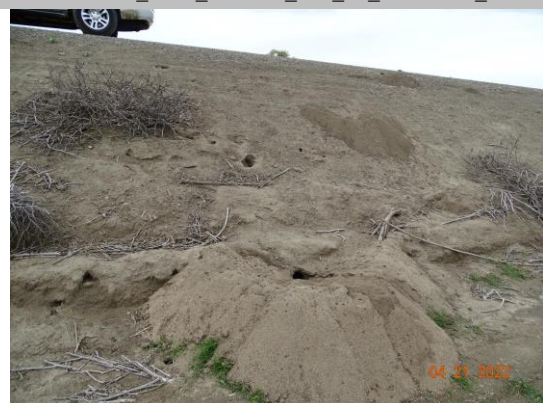
Photo 1 of 1 : SP_2022_NA0010_121_11_20220425_00021.jpg

View of several rodent holes with large amounts of material displaced.
(Spring 2022)

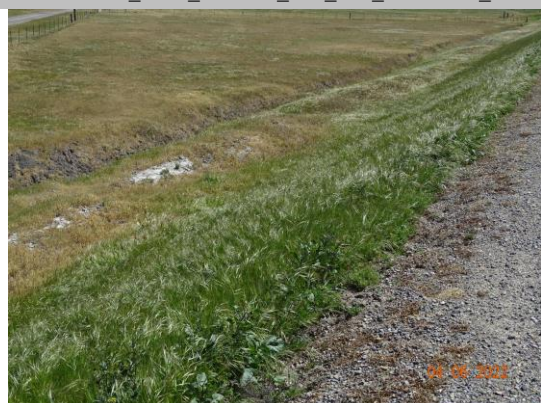
Photo 1 of 1 : SP_2022_NA0010_123_159_20220414_00367.jpg

View of vegetation on the landside slope looking upstream. (Spring 2022)

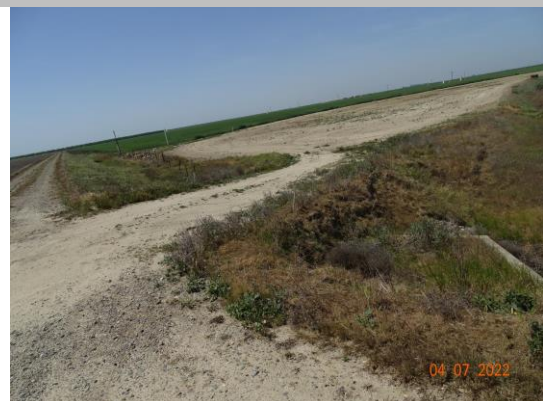
Photo 1 of 1 : SP_2022_NA0010_123_189_20220414_00377.jpg

View of ramp on the landside slope. (Spring 2022)

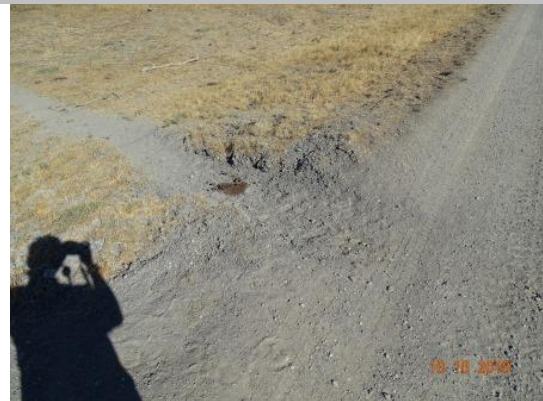
Photo 1 of 1 : SP_2022_NA0010_124_85_20220308_00020.jpg

View of livestock damage on waterside slope. (Fall 2018)

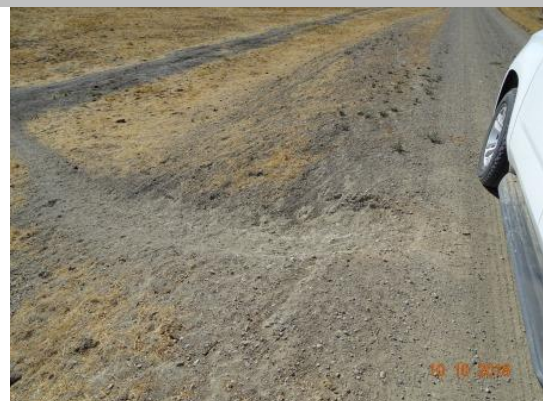
Photo 1 of 1 : SP_2022_NA0010_124_84_20220308_00019.jpg

Erosion to slope and into crown from livestock. (Fall 2018)

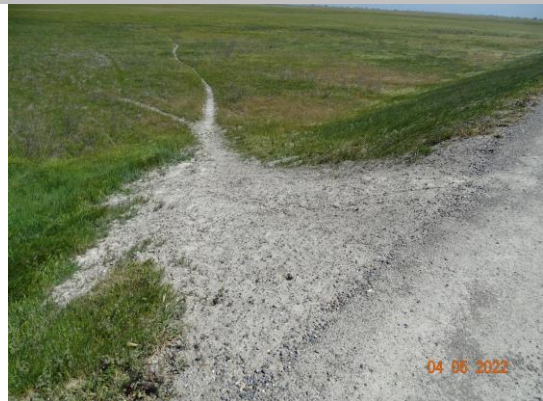
Photo 1 of 1 : SP_2022_NA0010_129_11_20220414_00035.jpg

View of slope damage on landside. (Spring 2022)

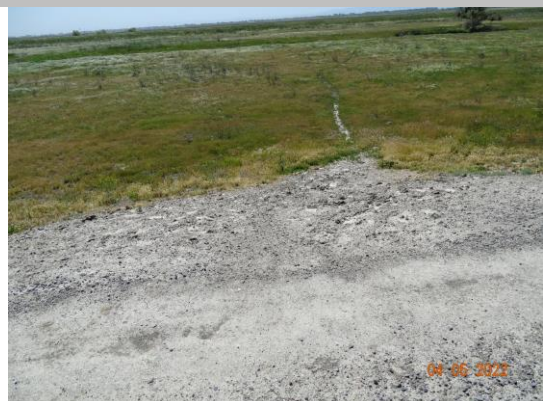
Photo 1 of 1 : SP_2022_NA0010_129_13_20220414_00036.jpg

View of damage on waterside shoulder and slope. (Spring 2022)

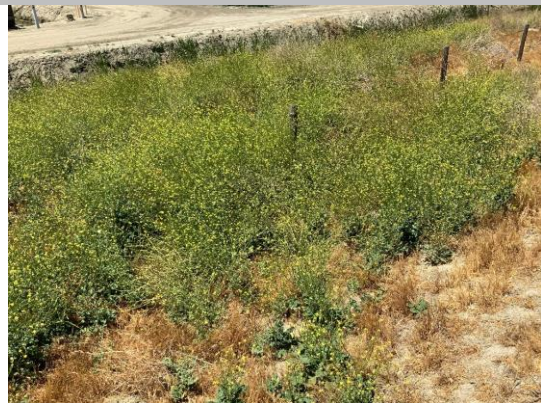
Photo 3 of 3 : UCIP_SP_2022_67728_100638.jpg

LS view: Dense vegetation and barbed wire at the toe, no pipe visible.

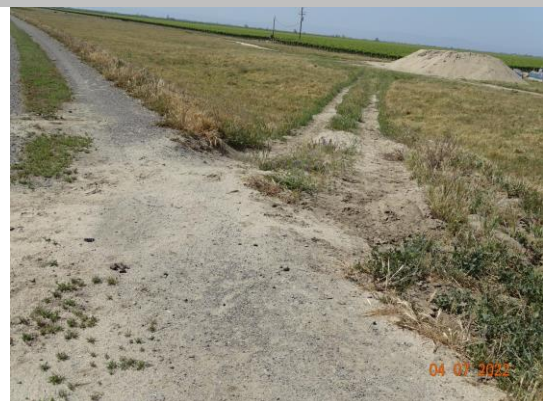
Photo 1 of 1 : SP_2022_NA0010_131_9_20220414_00014.jpg

Unauthorized ramp constructed on the landside slope. (Spring 2022)

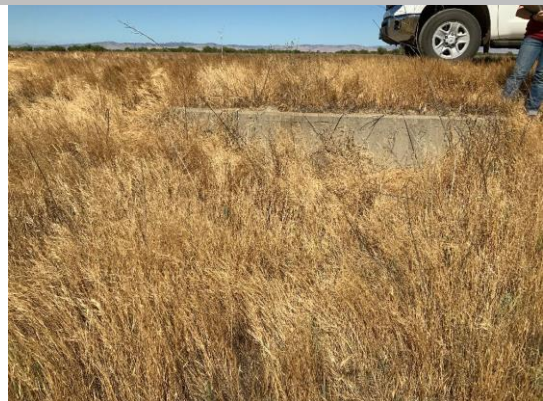
Photo 3 of 3 : UCIP_SP_2022_67747_100731.jpg

LS view: Headwall barely visible from toe.
