Flood Control Project Maintenance
Levee Inspections
LMA District Cover Sheet

Lower San Joaquin Levee District

**Flood Control Project Maintenance
Levee Inspections
Unit Cover Sheet**

Levee Inspection Report By Mile - Spring 2024

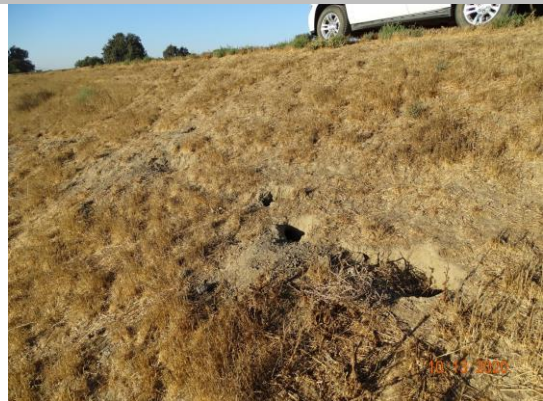
Photo 1 of 1 : SP_2024_NA0010_118_95_20240212_00005.jpg

Several rodent holes observed in the landside slope. (Fall 2020)

LM Start	0.45	Rating **	M	Issue No.	97
LM End	0.45	Issue Type +	Ma	Location *	WS
Category	Earthen Levee			GPS Latitude/Longitude	
				Start	End
Item	Animal Control			37.343243°	37.343243°
				-120.962159°	-120.962159°
DWR ID	DWR_NA0010_01_s_2021_97				
Comment Code					
A1 : Exterminate rodents and backfill and compact or grout burrows.					
Inspector Comment

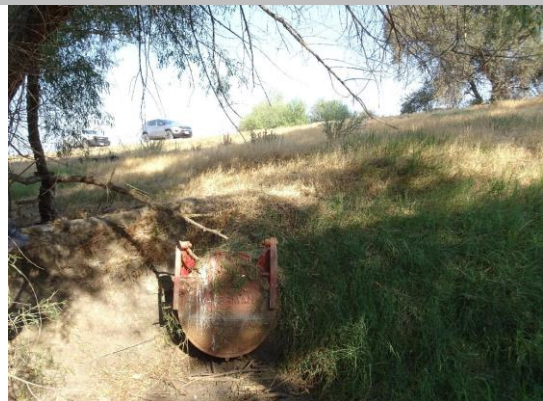
Photo 3 of 3 : UCIP_SP_2024_83236_90559.jpg

WS view: Concrete headwall and flapgate visible at WS toe

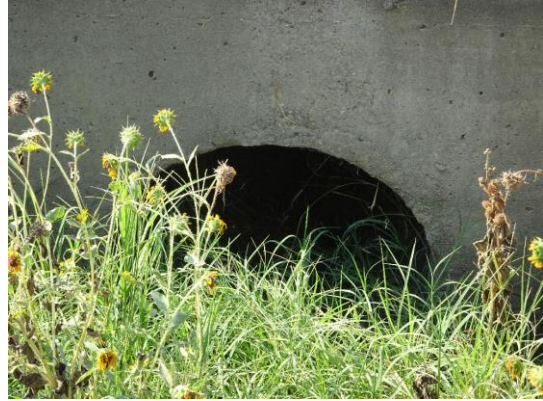
Photo 3 of 3 : UCIP_SP_2024_83238_90566.jpg

Pipe partially visible on LS toe

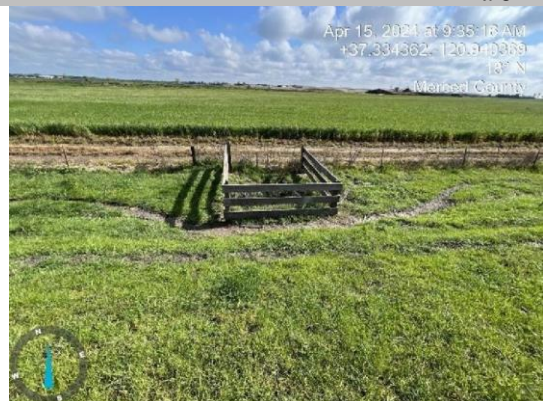
Photo 1 of 3 : UCIP_SP_2024_83239_121609.jpg

DS_ID:19591
FS_ID:83239
EP_NO: N/A
Repair Type: No Action Needed
EVAL Issue:
Crossing Status: Found
UCIP Comments: 04/23/2024 Record updated from Non-Urgent to No Action Needed. LMA has corrected the rodent activity noted in the previous inspection. DMP internal video inspection has found none or minor pipe defects. (M. Thao - DWR UCIP)
10/06/2020 Record remains Non-Urgent. Rodent activity found in the general area. No permit was found authorizing this encroachment. CVFPB will need to review crossing to determine owner. DWR DMP has not found internal issues, LOF between 1 and 2. Recommend inspection in 5 years. (B. Singh - GEI, O. Magana - DWR UCIP)
04/08/2014 Need to contact owner to determine crossing status. Inlet drop box silted in and needs to be cleaned out. (W. Wylie - DWR UCIP)
FIELD_STRUCT_DESC: 24-inch corrugated metal (CM) gravity drainage pipe through the levee, 9.7 feet below the crown. Flap gate on the waterside (WS) end. Brass cap No. 100 bench mark (BM) on the headwall on the landside (LS). Wooden barrier around drop inlet on the LS toe. [Additional Reference(s): DWR Levee Log, 2002, (HLM 1.98). USACE San Joaquin O&M Manual, Unit No. 601, Part No. 1, (SJR601.1), 1967, Revised 25 May 2011, (HLM 1.98)].

LS view: Rodent activity near crossing noted in 10/06/2020 inspection has been corrected (photo sent by LMA).

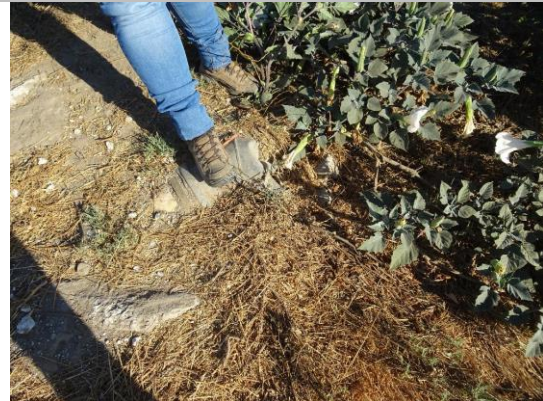
Photo 3 of 3 : UCIP_SP_2024_70655_90665.jpg

LS view: Abandoned pipe through levee crown

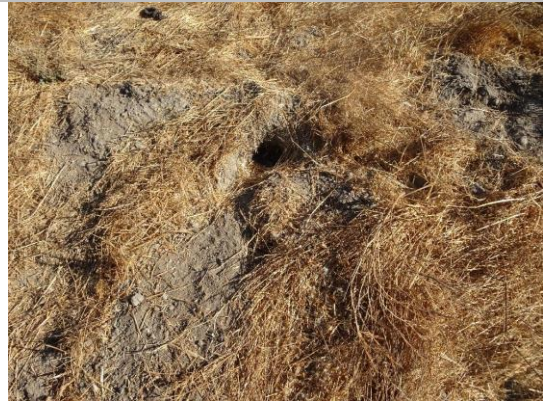
Photo 3 of 3 : UCIP_SP_2024_77849_90673.jpg

Observed burrowing on limited view of LS and WS slopes

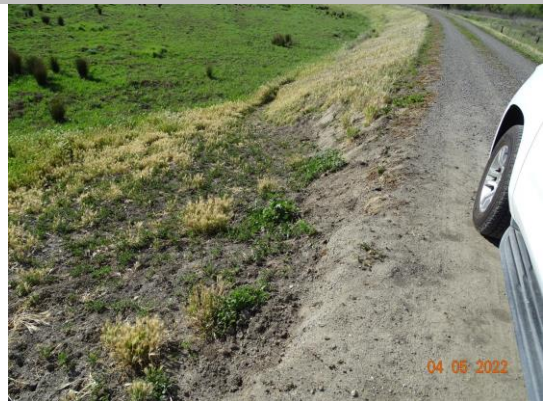
Photo 1 of 1 : SP_2024_NA0010_118_9_20240212_00003.jpg

View of damage to the landside slope from livestock. (Spring 2022)

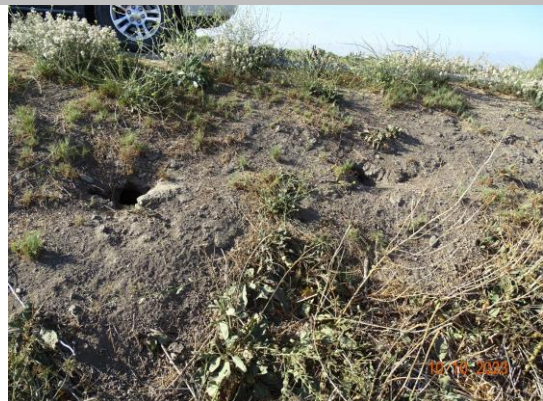
Photo 1 of 1 : SP_2024_NA0010_118_125_20240212_00023.jpg

View of rodent holes in the landside slope. (Fall 2023)

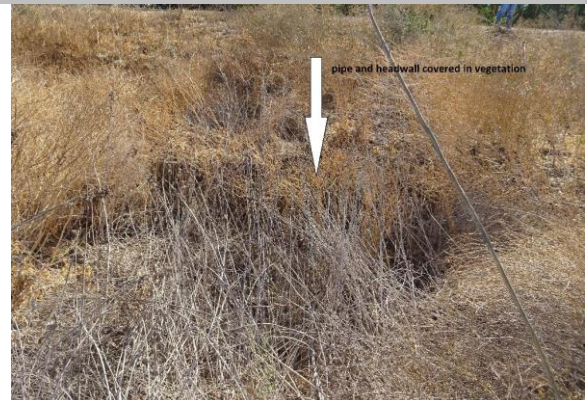
Photo 2 of 3 : UCIP_SP_2024_70675_90790.jpg

LS view: Headwall not visible due to high vegetation on LS toe and slope

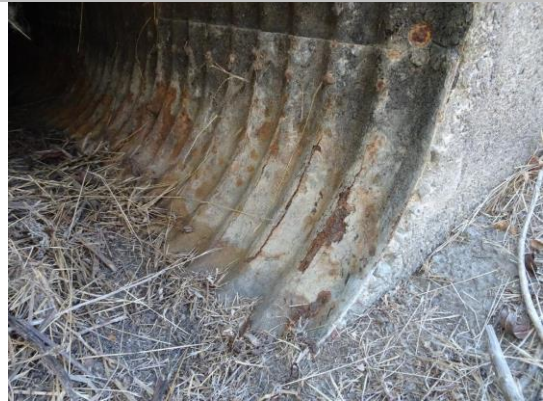
Photo 3 of 3 : UCIP_SP_2024_81164_90801.jpg

LS view: pipe corrosion visible at invert of pipe at LS toe

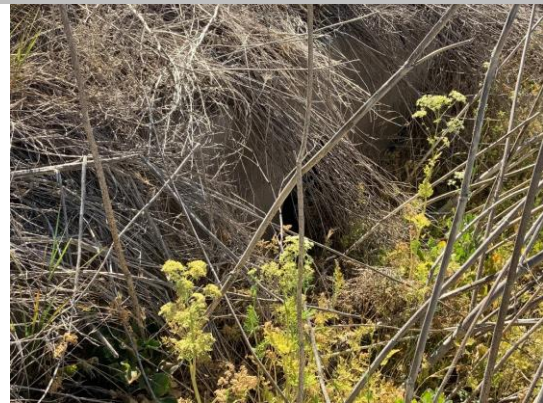
Photo 1 of 1 : UCIP_SP_2024_70933_100059.jpg

LS view: Close up of pipe inlet at toe, vegetation covering opening.

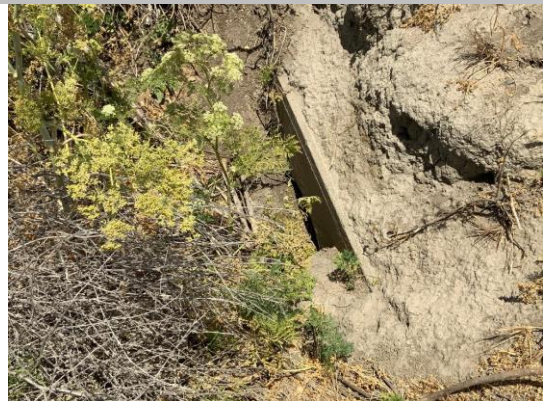
Photo 1 of 1 : UCIP_SP_2024_70943_100135.jpg

LS view: Headwall barely visible at toe, covered in sediment.

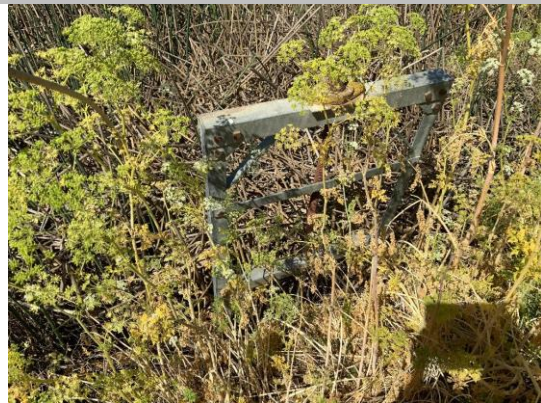
Photo 1 of 1 : UCIP_SP_2024_70961_100390.jpg

LS view: Headwall barely visible at toe, inlet covered in vegetation.

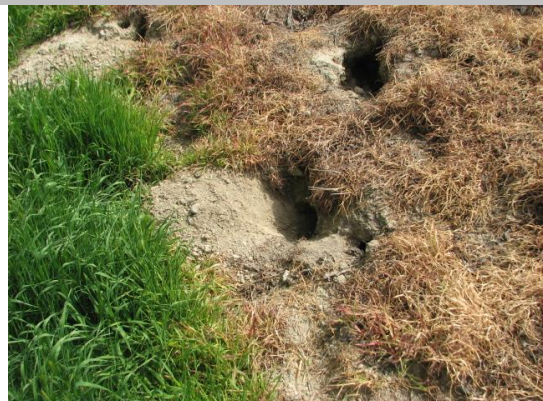
Photo 1 of 1 : SP_2024_NA0010_123_134_20240212_00028.jpg

Looking at typical rodent holes within this section. (Spring 2018)

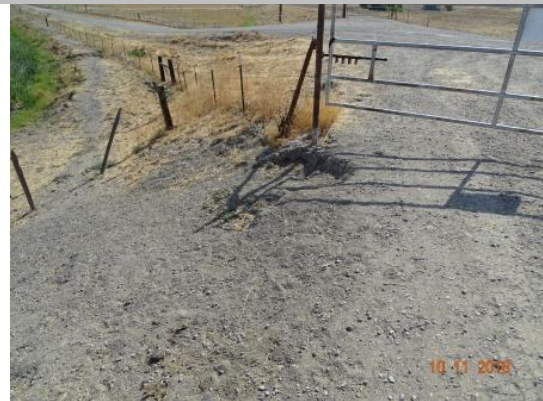
Photo 1 of 1 : SP_2024_NA0010_123_140_20240212_00032.jpg

Erosion on landward slope caused by animal foot traffic. (Fall 2018)

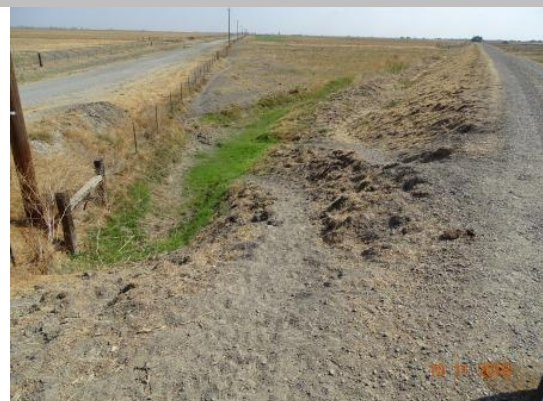
Photo 1 of 1 : SP_2024_NA0010_123_1309_20240212_00075.jpg

Looking upstream at damaged landside slope. (Fall 2018)

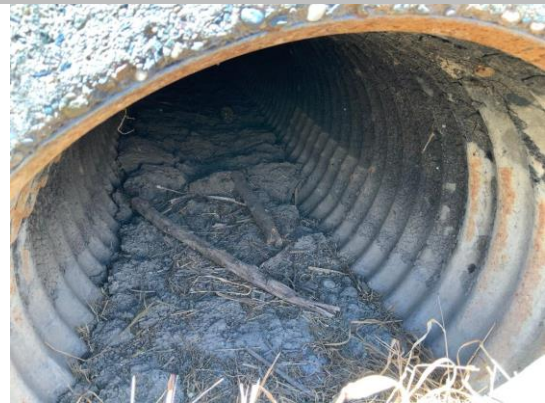
Photo 1 of 1 : UCIP_SP_2024_71000_100779.jpg

LS view: Closeup of pipe inlet with sediment buildup at toe.

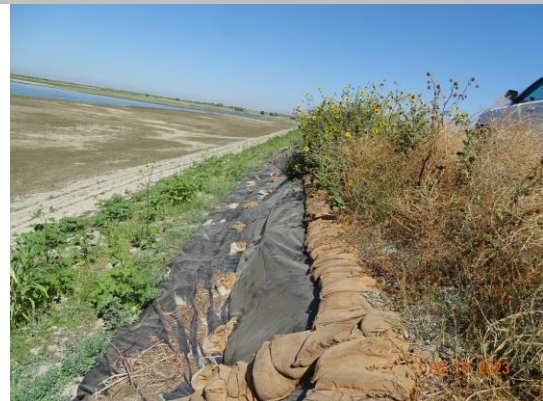
Photo 1 of 1 : SP_2024_NA0010_123_1_20240212_00001.jpg

8/10/2023: View of the erosion under wavewash protection.

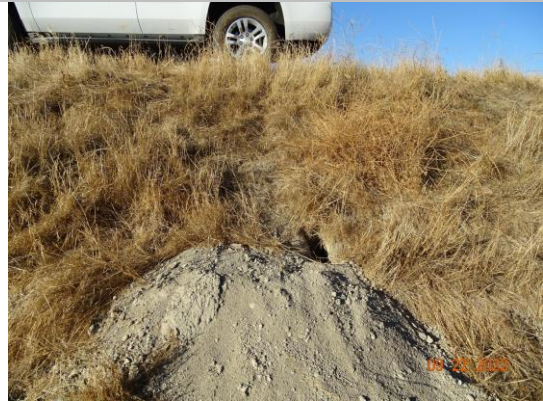
Photo 1 of 1 : SP_2024_NA0010_123_187_20240212_00066.jpg

View of a rodent burrow on the landside slope. (Fall 2022).

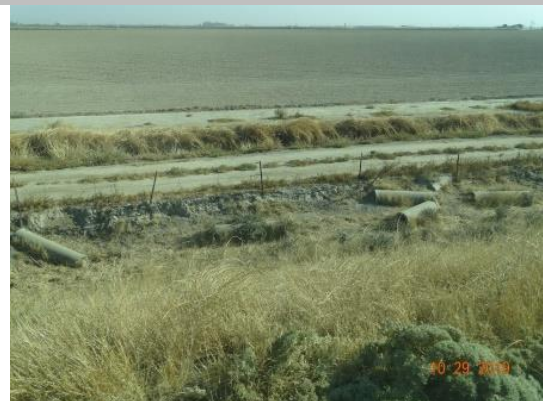
Photo 1 of 1 : SP_2024_NA0010_123_175_20240212_00060.jpg

Sections of concrete pipe left along the landside toe. (Fall 2019)

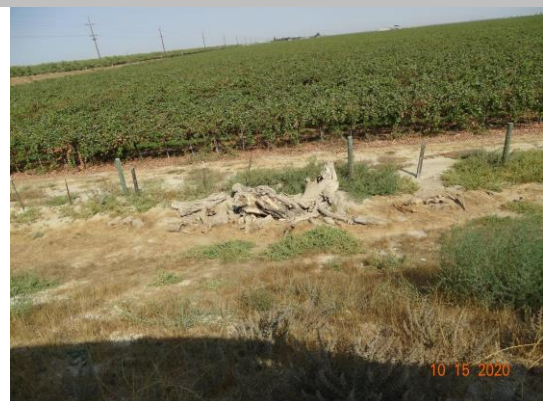
Photo 1 of 1 : SP_2024_NA0010_123_125_20240212_00022.jpg

Prunings left on the landside toe. (Fall 2020)

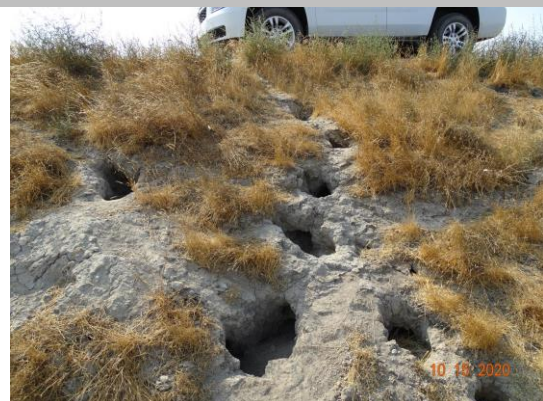
Photo 1 of 1 : SP_2024_NA0010_123_129_20240212_00025.jpg

Several large rodent holes noted at this location. (Fall 2020)

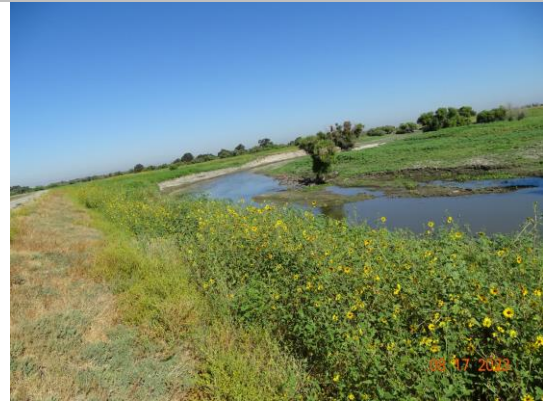
Photo 1 of 2 : SP_2024_NA0010_124_2_20240212_00003.jpg

8/17/2023: View of the erosion looking downstream.

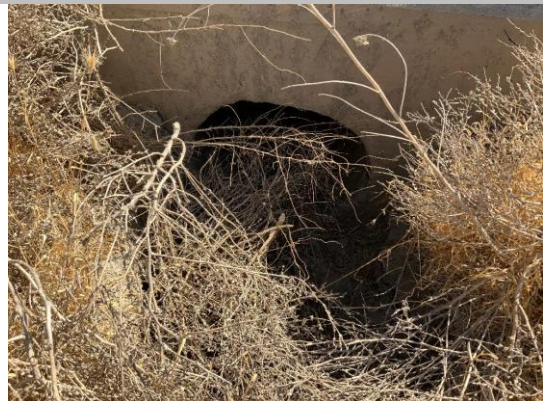
Photo 1 of 1 : UCIP_SP_2024_71104_103008.jpg

LS view: Closeup of pipe inlet at toe covered by tumbleweeds.

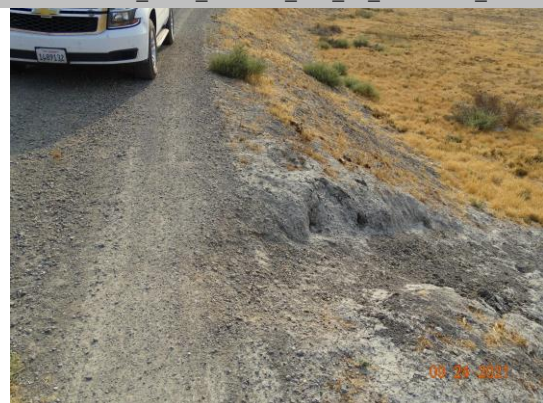
Photo 1 of 1 : SP_2024_NA0010_124_66_20240212_00010.jpg

View of damage to landside slope from livestock traffic looking downstream. (Fall 2021)

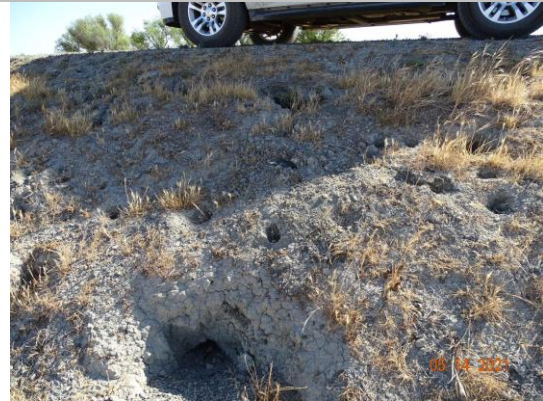
Photo 1 of 1 : SP_2024_NA0010_124_90_20240212_00025.jpg

Looking at multiple rodent holes in the landside slope. (Spring 2021)

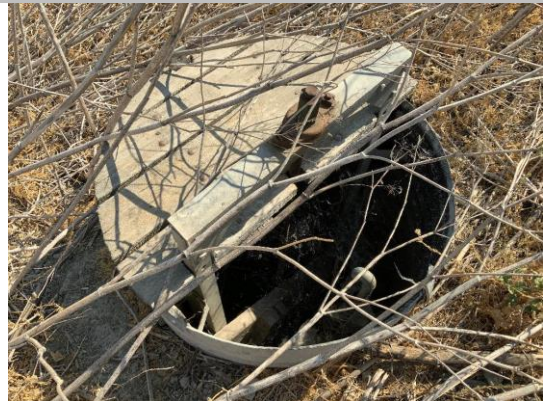
Photo 2 of 3 : UCIP_SP_2024_71152_102337.jpg

WS view: Closeup of riser on slope, broken lid.

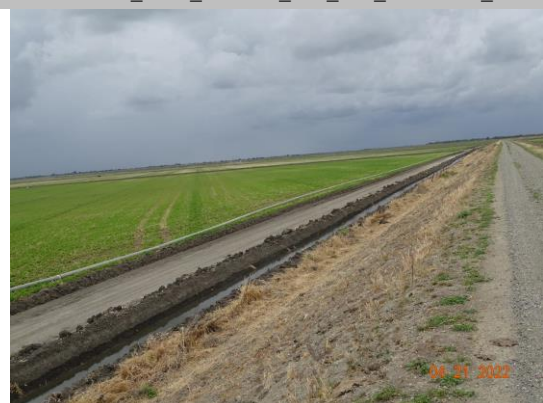
Photo 1 of 1 : SP_2024_NA0010_124_119_20240212_00042.jpg

Ditch landowner has dug on the landside toe. (Spring 2022)

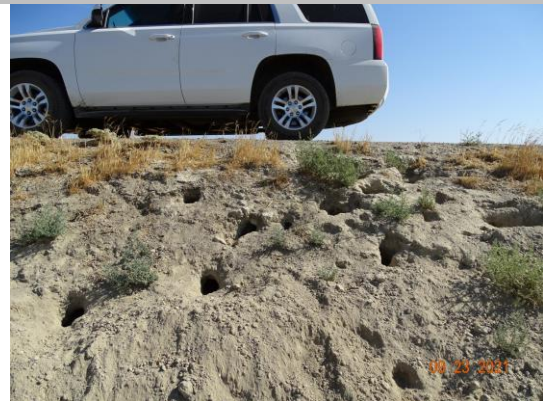
Photo 1 of 1 : SP_2024_NA0010_124_113_20240212_00037.jpg

Several rodent holes observed at this location. (Fall 2021)

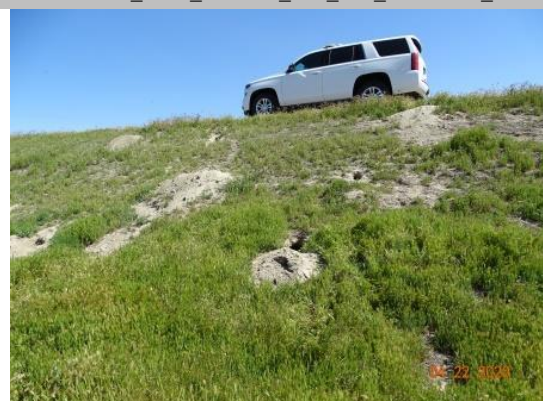
Photo 1 of 1 : SP_2024_NA0010_124_114_20240212_00038.jpg

View of rodent burrows on the landside slope. (Spring 2020)

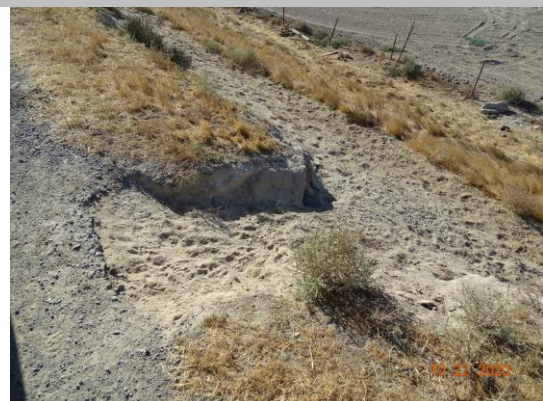
Photo 1 of 1 : SP_2024_NA0010_124_91_20240212_00026.jpg

Cattle trail damage to the landside slope and shoulder. (Fall 2020)

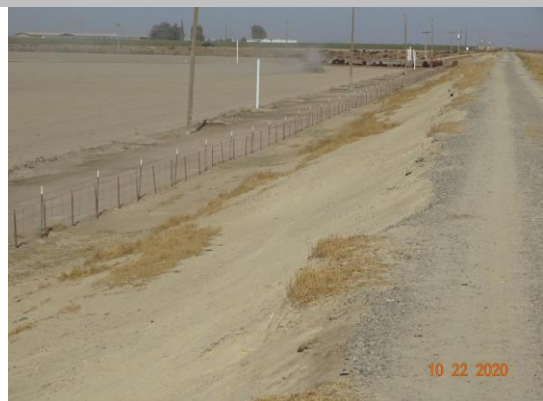
Photo 1 of 1 : SP_2024_NA0010_124_5_20240212_00006.jpg

Looking downstream at erosion from livestock. (Fall 2020)

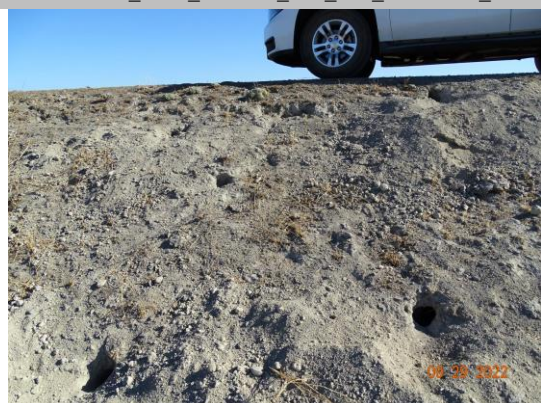
Photo 1 of 1 : SP_2024_NA0010_124_140_20240212_00058.jpg

View of multiple animal holes in the landside slope. (Fall 2022)

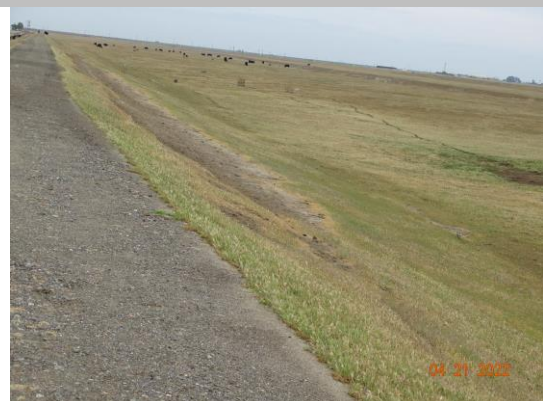
Photo 1 of 1 : SP_2024_NA0010_124_132_20240212_00051.jpg

View of erosion on the waterside slope. (Spring 2022)

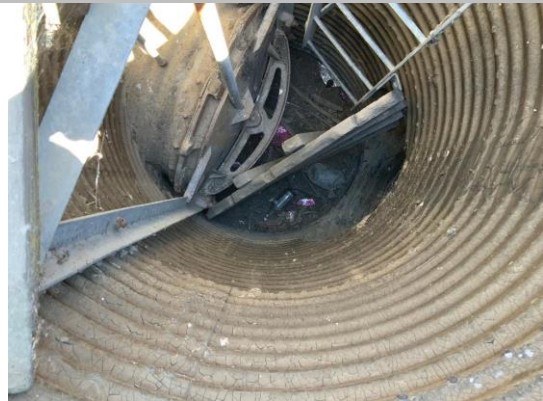
Photo 3 of 3 : UCIP_SP_2024_71167_99454.jpg

WS view: Close up of inside metal riser, wood pallets in the way.

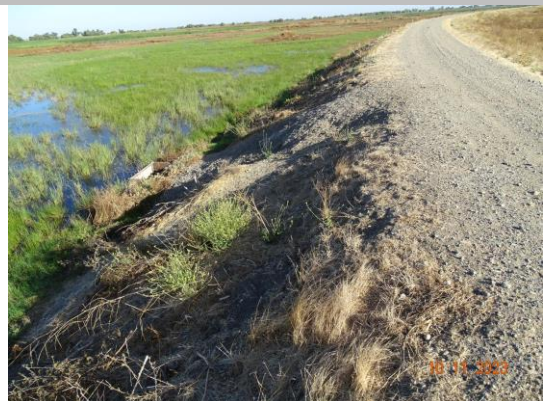
Photo 1 of 1 : SP_2024_NA0010_125_18_20240212_00006.jpg

View of damage from livestock looking upstream. (Fall 2023)

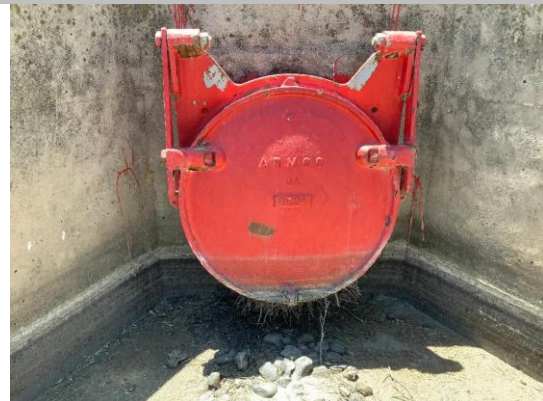
Photo 1 of 1 : UCIP_SP_2024_71182_99580.jpg

WS view: Close up of flapgate, vegetation coming out of it.

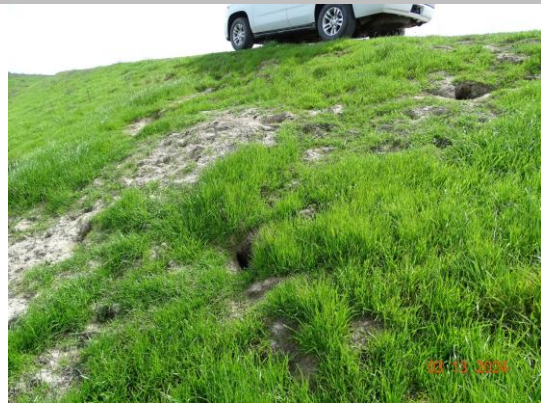
Photo 1 of 1 : SP_2024_NA0010_127_5_20240326_00009.jpg

View of multiple rodent holes on the landside slope. (Spring 2024)

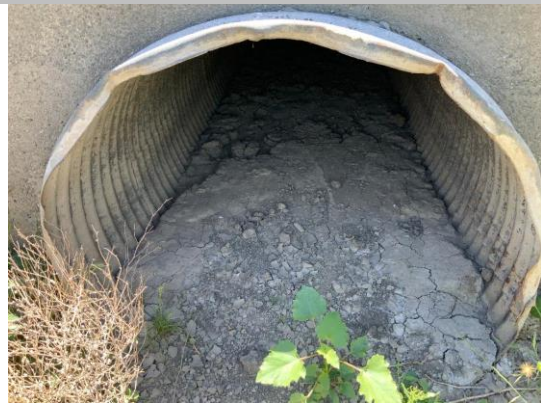
Photo 1 of 1 : UCIP_SP_2024_73277_100440.jpg

LS view: Close up of pipe inlet with sediment buildup and warped edges at toe.

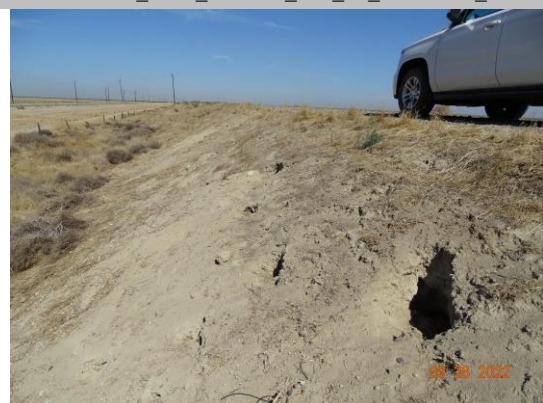
Photo 1 of 1 : SP_2024_NA0010_137_38_20240212_00010.jpg

Several rodent holes observed in this section. (Fall 2022)

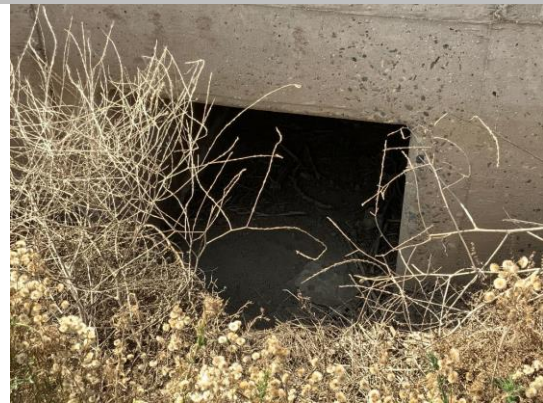
Photo 1 of 1 : UCIP_SP_2024_73578_102587.jpg

LS view: Closeup of pipe inlet at toe with sediment buildup.

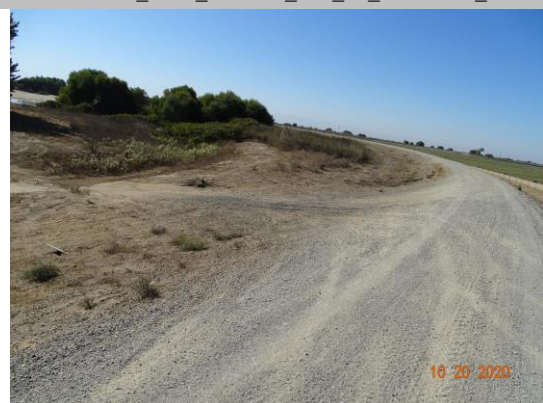
Photo 1 of 1 : SP_2024_NA0010_139_16_20240212_00002.jpg

View of ramp constructed on waterside slope. (Fall 2020)
