**Flood Control Project Maintenance
Levee Inspections**

Maintenance Issue Types Only, Levee Inspection Report By Mile - Fall 2014

Lower San Joaquin Levee District

Waterway	Bank	Unit Miles	Inspection Start/End	Inspector
Unit No. 01 San Joaquin River	Right	22.52	11/03/2014 11/06/2014	Richard Willoughby

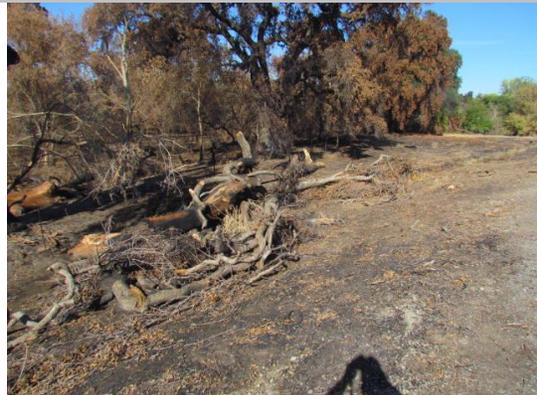
Photo 1 of 2 : FA_2014_NA0010_118_98_20141110_00022.jpg

Looking north at tree limbs on waterward toe.

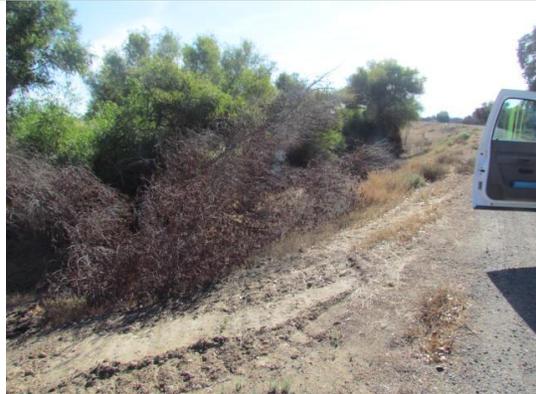
Photo 1 of 1 : FA_2014_NA0010_118_99_20141110_00023.jpg

Looking south at tree limbs on landward slope and toe.

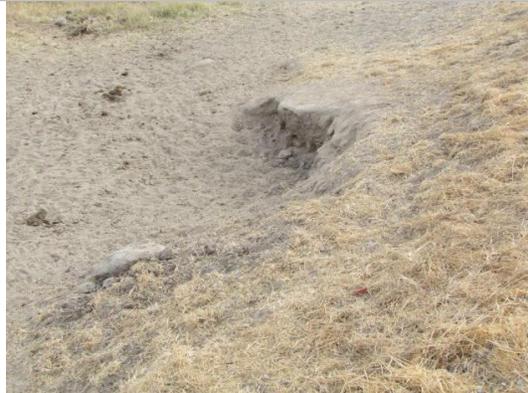
Photo 1 of 2 : FA_2014_NA0010_118_9_20141103_00005.jpg

LM Start	4.72	Rating **	M	Issue No.	9
LM End	4.72	Issue Type +	Ma	Location *	LS
Category	Earthen Levee		GPS Latitude/Longitude		
			Start	End	
Item	Animal Control		37.302398 °	37.302398 °	
			-120.920920 °	-120.920920 °	
DWR ID	DWR_NA0010_01_s_2013_9				
Action/Comments					
Repair the levee slope damaged by livestock and prevent large animal access. Inspector Comments: Levee landward toe damaged by livestock.

Looking southeast at erosion on landward toe.

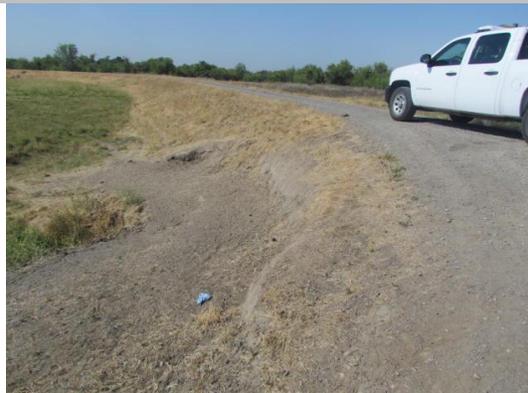
Photo 2 of 2 : FA_2014_NA0010_118_9_20141103_00006.jpg

Looking south at damage slope by livestock on landward slope.

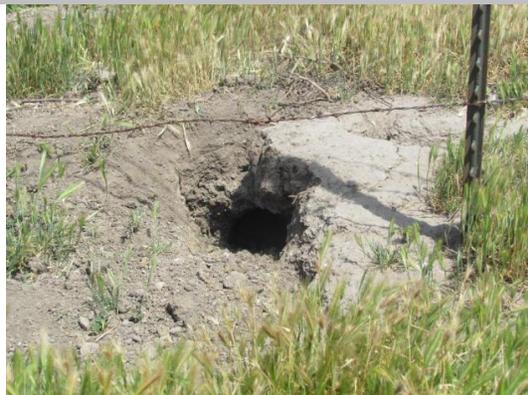
Photo 1 of 3 : FA_2014_NA0010_118_116_20141103_00015.jpg

LM Start	5.75	Rating **	A/W	Issue No.	116
LM End	5.75	Issue Type +	Ma	Location *	LS
Category	Earthen Levee		GPS Latitude/Longitude		
			Start	End	
Item	Animal Control		37.304057 °	37.304057 °	
			-120.907200 °	-120.907200 °	
DWR ID	DWR_NA0010_01_s_2012_116				
Action/Comments					
No rodents visible, but rodent burrows visible; need to backfill and compact or grout burrows. Inspector Comments: Large rodent holes on landside slope near fence pole.

Looking east at one of several rodent holes on landside shoulder and slope.

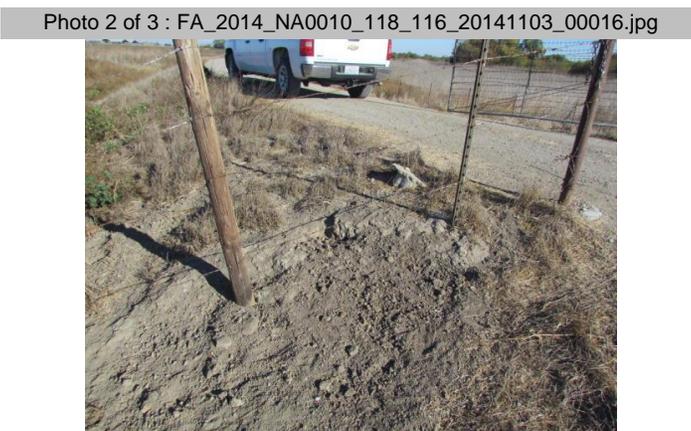
Looking south at repaired rodent site on landside slope. (Fall 2012)

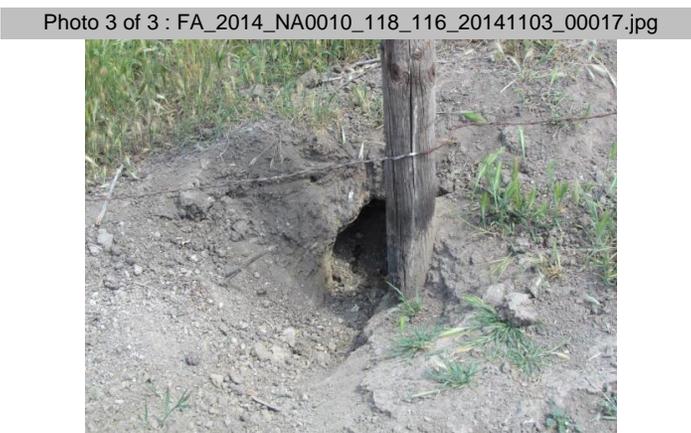
Looking northeast at one of several holes on landside shoulder and slope.

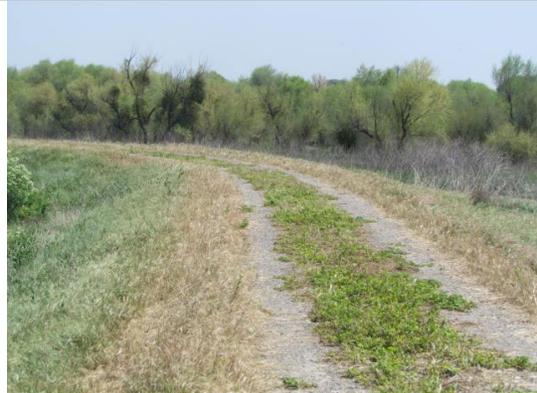
Photo 1 of 3 : FA_2014_NA0010_118_117_20141103_00018.jpg

Looking south at typical view of vegetation on levee crown.

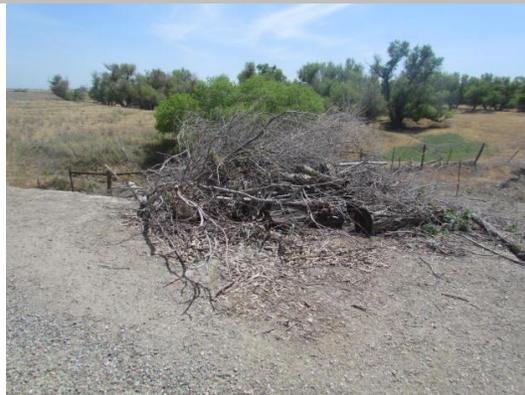
Photo 1 of 1 : FA_2014_NA0010_118_27_20141103_00011.jpg

Looking at prunings on waterward shoulder and slope.

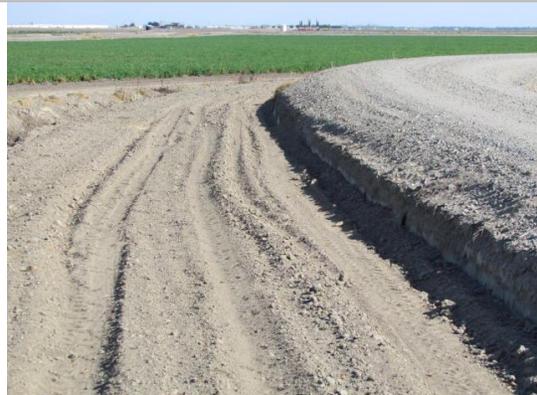
Photo 2 of 2 : FA_2014_NA0010_118_20_20141103_00008.jpg

Looking west at farmer discing landside slope.

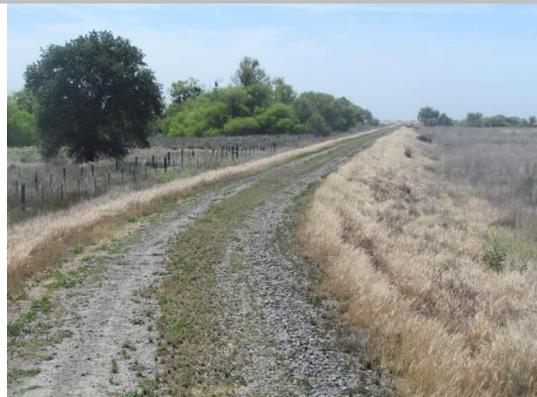
Photo 2 of 2 : FA_2014_NA0010_119_9_20141103_00006.jpg

Looking north at vegetation on levee crown.

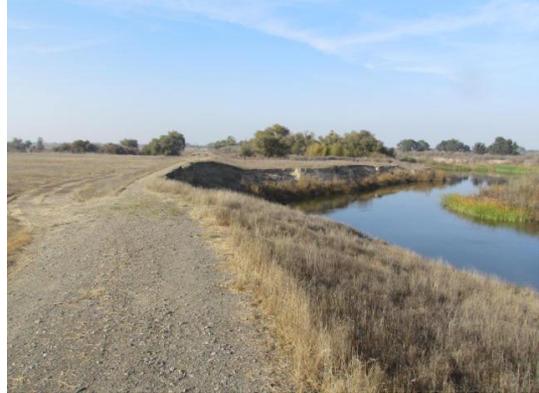
Photo 1 of 3 : FA_2014_NA0010_119_5_20141110_00008.jpg

LM Start	0.77	Rating **	U	Issue No.	5
LM End	0.77	Issue Type +	Ma	Location *	WS
Category	Earthen Levee		GPS Latitude/Longitude		
			Start	End	
Item	Erosion / Bank Caving		37.286877 °	37.286877 °	
			-120.874222 °	-120.874222 °	
DWR ID	DWR_NA0010_02A_s_2012_5				
Action/Comments					
Schedule repair of erosion site prior to the next inspection. Inspector Comments: A field investigation report in on file. For more information and pictures see field investigation report #4301.

Looking north at erosion on waterward slope. (Fall 2014)

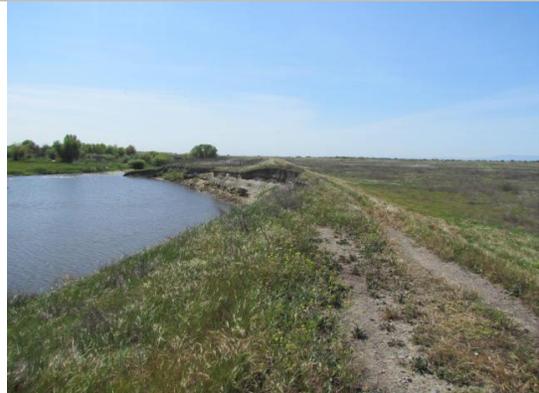
Photo 3 of 3 : FA_2014_NA0010_119_5_20141103_00005.jpg

Looking south at large erosion on waterside slope. (Spring 2012)

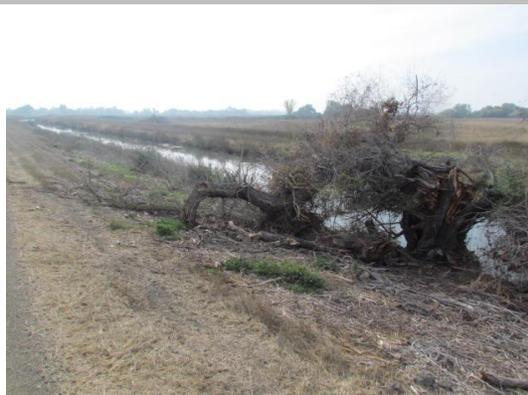
Photo 2 of 2 : FA_2014_NA0010_120_1_20141110_00008.jpg

Looking southwest at tree limb on waterward slope.

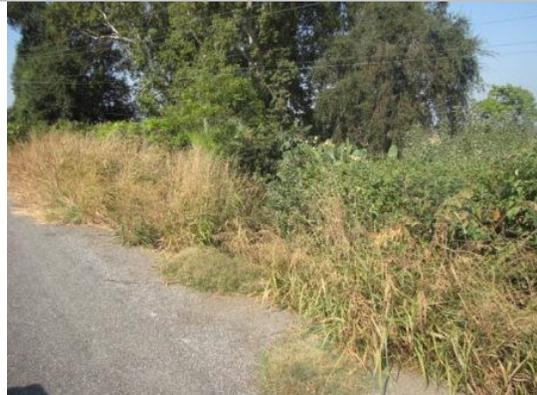
Photo 2 of 2 : FA_2014_NA0010_123_3_20141103_00003.jpg

Looking south at dense trees on landside slope.

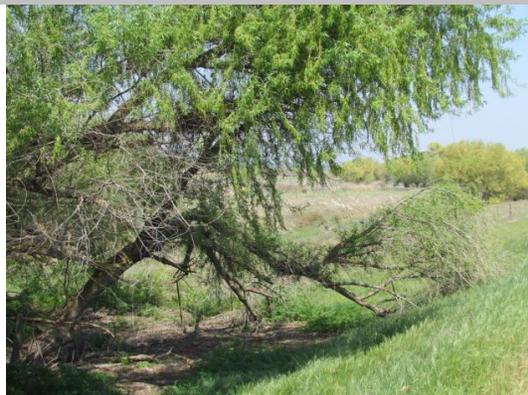
Photo 1 of 1 : FA_2014_NA0010_123_2_20141103_00001.jpg

Looking south at down tree limb on landside slope and toe.

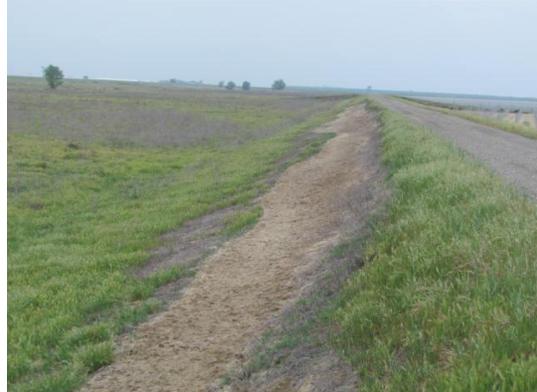
Photo 1 of 3 : FA_2014_NA0010_123_171_20141103_00012.jpg

LM Start	29.58	Rating **	M	Issue No.	171
LM End	29.70	Issue Type +	Ma	Location *	WS
Category	Earthen Levee		GPS Latitude/Longitude		
			Start	End	
Item	Erosion / Bank Caving		37.020272 °	37.018712 °	
			-120.433737 °	-120.432682 °	
DWR ID	DWR_NA0010_05_s_2014_171				
Action/Comments					
Note and monitor erosion site. Inspector Comments: Waterside erosion caused by livestock.

Looking south at erosion caused by livestock on landside slope.

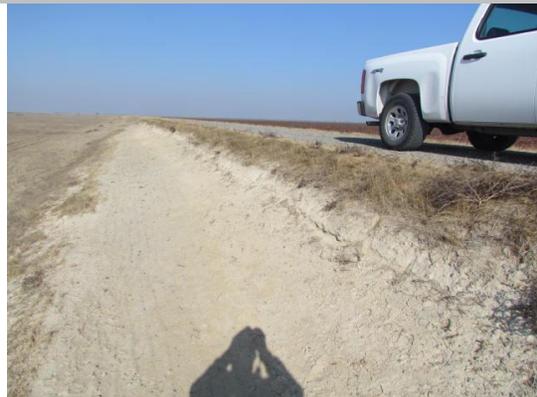
Photo 2 of 3 : FA_2014_NA0010_123_171_20141103_00013.jpg

Looking south at livestock erosion on landward slope.

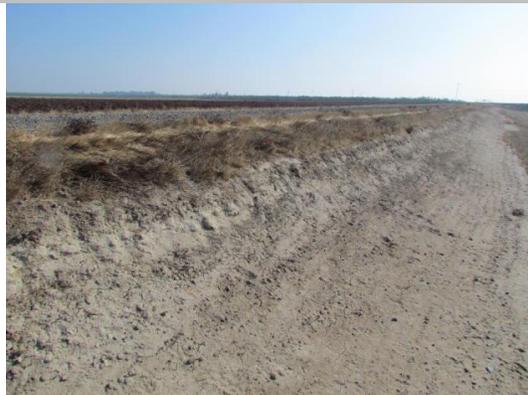
Photo 3 of 3 : FA_2014_NA0010_123_171_20141103_00014.jpg

LM Start	29.58	Rating **	M	Issue No.	171 (cont)
LM End	29.70	Issue Type +	Ma	Location *	WS
Category	Earthen Levee		GPS Latitude/Longitude		
			Start	End	
Item	Erosion / Bank Caving		37.020272 °	37.018712 °	
			-120.433737 °	-120.432682 °	
DWR ID	DWR_NA0010_05_s_2014_171				
Action/Comments					
Note and monitor erosion site. Inspector Comments: Waterside erosion caused by livestock.

Looking east at livestock eroision on landward slope.

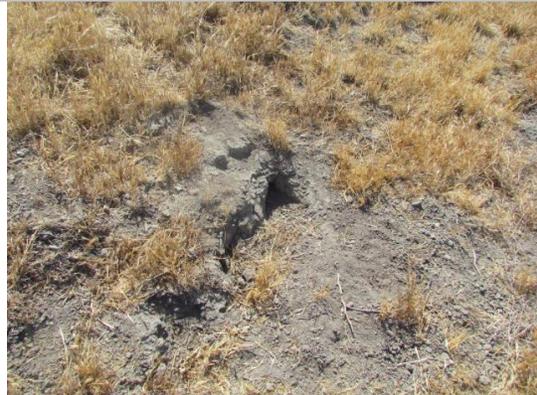
Photo 2 of 2 : FA_2014_NA0010_124_10_20141103_00011.jpg

Looking at typical rodent holes on landward slope.

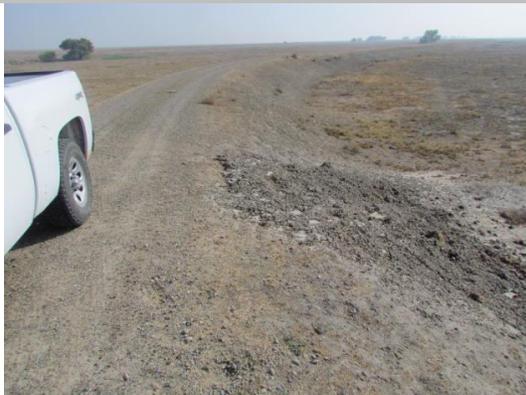
Photo 1 of 2 : FA_2014_NA0010_124_9_20141110_00014.jpg

LM Start	5.83	Rating **	A/W	Issue No.	9
LM End	5.83	Issue Type +	Ma	Location *	LS
Category	Earthen Levee		GPS Latitude/Longitude		
			Start	End	
Item	Slope Stability		37.238355 °	37.238355 °	
			-120.742677 °	-120.742677 °	
DWR ID	DWR_NA0010_06_s_2012_9				
Action/Comments					
Repair the levee slope damaged by vehicle traffic and prevent access where possible. Inspector Comments: Levee damage caused by motorcylce traffic.

Looking northwest damage slope corrected.

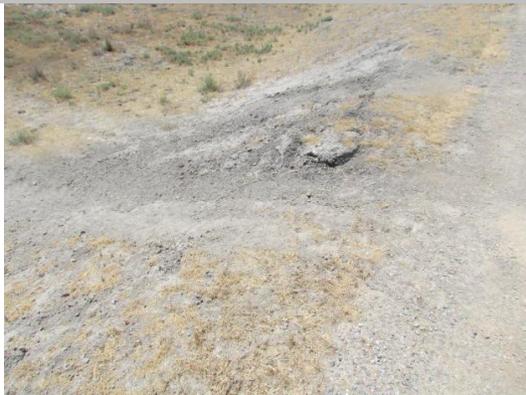
Photo 2 of 2 : FA_2014_NA0010_124_9_20141103_00009.jpg

Looking at slope damage cause by vehicle traffic on landward slope.

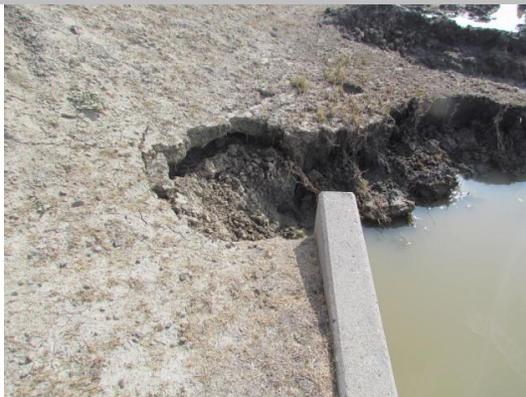
Photo 1 of 2 : FA_2014_NA0010_124_65_20141110_00015.jpg

Looking northwest at erosion around headwall of drainage structure on landward toe.

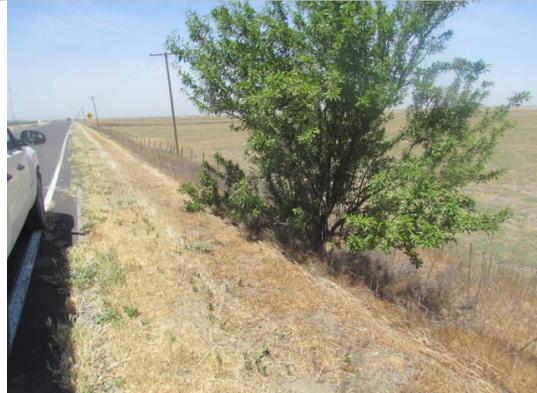
Photo 1 of 1 : FA_2014_NA0010_124_14_20141103_00012.jpg

Looking east at tree on waterward slope.

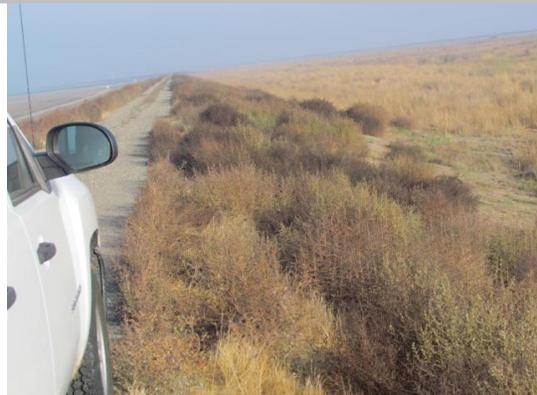
Photo 1 of 1 : FA_2014_NA0010_124_64_20141110_00017.jpg

Looking northeast at dense tumble weeds on waterward slope.

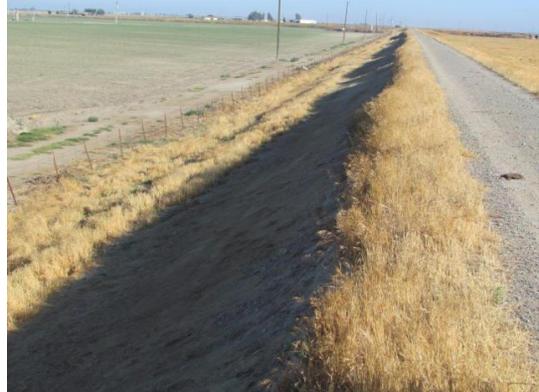
Photo 1 of 2 : FA_2014_NA0010_124_5_20141103_00007.jpg

Looking north at livestock erosion on landward slope.

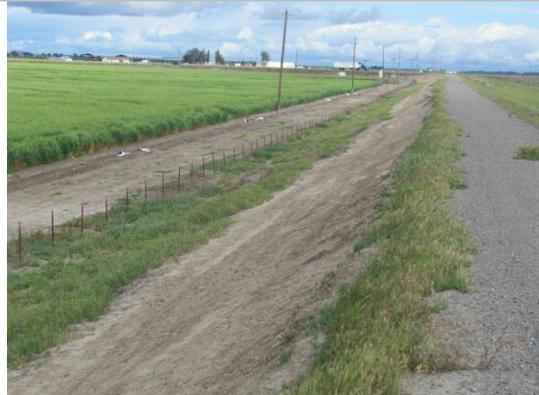
Photo 2 of 2 : FA_2014_NA0010_124_5_20141103_00008.jpg

Looking north at livestock erosion on landside slope.

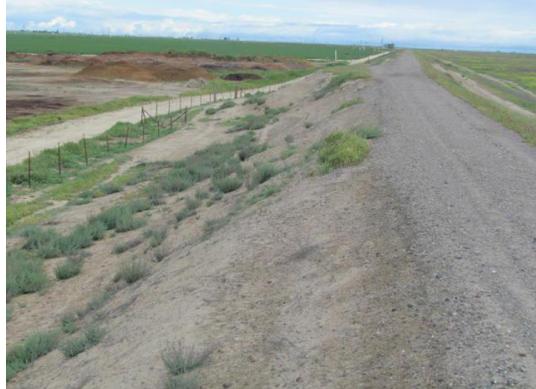
Photo 1 of 4 : FA_2014_NA0010_124_3_20141103_00003.jpg

Looking north at livestock erosion on landside shoulder and slope.

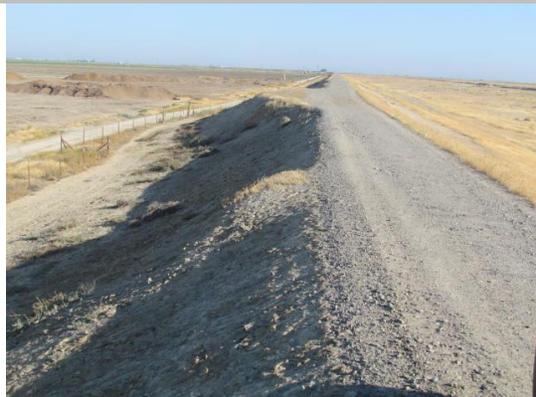
Looking north at livestock erosion on landward slope. (Spring 2013)

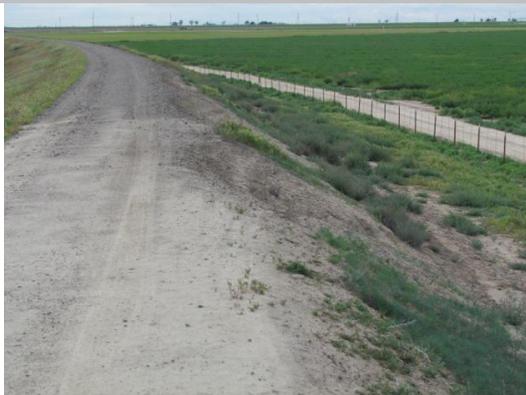
Photo 4 of 4 : FA_2014_NA0010_124_3_20141103_00006.jpg

Looking south at livestock erosion on landside shoulder and slope.

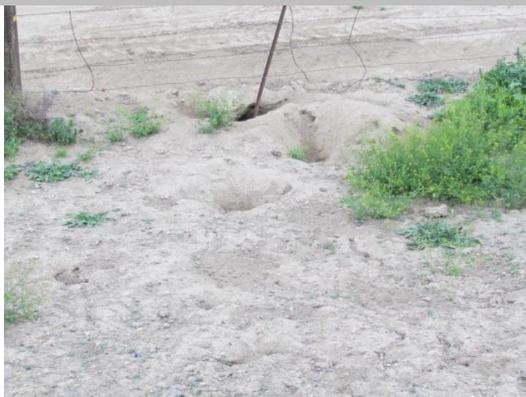
Photo 1 of 2 : FA_2014_NA0010_124_2_20141103_00001.jpg

Looking west at rodent holes on landside slope and toe near fence line.

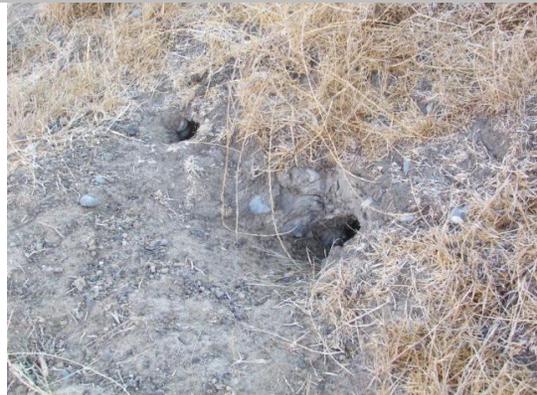
Photo 1 of 2 : FA_2014_NA0010_125_1_20141103_00001.jpg

Looking north at several rodent holes on landward slope.

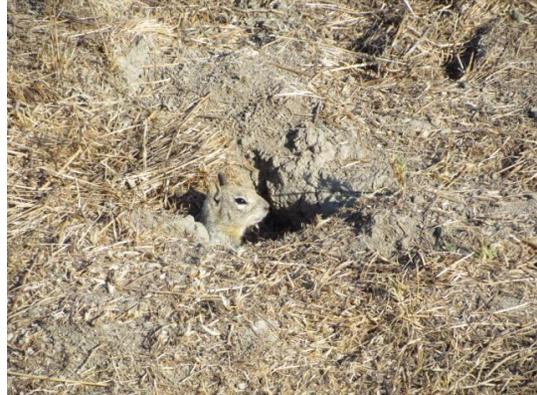
Photo 2 of 2 : FA_2014_NA0010_125_1_20141103_00002.jpg

Looking at east at active rodent holes on landside berm.

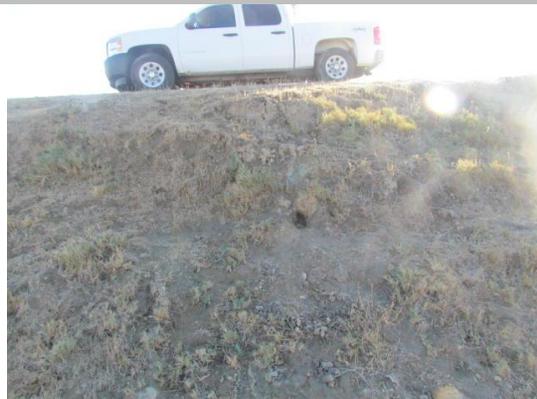
Photo 1 of 1 : FA_2014_NA0010_125_11_20141110_00016.jpg

Looking west at slope damage and rodent activity on landward slope.

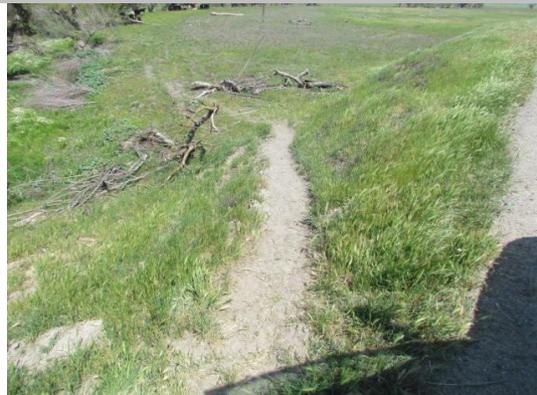
Photo 1 of 4 : FA_2014_NA0010_125_3_20141103_00003.jpg

Looking northeast at landside slope damaged by livestock.

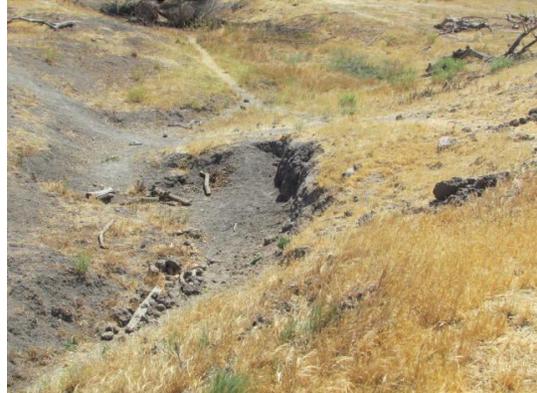
Photo 3 of 4 : FA_2014_NA0010_125_3_20141103_00005.jpg

Looking southeast at damage on landward toe.(Spring 2013)

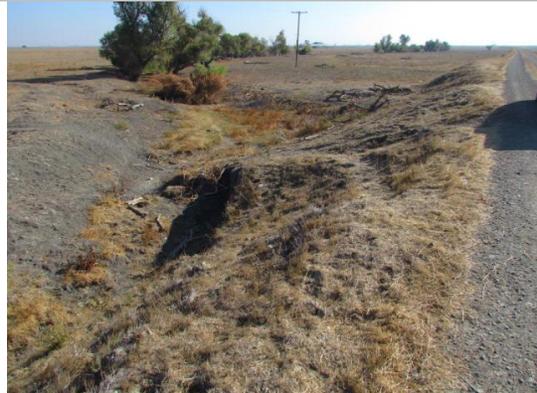
Photo 4 of 4 : FA_2014_NA0010_125_3_20141103_00006.jpg

Looking southeast at landside slope and toe damage by livestock.

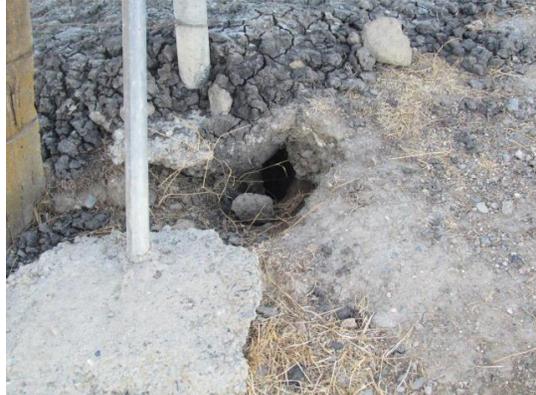
Photo 1 of 1 : FA_2014_NA0010_125_12_20141110_00017.jpg

Looking east at rodent hole next to fence post on landward shoulder.

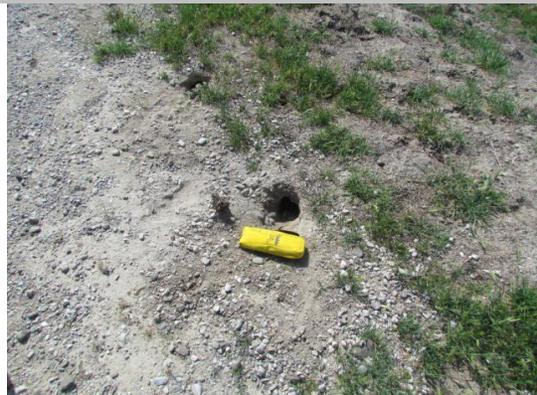
Photo 1 of 3 : FA_2014_NA0010_126_7_20141103_00004.jpg

Looking at typical rodent hole along the section.

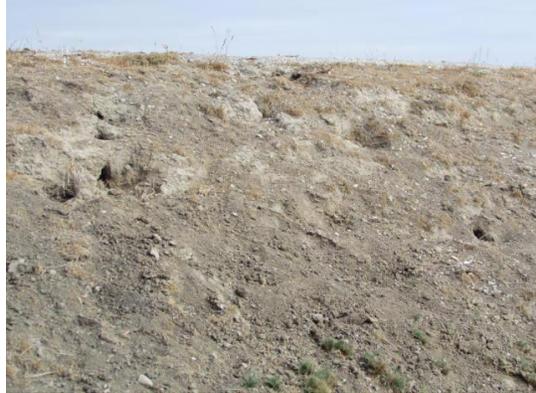
Photo 2 of 3 : FA_2014_NA0010_126_7_20141103_00005.jpg

Looking south at several rodent holes on landward slope.

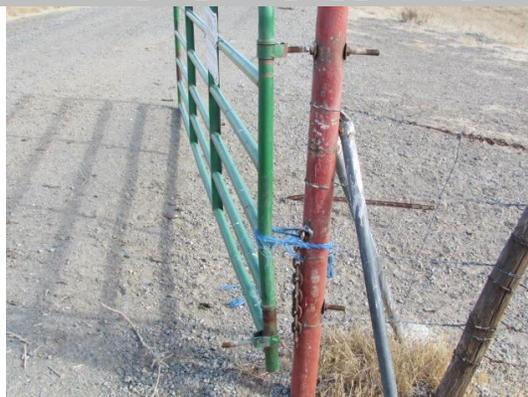
Photo 1 of 2 : FA_2014_NA0010_129_2_20141103_00001.jpg

Looking at bottom hinge broken on gate across levee crown.

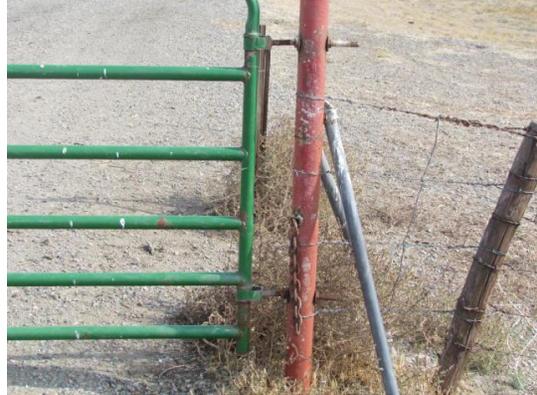
Photo 2 of 2 : FA_2014_NA0010_129_2_20141110_00005.jpg

Looking at gate in compliance with standards. (Fall 2014)

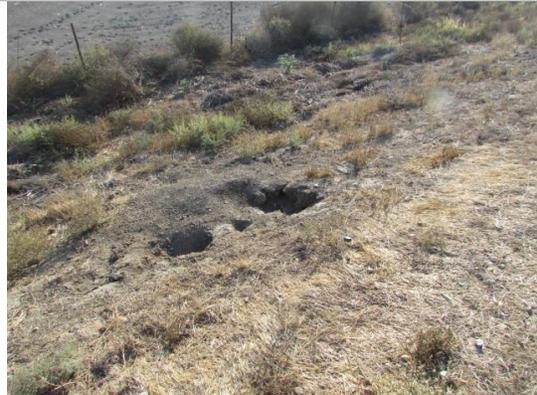
Photo 2 of 2 : FA_2014_NA0010_134_2_20141110_00003.jpg

Looking southwest at several rodent holes on landward slope.

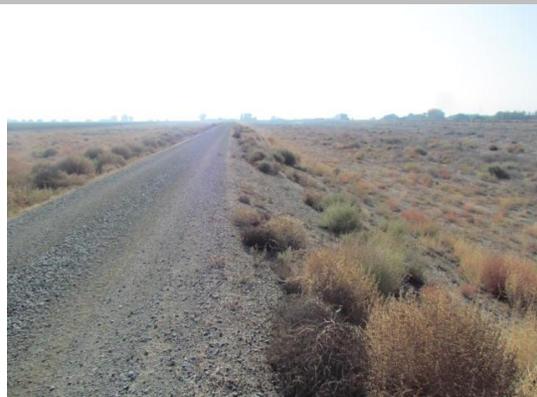
Photo 1 of 1 : FA_2014_NA0010_135_12_20141110_00003.jpg

Looking south at typical view of tumble weeds on waterward slope.

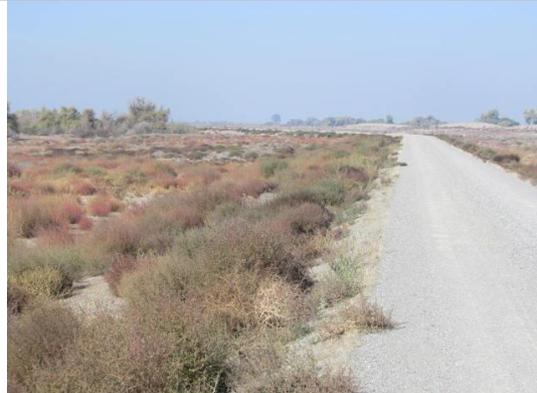
Photo 1 of 1 : FA_2014_NA0010_137_1_20141110_00003.jpg

Looking at typical view of tumble weeds on levee slopes.

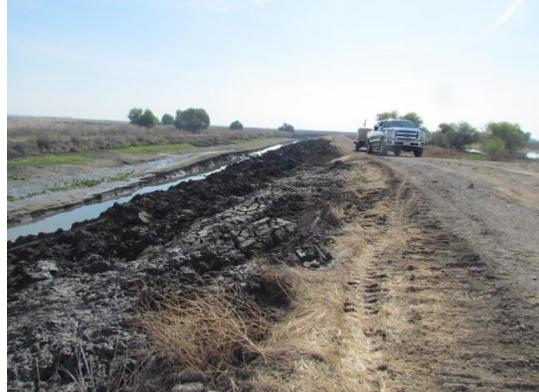
Photo 1 of 3 : FA_2014_NA0010_138_22_20141110_00016.jpg

Looking south at excavated waterward slope.

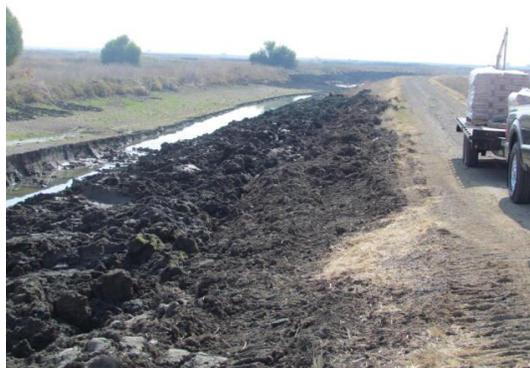
Photo 2 of 3 : FA_2014_NA0010_138_22_20141110_00017.jpg

Looking southeast at excavated waterward slope.

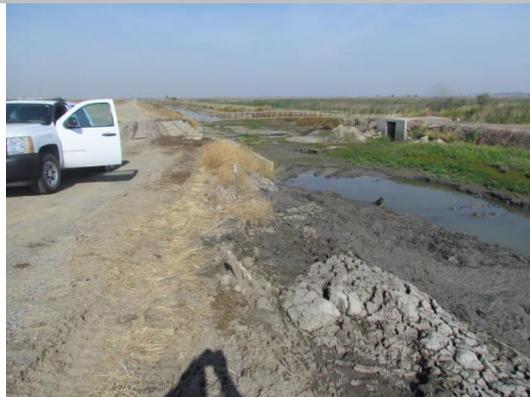
Photo 3 of 3 : FA_2014_NA0010_138_22_20141110_00018.jpg

Looking north at excavated waterward slope.

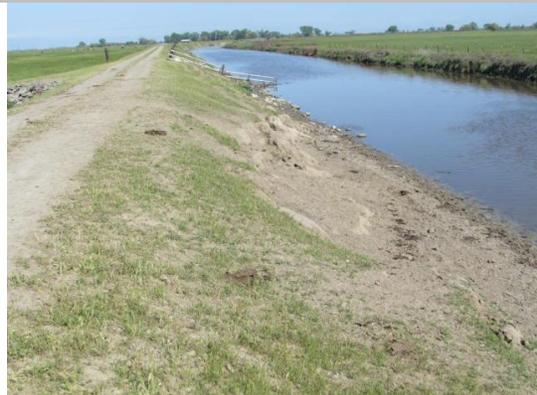
Photo 1 of 1 : FA_2014_NA0010_138_5_20141103_00007.jpg

Looking north at waterside erosion from livestock.

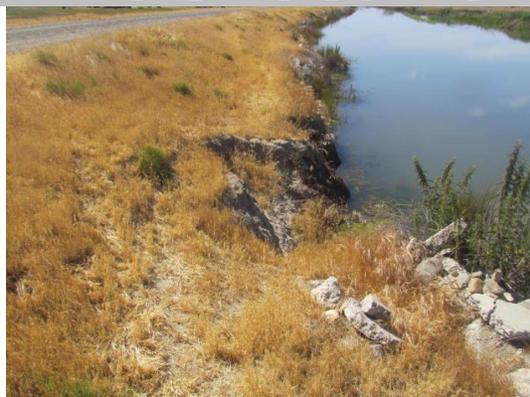
Photo 1 of 1 : FA_2014_NA0010_138_12_20141103_00011.jpg

Looking south at slope damage cause by animal traffic on waterside slope.

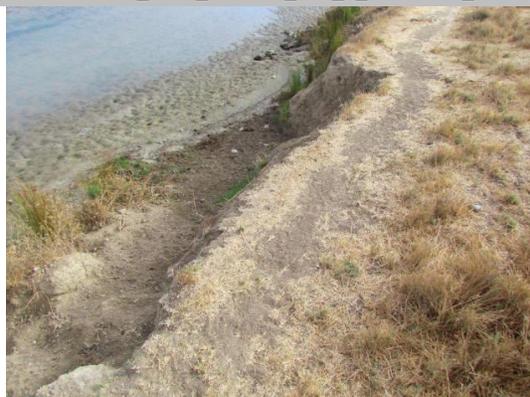
Photo 1 of 2 : FA_2014_NA0010_138_4_20141103_00005.jpg

Looking southeast at livestock erosion on waterward toe.

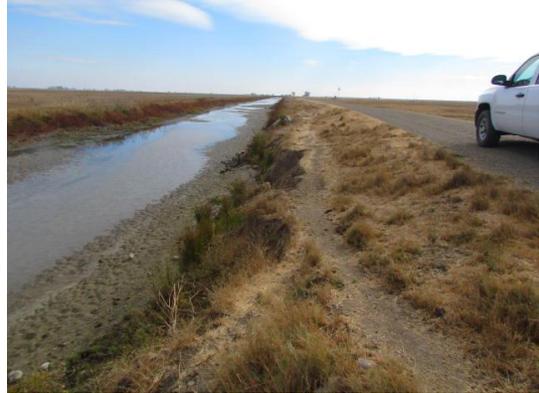
Photo 2 of 2 : FA_2014_NA0010_138_4_20141103_00006.jpg

Looking south livestock erosion on waterward toe.

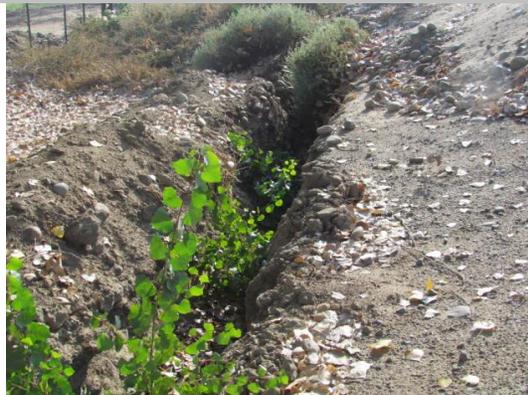
Photo 1 of 2 : FA_2014_NA0010_139_29_20141110_00018.jpg

Looking south at trench at landward toe.

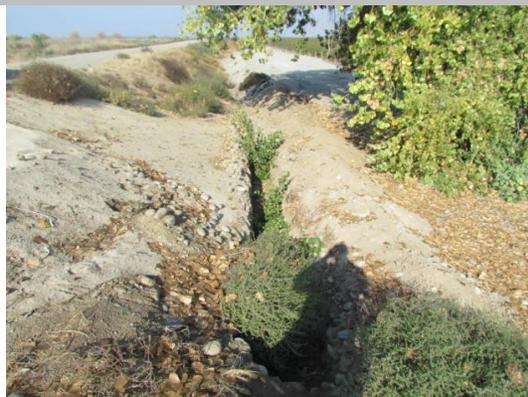
Photo 2 of 2 : FA_2014_NA0010_139_29_20141110_00019.jpg

Looking north at trench at landward toe.

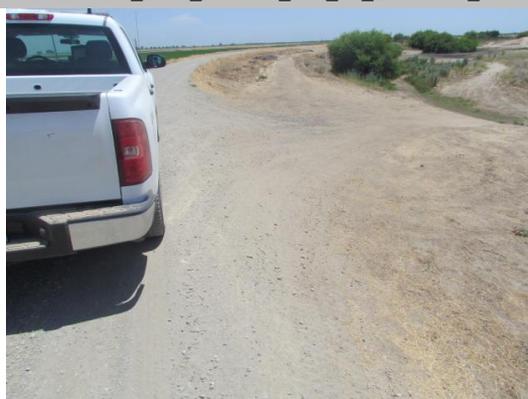
Photo 1 of 1 : FA_2014_NA0010_139_16_20141103_00015.jpg

Looking south at waterward slope damaged by vehicle traffic

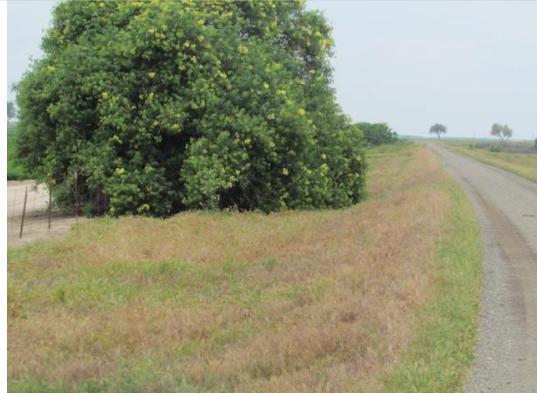
Photo 2 of 2 : FA_2014_NA0010_139_3_20141103_00004.jpg

Looking south at elderberry on landside toe and berm.

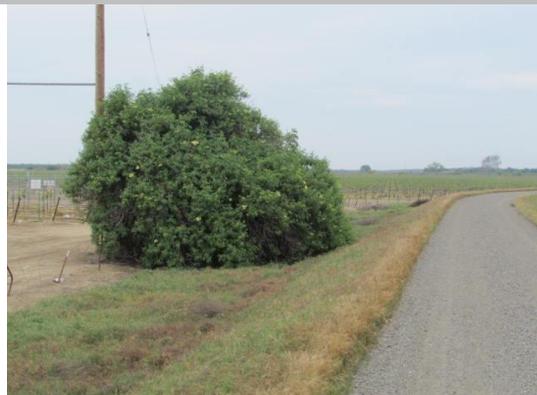
Photo 2 of 2 : FA_2014_NA0010_139_10_20141103_00010.jpg

Looking south at elderberry on landside toe and berm.

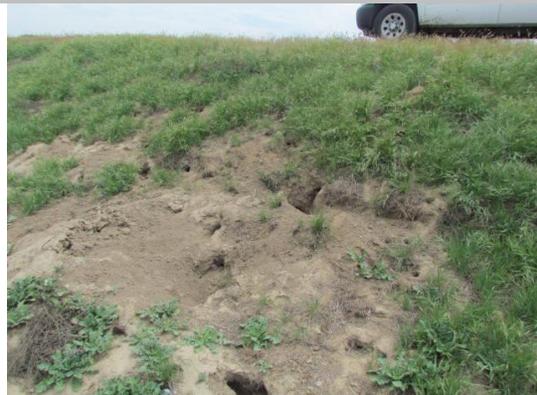
Photo 1 of 1 : FA_2014_NA0010_139_5_20141103_00005.jpg

Looking at several rodent holes on landside slope.

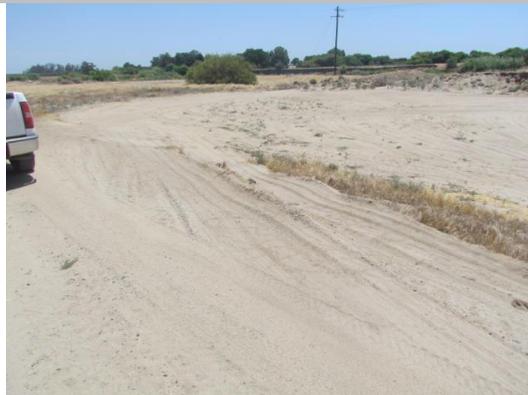
Photo 1 of 1 : FA_2014_NA0010_139_17_20141103_00016.jpg

Looking southwest at waterward slope damaged due to vehicle traffic.

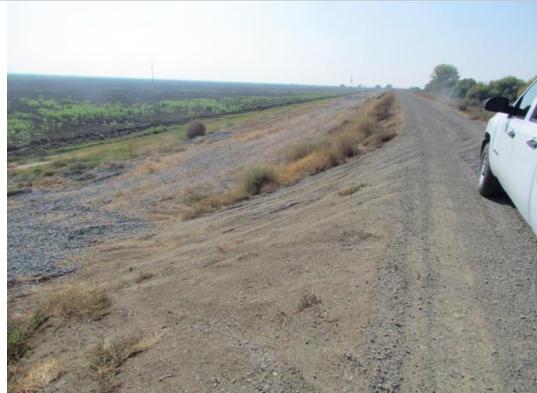
Photo 1 of 1 : FA_2014_NA0010_140_13_20141110_00005.jpg

Looking north at slope damage by vehicle traffic on landward slope.

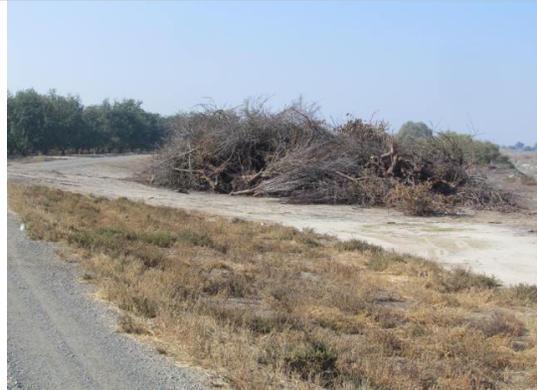
Photo 1 of 2 : FA_2014_NA0010_140_3_20141110_00006.jpg

Looking north at large pruning pile in channel.

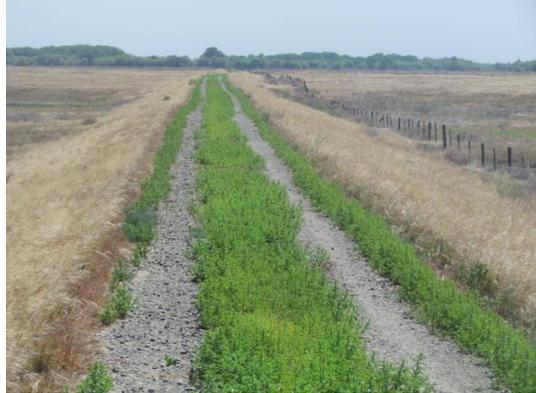
Photo 2 of 2 : FA_2014_NA0010_141_8_20141103_00001.jpg

Looking north at typical view of vegetation on levee crown.
