**Flood Control Project Maintenance
Levee Inspections**

Maintenance Issue Types Only, Levee Inspection Report By Mile - Spring 2015

Lower San Joaquin Levee District

Waterway	Bank	Unit Miles	Inspection Start/End	Inspector
Unit No. 01 San Joaquin River	Right	22.52	05/18/2015 05/22/2015	Richard Willoughby

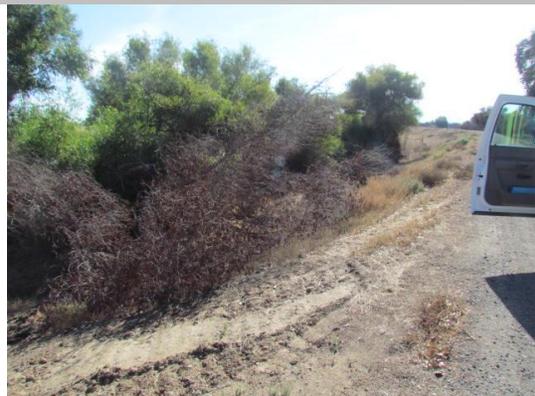
Photo 1 of 1 : SP_2015_NA0010_118_99_20150309_00014.jpg

Looking south at tree limbs on landward slope and toe.

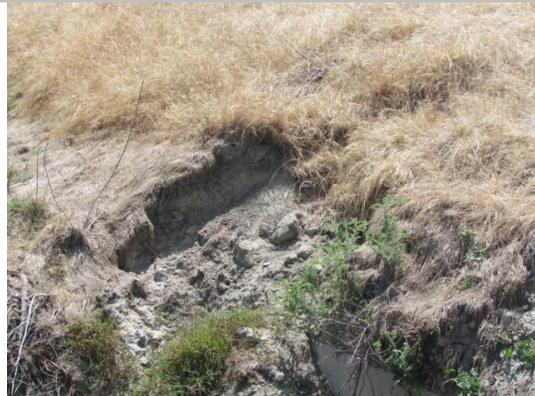
Photo 3 of 3 : SP_2015_NA0010_118_1179_20150527_00183.jpg

Looking west at erosion on landward slope and toe.

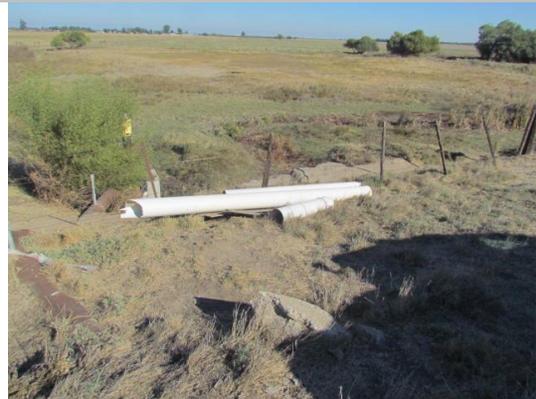
Photo 1 of 1 : SP_2015_NA0010_118_100_20150309_00015.jpg

Looking east at old pvc pipes on landward slope.

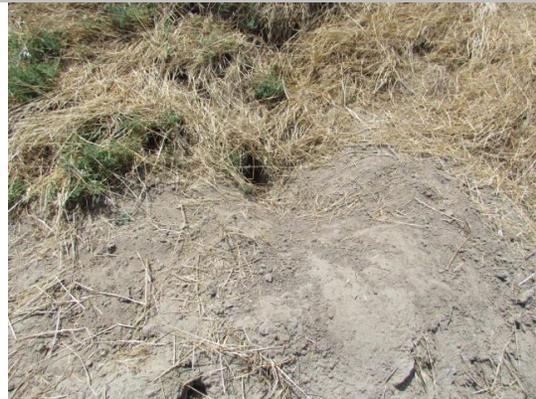
Photo 1 of 1 : SP_2015_NA0010_118_6_20150527_00184.jpg

LM Start	4.18	Rating **	M	Issue No.	6
LM End	4.18	Issue Type +	Ma	Location *	LS
Category	Earthen Levee			GPS Latitude/Longitude	
				Start	End
Item	Animal Control			37.308540 °	37.308540 °
				-120.924003 °	-120.924003 °
DWR ID	DWR_NA0010_01_s_2012_6				
Action/Comments					
Exterminate rodents and backfill and compact or grout burrows. Inspector Comments: Several rodent holes noted in this section.

Looking at typical rodent holes within this section.

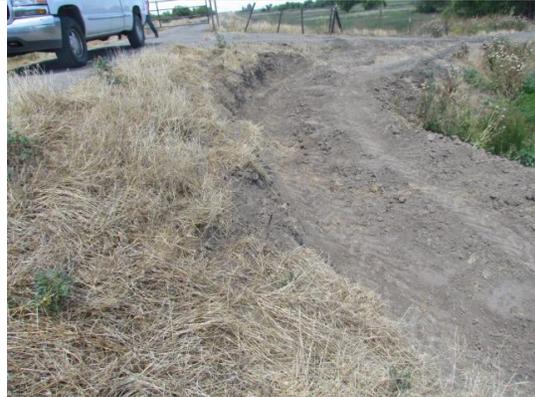
Photo 1 of 3 : SP_2015_NA0010_118_9_20150527_00185.jpg

LM Start	4.69	Rating **	A/W	Issue No.	9
LM End	4.69	Issue Type +	Ma	Location *	LS
Category	Earthen Levee			GPS Latitude/Longitude	
				Start	End
Item	Animal Control			37.302398 °	37.302398 °
				-120.920920 °	-120.920920 °
DWR ID	DWR_NA0010_01_s_2013_9				
Action/Comments					
Repair the levee slope damaged by livestock and prevent large animal access. Inspector Comments: Levee landward toe damaged by livestock.

Looking northeast at corrected site on landward slope.

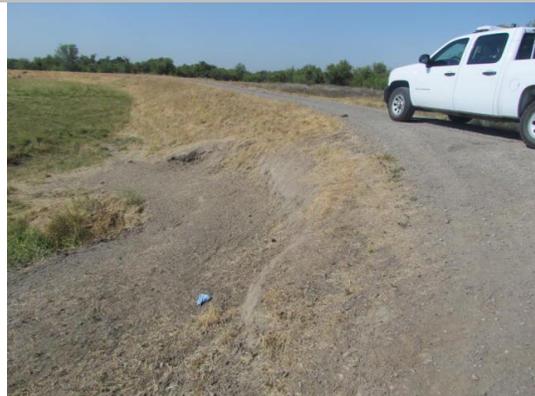
Photo 3 of 3 : SP_2015_NA0010_118_9_20150309_00006.jpg

Looking south at damage slope by livestock on landward slope.

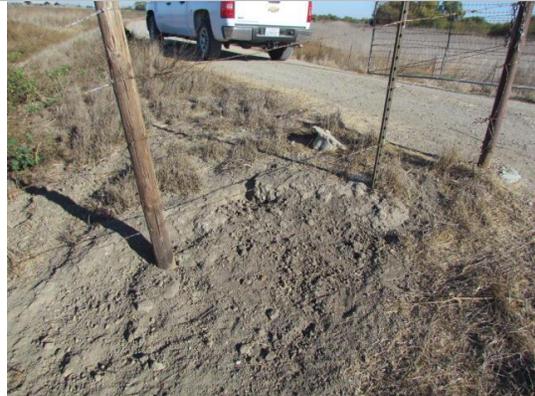
Photo 2 of 3 : SP_2015_NA0010_118_116_20150309_00017.jpg

Looking south at repaired rodent site on landside slope. (Fall 2012)

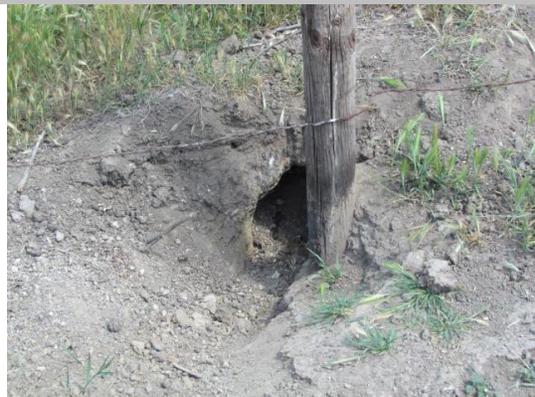
Photo 3 of 3 : SP_2015_NA0010_118_116_20150309_00018.jpg

Looking northeast at one of several holes on landside shoulder and slope.

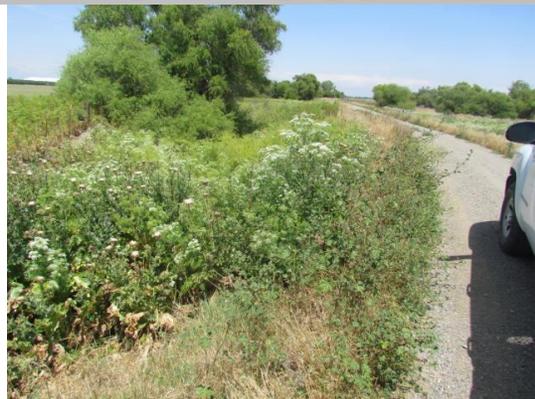
Photo 1 of 1 : SP_2015_NA0010_118_12_20150527_00186.jpg

Looking south at dense vegetation on landward slope.

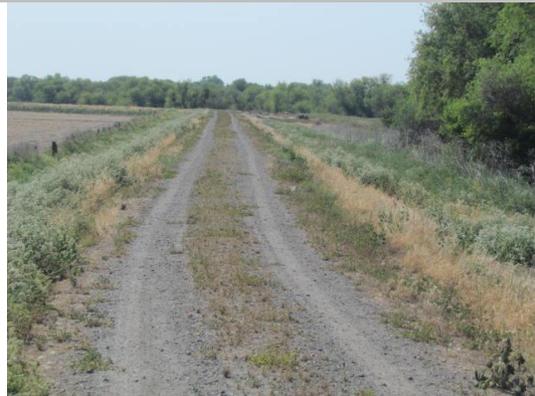
Photo 3 of 3 : SP_2015_NA0010_118_117_20150309_00021.jpg

Looking south at vegetation on levee crown. (Spring 2013)

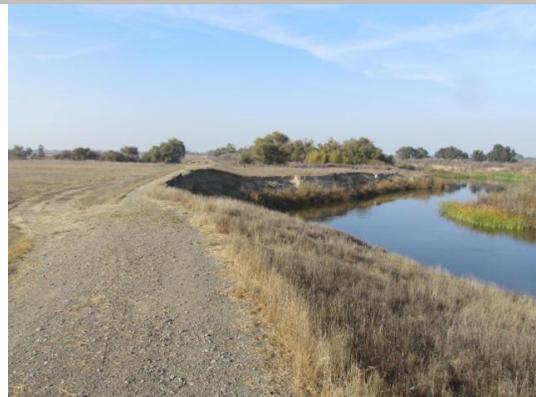
Photo 1 of 3 : SP_2015_NA0010_119_5_20150309_00003.jpg

LM Start	0.75	Rating **	U	Issue No.	5
LM End	0.75	Issue Type +	Ma	Location *	WS
Category	Earthen Levee			GPS Latitude/Longitude	
				Start	End
Item	Erosion / Bank Caving			37.286877 °	37.286877 °
				-120.874222 °	-120.874222 °
DWR ID	DWR_NA0010_02A_s_2012_5				
Action/Comments					
Schedule repair of erosion site prior to the next inspection. Inspector Comments: A field investigation report in on file. For more information and pictures see field investigation report #4301.

Looking north at erosion on waterward slope. (Fall 2014)

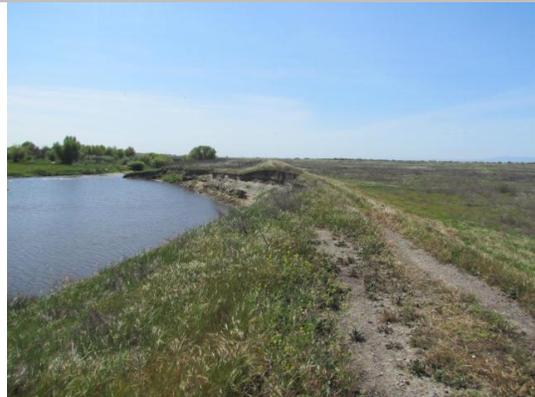
Photo 3 of 3 : SP_2015_NA0010_119_5_20150309_00005.jpg

Looking south at large erosion on waterside slope. (Spring 2012)

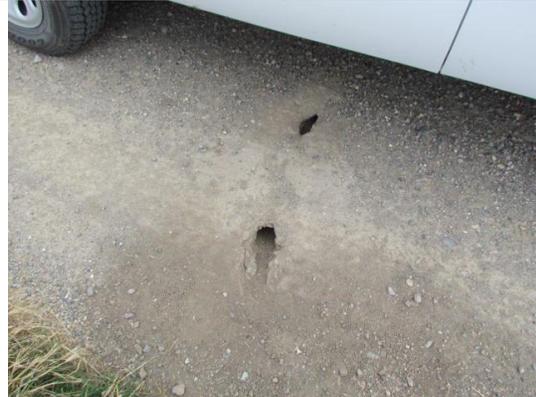
Photo 1 of 1 : SP_2015_NA0010_119_252_20150527_00008.jpg

Looking at rodent holes on levee crown.

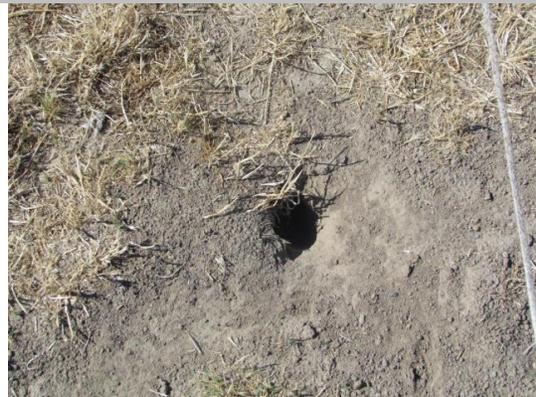
Photo 1 of 1 : SP_2015_NA0010_123_6_20150527_00461.jpg

Looking at typical view of rodent holes on waterward slope.

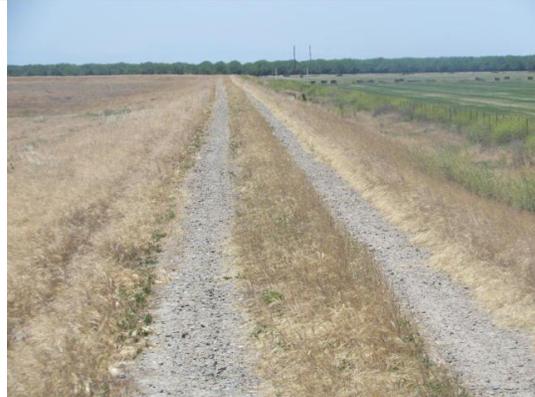
Photo 1 of 1 : SP_2015_NA0010_123_22_20150309_00010.jpg

Looking at vegetation on levee crown.

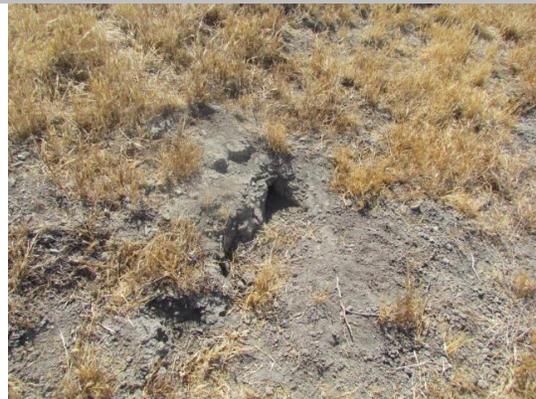
Photo 2 of 2 : SP_2015_NA0010_124_10_20150309_00012.jpg

Looking at typical rodent holes on landward slope.

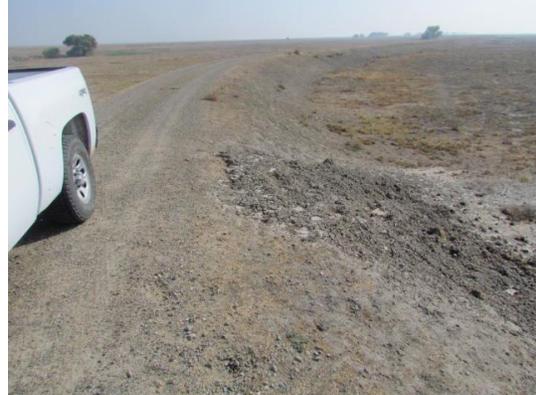
Photo 1 of 2 : SP_2015_NA0010_124_9_20150309_00009.jpg

Looking northwest at damaged slope repaired.

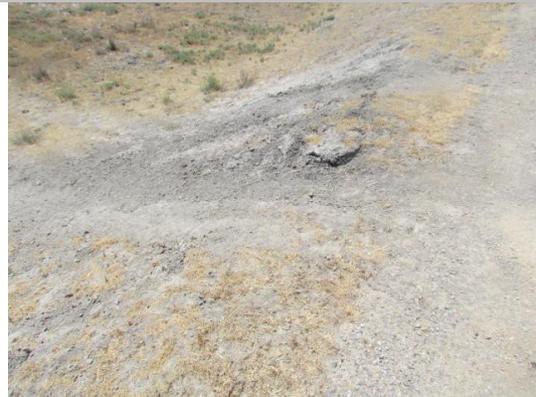
Photo 2 of 2 : SP_2015_NA0010_124_9_20150309_00010.jpg

Looking at slope damage caused by vehicle traffic on landward slope.

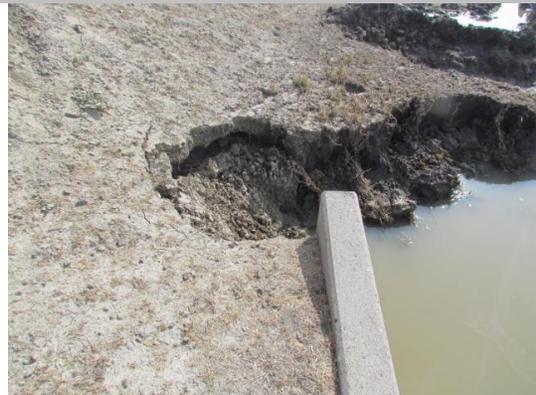
Photo 1 of 2 : SP_2015_NA0010_124_65_20150309_00016.jpg

Looking northwest at erosion around headwall of drainage structure on landward toe.

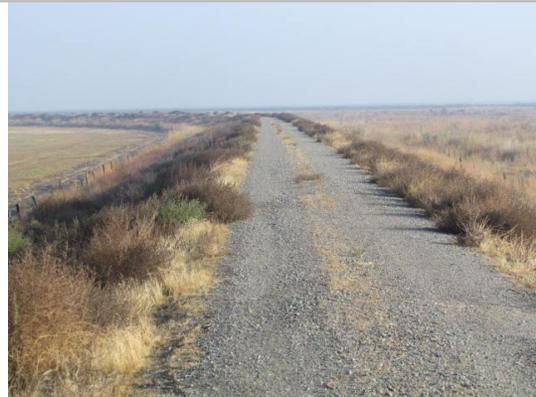
Photo 1 of 1 : SP_2015_NA0010_124_63_20150309_00014.jpg

Looking north at tumble weeds on levee slopes.

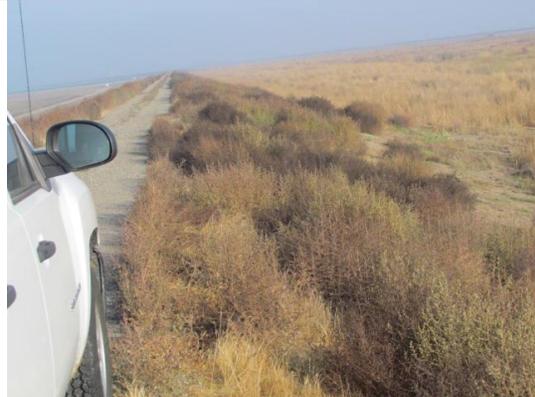
Photo 1 of 1 : SP_2015_NA0010_124_64_20150309_00015.jpg

Looking northeast at dense tumble weeds on waterward slope.

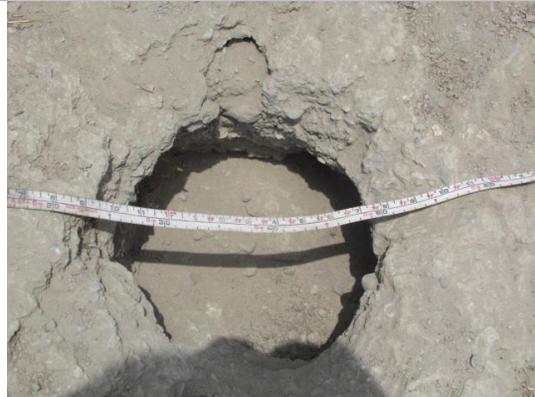
Photo 1 of 3 : SP_2015_NA0010_124_1211_20150528_00402.jpg

Looking at close-up view of large rodent hole on waterward slope.

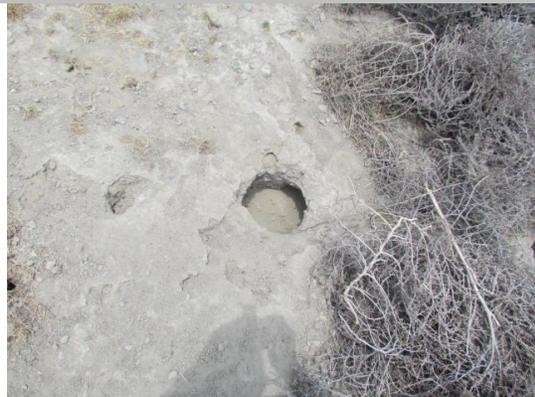
Photo 2 of 3 : SP_2015_NA0010_124_1211_20150528_00400.jpg

Looking at large rodent hole on waterward slope.

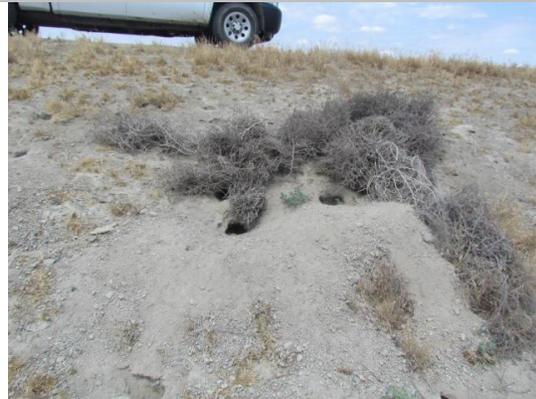
Photo 3 of 3 : SP_2015_NA0010_124_1211_20150528_00401.jpg

Looking east at several rodent holes on waterward slope.

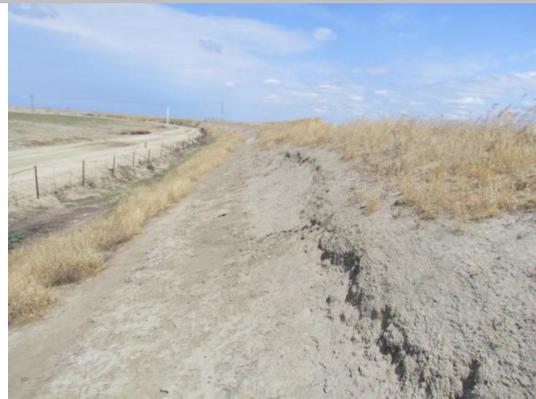
Photo 1 of 2 : SP_2015_NA0010_124_1209_20150528_00403.jpg

Looking north at livestock erosion on landward slope.

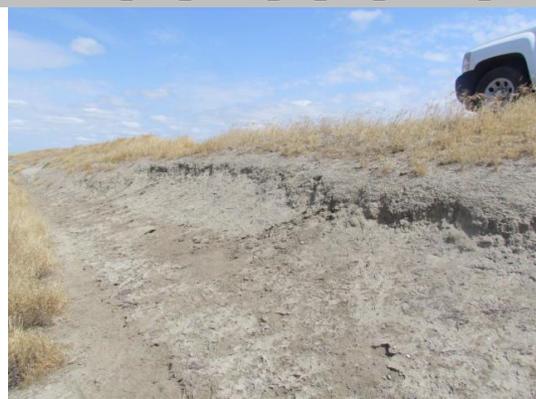
Photo 2 of 2 : SP_2015_NA0010_124_1209_20150528_00404.jpg

Looking northeast at livestock erosion on landward slope.

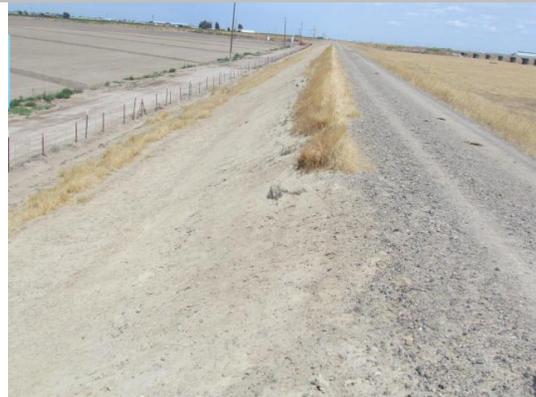
Photo 1 of 3 : SP_2015_NA0010_124_5_20150528_00406.jpg

Looking north at livestock erosion on landward slope. (Spring 2015)

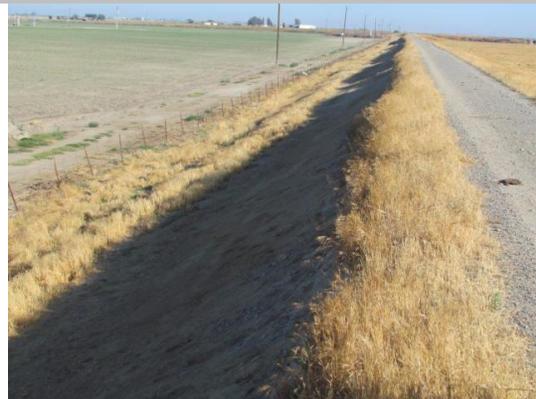
Photo 2 of 3 : SP_2015_NA0010_124_5_20150309_00007.jpg

Looking north at livestock erosion on landward slope. (Spring 2014)

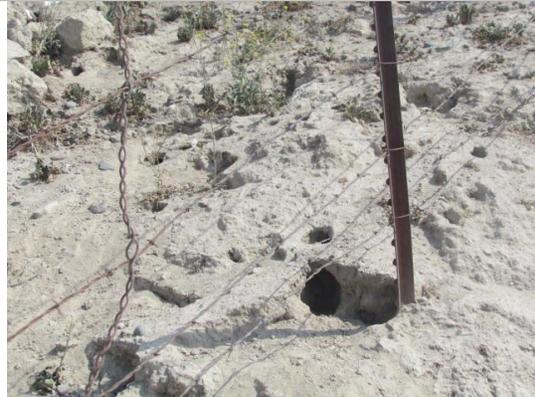
Photo 1 of 1 : SP_2015_NA0010_124_1208_20150528_00407.jpg

Looking northeast at several rodent holes on landward slope.

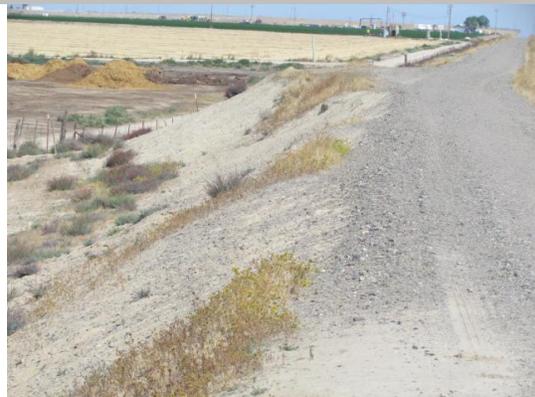
Photo 1 of 5 : SP_2015_NA0010_124_3_20150528_00408.jpg

Looking north at livestock erosion on landward shoulder and slope. (Spring 2015)

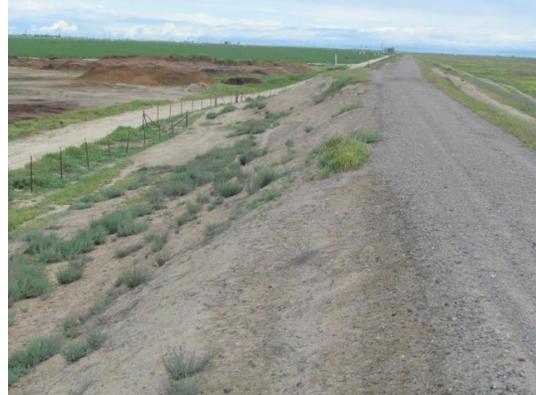
Photo 2 of 5 : SP_2015_NA0010_124_3_20150309_00003.jpg

Looking north at livestock erosion on landside shoulder and slope. (Fall 2014)

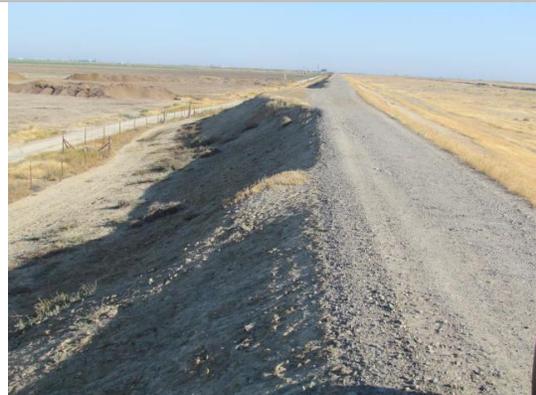
Photo 4 of 5 : SP_2015_NA0010_124_3_20150309_00005.jpg

Looking north at livestock erosion on landward slope. (Spring 2013)

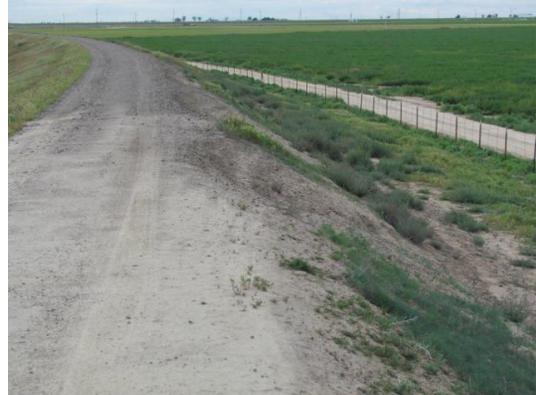
Photo 5 of 5 : SP_2015_NA0010_124_3_20150309_00006.jpg

Looking south at livestock erosion on landside shoulder and slope.

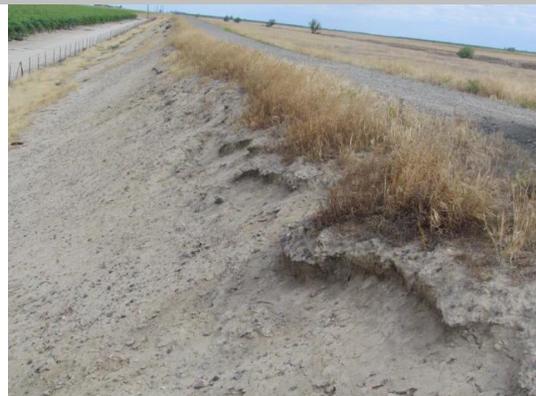
Photo 1 of 2 : SP_2015_NA0010_124_1207_20150528_00409.jpg

Looking northeast at livestock erosion on landward slope.

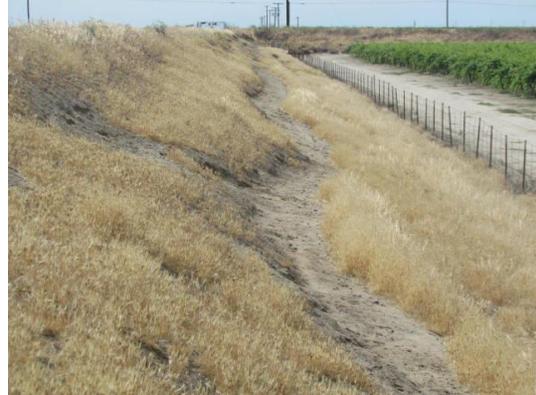
Photo 2 of 2 : SP_2015_NA0010_124_1207_20150528_00410.jpg

Looking south at livestock erosion on landward slope.

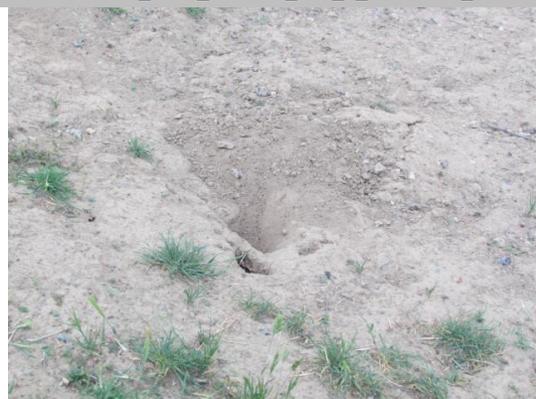
Photo 2 of 2 : SP_2015_NA0010_124_2_20150309_00002.jpg

Looking at typical rodent hole on landside slope.

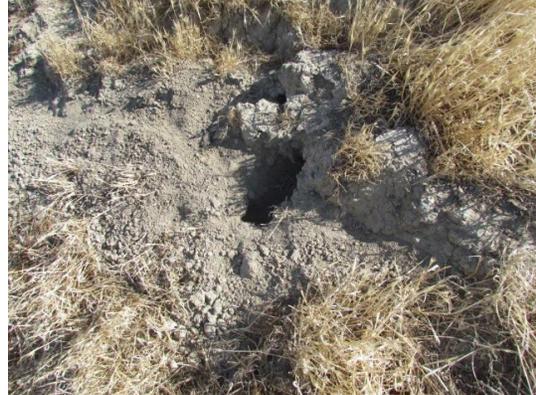
Photo 1 of 1 : SP_2015_NA0010_125_29_20150528_00010.jpg

Looking at typical view of rodent holes on landward slope.

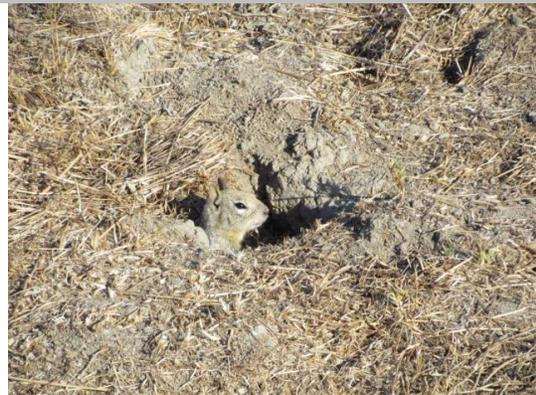
Photo 2 of 2 : SP_2015_NA0010_125_1_20150309_00002.jpg

Looking at east at active rodent holes on landside berm.

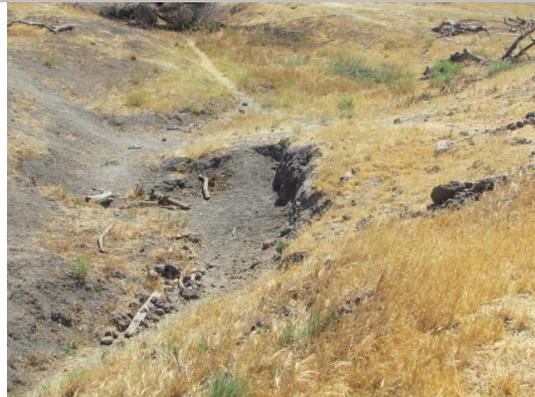
Photo 4 of 5 : SP_2015_NA0010_125_3_20150309_00005.jpg

Looking southeast at damage on landward toe.(Spring 2013)

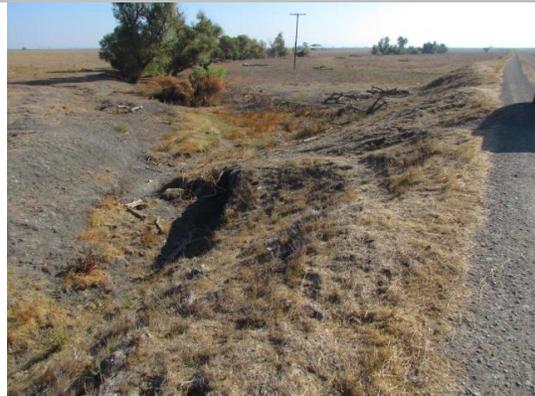
Photo 5 of 5 : SP_2015_NA0010_125_3_20150309_00006.jpg

Looking southeast at landside slope and toe damage by livestock.

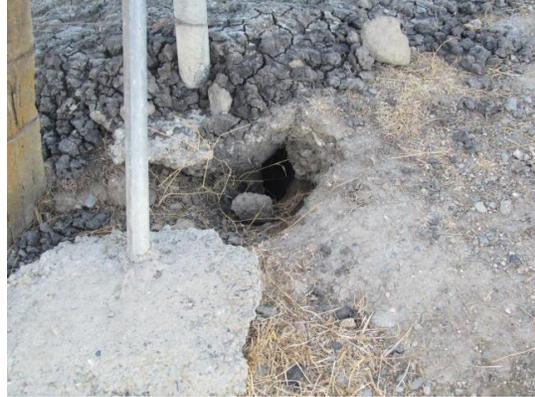
Photo 1 of 1 : SP_2015_NA0010_125_12_20150309_00009.jpg

Looking east at rodent hole next to fence post on landward shoulder.

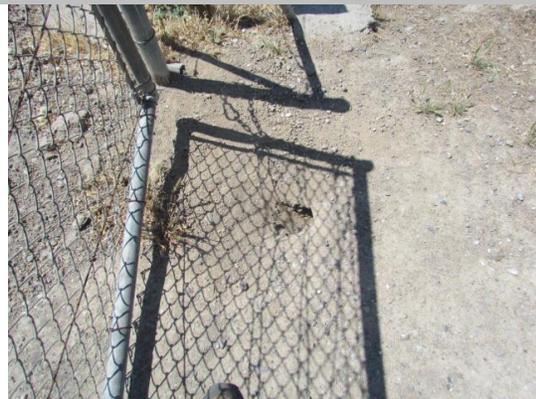
Photo 1 of 4 : SP_2015_NA0010_126_7_20150528_00034.jpg

Looking at several rodent holes near fence line on landward slope.

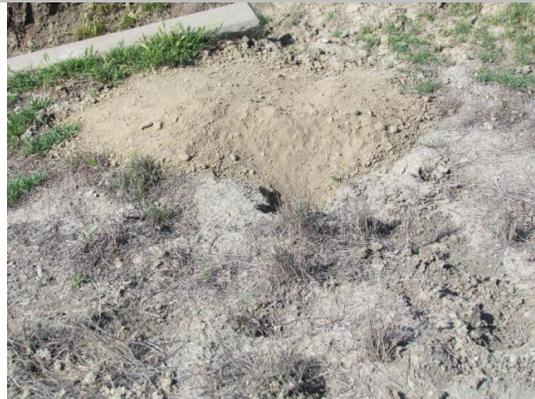
Photo 4 of 4 : SP_2015_NA0010_126_7_20150309_00003.jpg

Looking at typical rodent hole on landside slope near headwall.

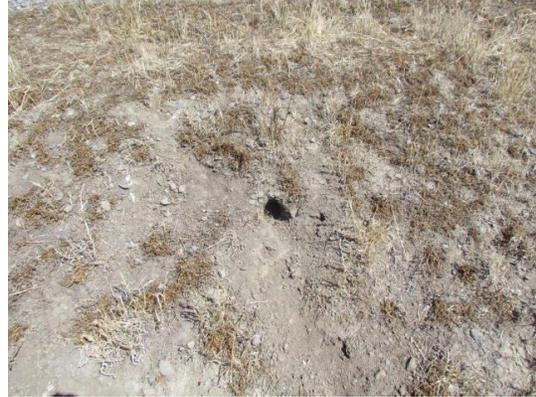
Photo 1 of 1 : SP_2015_NA0010_126_3_20150528_00035.jpg

Looking at typical view of rodent holes on landward slope.

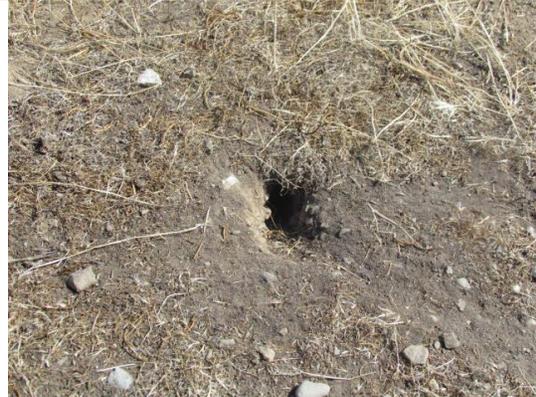
Photo 1 of 1 : SP_2015_NA0010_132_79_20150528_00032.jpg

Looking at typical view of rodent holes on landward slope.

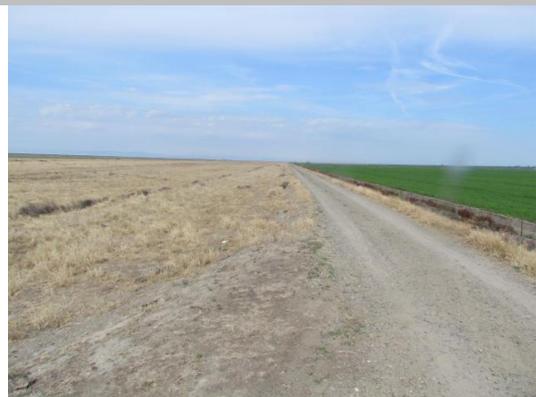
Photo 1 of 1 : SP_2015_NA0010_133_75_20150528_00009.jpg

Looking at typical view of growth on waterward slope.

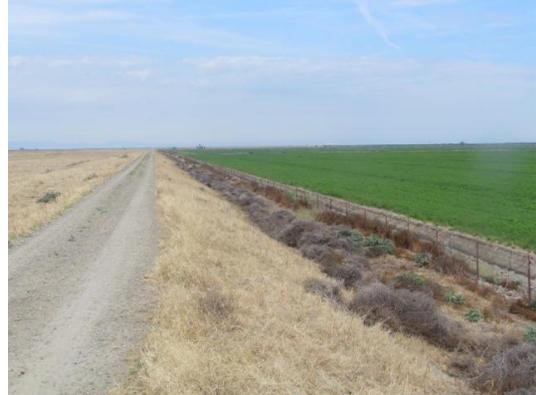
Photo 1 of 1 : SP_2015_NA0010_133_74_20150528_00010.jpg

Looking at typical view of growth on landward slope.

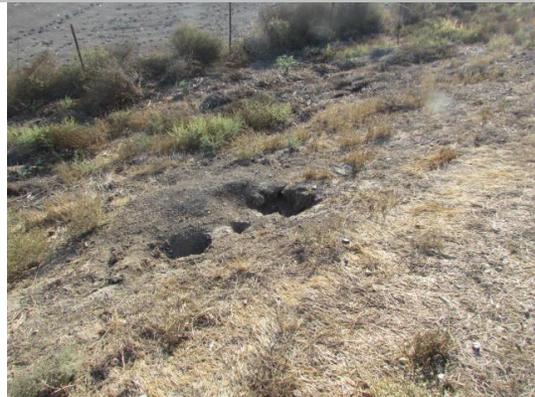
Photo 2 of 2 : SP_2015_NA0010_134_2_20150309_00002.jpg

Looking southwest at several rodent holes on landward slope.

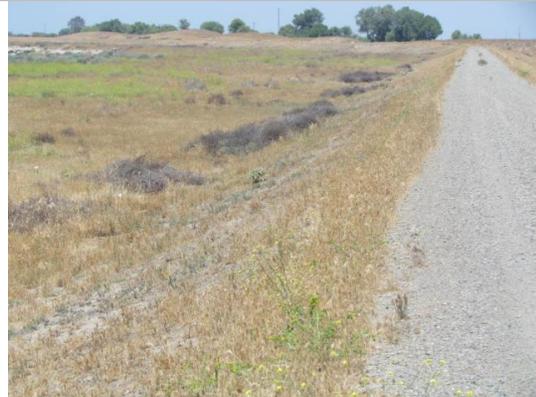
Photo 1 of 1 : SP_2015_NA0010_135_12_20150528_00113.jpg

Looking at typical view of growth on waterward slope.

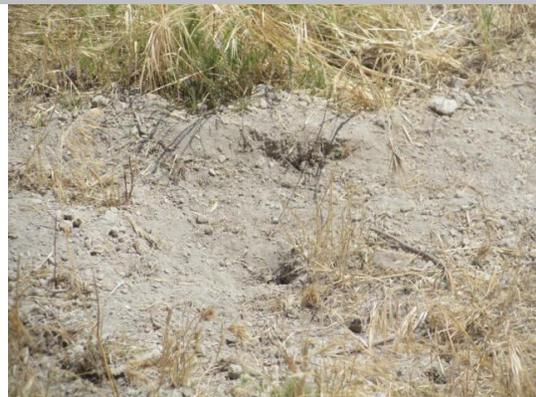
Photo 1 of 1 : SP_2015_NA0010_135_5_20150528_00116.jpg

Looking at typical view of rodent holes on landward slope.

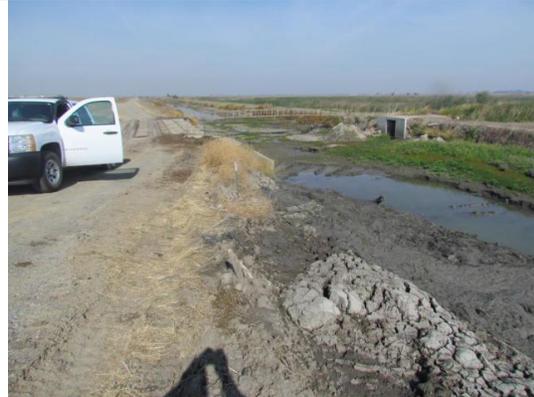
Photo 3 of 3 : SP_2015_NA0010_138_22_20150309_00014.jpg

Looking north at excavated waterward slope.

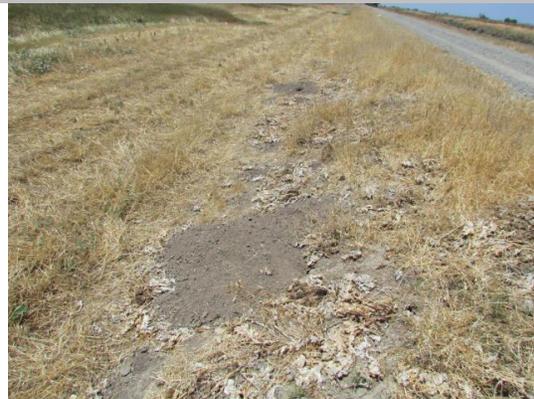
Photo 1 of 1 : SP_2015_NA0010_138_15_20150528_00049.jpg

Looking at several rodent holes on landward slope.

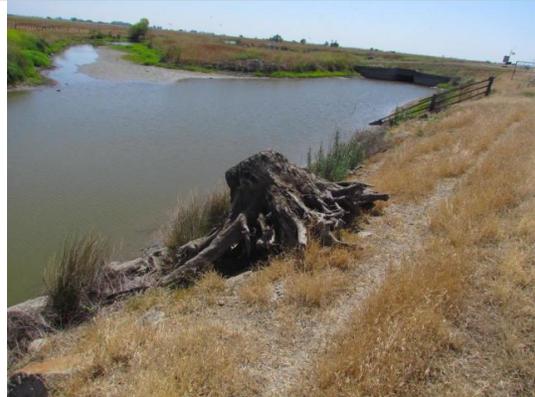
Photo 1 of 1 : SP_2015_NA0010_138_259_20150528_00050.jpg

Looking northeast at dead stump on waterward slope.

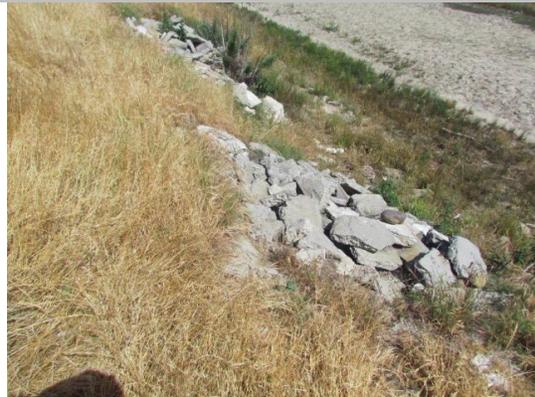
Photo 1 of 2 : SP_2015_NA0010_138_5_20150528_00052.jpg

Looking at erosion sites repaired with rip-rap on waterward slope and toe. (Spring 2015)

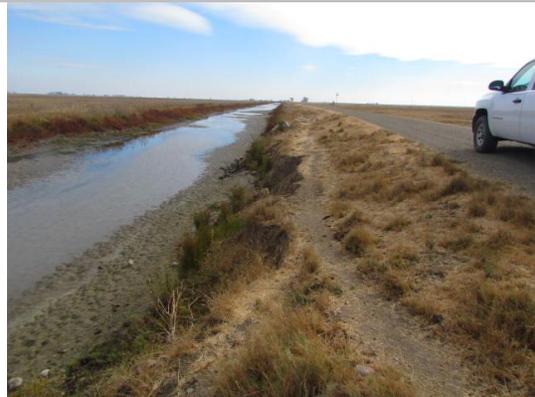
Photo 2 of 2 : SP_2015_NA0010_138_4_20150309_00006.jpg

Looking south livestock erosion on waterward toe.

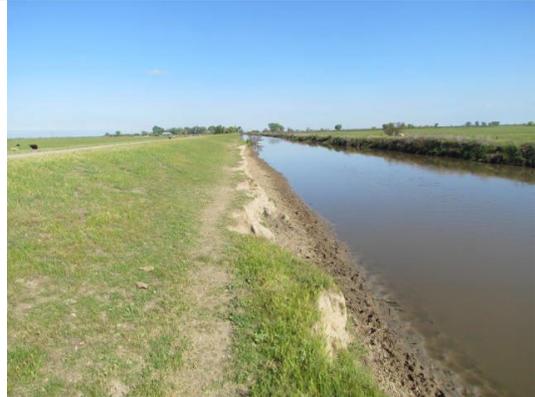
Photo 2 of 2 : SP_2015_NA0010_138_6_20150309_00009.jpg

Looking north at livestock erosion along waterside slope and toe.

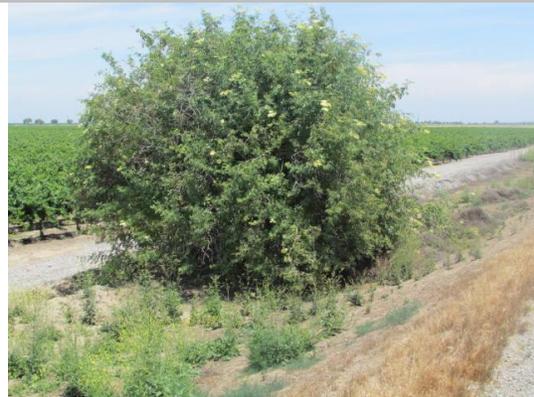
Photo 1 of 1 : SP_2015_NA0010_139_6_20150528_00114.jpg

Looking at elderberry on landward toe.

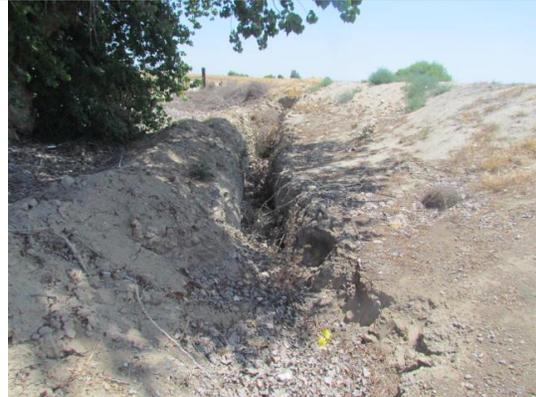
Photo 1 of 3 : SP_2015_NA0010_139_29_20150528_00115.jpg

Looking south at trench at landward toe. (Spring 2015)

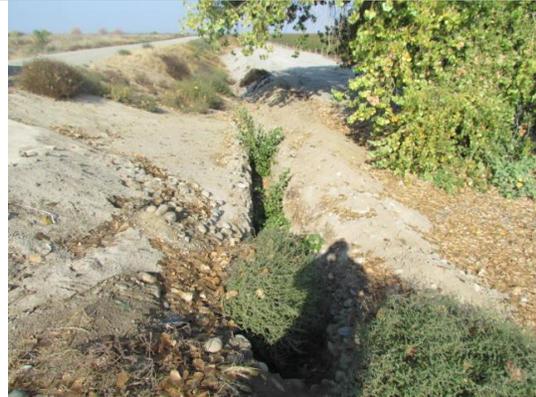
Photo 3 of 3 : SP_2015_NA0010_139_29_20150309_00014.jpg

Looking north at trench at landward toe.

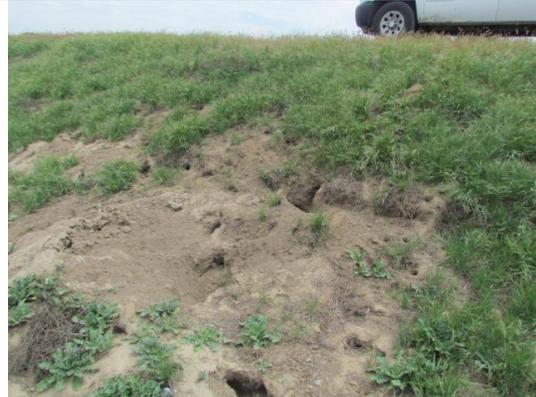
Photo 1 of 1 : SP_2015_NA0010_139_5_20150309_00003.jpg

Looking at several rodent holes on landside slope.

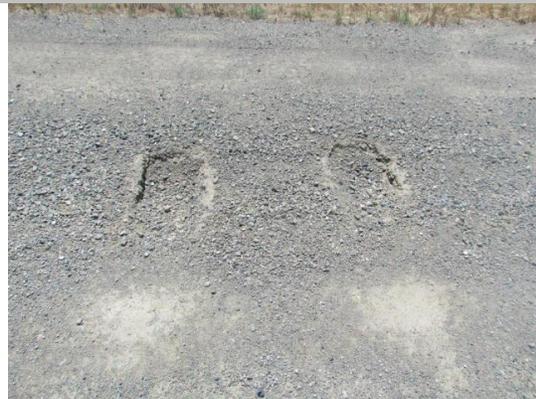
Photo 1 of 2 : SP_2015_NA0010_139_14_20150528_00119.jpg

Looking at two depression on levee crown.

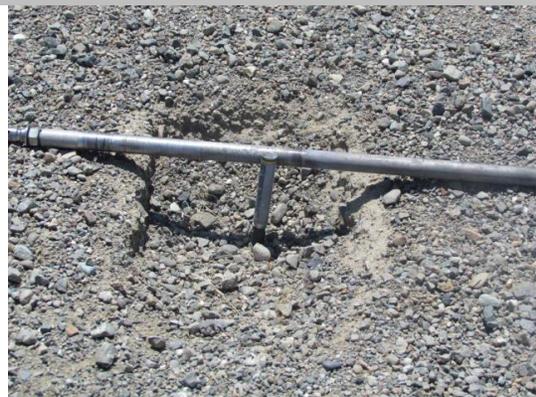
Photo 2 of 2 : SP_2015_NA0010_139_14_20150528_00120.jpg

Looking at one of two depression on levee crown.

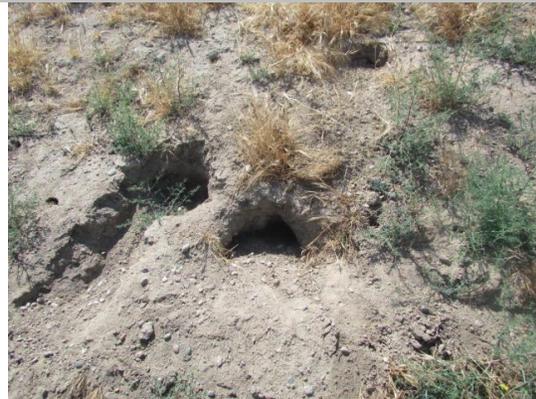
Photo 1 of 1 : SP_2015_NA0010_140_6_20150528_00070.jpg

Looking at several rodent holes on landward slope.

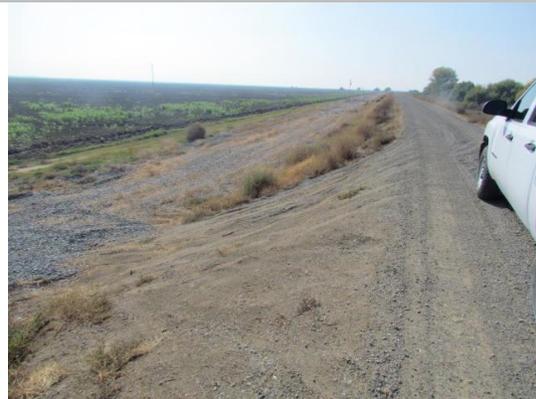
Photo 1 of 1 : SP_2015_NA0010_140_13_20150309_00004.jpg

Looking north at slope damage by vehicle traffic on landward slope.
