**Flood Control Project Maintenance  
Levee Inspections**

**Maintenance Issue Types Only, Levee Inspection Report By Mile - Spring 2016**

**Lower San Joaquin Levee District**

Waterway	Bank	Unit Miles	Inspection Start/End	Inspector
Unit No. 01 San Joaquin River	Right	22.52	05/16/2016 05/19/2016	Richard Willoughby

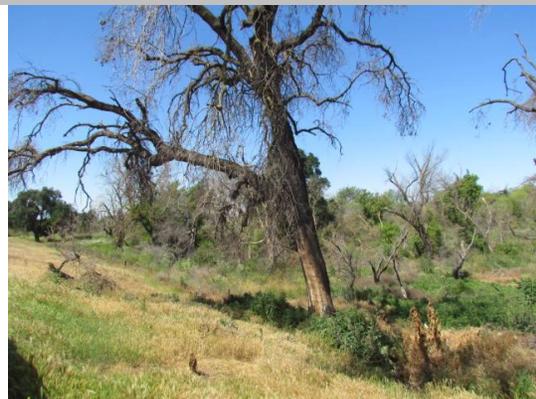
Photo 1 of 1 : SP\_2016\_NA0010\_118\_7\_20160523\_00232.jpg

Looking southwest at dead tree on landward slope and toe.

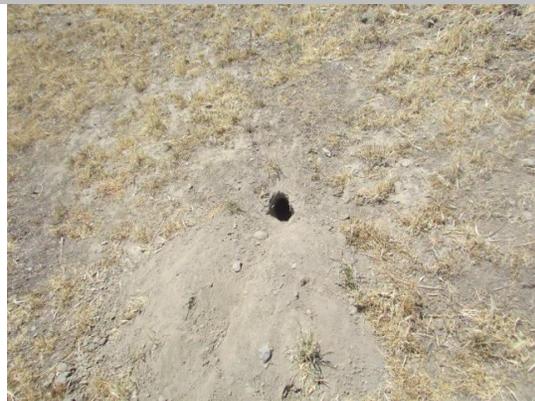
Photo 1 of 1 : SP\_2016\_NA0010\_118\_1\_20160512\_00001.jpg

Looking at typical rodent holes on landward slope.

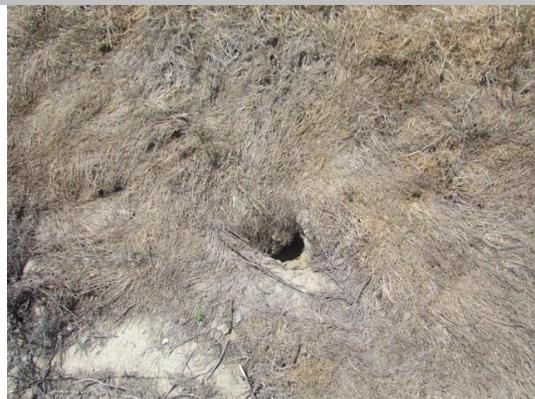
Photo 1 of 2 : SP\_2016\_NA0010\_118\_10\_20160512\_00008.jpg

LM Start	<b>3.16</b>	Rating **	M	Issue No.	<b>10</b>
LM End	<b>3.16</b>	Issue Type +	Ma	Location *	LS
Category	Earthen Levee		GPS Latitude/Longitude		
			Start	End	
Item	Animal Control		37.321053 °	37.321053 °	
			-120.928785 °	-120.928785 °	
DWR ID	DWR_NA0010_01_s_2012_10				
Comment Code					
A3 : No rodents visible, but rodent burrows visible; need to backfill and compact or grout burrows.					
Inspector Comment					
Several rodent holes noted in this section. Rodent hole noted on waterward shoulder next fence pole.

Looking at typical view of rodent holes on landward slope.

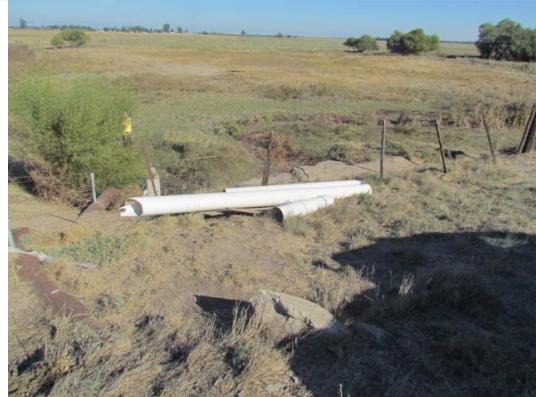
Photo 1 of 1 : SP\_2016\_NA0010\_118\_100\_20160512\_00018.jpg

Looking east at old pvc pipes on landward slope.

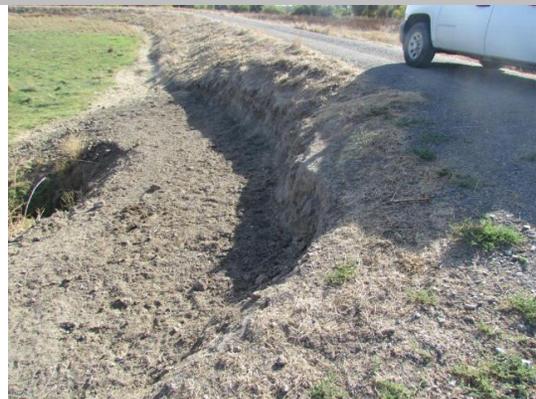
Photo 1 of 1 : SP\_2016\_NA0010\_118\_9\_20160512\_00007.jpg

LM Start	<b>4.69</b>	Rating **	U	Issue No.	<b>9</b>
LM End	<b>4.69</b>	Issue Type +	Ma	Location *	LS
Category	Earthen Levee		GPS Latitude/Longitude		
			Start	End	
Item	Animal Control		37.302398 °	37.302398 °	
			-120.920920 °	-120.920920 °	
DWR ID	DWR_NA0010_01_s_2013_9				
Comment Code					
A2 : Repair the levee slope damaged by livestock and prevent large animal access.					
Inspector Comment					
Levee landward toe damaged by livestock.

Looking at landward slope damaged by livestock.

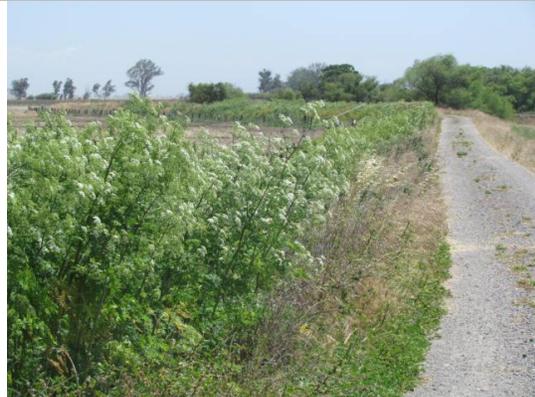
Photo 1 of 1 : SP\_2016\_NA0010\_118\_12\_20160523\_00238.jpg

Looking southeast at dense veg on landward slope.

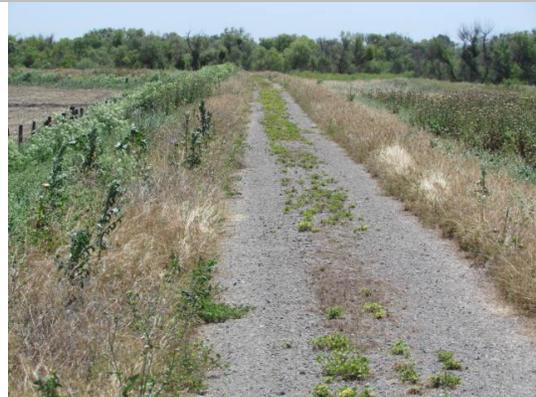
Photo 1 of 1 : SP\_2016\_NA0010\_118\_117\_20160523\_00240.jpg

Looking south at veg on levee crown.

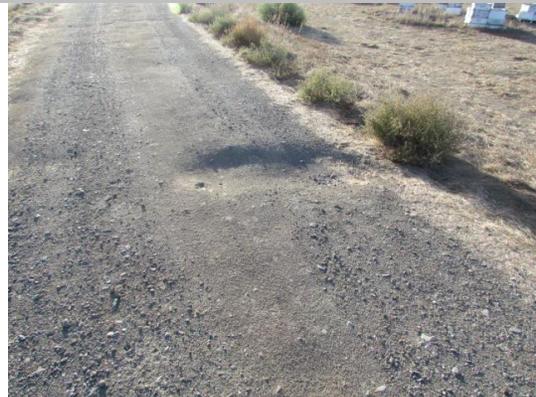
Photo 1 of 3 : SP\_2016\_NA0010\_118\_14\_20160512\_00009.jpg

LM Start	<b>9.57</b>	Rating **	M	Issue No.	<b>14</b>
LM End	<b>9.57</b>	Issue Type +	Ma	Location *	CR
Category	Earthen Levee		GPS Latitude/Longitude		
			Start	End	
Item	Crown Surface / Depressions / Rutting		37.295517 °	37.295517 °	
			-120.841452 °	-120.841452 °	
DWR ID	DWR_NA0010_01_s_2015_14				
Comment Code					
C2 : Repair depressions or ruts in the crown or slope.					
Inspector Comment					
Depression greater than 3" deep by 18" wide by 18" long on levee crown

Looking at depression on levee crown. (Fall 2015)

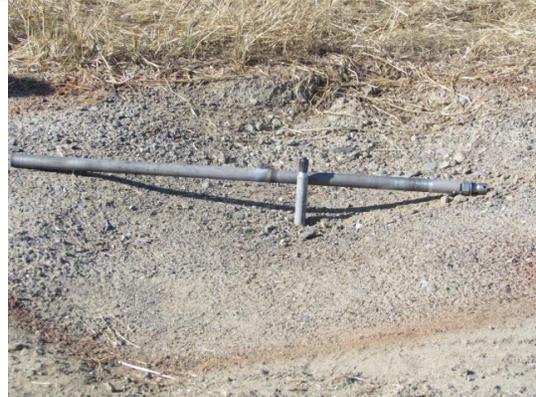
Photo 2 of 3 : SP\_2016\_NA0010\_118\_14\_20160512\_00010.jpg

LM Start	<b>9.57</b>	Rating **	M	Issue No.	<b>14 (cont)</b>
LM End	<b>9.57</b>	Issue Type +	Ma	Location *	CR
Category	Earthen Levee			GPS Latitude/Longitude	
				Start	End
Item	Crown Surface / Depressions / Rutting			37.295517 °	37.295517 °
				-120.841452 °	-120.841452 °
DWR ID	DWR_NA0010_01_s_2015_14				
Comment Code					
C2 : Repair depressions or ruts in the crown or slope.					
Inspector Comment					
Depression greater than 3" deep by 18" wide by 18" long on levee crown

Looking west at depression greater than three inches on levee crown.

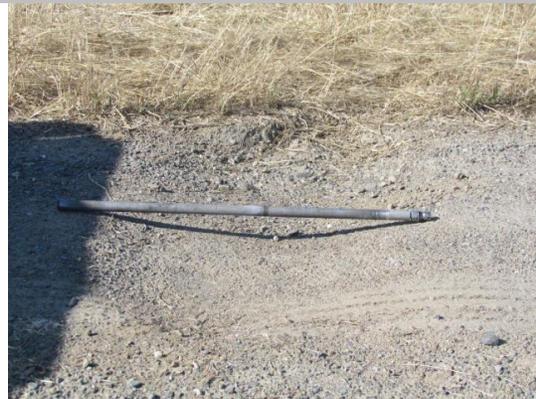
Photo 3 of 3 : SP\_2016\_NA0010\_118\_14\_20160512\_00011.jpg

Looking west at depression on levee crown.

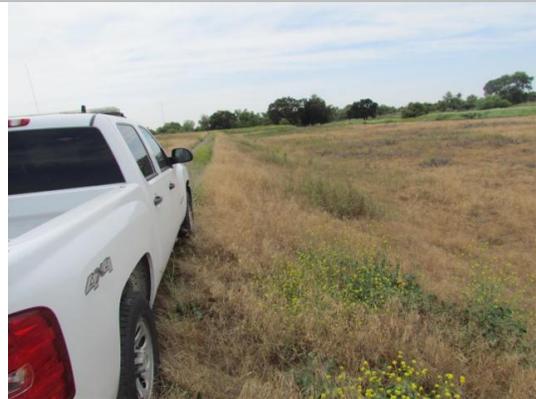
Photo 1 of 1 : SP\_2016\_NA0010\_119\_28\_20160523\_00071.jpg

Looking north at dense veg on waterward slope.

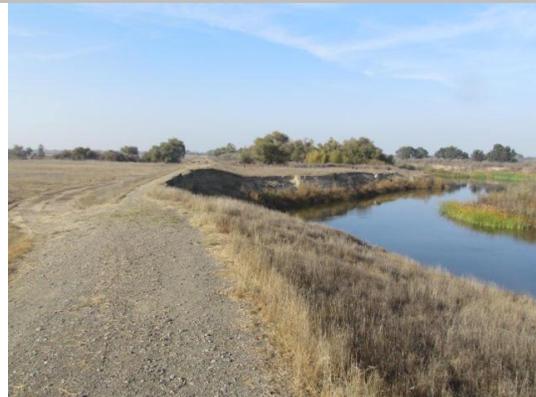
Photo 1 of 3 : SP\_2016\_NA0010\_119\_5\_20160512\_00003.jpg

LM Start	<b>0.75</b>	Rating **	U	Issue No.	<b>5</b>
LM End	<b>0.75</b>	Issue Type +	Ma	Location *	WS
Category	Earthen Levee		GPS Latitude/Longitude		
			Start	End	
Item	Erosion / Bank Caving		37.286877 °	37.286877 °	
			-120.874222 °	-120.874222 °	
DWR ID	DWR_NA0010_02A_s_2012_5				
Comment Code					
E2 : Schedule repair of erosion site prior to the next inspection.					
Inspector Comment					
A field investigation report in on file. For more information and pictures see field investigation report #4301.

Looking north at erosion on waterward slope. (Fall 2014)

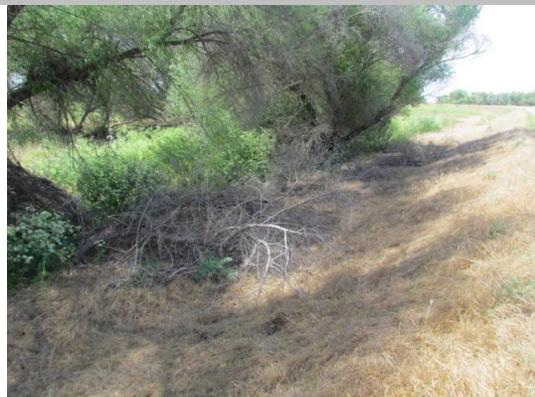
Photo 1 of 1 : SP\_2016\_NA0010\_120\_5\_20160523\_00008.jpg

LM Start	<b>9.76</b>	Rating **	M	Issue No.	<b>5</b>
LM End	<b>9.76</b>	Issue Type +	Ma	Location *	LS
Category	Earthen Levee		GPS Latitude/Longitude		
			Start	End	
Item	Encroachments		37.218959 °	37.218959 °	
			-120.784356 °	-120.784356 °	
DWR ID	DWR_NA0010_02B_s_2016_5				
Comment Code					
TR : Tree or limb					
Inspector Comment					
Broken tree limbs on landward toe.

Looking northwest at broken tree limb on landward toe.

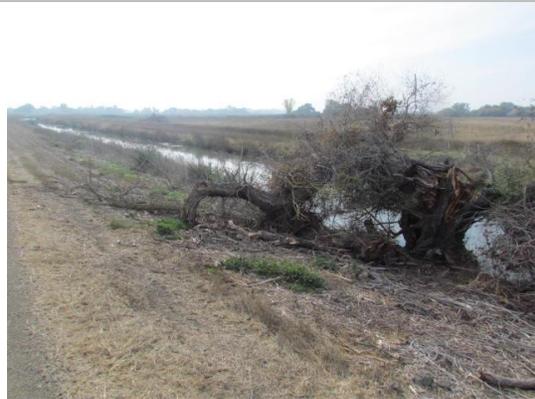
Photo 2 of 2 : SP\_2016\_NA0010\_120\_1\_20160512\_00002.jpg

Looking southwest at tree limb on waterward slope.

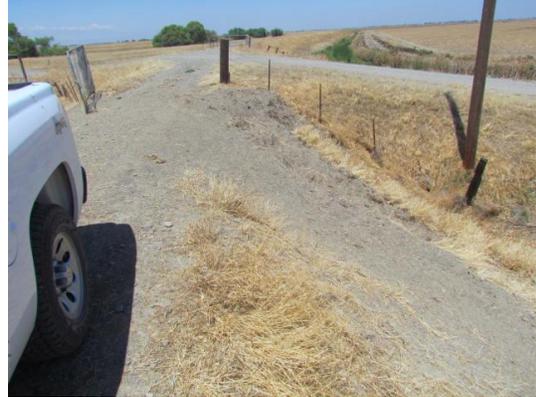
Photo 1 of 2 : SP\_2016\_NA0010\_123\_1309\_20160512\_00012.jpg

Looking north at damaged landward slope.

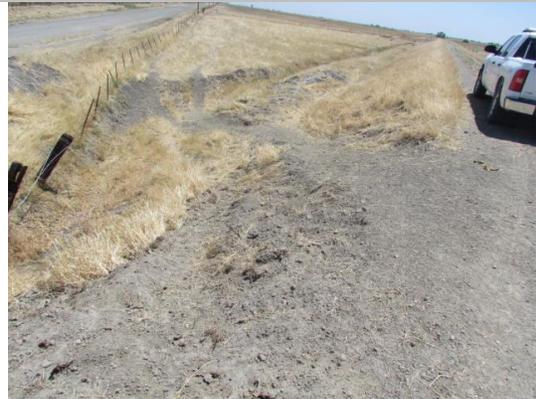
Photo 2 of 2 : SP\_2016\_NA0010\_123\_1309\_20160512\_00013.jpg

Looking east at damaged landward slope.

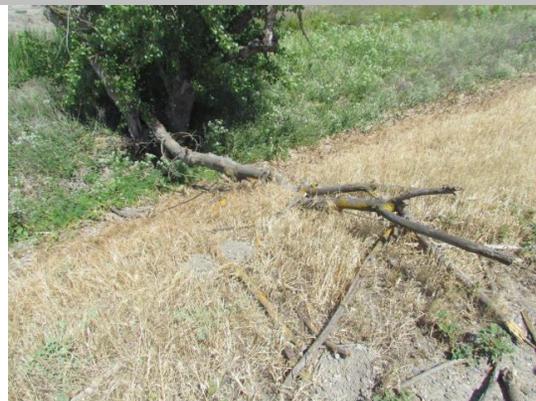
Photo 1 of 1 : SP\_2016\_NA0010\_123\_1311\_20160512\_00015.jpg

Looking east at a fallen tree limbs on waterward slope.

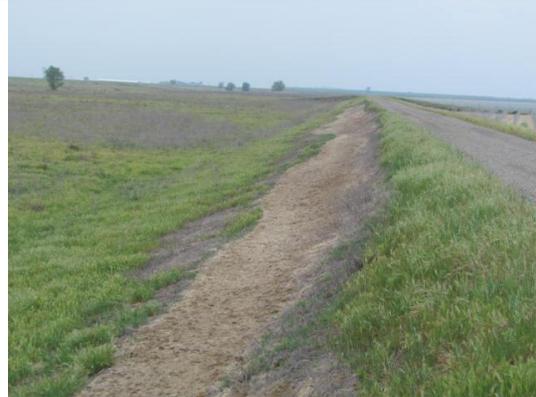
Photo 1 of 2 : SP\_2016\_NA0010\_123\_171\_20160512\_00009.jpg

Looking south at erosion caused by livestock on landside slope.

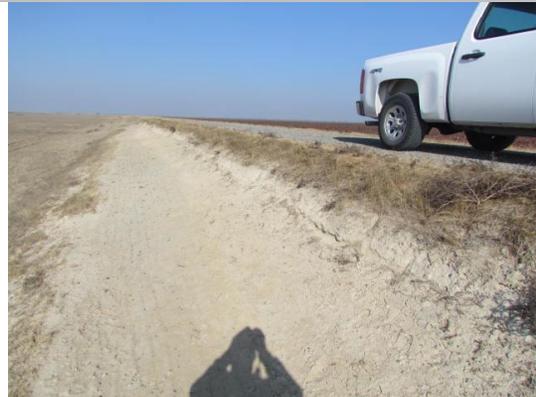
Photo 2 of 2 : SP\_2016\_NA0010\_123\_171\_20160512\_00010.jpg

Looking south at livestock erosion on landward slope.

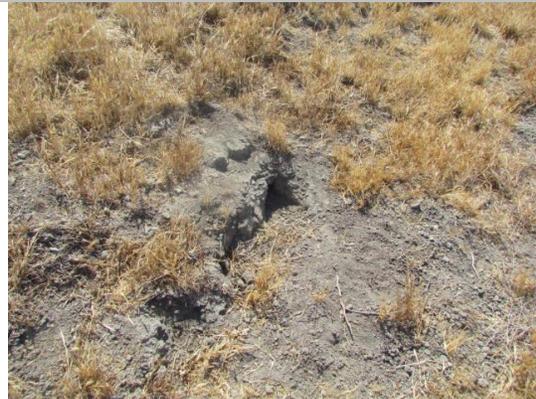
Photo 2 of 2 : SP\_2016\_NA0010\_124\_10\_20160512\_00013.jpg

Looking at typical rodent holes on landward slope.

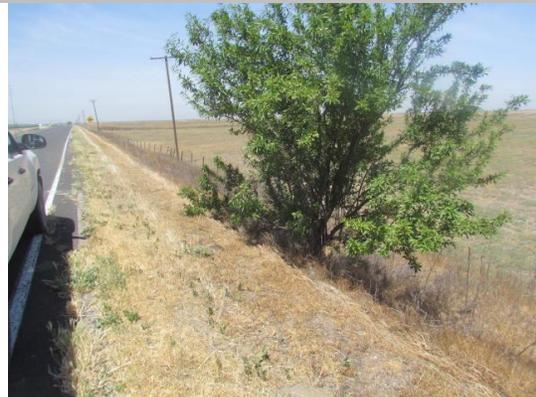
Photo 1 of 1 : SP\_2016\_NA0010\_124\_14\_20160512\_00014.jpg

Looking west at tree on waterward slope.

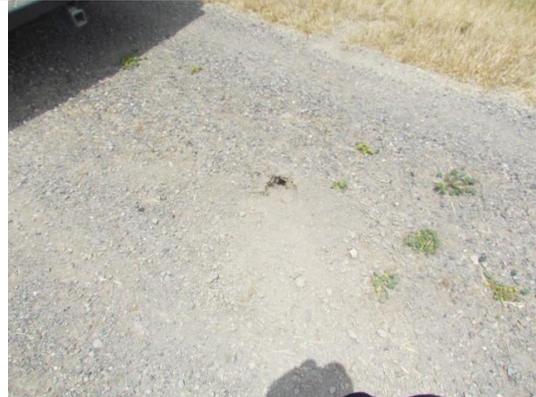
Photo 1 of 1 : SP\_2016\_NA0010\_124\_1212\_20160512\_00041.jpg

Looking at rodent hole on levee crown.

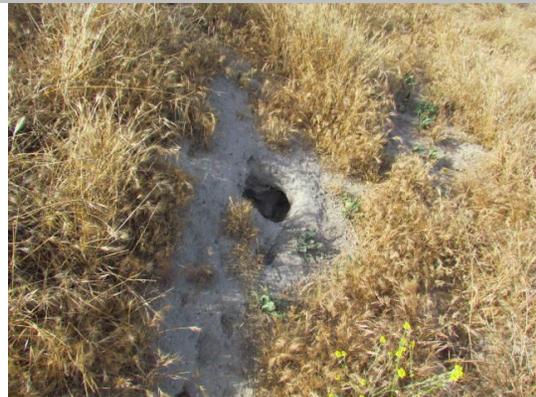
Photo 1 of 5 : SP\_2016\_NA0010\_124\_1211\_20160523\_00178.jpg

Looking at rodent hole on waterward slope. Spring 2016

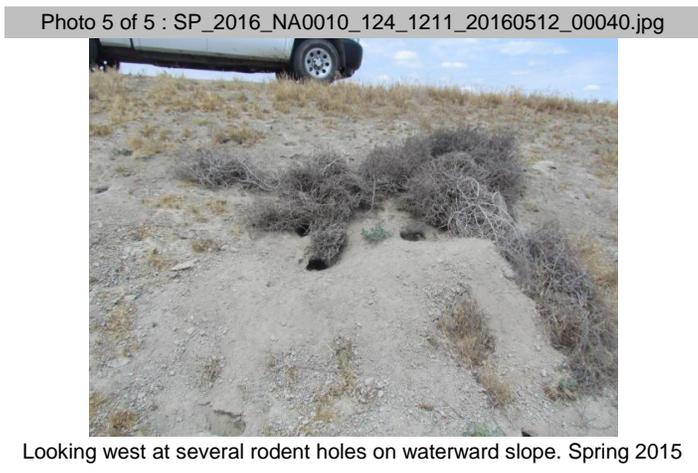
LM Start	<b>19.14</b>	Rating **	U	Issue No.	<b>1211 (cont)</b>
LM End	<b>19.14</b>	Issue Type +	Ma	Location *	WS
Category	Earthen Levee			GPS Latitude/Longitude	
				Start	End
Item	Animal Control			37.114793 °	37.114793 °
				-120.587582 °	-120.587582 °
DWR ID	DWR_NA0010_06_s_2015_1211				
Comment Code					
A1 : Exterminate rodents and backfill and compact or grout burrows.					
Inspector Comment					
Several large rodent holes with more than 2 cubic feet of material was noted on waterward slope

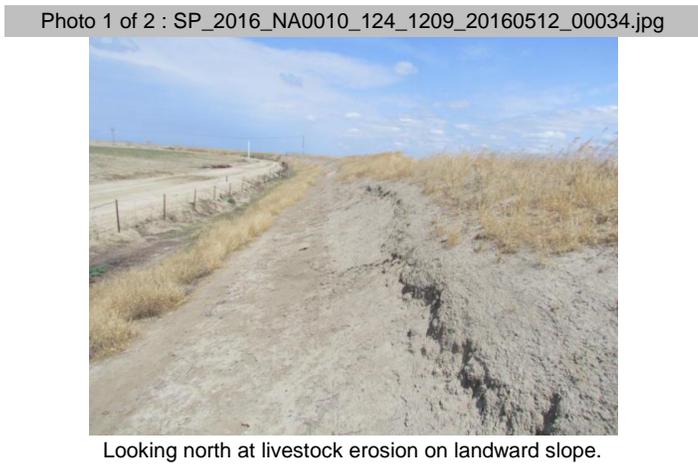
LM Start	<b>20.79</b>	Rating **	U	Issue No.	<b>1209</b>
LM End	<b>20.88</b>	Issue Type +	Ma	Location *	LS
Category	Earthen Levee			GPS Latitude/Longitude	
				Start	End
Item	Erosion / Bank Caving			37.113107 °	37.112176 °
				-120.563782 °	-120.562516 °
DWR ID	DWR_NA0010_06_s_2015_1209				
Comment Code					
E1 : Note and monitor erosion site.					
Inspector Comment					
Erosion on landward slope greater than 3 inches. Erosion caused by livestock.

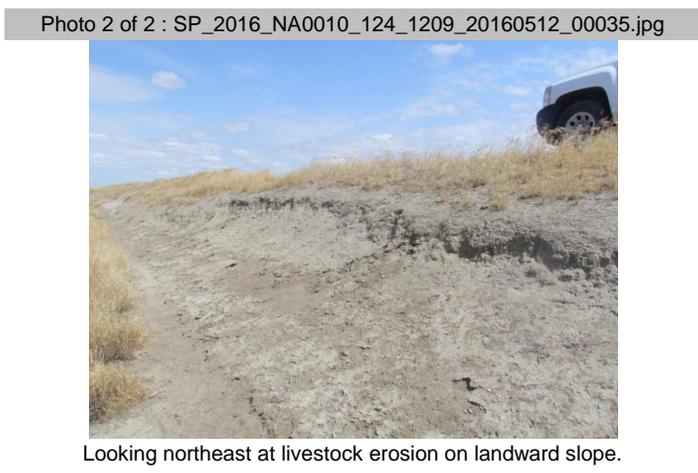
LM Start	<b>20.79</b>	Rating **	U	Issue No.	<b>1209 (cont)</b>
LM End	<b>20.88</b>	Issue Type +	Ma	Location *	LS
Category	Earthen Levee			GPS Latitude/Longitude	
				Start	End
Item	Erosion / Bank Caving			37.113107 °	37.112176 °
				-120.563782 °	-120.562516 °
DWR ID	DWR_NA0010_06_s_2015_1209				
Comment Code					
E1 : Note and monitor erosion site.					
Inspector Comment					
Erosion on landward slope greater than 3 inches. Erosion caused by livestock.

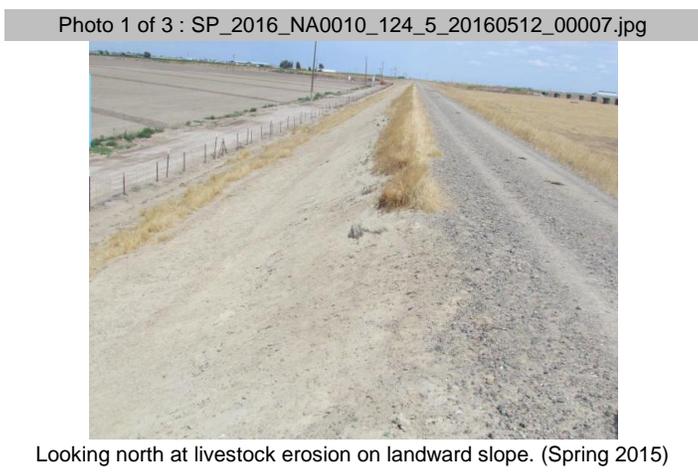
LM Start	<b>24.58</b>	Rating **	M	Issue No.	<b>5</b>
LM End	<b>24.93</b>	Issue Type +	Ma	Location *	LS
Category	Earthen Levee			GPS Latitude/Longitude	
				Start	End
Item	Slope Stability			37.071198 °	°
				-120.519220 °	°
DWR ID	DWR_NA0010_06_s_2012_5				
Comment Code					
S2 : Repair the levee slope damaged by foot traffic and prevent access where possible.					
Inspector Comment					
Landside erosion caused by livestock.

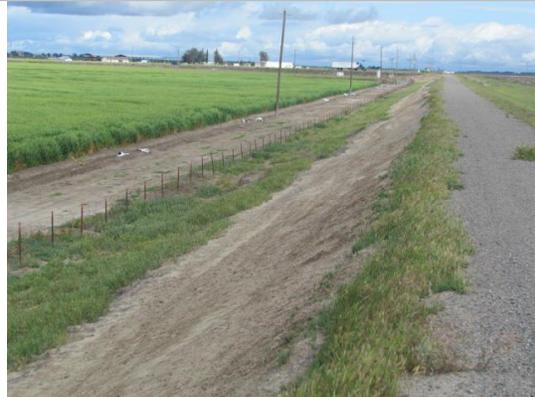
Photo 3 of 3 : SP\_2016\_NA0010\_124\_5\_20160512\_00009.jpg

Looking north at livestock erosion on landside slope. (Fall 2014)

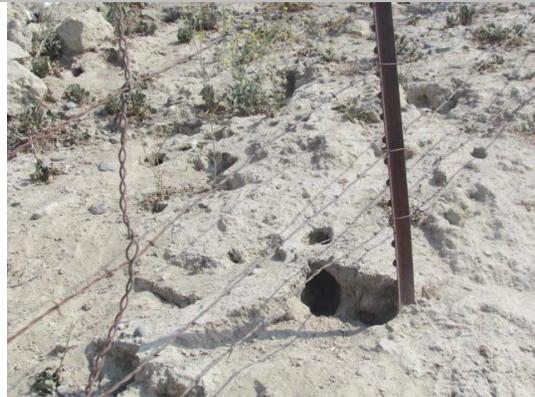
Photo 1 of 1 : SP\_2016\_NA0010\_124\_1208\_20160512\_00033.jpg

Looking northeast at several rodent holes on landward slope.

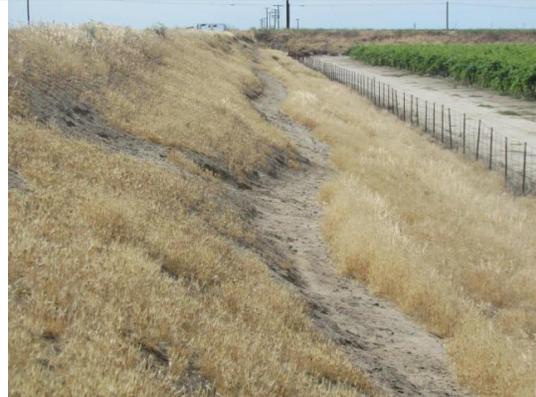
Photo 2 of 2 : SP\_2016\_NA0010\_124\_1207\_20160512\_00032.jpg

Looking south at livestock erosion on landward slope.

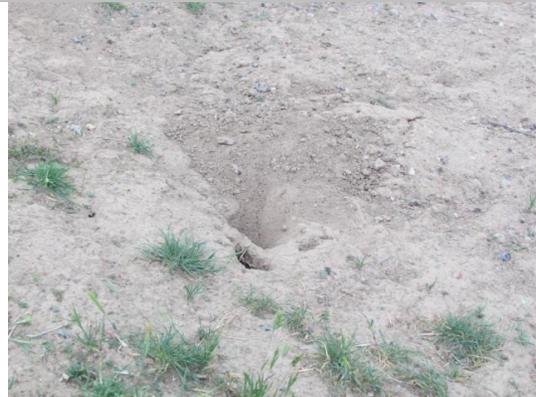
Photo 2 of 2 : SP\_2016\_NA0010\_124\_2\_20160512\_00002.jpg

Looking at typical rodent hole on landside slope.

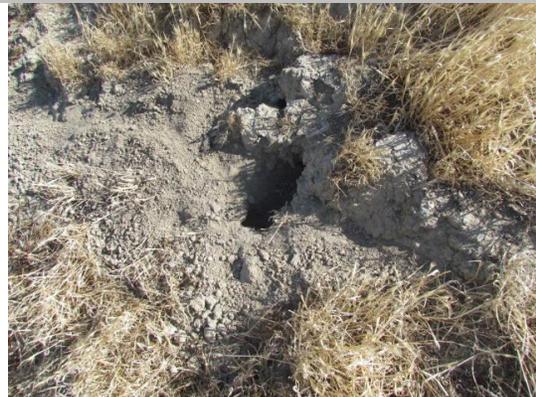
Photo 1 of 1 : SP\_2016\_NA0010\_125\_29\_20160512\_00011.jpg

Looking at typical view of rodent holes on landward slope.

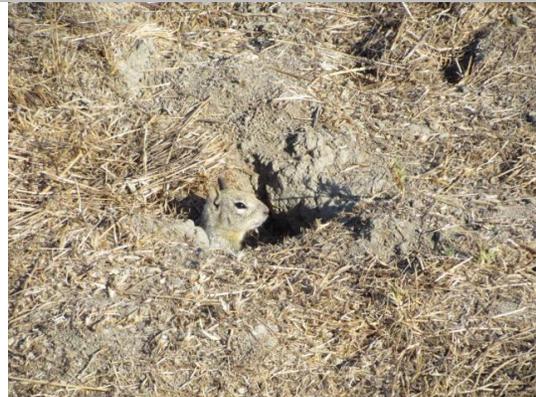
Photo 2 of 2 : SP\_2016\_NA0010\_125\_1\_20160512\_00002.jpg

Looking at east at active rodent holes on landside berm.

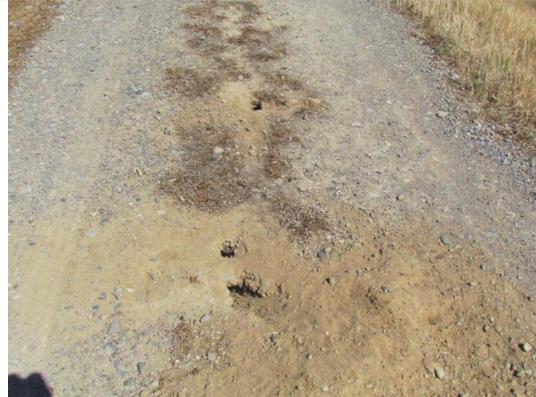
Photo 1 of 1 : SP\_2016\_NA0010\_125\_187\_20160512\_00012.jpg

Looking at several rodent holes on levee crown.

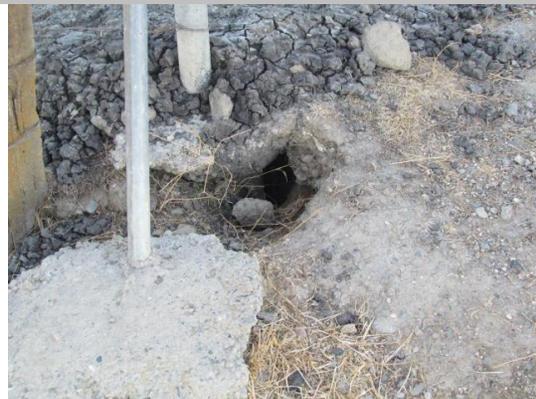
Photo 1 of 2 : SP\_2016\_NA0010\_125\_12\_20160512\_00010.jpg

Looking east at rodent hole next to fence post on landward shoulder.

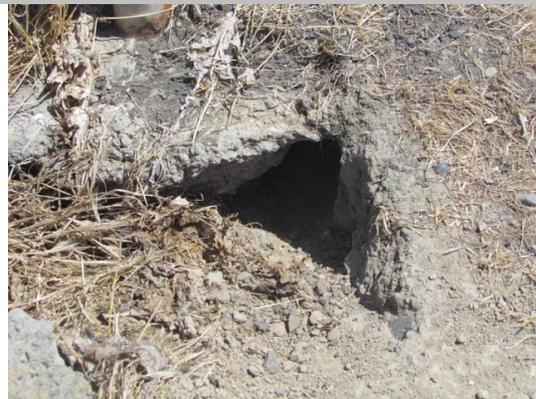
Photo 2 of 2 : SP\_2016\_NA0010\_125\_12\_20160523\_00025.jpg

Looking at rodent activity next to fence post

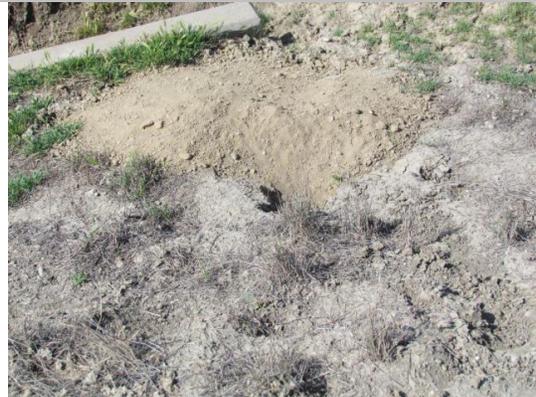
Photo 1 of 1 : SP\_2016\_NA0010\_126\_7\_20160512\_00002.jpg

Looking at typical rodent hole on landside slope near headwall.

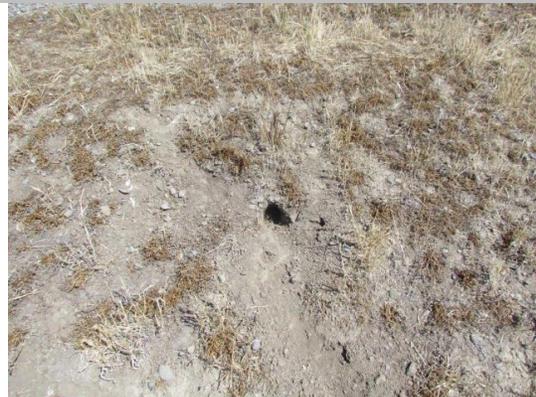
Photo 1 of 1 : SP\_2016\_NA0010\_126\_3\_20160512\_00001.jpg

Looking at typical view of rodent holes on landward slope.

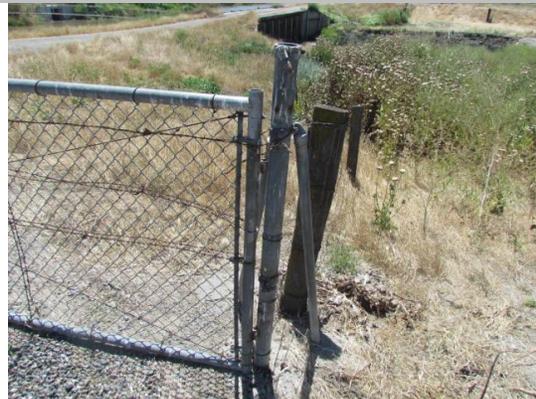
Photo 1 of 1 : SP\_2016\_NA0010\_127\_5\_20160523\_00009.jpg

Looking at missing hinges on fence post.

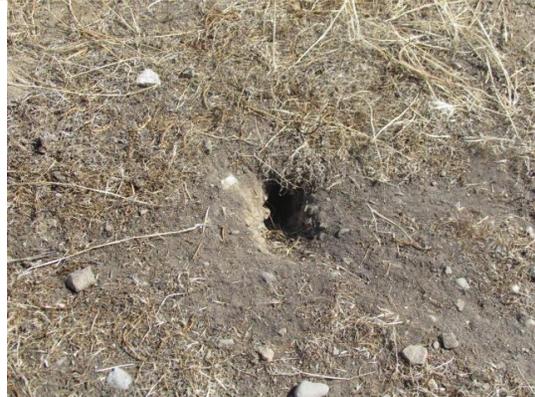
Photo 1 of 1 : SP\_2016\_NA0010\_132\_79\_20160512\_00001.jpg

Looking at typical view of rodent holes on landward slope.

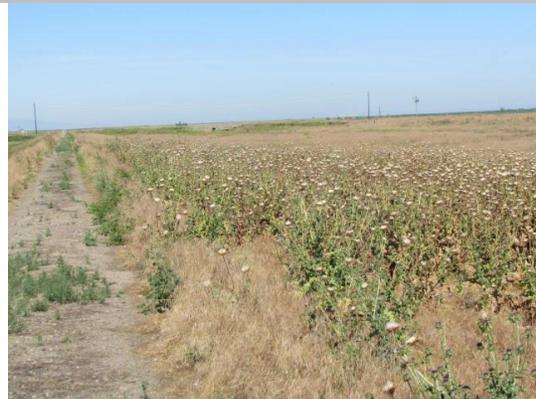
Photo 1 of 1 : SP\_2016\_NA0010\_134\_6\_20160524\_00011.jpg

Looking west at dense veg on waterward slope.

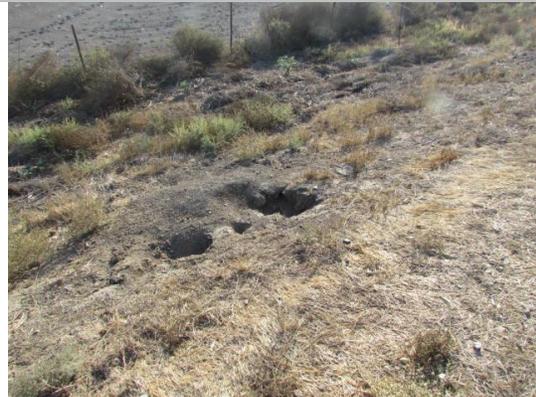
Photo 2 of 2 : SP\_2016\_NA0010\_134\_2\_20160512\_00002.jpg

Looking southwest at several rodent holes on landward slope.

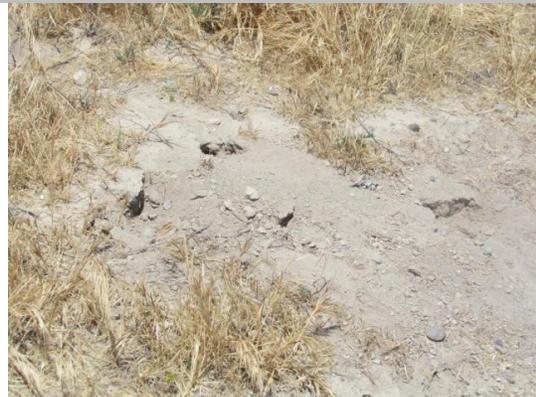
Photo 1 of 2 : SP\_2016\_NA0010\_135\_8\_20160512\_00005.jpg

Looking at several rodent holes on landward slope. (Spring 2015)

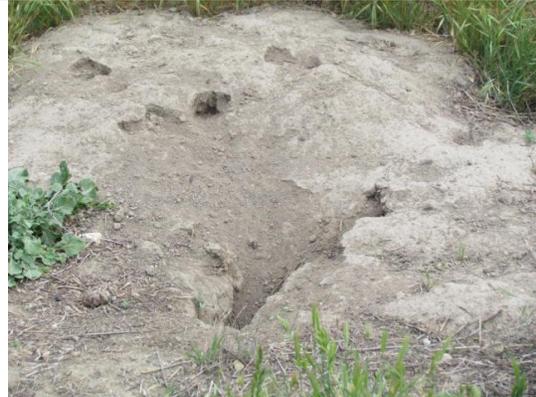
Photo 2 of 2 : SP\_2016\_NA0010\_135\_8\_20160512\_00006.jpg

Looking at several rodent holes on landside slope. (Fall 2014)

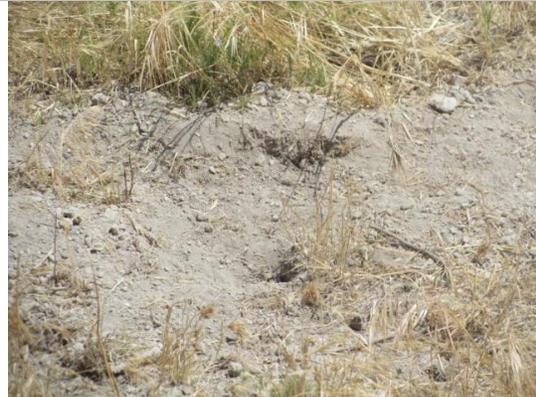
Photo 1 of 1 : SP\_2016\_NA0010\_135\_5\_20160512\_00004.jpg

Looking at typical view of rodent holes on landward slope.

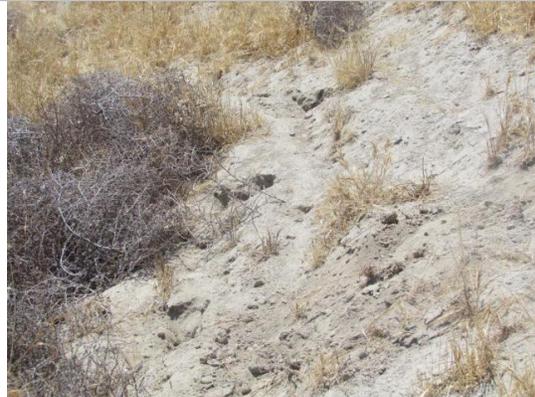
Photo 2 of 2 : SP\_2016\_NA0010\_135\_3\_20160512\_00002.jpg

Looking at several rodent holes on landward slope. Spring 2015

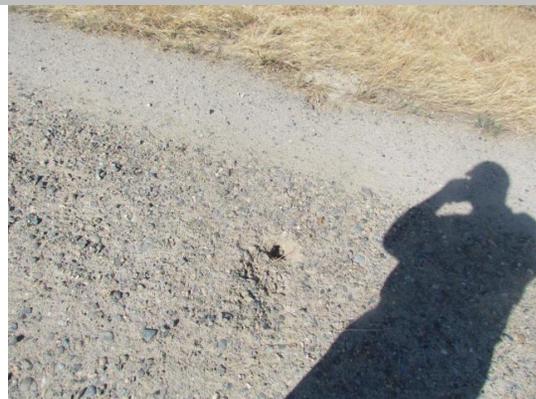
Photo 1 of 1 : SP\_2016\_NA0010\_137\_7\_20160512\_00002.jpg

Looking at typical view of rodent holes within this section on landward slope.

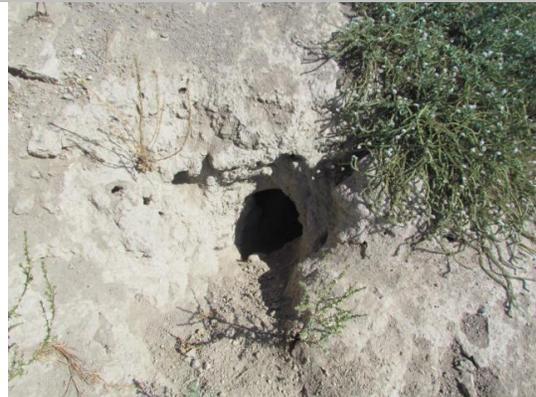
Photo 2 of 2 : SP\_2016\_NA0010\_137\_8\_20160512\_00004.jpg

Looking at close-up view of large rodent hole on landward slope.

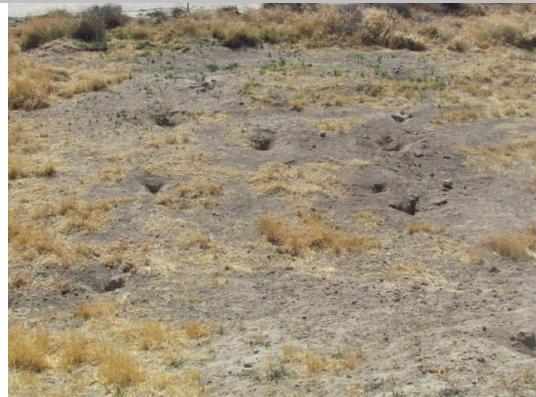
Photo 1 of 1 : SP\_2016\_NA0010\_137\_1\_20160512\_00001.jpg

Looking at several rodent holes on landward slope.

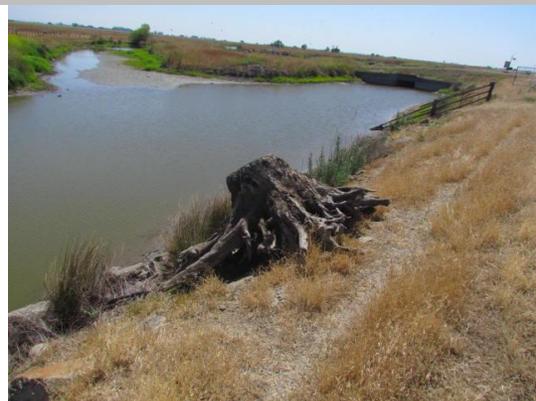
Photo 1 of 1 : SP\_2016\_NA0010\_138\_259\_20160512\_00012.jpg

Looking east at dead stump on waterward slope.

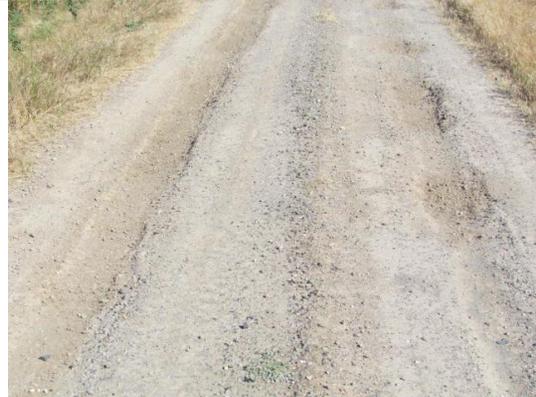
Photo 1 of 1 : SP\_2016\_NA0010\_138\_10\_20160524\_00025.jpg

Looking west at typical rutting on levee crown.

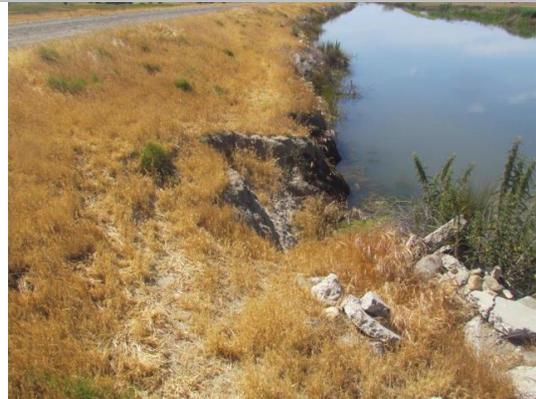
Photo 1 of 1 : SP\_2016\_NA0010\_138\_12\_20160512\_00007.jpg

Looking south at slope damage cause by animal traffic on waterside slope.

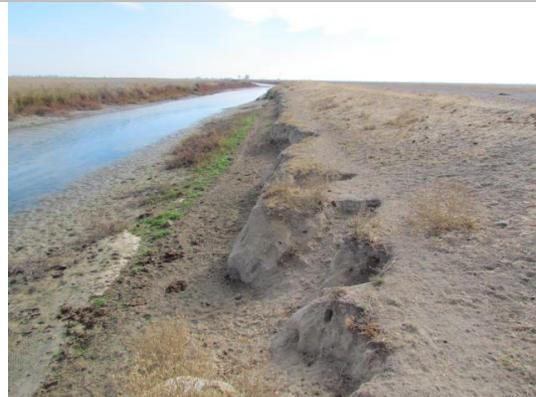
Photo 1 of 2 : SP\_2016\_NA0010\_138\_6\_20160512\_00005.jpg

Looking south at livestock erosion on waterward toe.

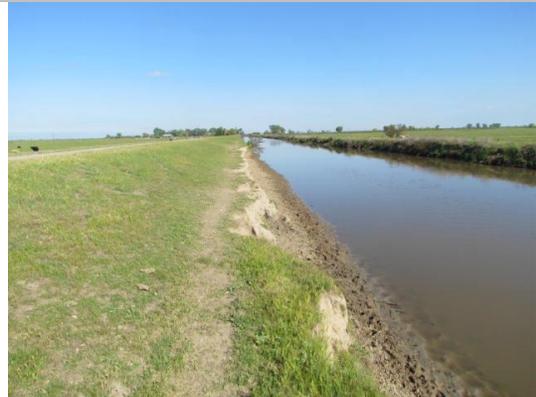
Photo 2 of 2 : SP\_2016\_NA0010\_138\_6\_20160512\_00006.jpg

Looking north at livestock erosion along waterside slope and toe.

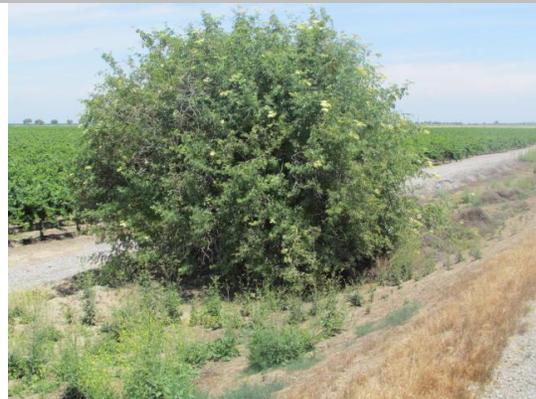
Photo 1 of 1 : SP\_2016\_NA0010\_139\_6\_20160512\_00006.jpg

Looking at elderberry on landward toe.

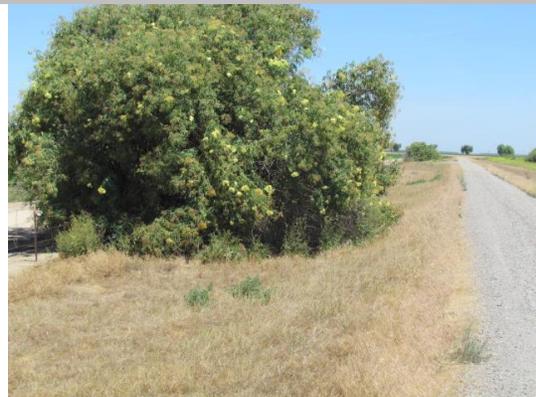
Photo 1 of 4 : SP\_2016\_NA0010\_139\_3\_20160524\_00054.jpg

Looking south at elderberry on landward toe and berm. (Spring 2016)

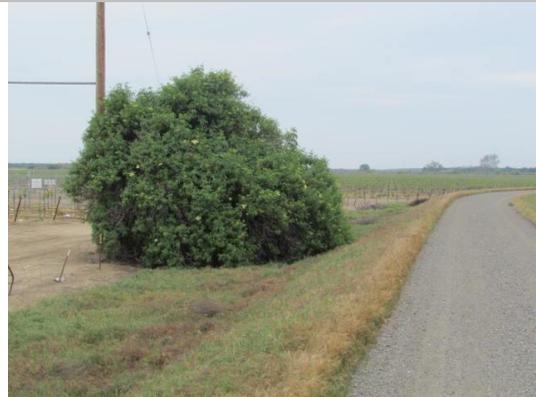
Photo 2 of 3 : SP\_2016\_NA0010\_139\_10\_20160512\_00009.jpg

Looking south at elderberry on landside toe and berm. (Spring 2015)

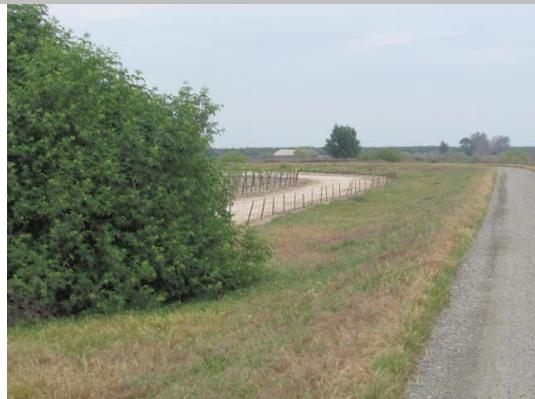
Photo 2 of 2 : SP\_2016\_NA0010\_139\_11\_20160512\_00011.jpg

Looking south at elderberry on landside toe and berm.

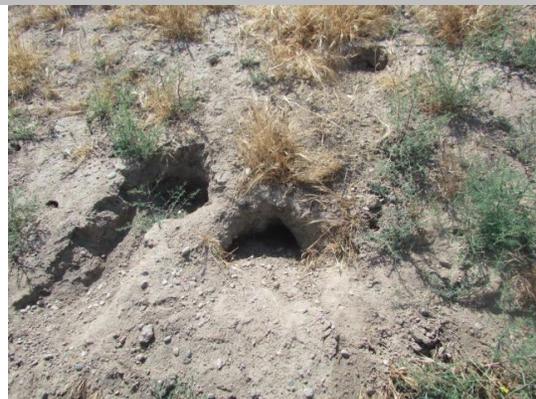
Photo 1 of 1 : SP\_2016\_NA0010\_140\_6\_20160512\_00005.jpg

Looking at several rodent holes on landward slope.

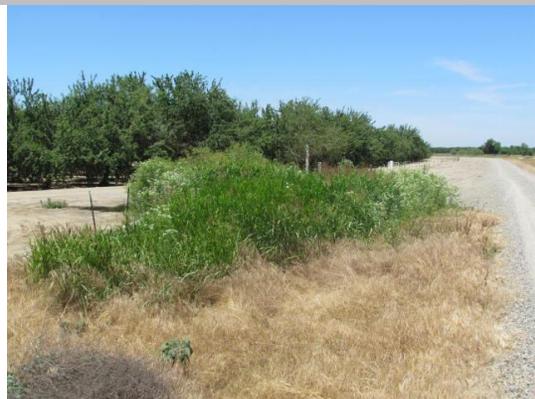
Photo 1 of 1 : SP\_2016\_NA0010\_140\_15\_20160524\_00037.jpg

Looking northwest at dense veg on landward slope and toe.
