**Flood Control Project Maintenance
Levee Inspections**

Maintenance Issue Types Only, Levee Inspection Report By Mile - Spring 2017

Lower San Joaquin Levee District

Waterway	Bank	Unit Miles	Inspection Start/End	Inspector
Unit No. 01 San Joaquin River	Right	22.52	04/17/2017 04/20/2017	Richard Willoughby

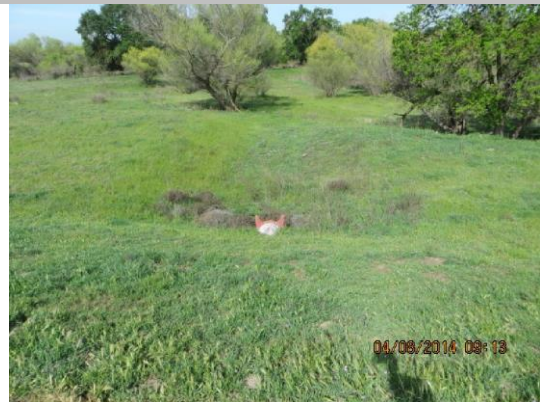
Photo 1 of 3 : UCIP_SP_2017_39095_60622.jpg

LM Start	0.60	Rating **	M	Issue No.	1187
LM End	0.60	Issue Type +	Ma	Location *	LS
Category	Supplemental			GPS Latitude/Longitude	
				Start	End
Item	DWR UCIP LMA Responsibility			37.341507 °	37.341507 °
				-120.961283 °	-120.961283 °
DWR ID					
Comment Code					
Inspector Comment					
FS_ID:39095 DS_ID:19583 EP_NO: N/A Repair Type: Non-Urgent Crossing Status: Found UCIP Comments: Recommend removing vegetation pile from waterward toe. FIELD_STRUCT_DESC: 24-inch CM stormdrain pipe through the levee, 8.5 feet below the crown. Flap gate on the waterward end. Brass cap No. 108 BM on headwall on the landward side. (USACE-1967). This entry matches the Drainage or Irrigation Structure referenced in O&M manual (HLM 0.62). FS Date: 4/8/2014

Flapgate and headwall visible on WS toe.

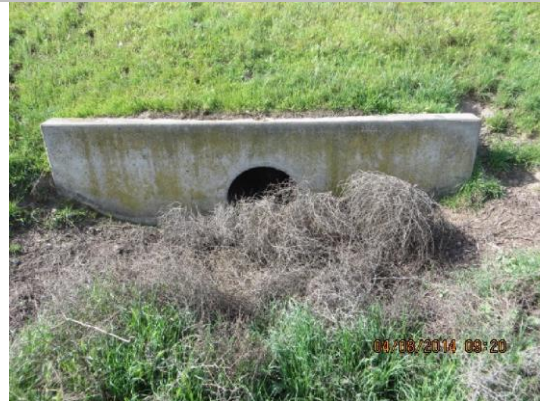
Photo 3 of 3 : UCIP_SP_2017_33524_60625.jpg

LM Start	0.85	Rating **	A/W	Issue No.	1188 (cont)	
LM End	0.85	Issue Type +	Ma	Location *	LS	
Category	Supplemental			GPS Latitude/Longitude		
				Start	End	
Item	DWR UCIP LMA Responsibility			37.339829 °	37.339829 °	
				-120.958621 °	-120.958621 °	
DWR ID						
Comment Code						
Inspector Comment						
FS_ID:33524						
DS_ID:19584						
EP_NO: N/A						
Repair Type: No Action Needed						
Crossing Status: Found						
UCIP Comments:						
FIELD_STRUCT_DESC: 24-inch CM pipe through the levee, 7-feet below the crown. Flap gate on the waterward end. Brass cap No. 108 BM on headwall on the landward side. (USACE-1967). This entry matches the Drainage or Irrigation Structure referenced in O&M manual (HLM 0.87).						
FS Date: 4/8/2014

Pipe and headwall visible on LS toe.

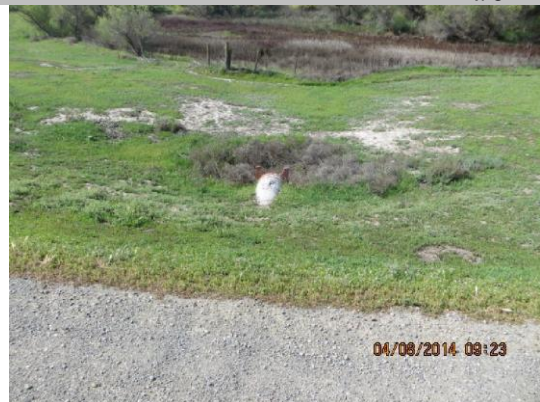
Photo 1 of 3 : UCIP_SP_2017_39096_60632.jpg

LM Start	0.93	Rating **	M	Issue No.	1189
LM End	0.93	Issue Type +	Ma	Location *	LS
Category	Supplemental			GPS Latitude/Longitude	
				Start	End
Item	DWR UCIP LMA Responsibility			37.339598 °	37.339598 °
				-120.957202 °	-120.957202 °
DWR ID					
Comment Code					
Inspector Comment					
FS_ID:39096 DS_ID:19585 EP_NO: N/A Repair Type: Non-Urgent Crossing Status: Found UCIP Comments: Moderate erosion around headwall on landward toe. May or may not be an issue. Need to contact owner to determine status of crossing and to address erosion issue on landward side. FIELD_STRUCT_DESC: 24-inch CM pipe through the levee, 7-feet below the crown. Flap gate on the waterward end. Brass cap No. 108 BM on headwall on the landward side. (USACE-1967). This entry matches the Drainage or Irrigation Structure referenced in O&M manual (HLM 0.95). FS Date: 4/8/2014

Flapgate, pipe, and headwall on WS toe.

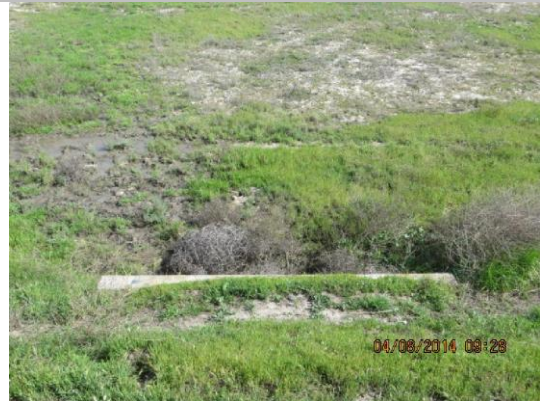
Photo 3 of 3 : UCIP_SP_2017_33543_60641.jpg

LM Start	1.15	Rating **	A/W	Issue No.	1190 (cont)	
LM End	1.15	Issue Type +	Ma	Location *	LS	
Category	Supplemental			GPS Latitude/Longitude		
				Start		End
Item	DWR UCIP LMA Responsibility			37.338005 °	37.338005 °	
				-120.953921 °	-120.953921 °	
DWR ID						
Comment Code						
Inspector Comment						
FS_ID:33543						
DS_ID:19586						
EP_NO: N/A						
Repair Type: No Action Needed						
Crossing Status: Found						
UCIP Comments:						
FIELD_STRUCT_DESC: 24-inch CM stormdrain pipe through the levee, 7.5 feet below the crown. Flap gate on the waterward end. Brass cap No. 108 BM on headwall on the landward side. (USACE-1967). This entry matches the Drainage or Irrigation Structure referenced in O&M manual (HLM 1.17).						
FS Date: 4/8/2014

Headwall and pipe visible on LS toe.

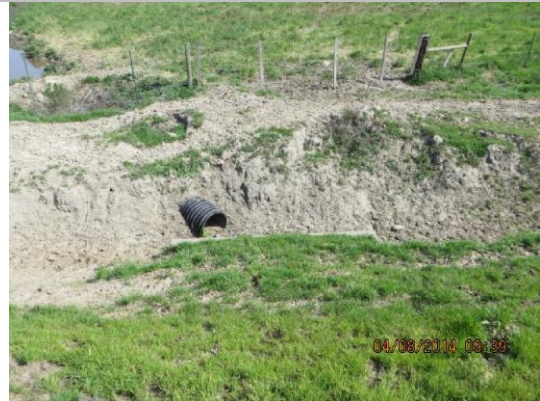
Photo 3 of 3 : UCIP_SP_2017_39099_60651.jpg

LM Start	1.46	Rating **	M	Issue No.	1192 (cont)
LM End	1.46	Issue Type +	Ma	Location *	LS
Category	Supplemental			GPS Latitude/Longitude	
				Start	End
Item	DWR UCIP LMA Responsibility			37.336866 °	37.336866 °
				-120.948520 °	-120.948520 °
DWR ID					
Comment Code					
Inspector Comment					
FS_ID:39099 DS_ID:19588 EP_NO: N/A Repair Type: Non-Urgent Crossing Status: Found UCIP Comments: Some sediment buildup inside pipe at LS toe. Recommend contacting owner to clear sediment buildup and check wall integrity through pipe section. FIELD_STRUCT_DESC: 24-inch CM stormdrain pipe through the levee, 11.0 feet below the crown. Flap gate on the waterward end. Brass cap No. 108 BM on headwall on the landward side. (USACE-1967). This entry matches the Drainage or Irrigation Structure referenced in O&M manual (HLM 1.48). FS Date: 4/8/2014

Pipe and concrete headwall visible on LS toe.

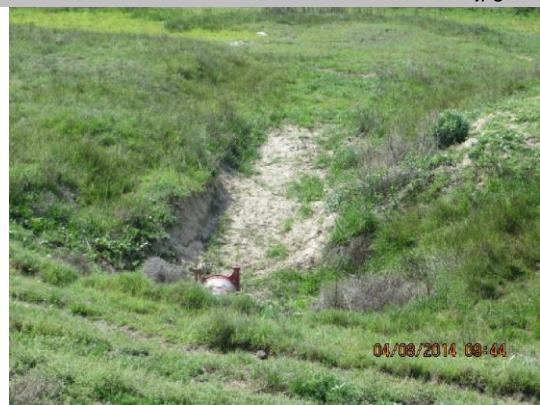
Photo 1 of 3 : UCIP_SP_2017_33563_60661.jpg

LM Start	1.67	Rating **	M	Issue No.	1193
LM End	1.67	Issue Type +	Ma	Location *	LS
Category	Supplemental			GPS Latitude/Longitude	
				Start	End
Item	DWR UCIP LMA Responsibility			37.336459 °	37.336459 °
				-120.944803 °	-120.944803 °
DWR ID					
Comment Code					
Inspector Comment					
FS_ID:33563					
DS_ID:19589					
EP_NO: N/A					
Repair Type: Non-Urgent					
Crossing Status: Found					
UCIP Comments: Heavy sediment buildup in pipe at LS toe.					
FIELD_STRUCT_DESC: 24-inch CM stormdrain pipe through the levee,					
13.6 feet below the crown. Flap gate on the waterward end. Brass cap					
No. 100 BM on headwall on the landward side. (USACE-1967). This					
entry matches the Drainage or Irrigation Structure referenced in O&M					
manual (HLM 1.69).					
FS Date: 4/8/2014

Pipe, headwall, and flapgate visible on WS toe.

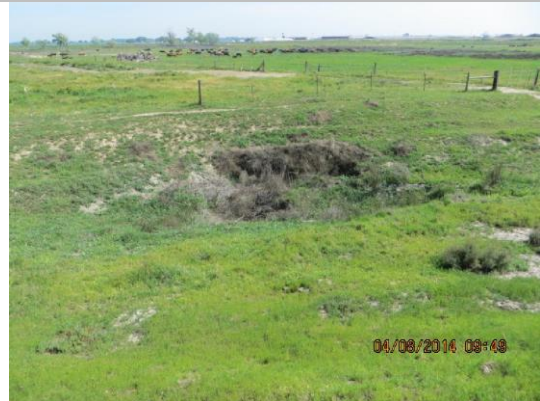
Photo 3 of 3 : UCIP_SP_2017_33564_60665.jpg

Pipe and concrete headwall visible at LS toe.

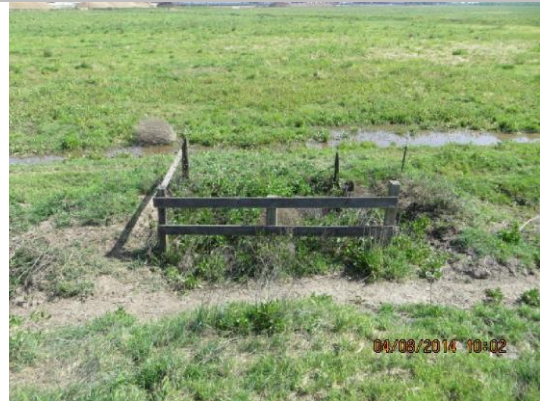
Photo 3 of 3 : UCIP_SP_2017_39123_60674.jpg

Wooded barrier around drop-inlet on LS toe.

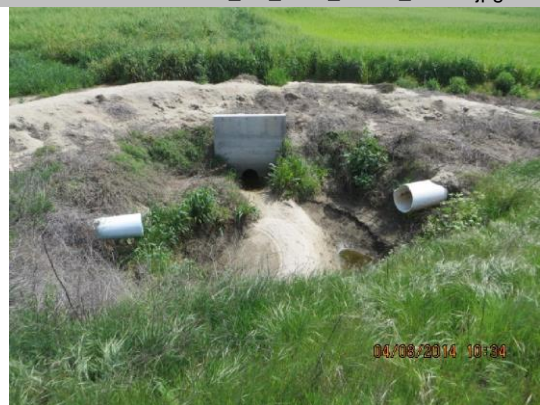
Photo 2 of 3 : UCIP_SP_2017_50054_60706.jpg

Pipe and headwall on LS toe.

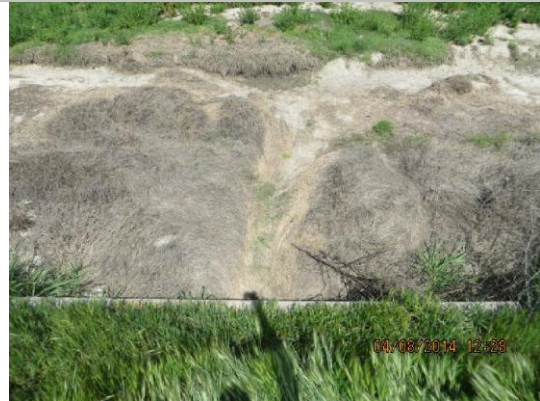
Photo 3 of 3 : UCIP_SP_2017_42851_60771.jpg

Pipe and Concrete headwall visible on LS toe.

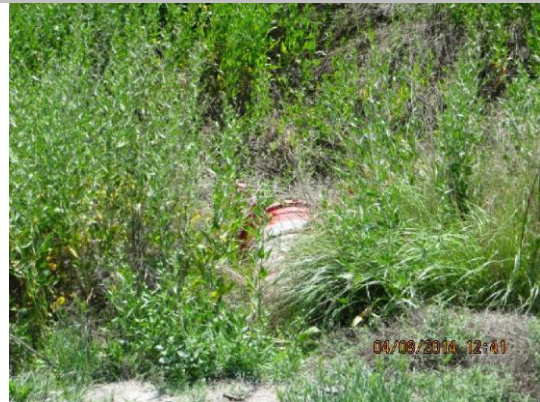
Photo 1 of 3 : UCIP_SP_2017_39161_60778.jpg

Pipe and flapgate visible on WS toe.

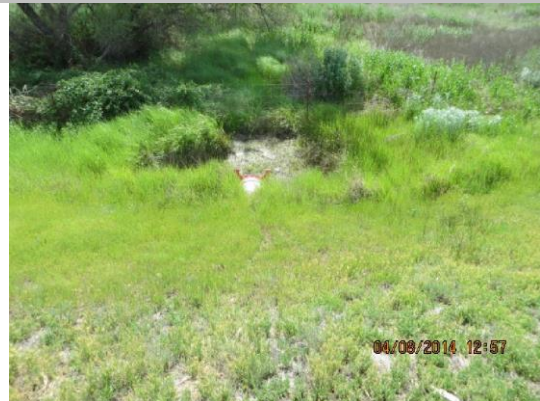
Photo 1 of 3 : UCIP_SP_2017_39244_60844.jpg

Pipe, Headwall, and flapgate at WS toe.

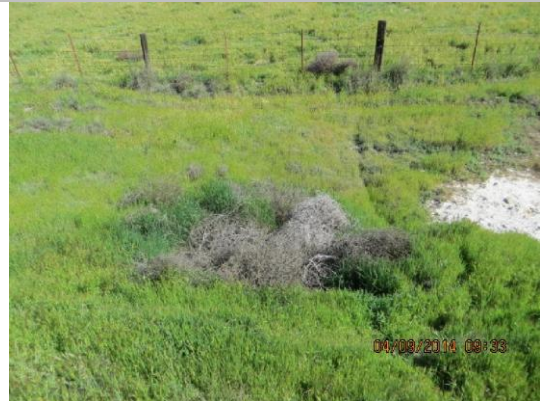
Photo 3 of 3 : UCIP_SP_2017_39245_60849.jpg

Pipe and concrete headwall at LS toe. Note heavy vegetation.

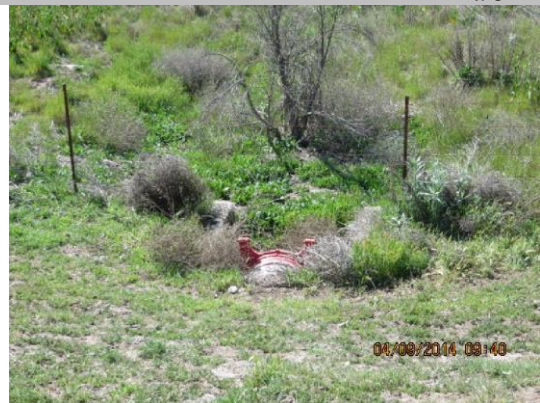
Photo 1 of 3 : UCIP_SP_2017_39246_60854.jpg

LM Start	8.57	Rating **	A/W	Issue No.	1220
LM End	8.57	Issue Type +	Ma	Location *	WS
Category	Supplemental			GPS Latitude/Longitude	
				Start	End
Item	DWR UCIP LMA Responsibility			37.296552 °	37.296552 °
				-120.858596 °	-120.858596 °
DWR ID					
Comment Code					
Inspector Comment					
FS_ID:39246 DS_ID:19622 EP_NO: N/A Repair Type: No Action Needed Crossing Status: Found UCIP Comments: FIELD_STRUCT_DESC: 24-inch CM stormdrain pipe through the levee, 9.0 feet below the crown. Flap gate on waterward end. Brass cap No. 80 BM on headwall on the landward side. (USACE-1967). This entry matches the Drainage or Irrigation Structure referenced in O&M manual (HLM 8.61). FS Date: 4/9/2014

Pipe, Flapgate, and headwall on WS toe.

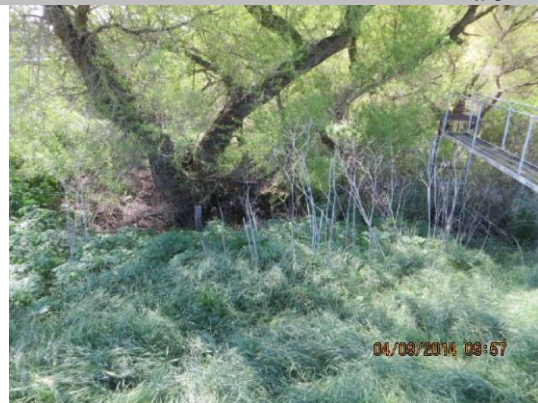
Photo 1 of 3 : UCIP_SP_2017_39249_60870.jpg

Pipe and flapgate visible on WS toe.

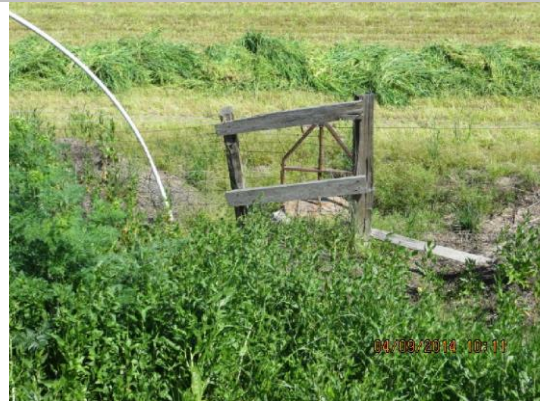
Photo 3 of 3 : UCIP_SP_2017_39251_60874.jpg

Concrete drop-inlet installed on pipe at LS toe.

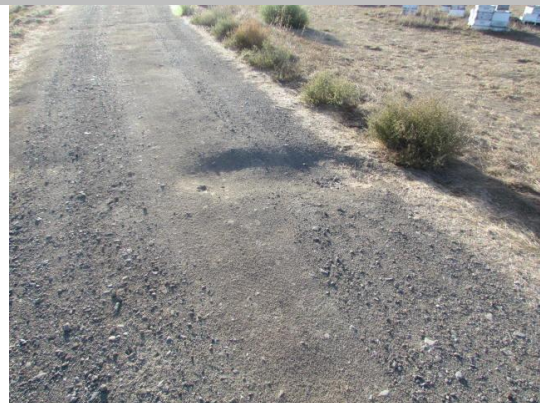
Photo 1 of 3 : SP_2017_NA0010_118_14_20170417_00012.jpg

LM Start	9.57	Rating **	M	Issue No.	14
LM End	9.57	Issue Type +	Ma	Location *	CR
Category	Earthen Levee			GPS Latitude/Longitude	
				Start	End
Item	Crown Surface / Depressions / Rutting			37.295517 °	37.295517 °
				-120.841452 °	-120.841452 °
DWR ID	DWR_NA0010_01_s_2015_14				
Comment Code					
C2 : Repair depressions or ruts in the crown or slope.					
Inspector Comment					
Depression greater than 3" deep by 18" wide by 18" long on levee crown

Looking at depression on levee crown. (Fall 2015)

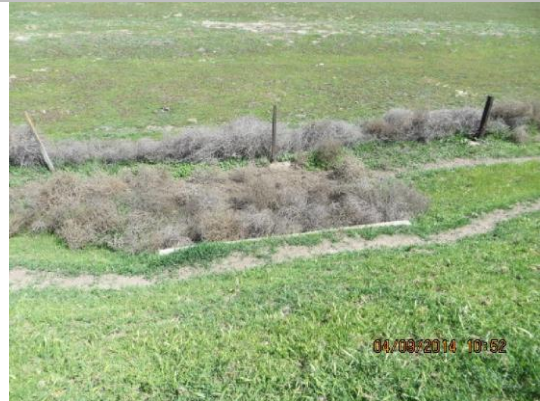
Photo 3 of 3 : UCIP_SP_2017_39255_60898.jpg

Pipe and headwall on LS toe.

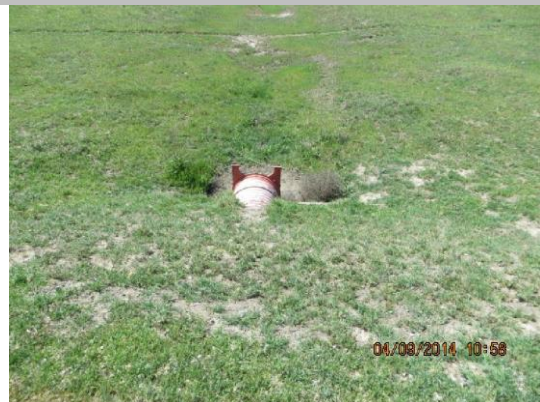
Photo 1 of 3 : UCIP_SP_2017_33690_60903.jpg

LM Start	11.14	Rating **	A/W	Issue No.	1231
LM End	11.14	Issue Type +	Ma	Location *	CR
Category	Supplemental			GPS Latitude/Longitude	
				Start	End
Item	DWR UCIP LMA Responsibility			37.281813 °	37.281813 °
				-120.825409 °	-120.825409 °
DWR ID					
Comment Code					
Inspector Comment					
FS_ID:33690					
DS_ID:19633					
EP_NO: N/A					
Repair Type: No Action Needed					
Crossing Status: Found					
UCIP Comments:					
FIELD_STRUCT_DESC: 24-inch CM stormdrain pipe through the levee, 5.0 feet below the crown. Flap gate on the waterward end. Brass cap No. 65 BM on headwall on the landward side. (USACE-1967). This entry matches the Drainage or Irrigation Structure referenced in O&M manual (HLM 11.18).					
FS Date: 4/9/2014

Pipe, headwall, and flapgate on WS toe.

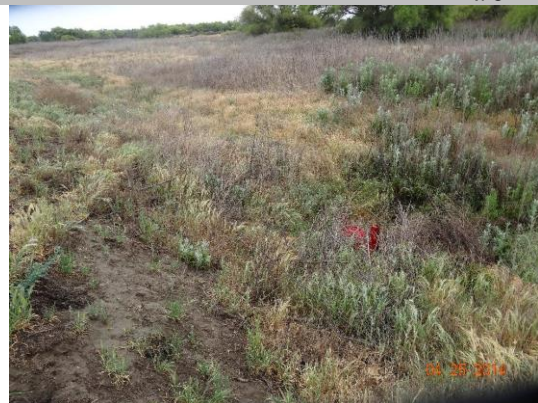
Photo 1 of 3 : UCIP_SP_2017_36169_65464.jpg

View of waterward side--flap gate visible through dense vegetation.

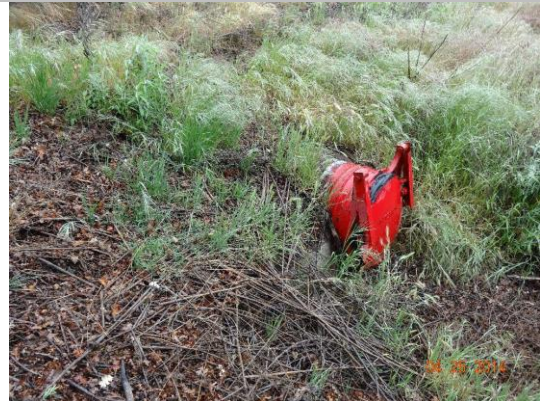
Photo 3 of 3 : UCIP_SP_2017_36171_65469.jpg

Side view of pipe and flap gate on waterward side.

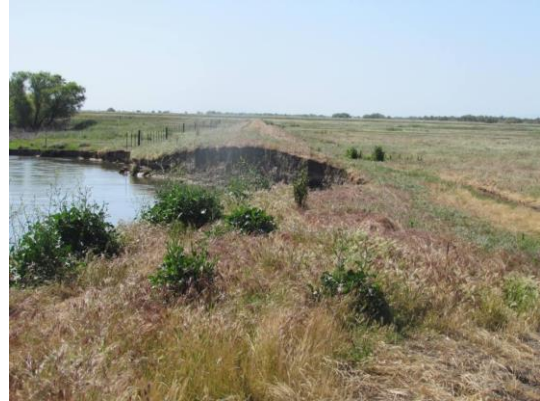
Photo 4 of 4 : SP_2017_NA0010_119_5_20170424_00075.jpg

Looking upstream at erosion fall 2017.

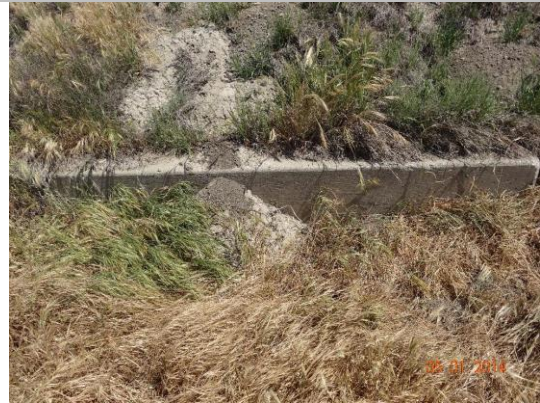
Photo 3 of 3 : UCIP_SP_2017_36512_66140.jpg

Non-functional crossing concrete headwall and inlet buried on landward side.

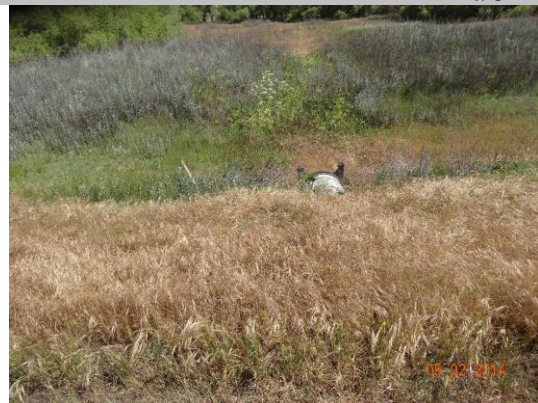
Photo 1 of 3 : UCIP_SP_2017_36525_66208.jpg

View of waterward side--pipe and flap gate visible.

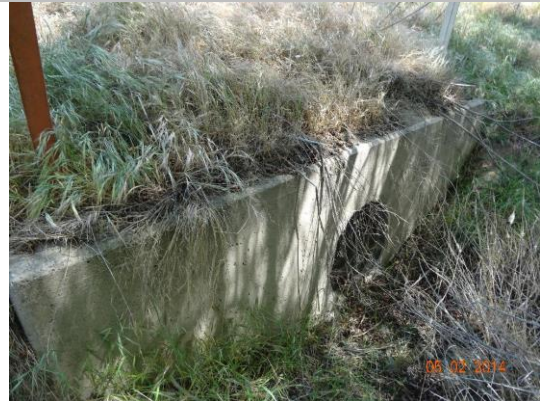
Photo 3 of 3 : UCIP_SP_2017_36527_66215.jpg

Concrete headwall visible on landward side.

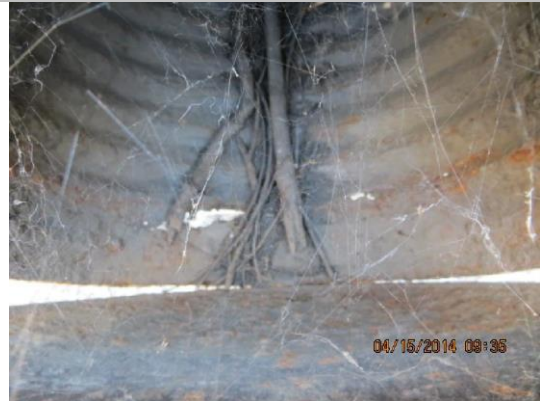
Photo 3 of 3 : UCIP_SP_2017_43055_60951.jpg

Pipe corroded through just behind flapgate at WS toe.

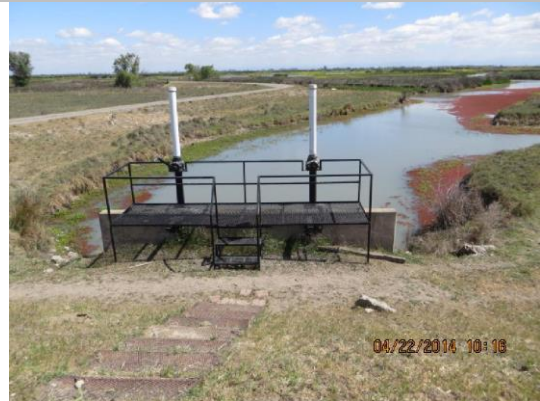
Photo 3 of 3 : UCIP_SP_2017_34267_62185.jpg

Slide gate mounted on concrete headwall at LS toe.

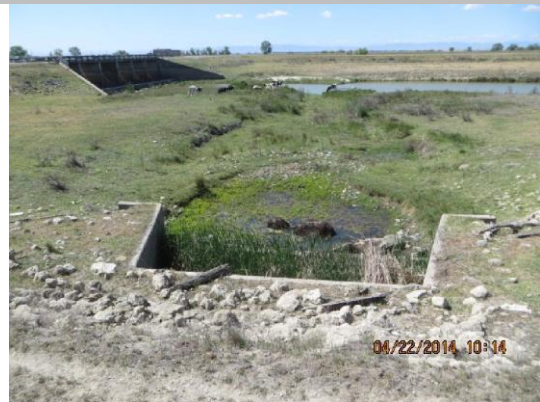
Photo 1 of 3 : UCIP_SP_2017_34268_62190.jpg

Concrete headwall on WS toe.

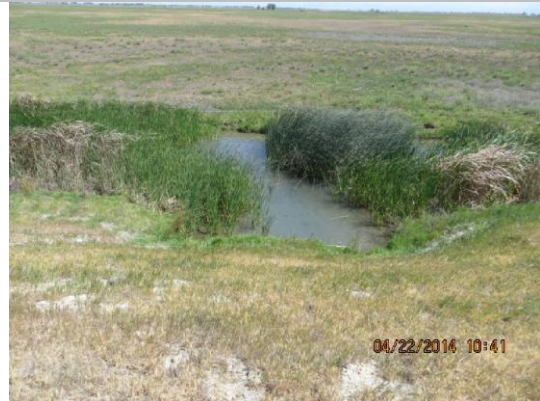
Photo 3 of 3 : UCIP_SP_2017_34273_62200.jpg

Concrete headwall and pipe on LS toe.

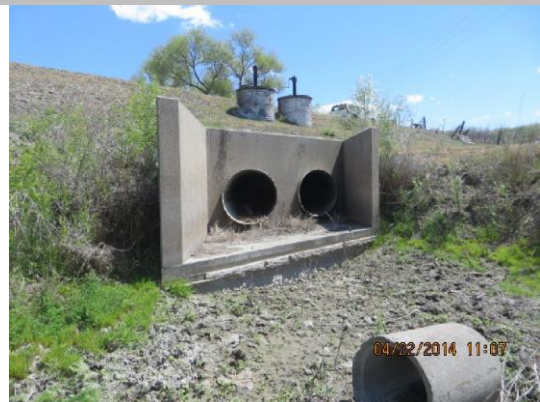
Photo 1 of 3 : UCIP_SP_2017_34281_62219.jpg

Slidegate in CMP riser, concrete headwall and pipe visible on WS slope.

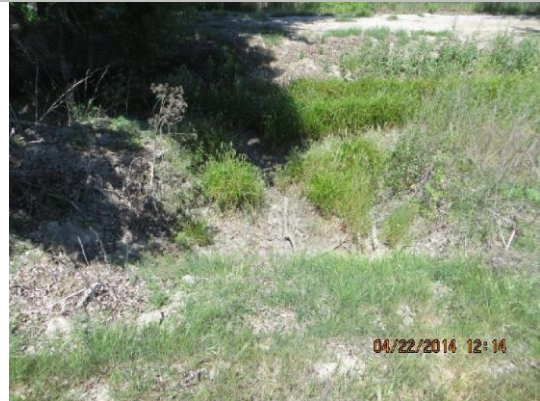
Photo 3 of 3 : UCIP_SP_2017_39593_62239.jpg

Headwall and pipe on LS toe.

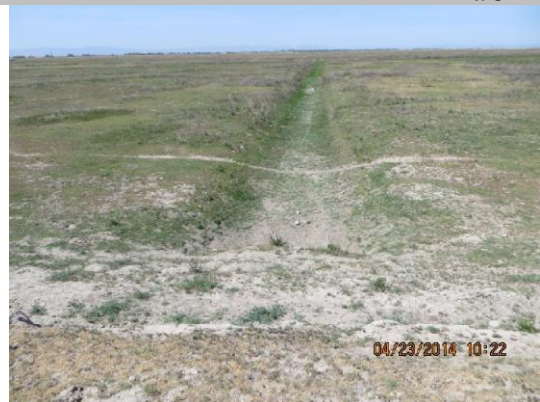
Photo 1 of 3 : UCIP_SP_2017_39597_62481.jpg

Headwall, flapgate, and pipe visible on WS toe.

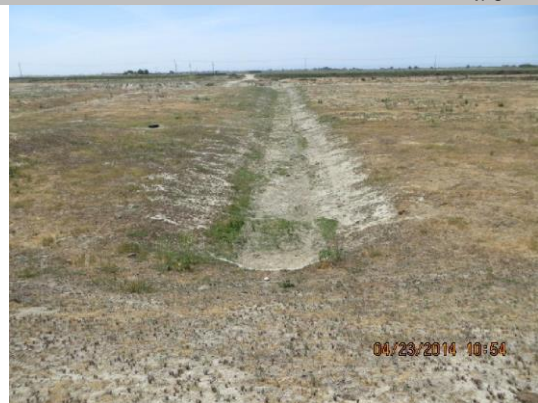
Photo 1 of 3 : UCIP_SP_2017_39601_62504.jpg

Headwall, pipe, and flapgate visible on WS toe.

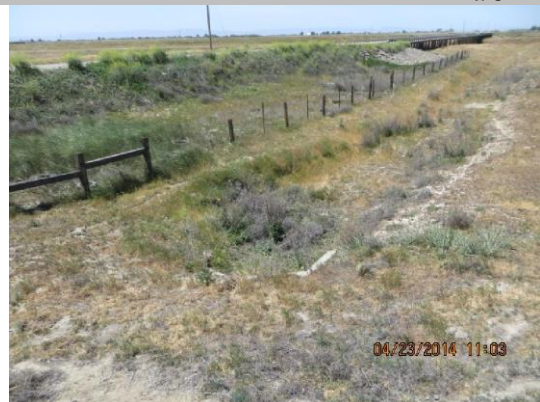
Photo 1 of 3 : UCIP_SP_2017_39602_62514.jpg

Headwall, pipe, and flapgate visible on WS toe.

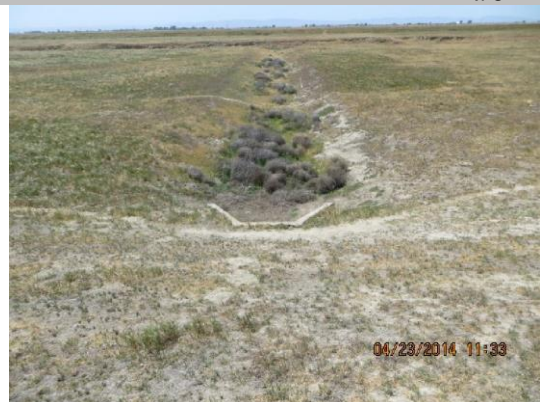
Photo 1 of 3 : UCIP_SP_2017_34757_62533.jpg

Headwall, pipe, and flapgate visible on WS toe.

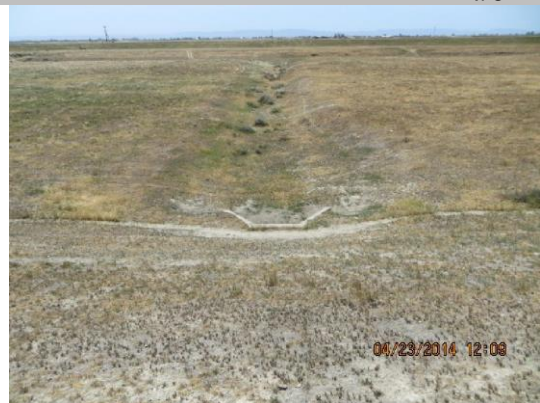
Photo 1 of 3 : UCIP_SP_2017_39614_62555.jpg

Headwall, pipe, and flapgate visible on WS toe.

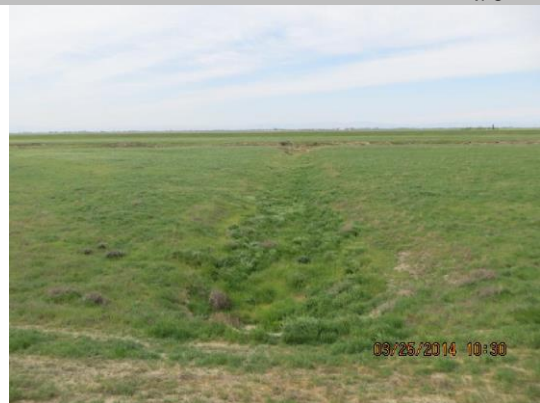
Photo 1 of 3 : UCIP_SP_2017_39623_59292.jpg

Concrete headwall on WS toe.

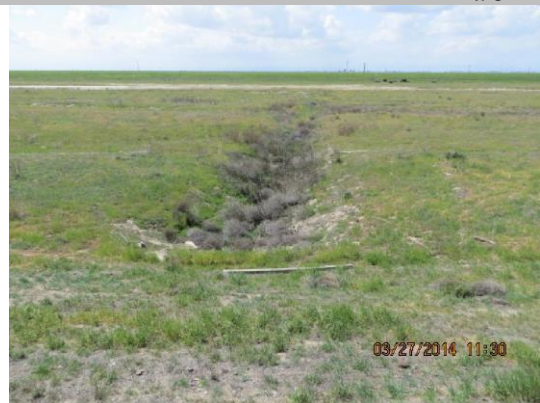
Photo 1 of 3 : UCIP_SP_2017_39633_59435.jpg

Concrete headwall on WS toe.

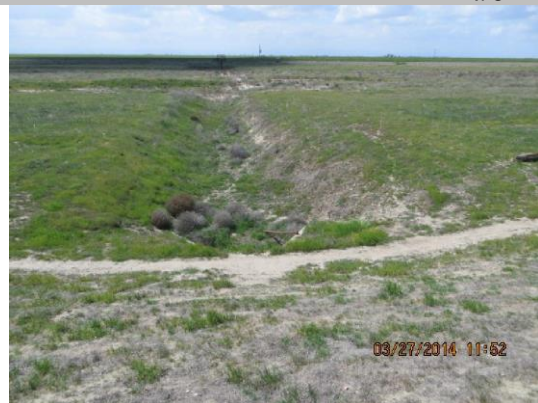
Photo 1 of 3 : UCIP_SP_2017_39644_59444.jpg

Concrete headwall on WS toe.

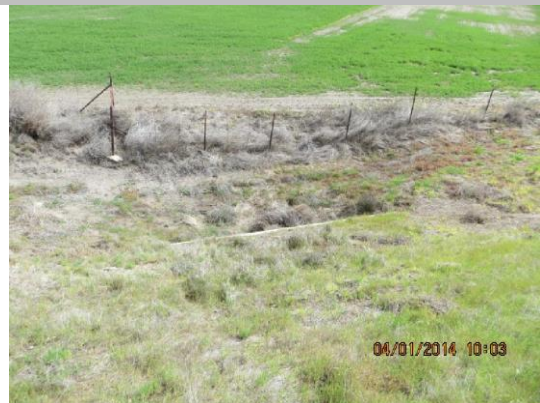
Photo 1 of 3 : UCIP_SP_2017_39646_59690.jpg

Concrete headwall at inlet on LS toe.

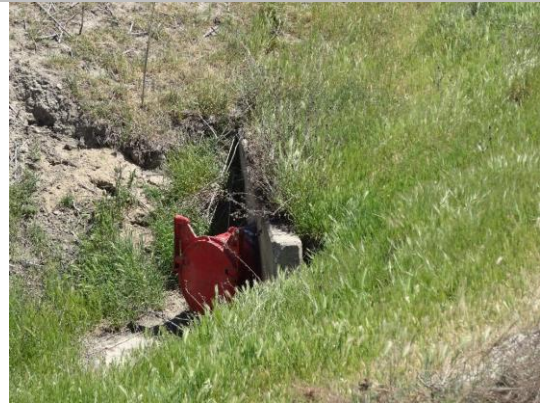
Photo 3 of 3 : UCIP_SP_2017_36584_66385.jpg

Crossing goes through the levee at an angle. Flap gate visible on waterward side.

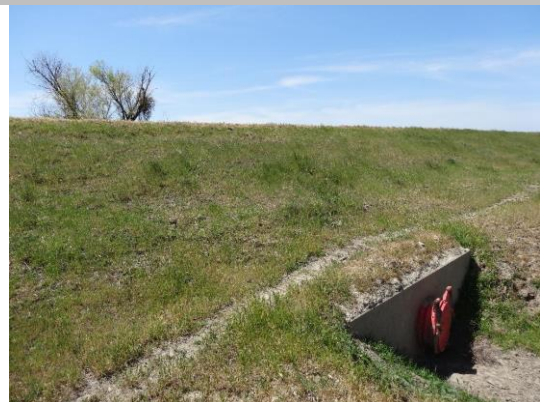
Photo 1 of 2 : UCIP_SP_2017_36607_66422.jpg

View of waterward side--concrete headwall and flap gate visible.

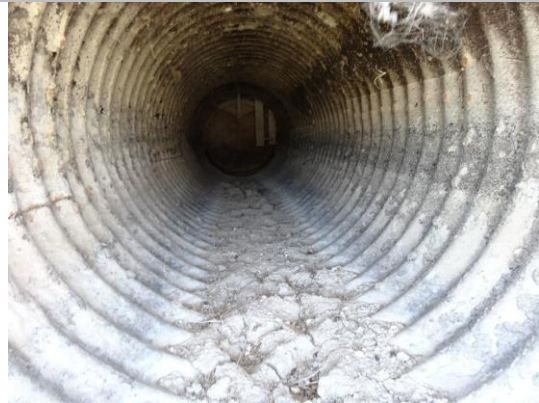
Photo 3 of 3 : UCIP_SP_2017_33984_61626.jpg

Inside view pipe from waterward side.

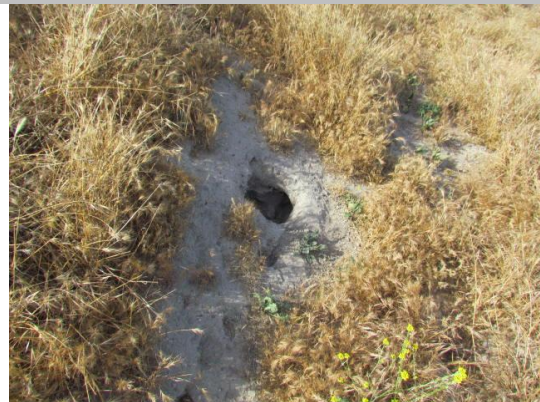
Photo 1 of 5 : SP_2017_NA0010_124_1211_20170417_00029.jpg

Looking at rodent hole on waterward slope. Spring 2016

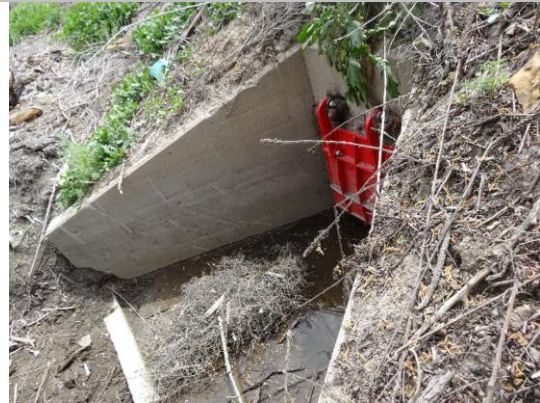
Photo 3 of 3 : UCIP_SP_2017_36689_66590.jpg

View of "U" concrete headwall located on waterward side.

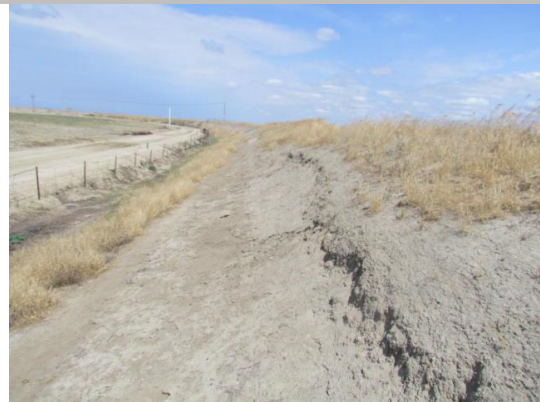
Photo 1 of 2 : SP_2017_NA0010_124_1209_20170417_00027.jpg

Looking north at livestock erosion on landward slope.

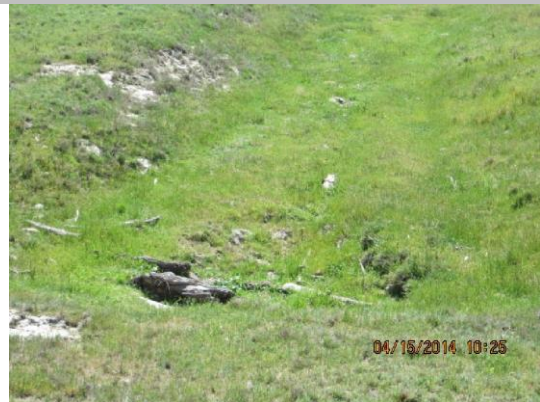
Photo 1 of 3 : UCIP_SP_2017_33725_60991.jpg

Concrete headwall and flapgate at WS toe.

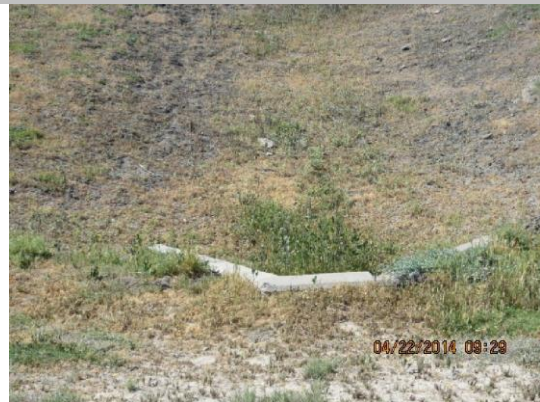
Photo 1 of 3 : UCIP_SP_2017_39515_62128.jpg

Headwall, flapgate, and pipe on WS toe.

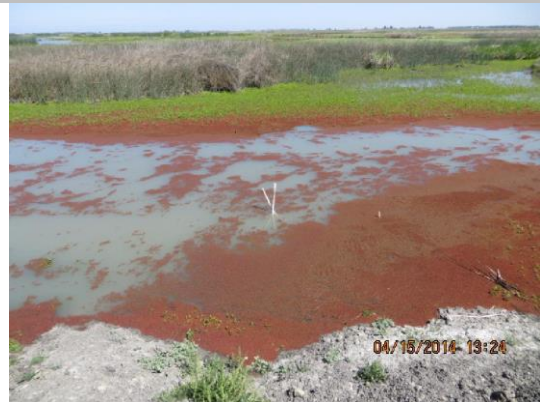
Photo 1 of 3 : UCIP_SP_2017_49959_61060.jpg

PVC pipes sticking up out of channel likely indicate pipe location on WS toe.

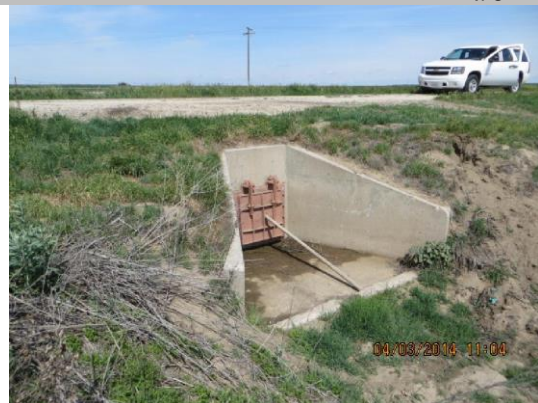
Photo 1 of 3 : UCIP_SP_2017_39544_59823.jpg

Flapgate on WS toe.
