**Flood Control Project Maintenance  
Levee Inspections**

## Maintenance Issue Types Only, Levee Inspection Report By Mile - Spring 2018

### Lower San Joaquin Levee District

Waterway	Bank	Unit Miles	Inspection Start/End	Inspector
Unit No. 01 San Joaquin River	Right	22.52	04/04/2018 04/16/2018	Richard Willoughby

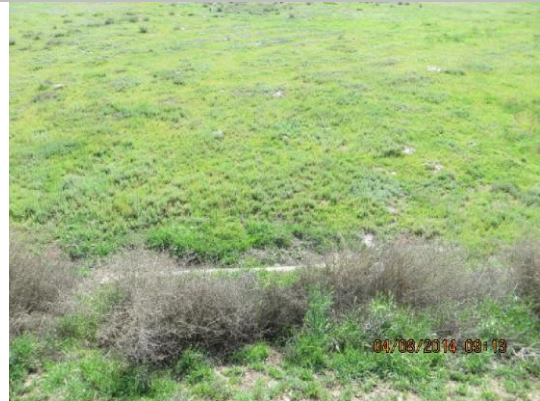
Photo 3 of 3 : UCIP\_SP\_2018\_39095\_60621.jpg

LM Start	0.60	Rating **	M	Issue No.	1187 (cont)	
LM End	0.60	Issue Type +	Ma	Location *		
Category	Supplemental			GPS Latitude/Longitude		
				Start	End	
Item	DWR UCIP LMA Responsibility			37.341507 °	37.341507 °	
				-120.961283 °	-120.961283 °	
DWR ID						
Comment Code						
Inspector Comment						
FS_ID:39095						
DS_ID:19583						
EP_NO: N/A						
Repair Type: Non-Urgent						
Crossing Status: Found						
UCIP Comments: Recommend removing vegetation pile from waterward toe.						
FIELD_STRUCT_DESC: 24-inch corrugated metal gravity drainage pipe through the levee, 8.5 feet below the crown. Flap gate on the waterside (WS) end. Brass cap No. 108 bench mark (BM) on the headwall on the landside (LS). [Additional Reference(s): DWR Levee Log, 2002. USACE San Joaquin O&M Manual 601.1, 1967, (HLM 0.62)].						
FS Date: 4/8/2014

Pipe and headwall visible on LS toe.

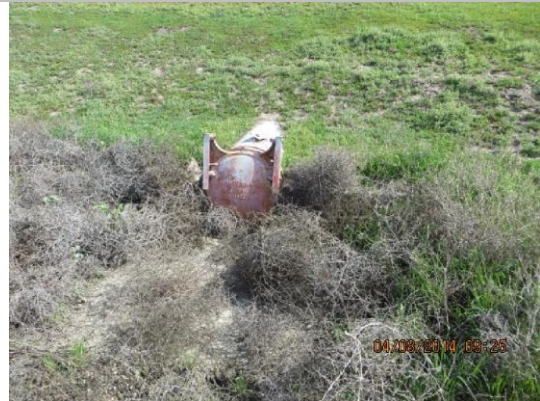
Photo 3 of 3 : UCIP\_SP\_2018\_39096\_60633.jpg

Comment Code						
Inspector Comment						
FS_ID:39096 DS_ID:19585 EP_NO: N/A Repair Type: Non-Urgent Crossing Status: Found UCIP Comments: Moderate erosion around headwall on landward toe. May or may not be an issue. Need to contact owner to determine status of crossing and to address erosion issue on landward side. FIELD_STRUCT_DESC: 24-inch corrugated metal gravity drainage pipe through the levee, 7 feet below the crown. Flap gate on the waterside (WS) end. Brass cap No. 108 bench mark (BM) on the headwall on the landside (LS). [Additional Reference(s): DWR Levee Log, 2002. USACE San Joaquin O&M Manual 601.1, 1967, (HLM 0.95)]. FS Date: 4/8/2014

Flapgate, pipe, and headwall on WS toe.

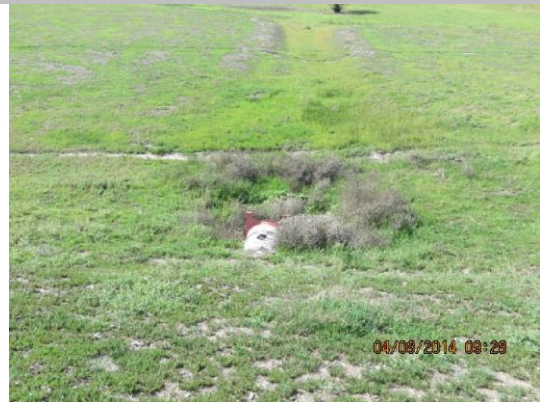
Photo 1 of 3 : UCIP\_SP\_2018\_33543\_60642.jpg

LM Start	1.15	Rating **	A/W	Issue No.	1190	
LM End	1.15	Issue Type +	Ma	Location *		
Category	Supplemental			GPS Latitude/Longitude		
				Start	End	
Item	DWR UCIP LMA Responsibility			37.338005 °	37.338005 °	
				-120.953921 °	-120.953921 °	
DWR ID						
Comment Code						
Inspector Comment						
FS_ID:33543						
DS_ID:19586						
EP_NO: N/A						
Repair Type: No Action Needed						
Crossing Status: Found						
UCIP Comments:						
FIELD_STRUCT_DESC: 24-inch corrugated metal gravity drainage pipe						
through the levee, 7.5 feet below the crown. Flap gate on the waterside						
(WS) end. Brass cap No. 108 bench mark (BM) on the headwall on the						
landside (LS). [Additional Reference(s): DWR Levee Log, 2002. USACE						
San Joaquin O&M Manual 601.1, 1967, (HLM 1.17)].						
FS Date: 4/8/2014

Pipe, headwall, and flapgate visible on WS toe.

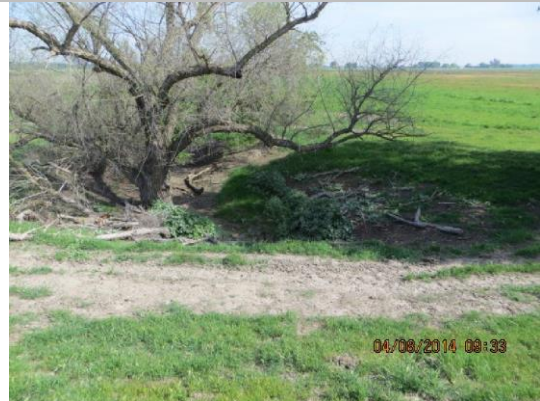
Photo 3 of 3 : UCIP\_SP\_2018\_33544\_60647.jpg

LM Start	1.32	Rating **	A/W	Issue No.	1191 (cont)	
LM End	1.32	Issue Type +	Ma	Location *		
Category	Supplemental			GPS Latitude/Longitude		
				Start	End	
Item	DWR UCIP LMA Responsibility			37.337361 °	37.337361 °	
				-120.950879 °	-120.950879 °	
DWR ID						
Comment Code						
Inspector Comment						
FS_ID:33544 DS_ID:19587 EP_NO: N/A Repair Type: No Action Needed Crossing Status: Found UCIP Comments: FIELD_STRUCT_DESC: 36-inch corrugated metal gravity drainage pipe through the levee, 12.8 feet below the crown. Flap gate on the waterside (WS) end. Brass cap No. 108 bench mark (BM) on the headwall on the landside (LS). Pipe crosses through the levee at about a 45 degree angle to the crown. [Additional Reference(s): DWR Levee Log, 2002. USACE San Joaquin O&M Manual 601.1, 1967, (HLM 1.34)]. FS Date: 4/8/2014

Concrete headwall and pipe visible at LS toe.

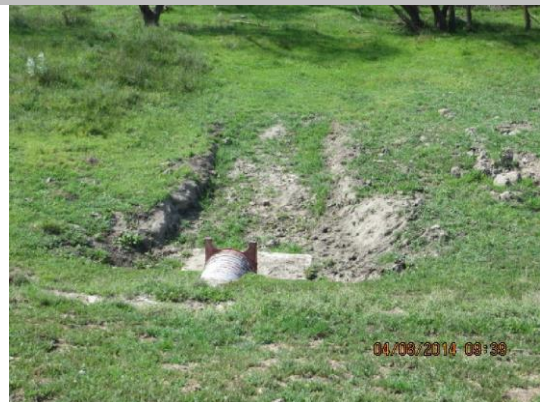
Photo 1 of 3 : UCIP\_SP\_2018\_39099\_60652.jpg

Comment Code					
Inspector Comment					
FS_ID:39099					
DS_ID:19588					
EP_NO: N/A					
Repair Type: Non-Urgent					
Crossing Status: Found					
UCIP Comments: Some sediment buildup inside pipe at LS toe.					
Recommend contacting owner to clear sediment buildup and check wall integrity through pipe section.					
FIELD_STRUCT_DESC: 24-inch corrugated metal gravity drainage pipe through the levee, 11 feet below the crown. Flap gate on the waterside (WS) end. Brass cap No. 108 bench mark (BM) on the headwall on the landside (LS). [Additional Reference(s): DWR Levee Log, 2002. USACE San Joaquin O&M Manual 601.1, 1967, (HLM 1.48)].					
FS Date: 4/8/2014

Pipe, flapgate, and concrete headwall visible on WS toe.

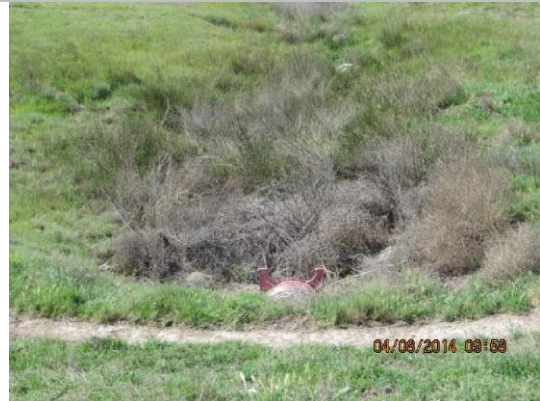
Photo 1 of 3 : UCIP\_SP\_2018\_39100\_60670.jpg

Concrete headwall and flapgate on WS toe.

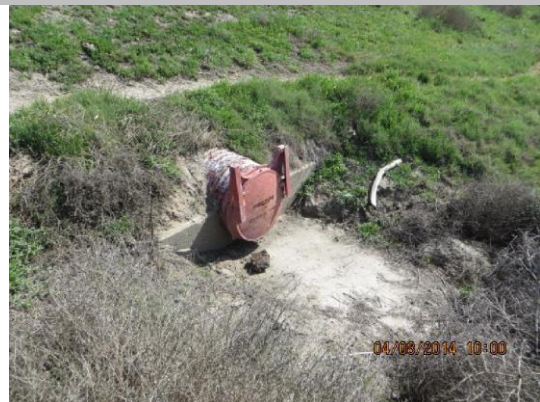
Photo 2 of 3 : UCIP\_SP\_2018\_39100\_60672.jpg

Pipe, flapgate, and headwall on WS toe.

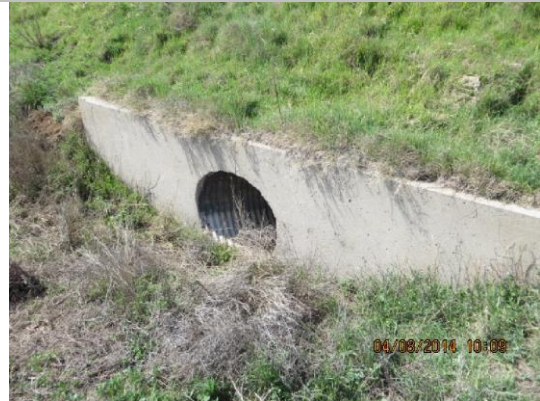
Photo 3 of 3 : UCIP\_SP\_2018\_39125\_71307.jpg

Pipe and headwall on LS toe.

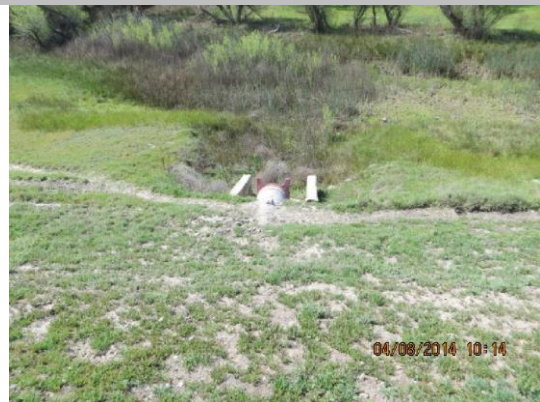
Photo 1 of 3 : UCIP\_SP\_2018\_33568\_60679.jpg

LM Start	2.50	Rating **	A/W	Issue No.	1198
LM End	2.50	Issue Type +	Ma	Location *	
Category	Supplemental			GPS Latitude/Longitude	
				Start	End
Item	DWR UCIP LMA Responsibility			37.328619 °	37.328619 °
				-120.934369 °	-120.934369 °
DWR ID					
Comment Code					
Inspector Comment					
FS_ID:33568					
DS_ID:19572					
EP_NO: N/A					
Repair Type: No Action Needed					
Crossing Status: Found					
UCIP Comments:					
FIELD_STRUCT_DESC: 24-inch corrugated metal gravity drainage pipe through the levee, 8 feet below the crown. Flap gate on the waterside (WS) end. Brass cap No. 100 bench mark (BM) on the headwall on the landside (LS). [Additional Reference(s): DWR Levee Log, 2002. USACE San Joaquin O&M Manual 601.1, 1967, (HLM 2.52)].					
FS Date: 4/8/2014

Pipe, headwall, and flapgate on WS toe.

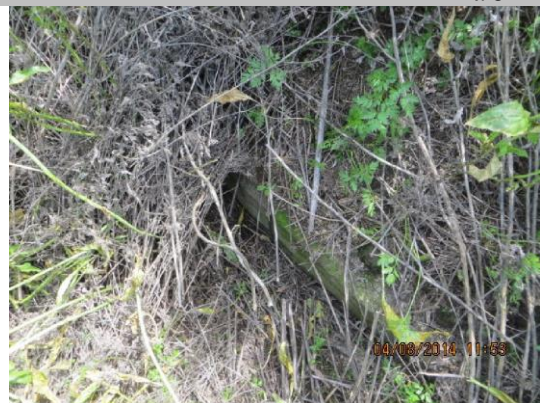
Photo 2 of 2 : UCIP\_SP\_2018\_39151\_60741.jpg

Top of concrete headwall just visible on LS toe.

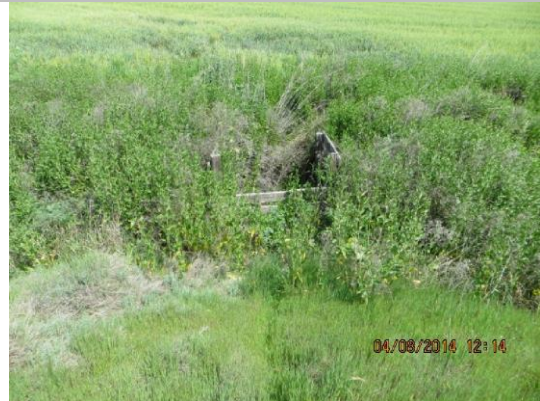
Photo 3 of 3 : UCIP\_SP\_2018\_49962\_60765.jpg

Wooden barrier around drop inlet on LS toe. Excess vegetation.

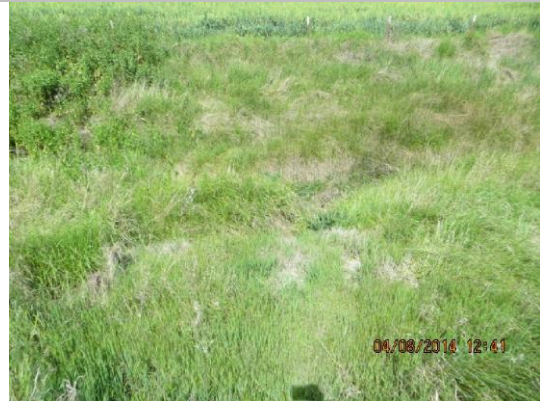
Photo 3 of 3 : UCIP\_SP\_2018\_39161\_60779.jpg

Concrete headwall and pipe visible off LS toe in heavy vegetation.

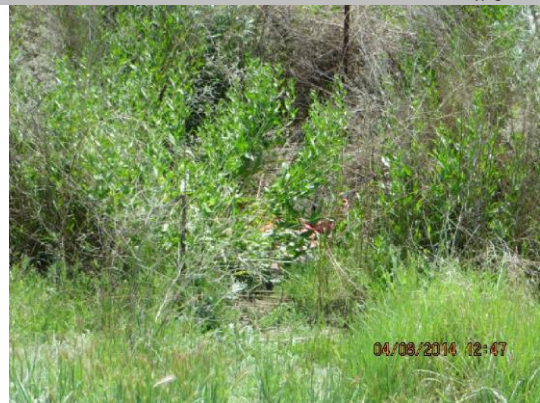
Photo 1 of 3 : UCIP\_SP\_2018\_39243\_60842.jpg

Flapgate and headwall at WS toe. Heavy vegetation on slopes.

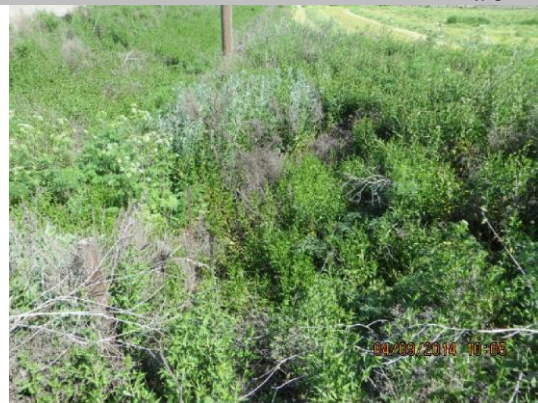
Photo 1 of 2 : UCIP\_SP\_2018\_39250\_60872.jpg

Heavy vegetation on LS toe.

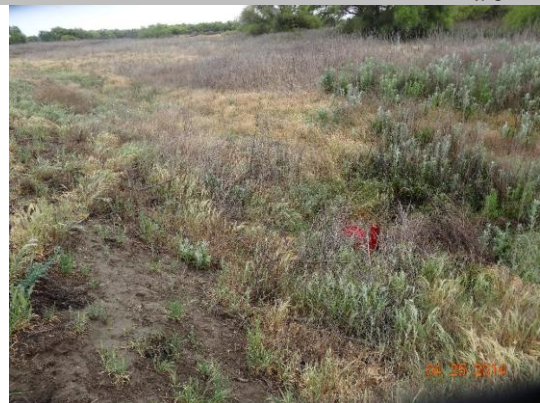
Photo 1 of 3 : UCIP\_SP\_2018\_36169\_65464.jpg

View of waterward side--flap gate visible through dense vegetation.

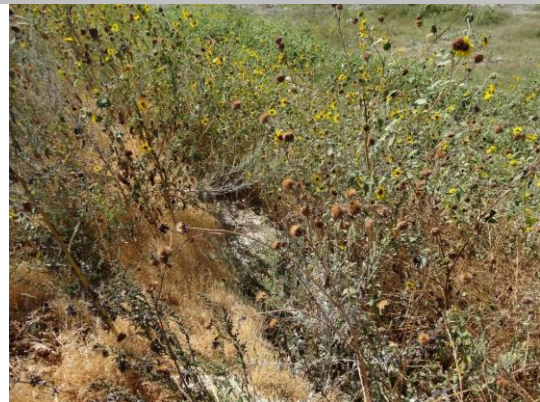
Photo 1 of 4 : SP\_2018\_NA0010\_123\_1\_20180307\_00001.jpg

Looking down at the erosion from the levee top. Note the dense vegetation.

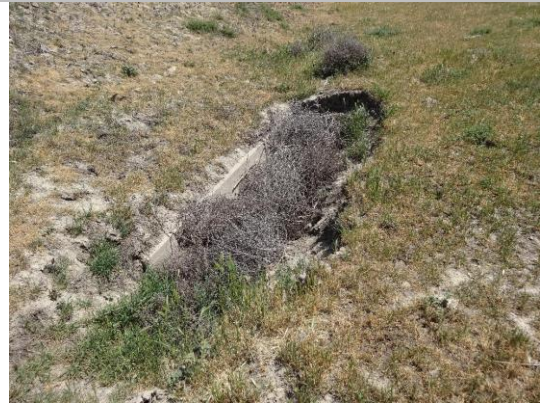
Photo 2 of 2 : UCIP\_SP\_2018\_36607\_66421.jpg

View of landward side--concrete headwall visible through dense vegetation.
