**Flood Control Project Maintenance  
Levee Inspections**

## Maintenance Issue Types Only, Levee Inspection Report By Mile - Spring 2019

### Lower San Joaquin Levee District

Waterway	Bank	Unit Miles	Inspection Start/End	Inspector
Unit No. 01 San Joaquin River	Right	22.52	03/26/2019 03/26/2019	Corey Fujitani

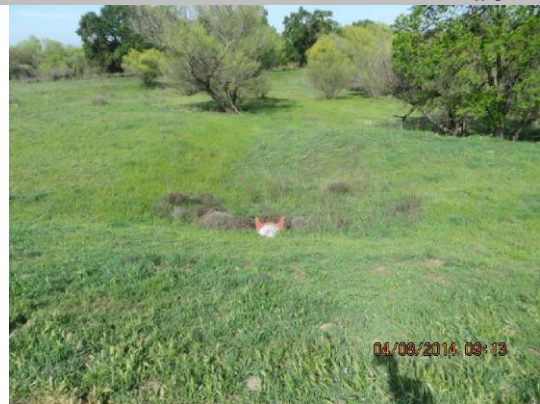
Photo 1 of 3 : UCIP\_SP\_2019\_39095\_60622.jpg

LM Start	0.60	Rating **	M	Issue No.	1187
LM End	0.60	Issue Type +	Ma	Location *	
Category	Supplemental			GPS Latitude/Longitude	
				Start	End
Item	DWR UCIP LMA Responsibility			37.341507 °	37.341507 °
				-120.961283 °	-120.961283 °
DWR ID	19583				
Comment Code					
Inspector Comment					
FS_ID:39095 DS_ID:19583 EP_NO: N/A Repair Type: Non-Urgent Crossing Status: Found UCIP Comments: 04/08/2014 Recommend removing vegetation pile through the levee, 8.5 feet below the crown. Flap gate on the waterside (WS) end. Brass cap No. 108 bench mark (BM) on the headwall on the landside (LS). [Additional Reference(s): DWR Levee Log, 2002. USACE San Joaquin O&M Manual 601.1, 1967, (HLM 0.62)]. FS Date: 4/8/2014

Flapgate and headwall visible on WS toe.

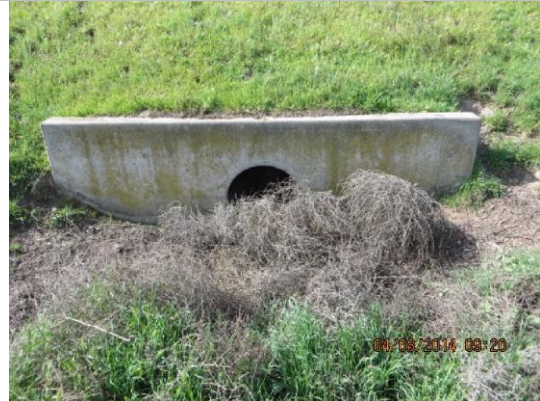
Photo 3 of 3 : UCIP\_SP\_2019\_33524\_60625.jpg

Pipe and headwall visible on LS toe.

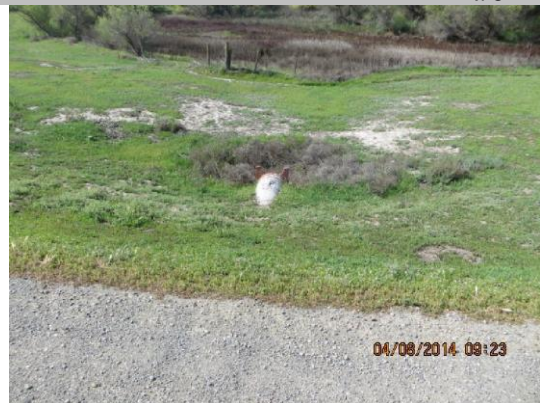
Photo 1 of 3 : UCIP\_SP\_2019\_39096\_60632.jpg

Comment Code						
Inspector Comment						
FS_ID:39096						
DS_ID:19585						
EP_NO: N/A						
Repair Type: Non-Urgent						
Crossing Status: Found						
UCIP Comments: 04/08/2014 Moderate erosion around headwall on landward toe. May or may not be an issue. Need to contact owner to determine status of crossing and to address erosion issue on landward side. (DWR UCIP - W. Wylie)						
FIELD_STRUCT_DESC: 24-inch corrugated metal gravity drainage pipe through the levee, 7 feet below the crown. Flap gate on the waterside (WS) end. Brass cap No. 108 bench mark (BM) on the headwall on the landside (LS). [Additional Reference(s): DWR Levee Log, 2002. USACE San Joaquin O&M Manual 601.1, 1967, (HLM 0.95)].						
FS Date: 4/8/2014

Flapgate, pipe, and headwall on WS toe.

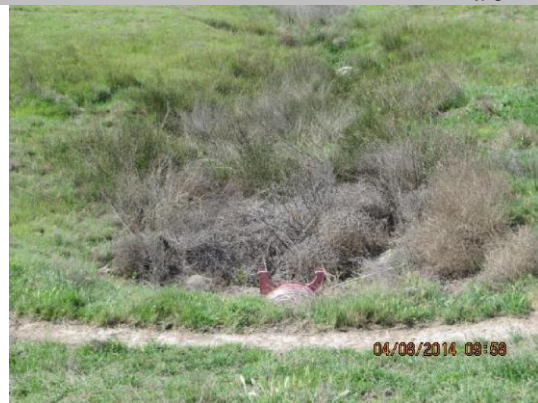
Photo 1 of 3 : UCIP\_SP\_2019\_39100\_60670.jpg

Concrete headwall and flapgate on WS toe.

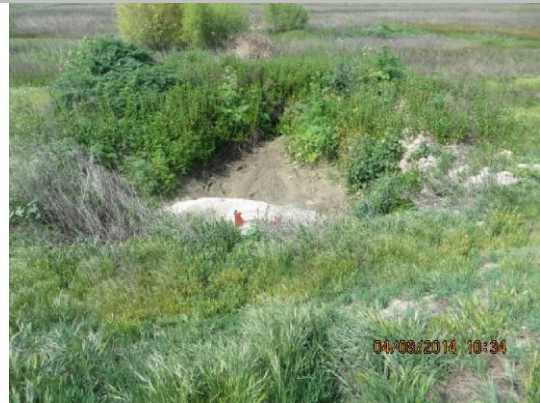
Photo 1 of 3 : UCIP\_SP\_2019\_53188\_60707.jpg

Pipe, headwall, and flapgate on WS toe.

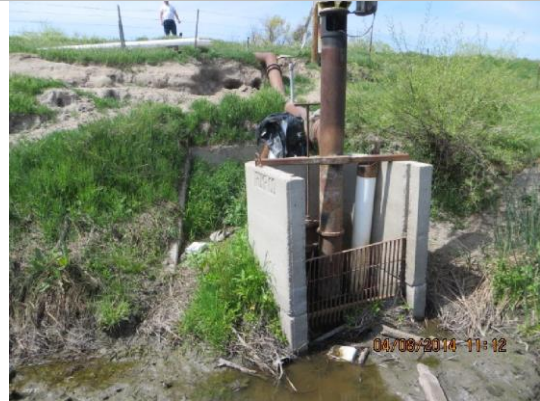
Photo 3 of 3 : UCIP\_SP\_2019\_39134\_60729.jpg

Concrete inlet, slidegate, and concrete headwall at LS toe.

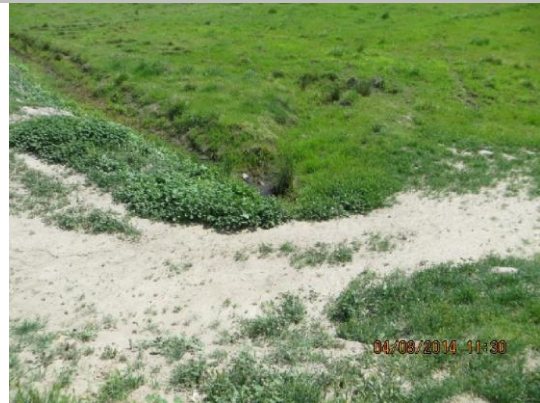
Photo 3 of 3 : UCIP\_SP\_2019\_39141\_60736.jpg

Pipe and concrete headwall on LS toe.

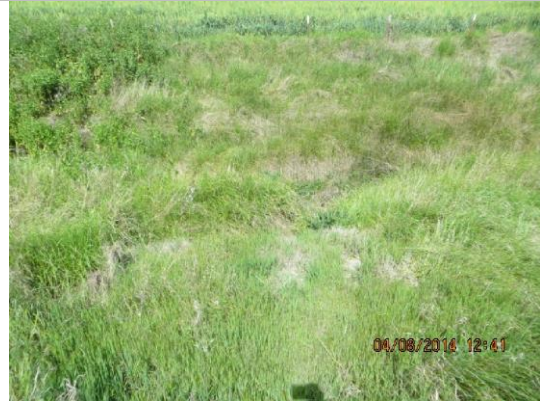
Photo 3 of 3 : UCIP\_SP\_2019\_39161\_60779.jpg

Concrete headwall and pipe visible off LS toe in heavy vegetation.

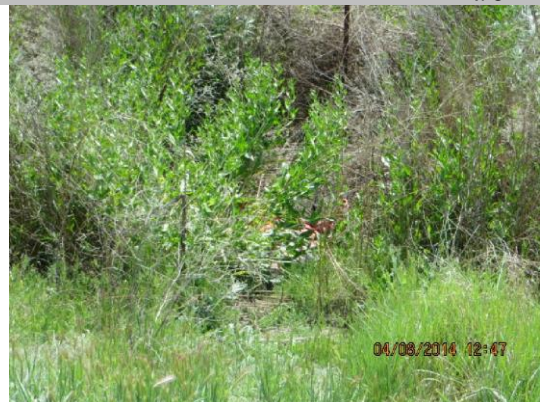
Photo 1 of 3 : UCIP\_SP\_2019\_39243\_60842.jpg

Flapgate and headwall at WS toe. Heavy vegetation on slopes.

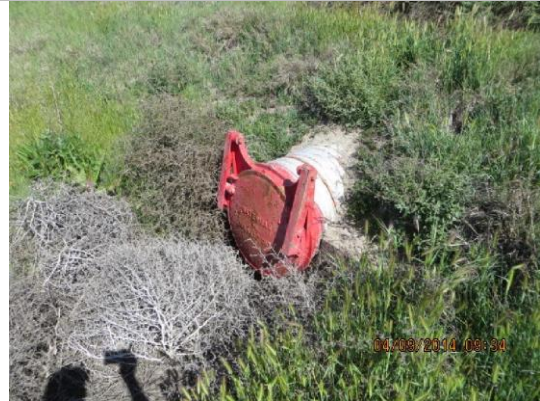
Photo 2 of 3 : UCIP\_SP\_2019\_39245\_60848.jpg

Concrete headwall, pipe, and flapgate at WS toe.

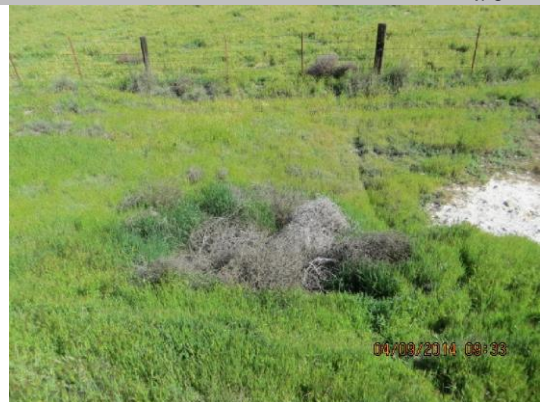
Photo 3 of 3 : UCIP\_SP\_2019\_39245\_60849.jpg

Pipe and concrete headwall at LS toe. Note heavy vegetation.

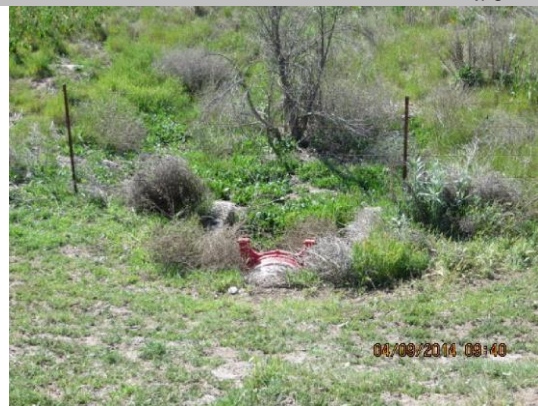
Photo 1 of 3 : UCIP\_SP\_2019\_39246\_60854.jpg

Pipe, Flapgate, and headwall on WS toe.

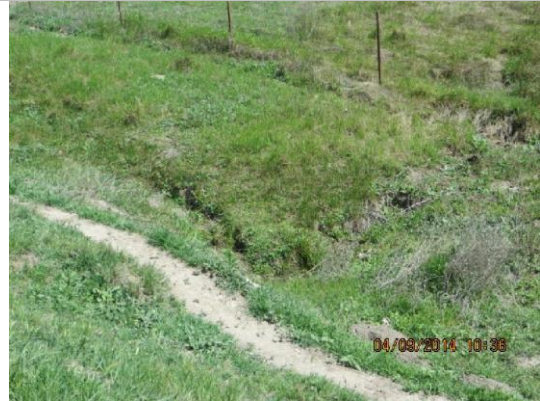
Photo 3 of 3 : UCIP\_SP\_2019\_39253\_60885.jpg

Pipe and headwall at LS toe.

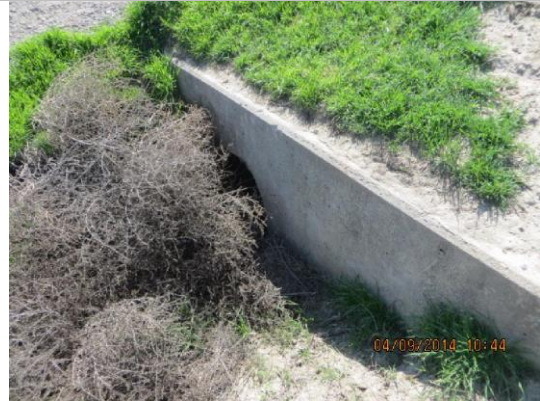
Photo 3 of 3 : UCIP\_SP\_2019\_33687\_60888.jpg

Pipe and headwall on LS toe.

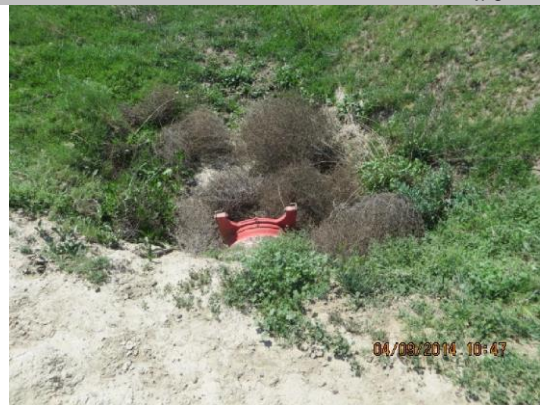
Photo 1 of 3 : UCIP\_SP\_2019\_39254\_60894.jpg

LM Start	10.69	Rating **	A/W	Issue No.	1229
LM End	10.69	Issue Type +	Ma	Location *	
Category	Supplemental			GPS Latitude/Longitude	
				Start	End
Item	DWR UCIP LMA Responsibility			37.283710 °	37.283710 °
				-120.833329 °	-120.833329 °
DWR ID	19631				
Comment Code					
Inspector Comment					
FS_ID:39254					
DS_ID:19631					
EP_NO: N/A					
Repair Type: No Action Needed					
Crossing Status: Found					
UCIP Comments:					
FIELD_STRUCT_DESC: 24-inch corrugated metal gravity drainage pipe					
through the levee, 7 feet below the crown. Flap gate on the waterside					
(WS) end. Brass cap No. 67 bench mark (BM) on the headwall on the					
landside (LS). [Additional Reference(s): DWR Levee Log, 2002. USACE					
San Joaquin O&M Manual 601.1, 1967, (HLM 10.72)].					
FS Date: 4/9/2014

Headwall, pipe, and flapgate on WS toe.

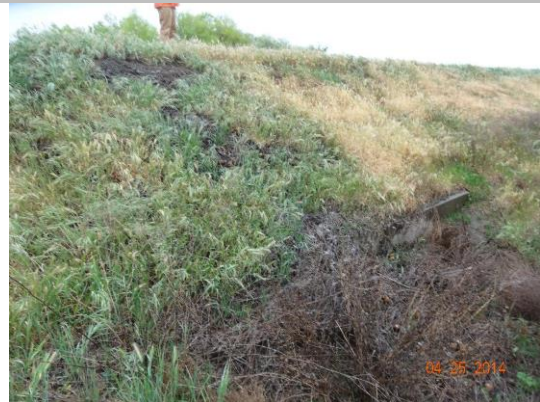
Photo 3 of 3 : UCIP\_SP\_2019\_36146\_65410.jpg

View of landward side--concrete headwall visible covered by dense vegetation.

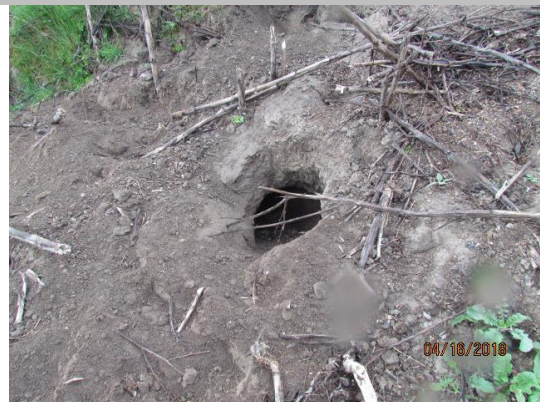
Photo 1 of 2 : SP\_2019\_NA0010\_118\_94\_20190307\_00017.jpg

Looking at large rodent hole on landward slope. (Spring 2018)

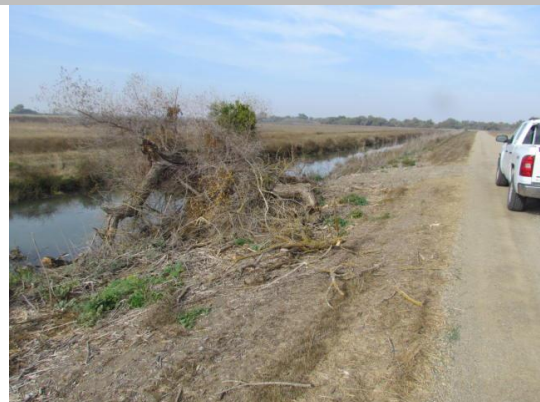
Photo 1 of 2 : SP\_2019\_NA0010\_120\_1\_20190307\_00001.jpg

Looking northwest at tree limb on landward slope.

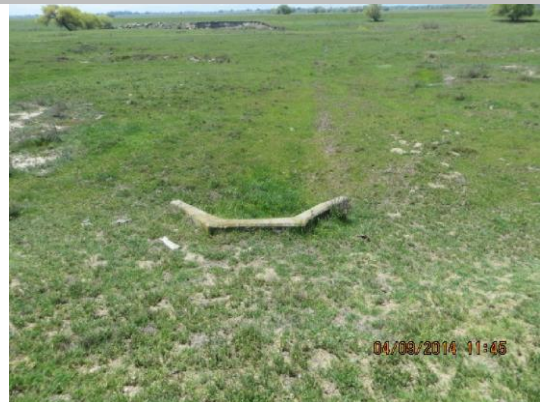
Photo 1 of 3 : UCIP\_SP\_2019\_39584\_60926.jpg

Concrete headwall, pipe, and flapgate on WS toe.

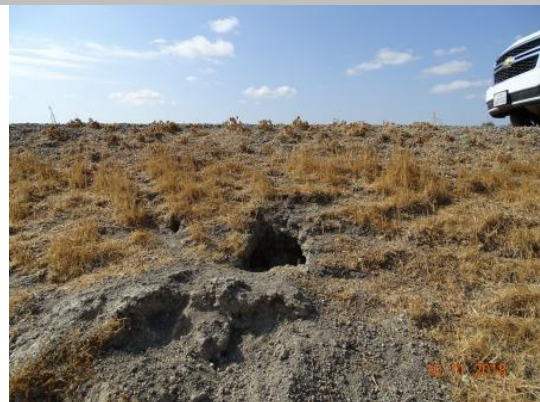
Photo 1 of 2 : SP\_2019\_NA0010\_123\_131\_20190307\_00030.jpg

View of a large rodent hole in landward slope. (Fall 2018)

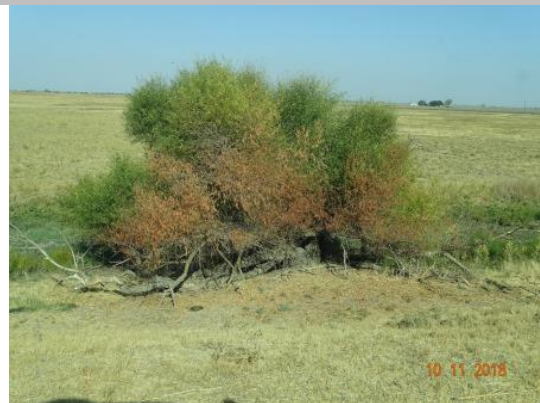
Photo 1 of 1 : SP\_2019\_NA0010\_123\_146\_20190307\_00044.jpg

Tree limbs and trunk on levee toe. (Fall 2018)

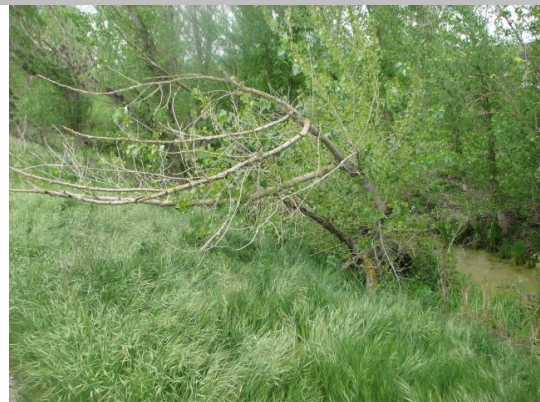
Photo 1 of 1 : SP\_2019\_NA0010\_123\_109\_20190307\_00017.jpg

Looking at broken tree on landward toe. (Spring 2018)

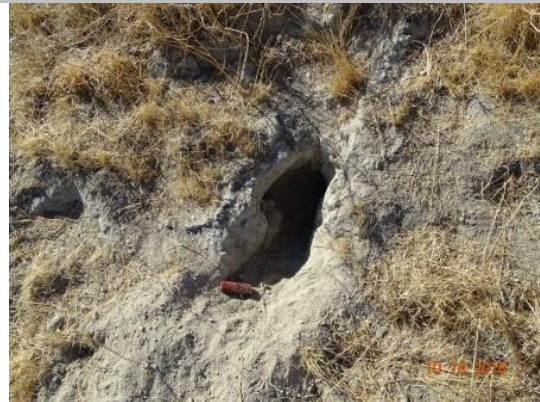
Photo 1 of 1 : SP\_2019\_NA0010\_123\_9\_20190307\_00006.jpg

View of representative rodent burrow. (Fall 2018)

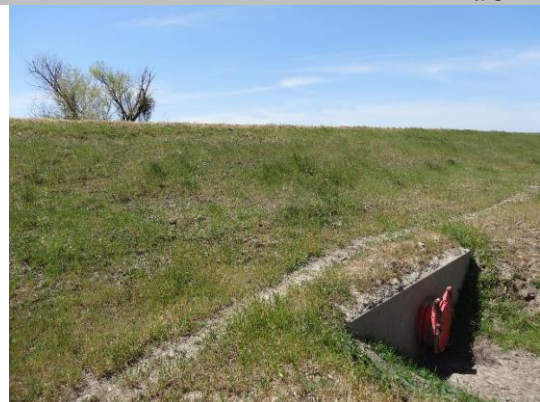
Photo 1 of 2 : UCIP\_SP\_2019\_36607\_66422.jpg

View of waterward side--concrete headwall and flap gate visible.

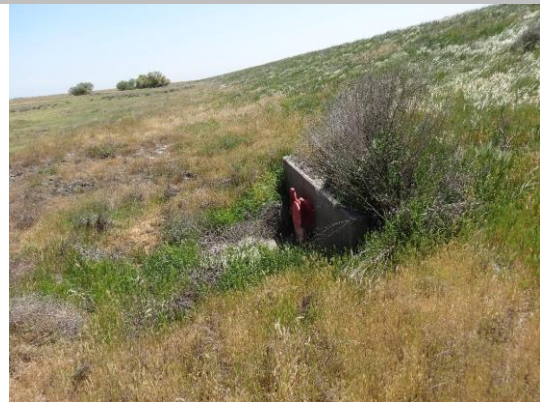
Photo 1 of 3 : UCIP\_SP\_2019\_36611\_66441.jpg

Concrete headwall and flap gate visible on waterward toe.

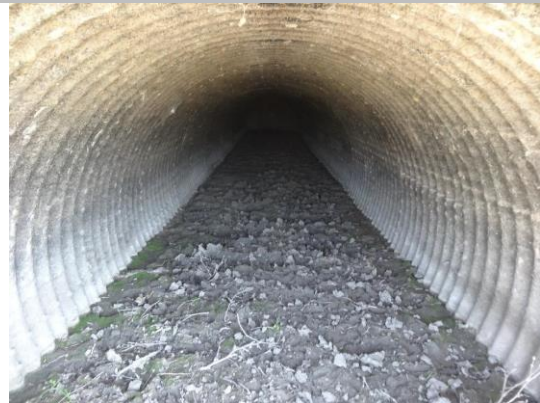
Photo 3 of 3 : UCIP\_SP\_2019\_39521\_62016.jpg

Inside view of pipe from waterward side--sediment build up.

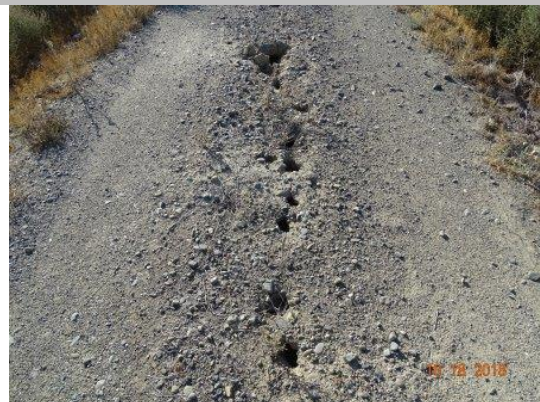
Photo 1 of 1 : SP\_2019\_NA0010\_135\_26\_20190307\_00017.jpg

View of rodent holes along the center of the crown. (Fall 2018)

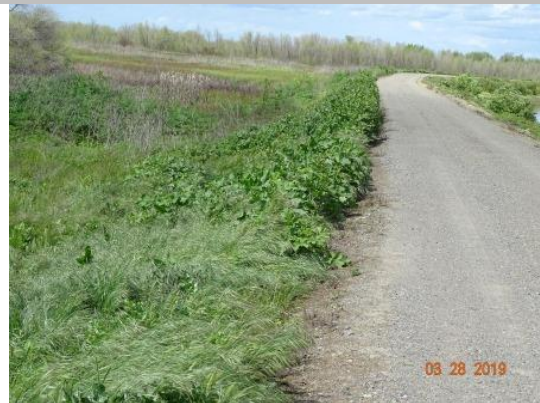
Photo 1 of 1 : SP\_2019\_NA0010\_138\_10\_20190418\_00049.jpg

Representative view of vegetation along landside slope. (Spring 2019)

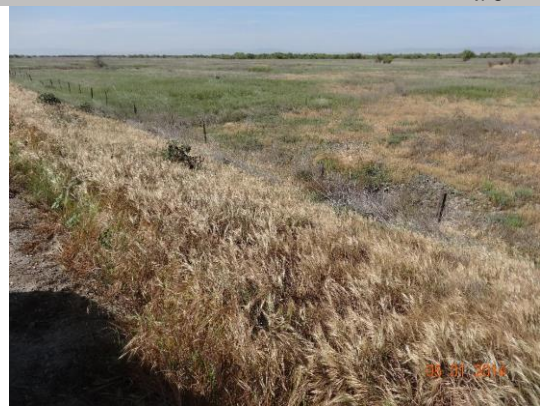
Photo 1 of 3 : UCIP\_SP\_2019\_39501\_67242.jpg

View of waterward side--dense vegetation on waterward side.
