**Flood Control Project Maintenance  
Levee Inspections**

## Maintenance Issue Types Only, Levee Inspection Report By Mile - Spring 2021

### Lower San Joaquin Levee District

Waterway	Bank	Unit Miles	Inspection Start/End	Inspector
Unit No. 01 San Joaquin River	Right	22.52	05/04/2021 05/04/2021	Corey Fujitani

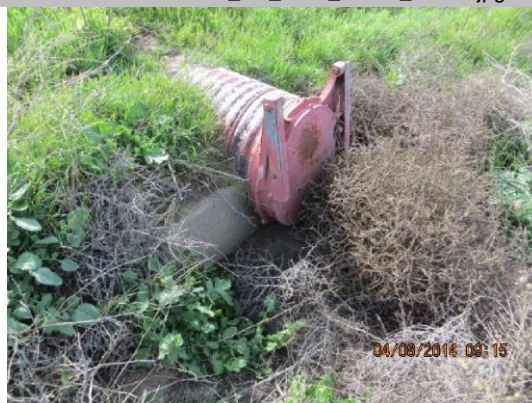
Photo 2 of 3 : UCIP\_SP\_2021\_62645\_60623.jpg

Comment Code						
Inspector Comment						
FS_ID:62645 DS_ID:19583 EP_NO: N/A Repair Type: Non-Urgent Crossing Status: Found UCIP Comments: 10/06/2020 Pipe status is still Non-Urgent. No permit was found authorizing this encroachment. Rodent activity; recommend mitigation. CVFPB will need to review crossing to determine owner. DWR DMP has not found internal issues, LOF between 1 and 2. Recommend inspection in 5 years. (B. Singh - GEI, O. Magana - DWR UCIP)04/08/2014 Recommend removing vegetation pile from waterward toe. (W. Wylie - DWR UCIP) FIELD_STRUCT_DESC: 24-inch corrugated metal gravity drainage pipe through the levee, 8.5 feet below the crown. Flap gate on the waterside (WS) end. Brass cap No. 108 bench mark (BM) on the headwall on the landside (LS). [Additional Reference(s): DWR Levee Log, 2002 (HLM 0.62), listed as a 24-inch corrugated metal pipe (CMP). USACE San Joaquin O&M Manual, Unit 601 Part 1 (SJR601.1), 1967, Revised 25 May 2011, (HLM 0.62), listed as a 24-inch CMP]. FS Date: 10/6/2020

Flapgate and headwall visible on WS toe.

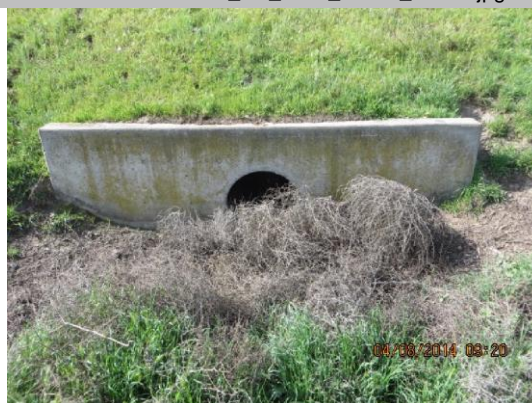
Photo 3 of 3 : UCIP\_SP\_2021\_62646\_60625.jpg

Pipe and headwall visible on LS toe.

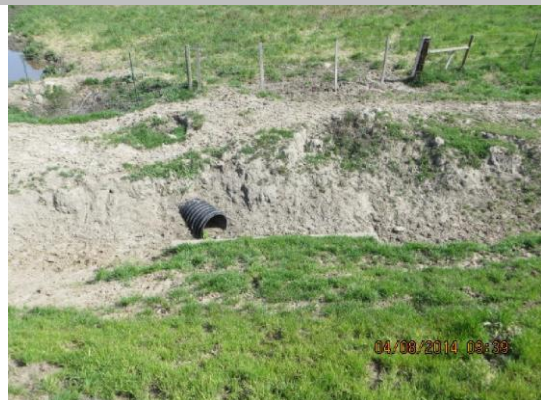
Photo 3 of 3 : UCIP\_SP\_2021\_62618\_60651.jpg

Pipe and concrete headwall visible on LS toe.

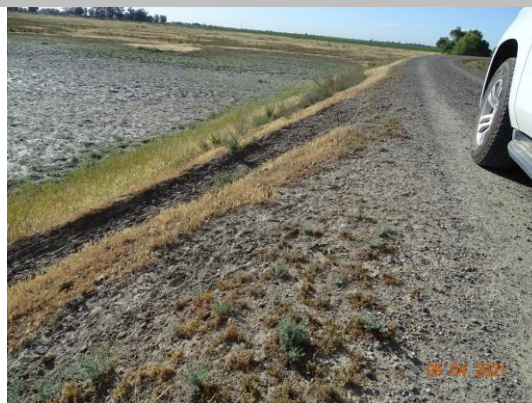
Photo 1 of 1 : SP\_2021\_NA0010\_118\_104\_20210517\_00303.jpg

LM Start	3.06	Rating **	M	Issue No.	104
LM End	3.06	Issue Type +	Ma	Location *	LS
Category	Earthen Levee			GPS Latitude/Longitude	
				Start	End
Item	Animal Control			37.322499 °	37.322499 °
				-120.928986 °	-120.928986 °
DWR ID	DWR_NA0010_01_f_2017_104				
Comment Code					
A2 : Repair the levee slope damaged by livestock and prevent large animal access.					
Inspector Comment					
Slope damage caused by animal foot traffic.

Slope damage on the landside slope from livestock traffic. (Spring 2021)

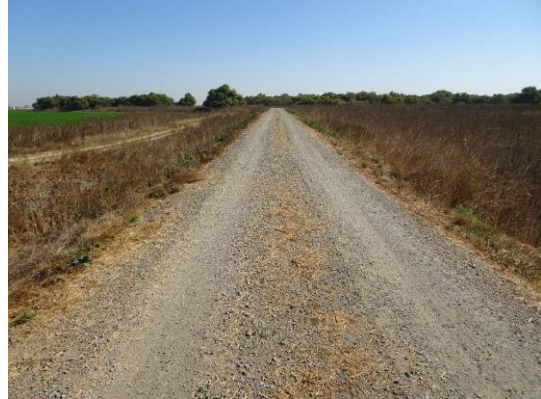
Photo 3 of 3 : UCIP\_SP\_2021\_62650\_90689.jpg

Overview of levee crown, looking US

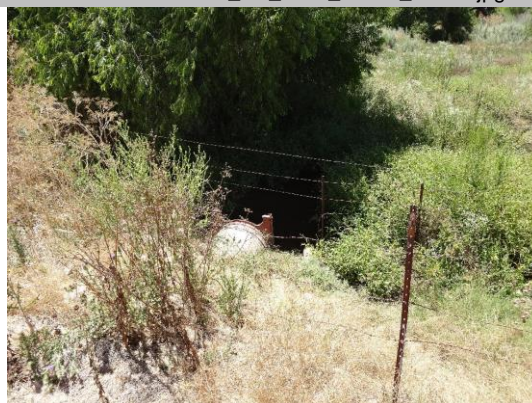
Photo 3 of 3 : UCIP\_SP\_2021\_62642\_75470.jpg

View of WS--fence limits access to flap gate.

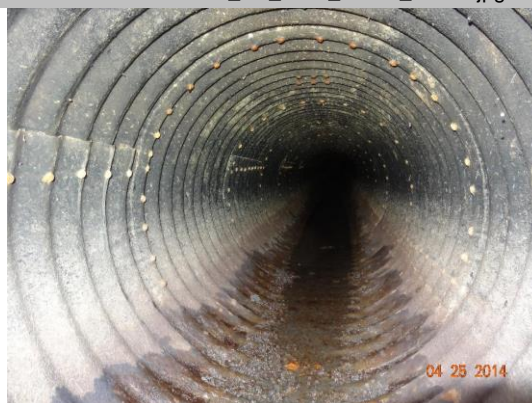
Photo 3 of 3 : UCIP\_SP\_2021\_62702\_65363.jpg

Inside view of pipe from waterward side.

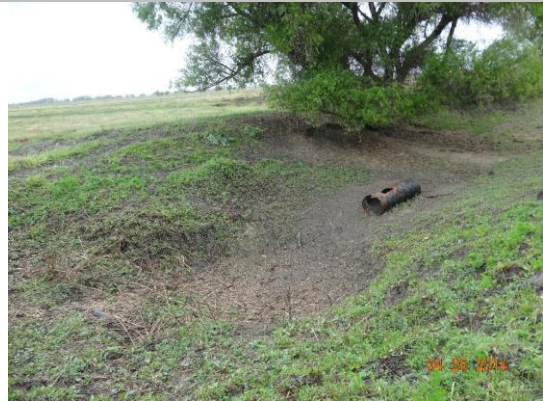
Photo 2 of 3 : UCIP\_SP\_2021\_62703\_65371.jpg

Landward side of crossing buried--damage pipe section visible on landward side.

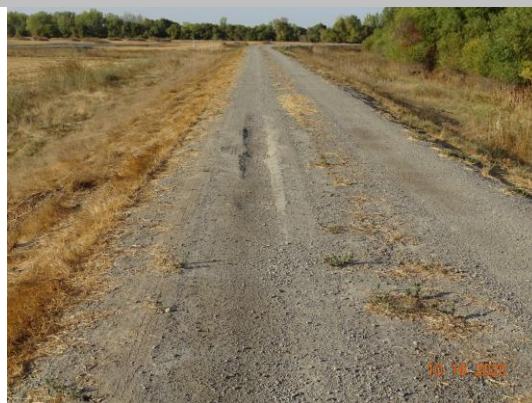
Photo 1 of 1 : SP\_2021\_NA0010\_119\_23\_20210308\_00006.jpg

Rutting along the levee crown. (Fall 2020)

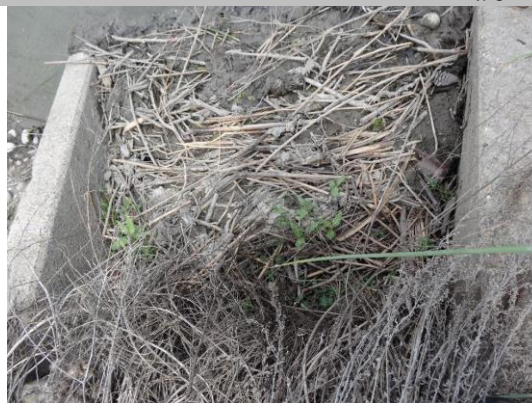
Photo 2 of 3 : UCIP\_SP\_2021\_62029\_61981.jpg

Sediment blocking flap gate located on waterward side.

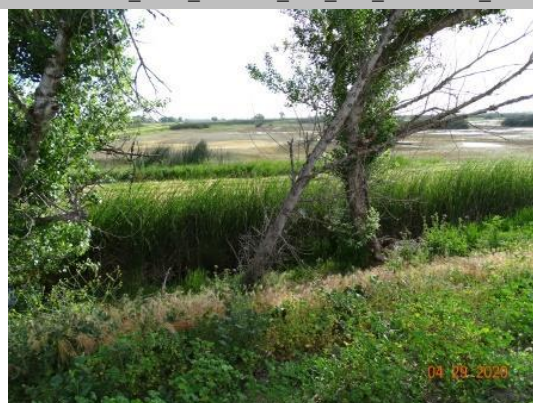
Photo 1 of 1 : SP\_2021\_NA0010\_123\_209\_20210308\_00049.jpg

Dead tree falling over on the landside toe. (Spring 2020)

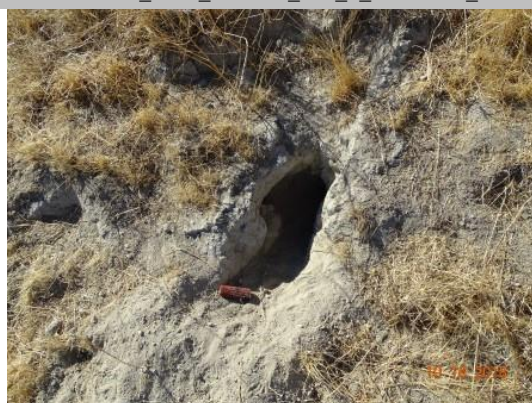
Photo 1 of 1 : SP\_2021\_NA0010\_123\_9\_20210308\_00007.jpg

View of representative rodent burrow. (Fall 2018)

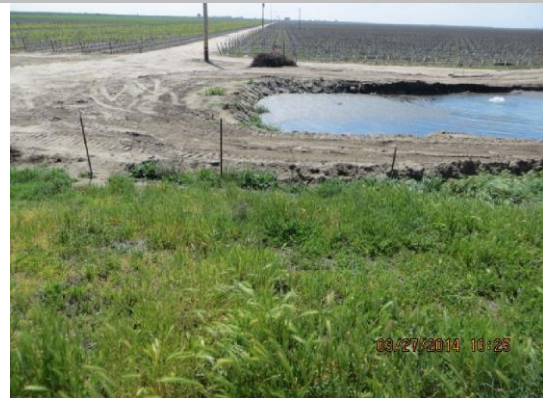
Photo 3 of 3 : UCIP\_SP\_2021\_62083\_59400.jpg

Inlet assumed to be within irrigation structure off LS toe.

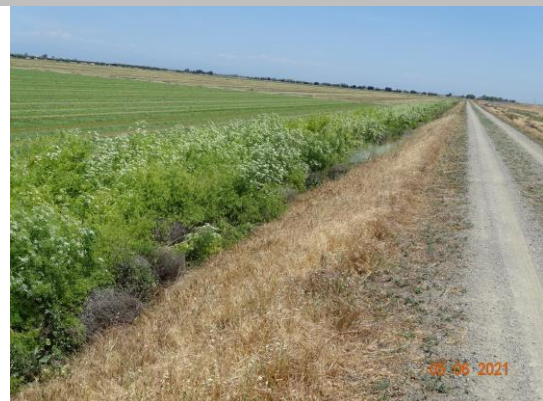
Photo 1 of 1 : SP\_2021\_NA0010\_133\_5\_20210518\_00013.jpg

View of vegetation growing on the landside slope and toe. (Spring 2021)

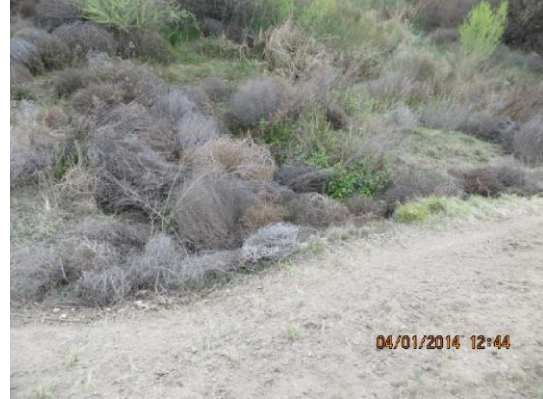
Photo 3 of 3 : UCIP\_SP\_2021\_62098\_59746.jpg

Concrete headwall at channel on LS toe. Heavy vegetation buildup.
