**Flood Control Project Maintenance
Levee Inspections**

Maintenance Issue Types Only, Levee Inspection Report By Mile - Spring 2022

Lower San Joaquin Levee District

Waterway	Bank	Unit Miles	Inspection Start/End	Inspector
Unit No. 01 San Joaquin River	Right	22.52	04/05/2022 04/05/2022	Corey Fujitani

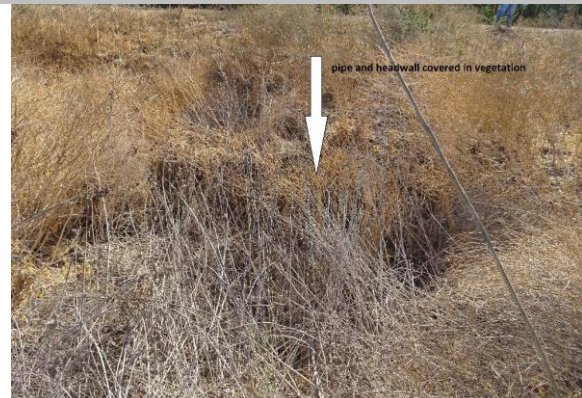
Photo 2 of 3 : UCIP_SP_2022_70675_90790.jpg

LS view: Headwall not visible due to high vegetation on LS toe and slope

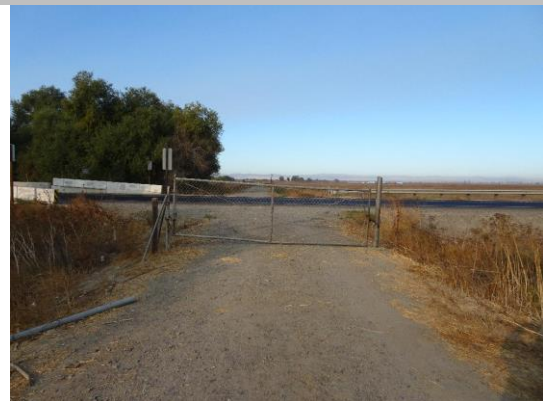
Photo 1 of 3 : UCIP_SP_2022_70676_90906.jpg

Overview of levee crown looking downstream.

Comment Code					
Inspector Comment					
FS_ID:70676 DS_ID:19626 EP_NO: N/A Repair Type: Non-Urgent Crossing Status: Found UCIP Comments: 10/21/2020 Record remains Non-Urgent. Dense vegetation inhibited proper inspection of pipe condition. No permit was found authorizing this encroachment. CVFPB will need to review crossing to determine owner. DWR DMP internal inspection is pending and scheduled for 2021. (B. Singh - GEI, O. Magana - DWR UCIP)04/09/2014 Dense vegetation limits the inspector's visibility to identify signs of pipe failure (leaks) along the slope. Recommend removing vegetation along pipe alignment to conduct proper inspection of structure. (W. Wylie - DWR UCIP) FIELD_STRUCT_DESC: 24-inch corrugated metal (CM) gravity drainage pipe through the levee, 10.0 feet below the crown. Flap gate on the waterside (WS) end. Brass cap No. 80 bench mark (BM) on the headwall on the landside (LS). [Additional Reference(s): DWR Levee Log, 2002, (HLM 9.03). USACE San Joaquin O&M Manual, Unit No. 601, Part No. 1, (SJR601.1), 1967, Revised 25 May 2011, (HLM 9.03)]. FS Date: 10/21/2020

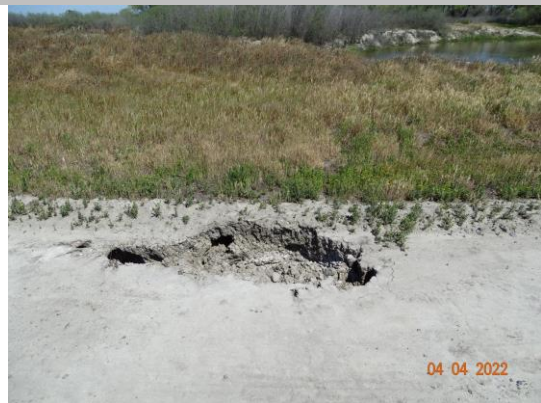
Photo 1 of 1 : SP_2022_NA0010_119_26_20220412_00072.jpg

Ground on the landside toe collapsed from rodent activity. (Spring 2022)

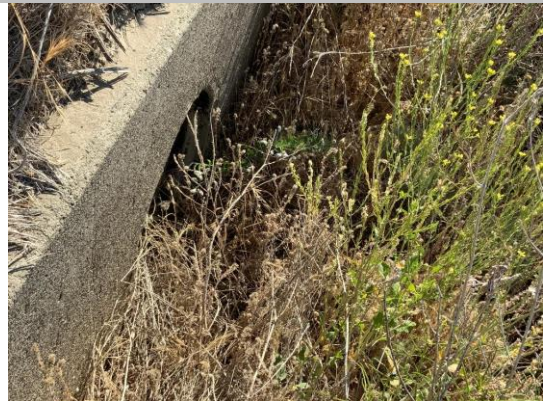
Photo 3 of 3 : UCIP_SP_2022_70936_100081.jpg

LS view: Headwall and inlet barely visible at toe due to vegetation.

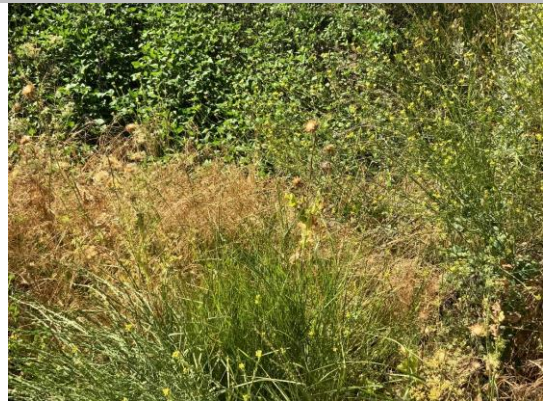
Photo 3 of 3 : UCIP_SP_2022_70938_100096.jpg

LS view: Headwall and inlet covered in vegetation at toe.

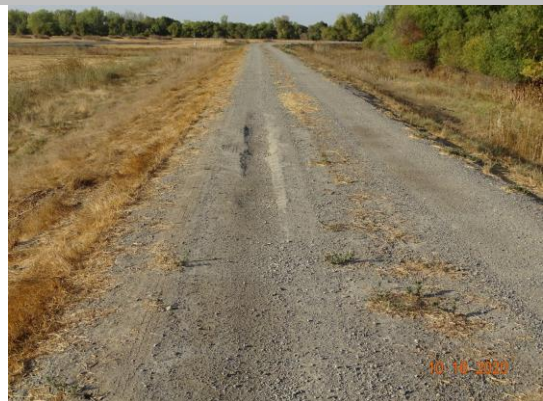
Photo 1 of 1 : SP_2022_NA0010_119_23_20220308_00005.jpg

Rutting along the levee crown. (Fall 2020)

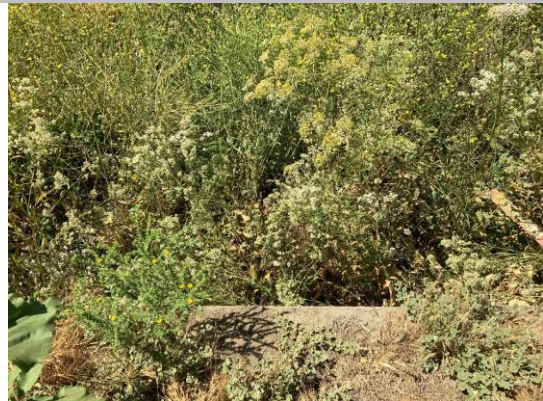
Photo 3 of 3 : UCIP_SP_2022_70957_100363.jpg

LS view: Top of headwall visible, pipe inlet covered with dense vegetation.

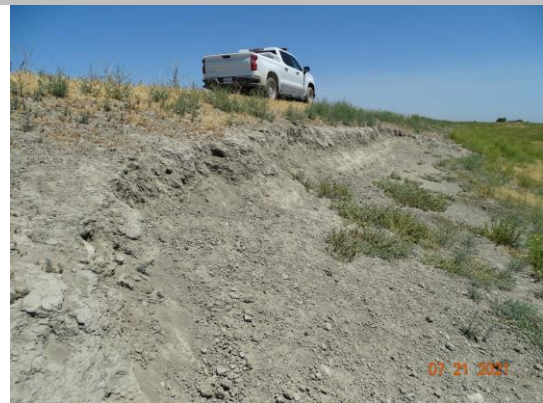
Photo 2 of 3 : SP_2022_NA0010_123_3_20220308_00005.jpg

7/21/2021: View of a large erosion pocket.

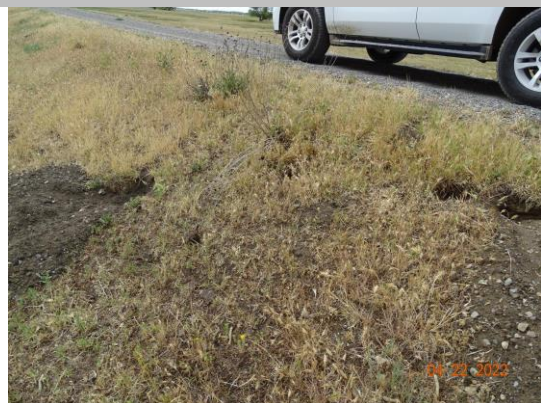
Photo 1 of 1 : SP_2022_NA0010_124_148_20220425_00229.jpg

View of active rodent burrows on waterside slope. (Spring 2022)

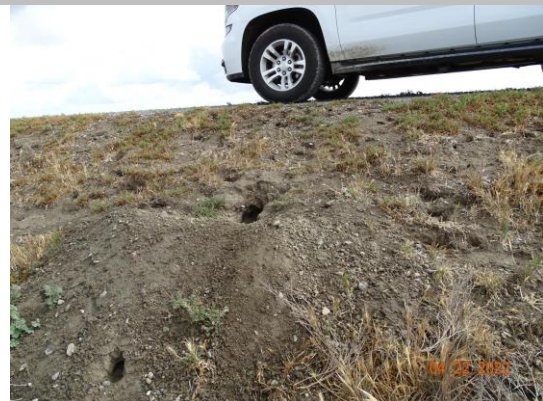
Photo 1 of 1 : SP_2022_NA0010_124_146_20220425_00230.jpg

View of rodent holes on the landside slope. (Spring 2022)

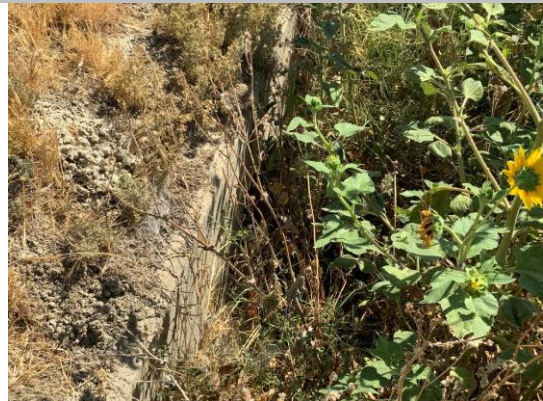
Photo 3 of 3 : UCIP_SP_2022_71096_102930.jpg

LS view: Closeup of pipe inlet at toe covered with vegetation.

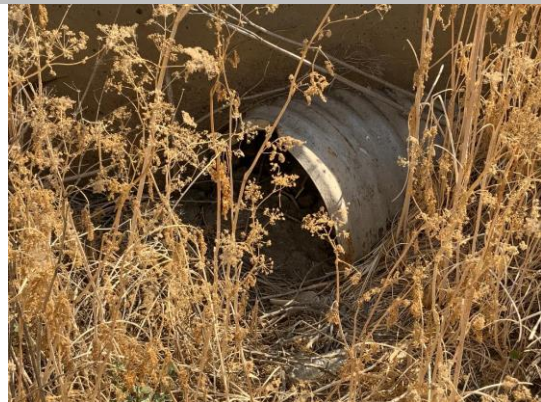
Photo 2 of 3 : UCIP_SP_2022_71133_102351.jpg

LS view: Closeup of pipe inlet at toe with sediment buildup.

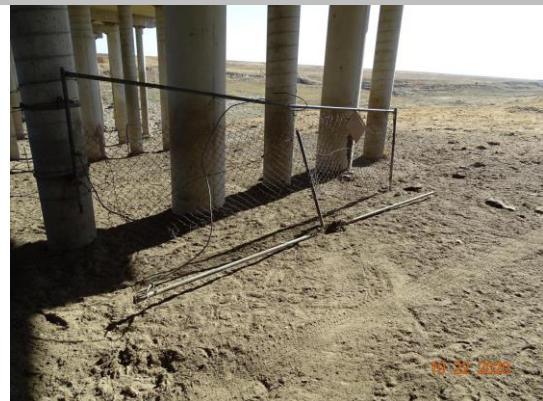
Photo 1 of 1 : SP_2022_NA0010_124_78_20220308_00014.jpg

View of damaged access gate under highway 152. (Fall 2020)

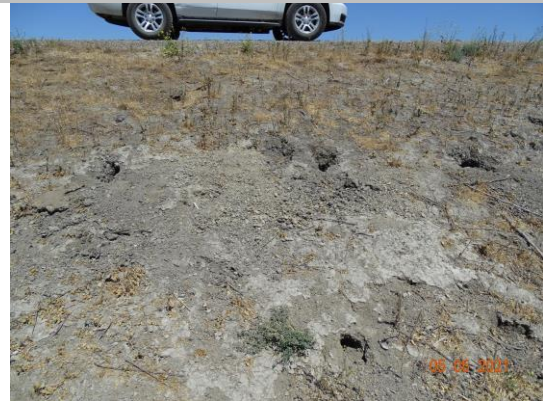
Photo 1 of 1 : SP_2022_NA0010_127_6_20220308_00003.jpg

View of rodent burrows in the waterside slope. (Spring 2021)

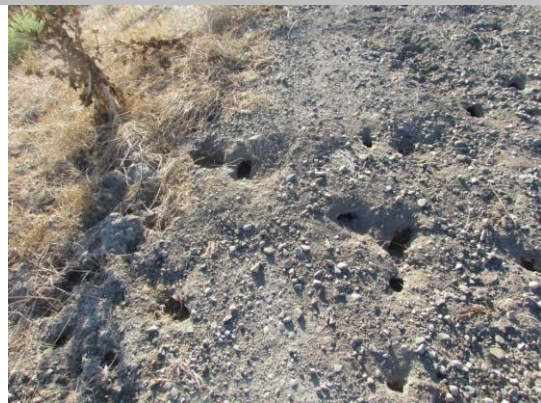
Photo 1 of 1 : SP_2022_NA0010_134_3_20220308_00002.jpg

Looking at several rodent holes and mole holes on levee crown.

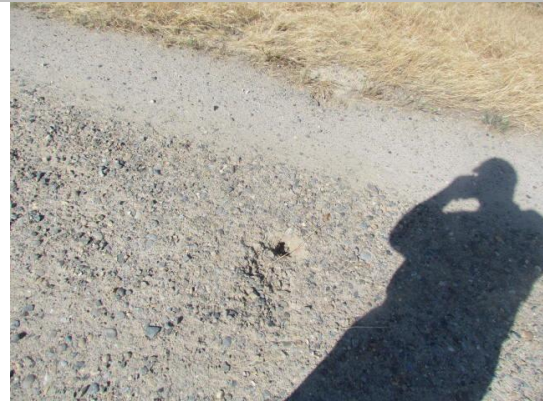
Photo 1 of 1 : SP_2022_NA0010_137_7_20220308_00001.jpg

Looking at typical view of rodent holes within this section on landward slope.

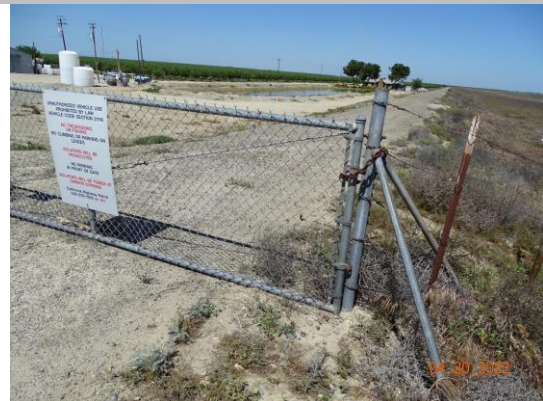
Photo 1 of 1 : SP_2022_NA0010_137_42_20220502_00059.jpg

View of broken hinges on the levee access gate. (Spring 2022)

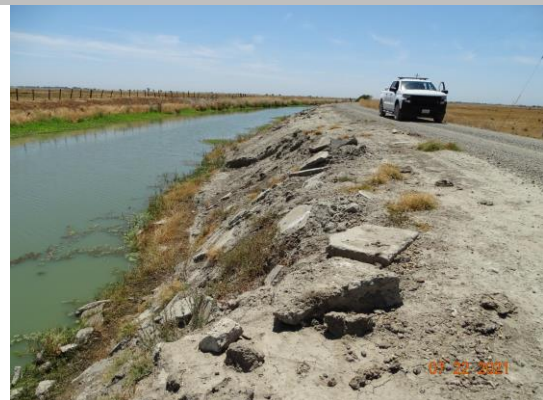
Photo 2 of 2 : SP_2022_NA0010_138_3_20220308_00006.jpg

7/22/2021: View of the eroded levee slope looking upstream.

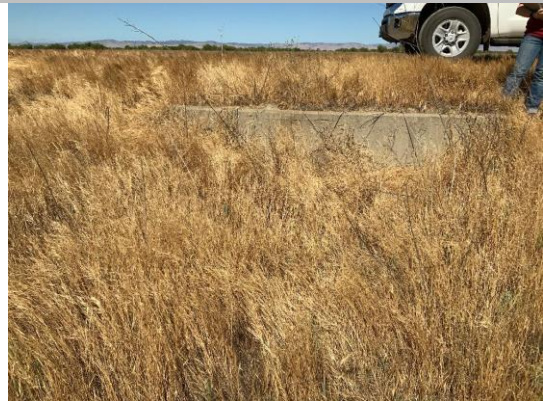
Photo 3 of 3 : UCIP_SP_2022_67747_100731.jpg

LS view: Headwall barely visible from toe.
