**Flood Control Project Maintenance
Levee Inspections**

Maintenance Issue Types Only, Levee Inspection Report By Mile - Spring 2024

Lower San Joaquin Levee District

Waterway	Bank	Unit Miles	Inspection Start/End	Inspector
Unit No. 01 San Joaquin River	Right	22.52	03/12/2024 03/12/2024	Corey Fujitani

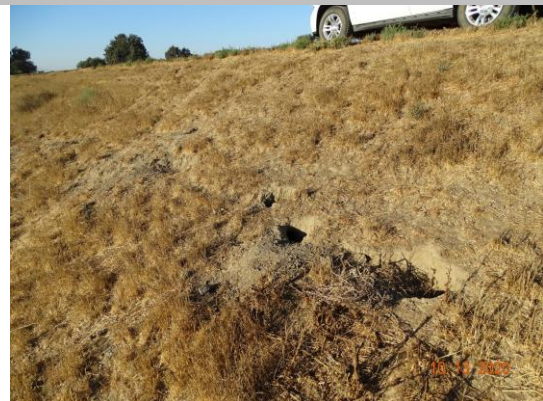
Photo 1 of 1 : SP_2024_NA0010_118_95_20240212_00005.jpg

Several rodent holes observed in the landside slope. (Fall 2020)

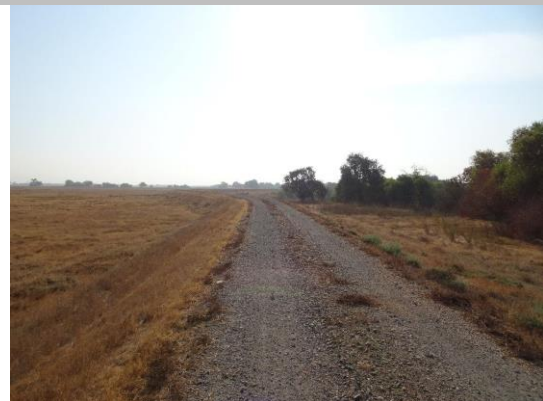
Photo 1 of 3 : UCIP_SP_2024_70639_90541.jpg

Overview of levee crown, looking US

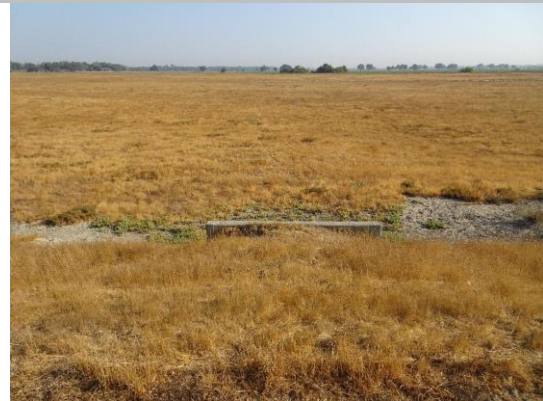
Photo 3 of 3 : UCIP_SP_2024_83233_90552.jpg

LS view: Headwall visible on LS toe

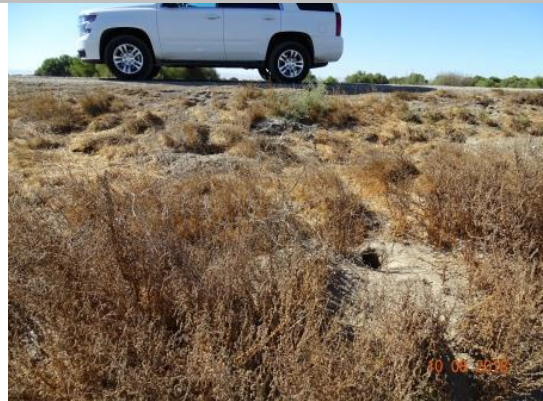
Photo 1 of 1 : SP_2024_NA0010_118_116_20240212_00017.jpg

View of landside slope with rodent holes. (Fall 2018)

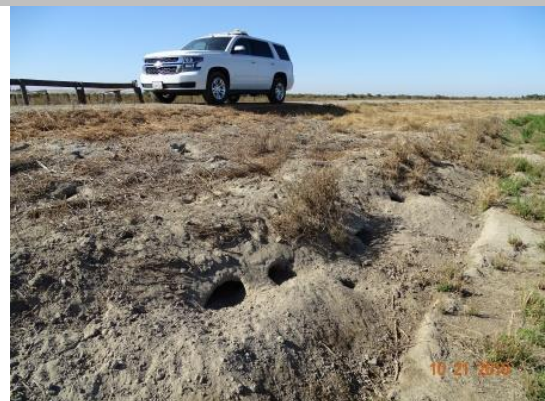
Photo 1 of 1 : SP_2024_NA0010_118_2_20240212_00001.jpg

View of rodent burrows in this section looking downstream. (Fall 2019)

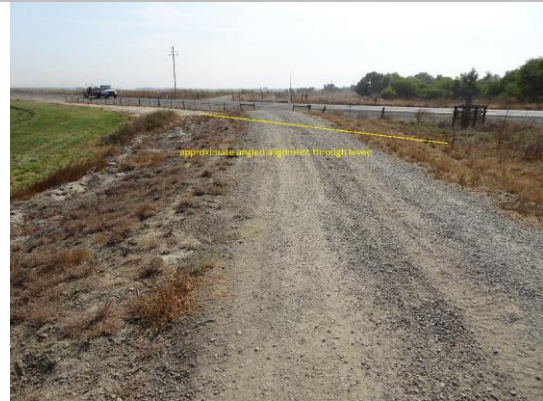
Photo 1 of 3 : UCIP_SP_2024_70653_90650.jpg

Overview of levee crown, looking US. Angled pipe alignment through levee crown approximated.

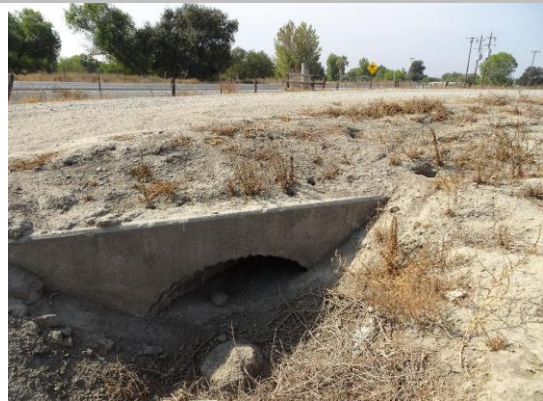
Photo 3 of 3 : UCIP_SP_2024_70653_90655.jpg

LS view: Pipe and headwall at LS toe. Heavy siltation at invert.

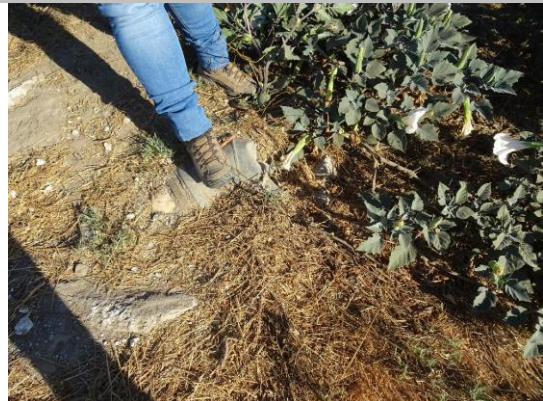
Photo 3 of 3 : UCIP_SP_2024_70655_90665.jpg

LS view: Abandoned pipe through levee crown

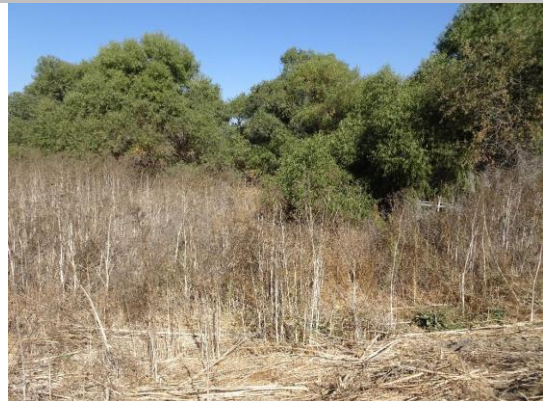
Photo 3 of 3 : UCIP_SP_2024_77851_90697.jpg

LS view: View toward LS toe. Slidegate visible through dense vegetation

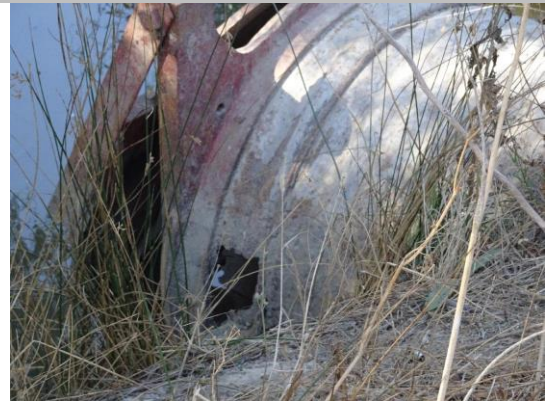
Photo 3 of 3 : UCIP_SP_2024_70664_90723.jpg

WS view: Extensive corrosion visible at WS invert

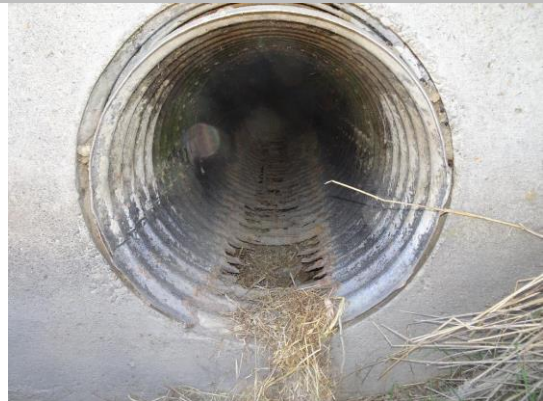
Photo 3 of 3 : UCIP_SP_2024_70665_90720.jpg

LS view: Headwall and deeply corroded pipe at LS toe

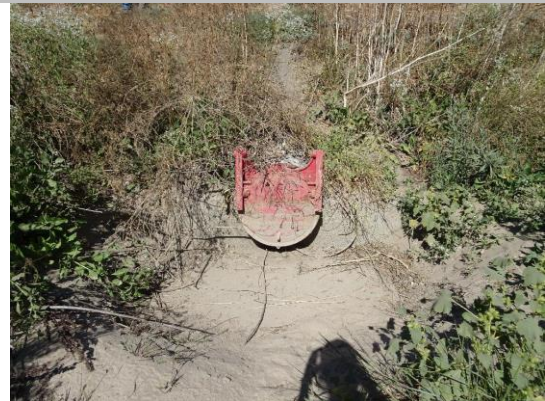
Photo 3 of 3 : UCIP_SP_2024_83244_90736.jpg

WS view: Pipe, flapgate and headwall at WS toe. Flapgate damaged and non-functional

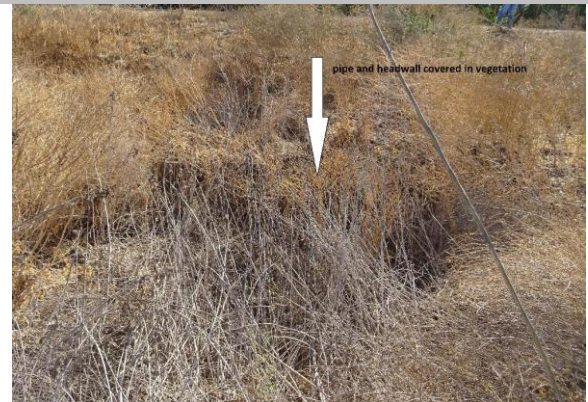
Photo 2 of 3 : UCIP_SP_2024_70675_90790.jpg

LS view: Headwall not visible due to high vegetation on LS toe and slope

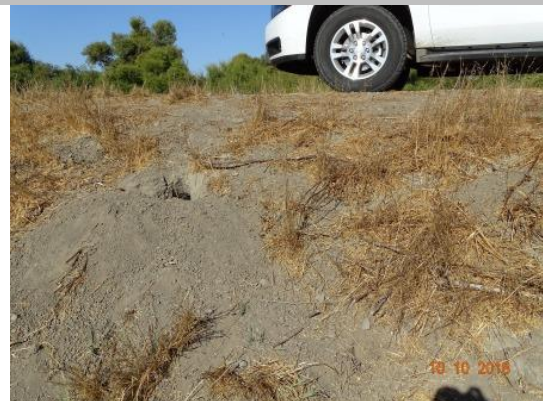
Photo 1 of 1 : SP_2024_NA0010_118_120_20240212_00020.jpg

View of rodent burrow in the landside slope. (Fall 2018)

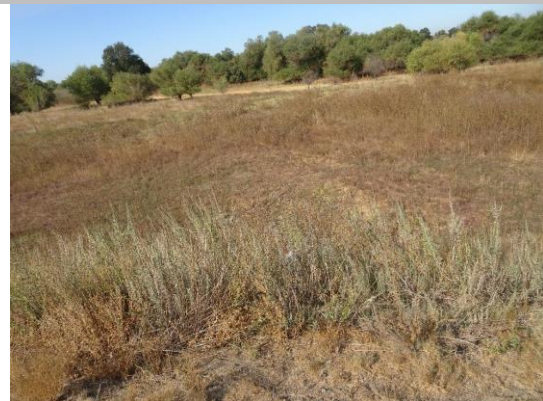
Photo 2 of 3 : UCIP_SP_2024_83274_90960.jpg

WS view: dense vegetation near WS toe.

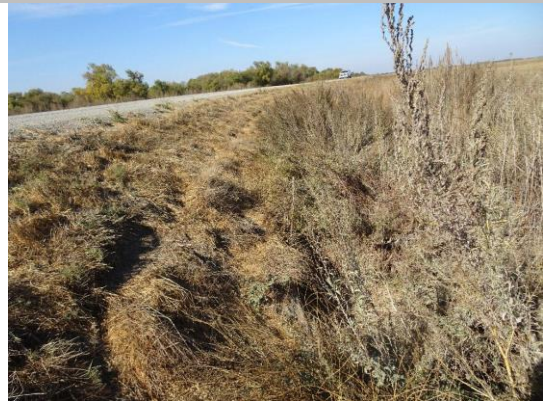
Photo 3 of 3 : UCIP_SP_2024_83265_90799.jpg

LS view: Headwall at LS toe. Dense vegetation inhibited proper inspection of pipe.

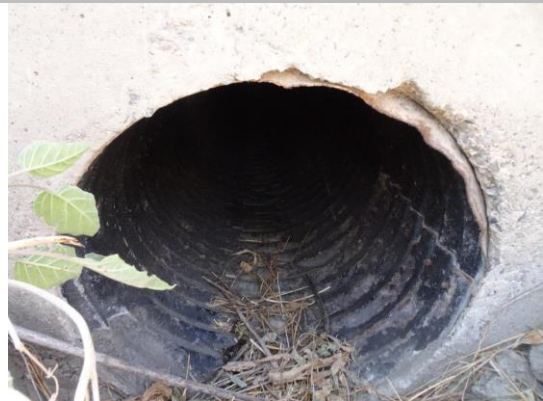
Photo 3 of 3 : UCIP_SP_2024_83268_90829.jpg

LS view: minor damage to headwall concrete at inlet on LS toe.

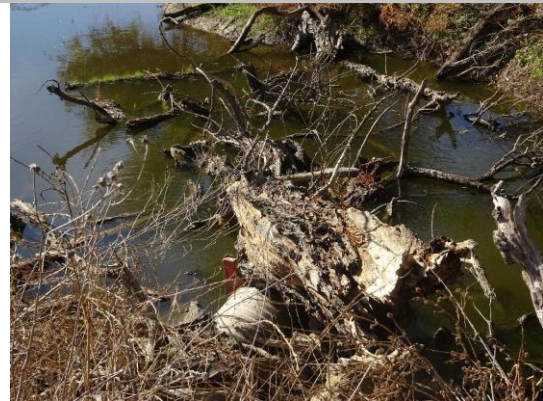
Photo 3 of 3 : UCIP_SP_2024_81000_90837.jpg

WS view: debris blocking pipe flapgate at WS toe.

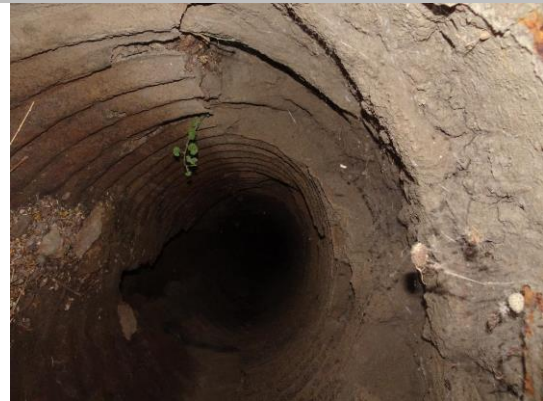
Photo 3 of 3 : UCIP_SP_2024_70708_90848.jpg

LS view: Considerable damage observed at LS inlet

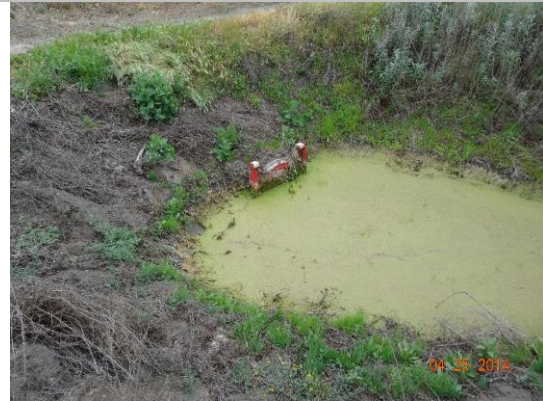
Photo 1 of 3 : UCIP_SP_2024_80999_66313.jpg

Flap gate half way submersed located on waterward side.

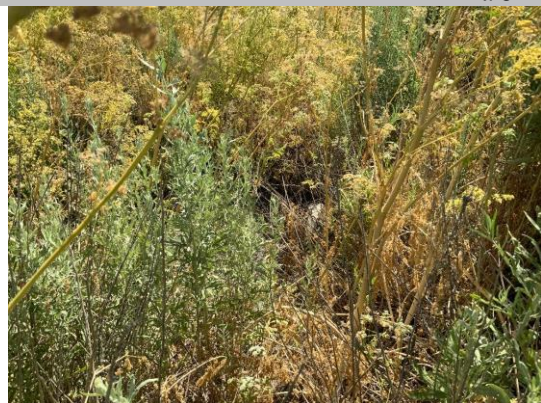
Photo 2 of 2 : UCIP_SP_2024_70960_100382.jpg

WS view: Dense vegetation covering flapgate at toe.

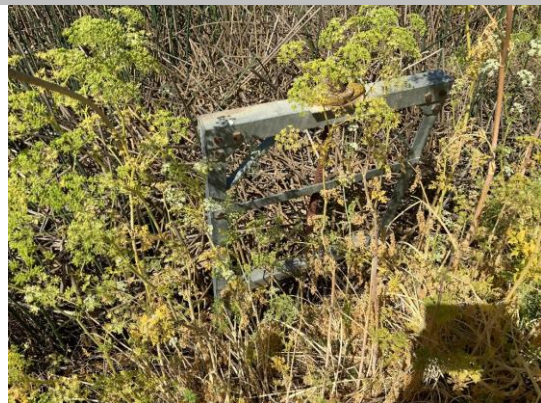
Photo 1 of 1 : UCIP_SP_2024_70961_100390.jpg

LS view: Headwall barely visible at toe, inlet covered in vegetation.

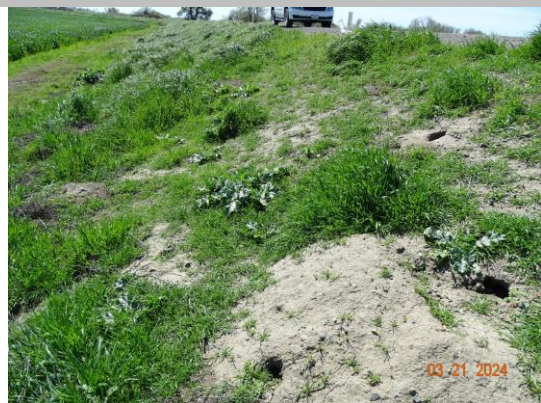
Photo 1 of 1 : SP_2024_NA0010_121_67_20240326_00017.jpg

View of rodent burrows on the landside slope. (Spring 2024)

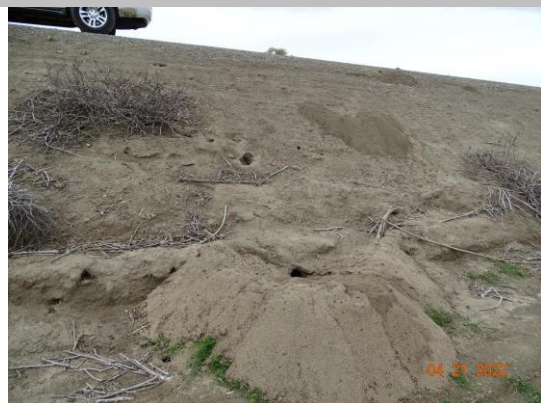
Photo 1 of 1 : SP_2024_NA0010_121_11_20240212_00004.jpg

View of several rodent holes with large amounts of material displaced. (Spring 2022)

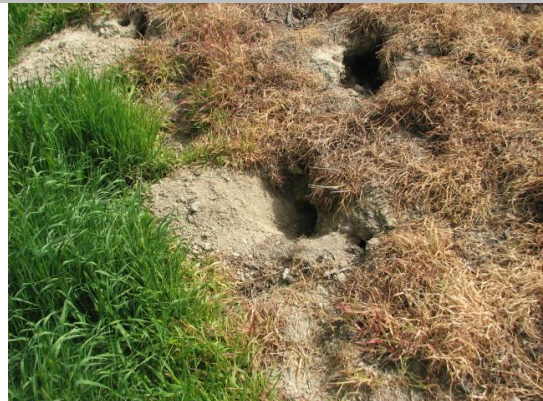
Photo 1 of 1 : SP_2024_NA0010_123_134_20240212_00028.jpg

Looking at typical rodent holes within this section. (Spring 2018)

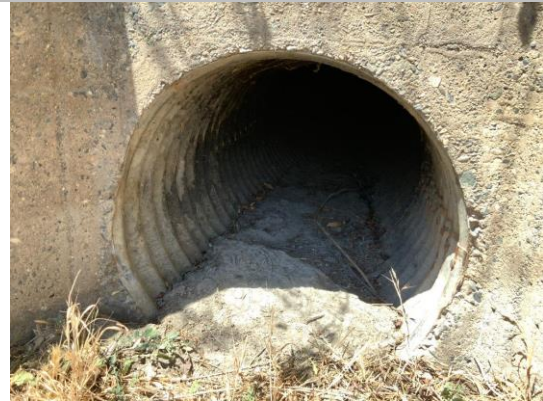
Photo 1 of 1 : UCIP_SP_2024_70993_99703.jpg

LS view: Close up of pipe inlet with sediment buildup at toe.

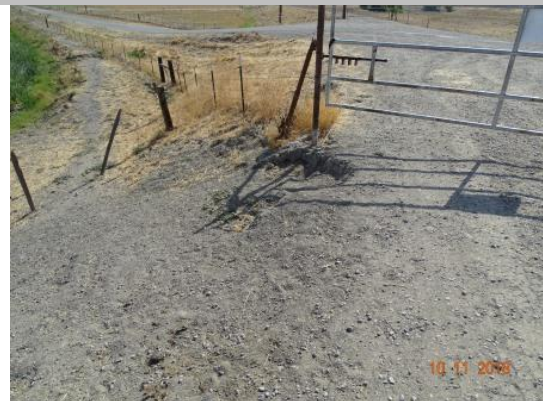
Photo 1 of 1 : SP_2024_NA0010_123_140_20240212_00032.jpg

Erosion on landward slope caused by animal foot traffic. (Fall 2018)

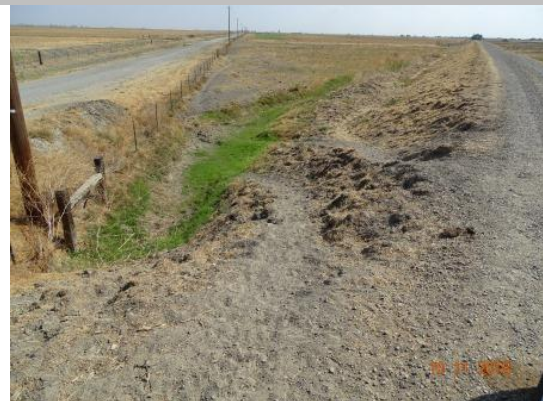
Photo 1 of 1 : SP_2024_NA0010_123_1309_20240212_00075.jpg

Looking upstream at damaged landside slope. (Fall 2018)

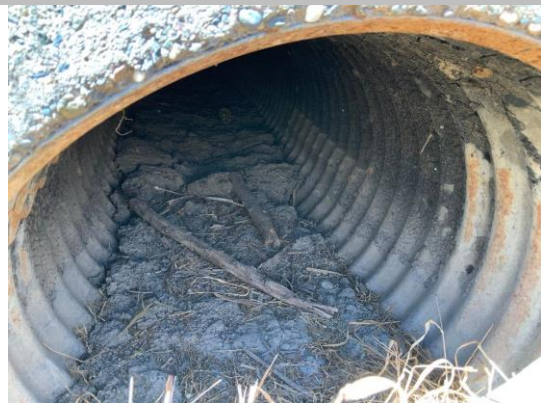
Photo 1 of 1 : UCIP_SP_2024_71000_100779.jpg

LS view: Closeup of pipe inlet with sediment buildup at toe.

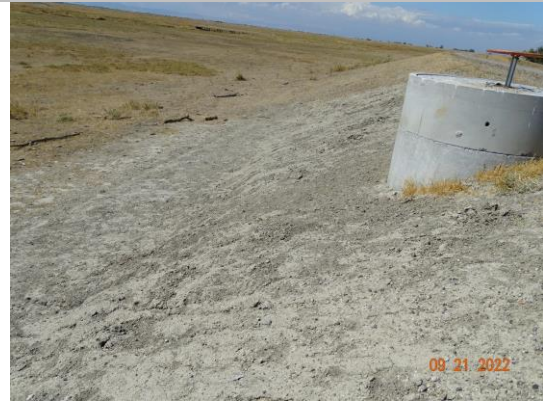
Photo 1 of 1 : SP_2024_NA0010_123_174_20240212_00059.jpg

Erosion on the waterside slope from livestock activity. (Fall 2022)

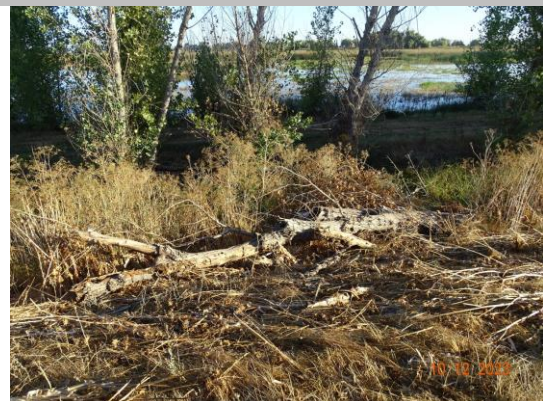
Photo 1 of 1 : SP_2024_NA0010_123_158_20240212_00045.jpg

View of downed tree limb on the landside slope. (Fall 2023)

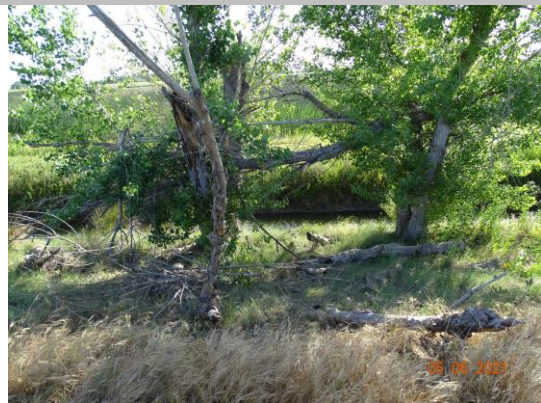
Photo 1 of 1 : SP_2024_NA0010_123_112_20240212_00014.jpg

View of tree limbs on the landside toe and slope. (Spring 2021)

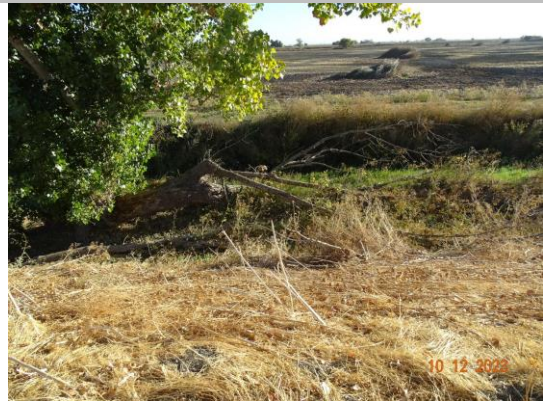
Photo 1 of 1 : SP_2024_NA0010_123_180_20240212_00061.jpg

Fallen trees and broken limbs on the landside slope and toe. (Fall 2023)

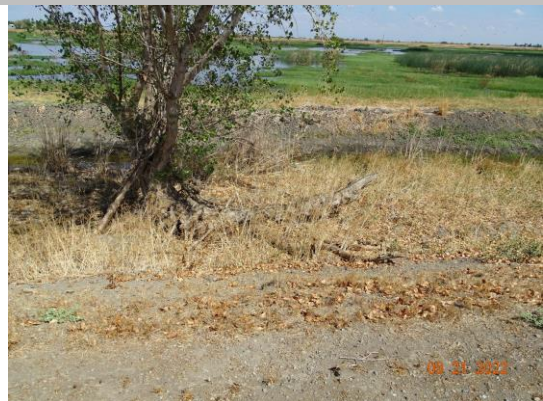
Photo 1 of 1 : SP_2024_NA0010_123_182_20240212_00062.jpg

Broken tree limbs on the landside toe and slope. (Fall 2022)

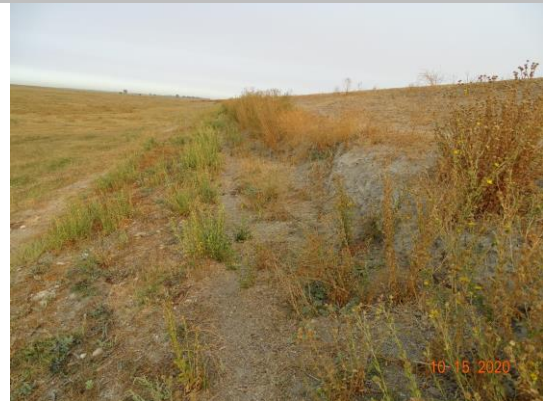
Photo 1 of 1 : SP_2024_NA0010_123_110_20240212_00013.jpg

Erosion along the waterside slope. (Fall 2020)

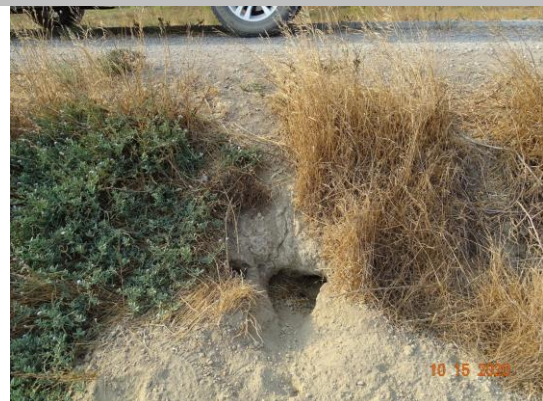
Photo 1 of 1 : SP_2024_NA0010_123_118_20240212_00017.jpg

Large rodent hole in the landside shoulder. (Fall 2020)

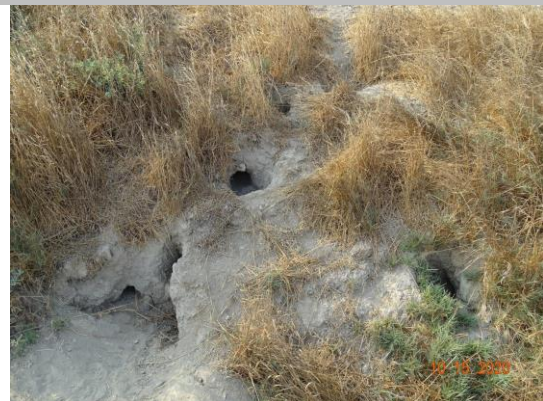
Photo 1 of 1 : SP_2024_NA0010_123_126_20240212_00023.jpg

Several large rodent holes observed at this location. (Fall 2020)

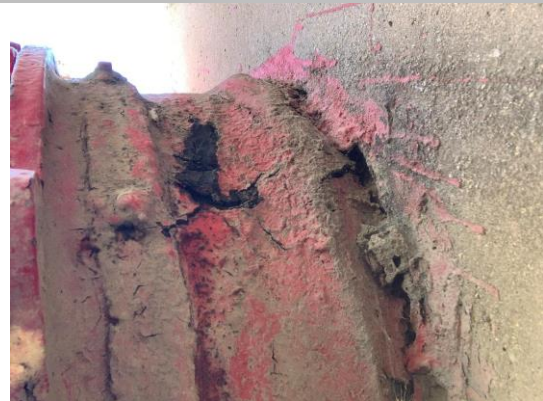
Photo 3 of 3 : UCIP_SP_2024_77915_104232.jpg

WS view: Some deterioration of flapgate at toe.

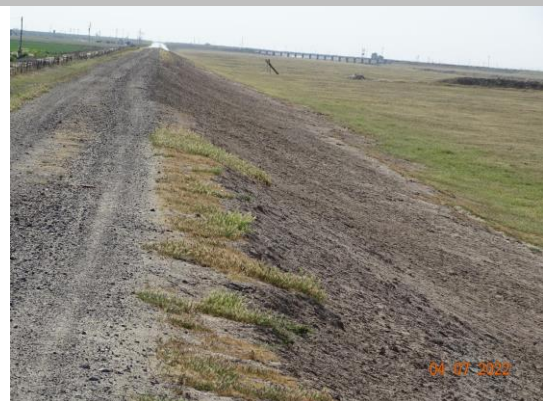
Photo 1 of 1 : SP_2024_NA0010_123_160_20240212_00047.jpg

Slope damage cause by livestock foot traffic. (Spring 2022)

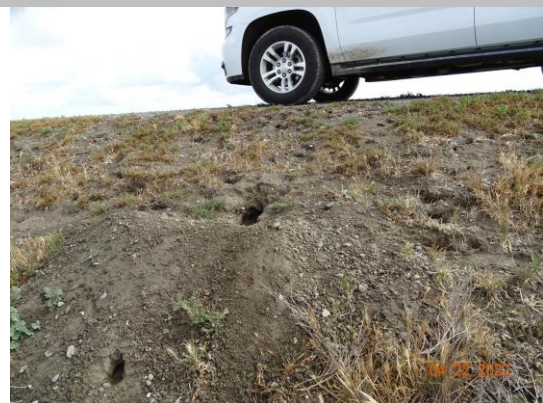
Photo 1 of 1 : SP_2024_NA0010_124_146_20240212_00064.jpg

View of rodent holes on the landside slope. (Spring 2022)

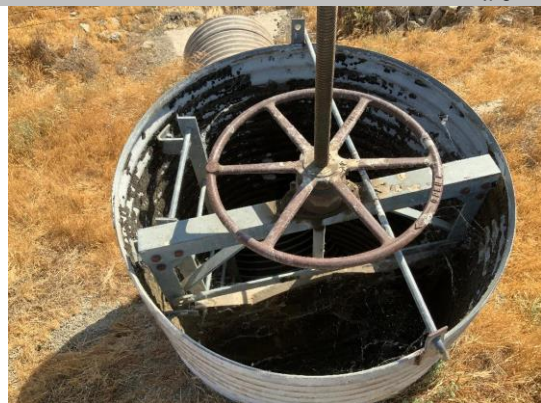
Photo 2 of 2 : UCIP_SP_2024_71106_103027.jpg

WS view: Closeup of riser without lid on slope.

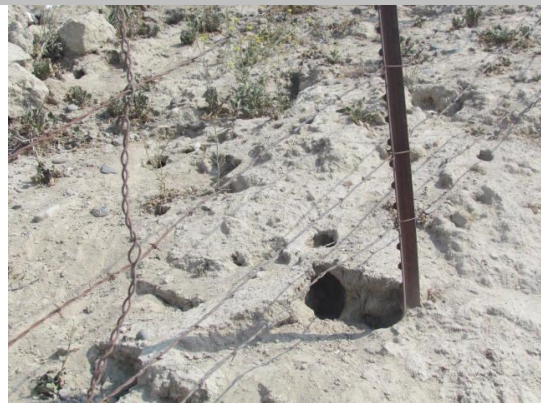
Photo 1 of 1 : SP_2024_NA0010_124_1208_20240212_00074.jpg

Rodent holes on landward slope.

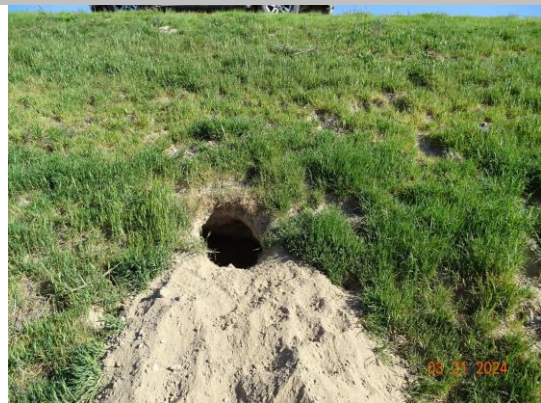
Photo 1 of 1 : SP_2024_NA0010_124_52_20240326_00158.jpg

Large rodent hole observed near the landside hinge point. (Spring 2024)

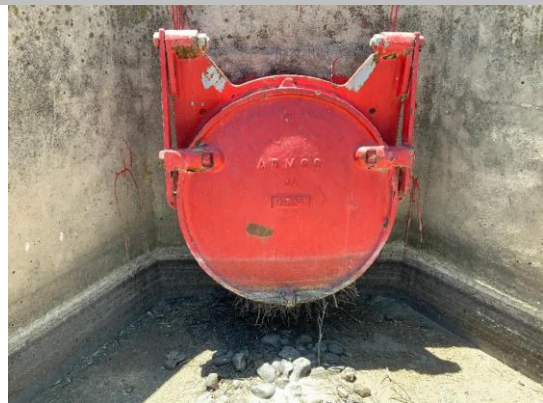
Photo 1 of 1 : UCIP_SP_2024_71182_99580.jpg

WS view: Close up of flapgate, vegetation coming out of it.

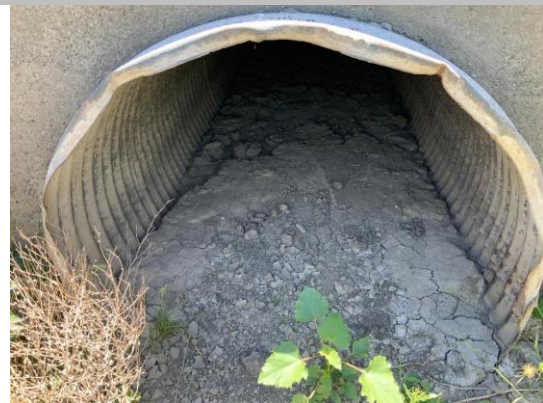
Photo 1 of 1 : UCIP_SP_2024_73277_100440.jpg

LS view: Close up of pipe inlet with sediment buildup and warped edges at toe.
