Flood Control Project Maintenance
2010 Structure Summary Report
Overall Unit and Item Ratings

Lower San Joaquin Levee District

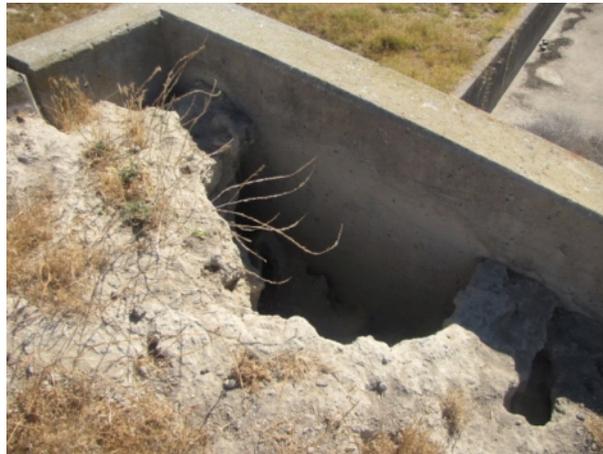
| richard_t_20100825_114.jpg | |

| Looking at erosion at west wing wall. | |

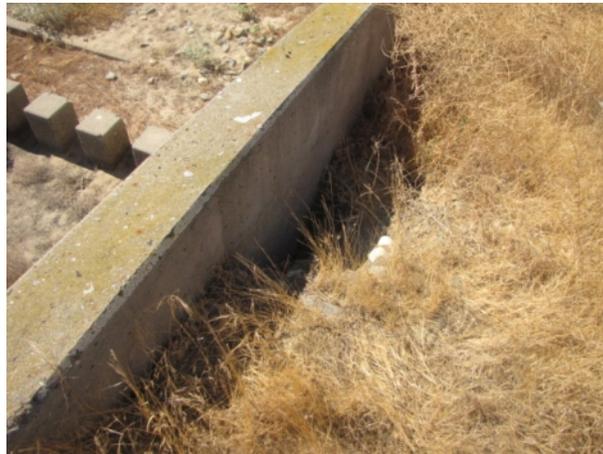
| richard_t_20100825_115.jpg | |

| Looking at minor erosion at west wing wall. | |

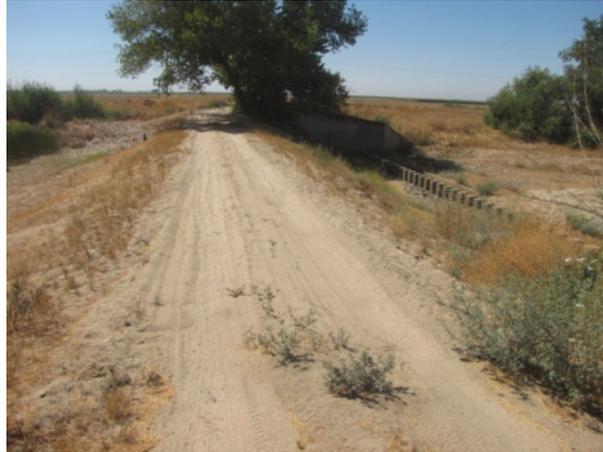
| richard_t_20100823_095.jpg | |

| Looking south at dam across east side (upstream) of structure. | |

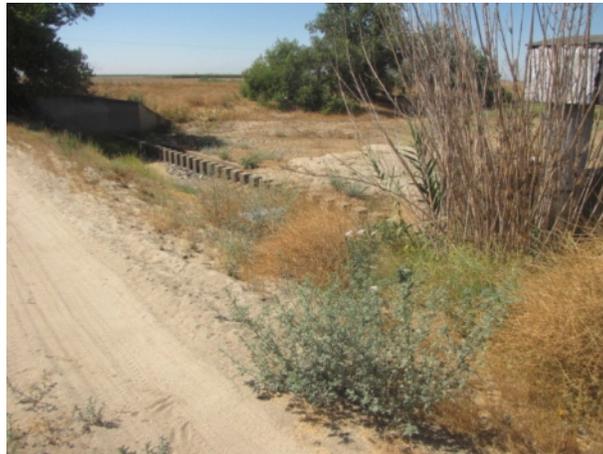
| richard_t_20100825_117.jpg | |

| Looking southwest at overgrown of vegetation on the west (downstream) side of structure. | |

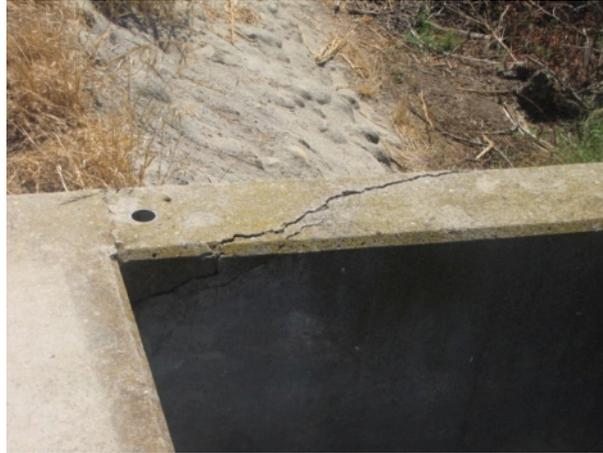
| richard_t_20100825_118.jpg | |

| LMR No. | Levee Mile | | Category | Item | Location | Rating | Action/Comment | GPS Latitude/Longitude | | Photo | Issue No. |
|---|---|---|---|---|---|---|--|---|---|---|---|
| 15 | | | Structures | Concrete Surfaces | | M | Inspector Comments: Minor cracking on downstream side of the north wing wall. Monitor and repair the cracks in the abutments as needed. | 37.254956 ° -120.718385 ° | 37.254956 ° -120.718385 ° | Y | 3 |

| Looking at north wing wall minor to modest cracking | |

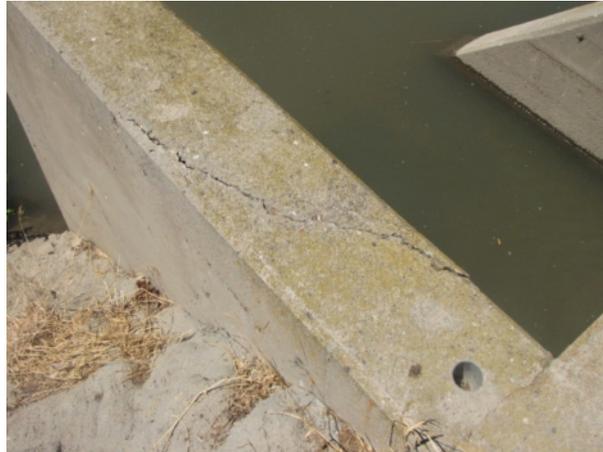
| richard_t_20100825_119.jpg | |

| Looking at cracking on north wing wall . | |

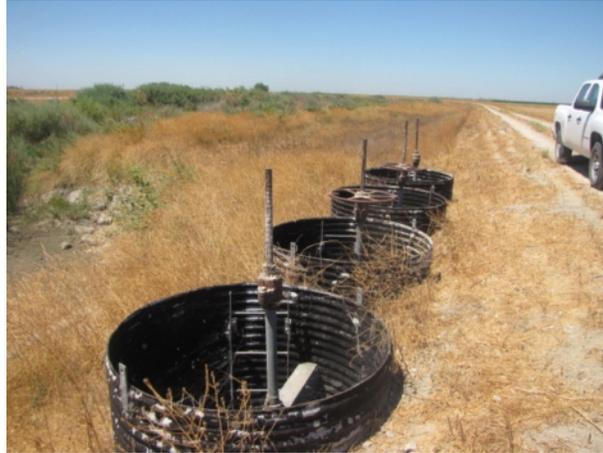
| richard_t_20100825_121.jpg | |

| LMR No. | Levee Mile | | Category | Item | Location * | Rating ** | Action/Comment | GPS Latitude/Longitude | | Photo | Issue No. |
|---|---|---|---|---|---|---|--|---|---|---|---|
| 14 | | | Structures | Manual Gate Operators | | M | Inspector Comments: Screw gate control wheels (2) are missing and broken (1). Need to repair or replace gate control wheels. | 36.975460 ° -120.359655 ° | 36.975460 ° -120.359655 ° | Y | 4 |

| Looking at broken and missing screw gate wheels. | |

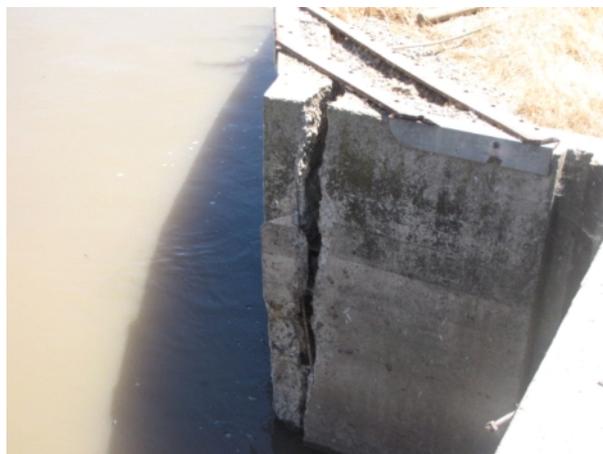
| richard_t_20100825_122.jpg | |

| LMR No. | Levee Mile | | Category | Item | Location * | Rating ** | Action/Comment | GPS Latitude/Longitude | | Photo | Issue No. |
|---|---|---|---|---|---|---|--|---|---|---|---|
| 15 | | | Structures | Concrete Surfaces | | U | Inspector Comments: Downstream side north wing wall is badly damage and should be replace. Also minor cracking on south wing wall. | 37.219700 ° -120.697977 ° | 37.219700 ° -120.697977 ° | Y | 3 |

| Looking at damage wing wall on the left bank of the downstream side of the structure | |

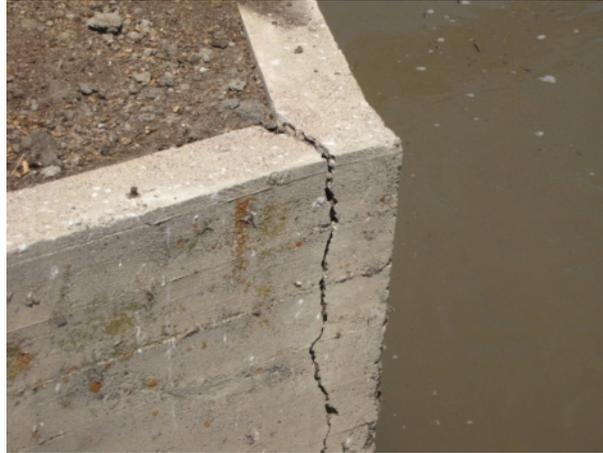
| richard_t_20100825_123.jpg | |

| Looking at cracking on south wing wall corner on east side of the structure. | |

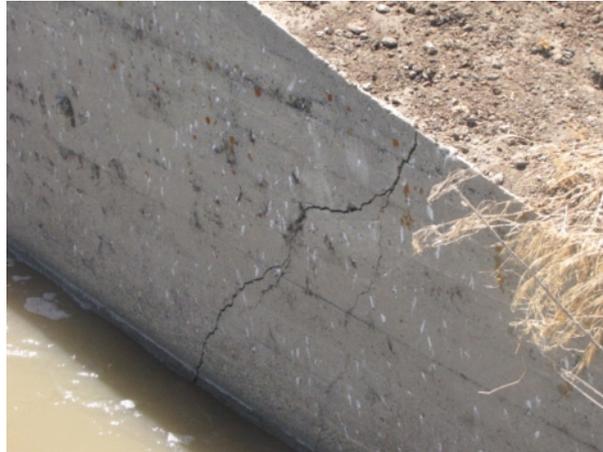
| richard_t_20100825_124.jpg | |

| Looking at cracking on south wing wall on east side (upstream) of structure. | |

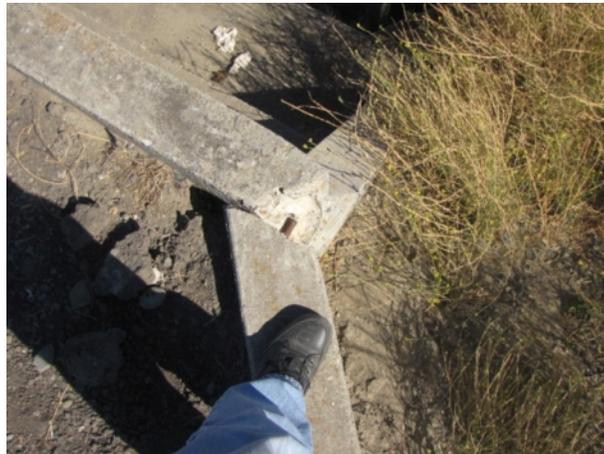
| richard_t_20100826_133.jpg | |

| LMR No. | Levee Mile | | Category | Item | Location * | Rating ** | Action/Comment | GPS Latitude/Longitude | | Photo | Issue No. |
|---|---|---|---|---|---|---|--|---|---|---|---|
| 16 | | | Structures | Concrete Surfaces | | M | Inspector Comments: Small Crack on right Wing Wall | 37.112363 ° -120.589492 ° | 37.112363 ° -120.589492 ° | Y | 7 |

| Looking at east (downstream) side of structure at small crack on right corner.(Sand Slough Structure) | |
