Flood Control Project Maintenance**2011 Structure Summary Report****Overall Unit and Item Ratings****Lower San Joaquin Levee District****Ash Slough Drop Structure No. 1**

Flood Control Project Maintenance

2011 Structure Summary Report

Overall Unit and Item Ratings

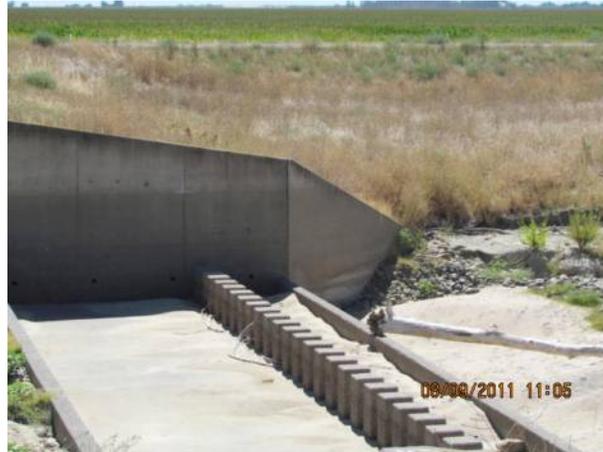
Levee Mile Report Line	5
Start Levee Mile	0.00
End Levee Mile	0.00
Location	
Category	Structures
Item	Revetments
Looking southwest a riprap displacement on downstream and upstream side of structure.	
richard_t_20110831_081.jpg

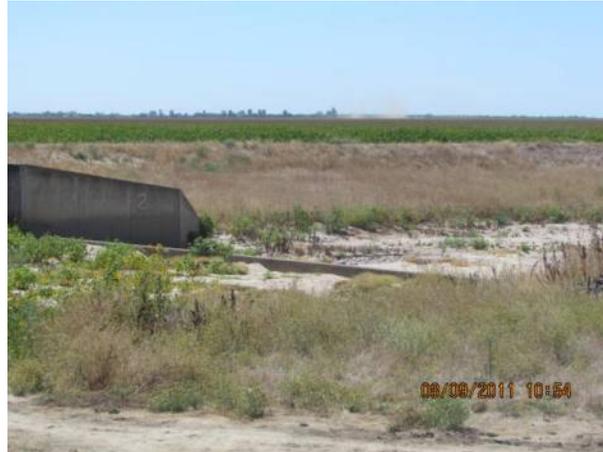
Levee Mile Report Line	1
Start Levee Mile	
End Levee Mile	
Location	
Category	Structures
Item	Photo Documentation
Looking south at upstream and downstream side of structure.	
richard_t_20110830_076.jpg

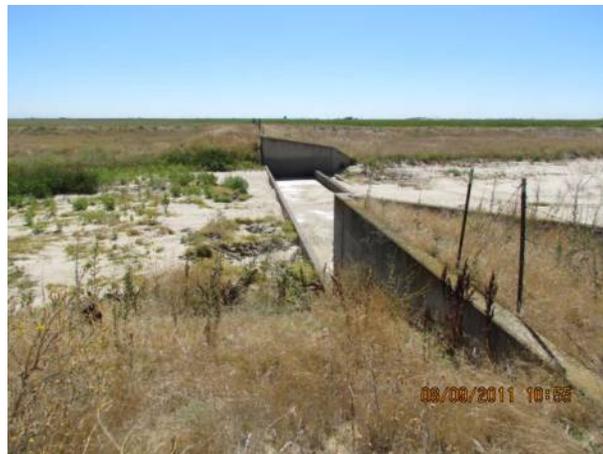
Levee Mile Report Line	1
Start Levee Mile	
End Levee Mile	
Location	
Category	Structures
Item	Photo Documentation
Looking south at close-up view of structure.	
richard_t_20110830_077.jpg

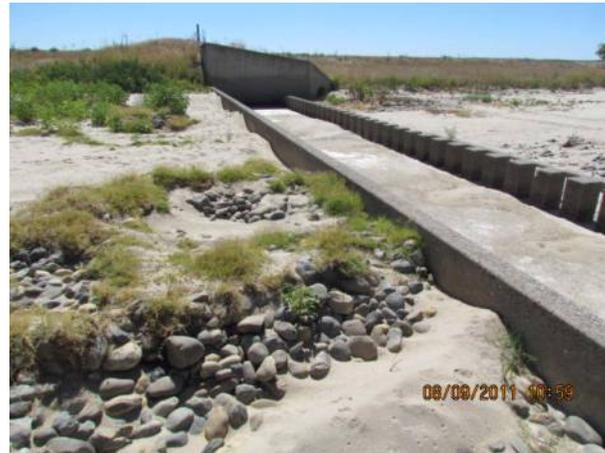
Levee Mile Report Line	5
Start Levee Mile	0.00
End Levee Mile	0.00
Location	
Category	Structures
Item	Revetments
Looking west at revetment on downstream side of structure.	
richard_t_20110830_079.jpg

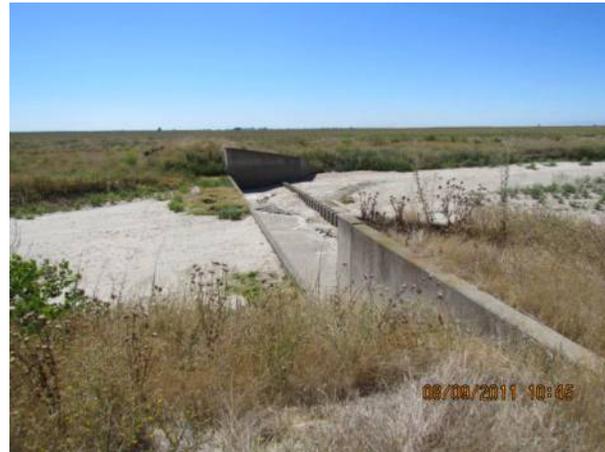
Levee Mile Report Line	1
Start Levee Mile	
End Levee Mile	
Location	
Category	Structures
Item	Photo Documentation
Looking south at close-up view of structure.	
richard_t_20110830_073.jpg

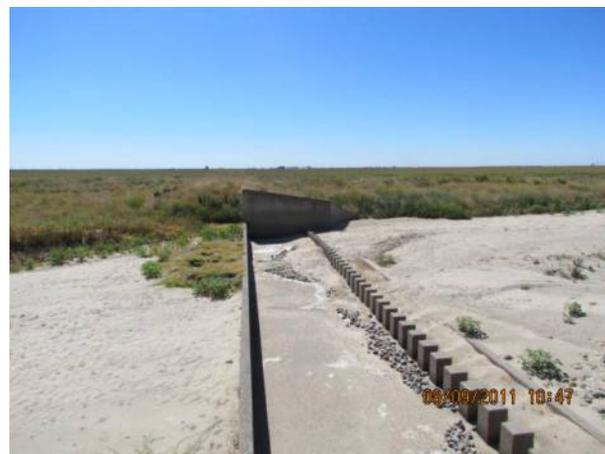
Levee Mile Report Line	1
Start Levee Mile	
End Levee Mile	
Location	
Category	Structures
Item	Photo Documentation
Looking southeast at upstream side of structure.	
richard_t_20110830_074.jpg

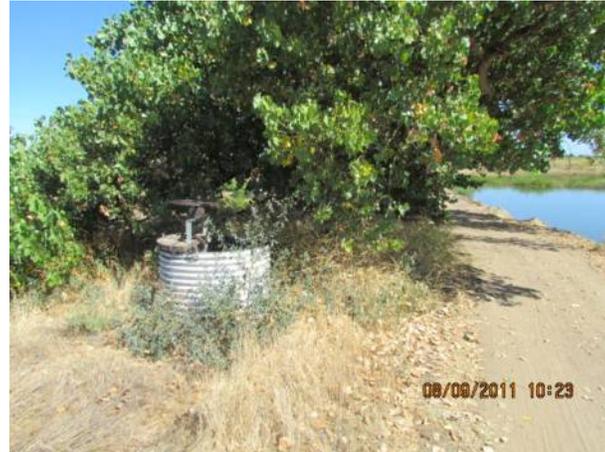
Levee Mile Report Line	6
Start Levee Mile	0.00
End Levee Mile	0.00
Location	
Category	Structures
Item	Encroachments
Looking south at sand dam across drop structure.	
richard_t_20110830_068.jpg

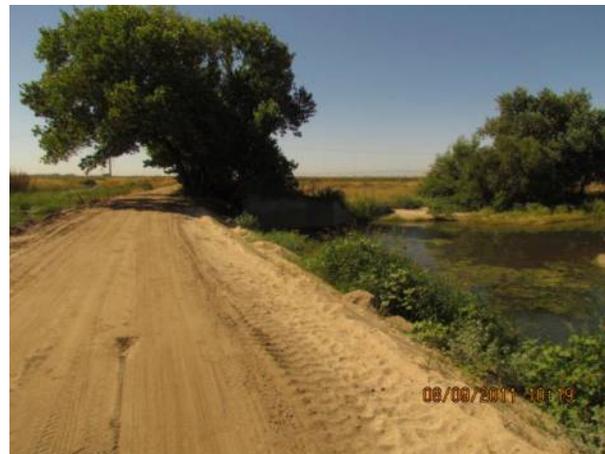
Levee Mile Report Line	6
Start Levee Mile	0.00
End Levee Mile	0.00
Location	
Category	Structures
Item	Encroachments
Looking north at sand dam and pipe through sand dam.	
richard_t_20110830_069.jpg

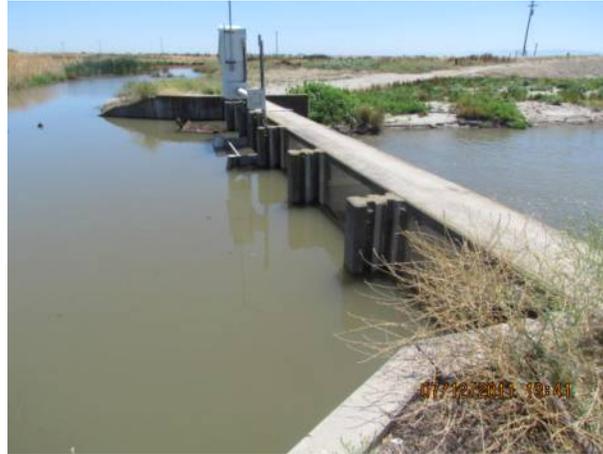
Levee Mile Report Line	1
Start Levee Mile	
End Levee Mile	
Location	
Category	Structures
Item	Photo Documentation
Looking south at overview of structure with a new electrical conduit on downstream side of structure.	
richard_t_20110725_006.jpg

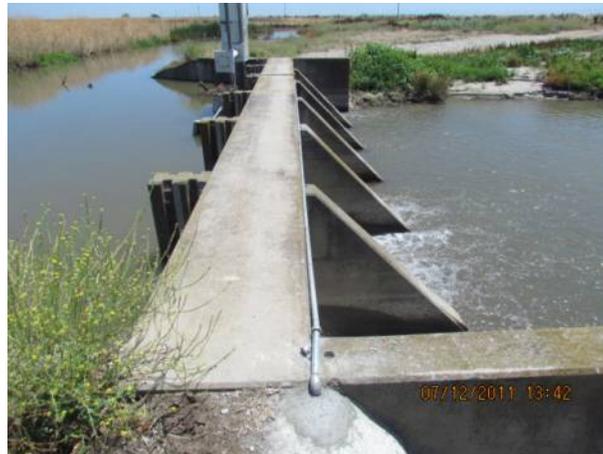
Levee Mile Report Line	1
Start Levee Mile	
End Levee Mile	
Location	
Category	Structures
Item	Photo Documentation
Looking north at overview of structure.	
richard_t_20110725_007.jpg

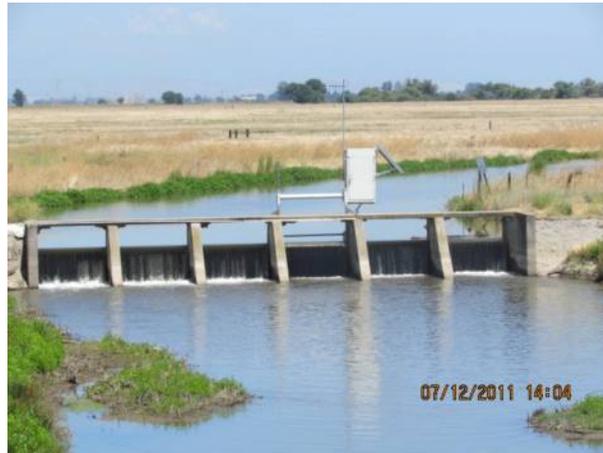
6	0.00	0.00	Structures	Encroachments		A	Inspector Comments: Steveson Irrigation replaced pvc electrical conduit with half inch steel pipe.	37.254970 ° -120.718450 °	37.254970 ° -120.718450 °	6 Y
7	0.00	0.00	Structures	Culverts: Inlets / Outlets		A	Inspector Comments: There are no debris blocking the culverts.	37.254970 ° -120.718450 °	37.254970 ° -120.718450 °	7
8	0.00	0.00	Structures	Culverts: Breaks / Holes / Cracks		A	Inspector Comments: No visible damage to culverts.	37.254970 ° -120.718450 °	37.254970 ° -120.718450 °	8
9	0.00	0.00	Structures	Metal Pipes		N	Inspector Comments: Item does not exist on this structure	37.254970 ° -120.718450 °	37.254970 ° -120.718450 °	9
10	0.00	0.00	Structures	Trash Racks		N	Inspector Comments: Item does not exist on this structure	37.254970 ° -120.718450 °	37.254970 ° -120.718450 °	10
11	0.00	0.00	Structures	Flap Gates		N	Inspector Comments: Item does not exist on this structure	37.254970 ° -120.718450 °	37.254970 ° -120.718450 °	11

Levee Mile Report Line	6
Start Levee Mile	0.00
End Levee Mile	0.00
Location	
Category	Structures
Item	Encroachments
Looking at new electrical conduit on downstream side of structure.	
richard_t_20110725_003.jpg

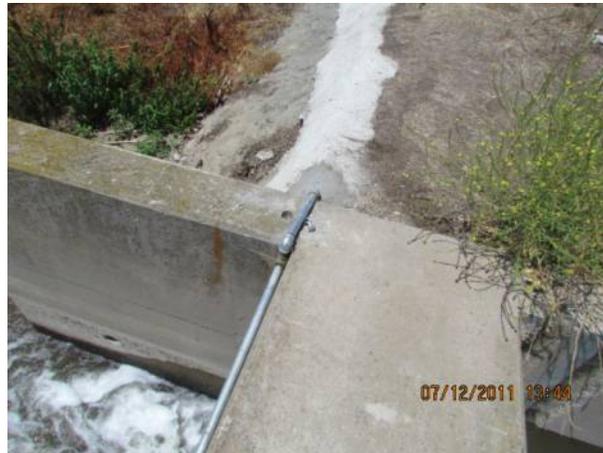
Levee Mile Report Line	6
Start Levee Mile	0.00
End Levee Mile	0.00
Location	
Category	Structures
Item	Encroachments
Looking northwest at remote control gate on upstream side of structure.	
richard_t_20110725_004.jpg

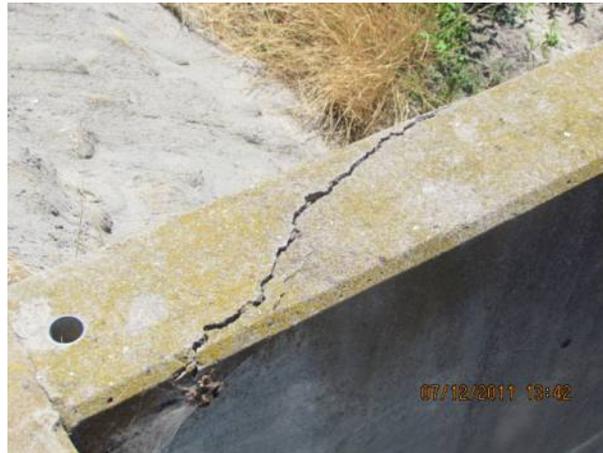
Levee Mile Report Line	15
Start Levee Mile	0.00
End Levee Mile	0.00
Location	
Category	Structures
Item	Concrete Surfaces
Looking northwest at cracking on left wing wall	
richard_t_20110725_002.jpg

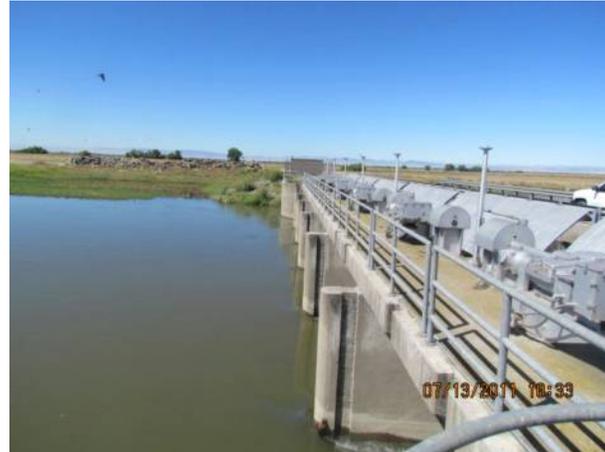
Levee Mile Report Line	1
Start Levee Mile	
End Levee Mile	
Location	
Category	Structures
Item	Photo Documentation
Looking at one of seven motors on upstream side of structure.	
richard_t_20110726_017.jpg

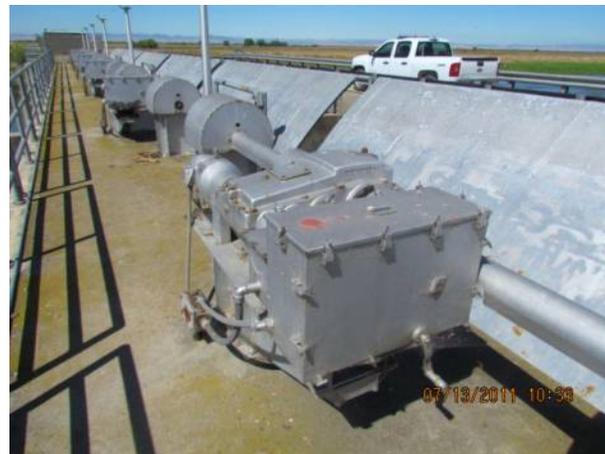
Levee Mile Report Line	1
Start Levee Mile	
End Levee Mile	
Location	
Category	Structures
Item	Photo Documentation
Looking south at downstream side of structure.	
richard_t_20110726_018.jpg

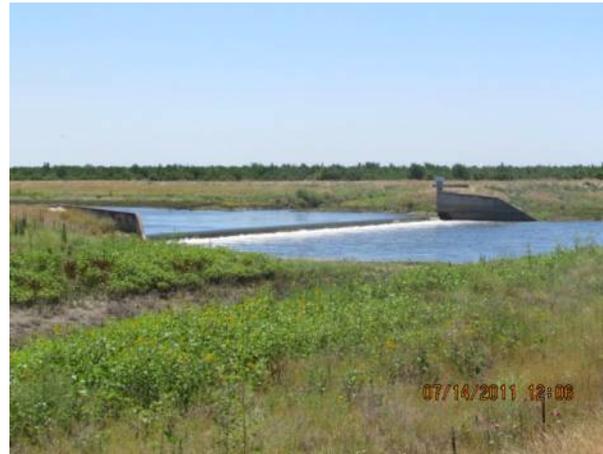
Levee Mile Report Line	1
Start Levee Mile	
End Levee Mile	
Location	
Category	Structures
Item	Photo Documentation
Looking south at general overview of structure.	
richard_t_20110727_057.jpg

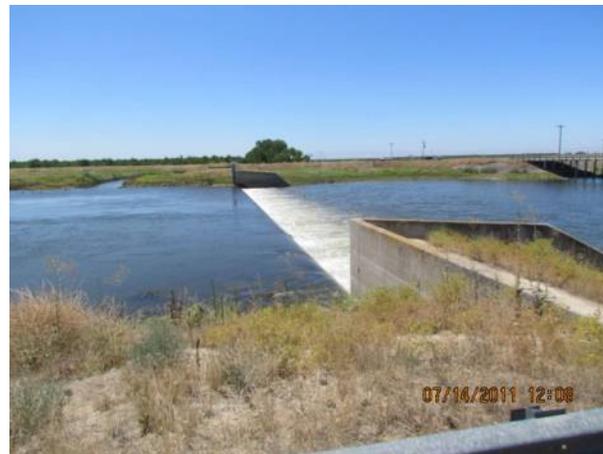
Levee Mile Report Line	1
Start Levee Mile	
End Levee Mile	
Location	
Category	Structures
Item	Photo Documentation
Looking south at close-up view of downstream side of structure.	
richard_t_20110727_058.jpg

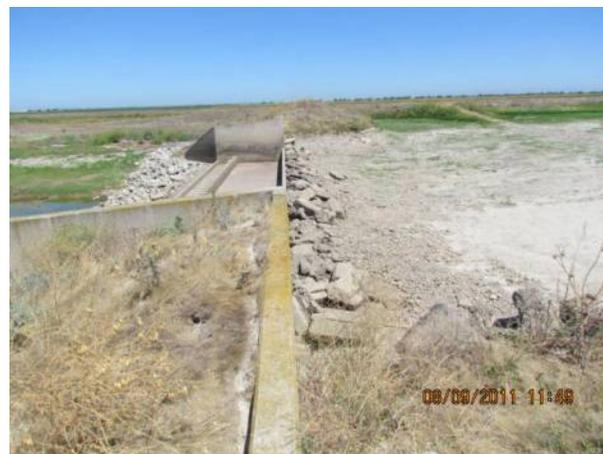
Levee Mile Report Line	1
Start Levee Mile	
End Levee Mile	
Location	
Category	Structures
Item	Photo Documentation
Looking northeast at downstream side of structure.	
richard_t_20110831_084.jpg

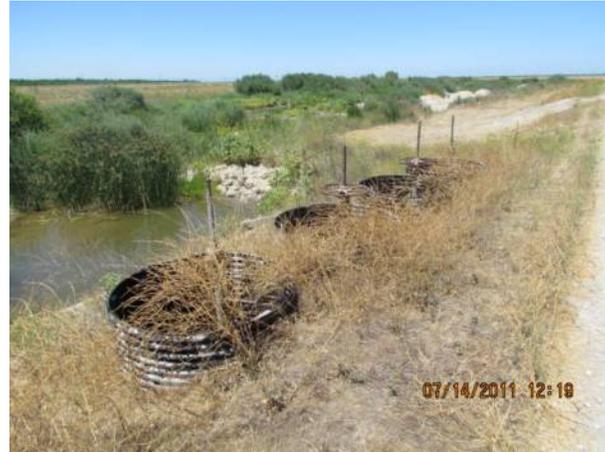
Levee Mile Report Line	7
Start Levee Mile	0.00
End Levee Mile	0.00
Location	
Category	Structures
Item	Culverts: Inlets / Outlets
Looking west inlet side of structure.	
richard_t_20110728_062.jpg

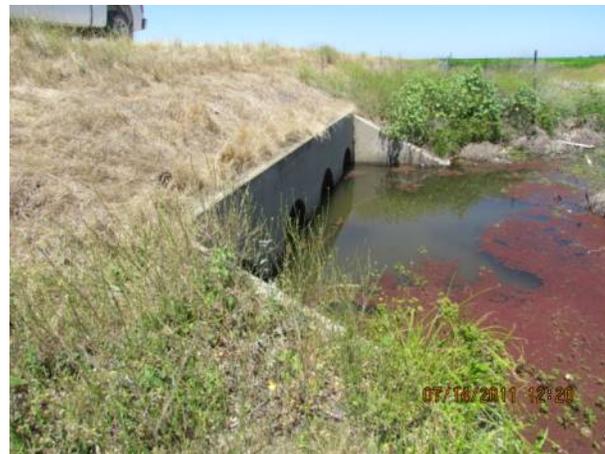
Levee Mile Report Line	11
Start Levee Mile	0.00
End Levee Mile	0.00
Location	
Category	Structures
Item	Flap Gates
Looking northwest on downstream side at flap gates.	
richard_t_20110728_061.jpg

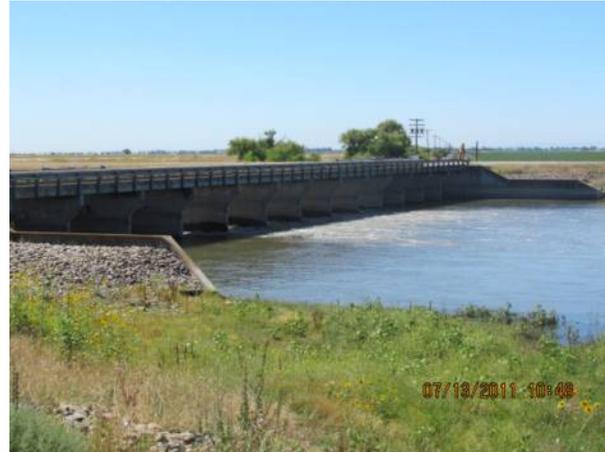
Levee Mile Report Line	1
Start Levee Mile	
End Levee Mile	
Location	
Category	Structures
Item	Photo Documentation
Looking south at upstream side of structure.	
richard_t_20110726_020.jpg

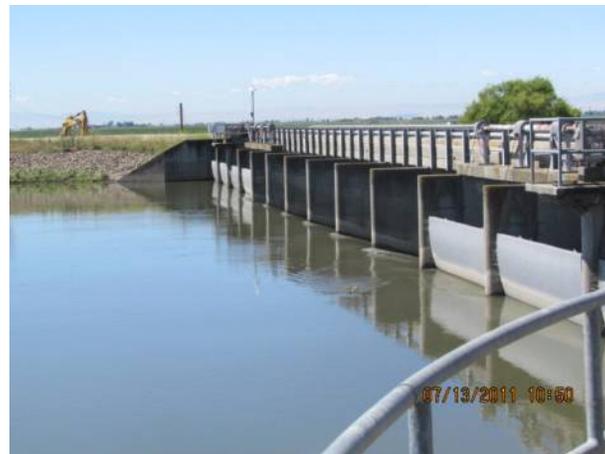
Levee Mile Report Line	1
Start Levee Mile	
End Levee Mile	
Location	
Category	Structures
Item	Photo Documentation
Looking east at three (3) screw gates on north side of the structure.	
richard_t_20110726_021.jpg

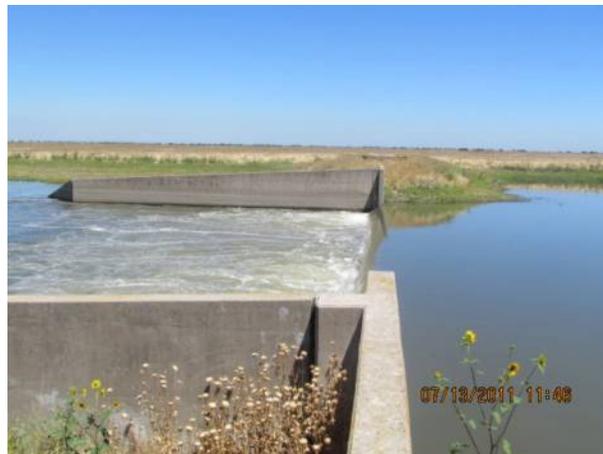
Levee Mile Report Line	22
Start Levee Mile	0.00
End Levee Mile	0.00
Location	
Category	Structures
Item	Monolith Joints
Looking east at left wing wall joint.	
richard_t_20110726_027.jpg

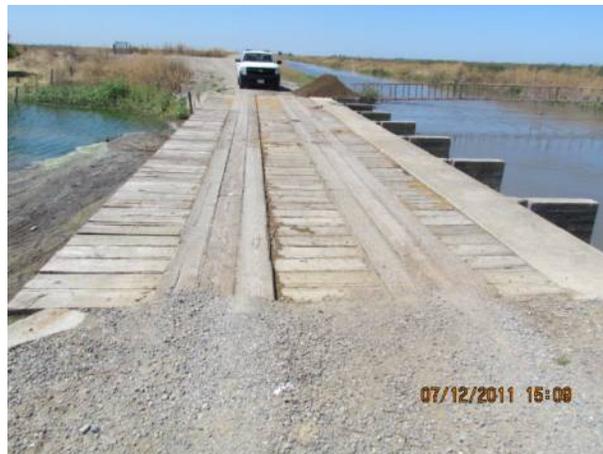
Levee Mile Report Line	1
Start Levee Mile	
End Levee Mile	
Location	
Category	Structures
Item	Photo Documentation
Looking at upstream side overview of structure.	
richard_t_20110726_031.jpg

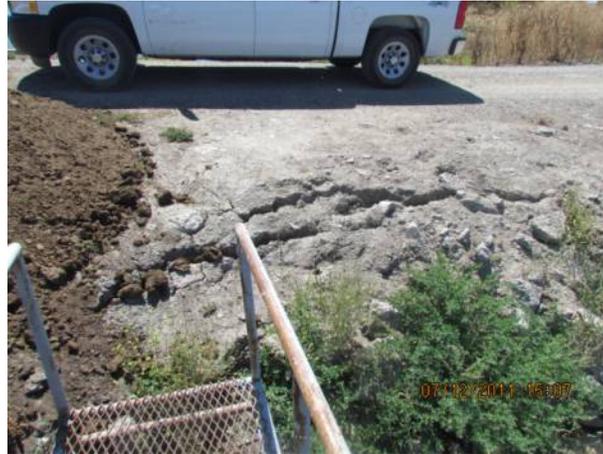
Levee Mile Report Line	15
Start Levee Mile	0.00
End Levee Mile	0.00
Location	
Category	Structures
Item	Concrete Surfaces
Looking at cracking on upstream side right wall.	
richard_t_20110726_032.jpg

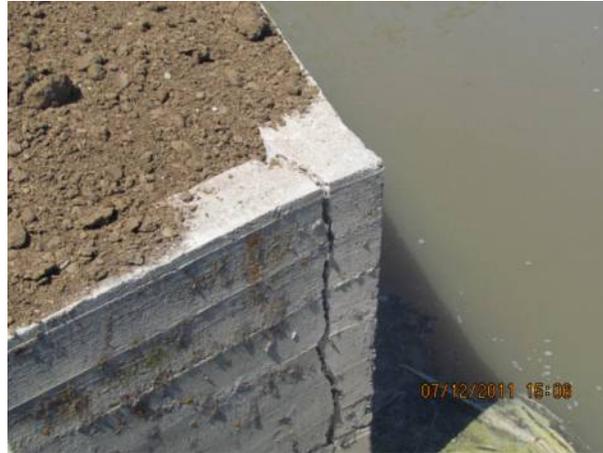
Levee Mile Report Line	15
Start Levee Mile	0.00
End Levee Mile	0.00
Location	
Category	Structures
Item	Concrete Surfaces
Looking at cracking on upstream side right wing wall.	
richard_t_20110726_033.jpg

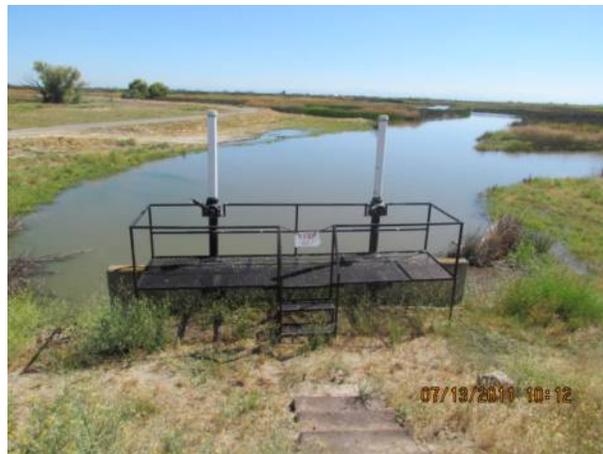
Levee Mile Report Line	7
Start Levee Mile	0.00
End Levee Mile	0.00
Location	
Category	Structures
Item	Culverts: Inlets / Outlets
Looking southwest at outlet of structure.	
richard_t_20110727_034.jpg
