**Flood Control Project Maintenance
Levee Inspections**

2008 Channel Summary Report

Madera County FCWCA

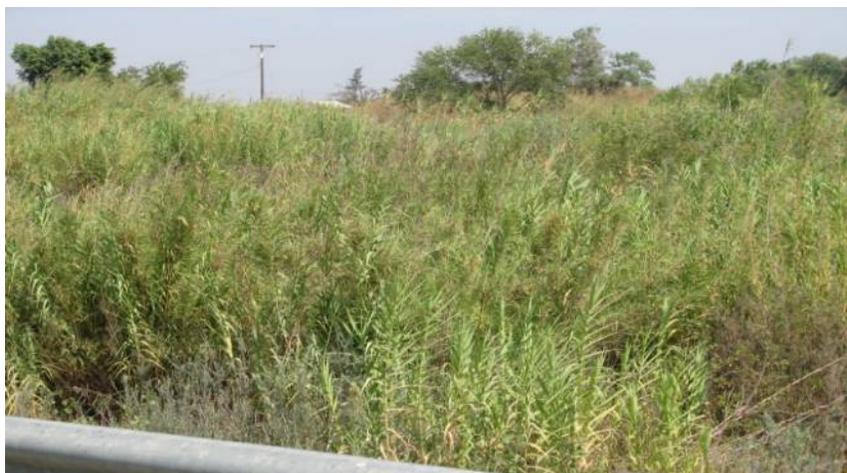
Report Line	3
Location	
Category	Rivers, Channels & Designated Floodways
Item	Vegetation & Obstructions
Upstream from Road 13. (Note heavy growth of bambo)

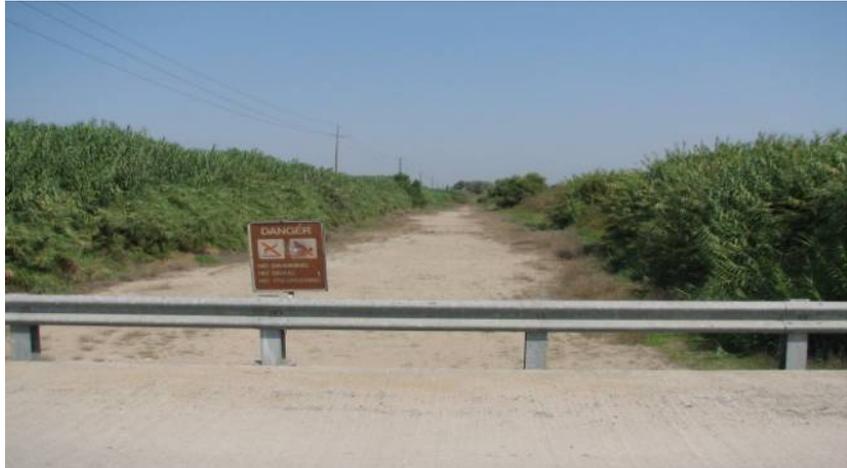
Report Line	4
Location	
Category	Rivers, Channels & Designated Floodways
Item	Vegetation & Obstructions
Downstream from Road 12.

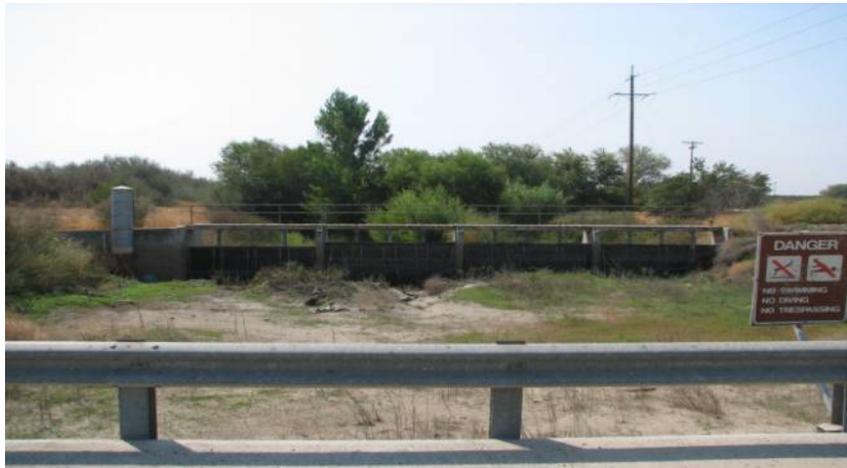
Report Line	5
Location	
Category	Rivers, Channels & Designated Floodways
Item	Vegetation & Obstructions
upstream from Road 12 bridge looking back towards the weir. Note the heavy growth just upstream from weir structure.

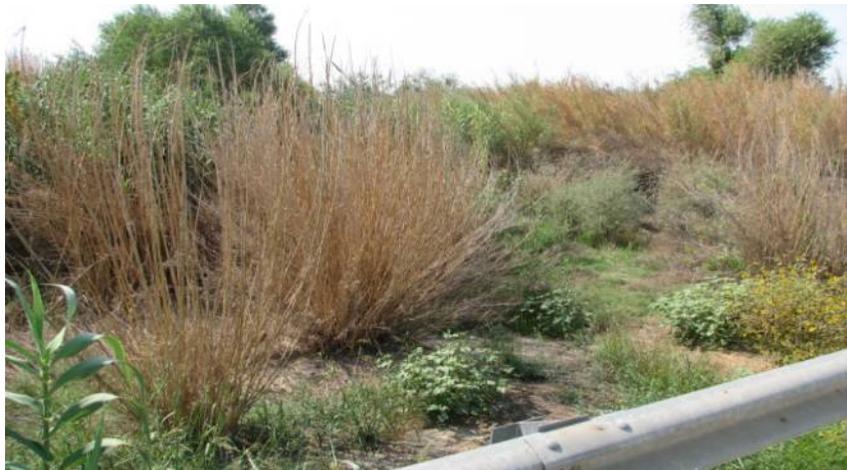
Report Line	6
Location	
Category	Rivers, Channels & Designated Floodways
Item	Vegetation & Obstructions
Upstream from Avenue 18 1/2 bridge. (Note growth in channel below bridge)

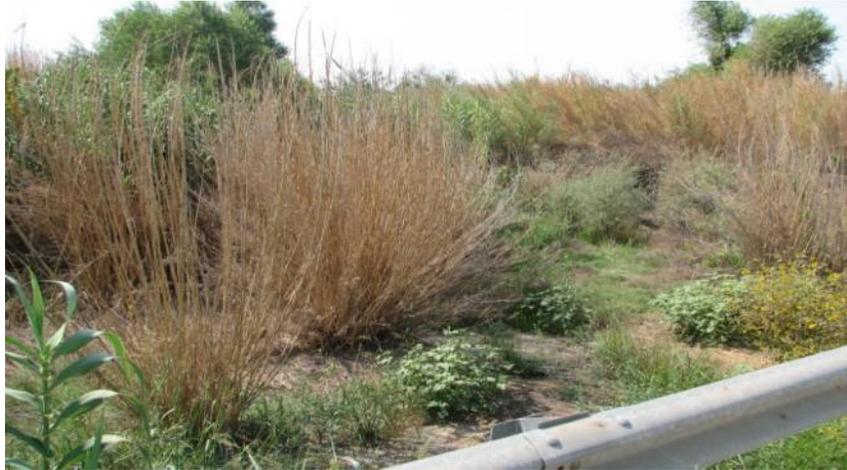
Report Line	6
Location	
Category	Rivers, Channels & Designated Floodways
Item	Vegetation & Obstructions
Downstream from Avenue 18 1/2.

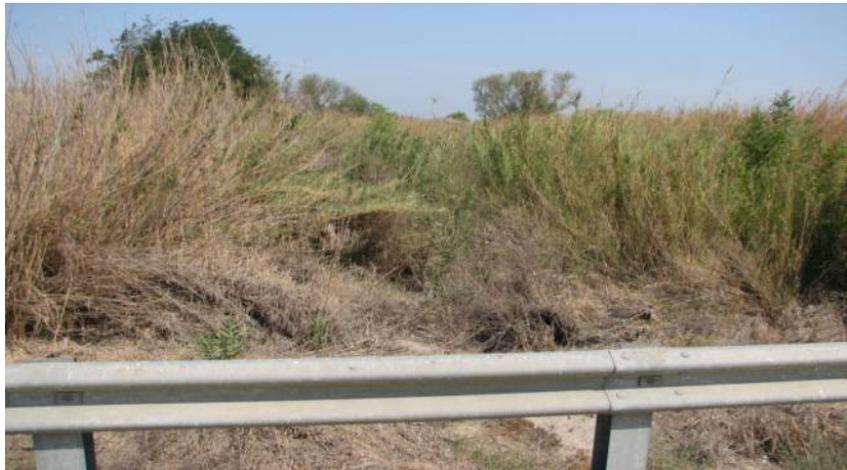
Report Line	7
Location	
Category	Rivers, Channels & Designated Floodways
Item	Vegetation & Obstructions
Upstream from Avenue 19.

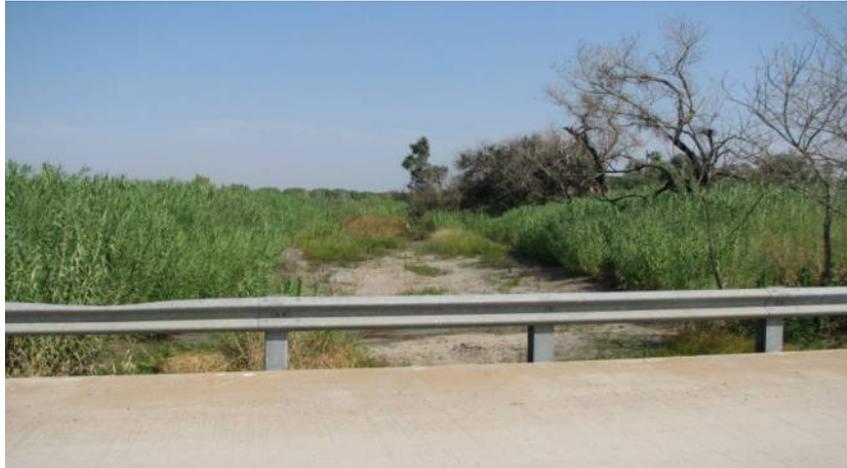
Report Line	9
Location	
Category	Rivers, Channels & Designated Floodways
Item	Vegetation & Obstructions
Downstream from Avenue 21.

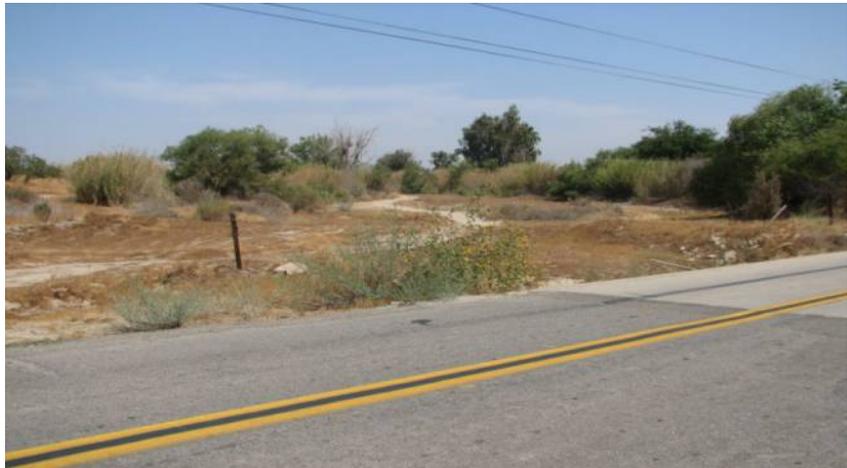
Report Line	10
Location	
Category	Rivers, Channels & Designated Floodways
Item	Vegetation & Obstructions
Upstream from Avenue 23 1/2. (Low water crossing)

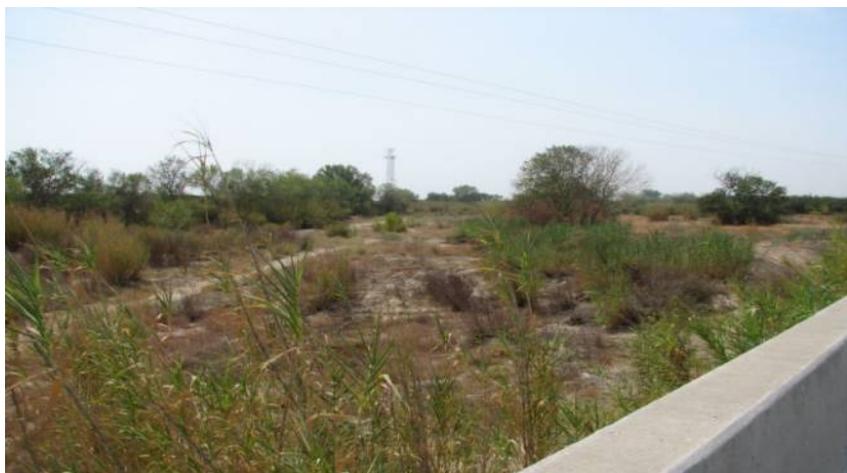
Report Line	11
Location	
Category	Rivers, Channels & Designated Floodways
Item	Vegetation & Obstructions
Down stream from road 152.

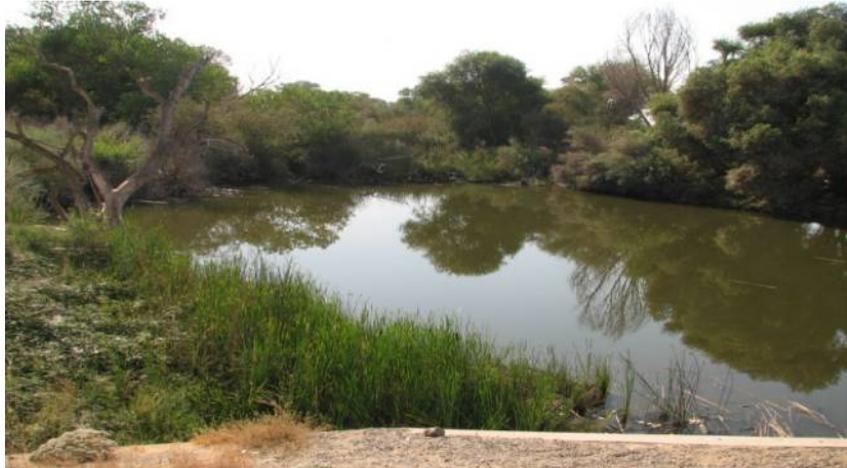
Report Line	1
Location	
Category	Rivers, Channels & Designated Floodways
Item	Vegetation & Obstructions
Downstream from the Berenda Slough bifurcation structure.

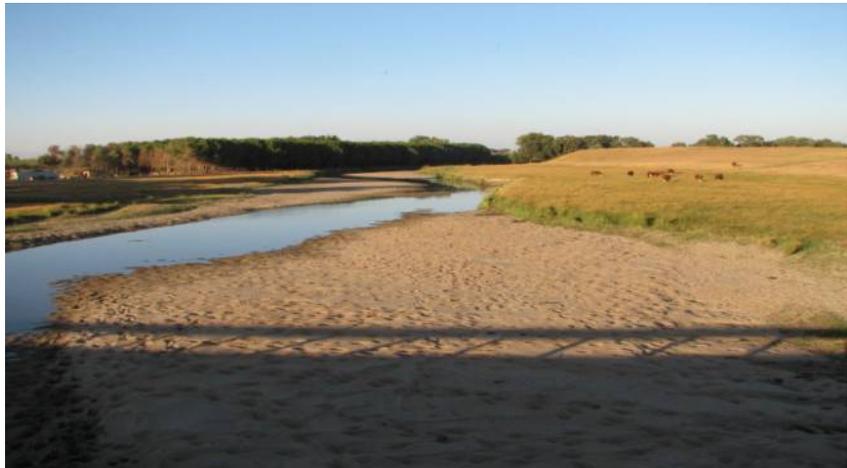
Report Line	2
Location	
Category	Rivers, Channels & Designated Floodways
Item	Vegetation & Obstructions
Upstream from Santa Fe Drive

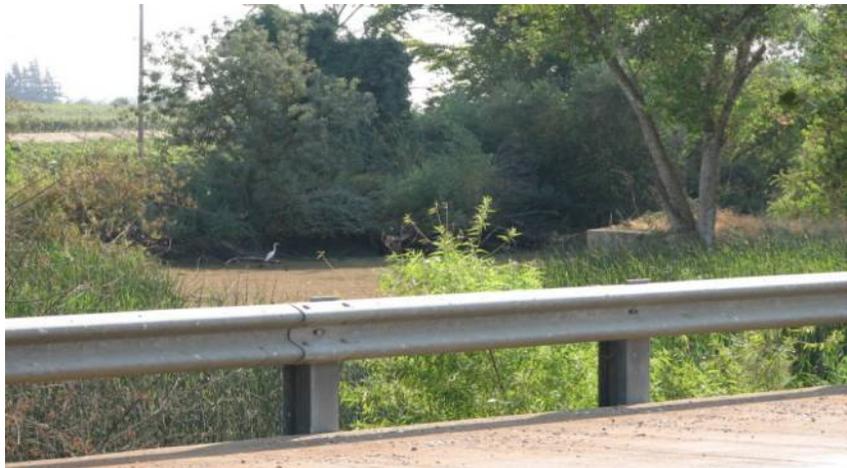
Report Line	3
Location	
Category	Rivers, Channels & Designated Floodways
Item	Vegetation & Obstructions
Downstream from Avenue 26.

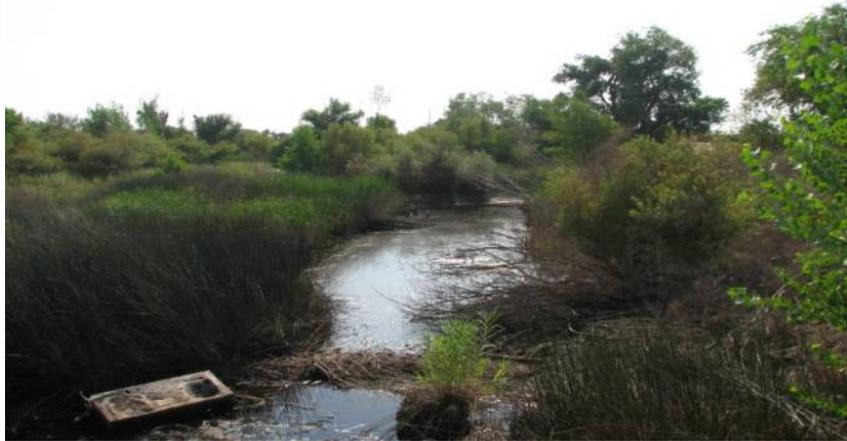
Report Line	4
Location	
Category	Rivers, Channels & Designated Floodways
Item	Vegetation & Obstructions
Downstream from Road 19.

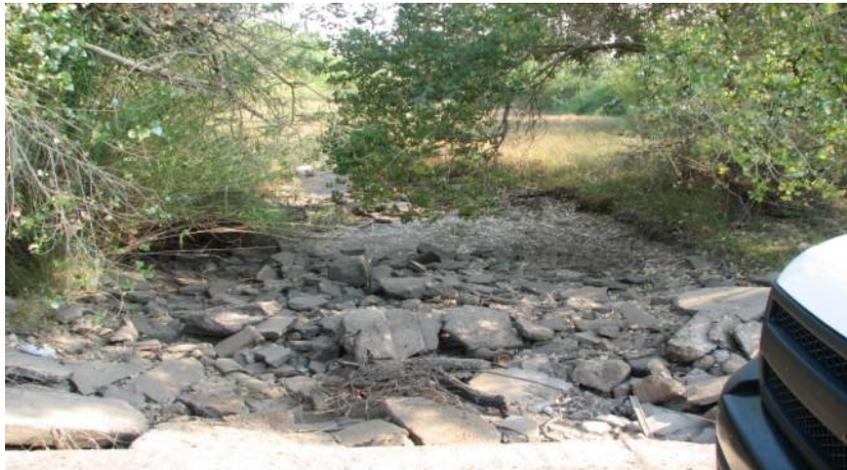
Report Line	5
Location	
Category	Rivers, Channels & Designated Floodways
Item	Vegetation & Obstructions
Downstream from Avenue 22 1/2 low water crossing.

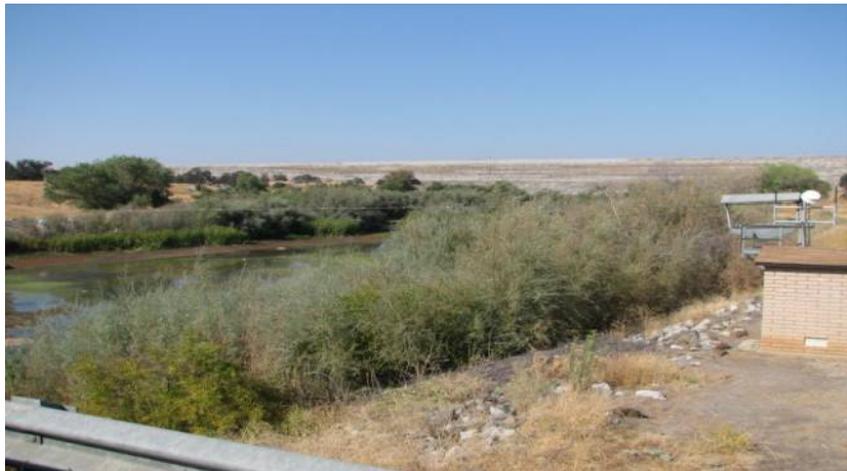
Report Line	1
Location	
Category	Rivers, Channels & Designated Floodways
Item	Vegetation & Obstructions
<p>From bridge downstream from Buchanan Dam, vegetation on both banks does not obstruct flow.</p>

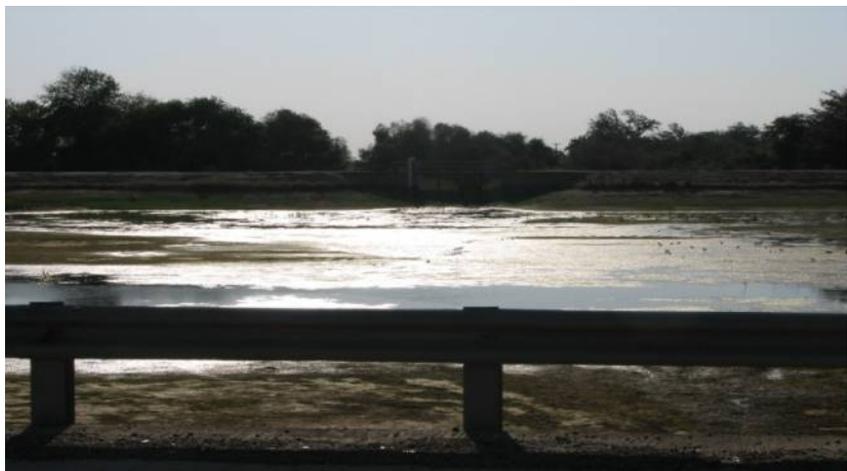
Report Line	2
Location	
Category	Rivers, Channels & Designated Floodways
Item	Vegetation & Obstructions
<p>Downstream from Road 15 (Minturn Road).</p>

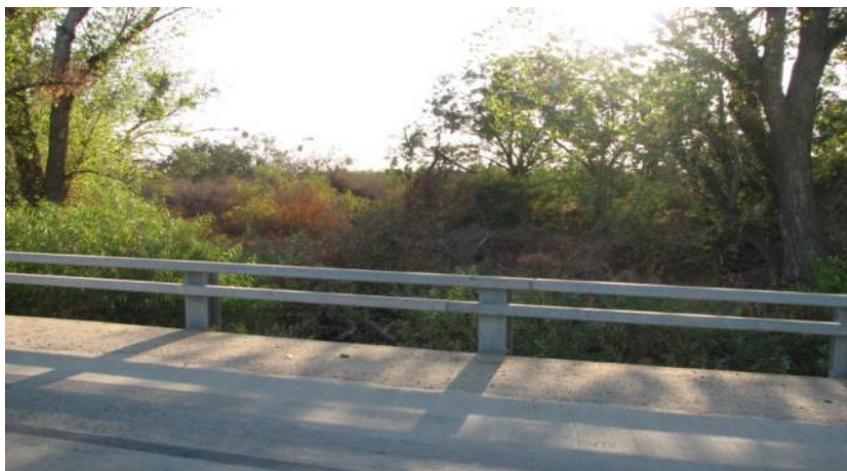
Report Line	3
Location	
Category	Rivers, Channels & Designated Floodways
Item	Vegetation & Obstructions
<p>Downstream from Road 13 (Vista Avenue).</p>

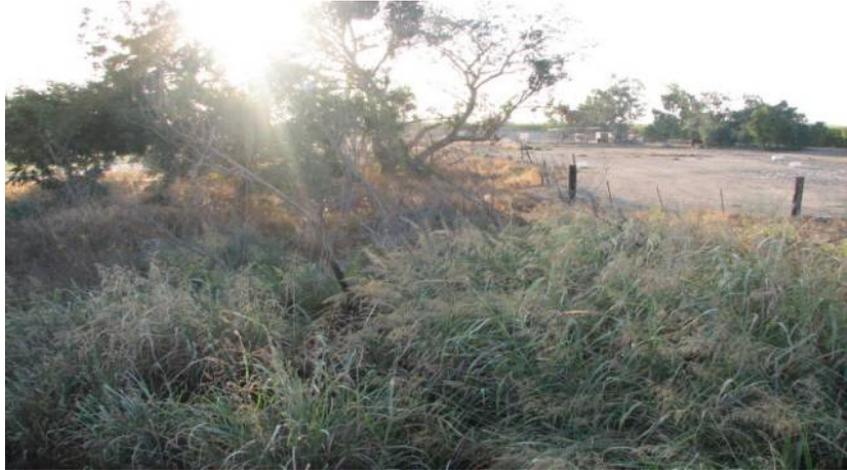
Report Line	4
Location	
Category	Rivers, Channels & Designated Floodways
Item	Vegetation & Obstructions
Downstream from Road 9 (Bliss Road).

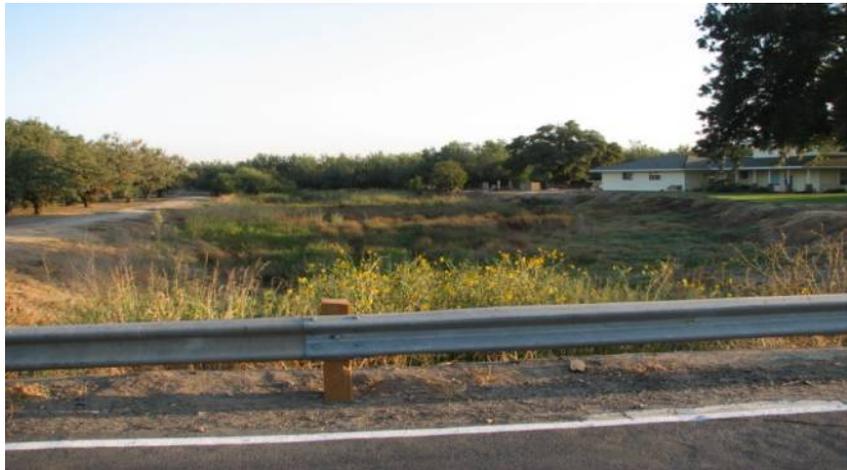
Report Line	5
Location	
Category	Rivers, Channels & Designated Floodways
Item	Vegetation & Obstructions
Upstream of Avenue 25 (Washington Road).

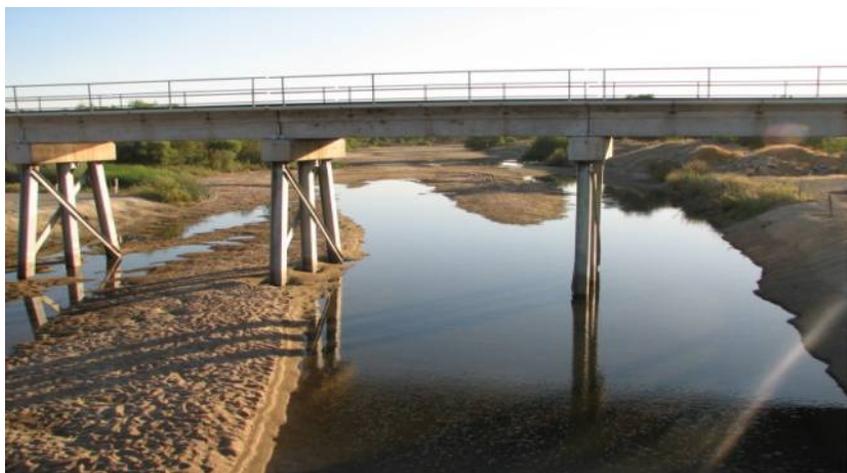
Report Line	6
Location	
Category	Rivers, Channels & Designated Floodways
Item	Encroachments
Downstream from Santa Fe Drive, this is a new Train Track Structure that was replaced 2007. The timber one burned down.

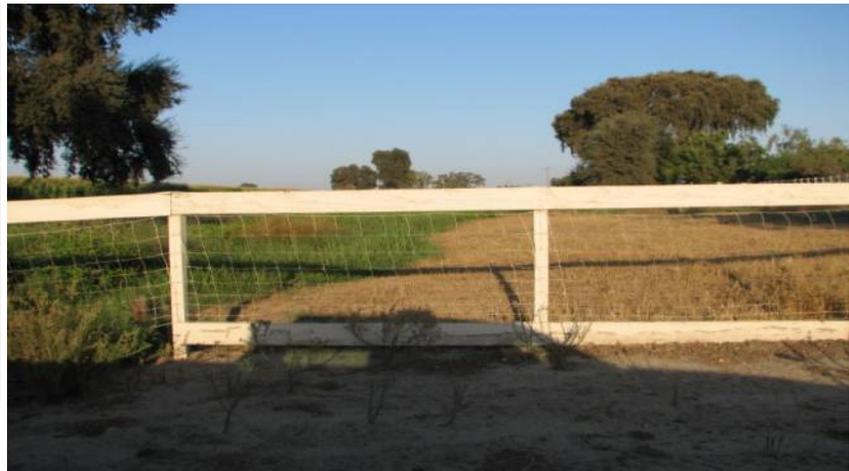
Report Line	7
Location	
Category	Rivers, Channels & Designated Floodways
Item	Encroachments

Upstream on Road 11. Fencing across the channel

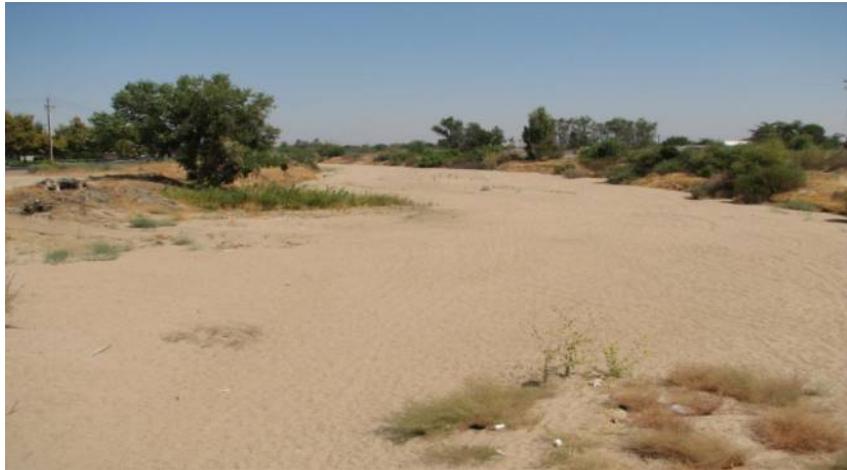
Report Line	3
Location	
Category	Rivers, Channels & Designated Floodways
Item	Vegetation & Obstructions
Downstream from Cleveland Avenue.

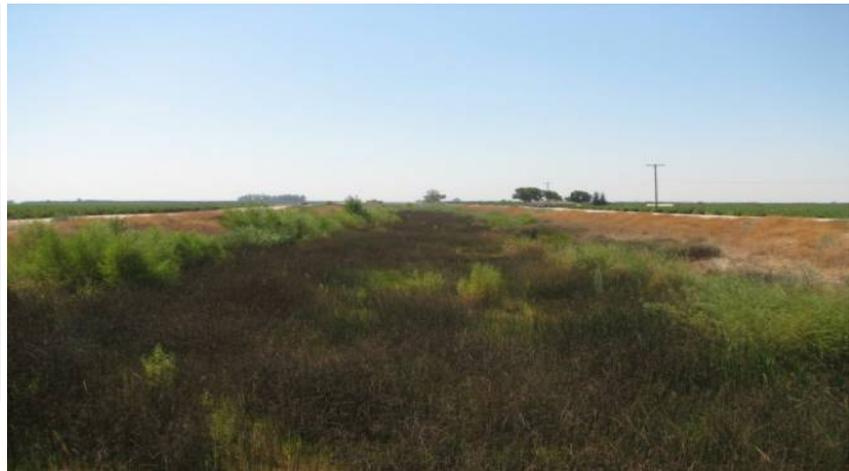
Report Line	7
Location	
Category	Rivers, Channels & Designated Floodways
Item	Vegetation & Obstructions

Upstream from the downstream boundary.
