**Flood Control Project Maintenance
Levee Inspections**

2009 Channel Summary Report

Madera County FCWCA

Flood Control Project Maintenance
Unit Cover Sheet
2009 Channel Inspection Results

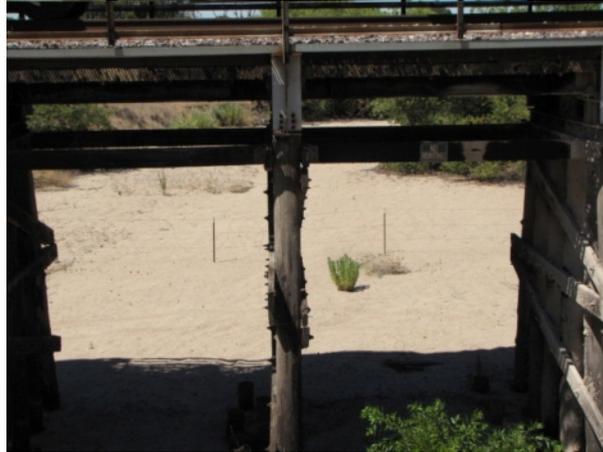
Levee Mile Report Line	11
Start Levee Mile	0.00
End Levee Mile	0.00
Location	
Category	Channels
Item	Vegetation & Obstructions
This photo show fence in back grown across channel.	
phillips_20100106_56.jpg

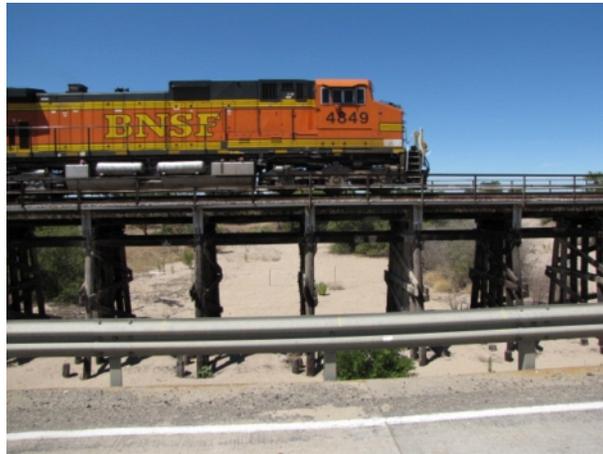
Levee Mile Report Line	16
Start Levee Mile	0.00
End Levee Mile	0.00
Location	
Category	Channels
Item	Vegetation & Obstructions
Downstream from Santa Fe Drive.	
phillips_20090902_50.jpg

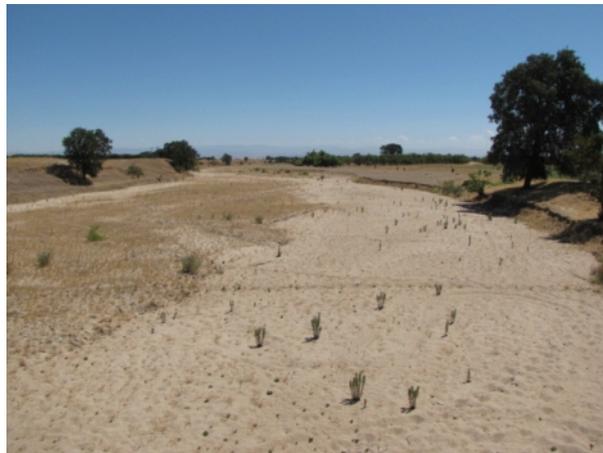
Levee Mile Report Line	21
Start Levee Mile	0.00
End Levee Mile	0.00
Location	
Category	Channels
Item	Vegetation & Obstructions
Clear channel no vegetation. From this view there is no erosion in view that would cause a problem.	
phillips_20100106_55.jpg

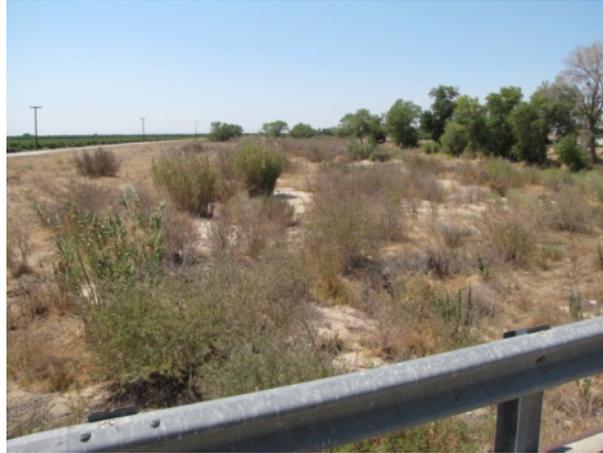
Levee Mile Report Line	31
Start Levee Mile	0.00
End Levee Mile	0.00
Location	
Category	Channels
Item	Vegetation & Obstructions
Upstream from Road 13 bridge.	
phillips_20090901_46.jpg

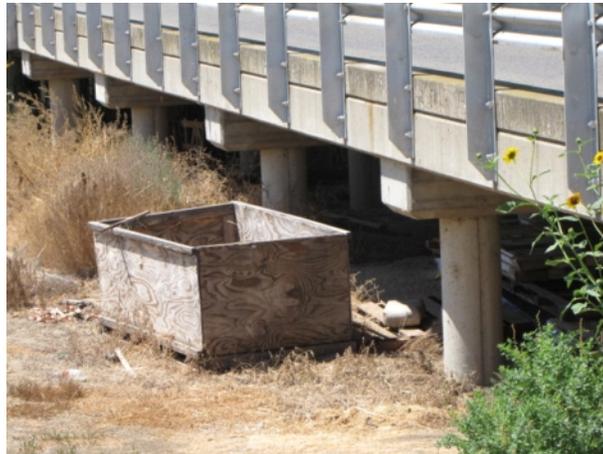
Levee Mile Report Line	45
Start Levee Mile	0.00
End Levee Mile	0.00
Location	
Category	Channels
Item	Encroachments
Upstream from Avenue 25 bridge land owner has used this bridge as storage. There are several item underneath the bridge.	
phillips_20090901_47.jpg

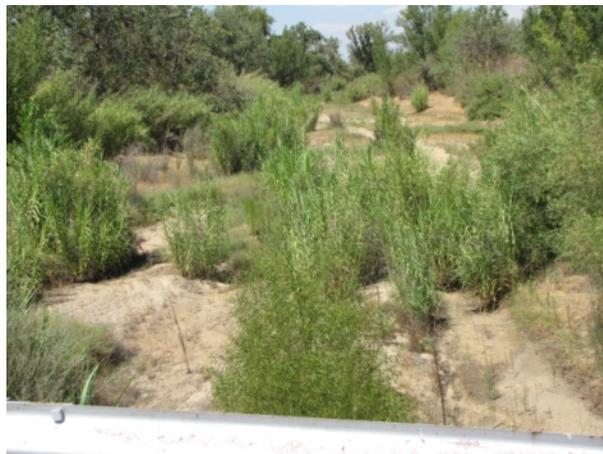
Levee Mile Report Line	46
Start Levee Mile	0.00
End Levee Mile	0.00
Location	
Category	Channels
Item	Vegetation & Obstructions
downstream from Avenue 25.	
phillips_20090901_49.jpg

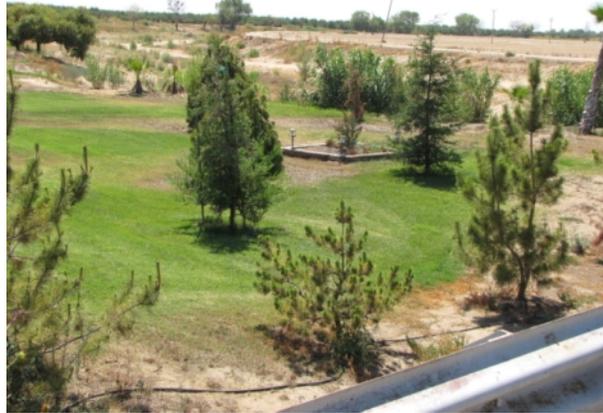
Levee Mile Report Line	50
Start Levee Mile	0.00
End Levee Mile	0.00
Location	
Category	Channels
Item	Encroachments
Trees planted in the channel bank.	
phillips_20090901_48.jpg

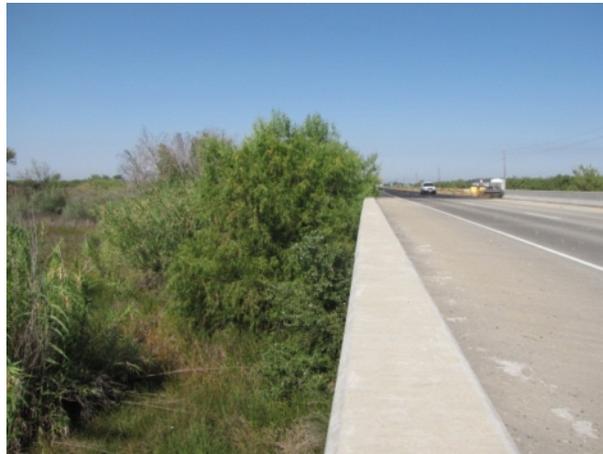
Levee Mile Report Line	61
Start Levee Mile	0.00
End Levee Mile	0.00
Location	
Category	Channels
Item	Vegetation & Obstructions
Upstream from Highway 152.	
phillips_20090902_51.jpg

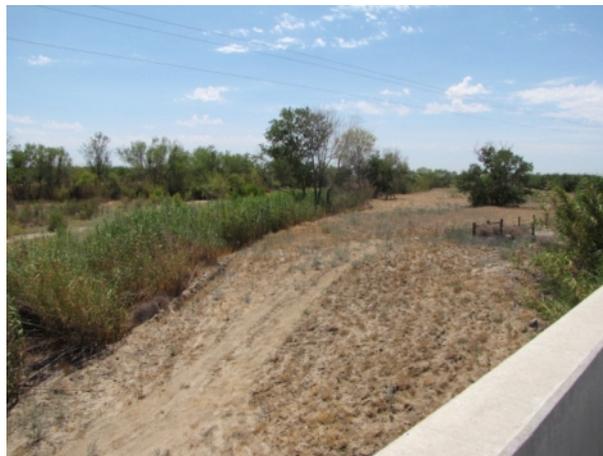
Levee Mile Report Line	66
Start Levee Mile	0.00
End Levee Mile	0.00
Location	
Category	Channels
Item	Vegetation & Obstructions
Downstream From Highway 152.	
phillips_20090902_52.jpg

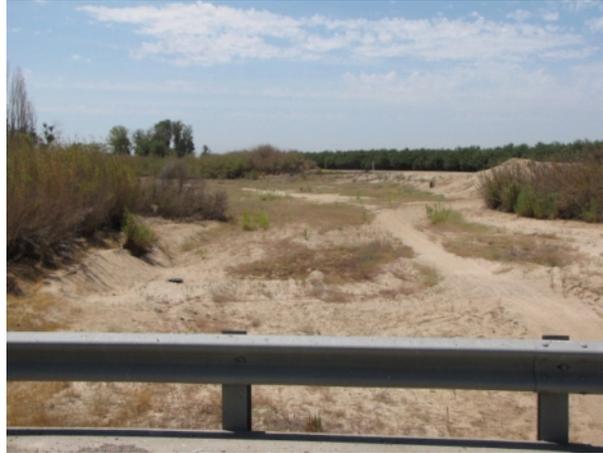
Levee Mile Report Line	71
Start Levee Mile	0.00
End Levee Mile	0.00
Location	
Category	Channels
Item	Vegetation & Obstructions
Upstream from Road 9.	
phillips_20090901_45.jpg

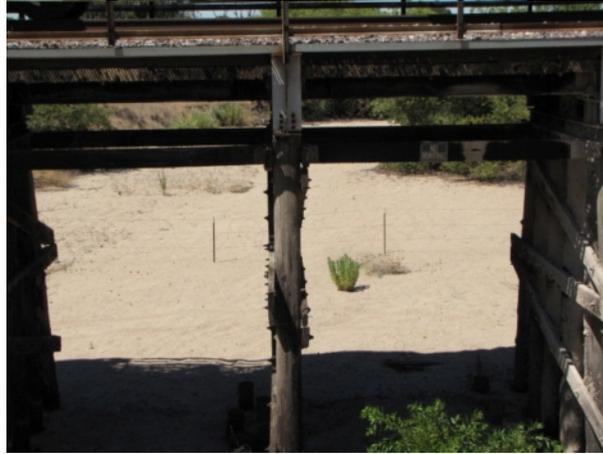
Levee Mile Report Line	3
Start Levee Mile	0.00
End Levee Mile	0.00
Location	
Category	Channels
Item	Encroachments
<p>Fence across channel downstream from train tressel. This could cause debree to hang up during high waterflows.</p>	
<p>phillips_20090828_36.jpg</p>

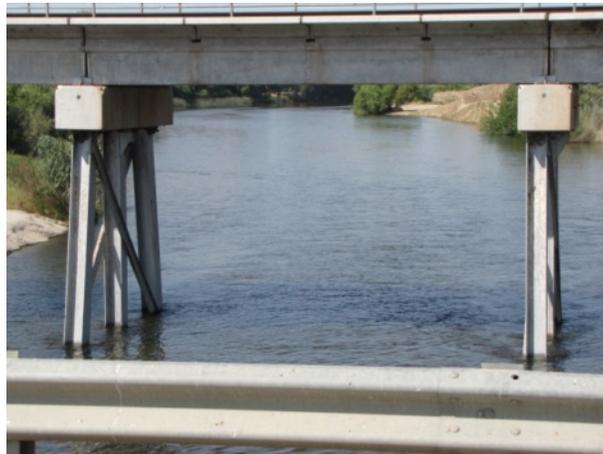
Levee Mile Report Line	4
Start Levee Mile	0.00
End Levee Mile	0.00
Location	
Category	Channels
Item	Vegetation & Obstructions
<p>Down stream from Santa Fe Drive.</p>	
<p>phillips_20090828_35.jpg</p>

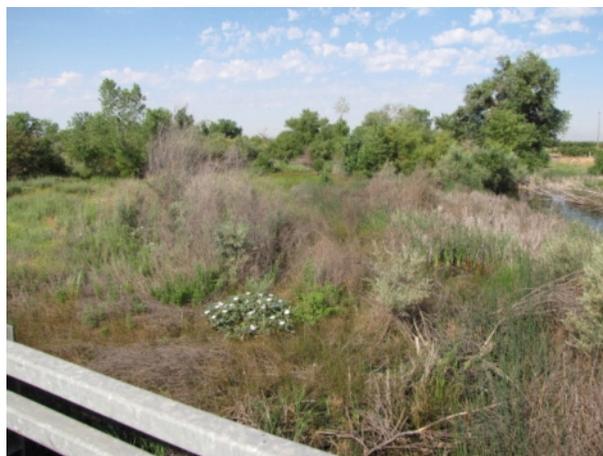
Levee Mile Report Line	24
Start Levee Mile	0.00
End Levee Mile	0.00
Location	
Category	Channels
Item	Vegetation & Obstructions
<p>Upstream from Road 19, growth in channel. Public dumping trash downstream of bridge.</p>	
<p>phillips_20090831_38.jpg</p>

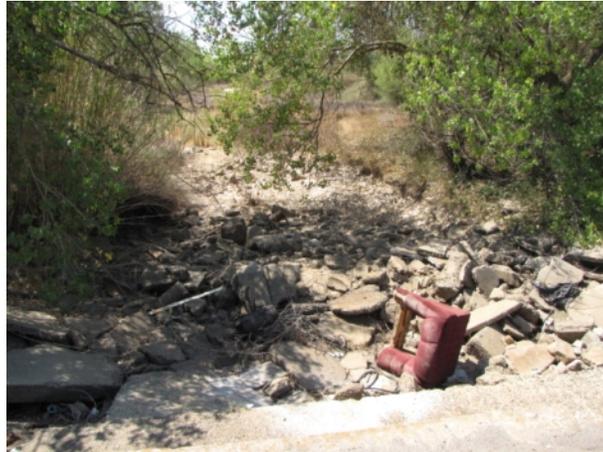
Levee Mile Report Line	34
Start Levee Mile	0.00
End Levee Mile	0.00
Location	
Category	Channels
Item	Vegetation & Obstructions
Downstream from 22 1/2 Avenue low water crossing. This shpt show where some one has dumped furniture in channel.	
phillips_20090831_40.jpg

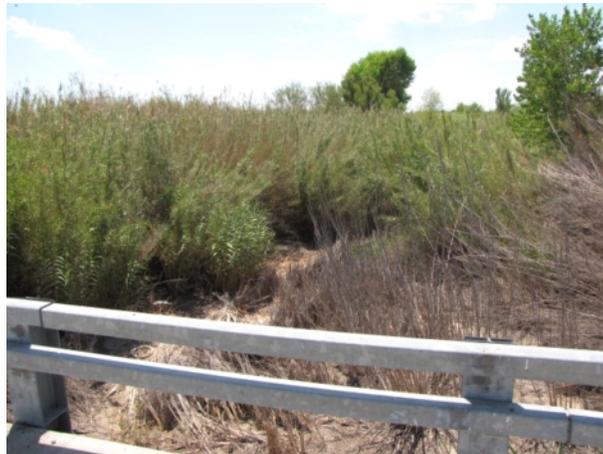
Levee Mile Report Line	39
Start Levee Mile	
End Levee Mile	
Location	
Category	Channels
Item	Vegetation & Obstructions
Upstream from Avenue 20. Orundo present on both banks and in channel.	
phillips_20090903_54.jpg

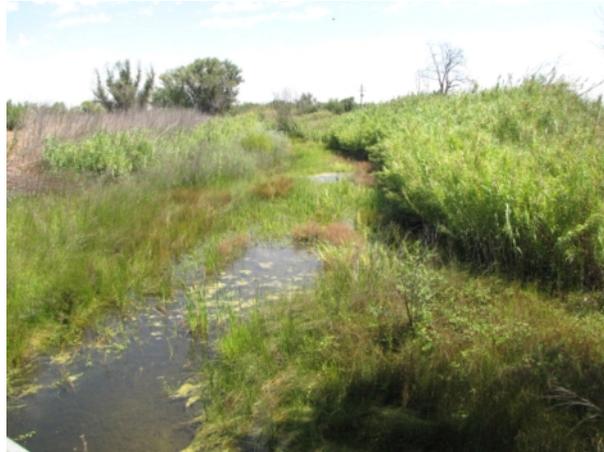
Levee Mile Report Line	49
Start Levee Mile	
End Levee Mile	
Location	
Category	Channels
Item	Vegetation & Obstructions
Up stream of Road 14. Growth in channels and both banks.	
phillips_20090901_43.jpg

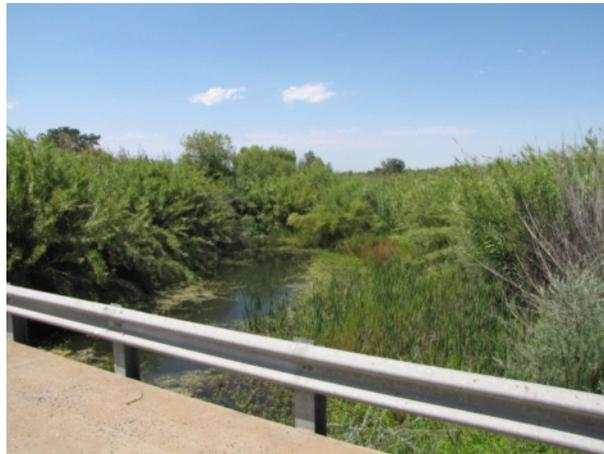
Levee Mile Report Line	54
Start Levee Mile	
End Levee Mile	
Location	
Category	Channels
Item	Vegetation & Obstructions
Downstream from Road 14. Bambo and willow trees in channel and on both banks.	
phillips_20090901_44.jpg

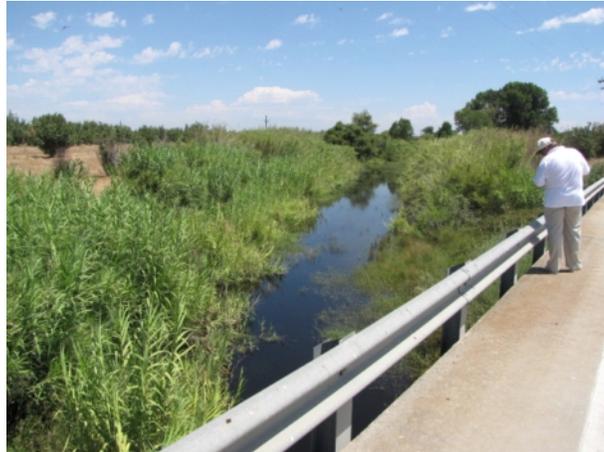
Levee Mile Report Line	64
Start Levee Mile	0.00
End Levee Mile	0.00
Location	
Category	Channels
Item	Vegetation & Obstructions
Downstream from Avenue 18 1/2. Wild growth bambo on both banks of channel.	
phillips_20090901_42.jpg

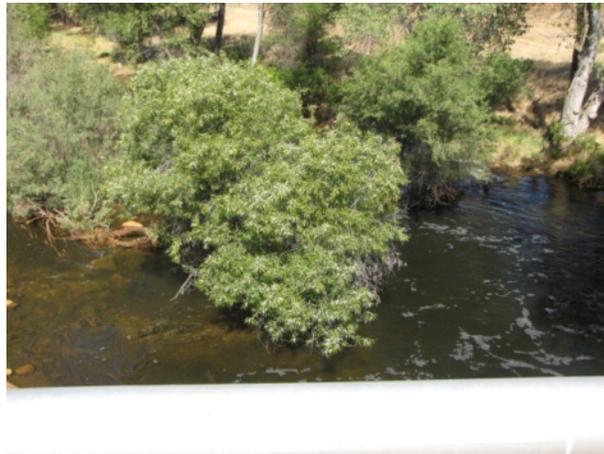
Levee Mile Report Line	6
Start Levee Mile	0.00
End Levee Mile	0.00
Location	
Category	Channels
Item	Vegetation & Obstructions
Looking downstream from Road 165 bridge.	
phillips_20090824_2.jpg

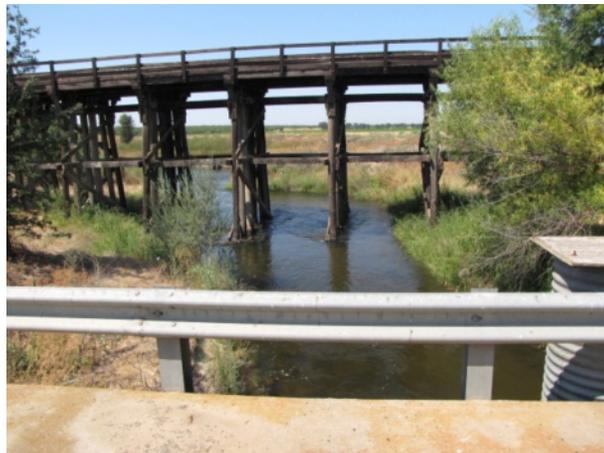
Levee Mile Report Line	11
Start Levee Mile	0.00
End Levee Mile	0.00
Location	
Category	Channels
Item	Vegetation & Obstructions
Downstream from Santa Fe Drive.	
phillips_20090824_3.jpg

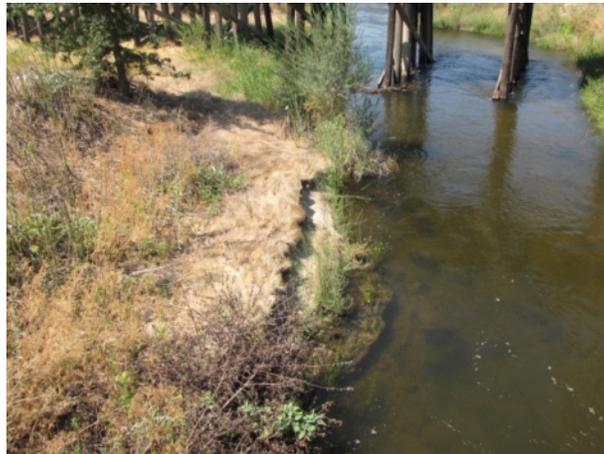
Levee Mile Report Line	18
Start Levee Mile	0.00
End Levee Mile	0.00
Location	
Category	Channels
Item	Erosion / Bank Caving
View of bank erosion just downstream from bridge left bank of channel.	
phillips_20090824_5.jpg

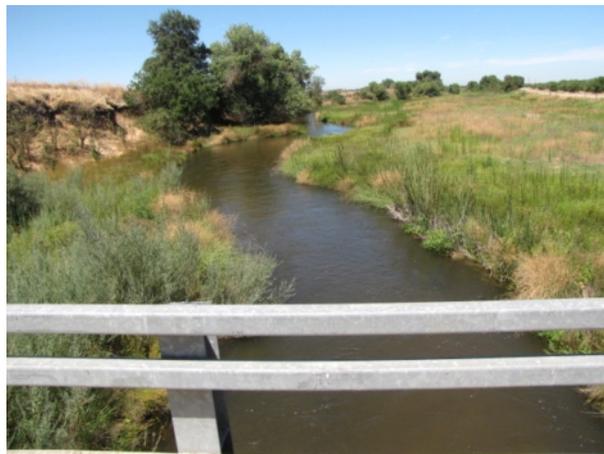
Levee Mile Report Line	21
Start Levee Mile	0.00
End Levee Mile	0.00
Location	
Category	Channels
Item	Vegetation & Obstructions
Upstream from White Rock Road.	
phillips_20090824_6.jpg

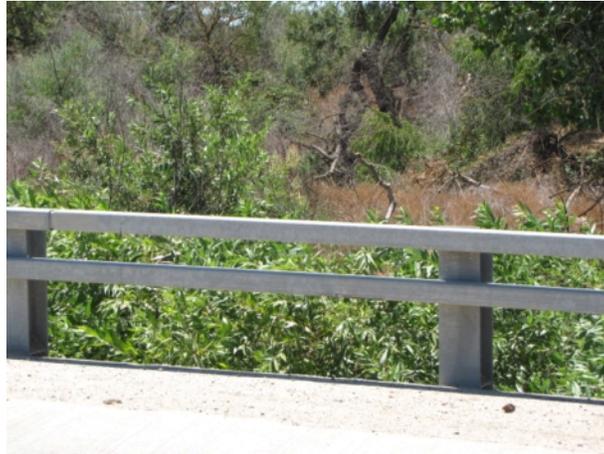
Levee Mile Report Line	31
Start Levee Mile	0.00
End Levee Mile	0.00
Location	
Category	Channels
Item	Vegetation & Obstructions
Dpwnstream Road 13 (Vista Avenue). Vegetation at bridge and in channel.	
phillips_20090824_10.jpg

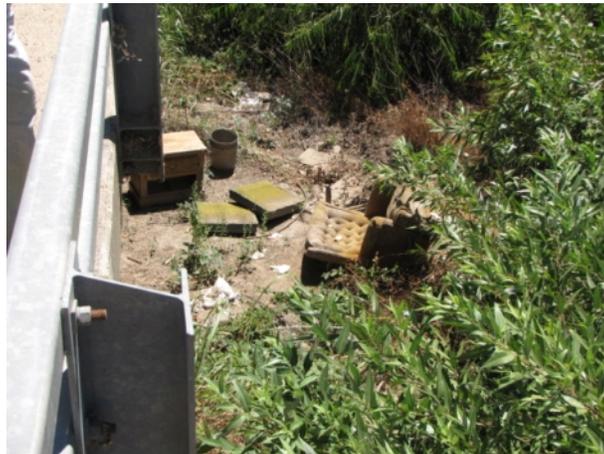
Levee Mile Report Line	35
Start Levee Mile	0.00
End Levee Mile	0.00
Location	
Category	Channels
Item	Encroachments
There is lots of trash and garbage dumped around bridge.	
phillips_20090824_8.jpg

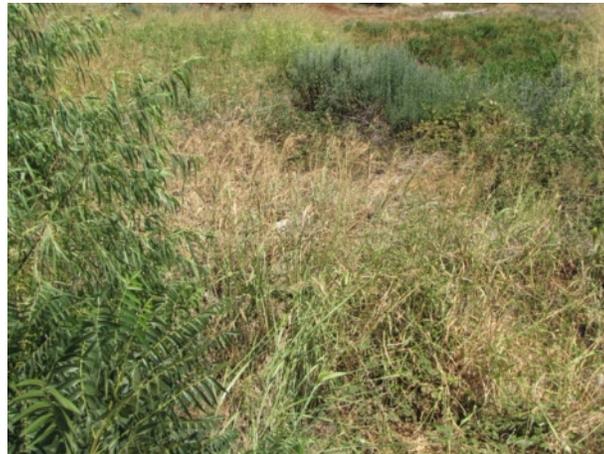
Levee Mile Report Line	36
Start Levee Mile	0.00
End Levee Mile	0.00
Location	
Category	Channels
Item	Vegetation & Obstructions
This photo shows a earthen dam partially across channel	
phillips_20090824_11.jpg

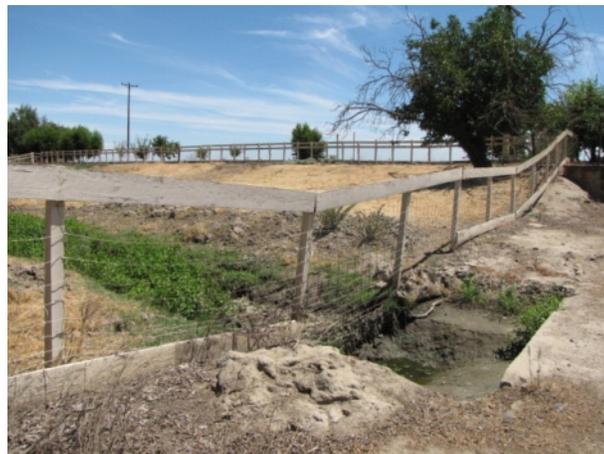
Levee Mile Report Line	41
Start Levee Mile	0.00
End Levee Mile	0.00
Location	
Category	Channels
Item	Vegetation & Obstructions
Downstream Road 11 Fencing across the channel (This is the low water crossing)	
phillips_20090825_12.jpg

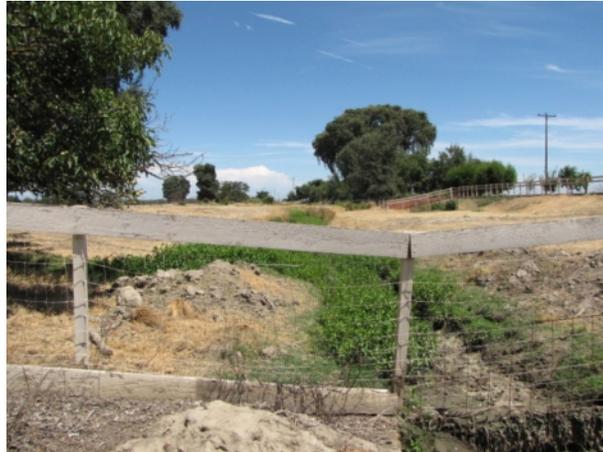
Levee Mile Report Line	50
Start Levee Mile	0.00
End Levee Mile	0.00
Location	
Category	Channels
Item	Encroachments
This is view of fence looking downstream of the Lowwaterr crossing.	
phillips_20090825_13.jpg

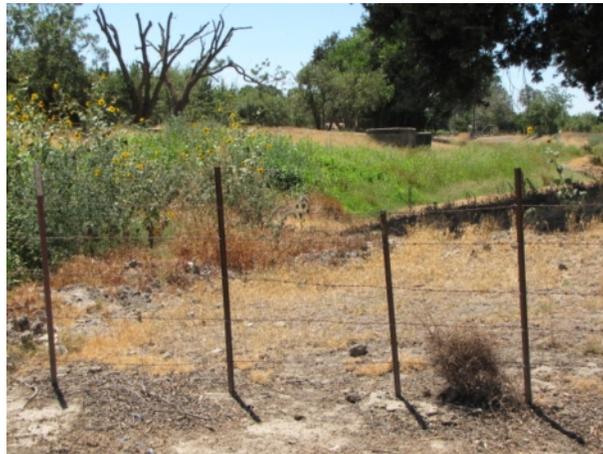
Levee Mile Report Line	51
Start Levee Mile	0.00
End Levee Mile	0.00
Location	
Category	Channels
Item	Vegetation & Obstructions
Upstream from Road 9 (Bliss Road) fence in view not authorized.	
phillips_20090825_14.jpg

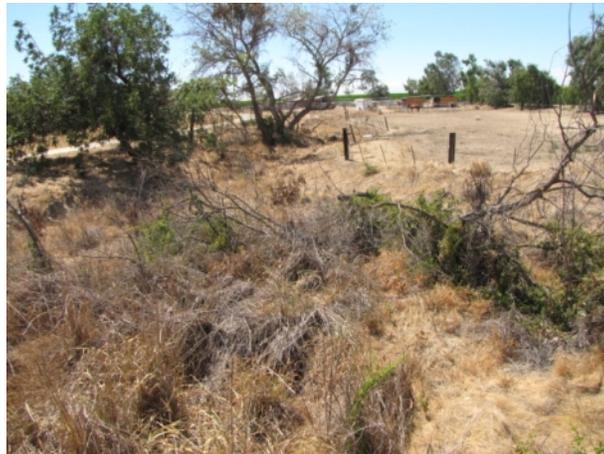
Levee Mile Report Line	60
Start Levee Mile	0.00
End Levee Mile	0.00
Location	
Category	Channels
Item	Encroachments
This photo shows a corral with horses within the channel.	
phillips_20090825_16.jpg

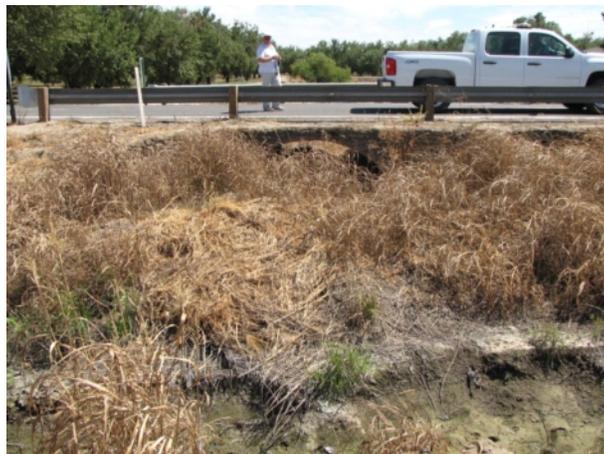
Levee Mile Report Line	63
Start Levee Mile	0.00
End Levee Mile	0.00
Location	
Category	Channels
Item	Erosion / Bank Caving
View from upstream of bridge looking downstream left bank some sloughing on bank.	
phillips_20090825_20.jpg

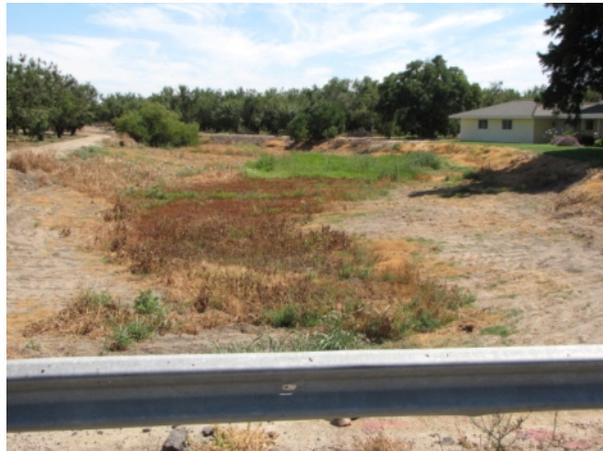
Levee Mile Report Line	66
Start Levee Mile	0.00
End Levee Mile	0.00
Location	
Category	Channels
Item	Vegetation & Obstructions
Downstream of Avenue 25 (Washington Road). Open channel.	
phillips_20090825_19.jpg

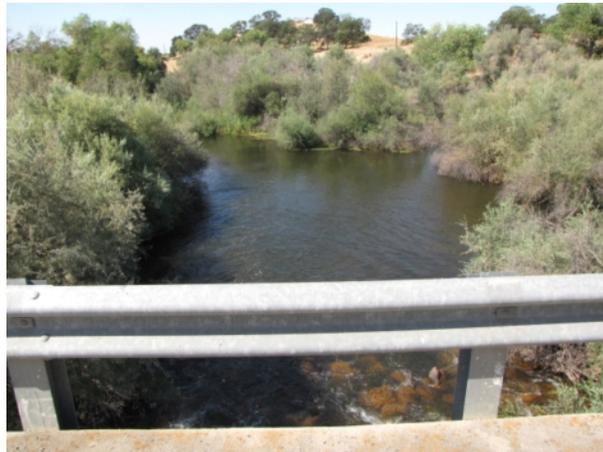
Levee Mile Report Line	6
Start Levee Mile	0.00
End Levee Mile	0.00
Location	
Category	Channels
Item	Vegetation & Obstructions
View from bridge looking downstream, there is growth in channel and both banks.	
phillips_20090826_22.jpg

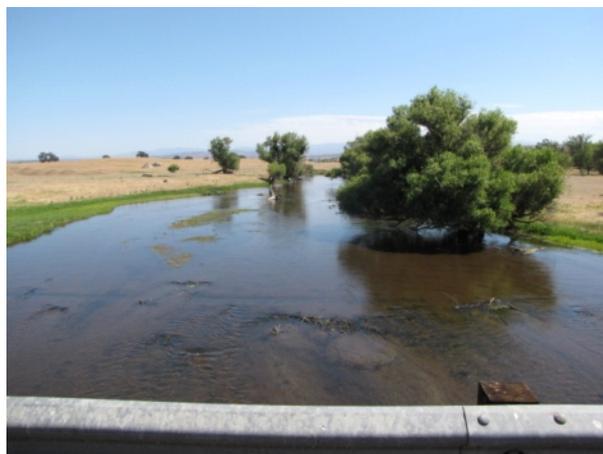
Levee Mile Report Line	12
Start Levee Mile	0.00
End Levee Mile	0.00
Location	
Category	Channels
Item	Shoaling / Sedimentation
View from tember bridge looking upstream.	
phillips_20090826_23.jpg

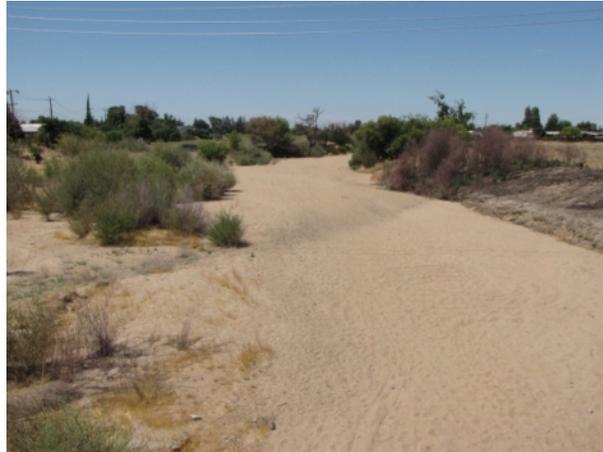
Levee Mile Report Line	21
Start Levee Mile	0.00
End Levee Mile	0.00
Location	
Category	Channels
Item	Vegetation & Obstructions
Downstream from Cleveland Avenue Bridge crossing.	
phillips_20090826_25.jpg

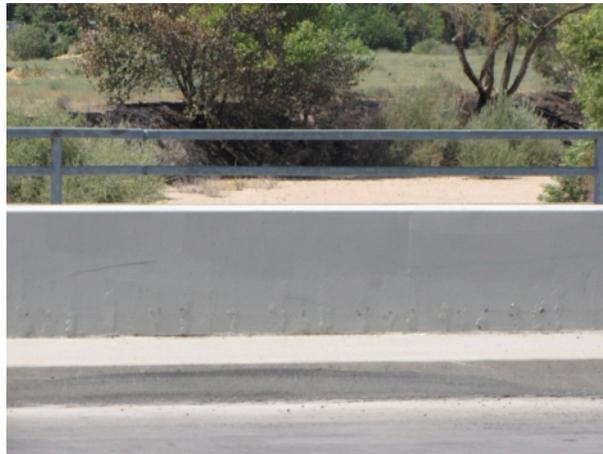
Levee Mile Report Line	21
Start Levee Mile	0.00
End Levee Mile	0.00
Location	
Category	Channels
Item	Vegetation & Obstructions
Upstream of Cleveland Avenue Bridge.	
phillips_20090826_26.jpg

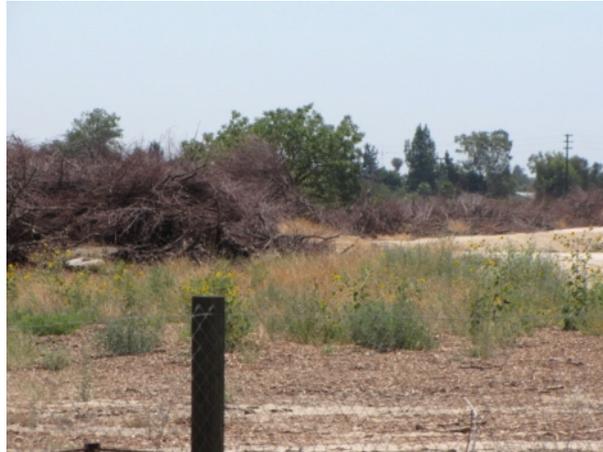
Levee Mile Report Line	45
Start Levee Mile	0.00
End Levee Mile	0.00
Location	
Category	Channels
Item	Encroachments
Grape vines wire and other materials stock piled here on left bank of channel.	
phillips_20090827_29.jpg

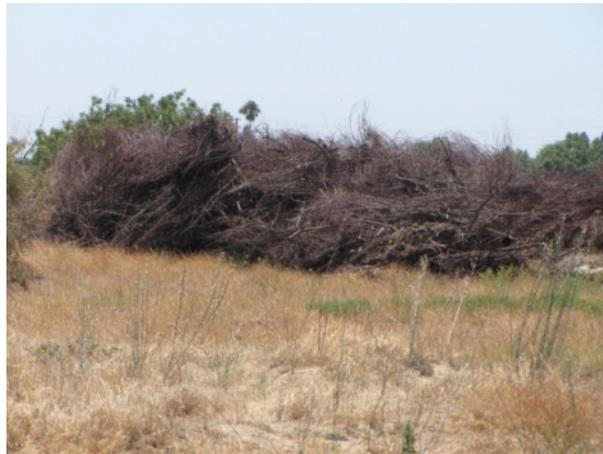
Levee Mile Report Line	45
Start Levee Mile	0.00
End Levee Mile	0.00
Location	
Category	Channels
Item	Encroachments
View of stock pile of grape vine cutting along with other materials left bank of channel.	
phillips_20090827_30.jpg

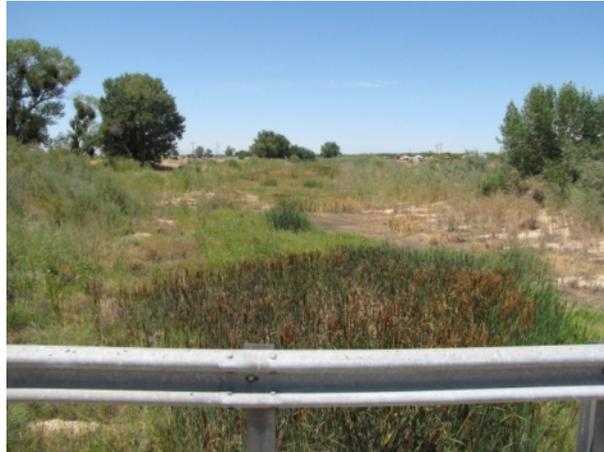
Levee Mile Report Line	66
Start Levee Mile	0.00
End Levee Mile	0.00
Location	
Category	Channels
Item	Vegetation & Obstructions
Downstream from Road 20. Bambo and small trees present in channel on both banks.	
phillips_20090827_31.jpg

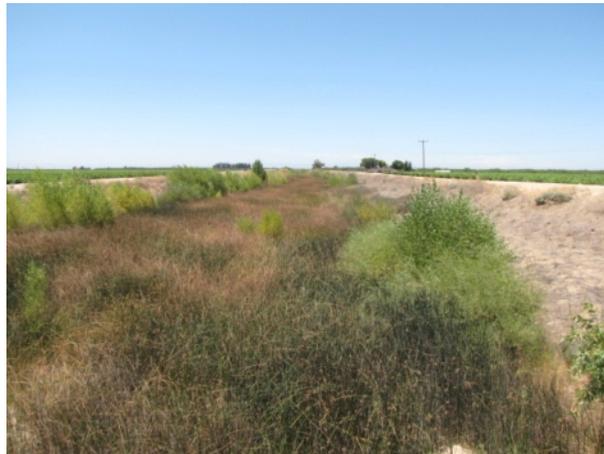
Levee Mile Report Line	71
Start Levee Mile	0.00
End Levee Mile	0.00
Location	
Category	Channels
Item	Vegetation & Obstructions
Upstream from Bridge from downstream boundry.	
phillips_20090827_32.jpg
