**Flood Control Project Maintenance
Levee Inspections**

2012 Channel Summary Report

Madera County FCWCA

**Flood Control Project Maintenance
Channel Inspections**

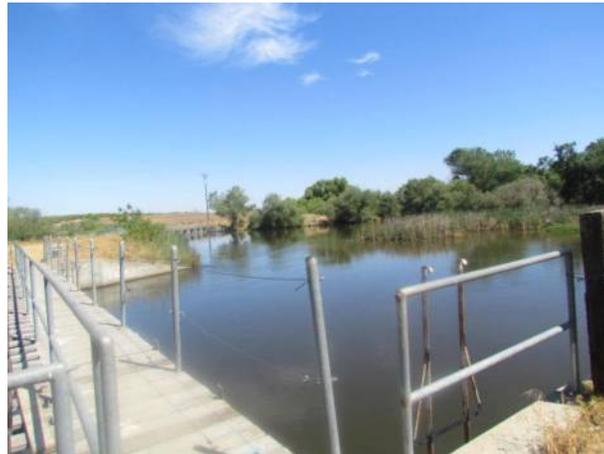
Levee Mile Report Line	6
Start Levee Mile	
End Levee Mile	
Location	
Category	Channels
Item	Vegetation & Obstructions
Looking west (downstream) from Ash Slough & Chowchilla headwall. (2012 Inspection)	
richard_c_20120808_064.JPG

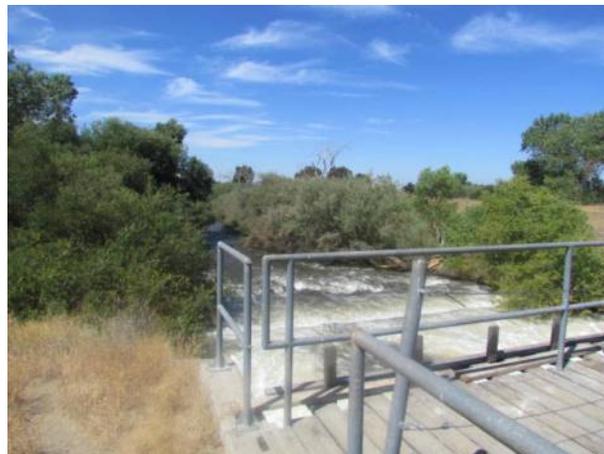
Levee Mile Report Line	11
Start Levee Mile	0.00
End Levee Mile	0.00
Location	
Category	Channels
Item	Vegetation & Obstructions
Looking east (upstream) from Santa Fe Dr. (2012 Inspection)	
richard_c_20120808_065.JPG

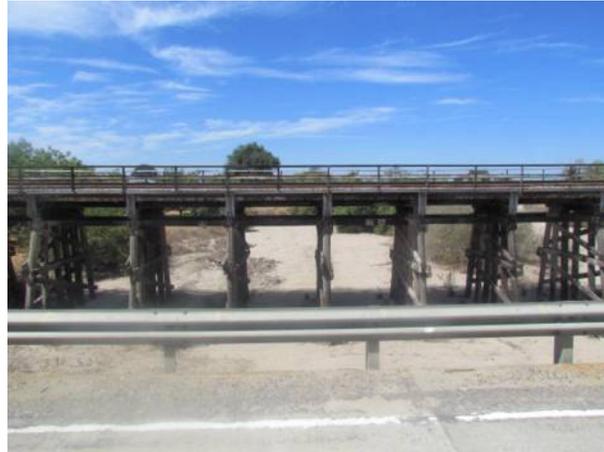
Levee Mile Report Line	21
Start Levee Mile	0.00
End Levee Mile	0.00
Location	
Category	Channels
Item	Vegetation & Obstructions
Looking east (upstream) from White Rock Rd/Road 19.	
richard_c_20120808_067.JPG

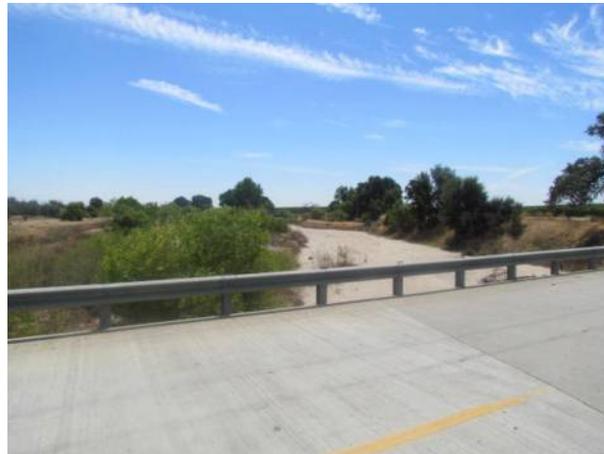
Levee Mile Report Line	26
Start Levee Mile	0.00
End Levee Mile	0.00
Location	
Category	Channels
Item	Vegetation & Obstructions
Looking west (downstream) from White Rock Rd/Road 19.(2012 Inspection)	
richard_c_20120808_068.JPG

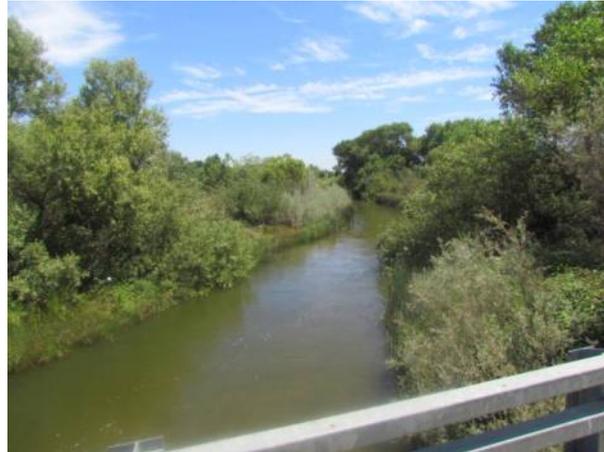
Levee Mile Report Line	30
Start Levee Mile	0.00
End Levee Mile	0.00
Location	
Category	Channels
Item	Vegetation & Obstructions
Looking northeast (upstream) from Road 13	
richard_c_20120808_070.JPG

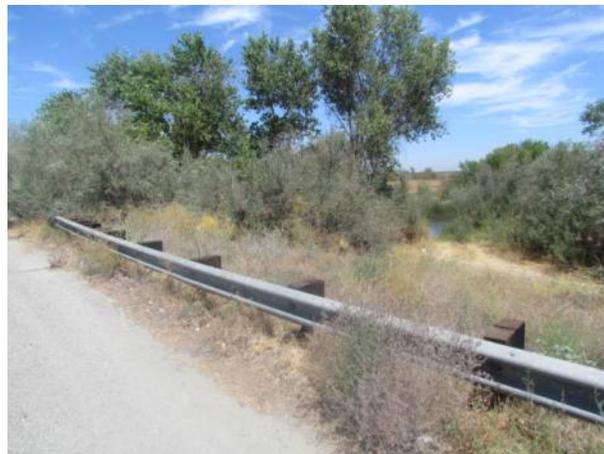
Levee Mile Report Line	35
Start Levee Mile	0.00
End Levee Mile	0.00
Location	
Category	Channels
Item	Vegetation & Obstructions
Looking west (downstream) from Road 13.	
richard_c_20120808_071.JPG

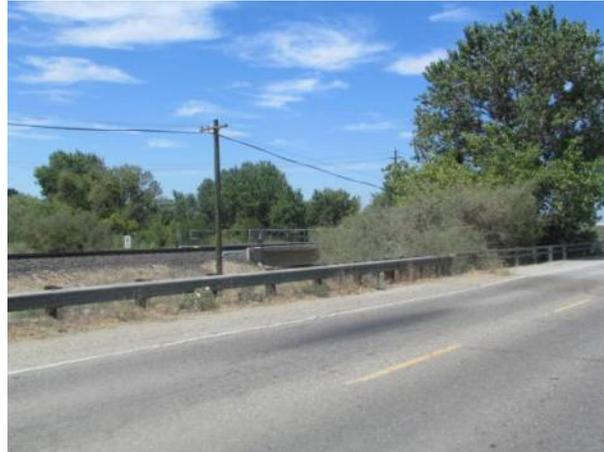
Levee Mile Report Line	50
Start Levee Mile	0.00
End Levee Mile	0.00
Location	
Category	Channels
Item	Vegetation & Obstructions
Looking east (upstream) from Road 12. (2012 Inspection)	
richard_c_20120808_073.JPG

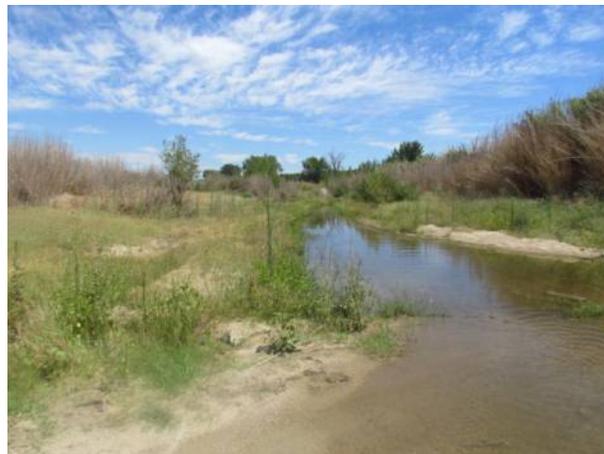
Levee Mile Report Line	55
Start Levee Mile	0.00
End Levee Mile	0.00
Location	
Category	Channels
Item	Vegetation & Obstructions
Looking west (downstream) from Road 12. (2012 Inspection)	
richard_c_20120808_074.JPG

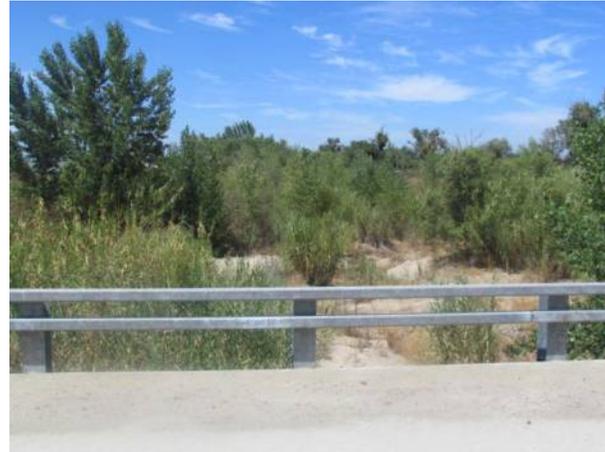
Levee Mile Report Line	65
Start Levee Mile	0.00
End Levee Mile	0.00
Location	
Category	Channels
Item	Vegetation & Obstructions
Looking west (downstream) from Avenue 23 1/2. (2012 Inspection)	
richard_c_20120808_076.JPG

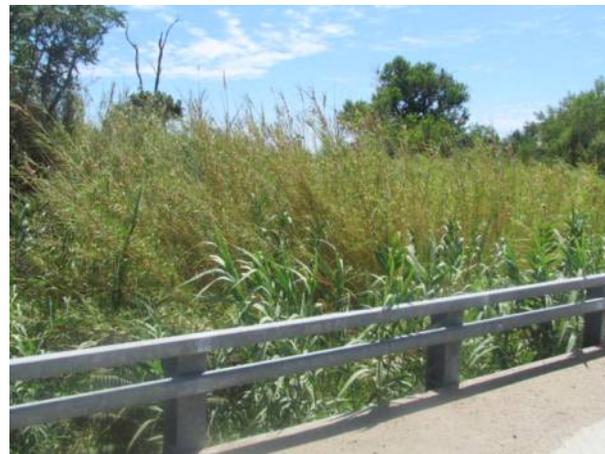
Levee Mile Report Line	70
Start Levee Mile	0.00
End Levee Mile	0.00
Location	
Category	Channels
Item	Vegetation & Obstructions
Looking east (upstream) from Hwy 152. (2012 Inspection)	
richard_c_20120808_077.JPG

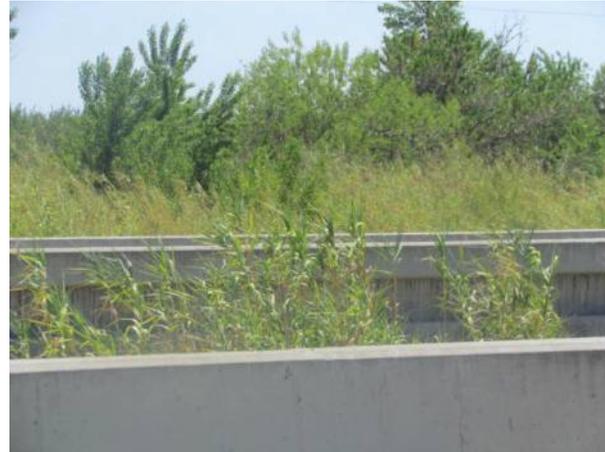
Levee Mile Report Line	80
Start Levee Mile	0.00
End Levee Mile	0.00
Location	
Category	Channels
Item	Vegetation & Obstructions
Looking east (upstream) from Road 9. (2012 Inspection)	
richard_c_20120808_079.JPG

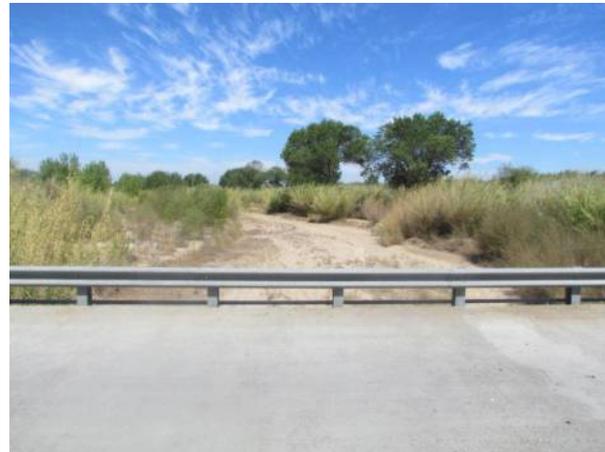
Levee Mile Report Line	85
Start Levee Mile	0.00
End Levee Mile	0.00
Location	
Category	Channels
Item	Vegetation & Obstructions
Looking west (downstream) from Road 19. (2012 Inspection)	
richard_c_20120808_080.JPG

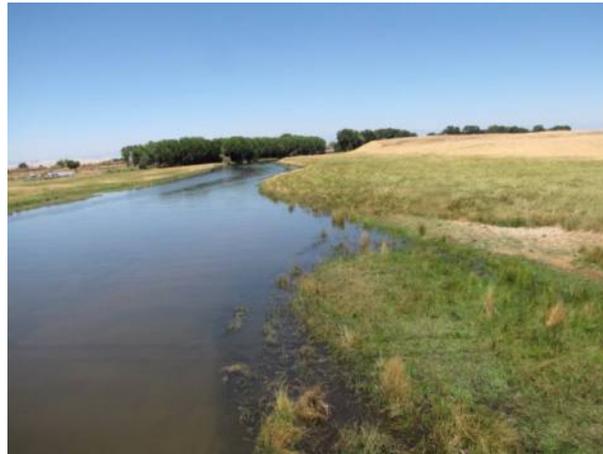
Levee Mile Report Line	6
Start Levee Mile	0.00
End Levee Mile	0.00
Location	
Category	Channels
Item	Vegetation & Obstructions
Berenda Slough looking downstream channel clear of any vegetation for several hundred yards. Photo taken 7-24-2012.	
phillips_c_20120822_144.jpg

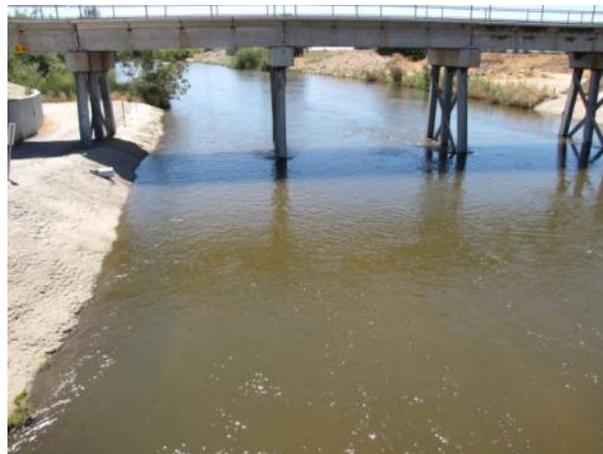
Levee Mile Report Line	11
Start Levee Mile	0.00
End Levee Mile	0.00
Location	
Category	Channels
Item	Vegetation & Obstructions
Berenda Slough looking from 26 Avenue. Channel completely overgrown with tullies and other plant growth. Photo taken 7-24-2012.	
phillips_c_20120822_145.jpg

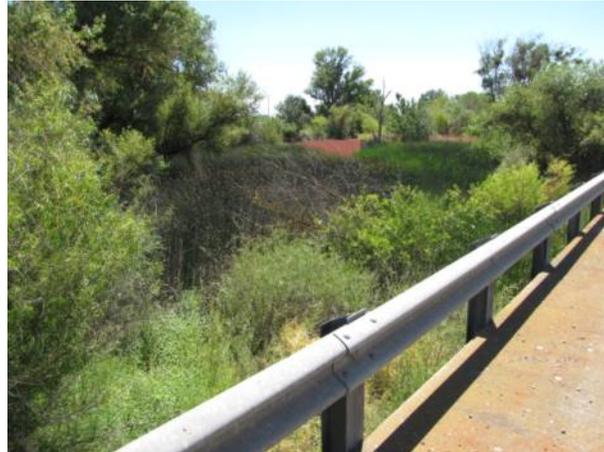
Levee Mile Report Line	21
Start Levee Mile	0.00
End Levee Mile	0.00
Location	
Category	Channels
Item	Vegetation & Obstructions
<p>Berenda Slough looking upstream from Rd. 19, as far as you can see this channel is choked with tullies, wild berries and willow trees. Photo taken 7-24-2012.</p>	
<p>phillips_c_20120823_147.jpg</p>

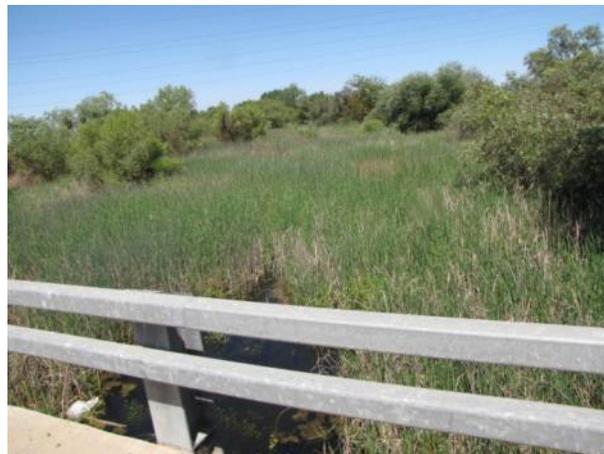
Levee Mile Report Line	26
Start Levee Mile	0.00
End Levee Mile	0.00
Location	
Category	Channels
Item	Vegetation & Obstructions
<p>Berenda Slough looking downstream from Road 19. Channel choked with tullies and other wild growth. Photo taken 7-24-2012.</p>	
<p>phillips_c_20120823_148.jpg</p>

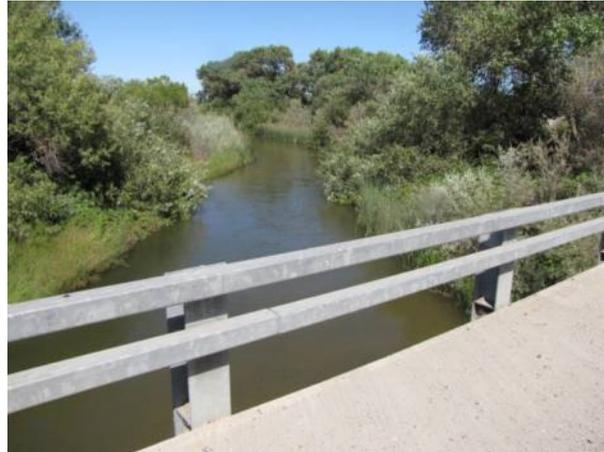
Levee Mile Report Line	36
Start Levee Mile	0.00
End Levee Mile	0.00
Location	
Category	Channels
Item	Vegetation & Obstructions
Berenda Slough looking downstream from Chowchilla Blvd. Photo taken 7-24-2012.	
phillips_c_20120827_150.jpg

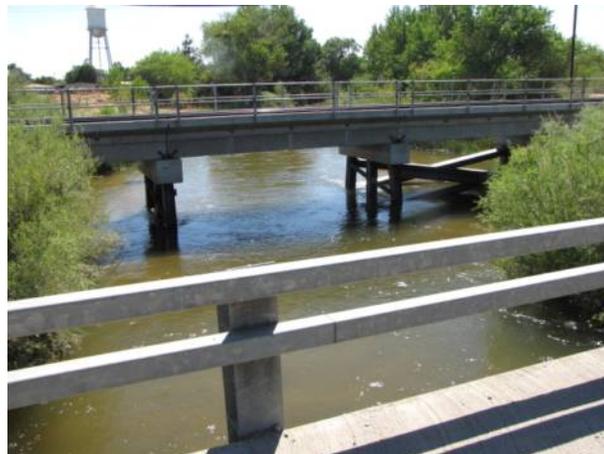
Levee Mile Report Line	41
Start Levee Mile	0.00
End Levee Mile	0.00
Location	
Category	Channels
Item	Vegetation & Obstructions
Berenda Slough looking upstream from Road 16 crossing. Photo taken 7-24-2012.	
phillips_c_20120827_151.jpg

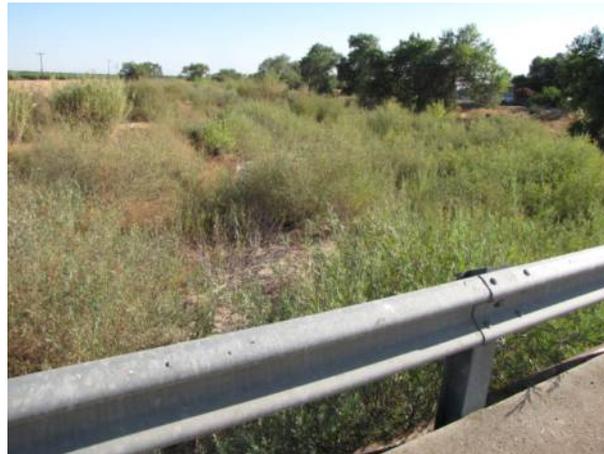
Levee Mile Report Line	66
Start Levee Mile	
End Levee Mile	
Location	
Category	Channels
Item	Vegetation & Obstructions
Berenda Slough looking downstream from Ave. 21. Photo taken 7-24-2012.	
phillips_c_20120827_156.jpg

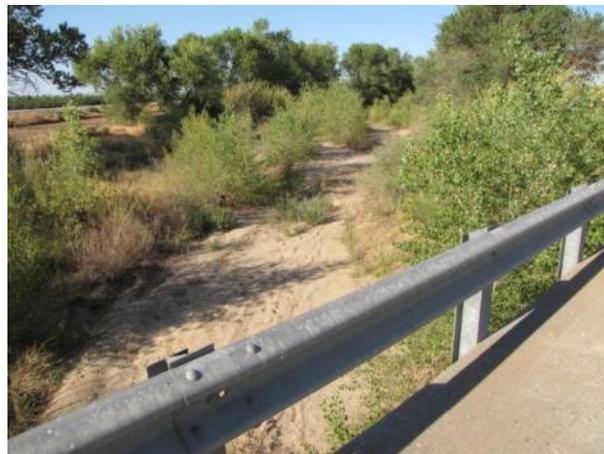
Levee Mile Report Line	71
Start Levee Mile	0.00
End Levee Mile	0.00
Location	
Category	Channels
Item	Vegetation & Obstructions
Berenda Slough looking upstream from Ave. 20. Photo taken 7-24-2012.	
phillips_c_20120827_157.jpg

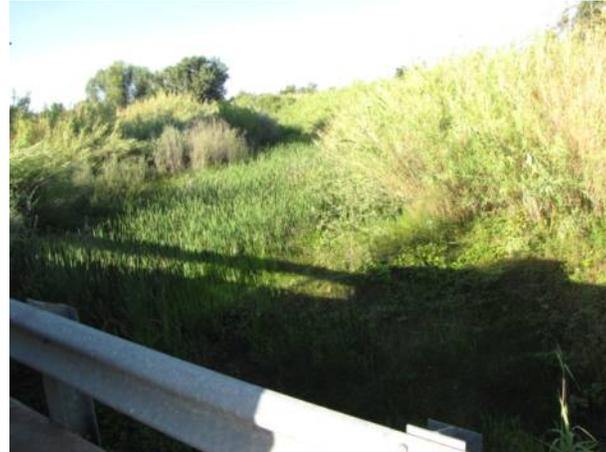
Levee Mile Report Line	96
Start Levee Mile	0.00
End Levee Mile	0.00
Location	
Category	Channels
Item	Vegetation & Obstructions
Berenda slough looking downstream from Road 14.	
phillips_c_20120827_161.jpg

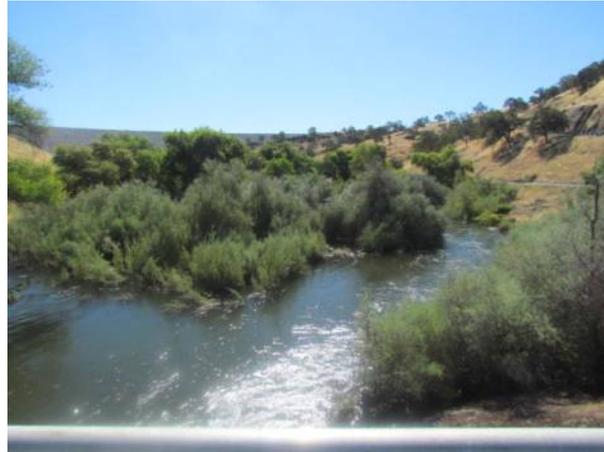
Levee Mile Report Line	6
Start Levee Mile	
End Levee Mile	
Location	
Category	Channels
Item	Vegetation & Obstructions
Looking downstream from County Road 29 just below Buchanan Dam.	
richard_c_20120806_043.JPG

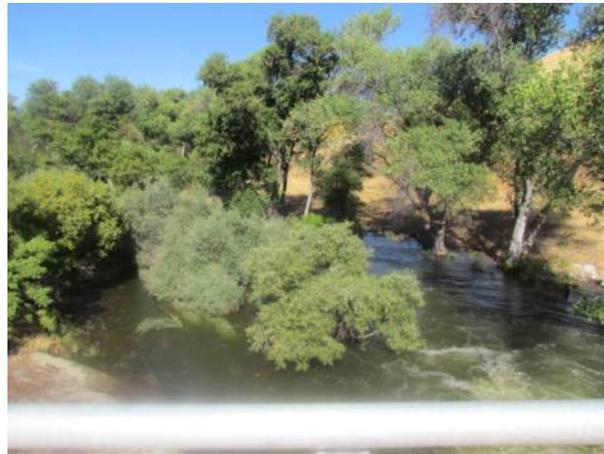
Levee Mile Report Line	11
Start Levee Mile	
End Levee Mile	
Location	
Category	Channels
Item	Vegetation & Obstructions
Looking northeast (upstream) from Santa Fe Dr.	
richard_c_20120806_044.JPG

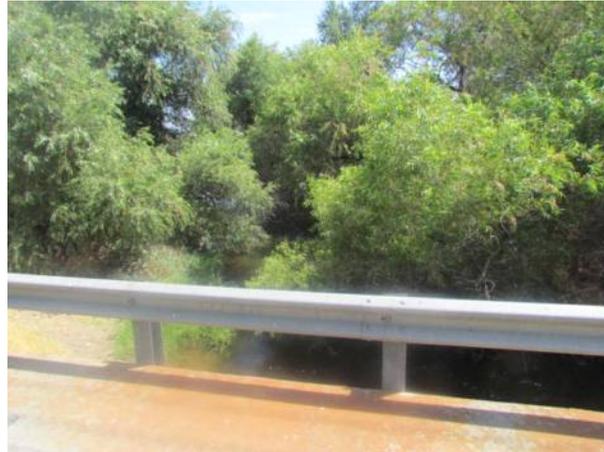
Levee Mile Report Line	16
Start Levee Mile	
End Levee Mile	
Location	
Category	Channels
Item	Vegetation & Obstructions
Looking west (downstream) from Santa Fe Drive.	
richard_c_20120806_046.JPG

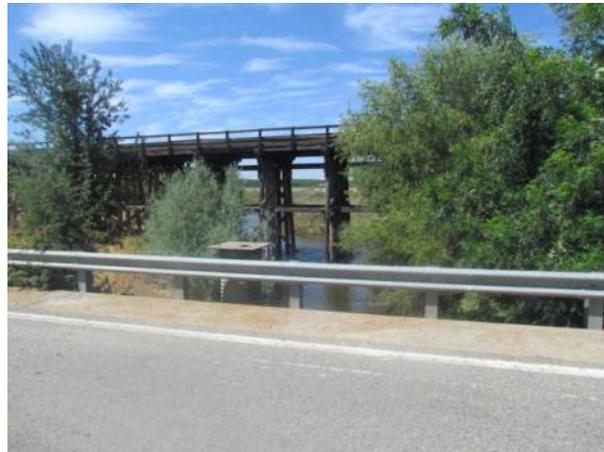
Levee Mile Report Line	21
Start Levee Mile	
End Levee Mile	
Location	
Category	Channels
Item	Vegetation & Obstructions
Looking east (upstream) from White Rock Rd/Road 19.	
richard_c_20120806_047.JPG

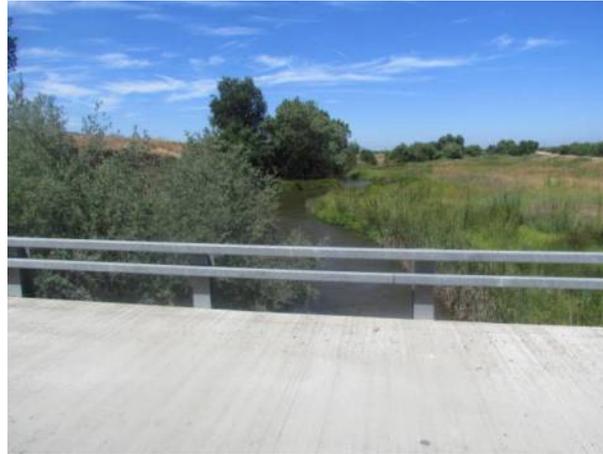
Levee Mile Report Line	31
Start Levee Mile	
End Levee Mile	
Location	
Category	Channels
Item	Vegetation & Obstructions
Looking east (upstream) from Road 13 1/2 Vista Ave.	
richard_c_20120806_049.JPG

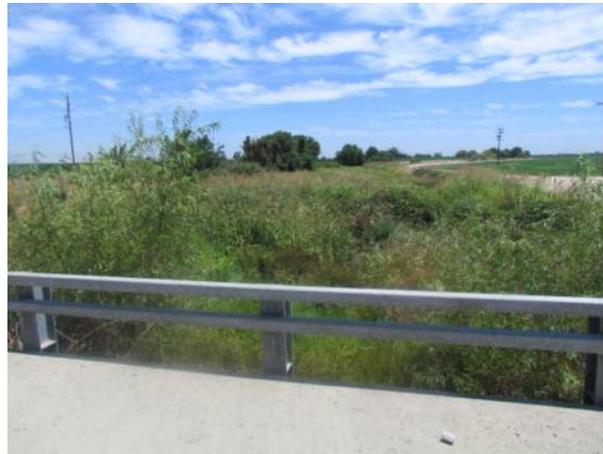
Levee Mile Report Line	36
Start Levee Mile	
End Levee Mile	
Location	
Category	Channels
Item	Vegetation & Obstructions
Looking west (downstream) from Road 13 1/2 Vista Ave.	
richard_c_20120806_050.JPG

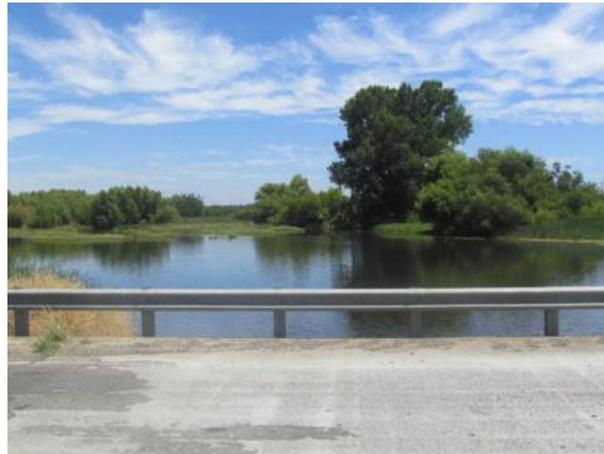
Levee Mile Report Line	46
Start Levee Mile	
End Levee Mile	
Location	
Category	Channels
Item	Vegetation & Obstructions
Looking west (downstream) at Check Dam from Road 15	
richard_c_20120806_052.JPG

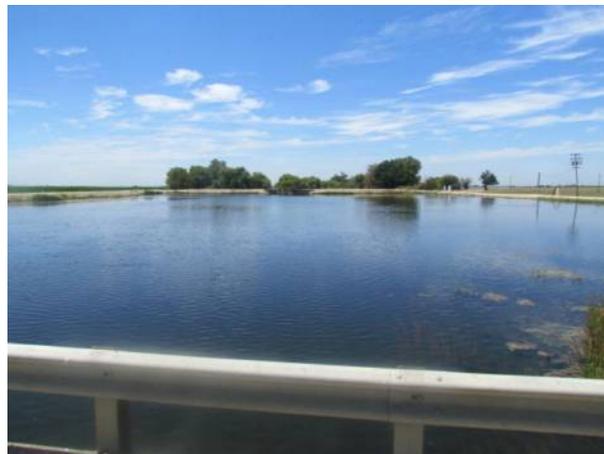
Levee Mile Report Line	51
Start Levee Mile	
End Levee Mile	
Location	
Category	Channels
Item	Vegetation & Obstructions
Looking east (upstream) from Low-water crossing at Road 11	
richard_c_20120806_053.JPG

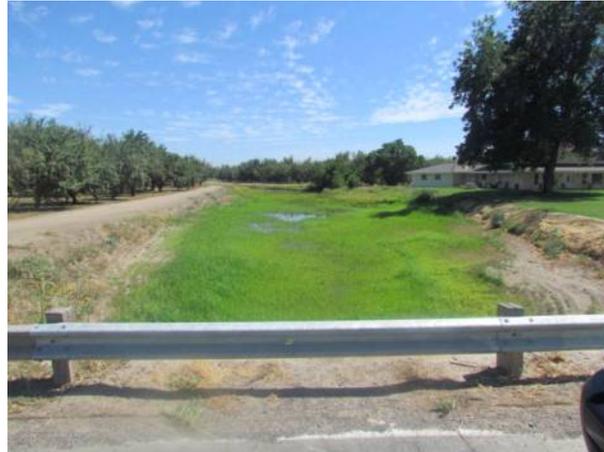
Levee Mile Report Line	72
Start Levee Mile	
End Levee Mile	
Location	
Category	Channels
Item	Shoaling / Sedimentation
Looking northwest at sedimentation in channel upstream of Washington Rd.	
richard_c_20120806_058.JPG
