**Flood Control Project Maintenance  
Levee Inspections**

**2015 Channel Summary Report**

**Madera County FCWCA**

**2015 Channel Inspection Results**

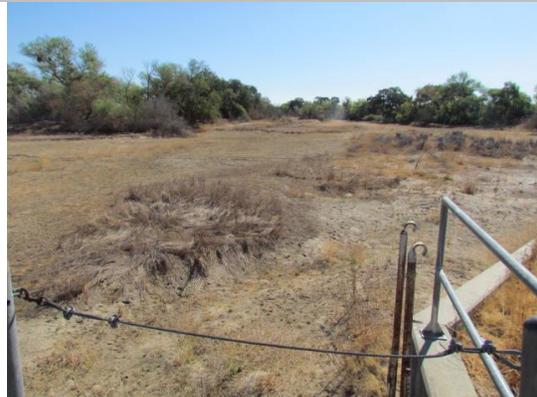
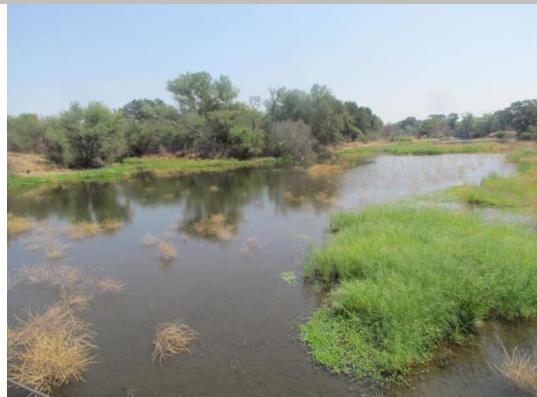
Photo 1 of 2 : CH\_2015\_NA0011\_38\_92\_20150813\_00019.jpg

Check Point / View			
<b>Low Water Crossing / Up</b>			
Rating **	A	Issue No. <b>92</b>	GPS Lat/Long
Issue Type +	Ma	Location *	37.157888 °
Category	Rivers, Channels & Designated Flood		-120.124010 °
Item	Vegetation & Obstructions		
DWR ID	DWR_NA0011_38_c_2012_92		
Action/Comments			
Inspector Comments: No vegetation or obstructions present to impede flow.

Looking east upstream at channel from low water crossing. (2015)

Looking east upstream at channel from low water crossing. (2014)

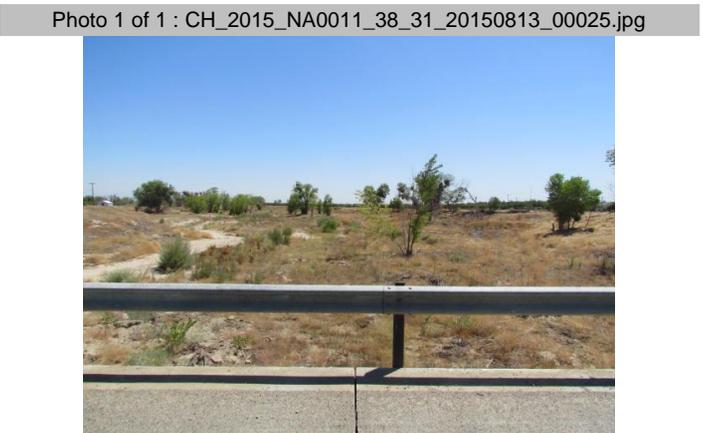
Check Point / View				
<b>Rd 13 / Up</b>				
Rating **	A	Issue No.	<b>31</b>	GPS Lat/Long
Issue Type +	Ma	Location *		37.120400 °
Category	Rivers, Channels & Designated Flood			-120.310890 °
Item	Vegetation & Obstructions			
DWR ID	DWR_NA0011_38_c _ 2012_31			
Action/Comments				
Inspector Comments: Established tree near bridge should be removed for clear view of channel.

Looking upstream at channel from Road 13.

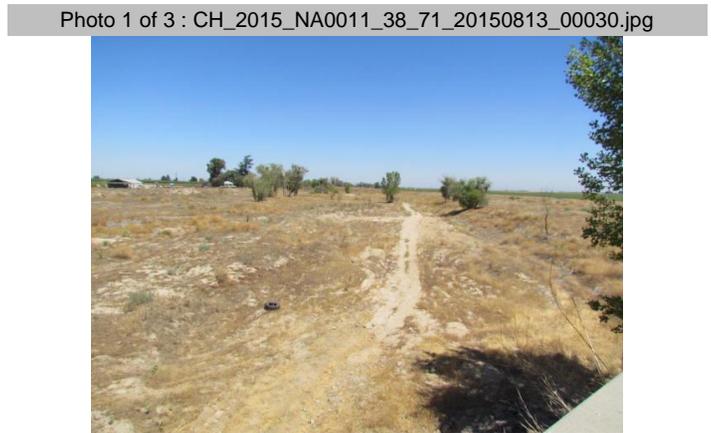
Check Point / View				
<b>Hwy 152 / Up</b>				
Rating **	A	Issue No.	<b>71</b>	GPS Lat/Long
Issue Type +	Ma	Location *		37.083010 °
Category	Rivers, Channels & Designated Flood			-120.361040 °
Item	Vegetation & Obstructions			
DWR ID	DWR_NA0011_38_c_2012_71			
Action/Comments				
Inspector Comments: A minimal amount of vegetation near the bridge that should be controlled, but does not impede channel flow.

Looking east (upstream) at channel from Hwy 152.

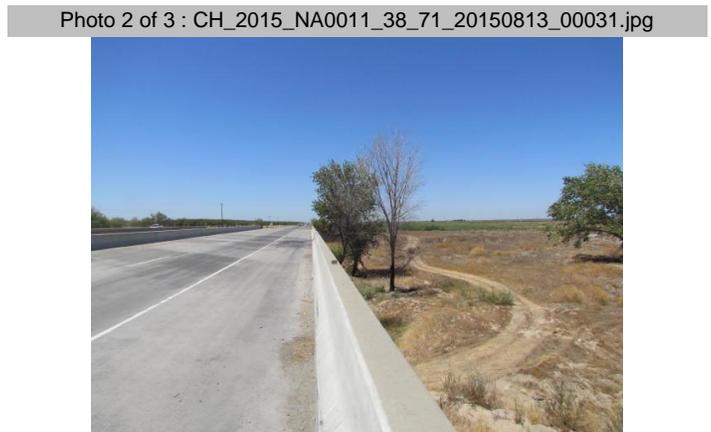
Rating **	A	Issue No.	<b>71 (cont)</b>	GPS Lat/Long
Issue Type +	Ma	Location *		37.083010 °
Category	Rivers, Channels & Designated Flood			-120.361040 °
Item	Vegetation & Obstructions			
DWR ID	DWR_NA0011_38_c_2012_71

Looking northeast at trees near bridge.

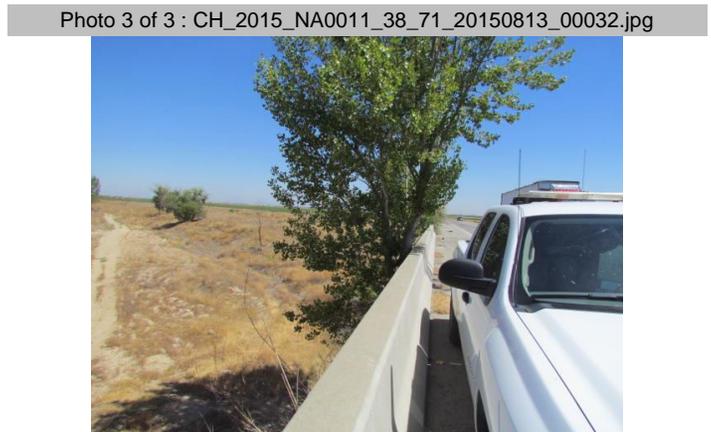
Rating **	A	Issue No.	<b>71 (cont)</b>	GPS Lat/Long
Issue Type +	Ma	Location *		37.083010 °
Category	Rivers, Channels & Designated Flood			-120.361040 °
Item	Vegetation & Obstructions			
DWR ID	DWR_NA0011_38_c_2012_71

Looking southeast at trees near bridge.

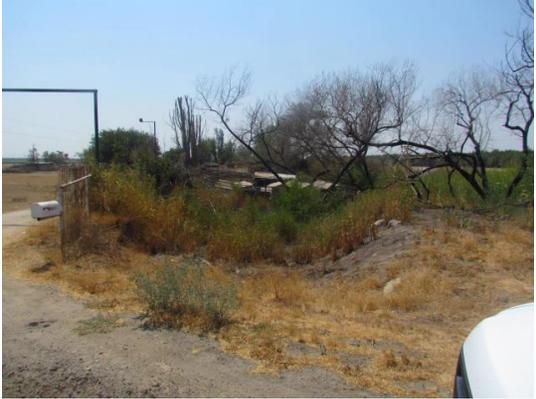
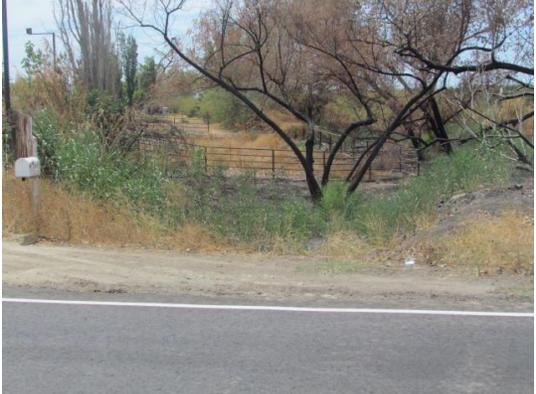
Photo 1 of 2 : CH\_2015\_NA0011\_38\_90\_20150610\_00015.jpg

Looking west at animal pen with animal cages in channel from Road 9. (2014)

Looking west at animal pen in channel from Road 9. (2013)

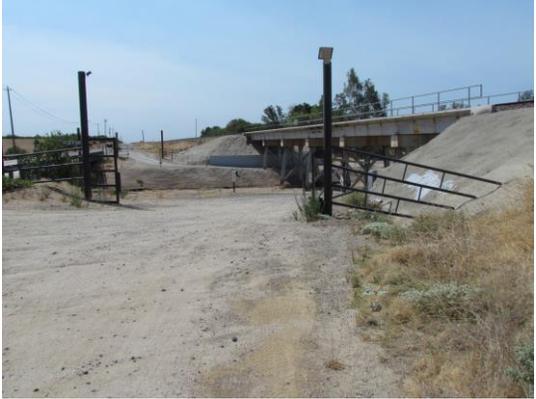
Photo 1 of 2 : CH\_2015\_NA0011\_39\_10\_20150812\_00028.jpg

The landowner has placed this fence and gate on the right bank of the Brenda Slough downstream of the crossing.

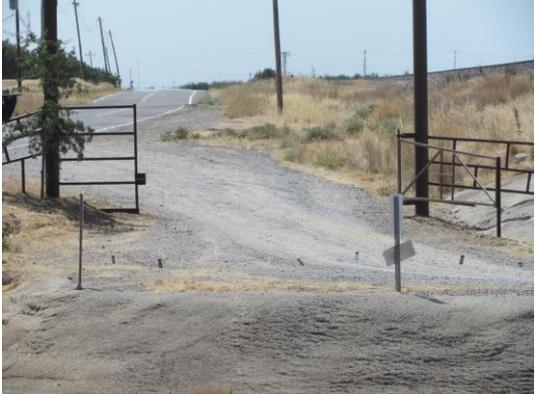
Photo 2 of 2 : CH\_2015\_NA0011\_39\_10\_20150812\_00029.jpg

Another view of the gate and fence looking across the channel.

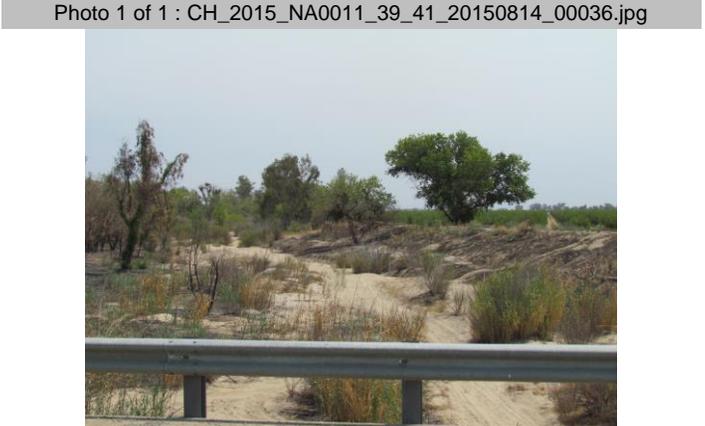
Check Point / View				
<b>Rd 16 / Up</b>				
Rating **	A	Issue No.	41	GPS Lat/Long
Issue Type +	Ma	Location *		37.099721 °
Category	Rivers, Channels & Designated Flood			-120.256744 °
Item	Vegetation & Obstructions			
DWR ID	DWR_NA0011_39_c _ 2012_41			
Action/Comments				
Inspector Comments: The vegetation has been removed from channel, due to wild fire.

Brenda Slough looking upstream from Road 16.

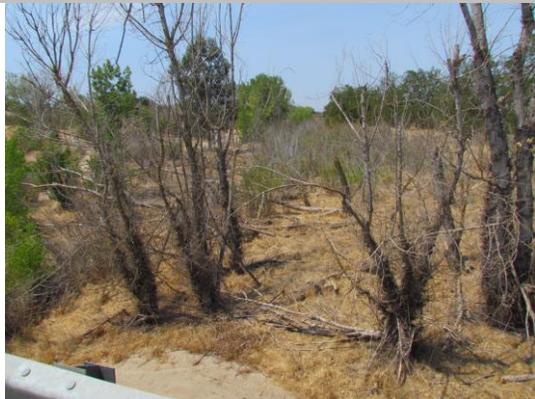
Photo 1 of 1 : CH\_2015\_NA0011\_39\_46\_20150814\_00037.jpg

Brenda Slough looking downstream from Road 16. Dead trees in channel under and near bridge.

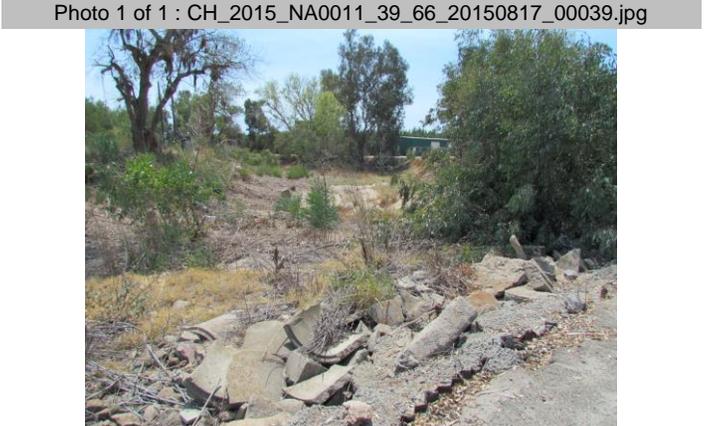
Check Point / View				
<b>Ave 22 / Down</b>				
Rating **	M	Issue No.	<b>66</b>	GPS Lat/Long
Issue Type +	Ma	Location *		37.069003 °
Category	Rivers, Channels & Designated Flood			-120.278523 °
Item	Vegetation & Obstructions			
DWR ID	DWR_NA0011_39_c _ 2012_66			
Action/Comments				
Inspector Comments: Minimal, scattered obstructions or vegetation. The flow is not impeded.

Brenda Slough at Avenue 22 low water crossing.

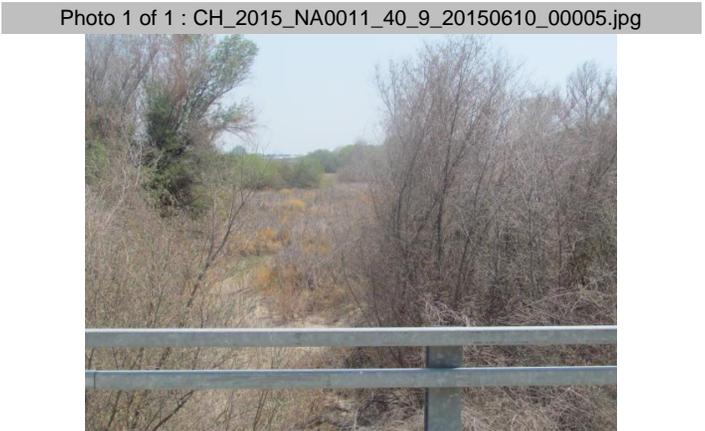
Check Point / View				
<b>White Rock Rd / Up</b>				
Rating **	A	Issue No.	<b>9</b>	GPS Lat/Long
Issue Type +	Ma	Location *		37.161820 °
Category	Rivers, Channels & Designated Flood			-120.202050 °
Item	Vegetation & Obstructions			
DWR ID	DWR_NA0011_40_c_2012_9			
Action/Comments				
Inspector Comments: Established trees near bridge should be controlled.

Looking east (upstream) at channel from White Rock Road.

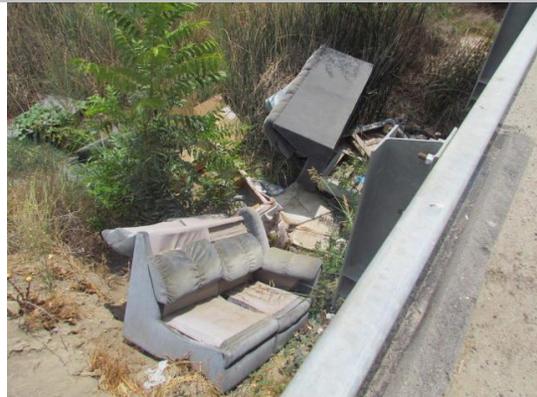
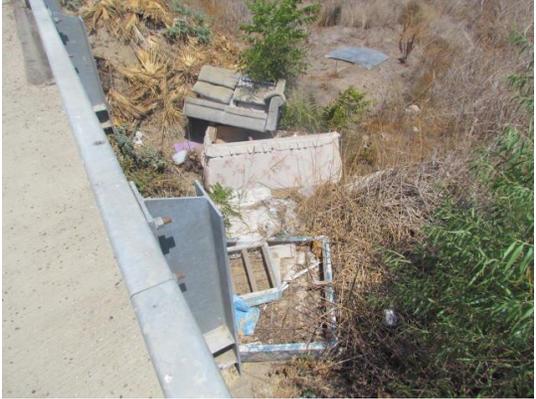
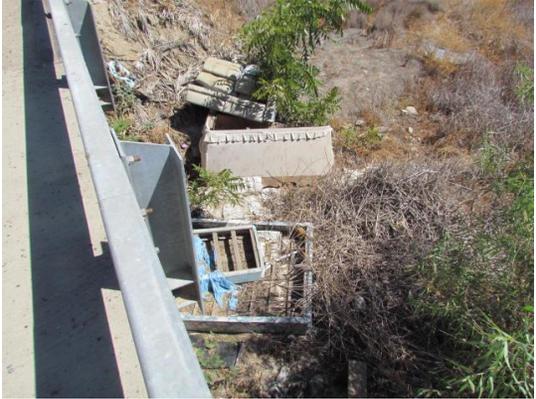
Looking southeast at trash in channel. (2013)

Looking southeast at trash in channel from Road 13. (2014)

Looking southeast at trash in channel. (2015)

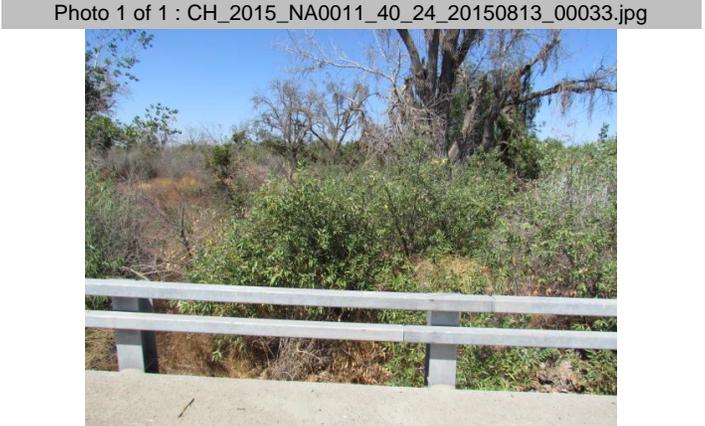
Check Point / View				
<b>Rd 13/ Vista Ave / Down</b>				
Rating **	M	Issue No.	<b>24</b>	GPS Lat/Long
Issue Type +	Ma	Location *		37.140600 °
Category	Rivers, Channels & Designated Flood			-120.310110 °
Item	Vegetation & Obstructions			
DWR ID	DWR_NA0011_40_c_2012_24			
Action/Comments				
Inspector Comments: Established trees and vegetation near bridge should be removed.

Looking downstream from Road 13.

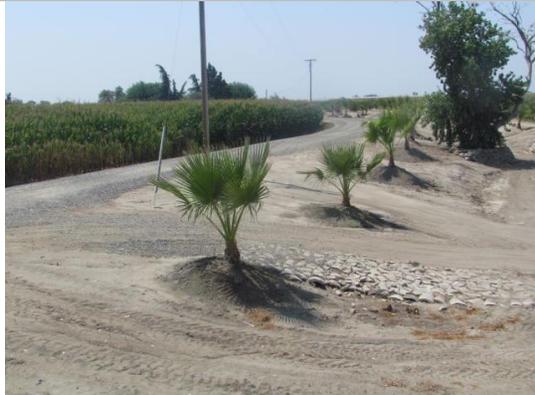
Photo 2 of 2 : CH\_2015\_NA0011\_40\_44\_20150610\_00023.jpg

Looking west (downstream) at plam trees in channel from Road 9. (2014)

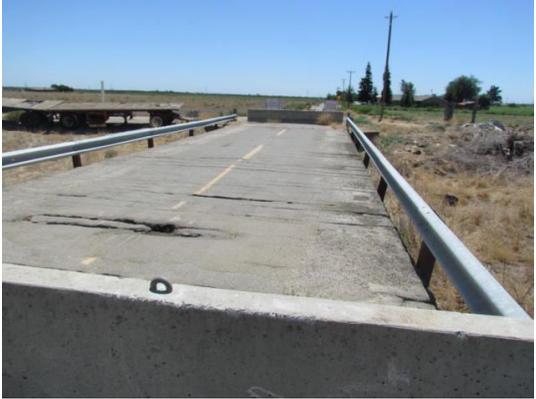
Photo 1 of 2 : CH\_2015\_NA0011\_40\_47\_20150813\_00047.jpg

Looking south at bridge across channel with cracks on road top.

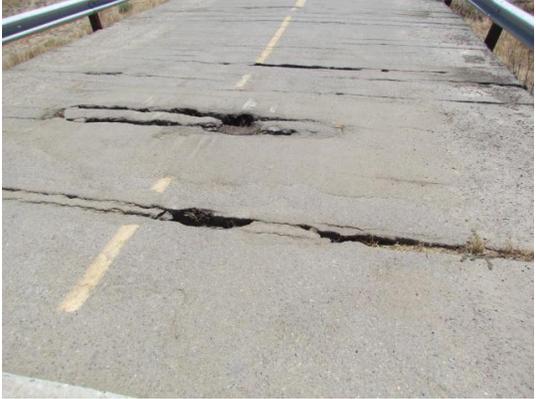
Photo 2 of 2 : CH\_2015\_NA0011\_40\_47\_20150813\_00048.jpg

Looking at large crack on road top.

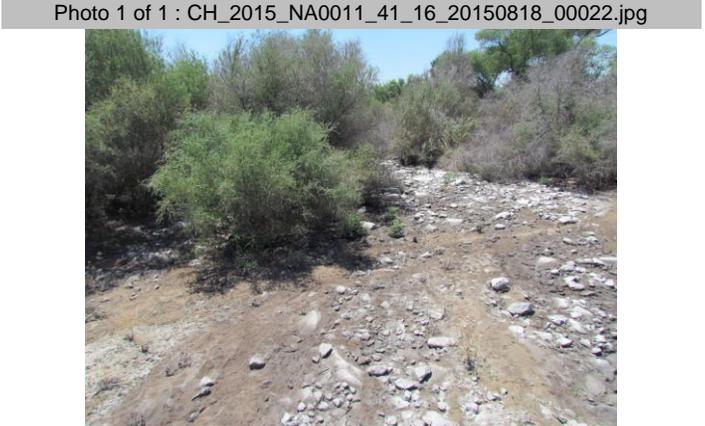
Check Point / View				
<b>Timber Bridge at Madera Canal / Down</b>				
Rating **	M	Issue No.	<b>16</b>	GPS Lat/Long
Issue Type +	Ma	Location *		37.070110 °
Category	Rivers, Channels & Designated Flood			-119.910220 °
Item	Vegetation & Obstructions			
DWR ID	DWR_NA0011_41_c_2012_16			
Action/Comments				
Inspector Comments: The vegetation present in channel does not obstruct flow under the bridge.

Fresno River downstream from the timber bridge crossing.

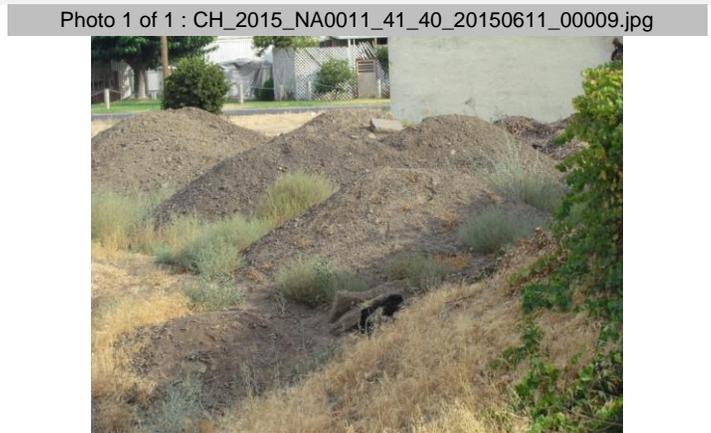
Check Point / View				
<b>Gateway Dr / Down (cont)</b>				
Rating **	M	Issue No.	<b>40</b>	GPS Lat/Long
Issue Type +	Ma	Location *		36.968760 °
Category	Rivers, Channels & Designated Flood			-120.067840 °
Item	Encroachments			
DWR ID	DWR_NA0011_41_c_2012_40			
Action/Comments				
Inspector Comments: Dirt piles placed on berm downstream from bridge left bank. The GPS lat/long 36.968101,-120.067756.

Dirt piles and concrete dumped on left bank downstream of bridge on the berm.
