**Flood Control Project Maintenance
Levee Inspections**

Fall 2011 Levee Maintenance Deficiency Summary Report

Levee Inspection Report By Mile - Fall 2011

Madera County FCWCA

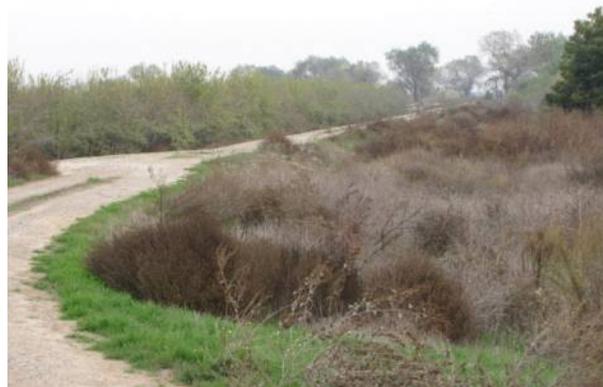
Levee Mile Report Line	1
Start Levee Mile	0.01
End Levee Mile	0.47
Location	Water Side
Category	Earthen Levee
Item	Vegetation

Madera County Unit 1 Ash Slough Leve mile 0.00 looking downstream waterward. Photo taken 11-23-2011.

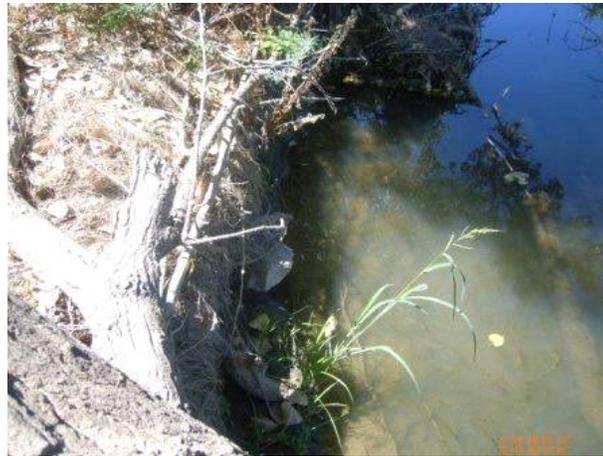
Levee Mile Report Line	8
Start Levee Mile	1.11
End Levee Mile	1.20
Location	Water Side
Category	Supplemental
Item	DWR Erosion Survey

Close-in view at the erosion site

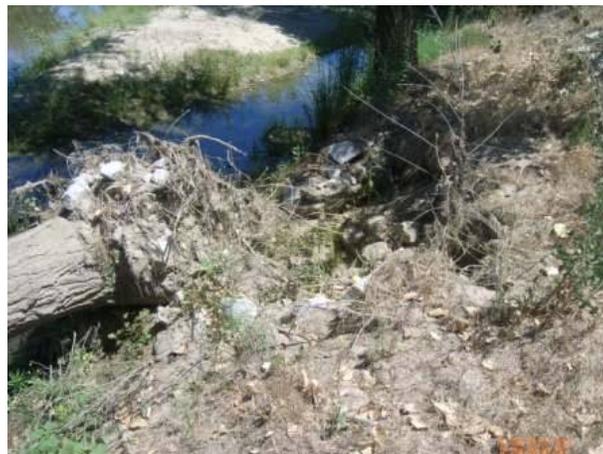
Levee Mile Report Line	8
Start Levee Mile	1.11
End Levee Mile	1.20
Location	Water Side
Category	Supplemental
Item	DWR Erosion Survey

The fallen tree about 20 feet from the site.

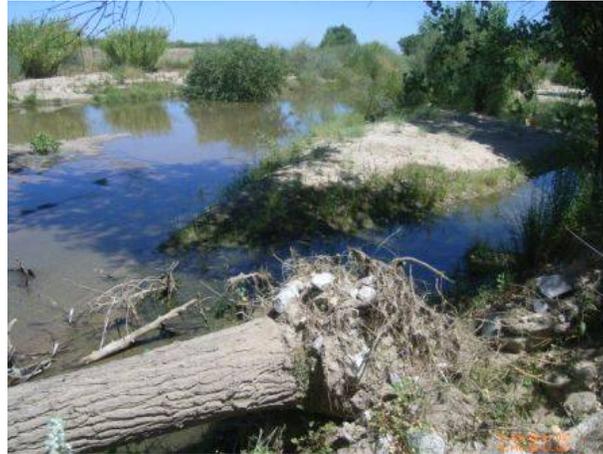
Levee Mile Report Line	8
Start Levee Mile	1.11
End Levee Mile	1.20
Location	Water Side
Category	Supplemental
Item	DWR Erosion Survey

The fallen tree and exposed root

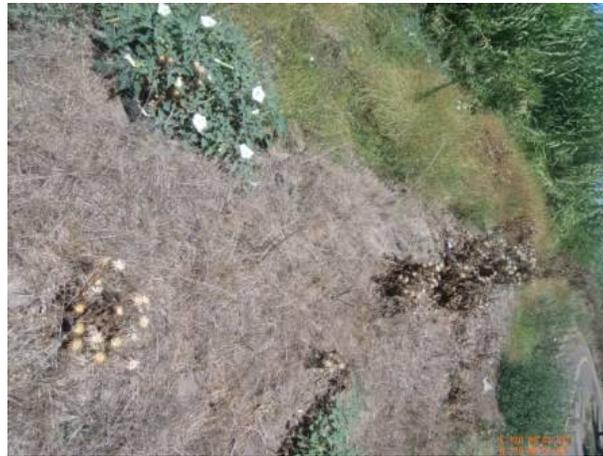
Levee Mile Report Line	13
Start Levee Mile	2.37
End Levee Mile	2.39
Location	Water Side
Category	Supplemental
Item	DWR Erosion Survey

Close look at the site

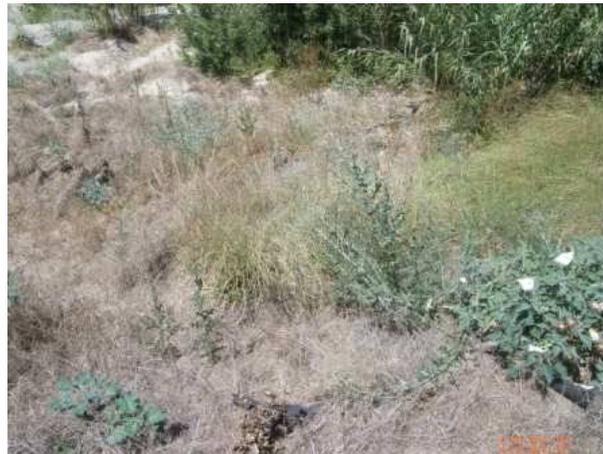
Levee Mile Report Line	13
Start Levee Mile	2.37
End Levee Mile	2.39
Location	Water Side
Category	Supplemental
Item	DWR Erosion Survey

The erosion is covered with dense grass and bushes.

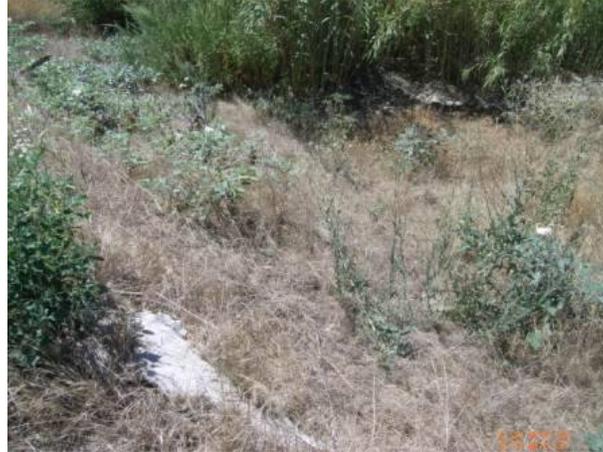
Levee Mile Report Line	13
Start Levee Mile	2.37
End Levee Mile	2.39
Location	Water Side
Category	Supplemental
Item	DWR Erosion Survey
<p>The erosion is covered with dense grass and bushes.</p>	
<p>SJR2011_NA0011U01RM3.8_3.jpg</p>

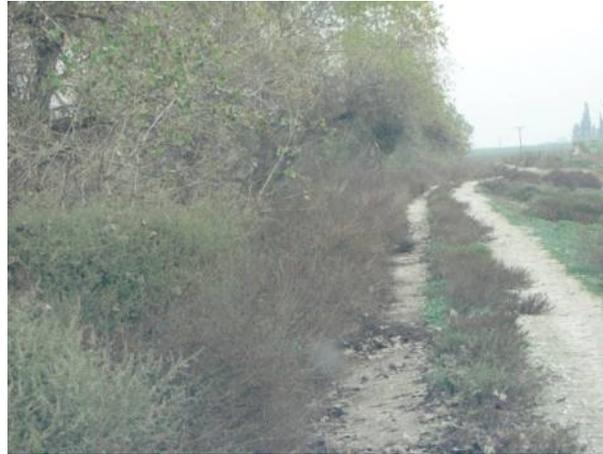
Levee Mile Report Line	3
Start Levee Mile	0.03
End Levee Mile	0.42
Location	Water Side
Category	Earthen Levee
Item	Vegetation

Unsatisfactory growth waterward Unit 2. Photo taken 11-23-2011.

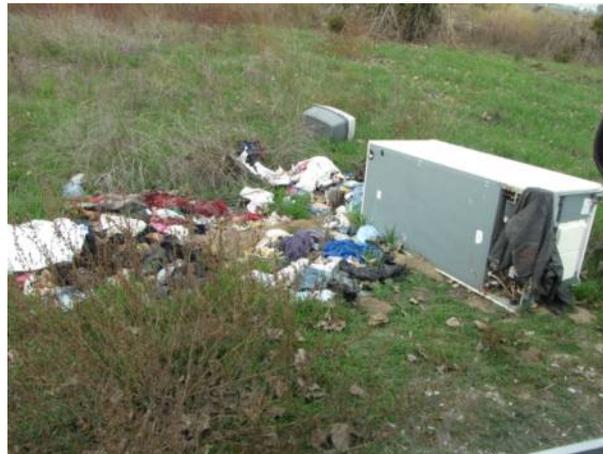
Levee Mile Report Line	19
Start Levee Mile	1.75
End Levee Mile	1.75
Location	Water Side
Category	Earthen Levee
Item	Encroachments

Garbage on waterward berm Unit 2 Ash Slough. Photo taken 11-23-2011.

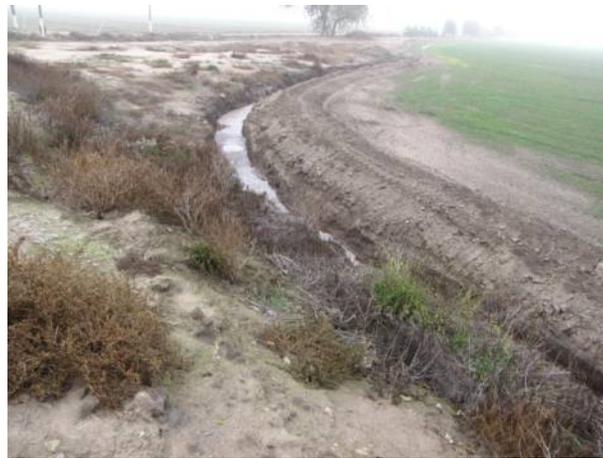
Levee Mile Report Line	3
Start Levee Mile	0.03
End Levee Mile	0.03
Location	Land Side
Category	Earthen Levee
Item	Encroachments

Unauthorized agriculture ditch landward toe. Photo taken 11-23-2011

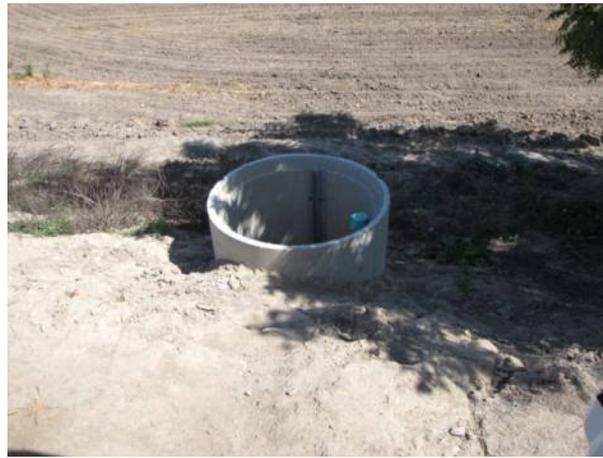
Levee Mile Report Line	5
Start Levee Mile	0.05
End Levee Mile	0.05
Location	Land Side
Category	Earthen Levee
Item	Encroachments

This stand pipe was installed within the landward slope and toe of the right bank Unit 3 levee mile 0.09. No permit from the Central Valley Flood Protection Board. Photo taken 5-4-2011.

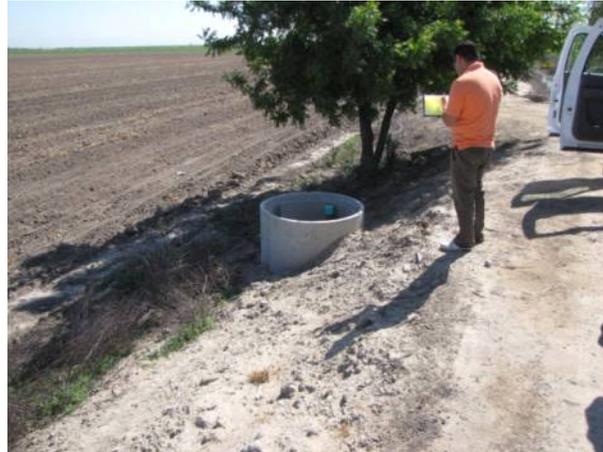
Levee Mile Report Line	5
Start Levee Mile	0.05
End Levee Mile	0.05
Location	Land Side
Category	Earthen Levee
Item	Encroachments
Standing at the upstream end of stand pipe within the landward slope and toe of levee mile 0.09 Unit 3. Mileage runs upstream.	
phillips_f_20110929_031.jpg

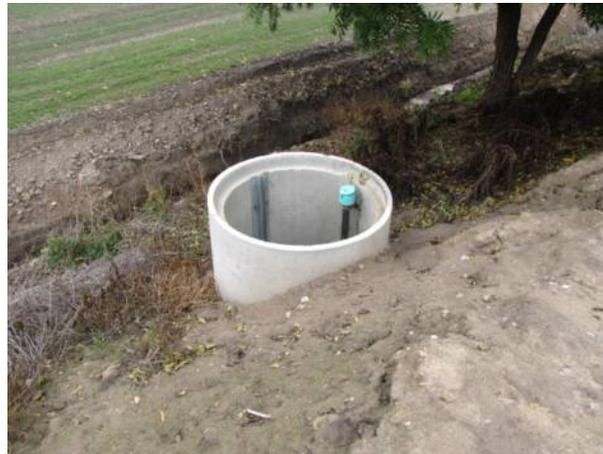
Levee Mile Report Line	5
Start Levee Mile	0.05
End Levee Mile	0.05
Location	Land Side
Category	Earthen Levee
Item	Encroachments
Unauthorized pipe within landward toe. Photo taken 11-23-2011. Installed by Chowchilla Irrigation District.	
phillips_f_20111209_145.jpg

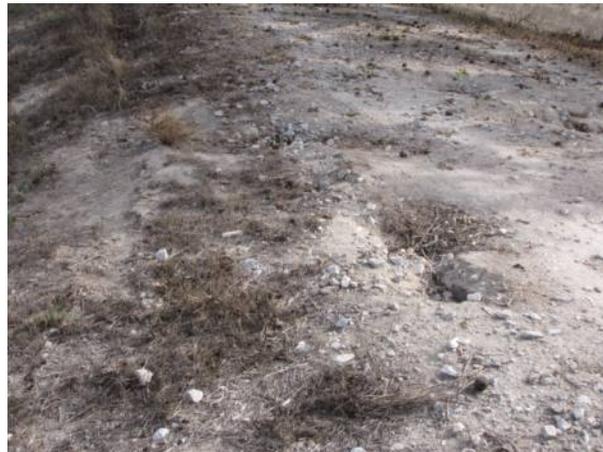
Levee Mile Report Line	26
Start Levee Mile	1.50
End Levee Mile	1.53
Location	Crown
Category	Earthen Levee
Item	Animal Control
There are several rodent holes in the shoulder and crown of the roadway.	
phillips_f_20110929_028.jpg

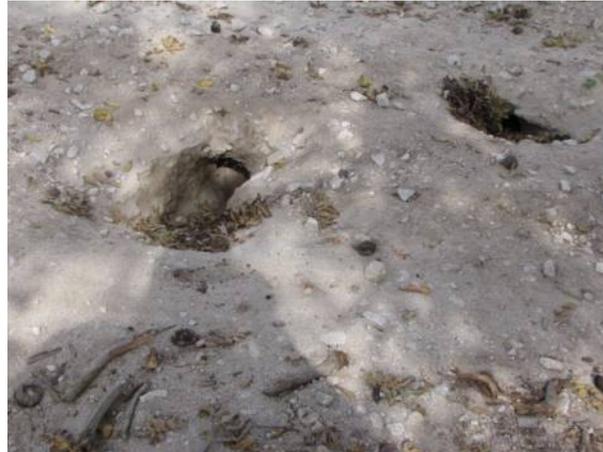
This photo shows holes in crown and shoulder.

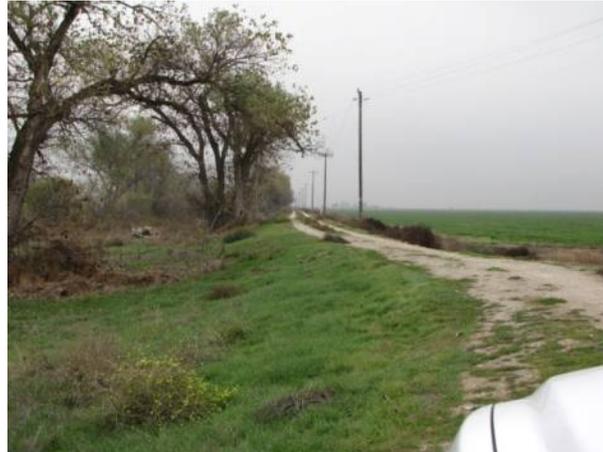
Levee Mile Report Line	1
Start Levee Mile	0.00
End Levee Mile	0.00
Location	Land Side
Category	Earthen Levee
Item	Vegetation
Unit 4 looking downstream from levee mile 0.00 Berenda Slough waterward. Photo taken 11-23-2011.	
phillips_f_20111212_150.jpg

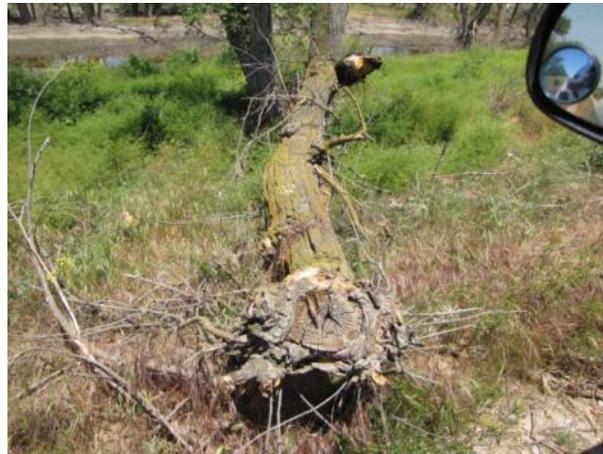
Levee Mile Report Line	3
Start Levee Mile	0.04
End Levee Mile	0.04
Location	Water Side
Category	Earthen Levee
Item	Encroachments
This tree needs to be cut up and removed from levee section.	
phillips_f_20110929_032.jpg

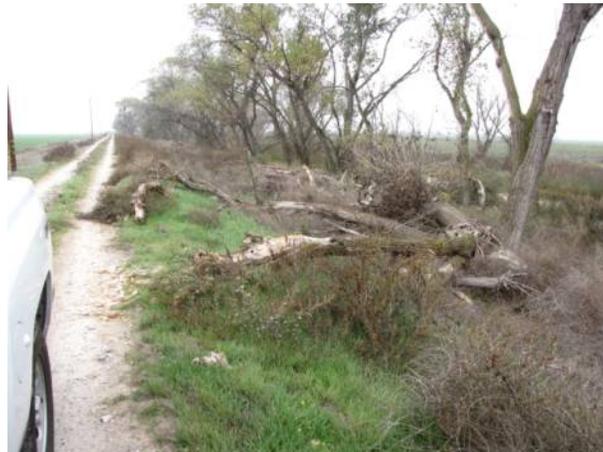
Levee Mile Report Line	9
Start Levee Mile	0.40
End Levee Mile	0.40
Location	Water Side
Category	Earthen Levee
Item	Encroachments
Looking downstream levee mile 0.40 at dead trees on waterward slope and toe of Unit 4. Photo taken 11-23-2011.	
phillips_f_20111212_149.jpg

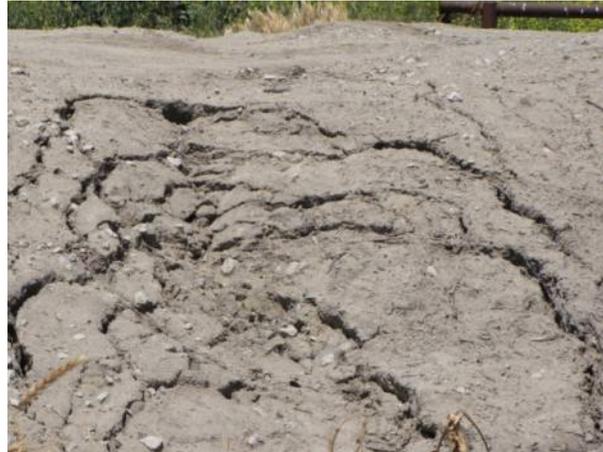
Levee Mile Report Line	11
Start Levee Mile	1.51
End Levee Mile	1.51
Location	Land Side
Category	Earthen Levee
Item	Slope Stability
Standing on Ave. 17 looking at levee damage levee mile 1.51. The damage is just upstream of Road 11.	
phillips_f_20110929_033.jpg

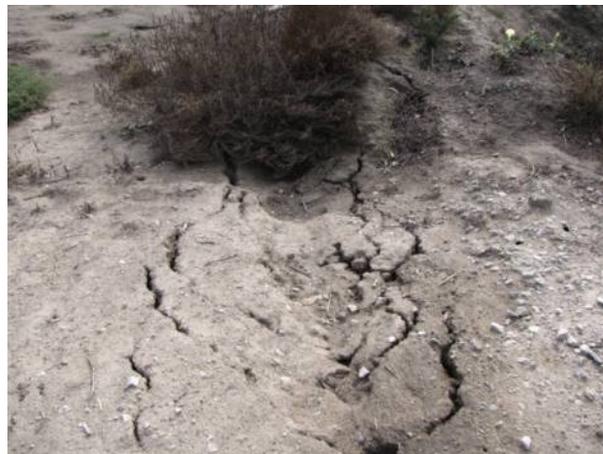
Levee Mile Report Line	11
Start Levee Mile	1.51
End Levee Mile	1.51
Location	Land Side
Category	Earthen Levee
Item	Slope Stability
Looking down at the erosion landward Unit 4. Photo taken 11-23-2011.	
phillips_f_20111212_147.jpg

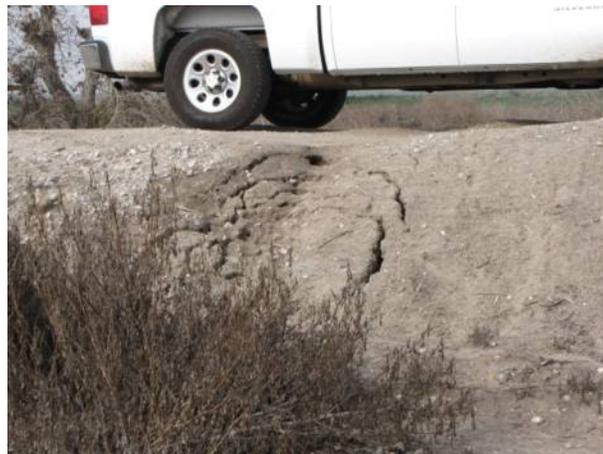
Levee Mile Report Line	11
Start Levee Mile	1.51
End Levee Mile	1.51
Location	Land Side
Category	Earthen Levee
Item	Slope Stability
Another view of the levee damage landward of Unit 4 levee mile 1.51. Photo taken 11-23-2011.	
phillips_f_20111212_148.jpg

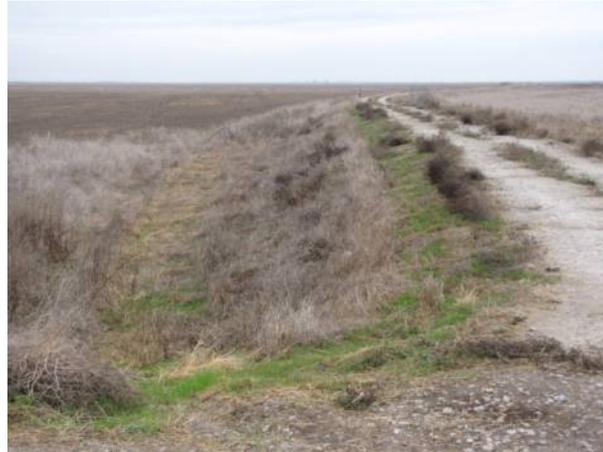
Levee Mile Report Line	1
Start Levee Mile	0.00
End Levee Mile	0.00
Location	Water Side
Category	Earthen Levee
Item	Vegetation
Looking downstream from levee mile 0.00 land side of Unit 5 Fresno River. Photo taken 11-24-2010	
phillips_f_20110929_034.jpg

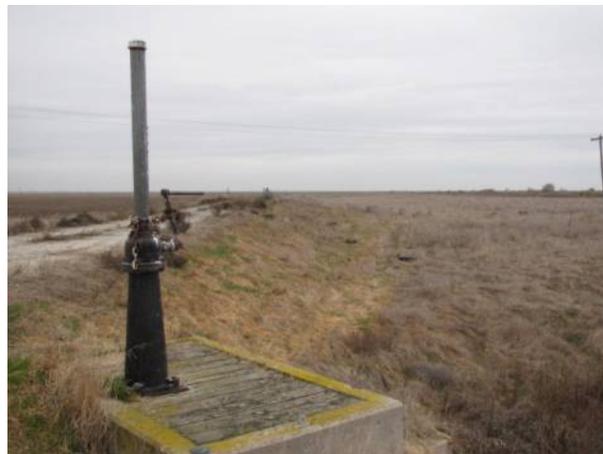
Levee Mile Report Line	1
Start Levee Mile	0.00
End Levee Mile	0.00
Location	Water Side
Category	Earthen Levee
Item	Vegetation
Looking down from levee mile 0.00 water side Unit 5 Fresno River. Photo taken 11-24-2010	
phillips_f_20110929_035.jpg

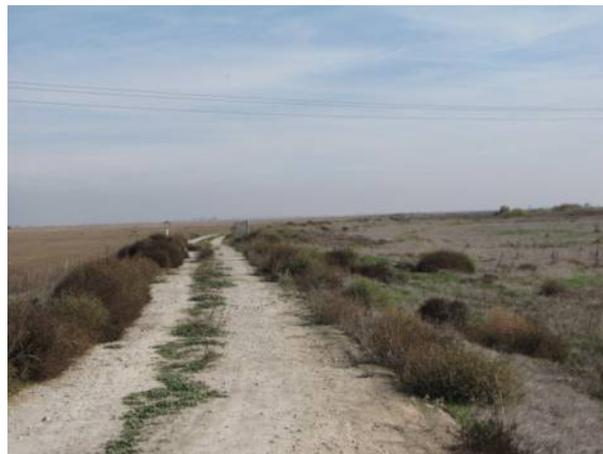
Levee Mile Report Line	1
Start Levee Mile	0.00
End Levee Mile	0.00
Location	Water Side
Category	Earthen Levee
Item	Vegetation
Fresno River Unit 5 levee mile 0.00 looking downstream waterside. Photo taken 11-22-2011.	
phillips_f_20111209_136.jpg

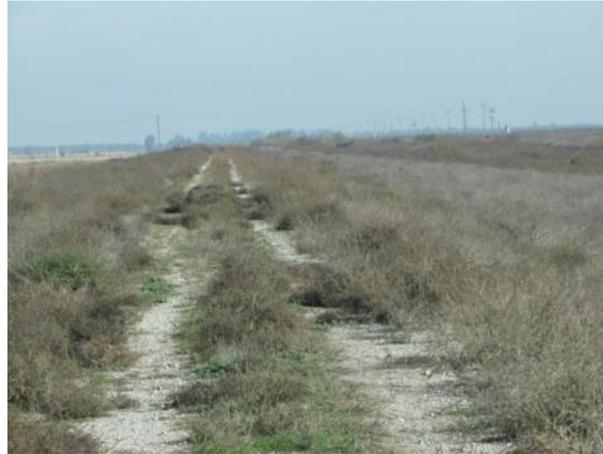
Levee Mile Report Line	13
Start Levee Mile	2.34
End Levee Mile	3.25
Location	Crown
Category	Earthen Levee
Item	Vegetation
Levee mile 2.34-3.25 unsatisfactory growth crown roadway and both slopes. Photo taken 11-22,-2011.	
phillips_f_20111209_137.jpg

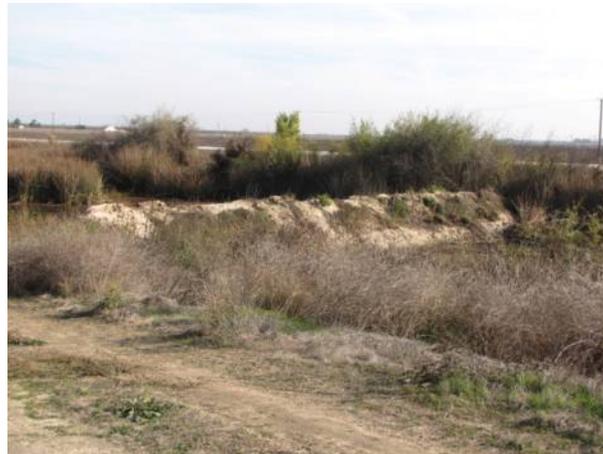
Levee Mile Report Line	21
Start Levee Mile	6.63
End Levee Mile	6.63
Location	Crown
Category	Channels
Item	Vegetation & Obstructions
Unauthorized earthen dam across channel levee mile 6.63. Photo taken 11-22-2011.	
phillips_f_20111209_138.jpg

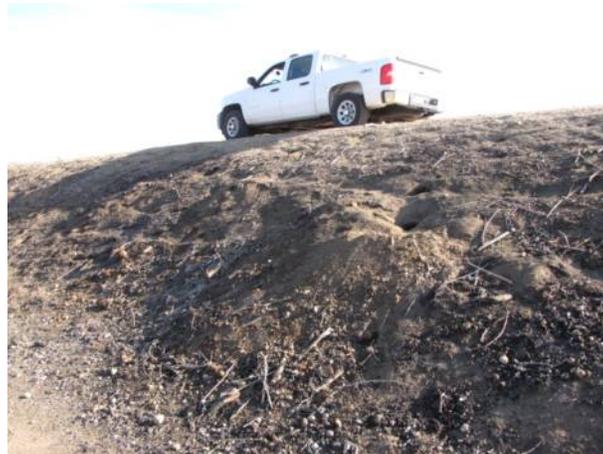
Levee Mile Report Line	22
Start Levee Mile	6.67
End Levee Mile	6.75
Location	Land Side
Category	Earthen Levee
Item	Animal Control
Unsatisfactory animal control unit 5. Photo taken 11-22,-2011.	
phillips_f_20111209_139.jpg

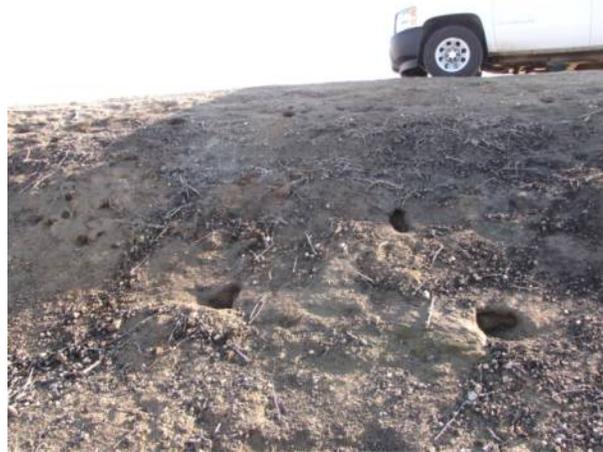
Levee Mile Report Line	22
Start Levee Mile	6.67
End Levee Mile	6.75
Location	Land Side
Category	Earthen Levee
Item	Animal Control
Continue animal control landward 6.67 to 6.75. Photo taken 11-22-2011.	
phillips_f_20111209_140.jpg

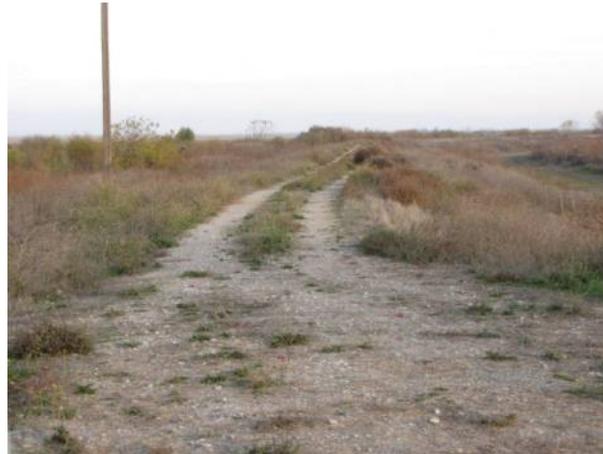
Levee Mile Report Line	1
Start Levee Mile	0.00
End Levee Mile	0.00
Location	Land Side
Category	Earthen Levee
Item	Vegetation
Levee mile 0.00 Unit 6 Fresno River looking upstream. Photo taken 11-22-2011.	
phillips_f_20111209_143.jpg

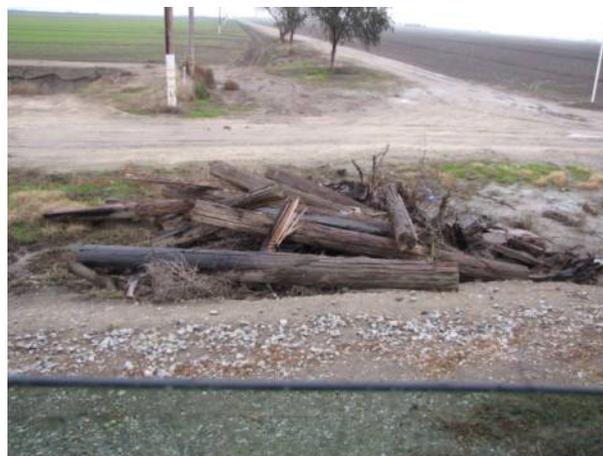
Levee Mile Report Line	9
Start Levee Mile	5.72
End Levee Mile	5.72
Location	Land Side
Category	Earthen Levee
Item	Encroachments
Levee mile 5.72 discarded power poles on landside toe need to be removed from levee section. Photo taken 11-23-2010	
phillips_f_20110929_036.jpg

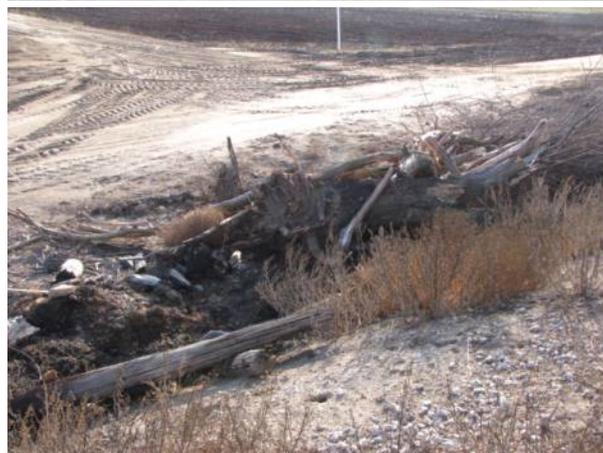
Levee Mile Report Line	9
Start Levee Mile	5.72
End Levee Mile	5.72
Location	Land Side
Category	Earthen Levee
Item	Encroachments
Power poles have not been removed. New photo 11-22-2011.	
phillips_f_20111209_141.jpg

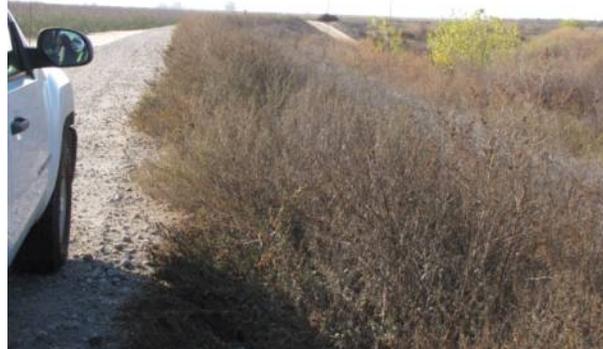
Levee Mile Report Line	19
Start Levee Mile	8.75
End Levee Mile	9.02
Location	Water Side
Category	Earthen Levee
Item	Vegetation
Looking upstream of Unit 6 Fresno River from levee mile 8.75. Photo taken 11-22-2011.	
phillips_f_20111209_142.jpg
