**Flood Control Project Maintenance
Levee Inspections**

Fall 2015 Levee Maintenance Deficiency Summary Report

San Joaquin River Basin

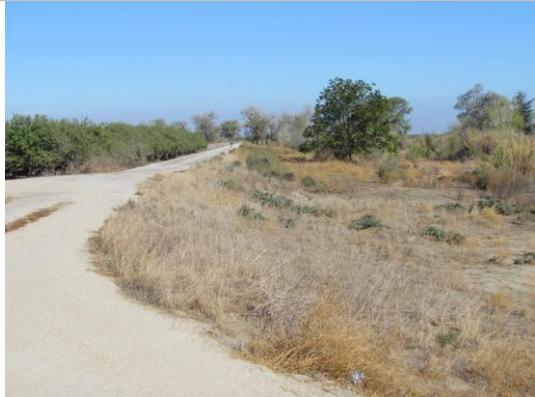
Photo 1 of 1 : FA_2015_NA0011_142_26_20151021_00014.jpg

Ash Slough looking upstream at the waterside slope, tall unwanted weeds on the slope.

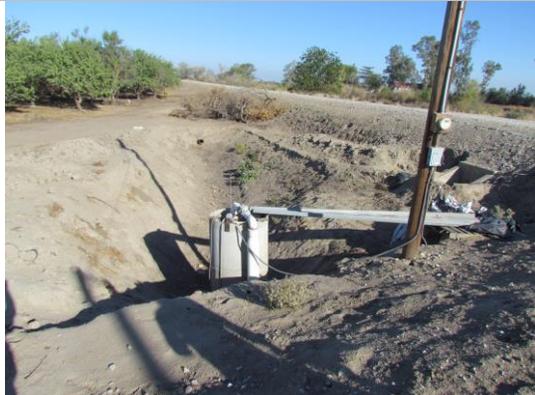
Photo 1 of 1 : FA_2015_NA0011_142_18_20151021_00021.jpg

LM Start	0.03	Rating **	U	Issue No.	18
LM End	0.06	Issue Type +	En	Location *	LS
Category	Earthen Levee		GPS Latitude/Longitude		
			Start	End	
Item	Encroachments		37.046566 °	37.046715 °	
			-120.427512 °	-120.426964 °	
DWR ID	DWR_NA0011_01_s_2014_18				
Action/Comments					
Ditch Inspector Comments: There seem to be lots of activity going on at this location. This ditch will cause more damage to the levee slope and toe.

Irrigation ditch within the landside levee toe.

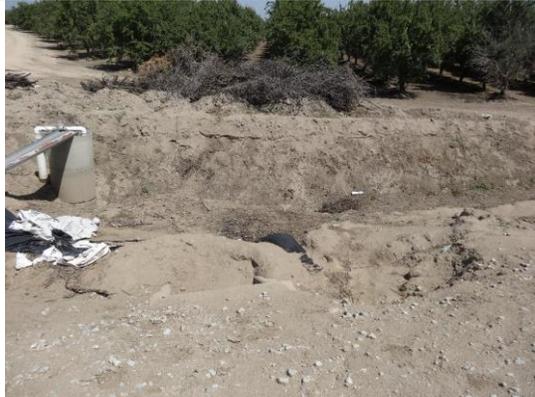
Photo 3 of 3 : UCIP_FA_2015_4889.jpg

LM Start	0.04	Rating **	U	Issue No.	45 (cont)
LM End	0.04	Issue Type +	En	Location *	LS
Category	Supplemental			GPS Latitude/Longitude	
				Start	End
Item	DWR UCIP Field Study			37.046618 °	37.046618 °
				-120.427350 °	-120.427350 °
DWR ID					
Action/Comments					
Inspector Comments: FS_ID:42856 DS_ID:21513 EP_NO: N/A FS_HLM: 0.03 Repair Type: Urgent Crossing Status: Found

View of landward side--levee slope has been modified.

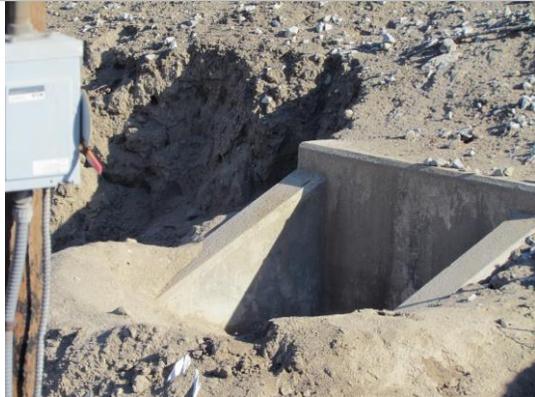
Photo 1 of 1 : FA_2015_NA0011_142_20_20151021_00022.jpg

LM Start	0.04	Rating **	U	Issue No.	20
LM End	0.05	Issue Type +	Ma	Location *	LS
Category	Earthen Levee			GPS Latitude/Longitude	
				Start	End
Item	Slope Stability			37.046624 °	37.046682 °
				-120.427317 °	-120.427108 °
DWR ID	DWR_NA0011_01_s_2014_20				
Action/Comments					
Repair slope instability. Inspector Comments: This is not a new erosion site, it should be repaired before the condition get any worse.

There is damage to the landside slope near the concrete wing wall.

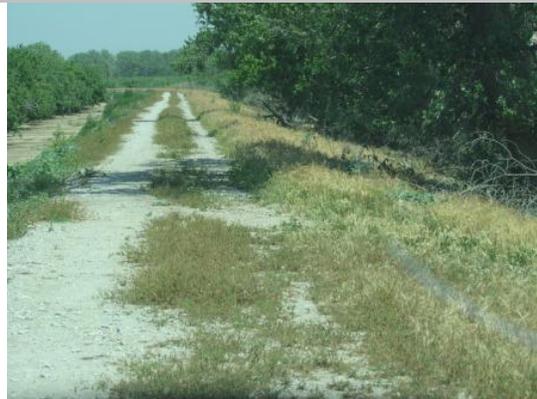
Photo 1 of 1 : FA_2015_NA0011_142_24_20150915_00008.jpg

The levee crown roadway is overgrown with weeds. Photo taken 4-29-2014.

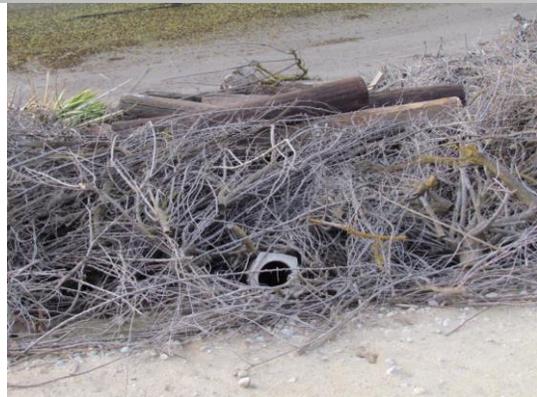
Photo 1 of 1 : FA_2015_NA0011_142_28_20150915_00009.jpg

Unwanted brush pile on the landside toe and slope.

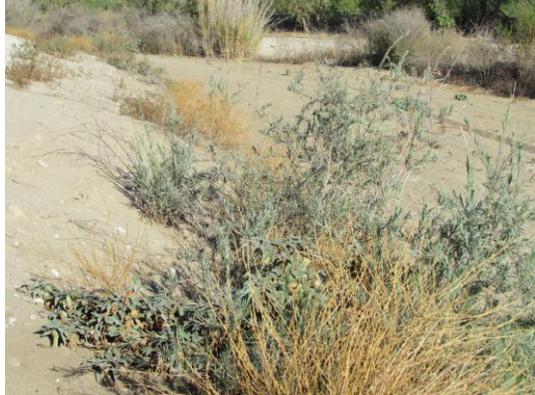
Photo 1 of 3 : FA_2015_NA0011_142_38_20151021_00018.jpg

LM Start	1.17	Rating **	U	Issue No.	38
LM End	1.37	Issue Type +	Ma	Location *	WS
Category	Earthen Levee		GPS Latitude/Longitude		
			Start	End	
Item	Slope Stability		37.056380 °	37.058520 °	
			-120.412483 °	-120.410257 °	
DWR ID	DWR_NA0011_01_f_2015_38				
Action/Comments					
Repair the levee slope damaged by vehicle traffic and prevent access where possible. Inspector Comments: The slope will have to be put back in place damaged by equipment.

The levee slope has been damaged by equipment, the farmer has cut the toe away while working too close to the levee.

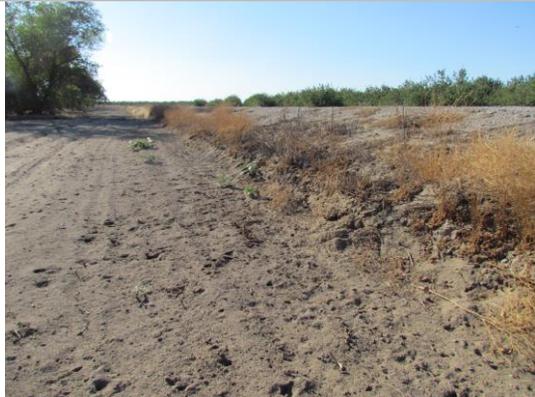
Photo 2 of 3 : FA_2015_NA0011_142_38_20151021_00019.jpg

Slope damage at toe of the water side levee section.

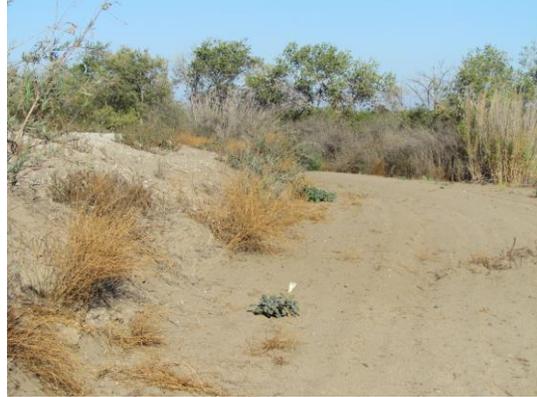
Photo 3 of 3 : FA_2015_NA0011_142_38_20151021_00020.jpg

LM Start	1.17	Rating **	U	Issue No.	38 (cont)
LM End	1.37	Issue Type +	Ma	Location *	WS
Category	Earthen Levee			GPS Latitude/Longitude	
				Start	End
Item	Slope Stability			37.056380 °	37.058520 °
				-120.412483 °	-120.410257 °
DWR ID	DWR_NA0011_01_f_2015_38				
Action/Comments					
Repair the levee slope damaged by vehicle traffic and prevent access where possible. Inspector Comments: The slope will have to be put back in place damaged by equipment.

Another view of the damaged toe.

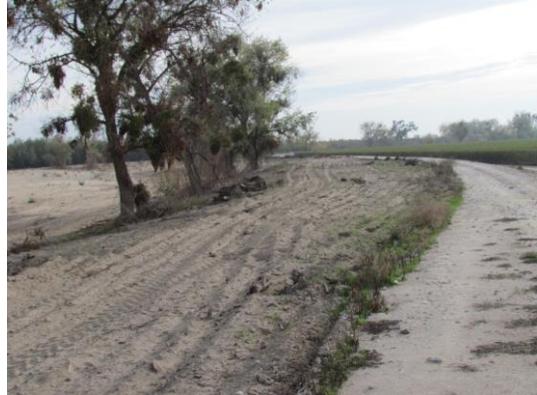
Photo 1 of 1 : FA_2015_NA0011_142_17_20150915_00004.jpg

LM Start	2.37	Rating **	U	Issue No.	17
LM End	2.40	Issue Type +	Ma	Location *	WS
Category	Earthen Levee			GPS Latitude/Longitude	
				Start	End
Item	Slope Stability			37.068737 °	37.068737 °
				-120.398570 °	-120.398570 °
DWR ID	DWR_NA0011_01_s_2013_17				
Action/Comments					
Repair slope instability. Inspector Comments: The farmer has plowed up the waterside berm too close to the levee toe causing damage to the levee toe also this method transfers the bamboo roots along the berm. Spraying is needed to kill the new growth. This method of maintaining the waterside cannot continue.

Ash Slough levee toe damaged by farm equipment discing too close.

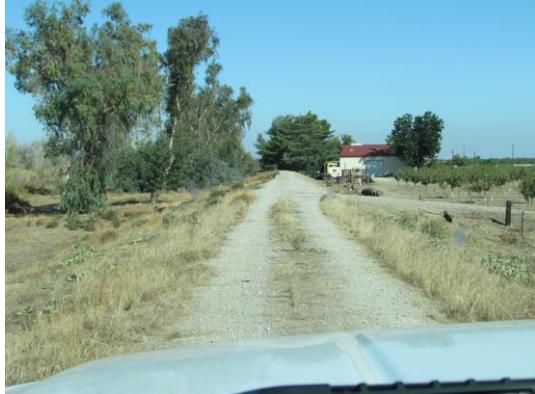
Photo 1 of 1 : FA_2015_NA0011_143_34_20151027_00011.jpg

Ash Slough looking upstream from levee mile 0.00 tall weeds covering water side levee slope and shoulder.

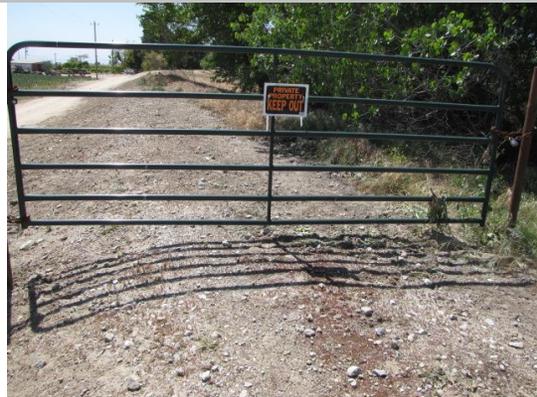
Photo 1 of 1 : FA_2015_NA0011_143_5_20150915_00001.jpg

LM Start	0.18	Rating **	M	Issue No.	5
LM End	0.31	Issue Type +	En	Location *	CR
Category	Earthen Levee		GPS Latitude/Longitude		
			Start	End	
Item	Encroachments		37.046315 °	37.463150 °	
			-120.424419 °	-120.424419 °	
DWR ID	DWR_NA0011_02_f_2012_5				
Action/Comments					
Fence Inspector Comments: This fence was not authorized by CVFPB. The District is aware of the fence. The landowner installed the fence and gate across the levee section because he has been broken into frequently and had many items stolen in the past. I met with the landowner 4-29-2014 and he let me put a State lock on his gate to gain access to the levee.

Unauthorized gate and metal fence placed on slope and toe of levee section. Photo taken 4-17-2013.

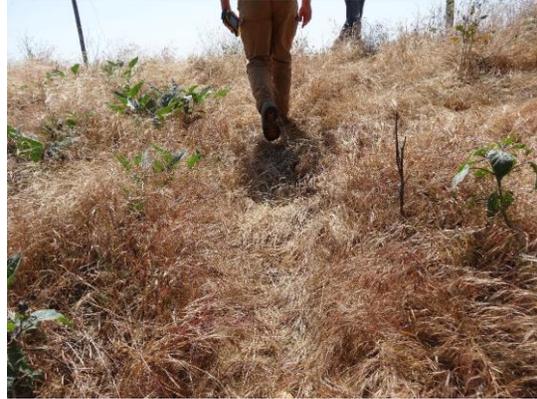
Photo 2 of 3 : UCIP_FA_2015_4049.jpg

Dense vegetation on waterward slope.

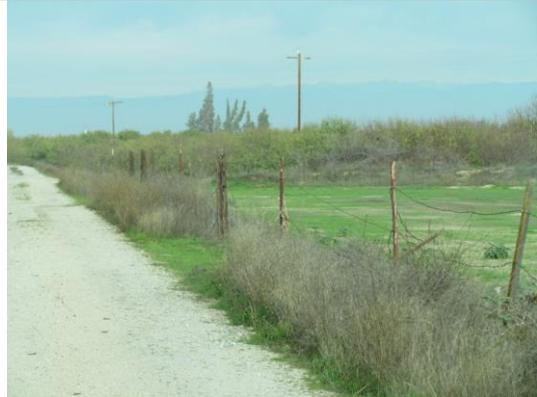
Photo 1 of 1 : FA_2015_NA0011_143_11_20150915_00002.jpg

Fence on the landside slope.

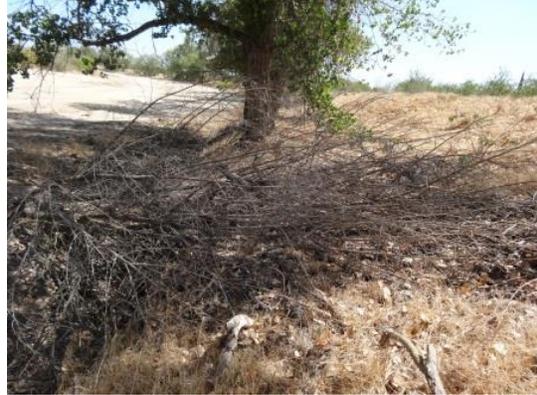
Photo 2 of 2 : SJR2015_NA0011U02RM2.57_4.jpg

Close view of the site with the dead tree.

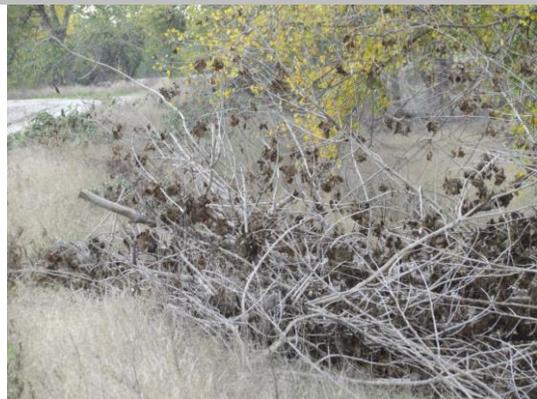
Photo 1 of 1 : FA_2015_NA0011_143_43_20150915_00007.jpg

Dead fallen tree not removed from levee section, reported in Spring inspection.

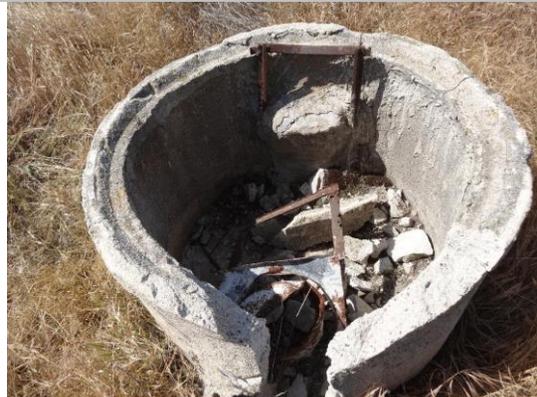
Photo 3 of 3 : UCIP_FA_2015_6805.jpg

36-inch pipe full of concrete debris located on waterward side.

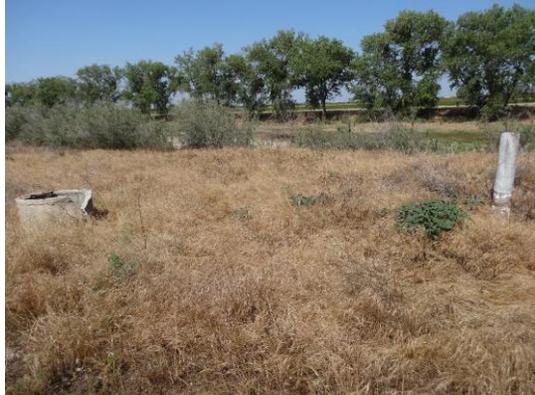
Photo 1 of 3 : UCIP_FA_2015_6794.jpg

Concrete standpipes visible on waterward side--dense vegetation on waterward side.

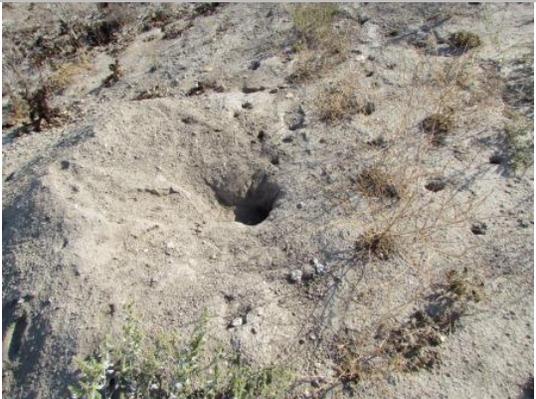
Photo 1 of 2 : FA_2015_NA0011_144_41_20151026_00010.jpg

Large rodent holes along the landside shoulder and slope of Berenda Slough.

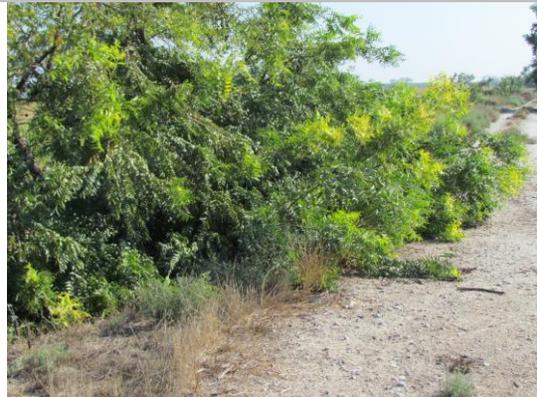
Photo 1 of 1 : FA_2015_NA0011_144_11_20151026_00013.jpg

Berenda Slough Unit 3 looking upstream from levee mile 1.04-1.05 walnut trees blocking the view of the landside levee section.

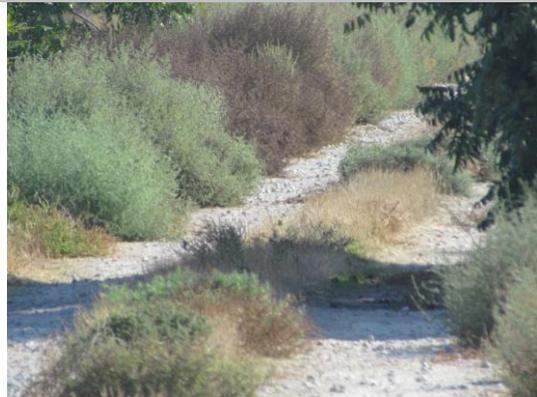
Photo 1 of 1 : FA_2015_NA0011_144_27_20151026_00014.jpg

Berenda Slough looking upstream from levee mile 1.12 to 1.52 unsatisfactory tall tumble weeds on the shoulder and slope.

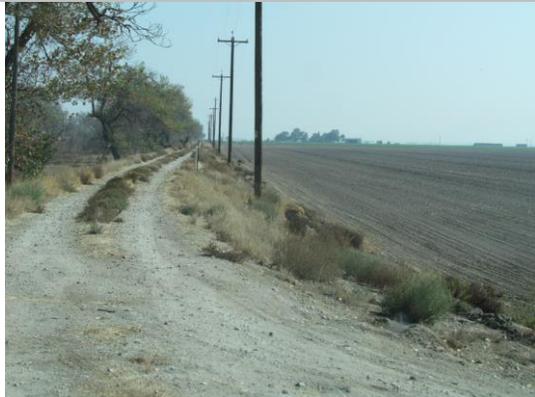
Photo 1 of 1 : FA_2015_NA0011_145_1_20151026_00015.jpg

Berenda Slough looking upstream from levee mile 0.01- 1.50 the tumble weeds has taken over the levee slope and crown.

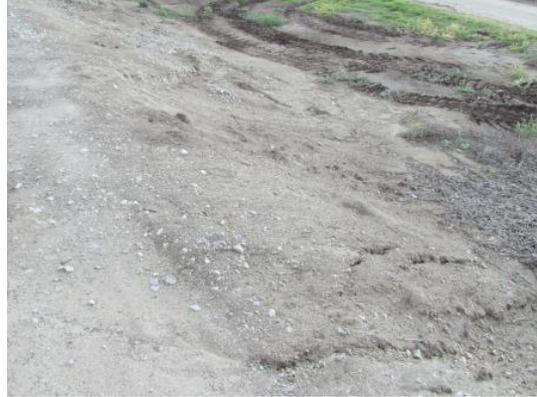
Photo 1 of 2 : FA_2015_NA0011_145_9_20150915_00005.jpg

Levee mile 1.51 levee damaged by the landowner. Photo taken 4-24-2014.

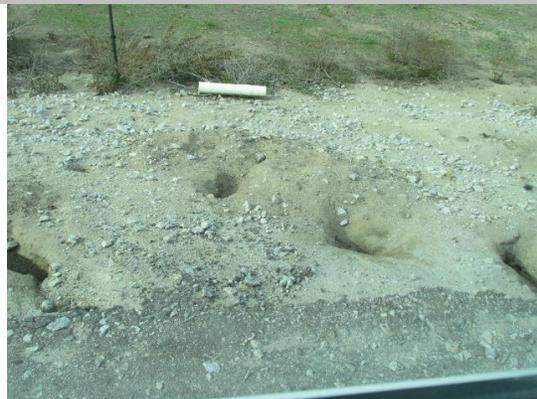
Photo 1 of 2 : FA_2015_NA0011_145_30_20150915_00011.jpg

Berenda Slough looking downstream from levee mile 1.65 waterside large rodent holes on slope.

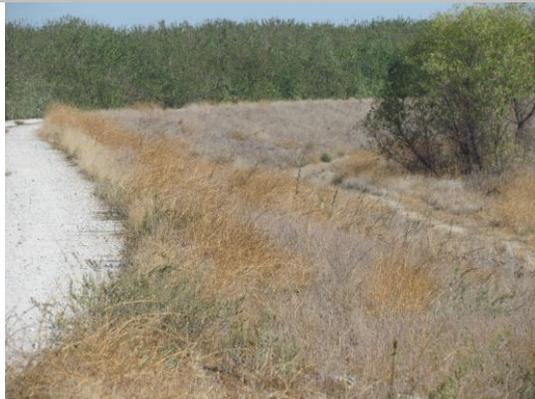
Photo 1 of 1 : FA_2015_NA0011_146_32_20151022_00016.jpg

Fresno River waterside levee slope unsatisfactory tall weeds present on shoulder and slope.

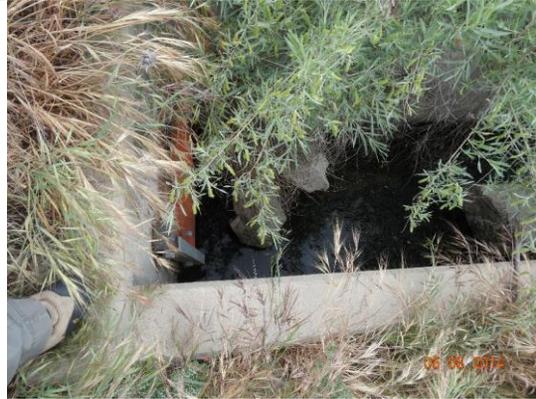
Photo 3 of 3 : UCIP_FA_2015_5008.jpg

Concrete headwall visible on waterward side and covered by dense vegetation.

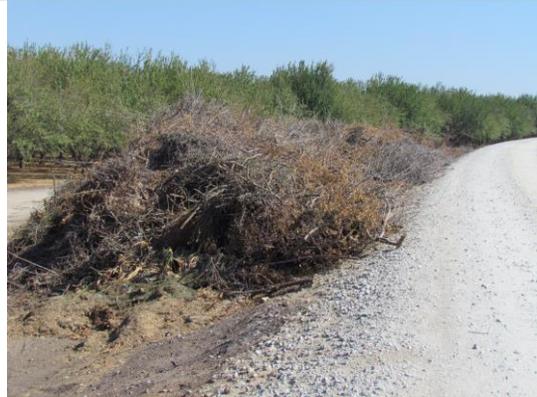
Photo 1 of 1 : FA_2015_NA0011_146_35_20151022_00018.jpg

Looking upstream at high pile of almond tree cuttings covering the landside shoulder,slope and toe.

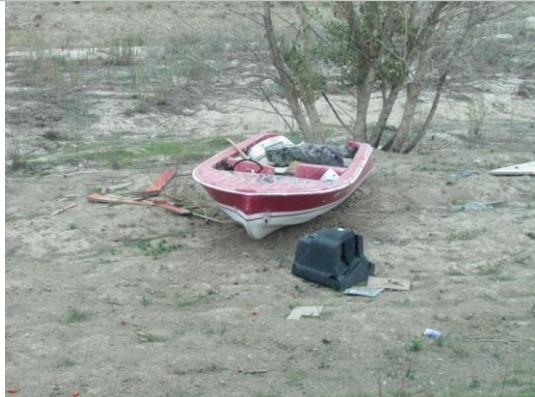
Photo 1 of 1 : FA_2015_NA0011_147_46_20150915_00011.jpg

Waterside levee mile 0.51 abandoned boat. Busted tv and other trash dumped on the dry channel.

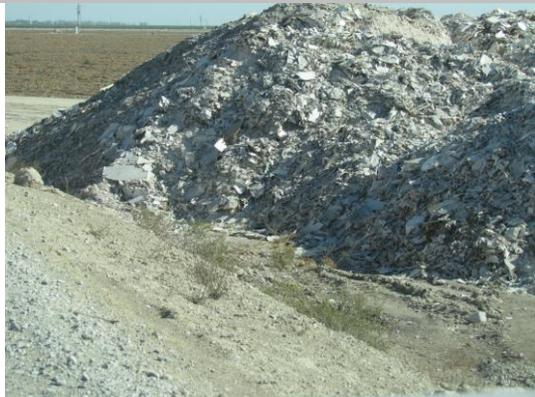
Photo 1 of 1 : FA_2015_NA0011_147_1_20151027_00018.jpg

Recycle sheet rock piles within the landside easement.

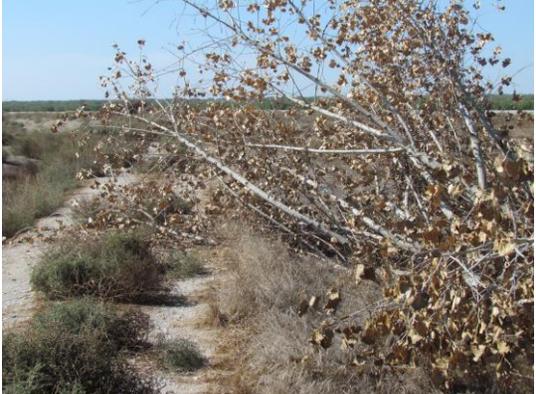
Photo 1 of 1 : FA_2015_NA0011_147_36_20151027_00021.jpg

Dead tree pushed upon the waterside slope and blocking the crown.

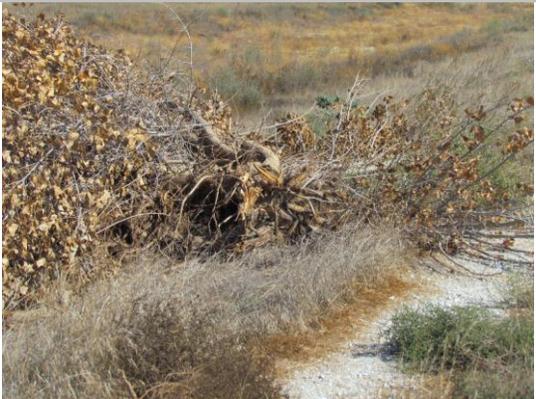
Photo 1 of 1 : FA_2015_NA0011_147_31_20151027_00015.jpg

Fresno River looking downstream from levee mile 8.09 dead tree blocking the crown roadway.

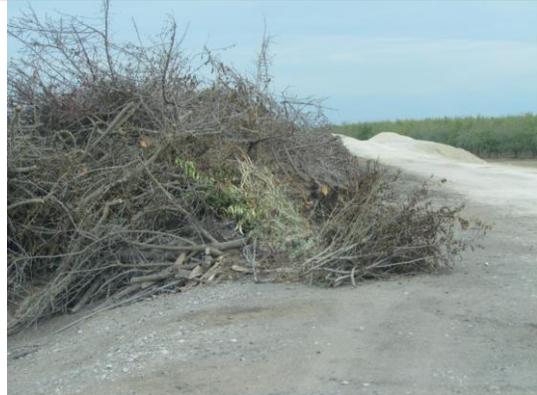
Photo 1 of 1 : FA_2015_NA0011_147_43_20150915_00010.jpg

Tree pruning's on the waterward levee shoulder blocking section of crown. Completly has the slope blocked on waterward side.
