**Flood Control Project Maintenance  
Levee Inspections**  
**LMA District Cover Sheet**  
**Spring 2015 Levee Inspection Results**  
**Madera County FCWCA**

**Spring 2015 Levee Inspection Results**

**Madera County FCWCA**

Waterway	Bank	Unit Miles
Unit No. 01 Ash Slough	Right	2.37

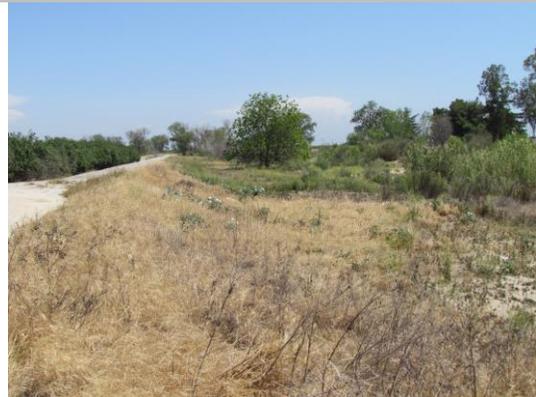
Photo 1 of 1 : SP\_2015\_NA0011\_142\_34\_20150508\_00072.jpg

Looking downstream from levee mile 0.01 waterside slope unsatisfactory tall weeds present on the levee section.

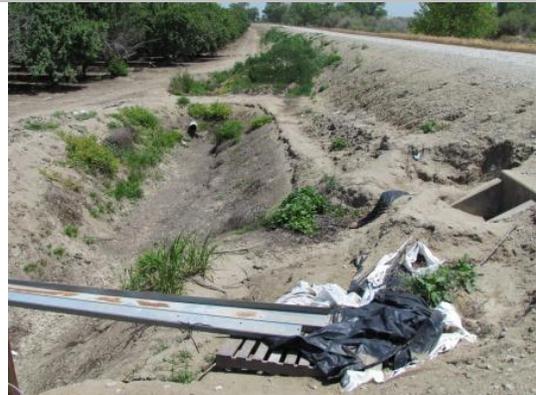
Photo 1 of 1 : SP\_2015\_NA0011\_142\_18\_20150312\_00005.jpg

LM Start	<b>0.03</b>	Rating **	U	Issue No.	<b>18</b>
LM End	<b>0.06</b>	Issue Type +	En	Location *	LS
Category	Earthen Levee			GPS Latitude/Longitude	
				Start	End
Item	Encroachments			37.046566 °	37.046715 °
				-120.427512 °	-120.426964 °
DWR ID	DWR_NA0011_01_s_2014_18				
Action/Comments					
Ditch Inspector Comments: There seem to be lots of activity going on at this location. This ditch will cause more damage to the levee slope and toe.

Irrigation ditch within the landside levee toe. Photo taken 4-29-2014. No new photo taken during fall 2014.

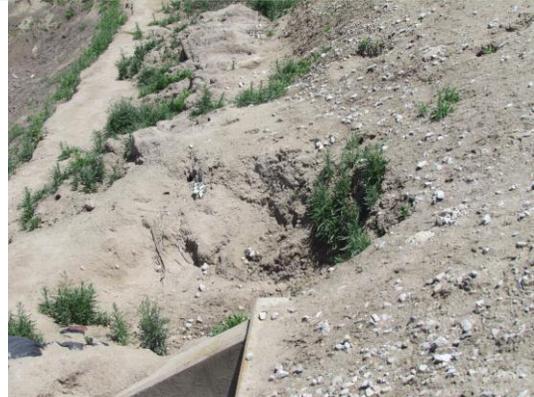
Photo 1 of 1 : SP\_2015\_NA0011\_142\_20\_20150508\_00077.jpg

LM Start	<b>0.04</b>	Rating **	U	Issue No.	<b>20</b>
LM End	<b>0.05</b>	Issue Type +	Ma	Location *	LS
Category	Earthen Levee			GPS Latitude/Longitude	
				Start	End
Item	Slope Stability			37.046624 °	37.046682 °
				-120.427317 °	-120.427108 °
DWR ID	DWR_NA0011_01_s_2014_20				
Action/Comments					
Repair slope instability. Inspector Comments: This is not a new erosion site, it should be repaired before the condition get any worse.

The landside levee slope and toe has been damaged and this was reported in the last inspection.

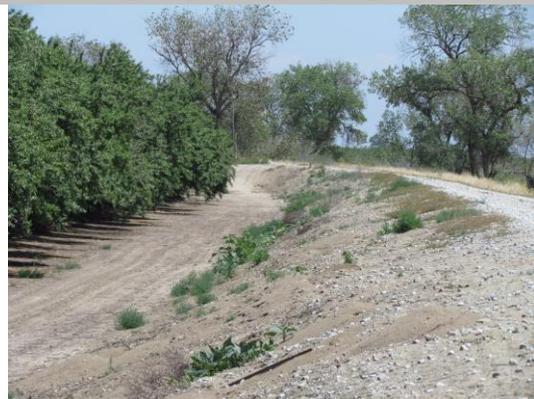
Photo 1 of 1 : SP\_2015\_NA0011\_142\_185\_20150508\_00078.jpg

The rodents are very active in this area.

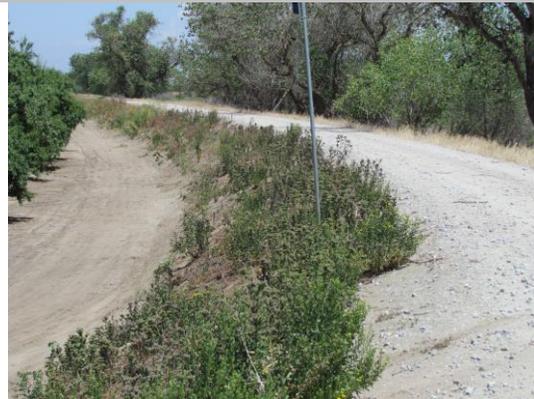
Photo 1 of 1 : SP\_2015\_NA0011\_142\_37\_20150508\_00079.jpg

Unsatisfactory tall weeds on the landside slope.

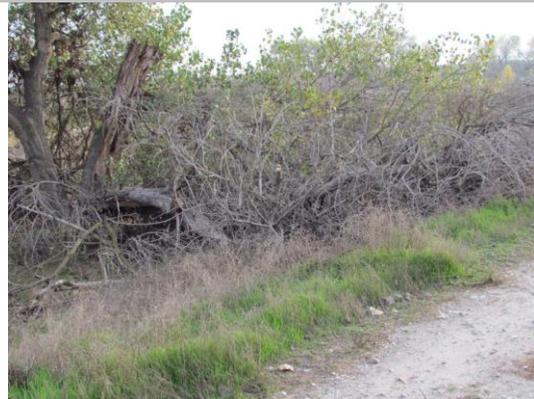
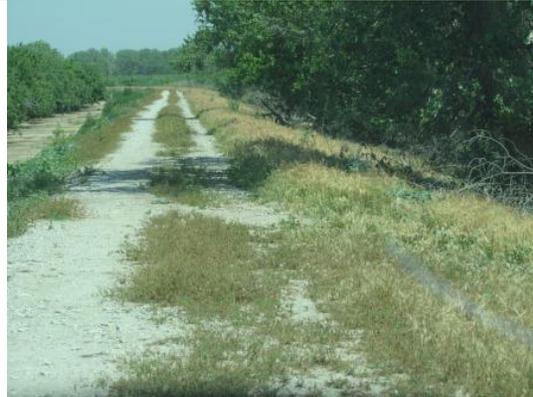
Photo 2 of 2 : SP\_2015\_NA0011\_142\_24\_20150312\_00008.jpg

The levee crown roadway is overgrown with weeds. Photo taken 4-29-2014.

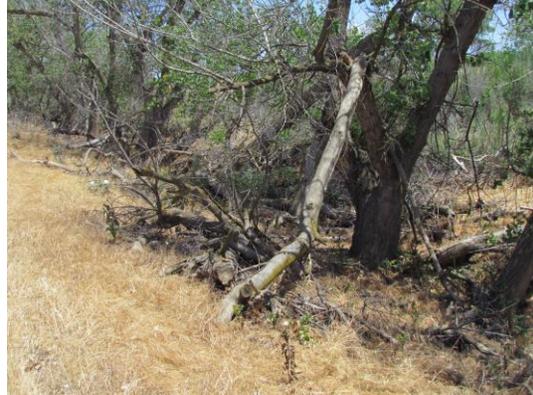
Photo 1 of 1 : SP\_2015\_NA0011\_142\_187\_20150508\_00080.jpg

There are several dead trees along the waterside slope and toe. These trees has been falling and many are dead. There has not been any water in the channel.

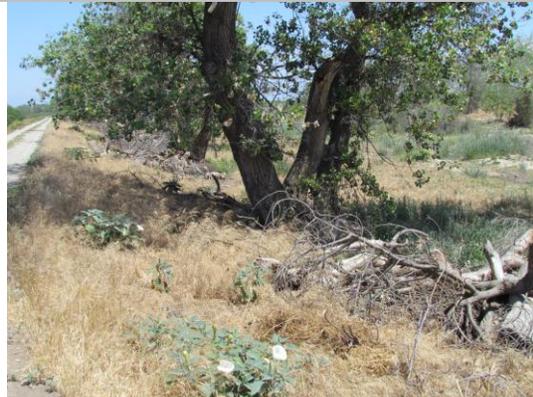
Photo 1 of 1 : SP\_2015\_NA0011\_142\_11\_20150508\_00081.jpg

Dead trees on the waterside slope that should have been removed already.

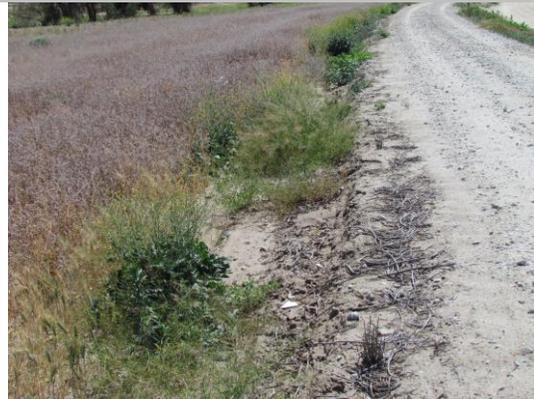
Photo 1 of 1 : SP\_2015\_NA0011\_142\_32\_20150508\_00073.jpg

LM Start	<b>1.36</b>	Rating **	U	Issue No.	<b>32</b>
LM End	<b>1.81</b>	Issue Type +	Ma	Location *	WS
Category	Earthen Levee			GPS Latitude/Longitude	
				Start	End
Item	Slope Stability			37.058460 °	37.062580 °
				-120.410390 °	-120.404180 °
DWR ID	DWR_NA0011_01_f_2014_32				
Action/Comments					
Repair slope instability. Inspector Comments: The toe has been damaged by disking too close to the levee toe waterward. 1.50-2.50 foot cut in toe

View looking downstream at the waterside toe damage.

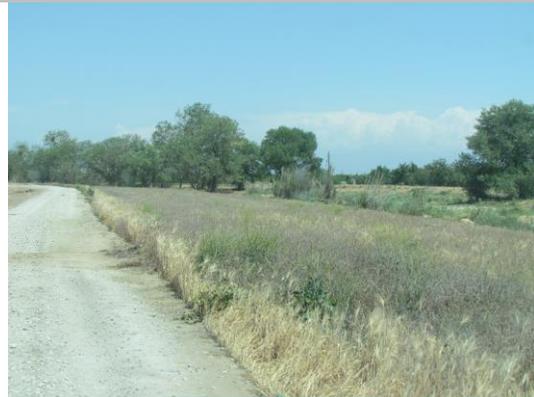
Photo 1 of 1 : SP\_2015\_NA0011\_142\_189\_20150508\_00074.jpg

Unauthorized crop planted on the waterside berm and disking within the toe of the levee.

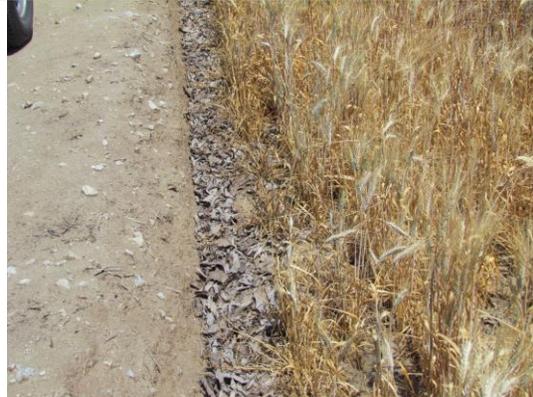
Photo 1 of 1 : SP\_2015\_NA0011\_142\_190\_20150508\_00075.jpg

LM Start	<b>1.42</b>	Rating **	U	Issue No.	<b>190</b>
LM End	<b>2.07</b>	Issue Type +	Ma	Location *	WS
Category	Earthen Levee		GPS Latitude/Longitude		
			Start	End	
Item	Slope Stability		37.058925 °	37.065360 °	
			-120.409392 °	-120.401108 °	
DWR ID	DWR_NA0011_01_s_2015_190				
Action/Comments					
Repair the levee slope damaged by vehicle traffic and prevent access where possible. Inspector Comments: The hinge point has been cut 1.5 inches deep.

The hinge point has been disced from levee mile 1.42 -2.07.

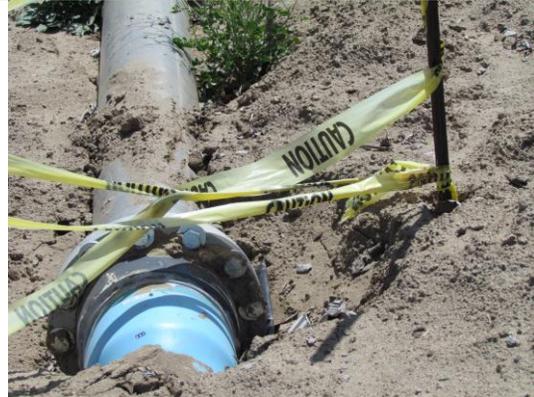
Photo 1 of 1 : SP\_2015\_NA0011\_142\_192\_20150508\_00076.jpg

Unauthorized pipe within levee section.

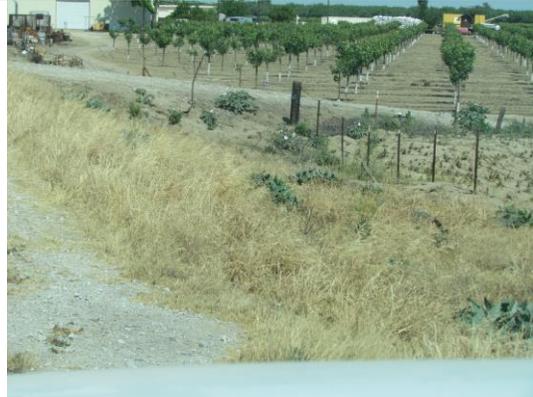
Photo 1 of 1 : SP\_2015\_NA0011\_143\_177\_20150511\_00039.jpg

Tall weeds present on the landside shoulder and slope.

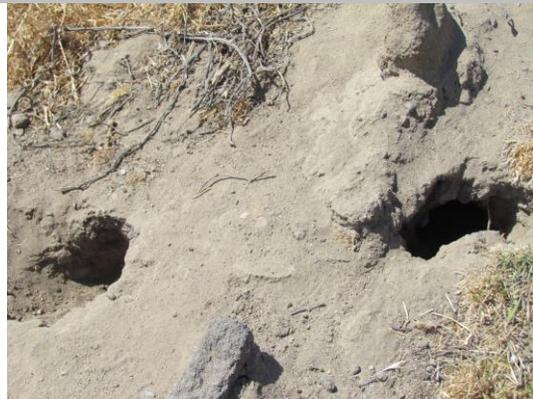
Photo 1 of 1 : SP\_2015\_NA0011\_143\_178\_20150511\_00040.jpg

There are many rodent holes present on the shoulder and slope of the landside section.

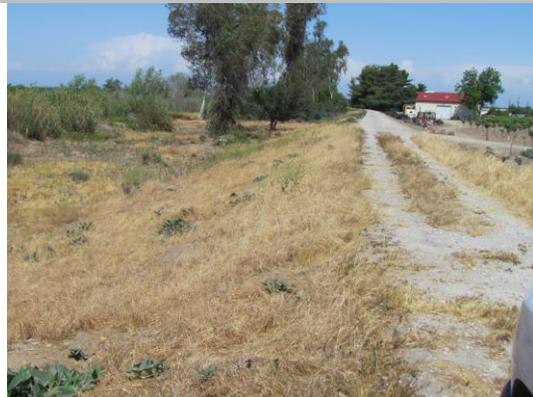
Photo 1 of 1 : SP\_2015\_NA0011\_143\_176\_20150511\_00041.jpg

Ash Slough looking upstream from the waterside at unsatisfactory tall weeds on the levee slope.

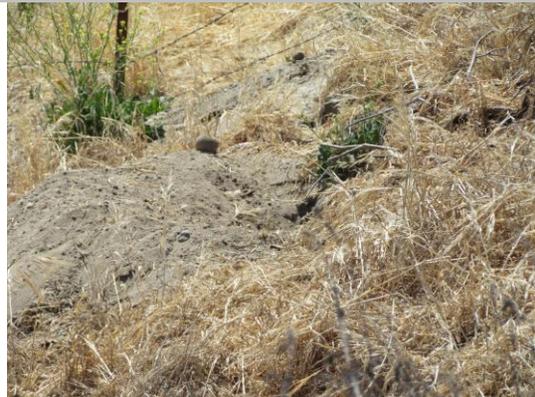
Photo 1 of 1 : SP\_2015\_NA0011\_143\_179\_20150511\_00042.jpg

From levee mile 0.03 through levee mile 2.03 rodent's are active and there are no bait stations in place.

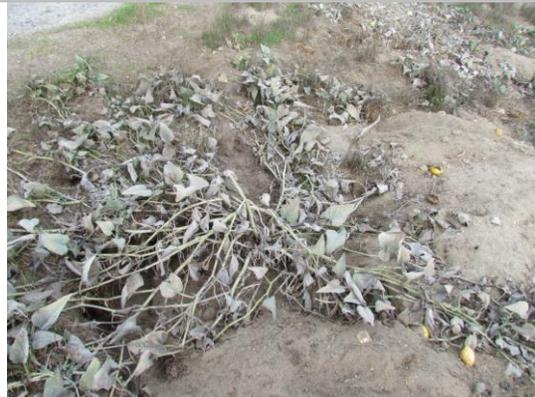
Photo 1 of 1 : SP\_2015\_NA0011\_143\_19\_20150312\_00003.jpg

Large rodent mounds underneath vine growth on the landside slope.

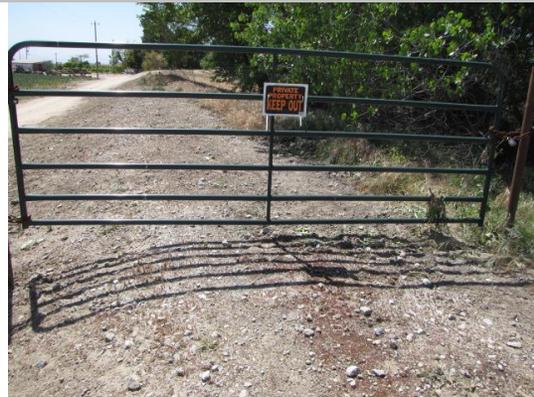
Photo 1 of 1 : SP\_2015\_NA0011\_143\_5\_20150312\_00001.jpg

Unauthorized gate and metal fence placed on slope and toe of levee section. Photo taken 4-17-2013.

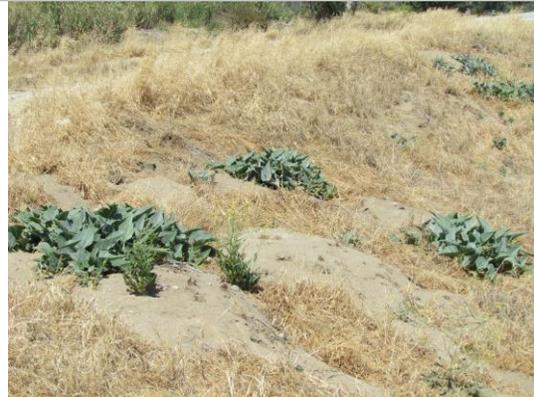
Photo 1 of 1 : SP\_2015\_NA0011\_143\_39\_20150511\_00043.jpg

Looking upstream from landside levee mile 0.32 wild weeds and broadleaf on levee slope. Rodent are active here also.

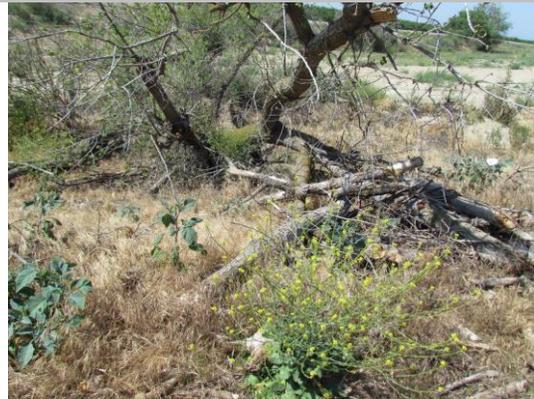
Photo 1 of 1 : SP\_2015\_NA0011\_143\_28\_20150511\_00044.jpg

This dead tree has not been removed since last inspection.

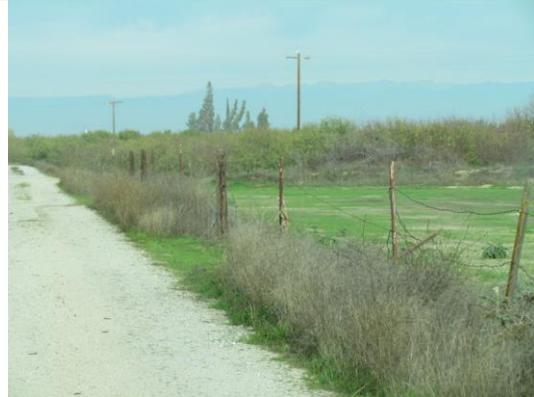
Photo 1 of 1 : SP\_2015\_NA0011\_143\_11\_20150312\_00002.jpg

Fence on the landside slope.

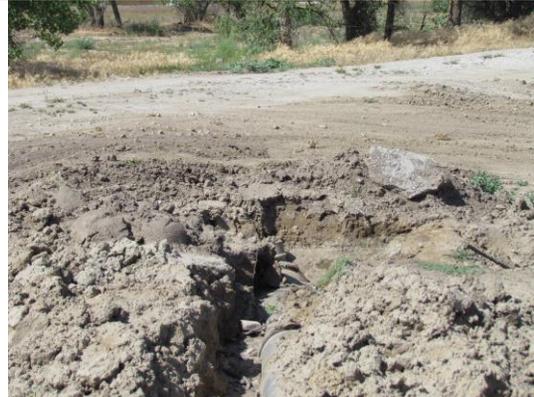
Photo 1 of 2 : SP\_2015\_NA0011\_143\_14\_20150511\_00045.jpg

This pipe goes all the way over to Unit 1 across the channel. No permit on file for this encroachment.

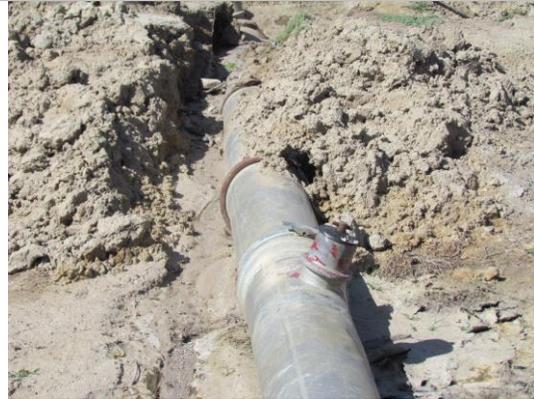
Photo 2 of 2 : SP\_2015\_NA0011\_143\_14\_20150511\_00046.jpg

Another view of the pipe; there is evidence of leakage at the joints.

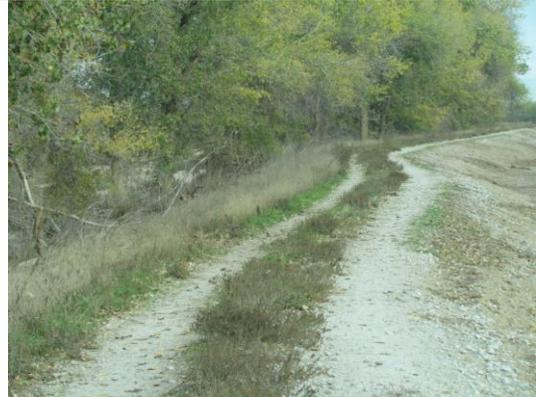
Photo 1 of 1 : SP\_2015\_NA0011\_143\_44\_20150312\_00010.jpg

View of the crown roadway with tall grasses present. No new picture.

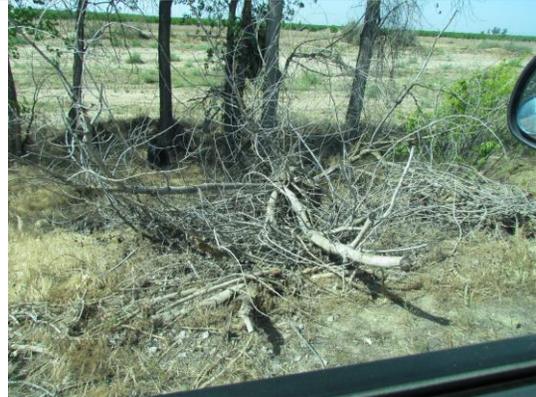
Photo 1 of 1 : SP\_2015\_NA0011\_143\_26\_20150511\_00047.jpg

Dead trees on waterside levee slope, this was listed on the last years report.

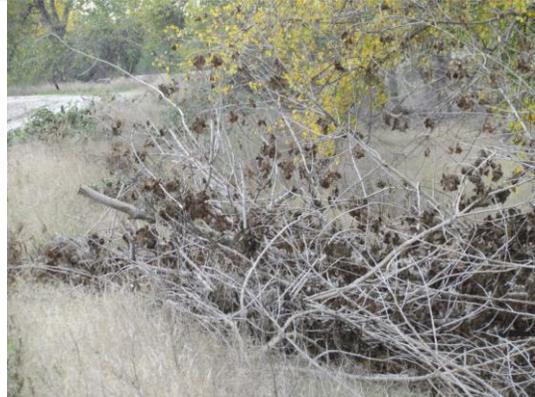
Photo 1 of 1 : SP\_2015\_NA0011\_143\_43\_20150312\_00009.jpg

Dead fallen tree not removed from levee section, reported in Spring inspection. No new photo 5-2015. Tree not removed.

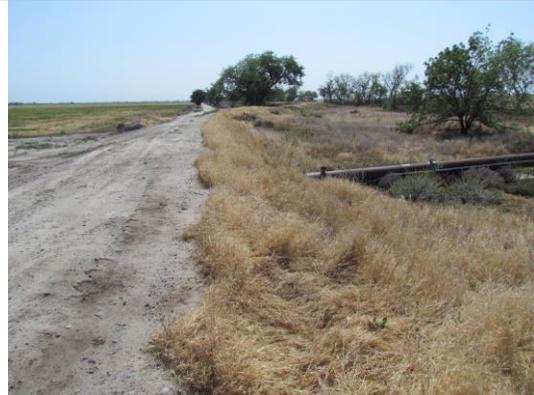
Photo 1 of 1 : SP\_2015\_NA0011\_144\_1\_20150511\_00025.jpg

Berenda Slough looking upstream from the waterside at unwanted tall weeds on the shoulder and slope.

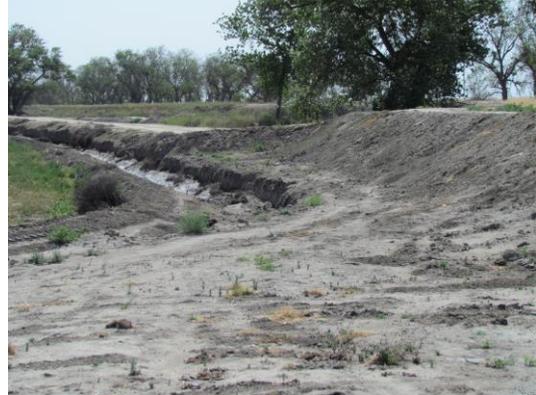
Photo 1 of 1 : SP\_2015\_NA0011\_144\_118\_20150513\_00027.jpg

Agriculture ditch within the 10-foot easement of the landside levee toe.

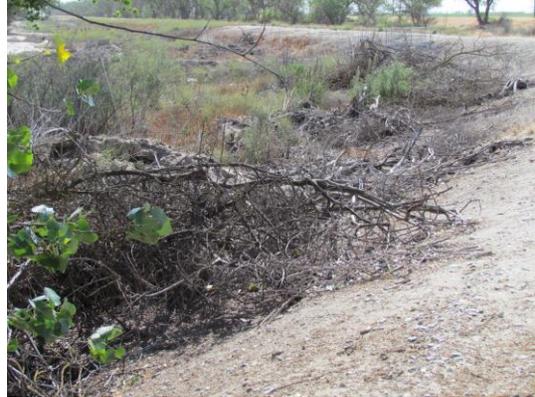
Photo 1 of 1 : SP\_2015\_NA0011\_144\_35\_20150511\_00026.jpg

Levee mile 0.03 landside dead trees still remain on the levee slope from last inspection.

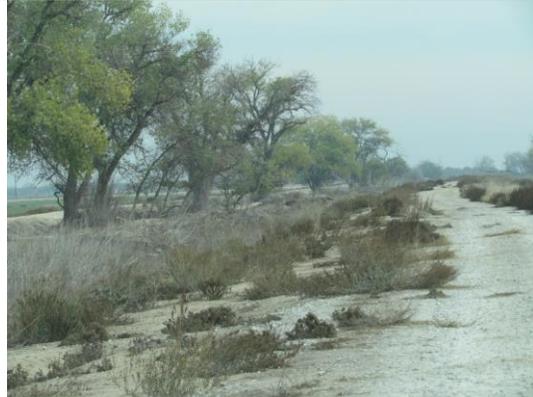
Photo 1 of 1 : SP\_2015\_NA0011\_144\_36\_20150312\_00005.jpg

Looking upstream at levee mile 0.36 wild growth covering the landward levee section to the levee mile 1.52. No new photo taken 5-6-2015.

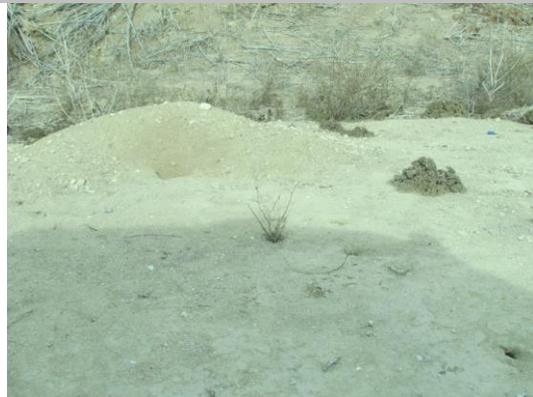
Photo 1 of 1 : SP\_2015\_NA0011\_144\_41\_20150312\_00007.jpg

Large rodent mounds on the landward levee slope. No new photo taken 5-2015, no change.

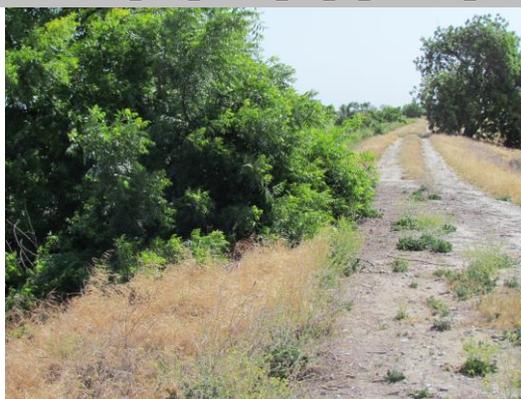
Photo 1 of 1 : SP\_2015\_NA0011\_144\_47\_20150513\_00029.jpg

Woody tree growth completely blocking the levee slope and shoulder on the landside.

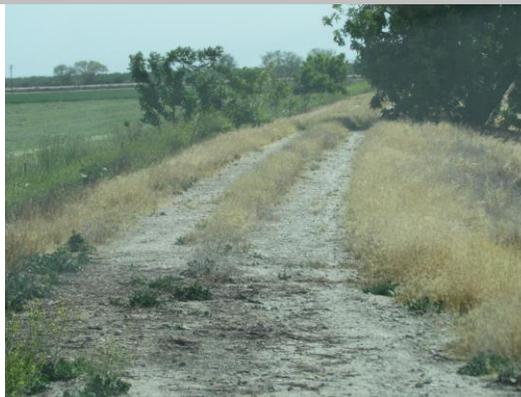
Photo 1 of 1 : SP\_2015\_NA0011\_144\_44\_20150513\_00030.jpg

Looking upstream from levee mile 1.04 to levee mile 1.52 crown roadway overgrown with tall weeds.

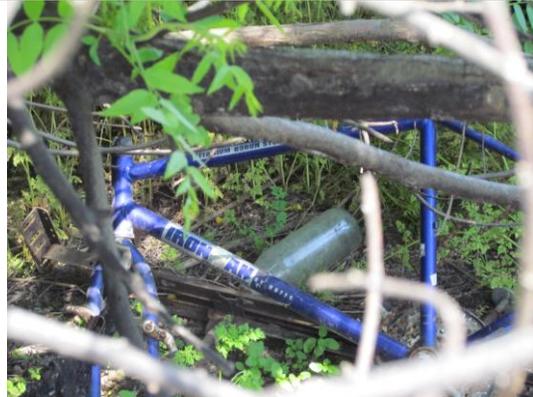
Photo 1 of 1 : SP\_2015\_NA0011\_144\_4\_20150513\_00031.jpg

Garbage, bicycle frame, and other materials dumped on levee slope.

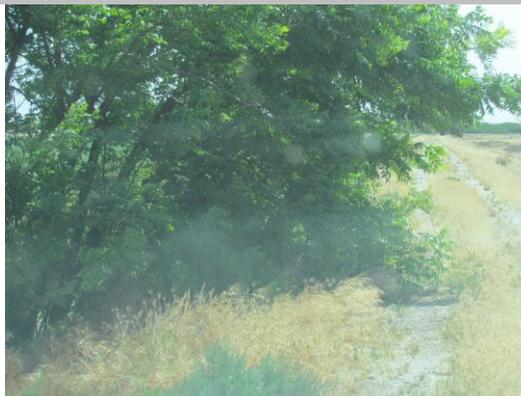
Photo 1 of 1 : SP\_2015\_NA0011\_144\_17\_20150513\_00033.jpg

Looking upstream from landward levee mile 1.24 tree growth blocks slope shoulder and portion of the crown roadway.

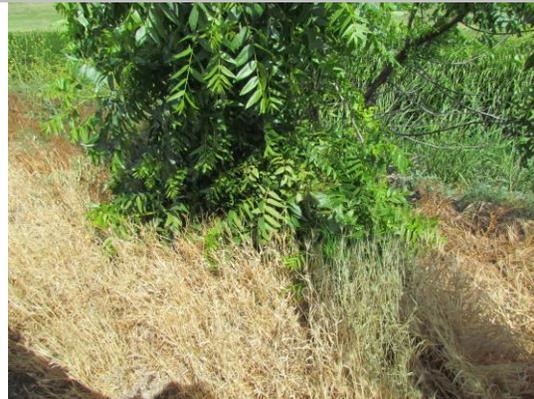
Photo 1 of 1 : SP\_2015\_NA0011\_144\_30\_20150513\_00034.jpg

Young nut tree on the landside levee slope.

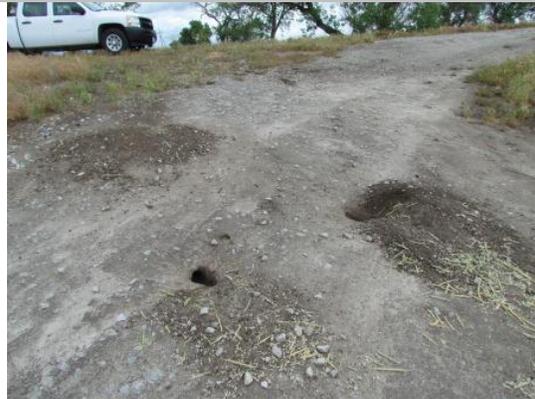
Photo 1 of 2 : SP\_2015\_NA0011\_145\_2\_20150312\_00002.jpg

Listed last year inspection 2014. The area has not changed. The slopes look the same.

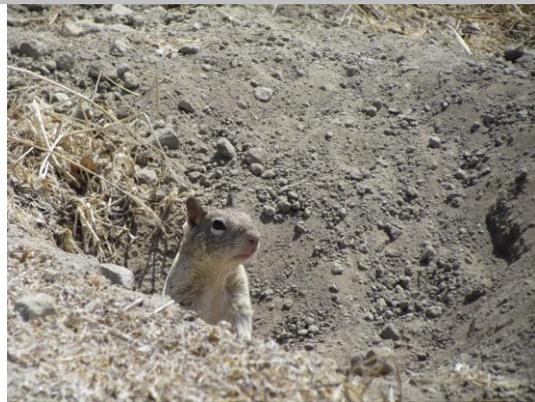
Photo 2 of 2 : SP\_2015\_NA0011\_145\_2\_20150513\_00089.jpg

Rodents are active in the area as listed during the last inspection. No bait stations on site.

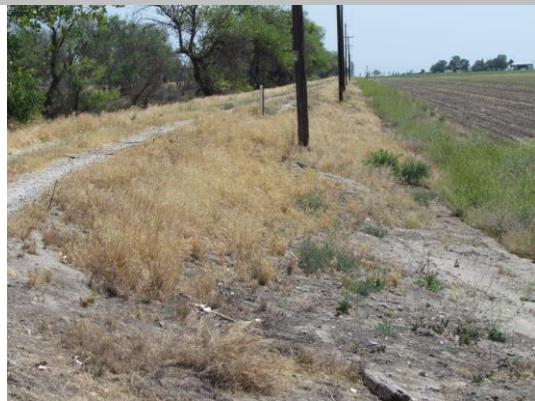
Photo 1 of 1 : SP\_2015\_NA0011\_145\_1\_20150513\_00088.jpg

Berenda Slough looking upstream from levee mile 0.01 to levee mile 1.50, tall weeds present on the landward levee slope.

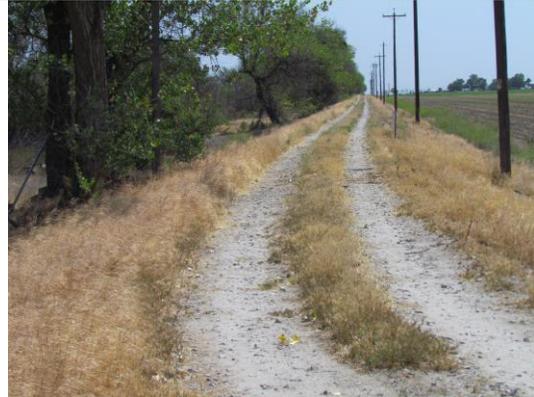
Photo 1 of 1 : SP\_2015\_NA0011\_145\_4\_20150513\_00090.jpg

Unacceptable wild growth on the waterside slope and shoulder.

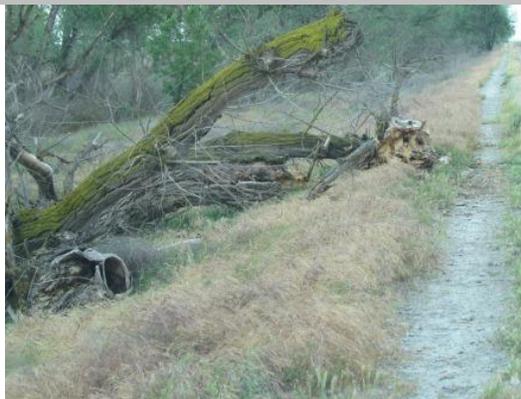
Photo 1 of 1 : SP\_2015\_NA0011\_145\_16\_20150312\_00008.jpg

A large cottonwood tree has fallen down across levee slope and shoulder should be removed from levee section. Tree not removed during Fall 2014.

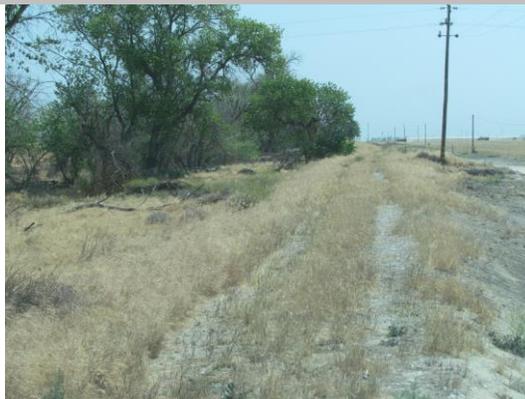
Photo 1 of 1 : SP\_2015\_NA0011\_145\_22\_20150513\_00093.jpg

Looking upstream where no maintenance has been done. Weeds are 3.0 foot tall on crown and both slopes.

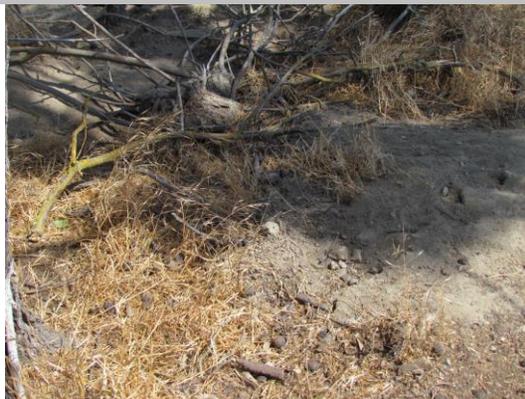
Photo 1 of 2 : SP\_2015\_NA0011\_145\_205\_20150513\_00091.jpg

Rodents are active at this location.

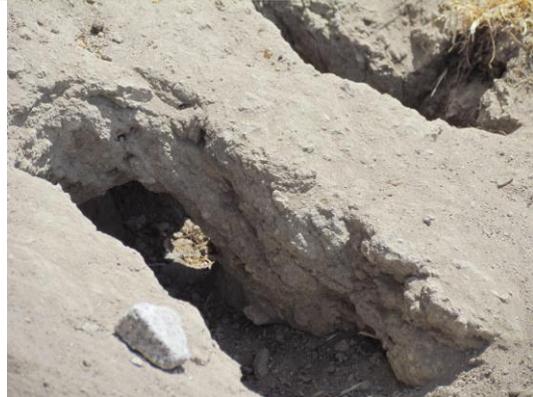
Photo 2 of 2 : SP\_2015\_NA0011\_145\_205\_20150513\_00092.jpg

Another view of the activity in area.

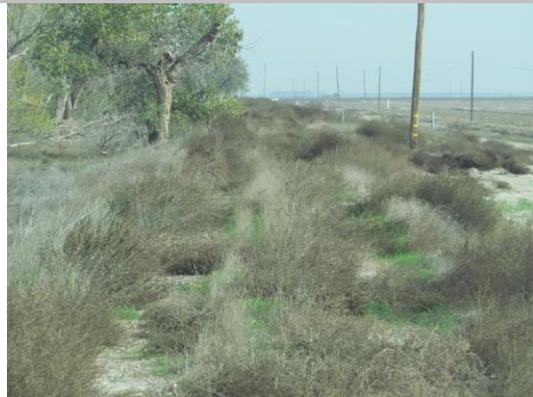
Photo 1 of 1 : SP\_2015\_NA0011\_145\_7\_20150312\_00004.jpg

Unwanted tall weeds completely covering the levee crown roadway. No new photo.

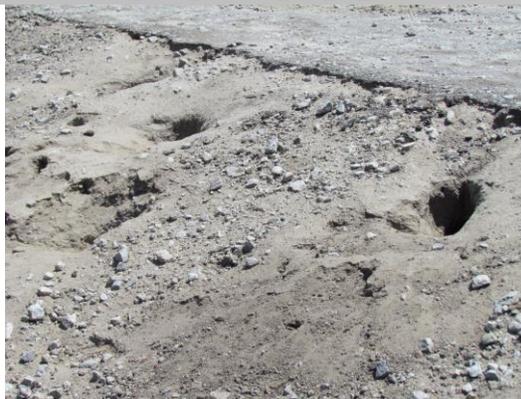
Photo 1 of 1 : SP\_2015\_NA0011\_145\_23\_20150513\_00094.jpg

Rodent mounds and holes covers the slope. The levee is like this through to the end of the unit.

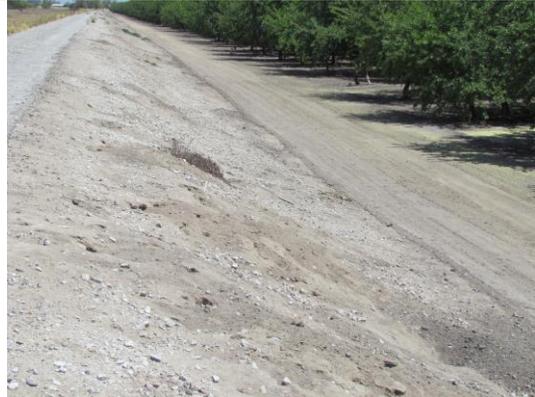
Photo 1 of 2 : SP\_2015\_NA0011\_145\_24\_20150513\_00095.jpg

Rodent are very active here from levee mile 1.50 to 1.87 slope and crown roadway.

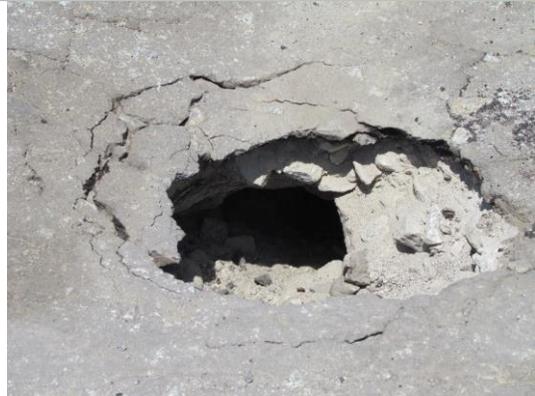
Photo 2 of 2 : SP\_2015\_NA0011\_145\_24\_20150513\_00096.jpg

Here in the crown roadway the rodent has burrowed through the blacktop.

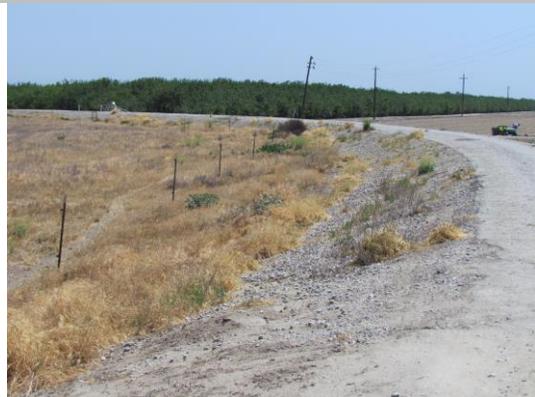
Photo 1 of 1 : SP\_2015\_NA0011\_145\_56\_20150513\_00098.jpg

Unauthorized fence within the 10-foot easement.

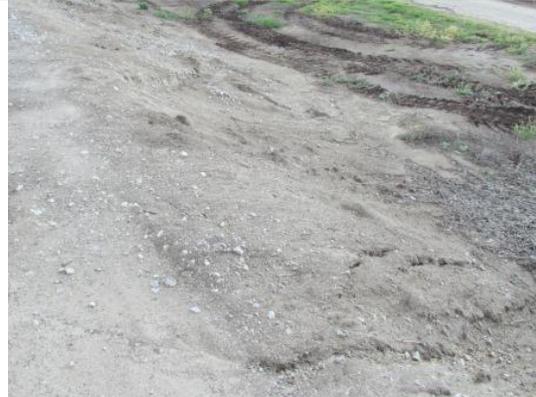
Photo 1 of 3 : SP\_2015\_NA0011\_145\_9\_20150312\_00005.jpg

Levee mile 1.51 levee damaged by the landowner. Photo taken 4-24-2014.

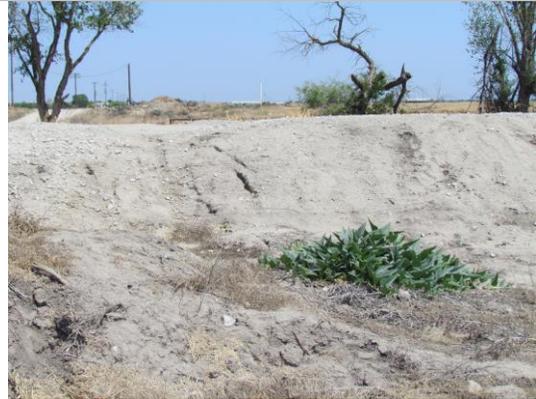
Photo 2 of 3 : SP\_2015\_NA0011\_145\_9\_20150513\_00097.jpg

No repairs to the levee observed on 5-6-2015.

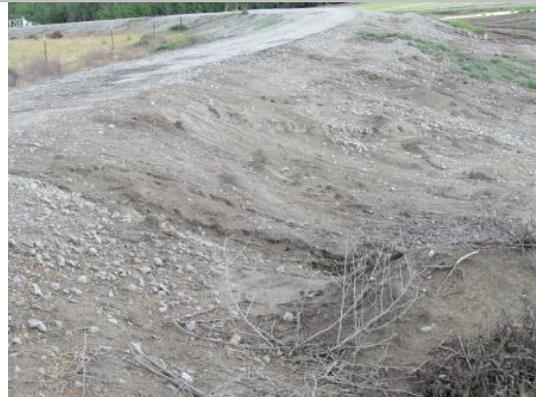
Photo 3 of 3 : SP\_2015\_NA0011\_145\_9\_20150312\_00006.jpg

Levee mile 1.51 landward slope remains unrepaired by the landowner. Photo taken 4-24-2014. No new photo taken Fall 2014. no change.

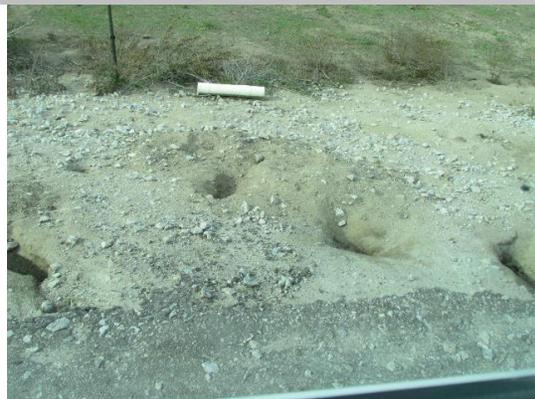
Photo 1 of 1 : SP\_2015\_NA0011\_145\_30\_20150312\_00011.jpg

Berenda Slough looking downstream along the waterside slope at large rodent holes on slope. No new photo.

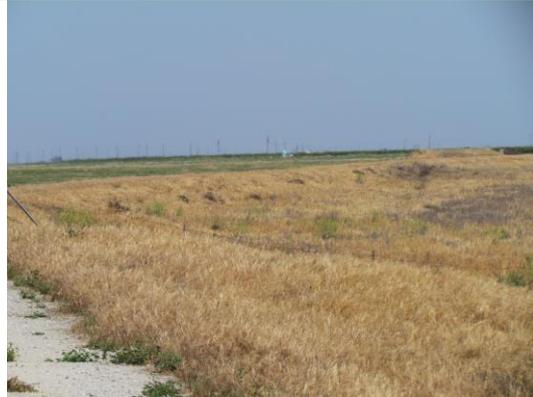
Photo 1 of 1 : SP\_2015\_NA0011\_146\_40\_20150513\_00157.jpg

Looking downstream from levee mile 0.03 tall weeds on the waterside slope.

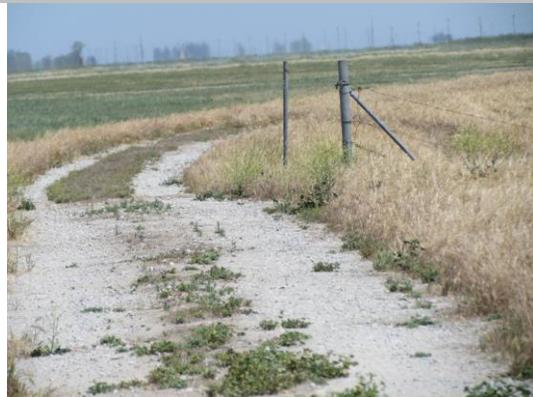
Photo 1 of 1 : SP\_2015\_NA0011\_146\_15\_20150513\_00156.jpg

Looking downstream at the crown roadway. It should be free of vegetation.

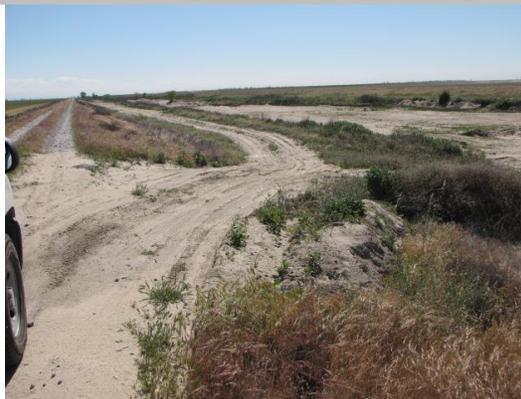
Photo 1 of 1 : SP\_2015\_NA0011\_146\_29\_20150312\_00003.jpg

Ramp placed on the waterward slope. Photo taken 4-16-2013.

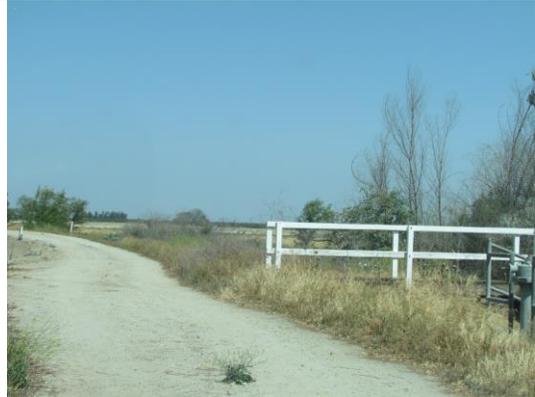
Photo 1 of 1 : SP\_2015\_NA0011\_146\_34\_20150527\_00159.jpg

Looking upstream at the waterside with tall weeds on the levee slope.

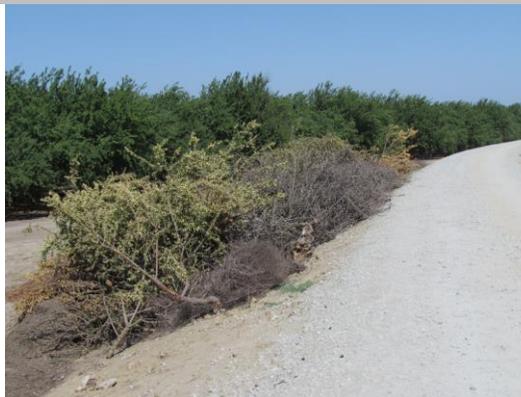
Photo 1 of 1 : SP\_2015\_NA0011\_146\_41\_20150527\_00160.jpg

Prunings on the landward levee slope, burn or remove from levee section.

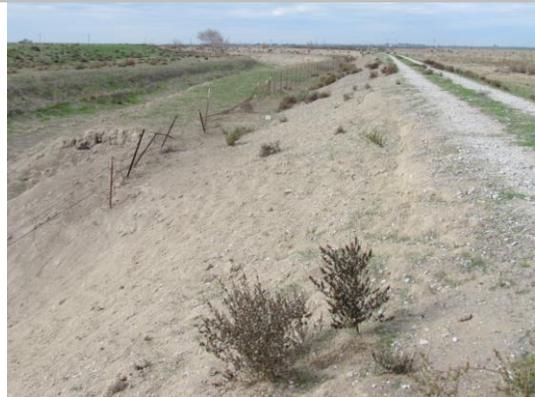
Photo 1 of 2 : SP\_2015\_NA0011\_147\_20\_20150312\_00004.jpg

Erosion at the levee shoulder and slope, this site was reported in the spring report tall weeds prevented view of damage. Looking upstream landward side of levee slope.

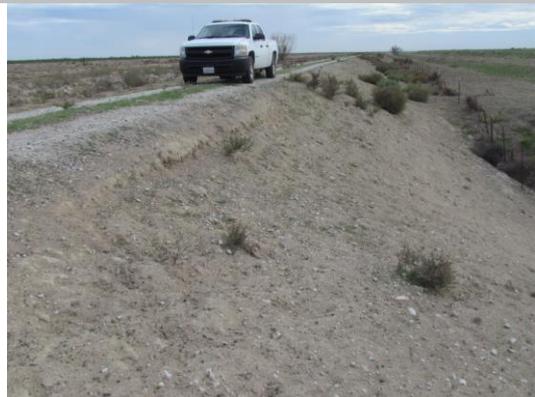
Photo 2 of 2 : SP\_2015\_NA0011\_147\_20\_20150312\_00005.jpg

Looking downstream at the erosion landward levee section, the erosion is at the hinge point of the levee shoulder. No new photo taken Spring 2015.

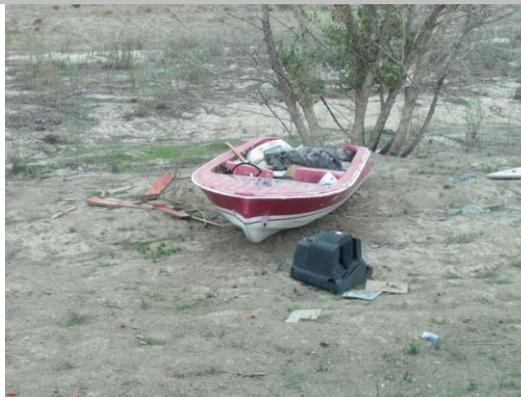
Photo 1 of 1 : SP\_2015\_NA0011\_147\_46\_20150312\_00012.jpg

View of an abandoned boat on the waterward side. Busted tv and other trash dumped on the dry channel.

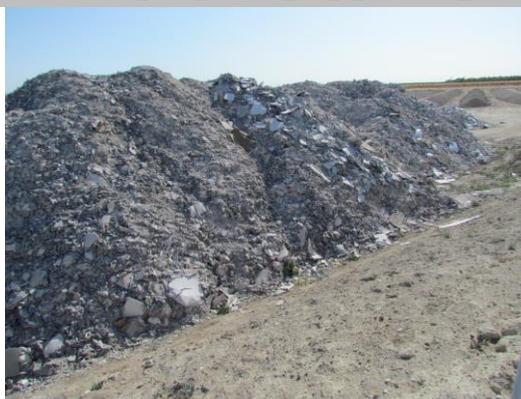
Photo 1 of 1 : SP\_2015\_NA0011\_147\_1\_20150528\_00139.jpg

This encroachment is within the 10-foot easement landward.

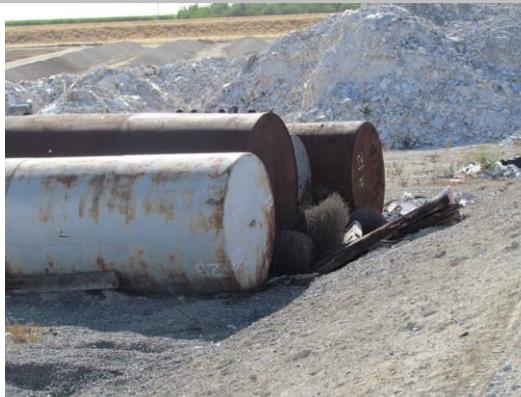
Photo 1 of 1 : SP\_2015\_NA0011\_147\_429\_20150528\_00145.jpg

Encroachment within 10-foot of the landside levee toe.

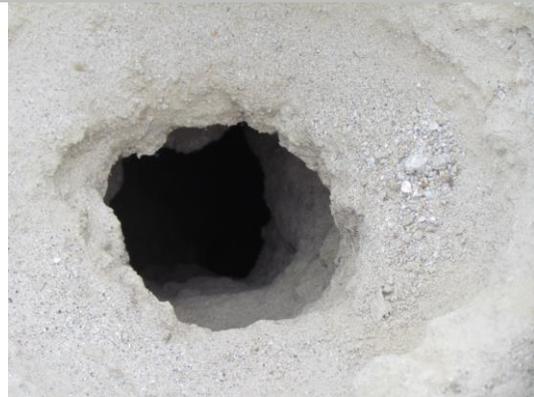
Photo 1 of 1 : SP\_2015\_NA0011\_147\_48\_20150312\_00013.jpg

Huge rodent hole in crown roadway.

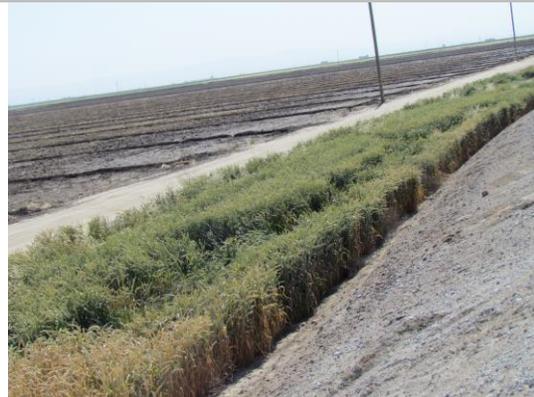
Photo 1 of 1 : SP\_2015\_NA0011\_147\_425\_20150528\_00143.jpg

Crop planted within the 10-foot easement landside toe.

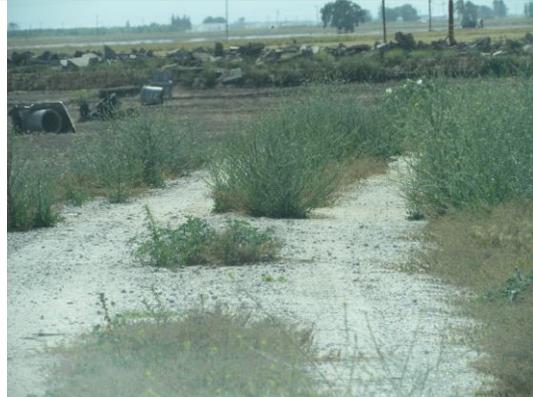
Photo 1 of 1 : SP\_2015\_NA0011\_147\_422\_20150528\_00144.jpg

View of unacceptable tall weeds growing on crown roadway.

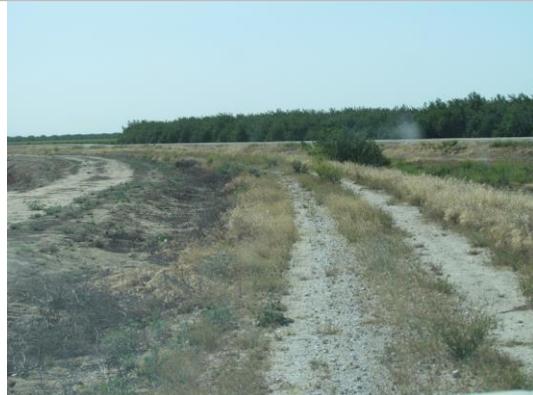
Photo 1 of 1 : SP\_2015\_NA0011\_147\_420\_20150528\_00141.jpg

Fresno River Unit 6 from levee mile 7.90-8.39 weeds are growing on crown roadway.
