**Flood Control Project Maintenance  
Levee Inspections**

## Maintenance Issue Types Only, Levee Inspection Report By Mile - Fall 2015

### Madera County FCWCA

Waterway	Bank	Unit Miles	Inspection Start/End	Inspector
Unit No. 01 Ash Slough	Right	2.37	10/21/2015 10/21/2015	Herman Phillips

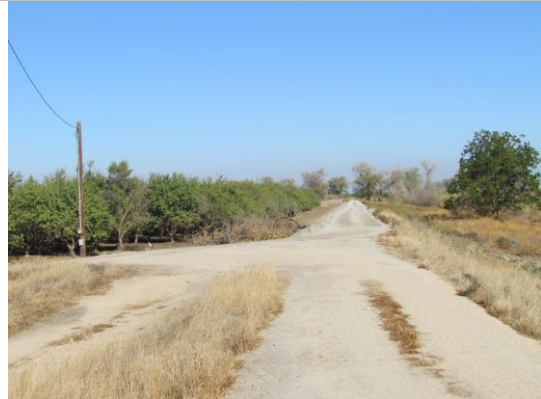
Photo 1 of 1 : FA\_2015\_NA0011\_142\_34\_20151021\_00013.jpg

LM Start	0.01	Rating **	A	Issue No.	34
LM End	0.25	Issue Type +	Ma	Location *	LS
Category	Earthen Levee			GPS Latitude/Longitude	
				Start	End
Item	Vegetation			37.046495 °	37.047545 °
				-120.427787 °	-120.423650 °
DWR ID	DWR_NA0011_01_f_2015_34				
Action/Comments					
Control annual grass and weeds on the levee slopes and easements. Inspector Comments: Looking upstream from the landside slope no unwanted vegetation.

Ash Slough looking upstream from landside levee shoulder.

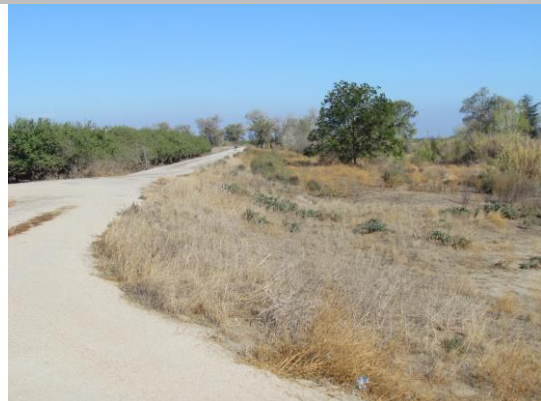
Photo 1 of 1 : FA\_2015\_NA0011\_142\_26\_20151021\_00014.jpg

LM Start	0.01	Rating **	U	Issue No.	26
LM End	1.77	Issue Type +	Ma	Location *	WS
Category	Earthen Levee			GPS Latitude/Longitude	
				Start	End
Item	Vegetation			37.046495 °	37.062037 °
				-120.427787 °	-120.404680 °
DWR ID	DWR_NA0011_01_f_2015_26				
Action/Comments					
Control annual grass and weeds on the levee slopes and easements. Inspector Comments: Looking upstream at the waterside slope tall unwanted weeds are present.

Ash Slough looking upstream at the waterside slope, tall unwanted weeds on the slope.

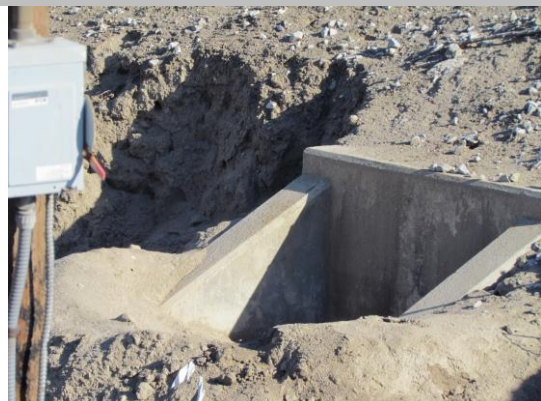
Photo 1 of 1 : FA\_2015\_NA0011\_142\_20\_20151021\_00022.jpg

LM Start	0.04	Rating **	U	Issue No.	20
LM End	0.05	Issue Type +	Ma	Location *	LS
Category	Earthen Levee			GPS Latitude/Longitude	
				Start	End
Item	Slope Stability			37.046624 °	37.046682 °
				-120.427317 °	-120.427108 °
DWR ID	DWR_NA0011_01_s_2014_20				
Action/Comments					
Repair slope instability.					
Inspector Comments: This is not a new erosion site, it should be repaired before the condition get any worse.

There is damage to the landside slope near the concrete wing wall.

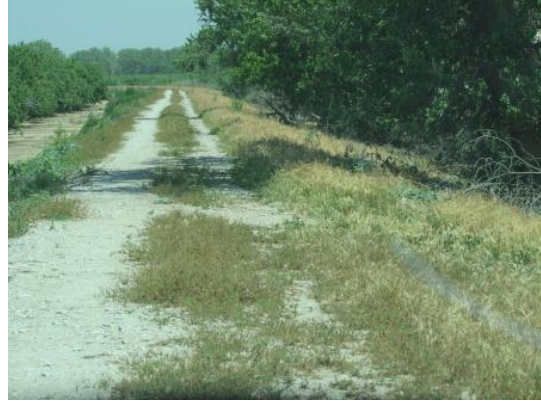
Photo 1 of 1 : FA\_2015\_NA0011\_142\_24\_20150915\_00008.jpg

The levee crown roadway is overgrown with weeds. Photo taken 4-29-2014.

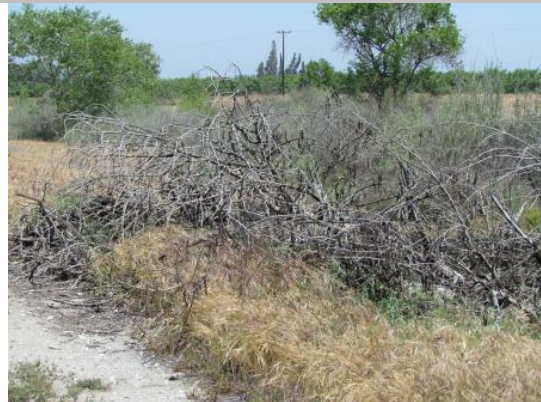
Photo 1 of 1 : FA\_2015\_NA0011\_142\_16\_20150915\_00003.jpg

This dead tree has not been removed from the levee section, the shoulder, slope and toe is blocked. Photo taken 4-29-2014. There is no new picture for this issue. No change has been made prior to Fall inspection 2014.

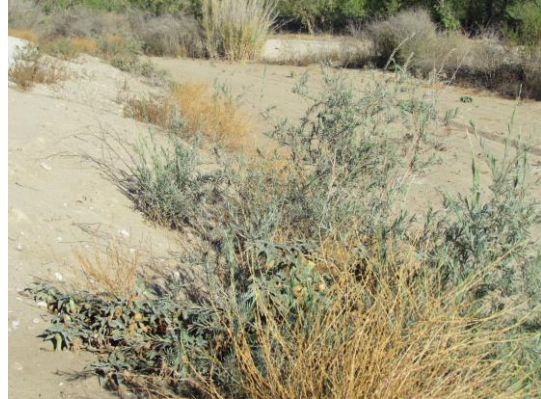
Photo 1 of 3 : FA\_2015\_NA0011\_142\_38\_20151021\_00018.jpg

LM Start	1.17	Rating **	U	Issue No.	38
LM End	1.37	Issue Type +	Ma	Location *	WS
Category	Earthen Levee			GPS Latitude/Longitude	
				Start	End
Item	Slope Stability			37.056380 °	37.058520 °
				-120.412483 °	-120.410257 °
DWR ID	DWR_NA0011_01_f _ 2015_38				
Action/Comments					
Repair the levee slope damaged by vehicle traffic and prevent access where possible.					
Inspector Comments: The slope will have to be put back in place damaged by equipment.

The levee slope has been damaged by equipment, the farmer has cut the toe away while working too close to the levee.

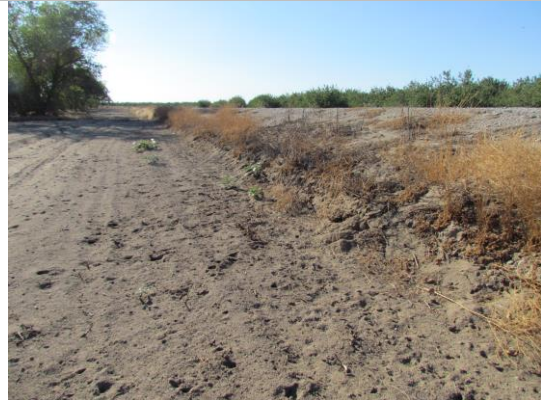
Photo 2 of 3 : FA\_2015\_NA0011\_142\_38\_20151021\_00019.jpg

Slope damage at toe of the water sidelevee section.

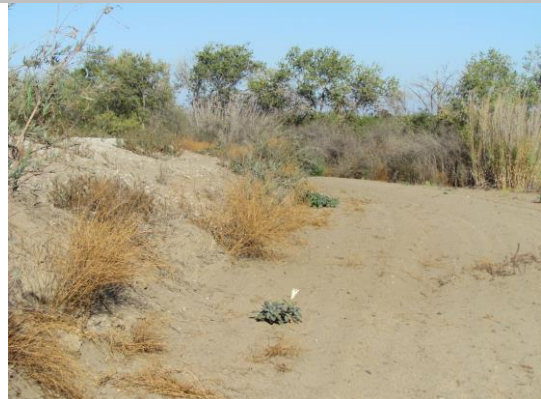
Photo 3 of 3 : FA\_2015\_NA0011\_142\_38\_20151021\_00020.jpg

Another view of the damaged toe.

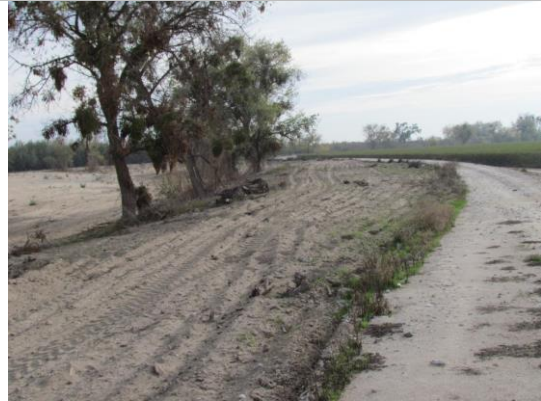
Photo 1 of 1 : FA\_2015\_NA0011\_142\_17\_20150915\_00004.jpg

LM Start	2.37	Rating **	U	Issue No.	17
LM End	2.40	Issue Type +	Ma	Location *	WS
Category	Earthen Levee			GPS Latitude/Longitude	
				Start	End
Item	Slope Stability			37.068737 °	37.068737 °
				-120.398570 °	-120.396570 °
DWR ID	DWR_NA0011_01_s _ 2013_17				
Action/Comments					
Repair slope instability. Inspector Comments: The farmer has plowed up the waterside berm too close to the levee toe causing damage to the levee toe also this method transfers the bamboo roots along the berm. Spraying is needed to kill the new growth. This method of maintaining the waterside cannot continue.

Ash Slough levee toe damaged by farm equipment discing too close.

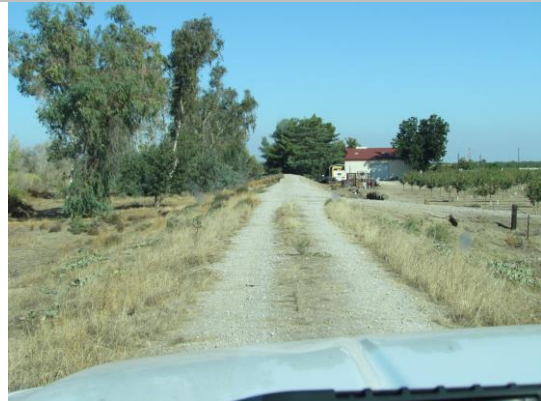
Photo 1 of 1 : FA\_2015\_NA0011\_143\_34\_20151027\_00011.jpg

LM Start	0.00	Rating **	U	Issue No.	34
LM End	2.03	Issue Type +	Ma	Location *	WS
Category	Earthen Levee			GPS Latitude/Longitude	
				Start	End
Item	Vegetation			37.045485 °	37.064023 °
				-120.427423 °	-120.401097 °
DWR ID	DWR_NA0011_02_f_2015_34				
Action/Comments					
Control annual grass and weeds on the levee slopes and easements. Inspector Comments: Remove the weeds from the waterside levee slope and shoulder.

Ash Slough looking upstream from levee mile 0.00 tall weeds covering water side levee slope and shoulder.

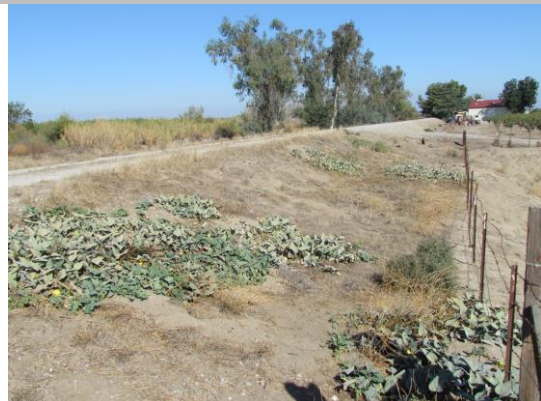
Photo 1 of 1 : FA\_2015\_NA0011\_143\_30\_20151026\_00009.jpg

LM Start	0.00	Rating **	U	Issue No.	30
LM End	2.04	Issue Type +	Ma	Location *	LS
Category	Earthen Levee			GPS Latitude/Longitude	
				Start	End
Item	Vegetation			37.045485 °	37.064122 °
				-120.427423 °	-120.401030 °
DWR ID	DWR_NA0011_02_f_2015_30				
Action/Comments					
Control annual grass and weeds on the levee slopes and easements. Inspector Comments: Control the wild vegetation on the landside levee slope. This vegetation is providing habitat for rodents.

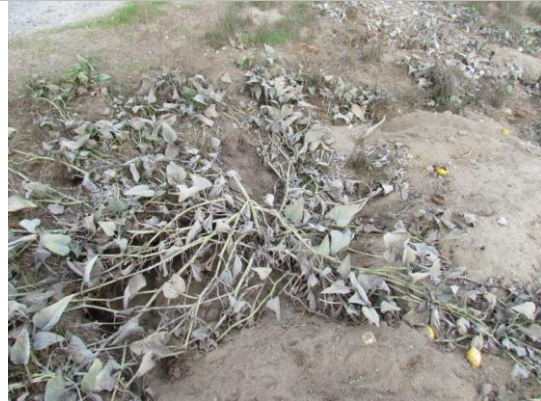
Photo 1 of 1 : FA\_2015\_NA0011\_143\_19\_20150915\_00003.jpg

Large rodent mounds underneath vine growth on the landside slope.

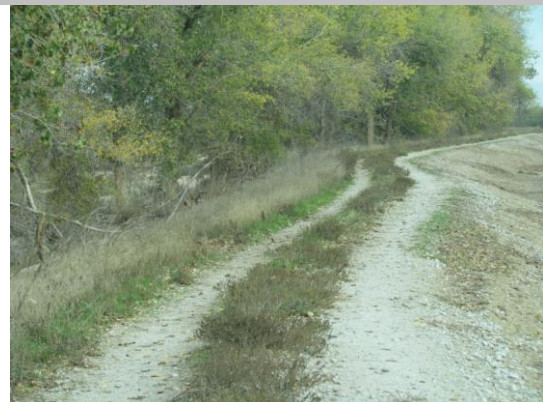
Photo 1 of 1 : FA\_2015\_NA0011\_143\_44\_20150915\_00008.jpg

Crown roadway from 0.98 to 1.40 tall grasses present.

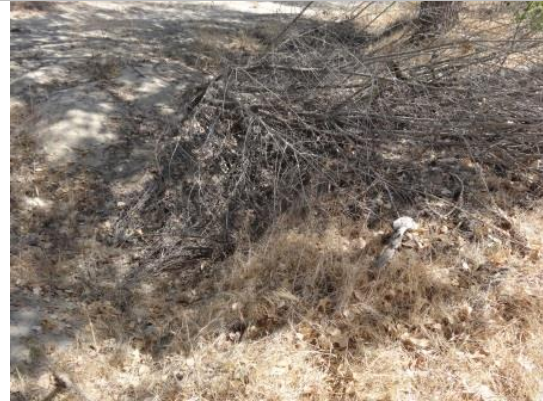
Photo 1 of 2 : SJR2015\_NA0011U02RM2.57\_3.jpg

LM Start	1.10	Rating **	U	Issue No.	1
LM End	1.19	Issue Type +	Ma	Location *	WS
Category	Supplemental			GPS Latitude/Longitude	
				Start	End
Item	DWR Erosion Survey			37.055596 °	37.055596 °
				-120.412647 °	-120.412647 °
DWR ID					
Action/Comments					
Inspector Comments: 09/08/2015: No significant change observed. 07/22/2014: No significant change observed. 08/30/2013: No significant change observed. 07/31/2012: Site was visited on 07/24/2012. No significant change observed. Dense vegetation around the site 08/09/2011: Site was inspected. No visible change was observed from the previous condition. A fallen tree was seen at the levee toe about 20 feet upstream, and tree root exposed. There has been no report from the district that this site was corrected. 11/30/2010: Site was not inspected due to time constraints. There have been no reports from the district that the site was corrected. Continue to monitor site during flood events. 08/05/2010: Recommended for annual assessment and monitoring during flood events, per CLRO. 2009: Site is recommended as a local maintenance issue, per Critical Levee Repair Office, Critical Erosion Sites Evaluation 2008 Report; site was previously rated "M" 9/6/2007: Undercutting of the toe; several trees along the WS slope with roots exposed. [2015 Site ID:NA0011U02RM2.57]

Debris at the site.

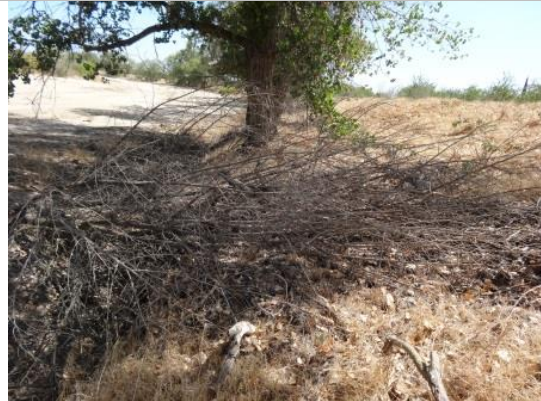
Photo 2 of 2 : SJR2015\_NA0011U02RM2.57\_4.jpg

LM Start	1.10	Rating **	U	Issue No.	1 (cont)	
LM End	1.19	Issue Type +	Ma	Location *	WS	
Category	Supplemental			GPS Latitude/Longitude		
				Start	End	
Item	DWR Erosion Survey			37.055596 °	37.055596 °	
				-120.412647 °	-120.412647 °	
DWR ID						
Action/Comments						
Inspector Comments: 09/08/2015: No significant change observed. 07/22/2014: No significant change observed. 08/30/2013: No significant change observed. 07/31/2012: Site was visited on 07/24/2012. No significant change observed. Dense vegetation around the site 08/09/2011: Site was inspected. No visible change was observed from the previous condition. A fallen tree was seen at the levee toe about 20 feet upstream, and tree root exposed. There has been no report from the district that this site was corrected. 11/30/2010: Site was not inspected due to time constraints. There have been no reports from the district that the site was corrected. Continue to monitor site during flood events. 08/05/2010: Recommended for annual assessment and monitoring during flood events, per CLRO. 2009: Site is recommended as a local maintenance issue, per Critical Levee Repair Office, Critical Erosion Sites Evaluation 2008 Report; site was previously rated "M" 9/6/2007: Undercutting of the toe; several trees along the WS slope with roots exposed. [2015 Site ID:NA0011U02RM2.57]

Close view of the site with the dead tree.

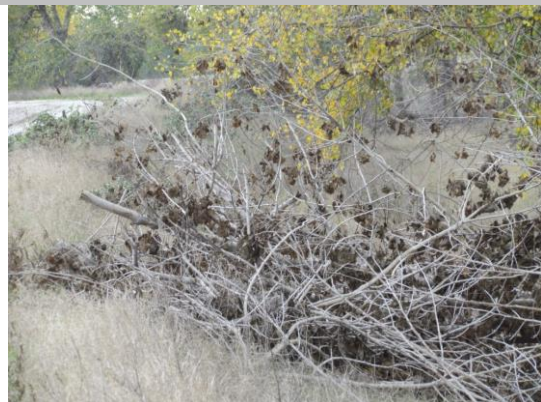
Photo 1 of 1 : FA\_2015\_NA0011\_143\_43\_20150915\_00007.jpg

Dead fallen tree not removed from levee section, reported in Spring inspection.

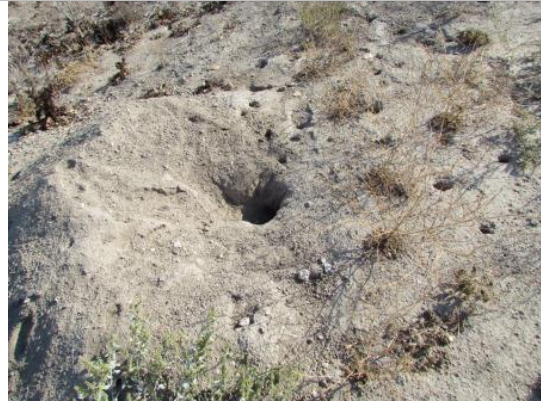
Photo 1 of 2 : FA\_2015\_NA0011\_144\_41\_20151026\_00010.jpg

LM Start	0.71	Rating **	U	Issue No.	41
LM End	1.51	Issue Type +	Ma	Location *	LS
Category	Earthen Levee			GPS Latitude/Longitude	
				Start	End
Item	Animal Control			36.996240 °	36.996583 °
				-120.361028 °	-120.346680 °
DWR ID	DWR_NA0011_03_f_2014_41				
Action/Comments					
Repair the levee slope damaged by livestock and prevent large animal access.					
Inspector Comments: Need bait stations present where rodents are active.

Large rodent holes along the landside shoulder and slope of Berenda Slough.

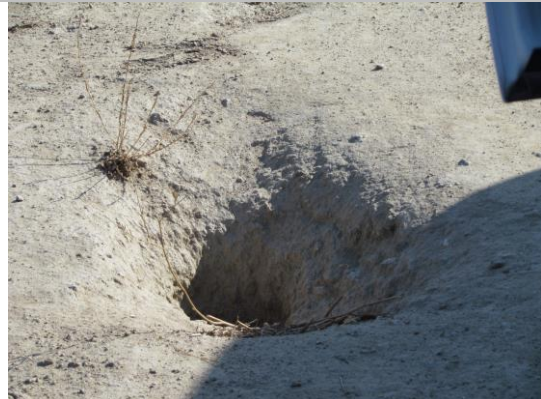
Photo 2 of 2 : FA\_2015\_NA0011\_144\_41\_20151026\_00011.jpg

View of other rodent holes in the landside levee slope.

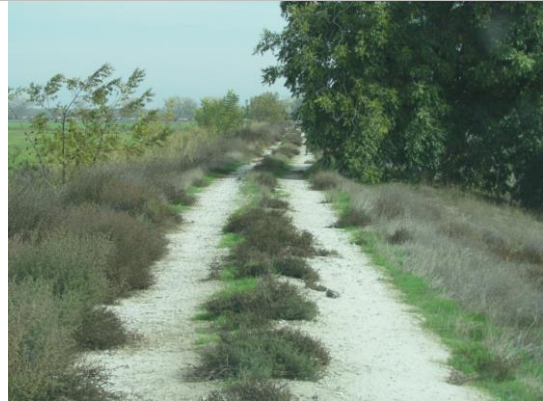
Photo 1 of 1 : FA\_2015\_NA0011\_144\_44\_20150915\_00007.jpg

Looking upstream from levee mile 1.04 to levee mile 1.52 crown roadway overgrown with tall weeds.

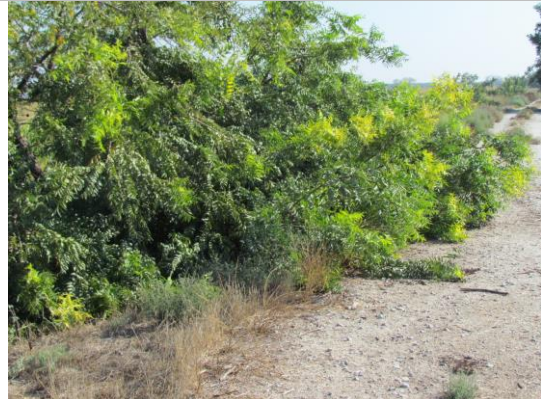
Photo 1 of 1 : FA\_2015\_NA0011\_144\_11\_20151026\_00013.jpg

Berenda Slough Unit 3 looking upstream from levee mile 1.04-1.05 walnut trees blocking the view of the landside levee section.

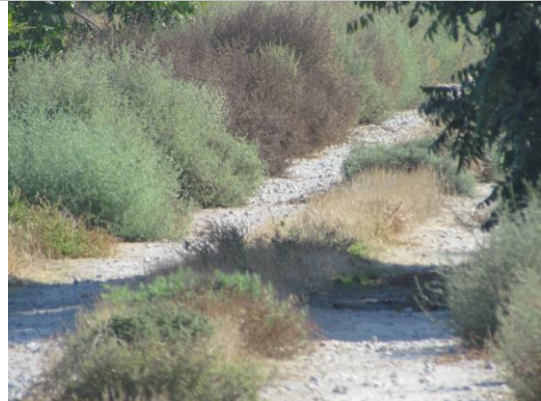
Photo 1 of 1 : FA\_2015\_NA0011\_144\_27\_20151026\_00014.jpg

Berenda Slough looking upstream from levee mile 1.12 to 1.52 unsatisfactory tall tumble weeds on the shoulder and slope.

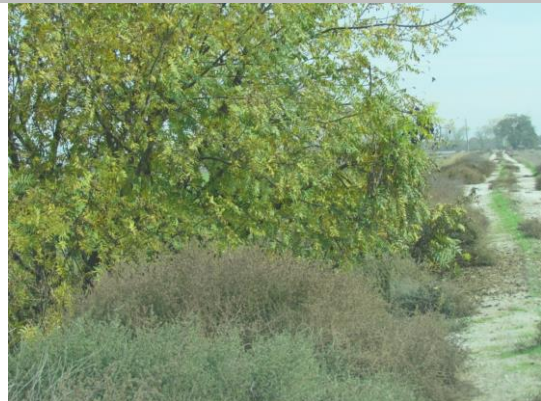
Photo 1 of 1 : FA\_2015\_NA0011\_144\_17\_20150915\_00004.jpg

Looking upstream landward levee mile 1.26 tree growth blocks slope, shoulder and portion on the crown roadway.

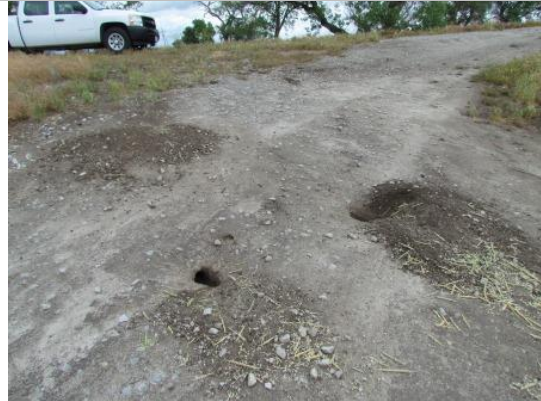
Photo 1 of 1 : FA\_2015\_NA0011\_145\_2\_20150915\_00002.jpg

Large rodent holes on landside slope looking upstream from levee mile 0.01. Photo taken 4-24-2014. No new photo taken no maintenance has been done Fall 2014.

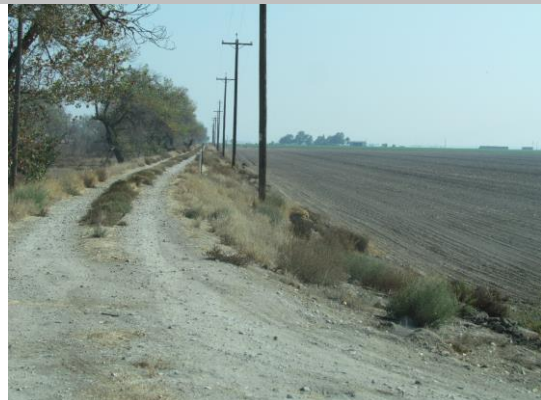
Photo 1 of 1 : FA\_2015\_NA0011\_145\_1\_20151026\_00015.jpg

Berenda Slough looking upstream from levee mile 0.01- 1.50the tumble weeds has taken over the levee slope and crown.

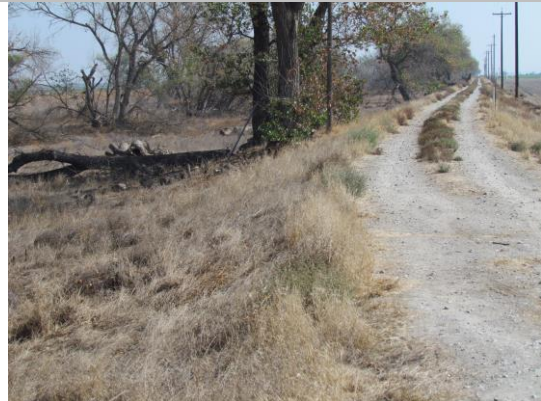
Photo 1 of 1 : FA\_2015\_NA0011\_145\_4\_20151026\_00014.jpg

LM Start	0.01	Rating **	U	Issue No.	4
LM End	1.60	Issue Type +	Ma	Location *	WS
Category	Earthen Levee			GPS Latitude/Longitude	
				Start	End
Item	Vegetation			36.995493 °	36.996215 °
				-120.373242 °	-120.344808 °
DWR ID	DWR_NA0011_04_f_2014_4				
Action/Comments					
Remove the wild growth other than native grasses from the levee slopes. Inspector Comments: No maintenance has been done in several years, the weeds are 3.0 feet tall. The condition of the levee slopes can't be seen through wild weeds.

Berenda Slough looking upstream at the waterside levee slope and shoulder levee mile 0.01- 1.60.

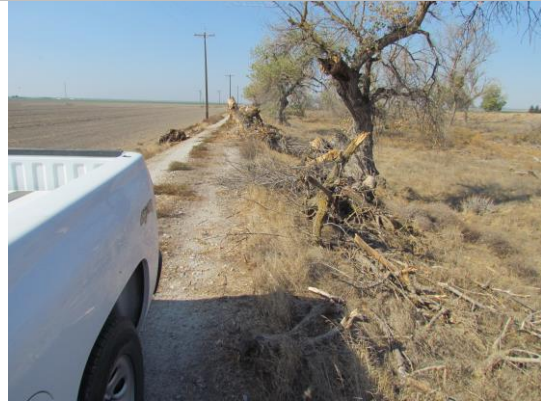
Photo 1 of 1 : FA\_2015\_NA0011\_145\_15\_20151026\_00017.jpg

Berenda Slough looking upstream from levee mile 0.14 at dead tree blocking the levee crown roadway.

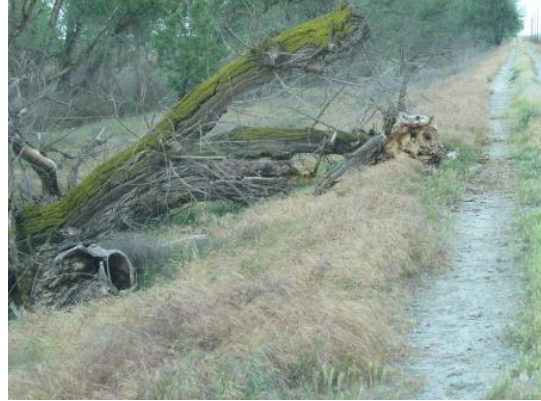
Photo 1 of 1 : FA\_2015\_NA0011\_145\_16\_20150915\_00008.jpg

A large cottonwood tree has fallen down across levee slope and shoulder should be removed from levee section. Tree not removed during Fall 2014.

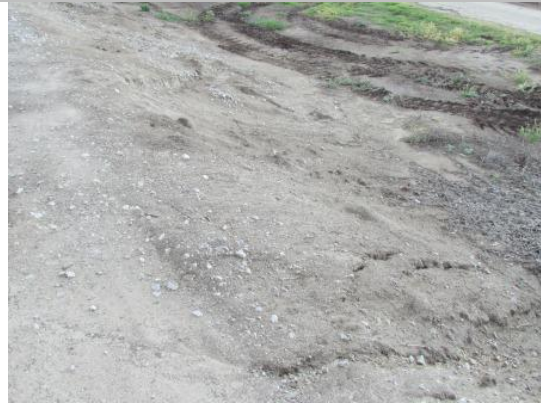
Photo 1 of 2 : FA\_2015\_NA0011\_145\_9\_20150915\_00005.jpg

LM Start	1.51	Rating **	U	Issue No.	9
LM End	1.51	Issue Type +	Ma	Location *	LS
Category	Earthen Levee			GPS Latitude/Longitude	
				Start	End
Item	Slope Stability			36.995611 °	36.995611 °
				-120.346236 °	-120.346236 °
DWR ID	DWR_NA0011_04_s _ 2012_9				
Action/Comments					
Repair slope instability. Inspector Comments: The Madera County Resource Management Agency will be sending the landowner a letter addressing this damage. The damage here was caused by a Contractor. 11-01-2012 no repairs have been done to this site. 4-16-2013 this site was inspected and no repairs have been made by landowner. Fall 2014 no change.

Levee mile 1.51 levee damaged by the landowner. Photo taken 4-24-2014.

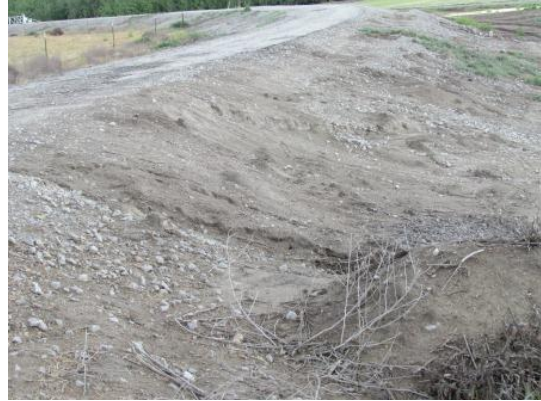
Photo 2 of 2 : FA\_2015\_NA0011\_145\_9\_20150915\_00006.jpg

LM Start	1.51	Rating **	U	Issue No.	9 (cont)	
LM End	1.51	Issue Type +	Ma	Location *	LS	
Category	Earthen Levee			GPS Latitude/Longitude		
				Start	End	
Item	Slope Stability			36.995611 °	36.995611 °	
				-120.346236 °	-120.346236 °	
DWR ID	DWR_NA0011_04_s _ 2012_9					
Action/Comments						
Repair slope instability. Inspector Comments: The Madera County Resource Management Agency will be sending the landowner a letter addressing this damage. The damage here was caused by a Contractor. 11-01-2012 no repairs have been done to this site. 4-16-2013 this site was inspected and no repairs have been made by landowner. Fall 2014 no change.

Levee mile 1.51 landward slope remains unrepaired by the landowner. Photo taken 4-24-2014. No new photo taken Fall 2014. no change.

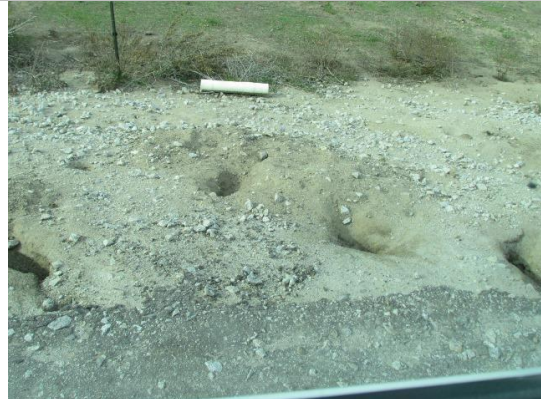
Photo 1 of 2 : FA\_2015\_NA0011\_145\_30\_20150915\_00011.jpg

Berenda Slough looking downstream from levee mile 1.65 waterside large rodent holes on slope.

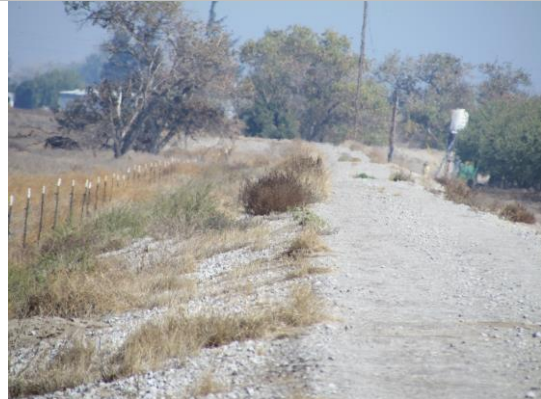
Photo 2 of 2 : FA\_2015\_NA0011\_145\_30\_20151026\_00019.jpg

Berenda Slough looking upstream water side levee slope covered with rodent holes.

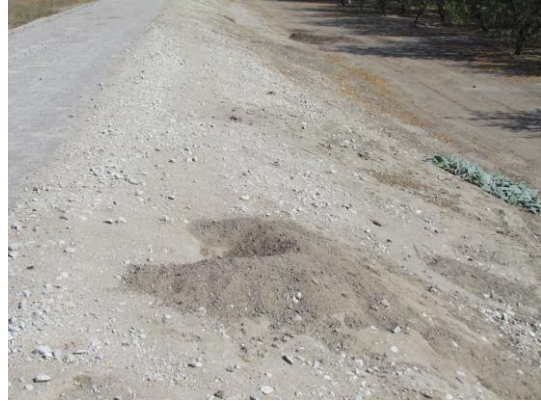
Photo 1 of 1 : FA\_2015\_NA0011\_145\_57\_20151026\_00018.jpg

Berenda Slough looking downstream from the landside slope at large rodent holes on the slope shoulder and crown roadway.

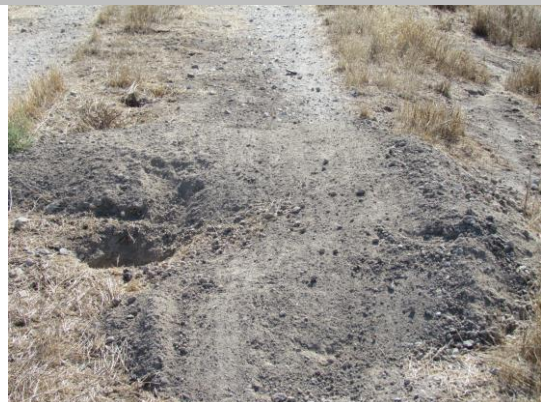
Photo 1 of 1 : FA\_2015\_NA0011\_146\_10\_20151022\_00012.jpg

Huge rodent holes in the crown road way levee mile 0.39 to 0.43.

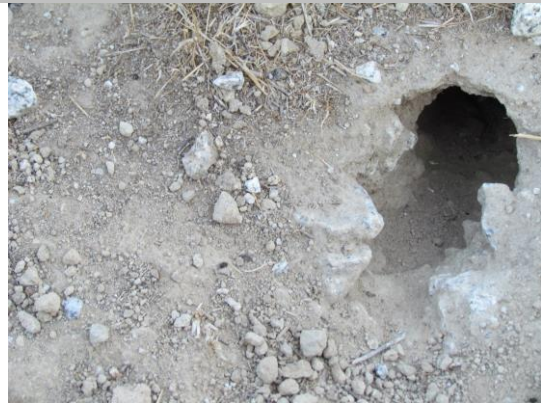
Photo 1 of 2 : FA\_2015\_NA0011\_146\_24\_20151022\_00013.jpg

Crown road way levee mile 2.80 to 3.23 covered with active rodent holes.

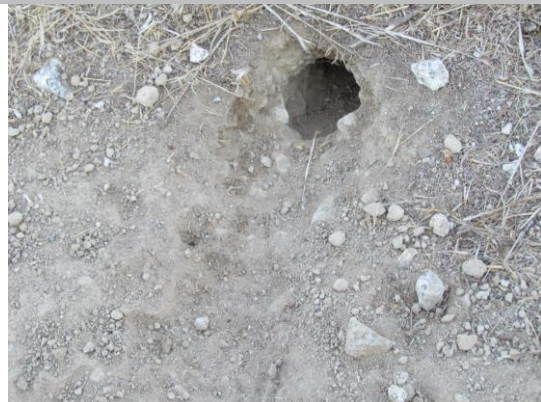
Photo 2 of 2 : FA\_2015\_NA0011\_146\_24\_20151022\_00014.jpg

More holes that shows activity.

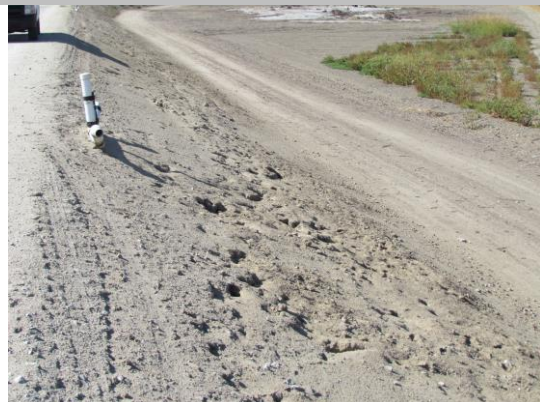
Photo 1 of 1 : FA\_2015\_NA0011\_146\_44\_20151022\_00015.jpg

This area was inundated with rodents from 6.63 to 6.82.

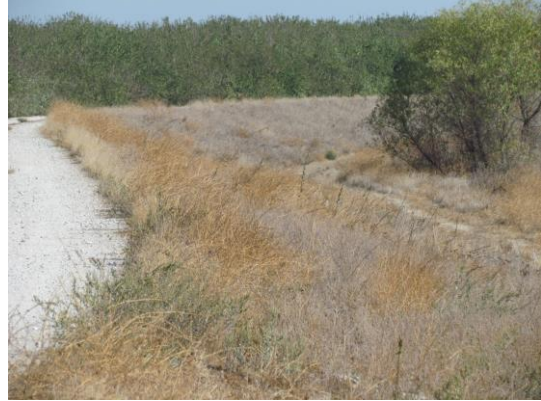
Photo 1 of 1 : FA\_2015\_NA0011\_146\_32\_20151022\_00016.jpg

Fresno River waterside levee slope unsatisfactory tall weeds present on shoulder and slope.

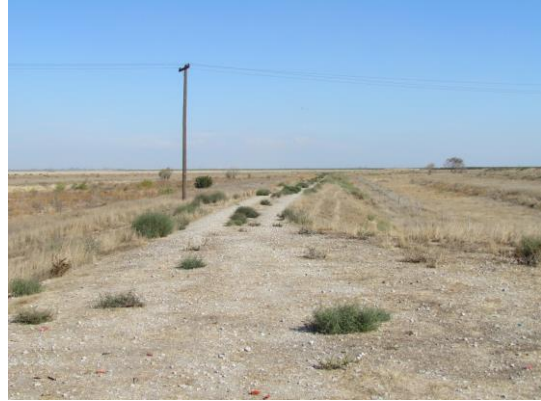
Photo 1 of 1 : FA\_2015\_NA0011\_147\_44\_20151027\_00017.jpg

Fresno River looking upstream from 0.00- 3.47 tall weeds taking over the waterside slope.

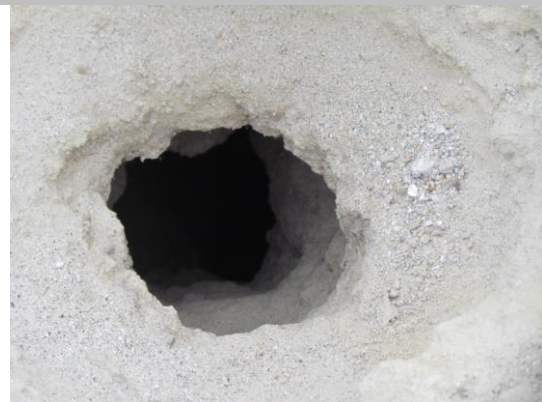
Photo 1 of 1 : FA\_2015\_NA0011\_147\_48\_20150915\_00012.jpg

Huge Rodent hole in crown roadway and many other holes at this location on the slope and toe.

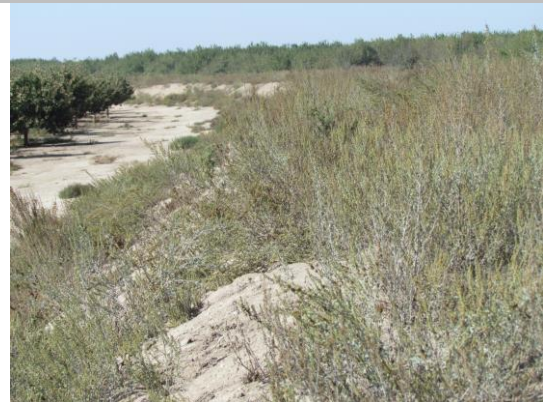
Photo 1 of 1 : FA\_2015\_NA0011\_147\_27\_20151027\_00020.jpg

Fresno River Looking at the landside levee slope unsatisfactory tall weeds has covered the slope, shoulder and crown.

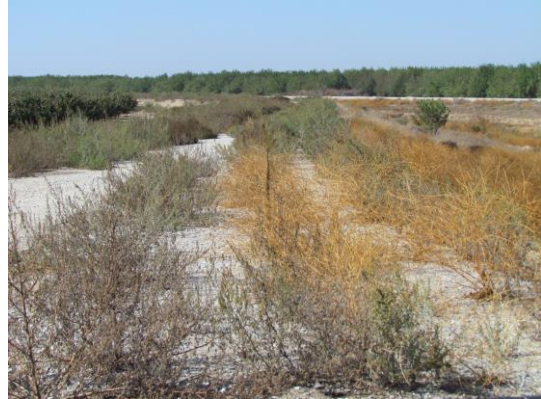
Photo 1 of 1 : FA\_2015\_NA0011\_147\_26\_20151027\_00014.jpg

Looking downstream from levee mile 7.68 to 8.52 tumble weed and other vegetation has covered the crown roadway.
