**Flood Control Project Maintenance
Levee Inspections**

Maintenance Issue Types Only, Levee Inspection Report By Mile - Fall 2016

Madera County FCWCA

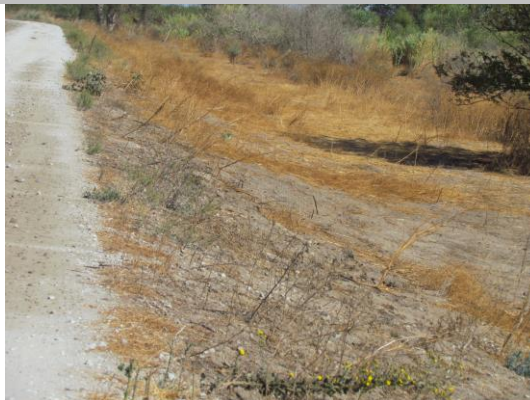
Photo 1 of 1 : FA_2016_NA0011_142_13_20161011_00027.jpg

Unit 1 looking upstream from levee miles 0.03-0.28.wateside slope.

| Control the wild annual grasses and weeds on the waterside slope, looking upstream from levee miles 0.03- 0.28. | | | | | |

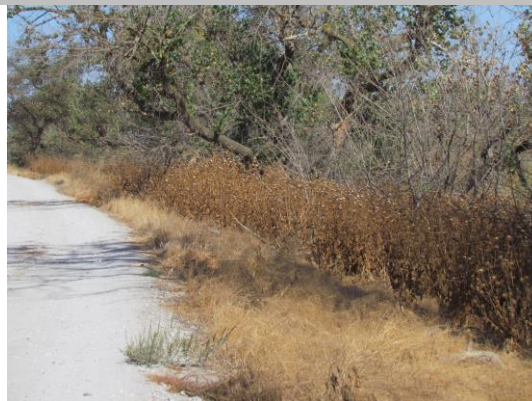
Photo 1 of 1 : FA_2016_NA0011_142_23_20161010_00024.jpg

Unit 1 Waterside looking upstream from levee mile 0.28 to levee mile 1.35.

| Remove the dead tall weeds from the water side slope working upstream. | | | | | |

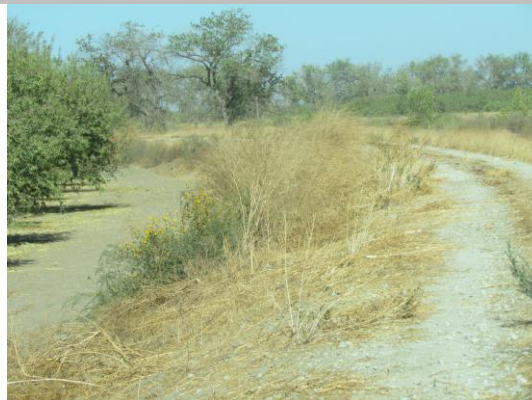
Photo 1 of 1 : FA_2016_NA0011_142_24_20161010_00025.jpg

Unit 1 landside levee mile 0.61-0.77 looking upstream of slope.

| Remove the tall weeds from the landside slope | | | | | |

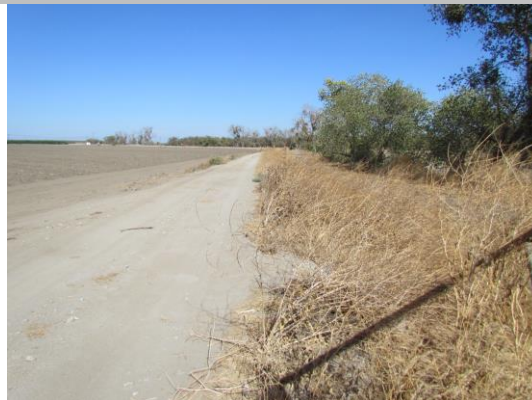
Photo 1 of 1 : FA_2016_NA0011_142_29_20161010_00026.jpg

Unit 1 Ash Slough looking upstream levee mile 2.09-2.22.

| Remove the tall dead weeds from the levee slope waterside. | | | | | |

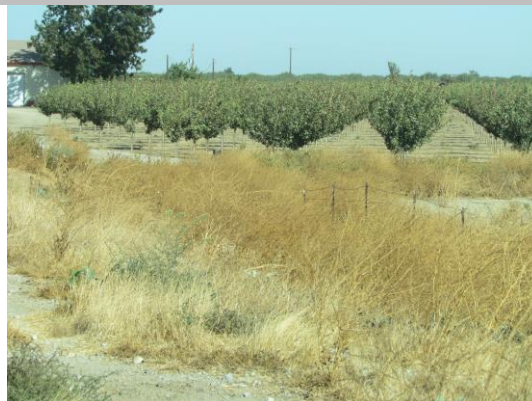
Photo 1 of 1 : FA_2016_NA0011_143_17_20161005_00029.jpg

Looking upstream from levee mile 0.00-0.05.

| Remove the tall weeds from the landside slope and toe. | | | | | |

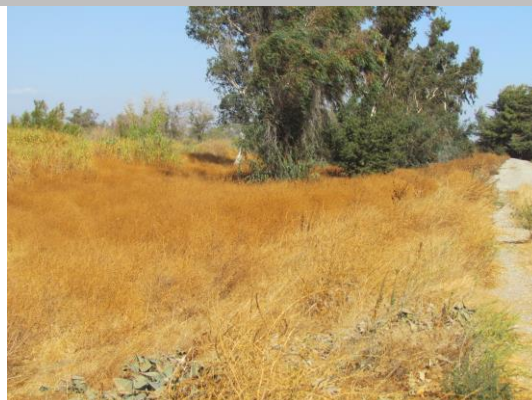
Photo 1 of 1 : FA_2016_NA0011_143_15_20161011_00032.jpg

Unit 2 waterside levee slope looking upstream from levee mile 0.00-0.15.

| Remove the tall dead weeds present on the waterside levee slope. | | | | | |

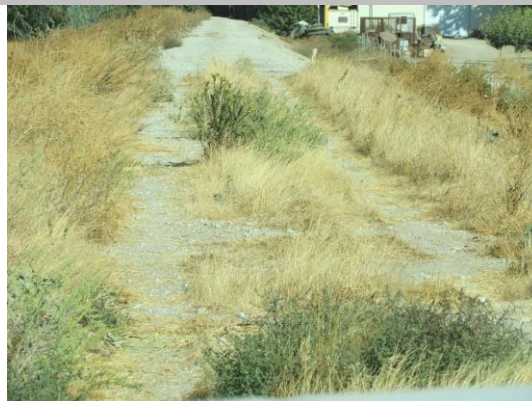
Photo 1 of 1 : FA_2016_NA0011_143_14_20161011_00031.jpg

Unit 2 looking upstream at crown roadway.

| The crown roadway is to be clear of all vegetation. | | | | | |

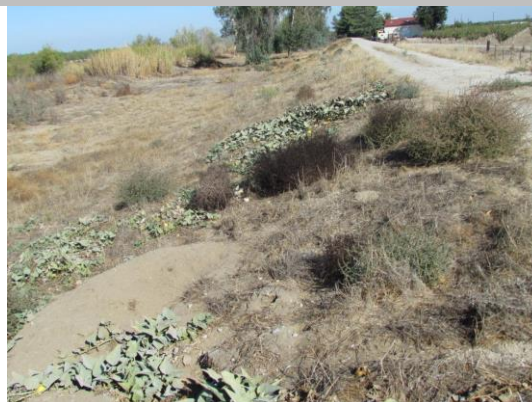
Photo 1 of 1 : FA_2016_NA0011_143_39_20161004_00007.jpg

| The levee section waterside is covered with rodents and rodent holes. There is no bait stations on this levee section and the weeds here are too tall to see the active rodents. No new photo was taken. | | | | | |

Ash Slough looking upstream from levee mile 0.00-1.67 waterside slope.

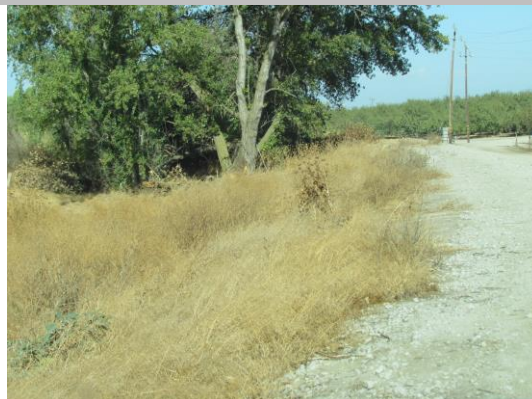
Photo 1 of 1 : FA_2016_NA0011_143_18_20161011_00033.jpg

Unit 2 Ash Slough looking upstream waterside slope and shoulder levee miles 0.22-1.38.

| Remove the unwanted wild dead weed growth from the waterside levee slope. | | | | | |

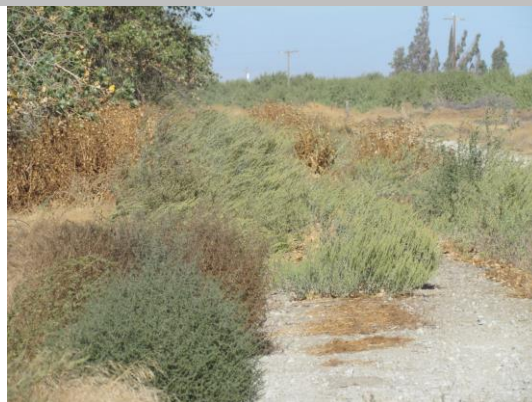
Photo 1 of 1 : FA_2016_NA0011_143_26_20161005_00028.jpg

Looking upstream Crown roadway levee mile 0.2-0.49.

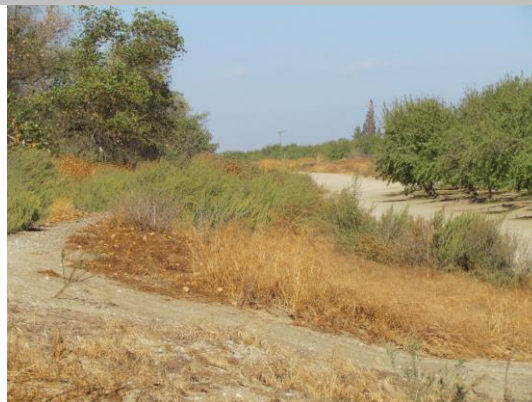
Photo 1 of 1 : FA_2016_NA0011_143_24_20161011_00036.jpg

Unit 2 looking upstream from levee mile 0.32 to levee mile 0.96 landside.

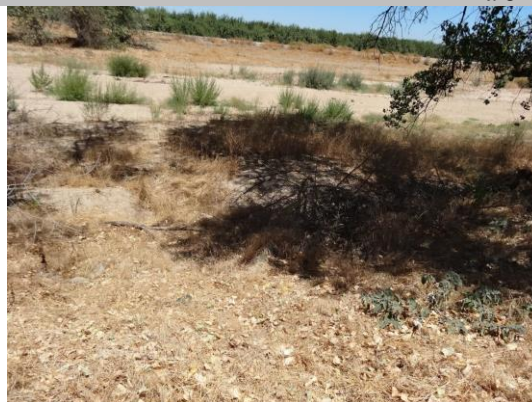
Photo 1 of 3 : SJR2016_NA0011U02RM2.57_1.jpg

| 07/22/2016: No significant change observed. 09/08/2015: No significant change observed. 07/22/2014: No significant change observed. 08/30/2013: No significant change observed. 07/31/2012: Site was visited on 07/24/2012. No significant change observed. Dense vegetation around the site 08/09/2011: Site was inspected. No visible change was observed from the previous condition. A fallen tree was seen at the levee toe about 20 feet upstream, and tree root exposed. There has been no report from the district that this site was corrected. 11/30/2010: Site was not inspected due to time constraints. There have been no reports from the district that the site was corrected. Continue to monitor site during flood events. 08/05/2010: Recommended for annual assessment and monitoring during flood events, per CLRO. 2009: Site is recommended as a local maintenance issue, per Critical Levee Repair Office, Critical Erosion Sites Evaluation 2008 Report; site was previously rated "M" 9/6/2007: Undercutting of the toe; several trees along the WS slope with roots exposed. [2016 Site ID:NA0011U02RM2.57] | | | | | |

View of the erosion site from the levee crest.

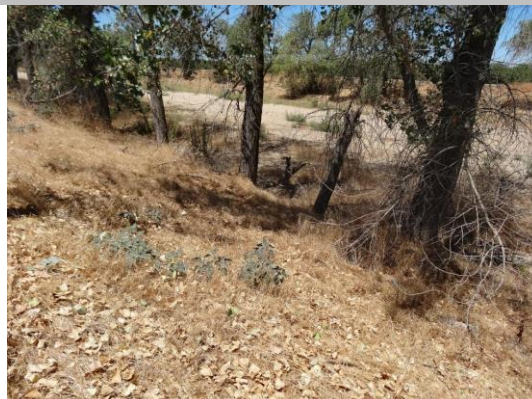
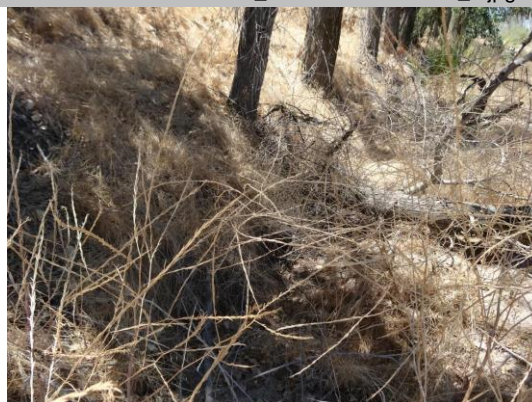
Close view of the site.

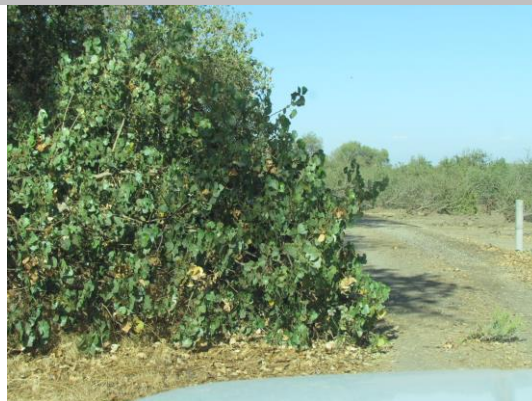
Photo 1 of 1 : FA_2016_NA0011_143_29_20161011_00035.jpg

Unit 2 Ash Slough waterside levee mile 1.23.

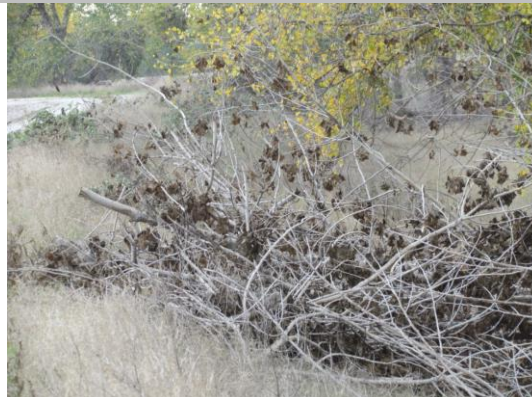
Photo 1 of 1 : FA_2016_NA0011_143_43_20161004_00008.jpg

Unit 2 levee mile 1.46-1.49 looking upstream from the levee slope waterside fallen dead tree on the levee section.

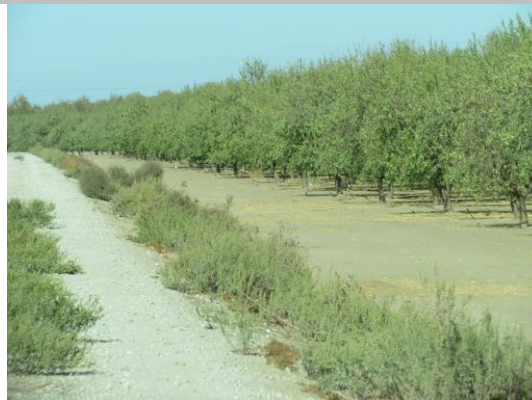
Photo 1 of 1 : FA_2016_NA0011_143_6_20161011_00034.jpg

Unit 2 looking upstream from levee mile 1.64 Crown roadway.

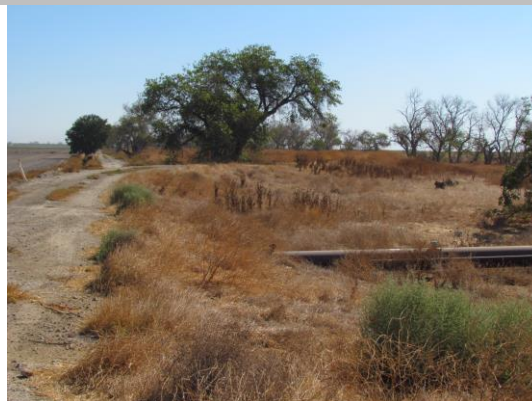
Photo 1 of 1 : FA_2016_NA0011_144_1_20161011_00015.jpg

Berenda Slough Unit 3 levee mile 0.00 looking upstream from the wateside slope.

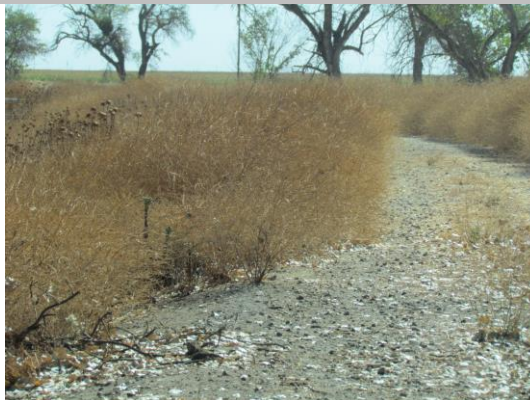
Photo 1 of 1 : FA_2016_NA0011_144_5_20161011_00021.jpg

Berenda Slough Unit 3 looking upstream from landside levee miles 0.05-1.51.

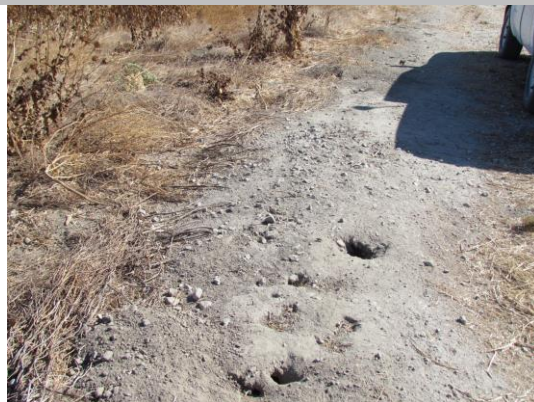
Photo 1 of 2 : FA_2016_NA0011_144_6_20161011_00016.jpg

Berenda Slough Unit 3 levee miles 0.40-1.51 landside shoulder and slope.

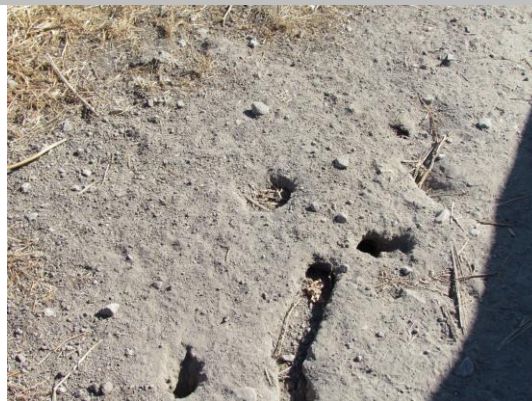
Photo 2 of 2 : FA_2016_NA0011_144_6_20161011_00018.jpg

More active rodents holes and foot traffic seen around holes though no rodents observed.

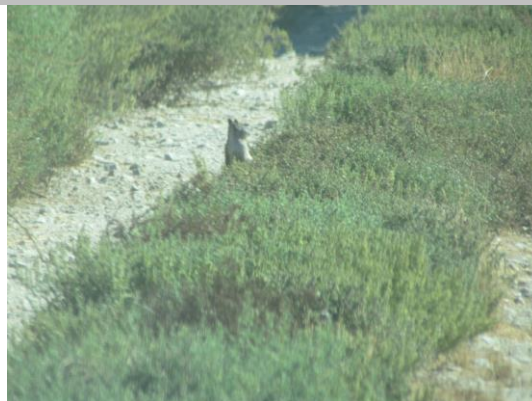
Photo 1 of 1 : FA_2016_NA0011_144_8_20161011_00022.jpg

Berenda Slough Unit 3 looking upstream from levee miles 0.71 - to 1.51.

| Exterminate rodents from the crown roadway in the area listed. Active rodents observed during inspection at this site. | | | | | |

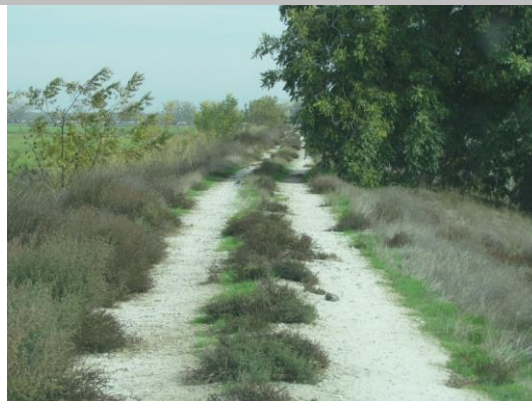
Photo 1 of 1 : FA_2016_NA0011_144_44_20161004_00008.jpg

Looking upstream from levee mile 1.04 to levee mile 1.52 crown roadway overgrown with tall weeds.

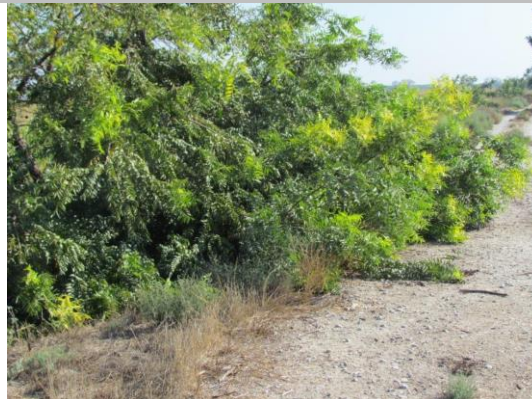
Photo 1 of 1 : FA_2016_NA0011_144_11_20161004_00003.jpg

Berenda Slough Unit 3 looking upstream from levee mile 1.04-1.05 walnut trees blocking the view of the landside levee section.

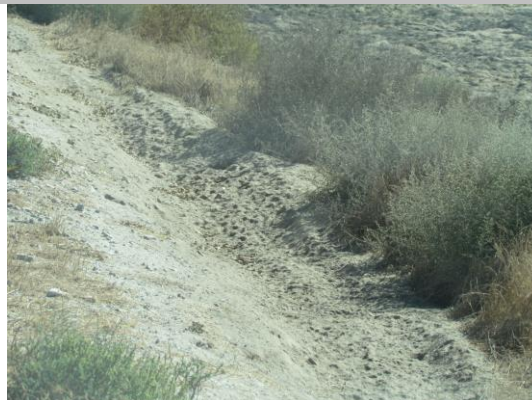
Photo 1 of 1 : FA_2016_NA0011_144_4_20161011_00020.jpg

Berenda Slough looking back upstream waterside at the shoulder and slope levee miles 1.24-1.25.

| Repair the slope instability and damaged shoulder at this location. The cause for this damage is the walnut trees landside encroaching onto the levee crown forcing the traffic to vere around. | | | | | |

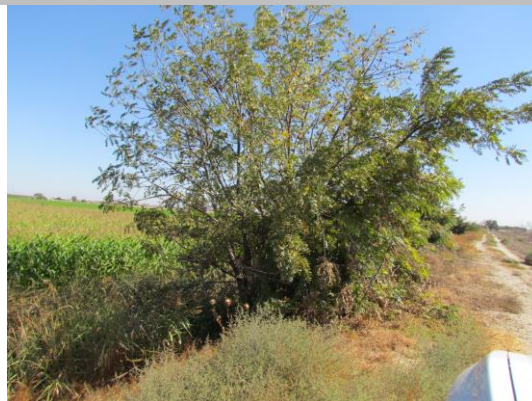
Photo 1 of 1 : FA_2016_NA0011_144_17_20161011_00019.jpg

Berenda Slough Unit 3 looking upstream from levee mile 1.26 Walnut trees on landside slope.

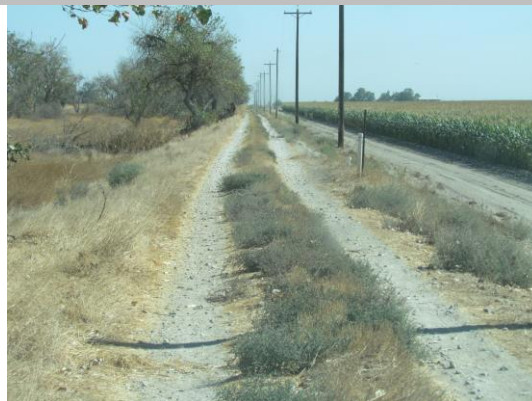
Photo 1 of 1 : FA_2016_NA0011_145_5_20161011_00016.jpg

Berenda Slough Unit 4 looking upstream from levee miles 0.01-1.49.

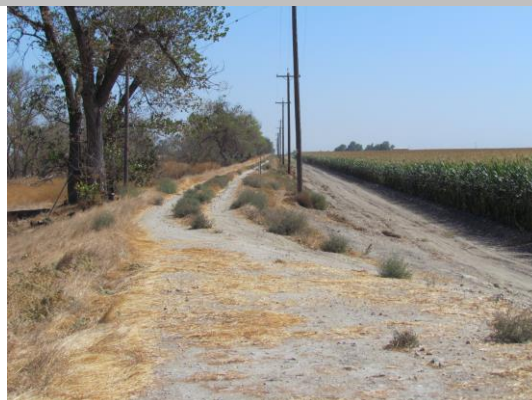
Photo 1 of 1 : FA_2016_NA0011_145_1_20161011_00017.jpg

Berenda Slough Unit 4 looking upstream from levee miles 0.01-1.50.

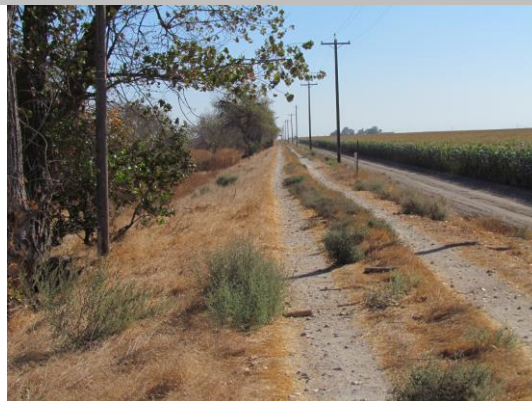
Photo 1 of 1 : FA_2016_NA0011_145_4_20161011_00018.jpg

Berenda Slough Unit 4 looking downstream from the waterside levee slope from levee mile 1.60 towards levee mile 0.01.

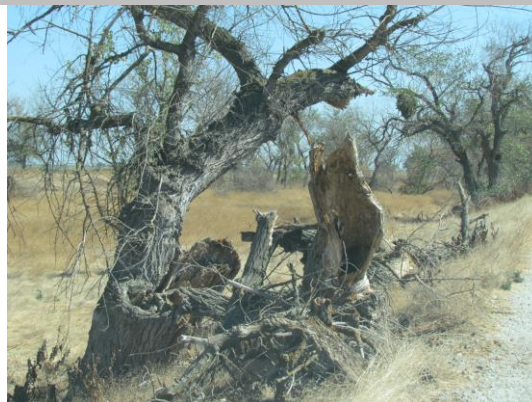
Photo 1 of 1 : FA_2016_NA0011_145_15_20161011_00019.jpg

Berenda Slough looking upstream from the levee mile 0.14.

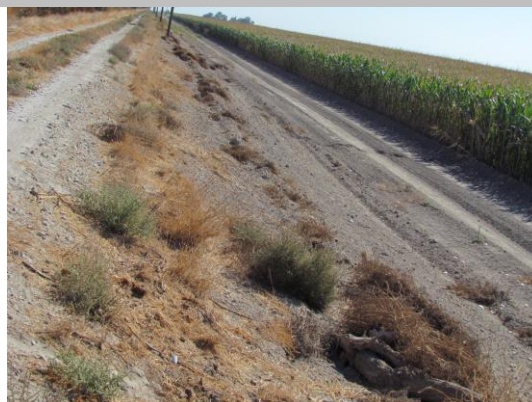
Photo 1 of 1 : FA_2016_NA0011_145_3_20161011_00020.jpg

| The slope in this area has been damaged by farm equipment on the slope. | | | | | |

Berenda Slough Unit 4 Looking upstream from levee mile 0.14-0.97.

| S1 : Repair slope instability. | | | | | |

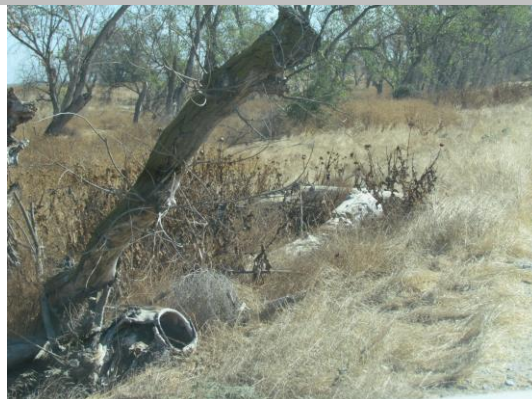
Photo 1 of 1 : FA_2016_NA0011_145_16_20161011_00021.jpg

Berenda Slough Unit 4 levee mile 0.47 looking back upstream.

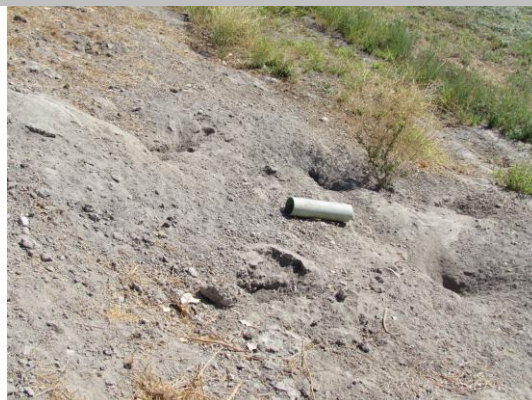
Photo 1 of 3 : FA_2016_NA0011_145_11_20161011_00022.jpg

Berenda Slough landside slope levee miles 0.62-1.25 looking upstream.

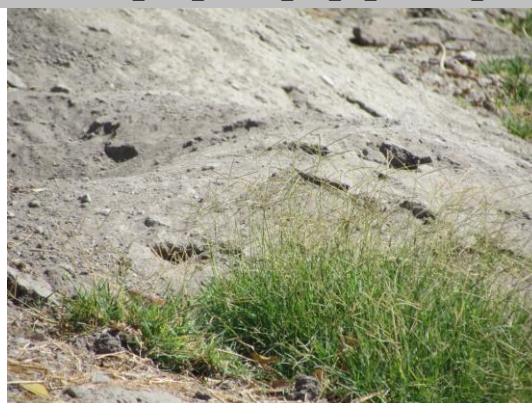
Photo 2 of 3 : FA_2016_NA0011_145_11_20161012_00027.jpg

Berenda Slough landside slope levee miles 0.62-1.25. looking upstream.

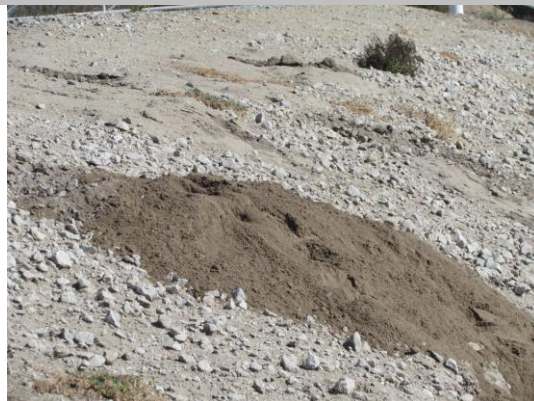
Photo 1 of 3 : FA_2016_NA0011_145_57_20161011_00023.jpg

Berenda Slough looking upstream landside slope.

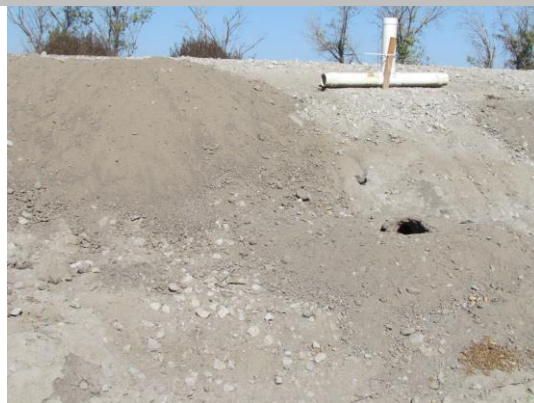
Photo 2 of 3 : FA_2016_NA0011_145_57_20161011_00026.jpg

More activity

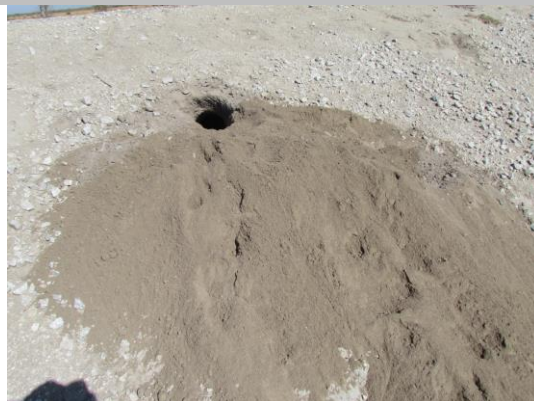
Photo 3 of 3 : FA_2016_NA0011_145_57_20161011_00025.jpg

Activity on the landside slope between the levee mile 1.63 and 2.23.

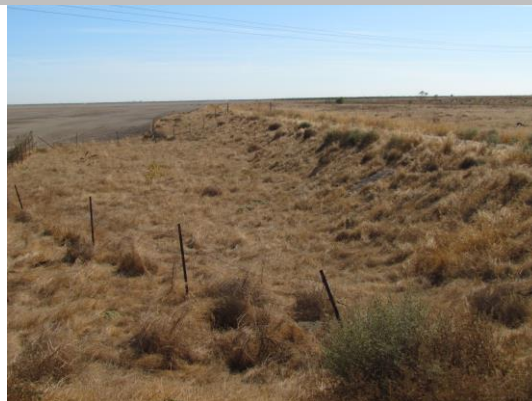
Photo 1 of 1 : FA_2016_NA0011_146_7_20161012_00017.jpg

Fresno River landside slope levee mile 0.00.

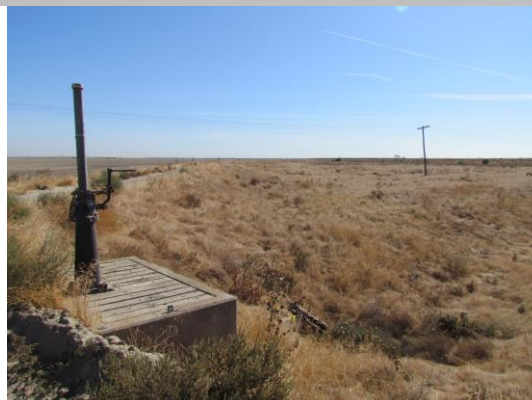
Photo 1 of 1 : FA_2016_NA0011_146_9_20161012_00019.jpg

Fresno River looking upstream levee mile 0.00 waterside slope.

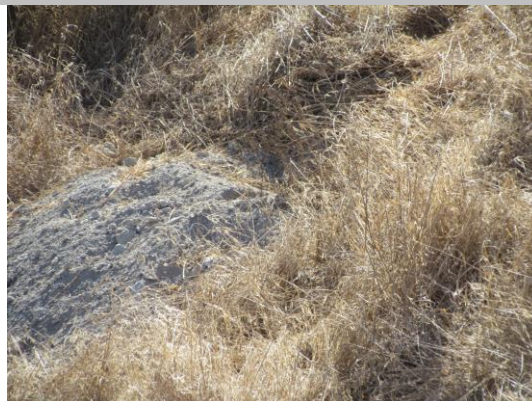
Photo 1 of 1 : FA_2016_NA0011_146_14_20161012_00018.jpg

Fresno River levee mile 0.00 looking upstream.

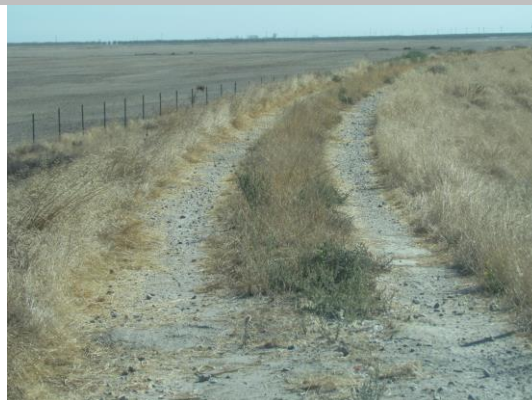
Photo 1 of 1 : FA_2016_NA0011_146_8_20161012_00020.jpg

Fresno River looking upstream levee mile 0.00.

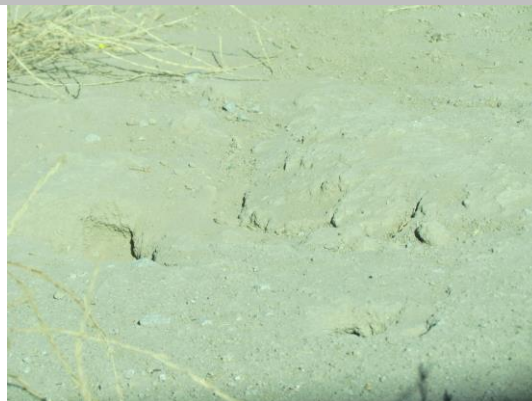
Photo 1 of 2 : FA_2016_NA0011_146_28_20161012_00021.jpg

Fresno River landside slope looking upstream of levee mile 6.75 -6.95.

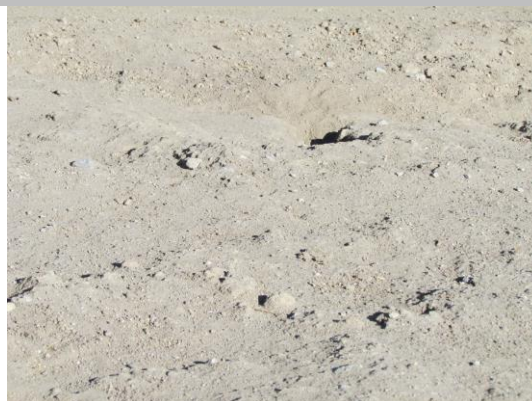
Photo 2 of 2 : FA_2016_NA0011_146_28_20161012_00023.jpg

Fresno River looking upstream of the landside slope levee miles 6.76-6.95.

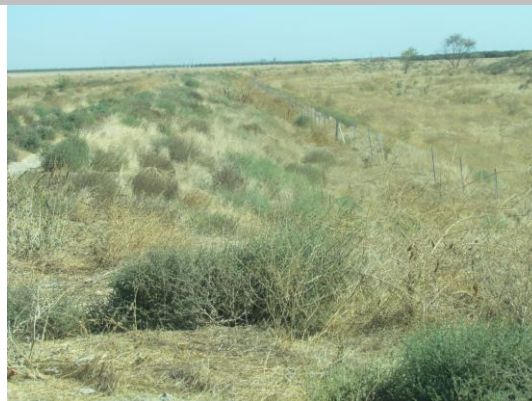
Photo 1 of 1 : FA_2016_NA0011_147_23_20161012_00028.jpg

Fresno River looking upstream from the landside slope levee mile 0.00-2.48.

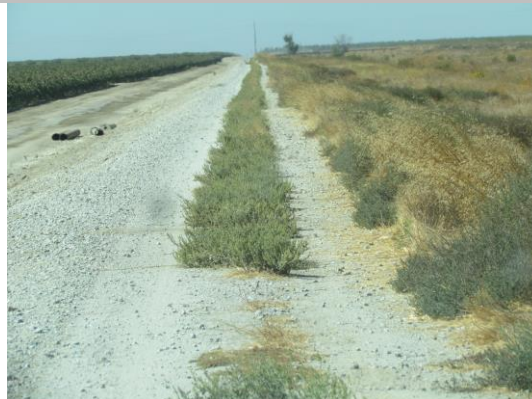
Photo 1 of 1 : FA_2016_NA0011_147_22_20161012_00029.jpg

Fresno River looking downstream crown roadway levee mile 3.47.

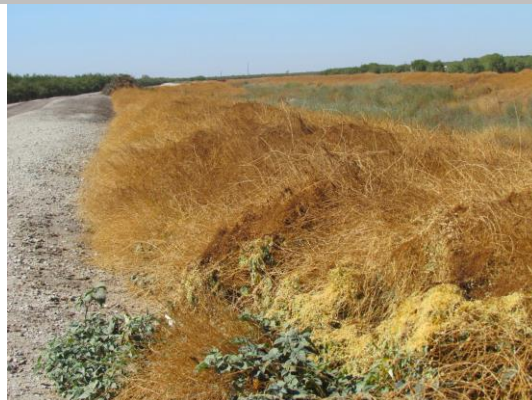
Photo 1 of 1 : FA_2016_NA0011_147_11_20161012_00030.jpg

Fresno River looking downstream from 9.02 waterside slope.

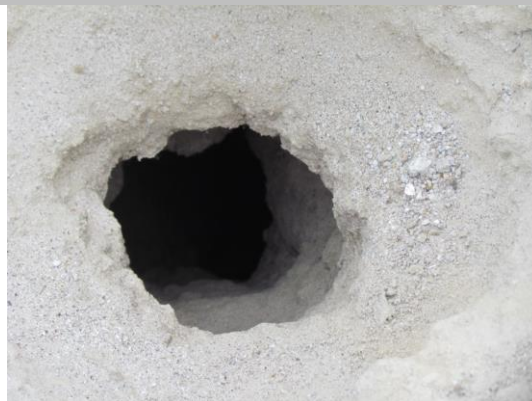
Photo 1 of 1 : FA_2016_NA0011_147_48_20161004_00009.jpg

Huge Rodent hole in crown roadway and many other holes at this location on the slope and toe.

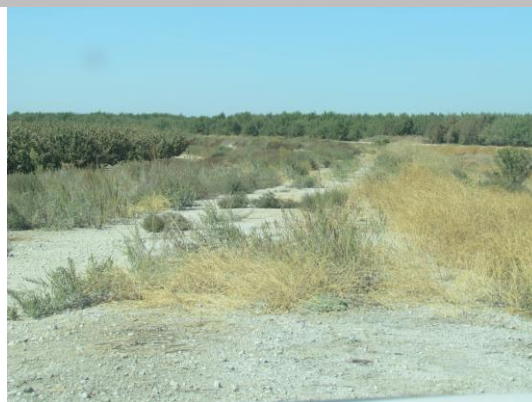
Photo 1 of 1 : FA_2016_NA0011_147_15_20161012_00035.jpg

Fresno River levee crown roadway from levee mile 8.52 looking downstream.

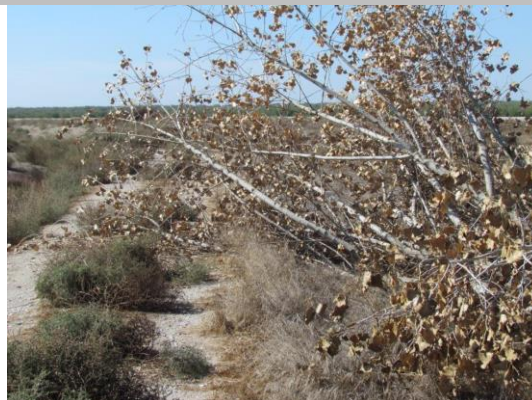
Photo 1 of 2 : FA_2016_NA0011_147_36_20161004_00005.jpg

Dead tree pushed upon the waterside slope and blocking the crown.

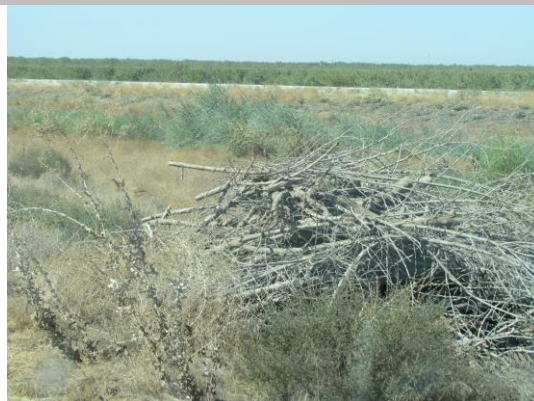
Photo 2 of 2 : FA_2016_NA0011_147_36_20161012_00034.jpg

Fresno River levee mile 8.03 waterside slope and shoulder.

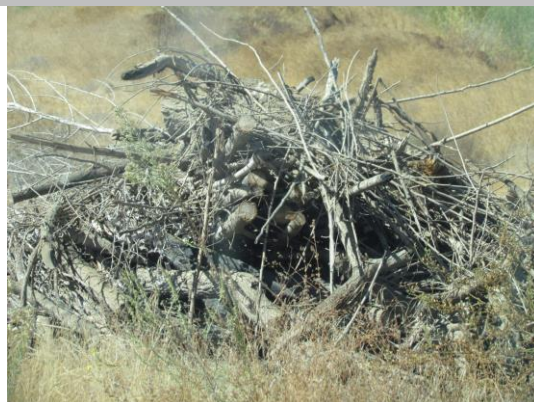
Photo 1 of 1 : FA_2016_NA0011_147_31_20161012_00033.jpg

Fresno River levee mile 8.09.
