**Flood Control Project Maintenance
Levee Inspections**

Maintenance Issue Types Only, Levee Inspection Report By Mile - Fall 2017

Madera County FCWCA

Waterway	Bank	Unit Miles	Inspection Start/End	Inspector
Unit No. 01 Ash Slough	Right	2.37	10/04/2017 10/04/2017	Keith Millard

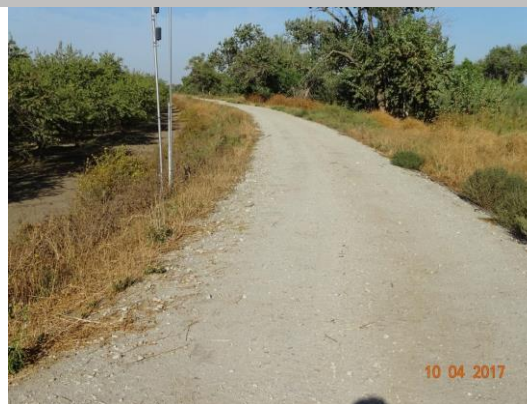
Photo 1 of 1 : FA_2017_NA0011_142_16_20171009_00024.jpg

LM Start	0.03	Rating **	A/W	Issue No.	16
LM End	0.38	Issue Type +	Ma	Location *	CR
Category	Earthen Levee			GPS Latitude/Longitude	
				Start	End
Item	Vegetation			37.046608 °	37.048818 °
				-120.427455 °	-120.421875 °
DWR ID	DWR_NA0011_01_s _ 2017_16				
Comment Code					
V9 : Keep the crown roadway free of vegetation.					
Inspector Comment

Crown is clear of vegetation.

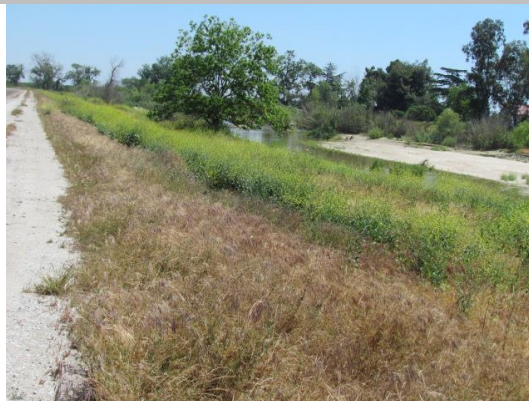
Photo 1 of 2 : FA_2017_NA0011_142_15_20171002_00002.jpg

Looking upstream from the levee mile 0.03-2.31 tall unwanted weeds present on the waterside slope.

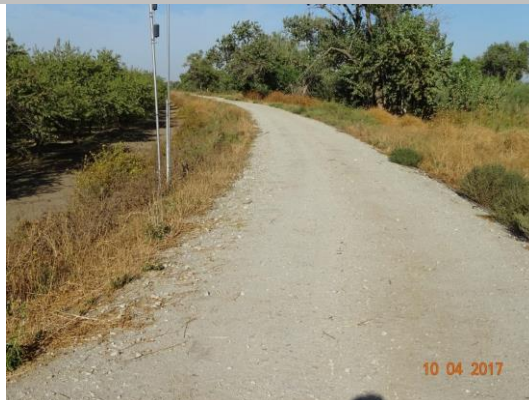
Photo 2 of 2 : FA_2017_NA0011_142_15_20171009_00025.jpg

LM Start	0.03	Rating **	U	Issue No.	15 (cont)
LM End	2.31	Issue Type +	Ma	Location *	WS

Tall weeds and grasses should be removed from waterside slope.

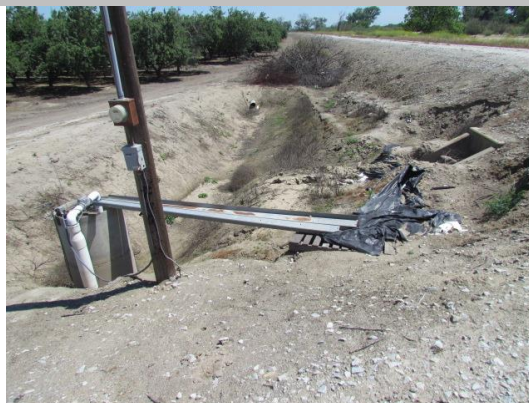
Photo 1 of 1 : FA_2017_NA0011_142_20_20171002_00004.jpg

LM Start	0.04	Rating **	U	Issue No.	20
LM End	0.05	Issue Type +	Ma	Location *	LS
Category	Earthen Levee			GPS Latitude/Longitude	
				Start	End
Item	Slope Stability			37.046624 °	37.046682 °
				-120.427317 °	-120.427108 °
DWR ID	DWR_NA0011_01_s _ 2014_20				
Comment Code					
S1 : Repair slope instability.					
Inspector Comment					
This is not a new erosion site, it should be repaired before the condition get any worse.

There is damage to the landside levee slope next to the concrete inlet structure.

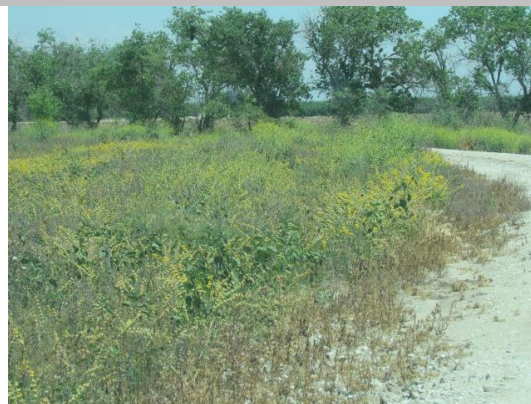
Photo 1 of 1 : FA_2017_NA0011_142_31_20171002_00009.jpg

Unwanted tall weed growth on the landside shoulder and slope.

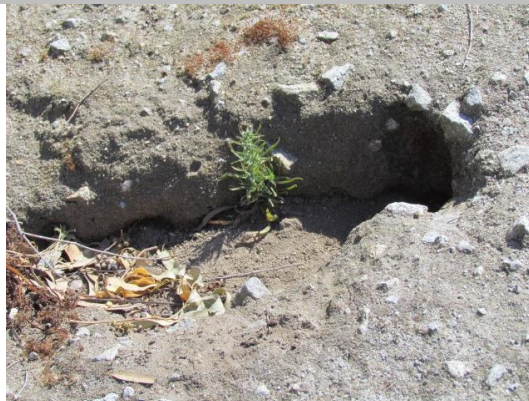
Photo 1 of 2 : FA_2017_NA0011_143_39_20171002_00014.jpg

Other rodent holes noted in the slope waterside levee section.

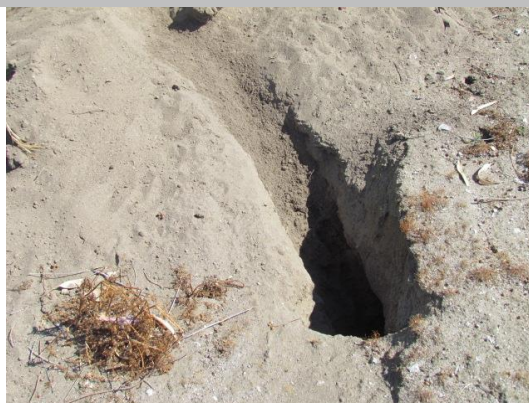
Photo 2 of 2 : FA_2017_NA0011_143_39_20171002_00015.jpg

LM Start	0.00	Rating **	U	Issue No.	39 (cont)
LM End	1.67	Issue Type +	Ma	Location *	WS

Active rodents spotted in the area waterside slope levee mile 0.00- 1.67.

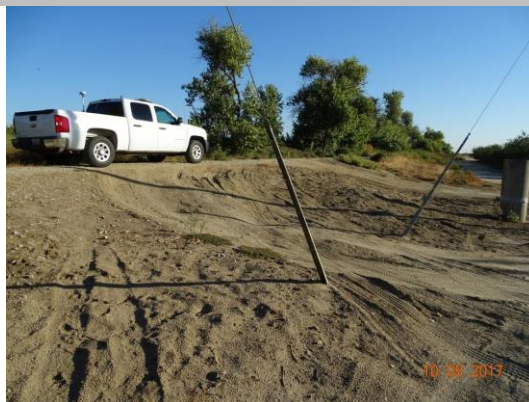
Photo 1 of 1 : FA_2017_NA0011_143_13_20171009_00034.jpg

LM Start	0.31	Rating **	M	Issue No.	13
LM End	0.31	Issue Type +	Ma	Location *	LS
Category	Earthen Levee			GPS Latitude/Longitude	
				Start	End
Item	Slope Stability			37.047266 °	37.047266 °
				-120.422393 °	-120.422393 °
DWR ID	DWR_NA0011_02_f_2017_13				
Comment Code					
S3 : Repair the levee slope damaged by vehicle traffic and prevent access where possible.					
Inspector Comment

Vehicle access to levee slope should be prevented and erosion repaired.

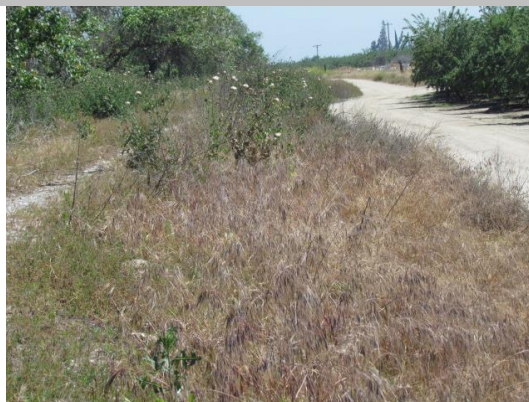
Photo 1 of 1 : FA_2017_NA0011_143_30_20171002_00009.jpg

LM Start	0.32	Rating **	U	Issue No.	30
LM End	0.97	Issue Type +	Ma	Location *	LS
Category	Earthen Levee			GPS Latitude/Longitude	
				Start	End
Item	Vegetation			37.047387 °	37.054878 °
				-120.422183 °	-120.415525 °
DWR ID	DWR_NA0011_02_s_2017_30				
Comment Code					
V2 : Remove the wild growth other than native grasses from the levee slopes.					
Inspector Comment					
Spray or mow the wild weeds on the landside levee slope.

Unwanted vegetation on the waterside levee slope.

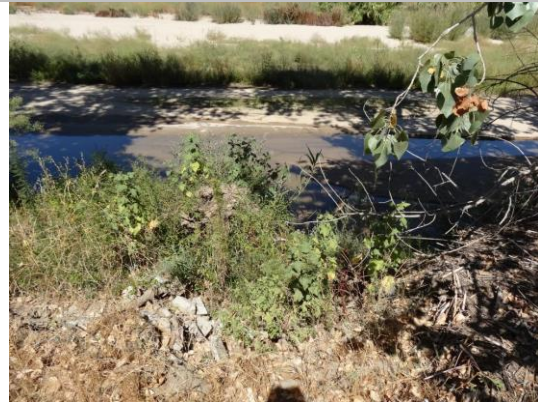
Photo 1 of 4 : SJR2017_NA0011U02RM2.57_1.jpg

Comment Code					
Inspector Comment					
09/20/2017: No significant change observed.					
07/22/2016: No significant change observed.					
09/08/2015: No significant change observed.					
07/22/2014: No significant change observed.					
08/30/2013: No significant change observed.					
07/31/2012: Site was visited on 07/24/2012. No significant change observed. Dense vegetation around the site					
08/09/2011: Site was inspected. No visible change was observed from the previous condition. A fallen tree was seen at the levee toe about 20 feet upstream, and tree root exposed. There has been no report from the district that this site was corrected.					
11/30/2010: Site was not inspected due to time constraints. There have been no reports from the district that the site was corrected. Continue to monitor site during flood events.					
08/05/2010: Recommended for annual assessment and monitoring during flood events, per CLRO.

2009: Site is recommended as a local maintenance issue, per Critical Levee Repair Office, Critical Erosion Sites Evaluation 2008 Report; site was previously rated "M"					
9/6/2007: Undercutting of the toe; several trees along the WS slope with roots exposed. [2017 Site ID:NA0011U02RM2.57]

View of the erosion site from the levee crest.

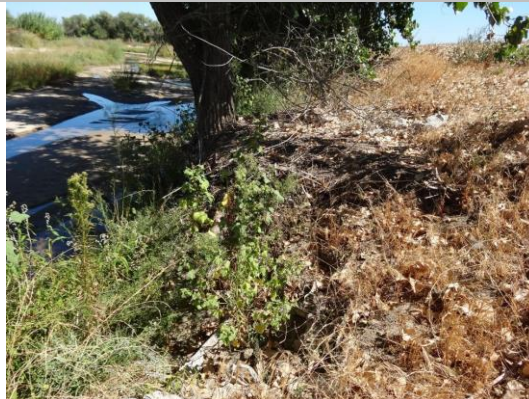
Photo 2 of 4 : SJR2017_NA0011U02RM2.57_2.jpg

2009: Site is recommended as a local maintenance issue, per Critical Levee Repair Office, Critical Erosion Sites Evaluation 2008 Report; site was previously rated "M"						
9/6/2007: Undercutting of the toe; several trees along the WS slope with roots exposed. [2017 Site ID:NA0011U02RM2.57]

Close view of the site.

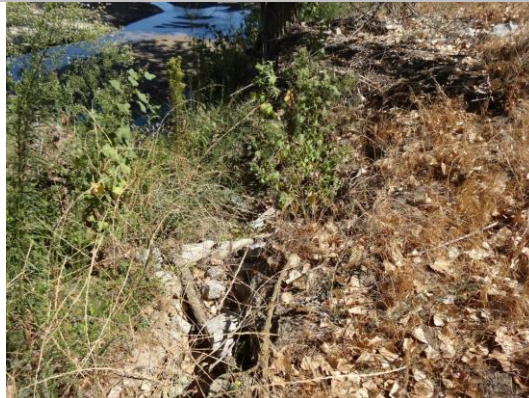
Photo 3 of 4 : SJR2017_NA0011U02RM2.57_3.jpg

Vegetation debris at the site.

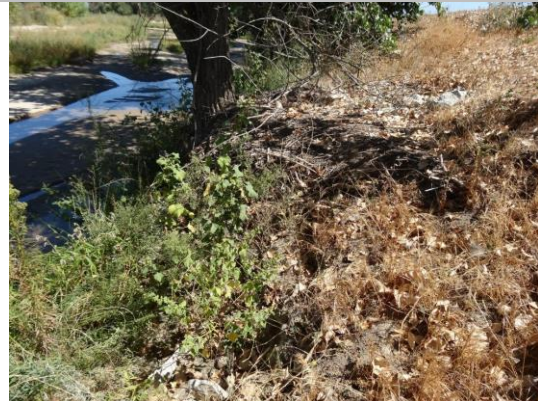
Photo 4 of 4 : SJR2017_NA0011U02RM2.57_4.jpg

2009: Site is recommended as a local maintenance issue, per Critical Levee Repair Office, Critical Erosion Sites Evaluation 2008 Report; site was previously rated "M"						
9/6/2007: Undercutting of the toe; several trees along the WS slope with roots exposed. [2017 Site ID:NA0011U02RM2.57]

Close view of the site.

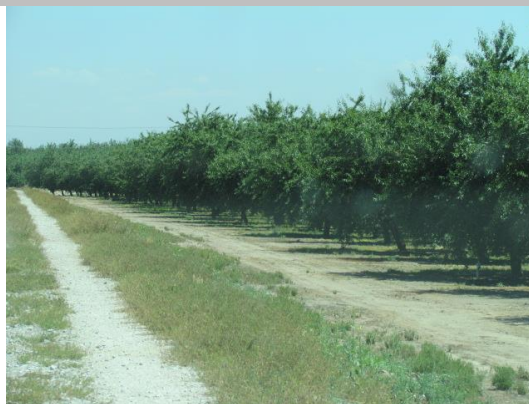
Photo 1 of 1 : FA_2017_NA0011_143_38_20171002_00013.jpg

Looking upstream from levee mile 1.66-2.00 tall weeds present on the landside slope.

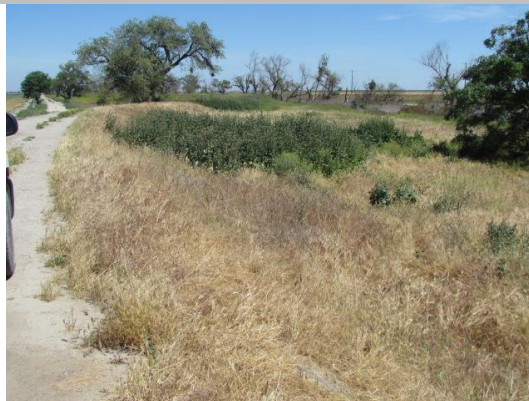
Photo 1 of 1 : FA_2017_NA0011_144_9_20171002_00005.jpg

Looking upstream from the waterside shoulder wild growth covering slope and toe.

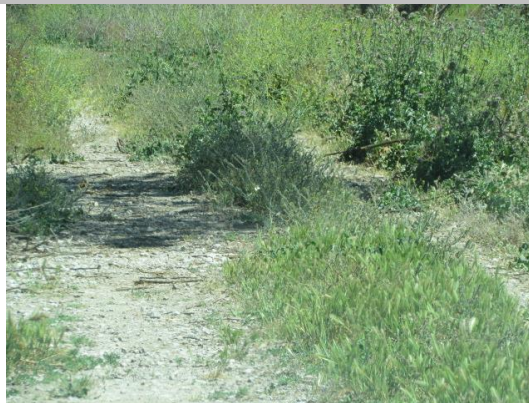
Photo 1 of 1 : FA_2017_NA0011_144_12_20171002_00008.jpg

Looking upstream at the crown roadway that's covered with wild vegetation.

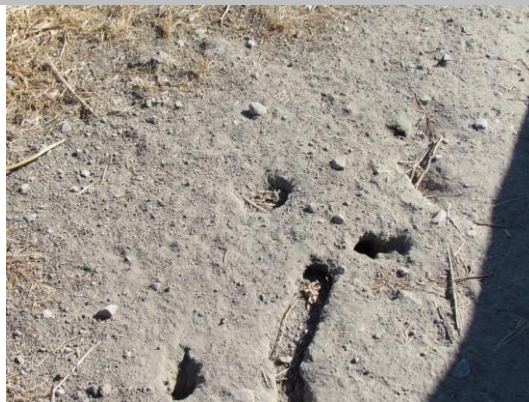
Photo 2 of 3 : FA_2017_NA0011_144_6_20171002_00003.jpg

More active rodents holes and foot traffic seen around holes though no rodents observed.

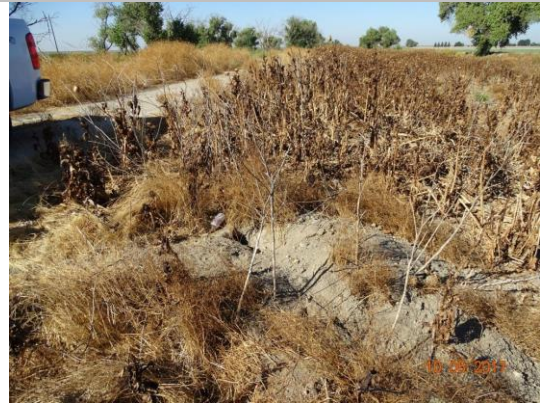
Photo 3 of 3 : FA_2017_NA0011_144_6_20171009_00016.jpg

Continued rodent activity.

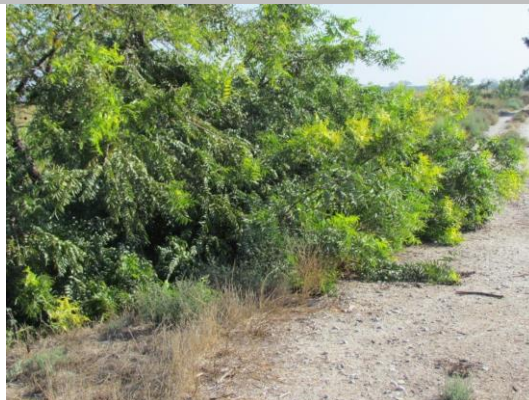
Photo 1 of 2 : FA_2017_NA0011_144_11_20171002_00006.jpg

Berenda Slough Unit 3 looking upstream from levee mile 1.04-1.05 walnut trees blocking the view of the landside levee section.

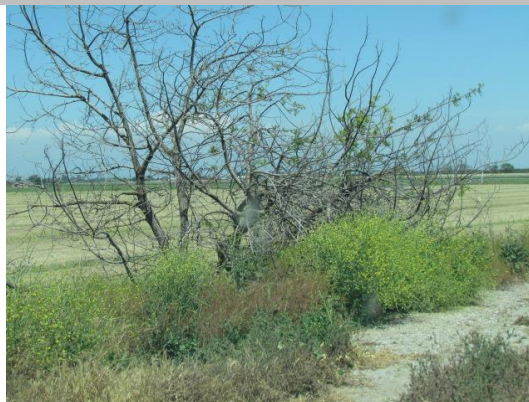
Photo 2 of 2 : FA_2017_NA0011_144_11_20171002_00007.jpg

LM Start	1.04	Rating **	U	Issue No.	11 (cont)
LM End	1.05	Issue Type +	Ma	Location *	LS

levee mile 1.04-1.05 landside slope and shoulder wild walnut tree growth was covered with leaves that blocked the view of the levee section.

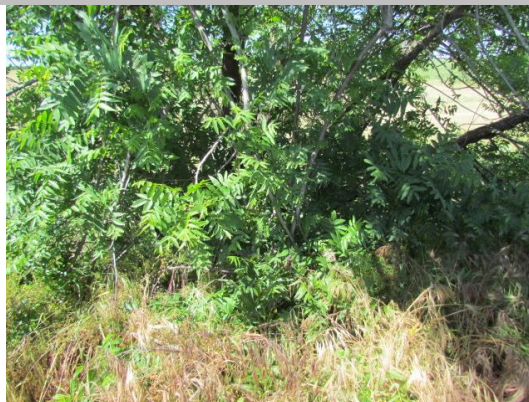
Photo 1 of 1 : FA_2017_NA0011_144_17_20171002_00009.jpg

Looking upstream from landside slope tree has blocked view of the slope and shoulder.

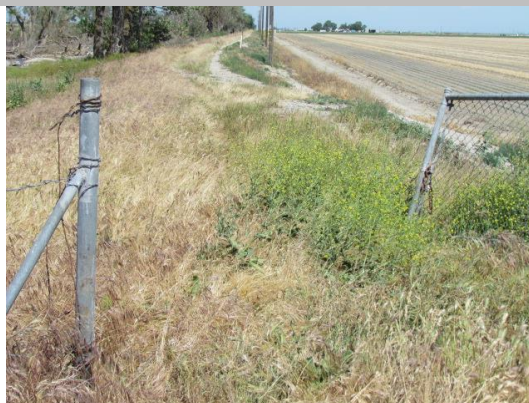
Photo 1 of 1 : FA_2017_NA0011_145_8_20171002_00002.jpg

Looking upstream from levee mile 0.01 at the wild vegetation growing on the crown roadway.

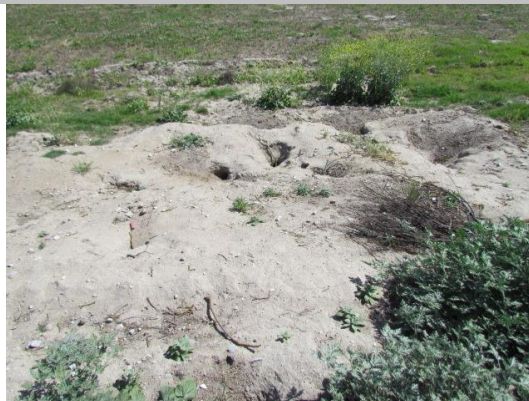
Photo 2 of 5 : FA_2017_NA0011_145_11_20171002_00004.jpg

Looking upstream at rodent activity on landward slope and toe.

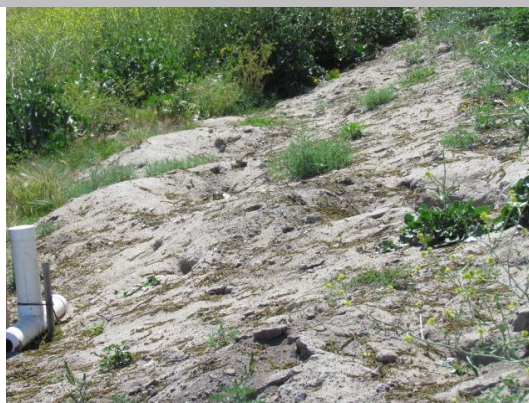
Photo 3 of 5 : FA_2017_NA0011_145_11_20171002_00005.jpg

Berenda Slough looking downstream levee 0.62 landside slope covered with rodent holes to levee mile 2.09.

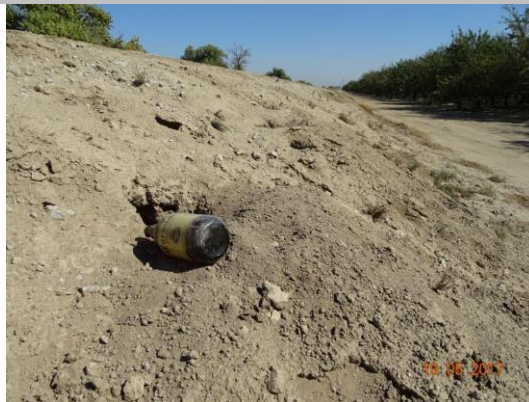
Photo 4 of 5 : FA_2017_NA0011_145_11_20171009_00013.jpg

Rodent activity at LM 2.27.

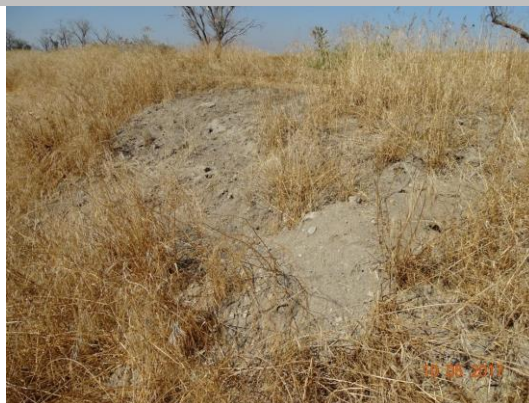
Photo 5 of 5 : FA_2017_NA0011_145_11_20171009_00015.jpg

Rodent activity at LM 1.44.

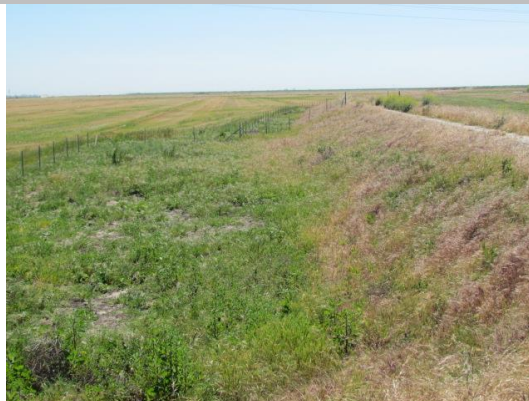
Photo 1 of 1 : FA_2017_NA0011_146_7_20171002_00001.jpg

Looking upstream from levee mile 0.00 landside slope unwanted tall weeds block view of levee slope.

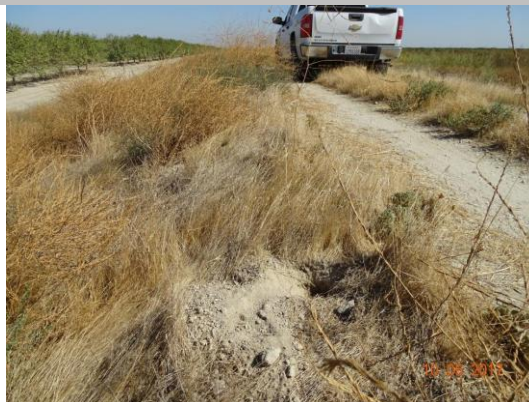
Photo 1 of 1 : FA_2017_NA0011_146_14_20171009_00016.jpg

Rodent activity on landside slope.

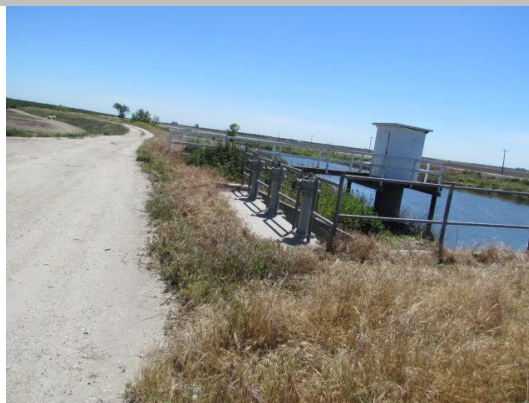
Photo 1 of 1 : FA_2017_NA0011_146_17_20171002_00003.jpg

Fresno River waterside looking upstream from levee mile 6.57, wild weed growth present on slope and shoulder.

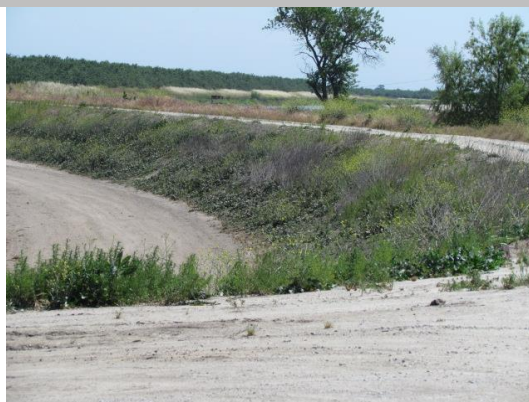
Photo 1 of 1 : FA_2017_NA0011_146_20_20171002_00004.jpg

Fresno River Unit 5 levee mile 6.58 looking upstream to 7.04 unsatisfactory weed growth covering levee slope.

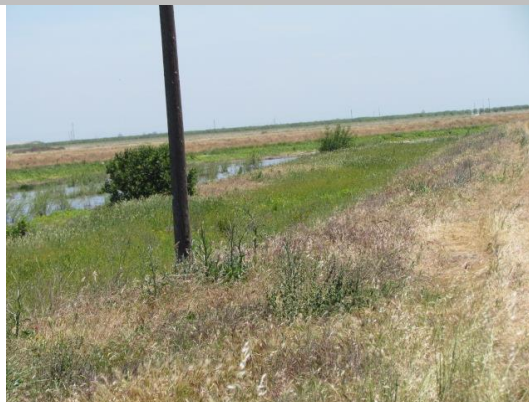
Photo 1 of 1 : FA_2017_NA0011_147_11_20171002_00002.jpg

Fresno River levee mile 0.01 looking upstream wild weed growth present on the slope and shoulder.

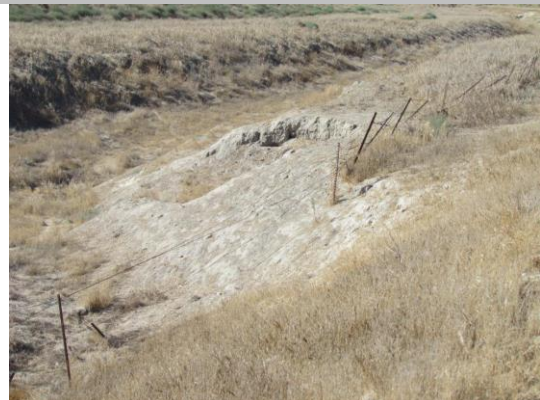
Photo 1 of 1 : FA_2017_NA0011_147_20_20171002_00004.jpg

Looking downstream at the old erosion site landside slope.

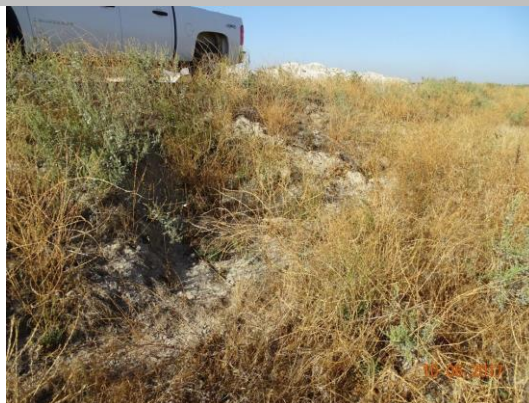
Photo 1 of 2 : FA_2017_NA0011_147_17_20171009_00030.jpg

Observed slump possibly exacerbated by rodent activity. 20' long x 8' high x 18" deep into levee slope.

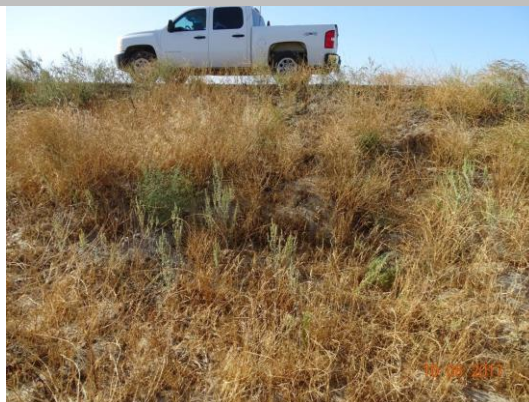
Photo 2 of 2 : FA_2017_NA0011_147_17_20171009_00031.jpg

Observed slump possibly exacerbated by rodent activity. 20' long x 8' high x 18" deep into levee slope.

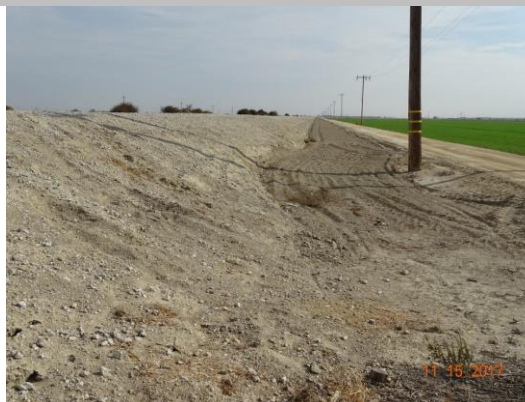
Photo 1 of 1 : FA_2017_NA0011_147_27_20171117_00034.jpg

Ag activity has cut into landside toe. Activity should be stopped and levee slope repaired.

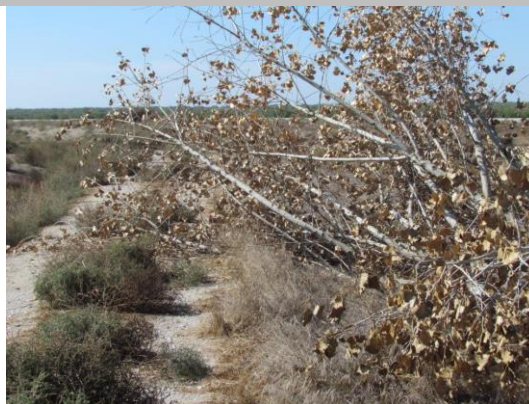
Photo 1 of 2 : FA_2017_NA0011_147_36_20171002_00008.jpg

Dead tree pushed upon the waterside slope and blocking the crown.
