**Flood Control Project Maintenance
Levee Inspections**

Maintenance Issue Types Only, Levee Inspection Report By Mile - Fall 2018

Madera County FCWCA

Waterway	Bank	Unit Miles	Inspection Start/End	Inspector
Unit No. 01 Ash Slough	Right	2.37	10/24/2018 10/24/2018	Corey Fujitani

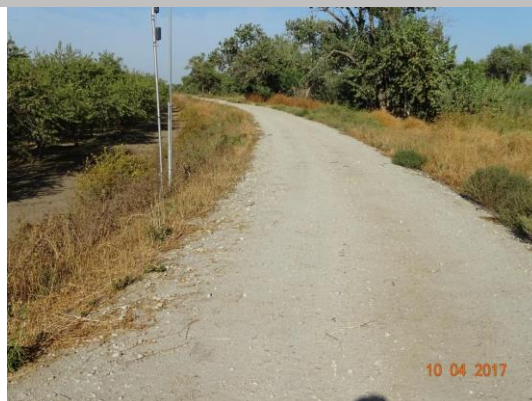
Photo 1 of 1 : FA_2018_NA0011_142_9_20180905_00001.jpg

Tall weeds should be removed from landside slope.

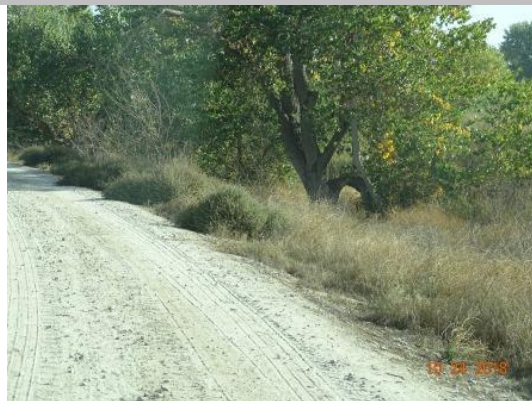
Photo 1 of 1 : FA_2018_NA0011_142_16_20181108_00031.jpg

LM Start	0.25	Rating **	U	Issue No.	16
LM End	0.81	Issue Type +	Ma	Location *	WS
Category	Earthen Levee			GPS Latitude/Longitude	
				Start	End
Item	Vegetation			37.047536 °	37.053646 °
				-120.423641 °	-120.417306 °
DWR ID	DWR_NA0011_01_f_2018_16				
Comment Code					
V1 : Control annual grass and weeds on the levee slopes and easements.					
Inspector Comment

dense vegetation on waterside slope. (Fall 2018)

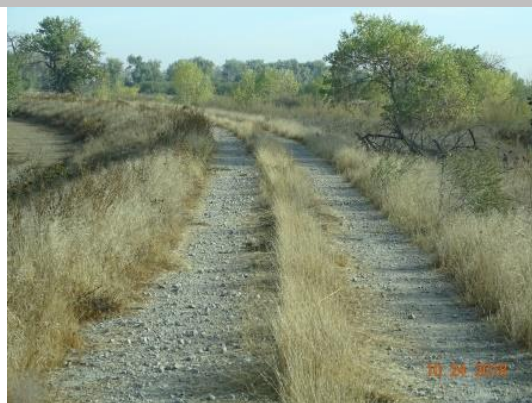
Photo 1 of 1 : FA_2018_NA0011_142_24_20181108_00032.jpg

control vegetation on levee crown. (Fall 2018)

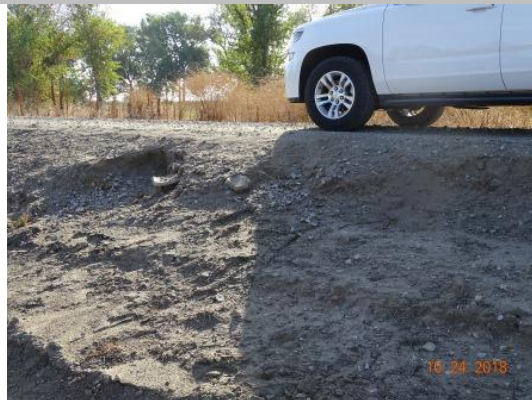
Photo 2 of 2 : FA_2018_NA0011_142_29_20181108_00036.jpg

Erosion on landside slope. (Fall 2018)

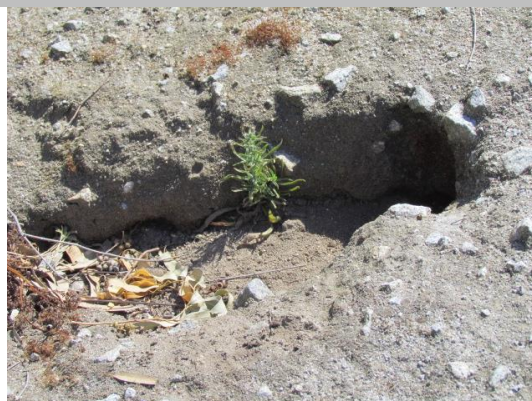
Photo 1 of 2 : FA_2018_NA0011_143_39_20180905_00024.jpg

Other rodent holes noted in the slope waterside levee section.

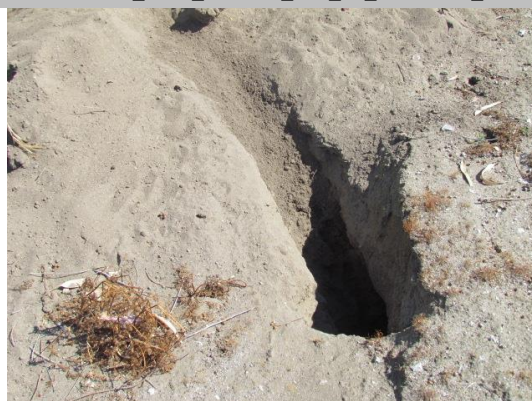
Photo 2 of 2 : FA_2018_NA0011_143_39_20180905_00025.jpg

LM Start	0.00	Rating **	U	Issue No.	39 (cont)
LM End	1.67	Issue Type +	Ma	Location *	WS

Active rodents spotted in the area waterside slope levee mile 0.00- 1.67.

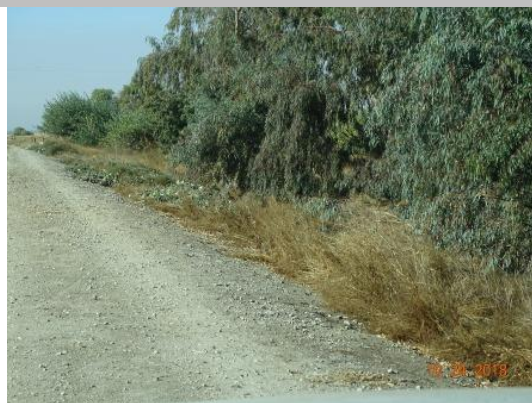
Photo 1 of 1 : FA_2018_NA0011_143_40_20181108_00044.jpg

View of vegetation on waterside slope. (Fall 2018)

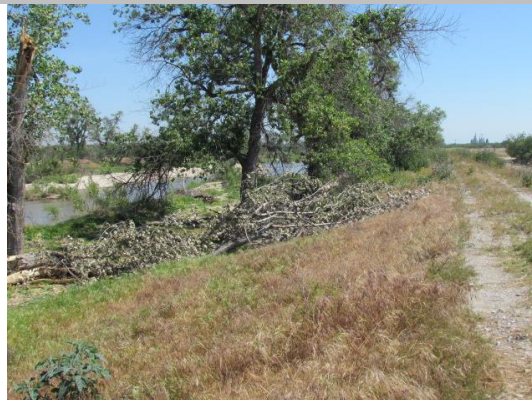
Photo 1 of 1 : FA_2018_NA0011_143_33_20180905_00022.jpg

Dead fallen trees on the waterside levee slope and shoulder.

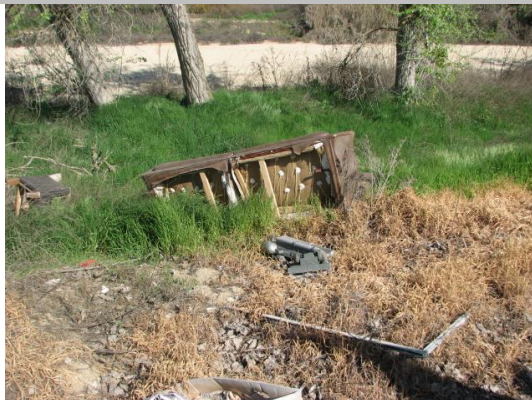
Photo 1 of 1 : FA_2018_NA0011_143_16_20180905_00011.jpg

Looking downstream at garage on waterward slope. (Spring 2018)

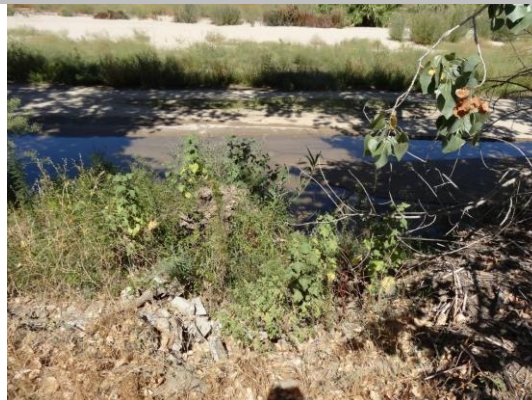
Photo 1 of 4 : FA_2018_NA0011_143_1_20180905_00001.jpg

09/20/2017: No significant change observed.
 07/22/2016: No significant change observed.
 09/08/2015: No significant change observed.
 07/22/2014: No significant change observed.
 08/30/2013: No significant change observed.
 07/31/2012: Site was visited on 07/24/2012. No significant change observed. Dense vegetation around the site
 08/09/2011: Site was inspected. No visible change was observed from the previous condition. A fallen tree was seen at the levee toe about 20 feet upstream, and tree root exposed. There has been no report from the district that this site was corrected.
 11/30/2010: Site was not inspected due to time constraints. There have been no reports from the district that the site was corrected. Continue to monitor site during flood events.
 08/05/2010: Recommended for annual assessment and monitoring during flood events, per CLRO.
 2009: Site is recommended as a local maintenance issue, per Critical Levee Repair Office, Critical Erosion Sites Evaluation 2008 Report; site was previously rated "M"

View of the erosion site from the levee crest.

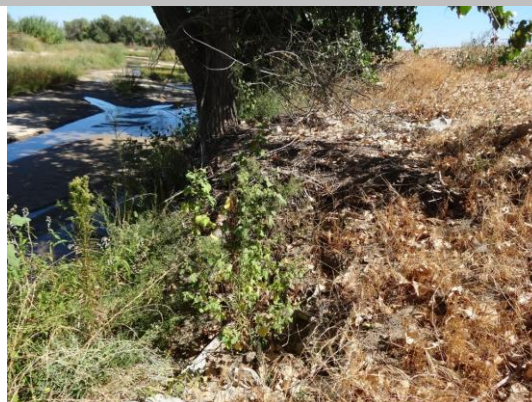
Photo 2 of 4 : FA_2018_NA0011_143_1_20180905_00002.jpg

Close view of the site.

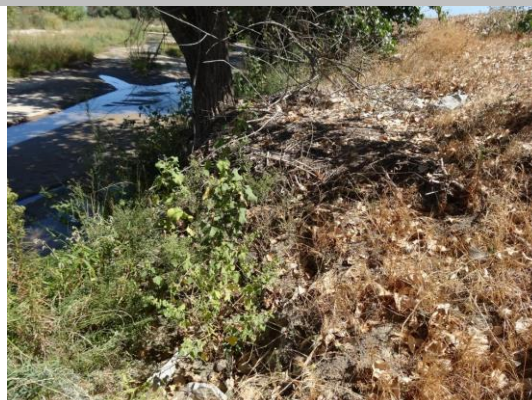
Photo 4 of 4 : FA_2018_NA0011_143_1_20180905_00004.jpg

09/20/2017: No significant change observed.
 07/22/2016: No significant change observed.
 09/08/2015: No significant change observed.
 07/22/2014: No significant change observed.
 08/30/2013: No significant change observed.
 07/31/2012: Site was visited on 07/24/2012. No significant change observed. Dense vegetation around the site
 08/09/2011: Site was inspected. No visible change was observed from the previous condition. A fallen tree was seen at the levee toe about 20 feet upstream, and tree root exposed. There has been no report from the district that this site was corrected.
 11/30/2010: Site was not inspected due to time constraints. There have been no reports from the district that the site was corrected. Continue to monitor site during flood events.
 08/05/2010: Recommended for annual assessment and monitoring during flood events, per CLRO.
 2009: Site is recommended as a local maintenance issue, per Critical Levee Repair Office, Critical Erosion Sites Evaluation 2008 Report; site was previously rated "M"

Close view of the site.

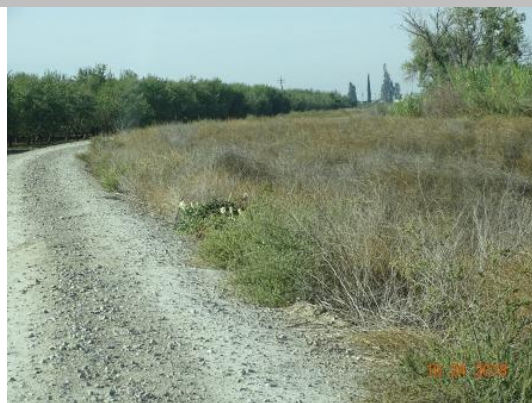
Photo 1 of 1 : FA_2018_NA0011_143_10_20181108_00048.jpg

control wild growth on waterside slope. (Fall 2018)

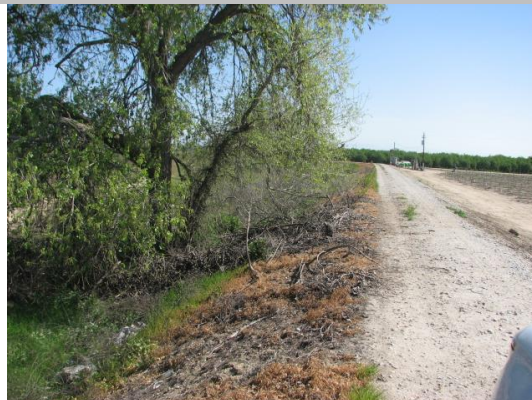
Photo 1 of 1 : FA_2018_NA0011_143_25_20180905_00016.jpg

Look downstream at untrimmed tree on waterward slope. (Spring 2018)

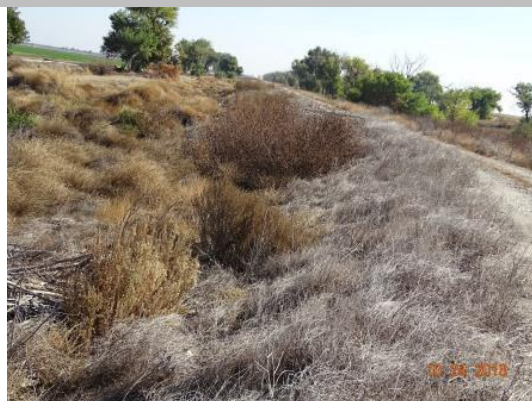
Photo 1 of 2 : FA_2018_NA0011_144_3_20181109_00028.jpg

Vegetation on landside slope. (Fall 2018)

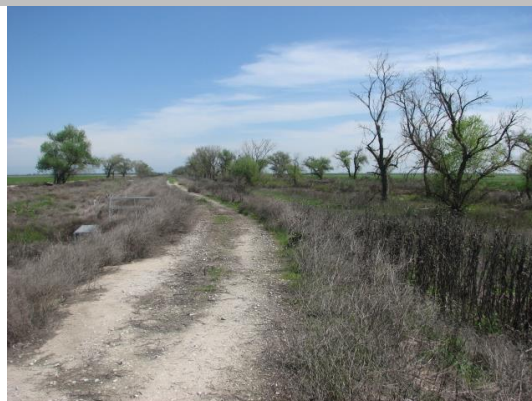
Photo 1 of 2 : FA_2018_NA0011_144_9_20180905_00012.jpg

Looking downstream at wild growth on waterward slope. (Spring 2018)

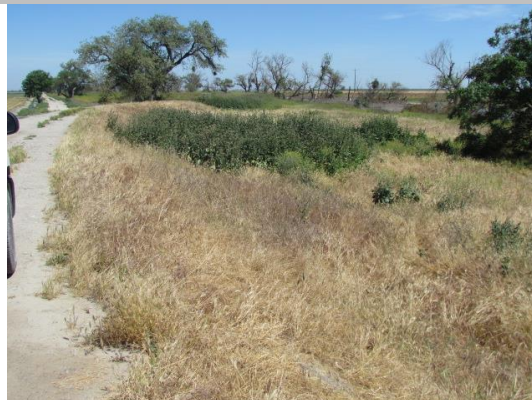
Photo 2 of 2 : FA_2018_NA0011_144_9_20180905_00013.jpg

Looking upstream from the waterside shoulder wild growth covering slope and toe.

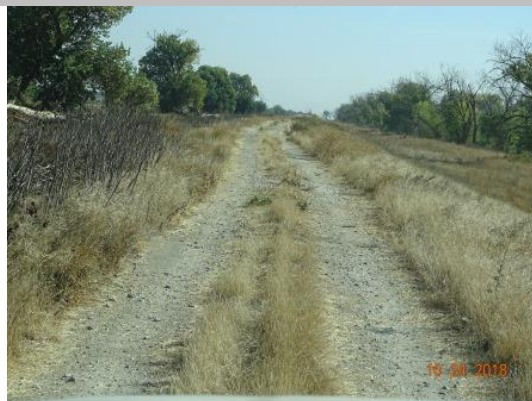
Photo 1 of 1 : FA_2018_NA0011_144_12_20181109_00029.jpg

Looking upstream at the crown roadway that's covered with wild vegetation. (Fall 2018)

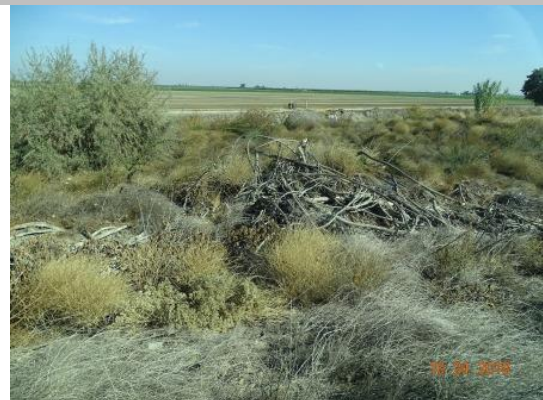
Photo 1 of 1 : FA_2018_NA0011_144_45_20181109_00031.jpg

View of dead branches on landside slope. (Fall 2018)

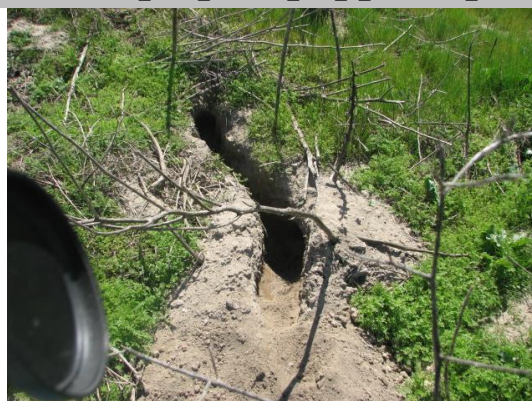
Photo 3 of 6 : FA_2018_NA0011_144_6_20180905_00007.jpg

LM Start	0.40	Rating **	U	Issue No.	6 (cont)	
LM End	1.51	Issue Type +	Ma	Location *	LS	
Category	Earthen Levee			GPS Latitude/Longitude		
				Start		End
Item	Animal Control			36.996208 °	36.996607 °	
				-120.366550 °	-120.346568 °	
DWR ID	DWR_NA0011_03_f_2016_6					
Comment Code						
A1 : Exterminate rodents and backfill and compact or grout burrows.						
Inspector Comment						
LMA should install rodent bait stations placed along the landside slope and or shoulder at levee miles listed. No new photo was taken. Unable to see the ground, observed rodents running across the roadway.

Looking at rodent hole with erosion on landward slope. (Spring 2018)

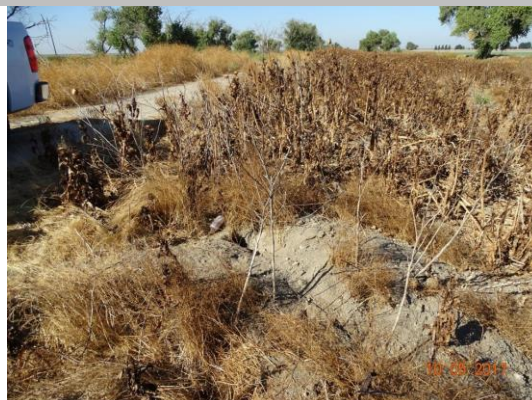
Photo 4 of 6 : FA_2018_NA0011_144_6_20180905_00008.jpg

Continued rodent activity.

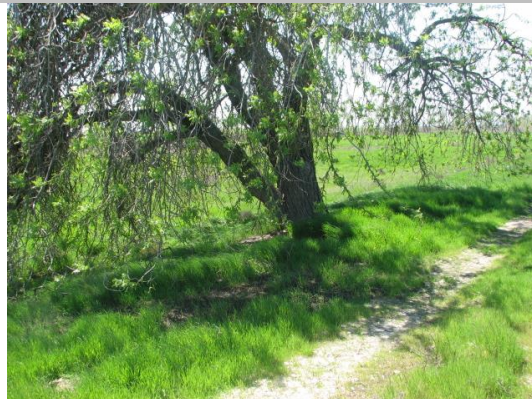
Photo 1 of 1 : FA_2018_NA0011_144_14_20180905_00017.jpg

Looking at untrimmed tree on waterward shoulder. (Spring 2018)

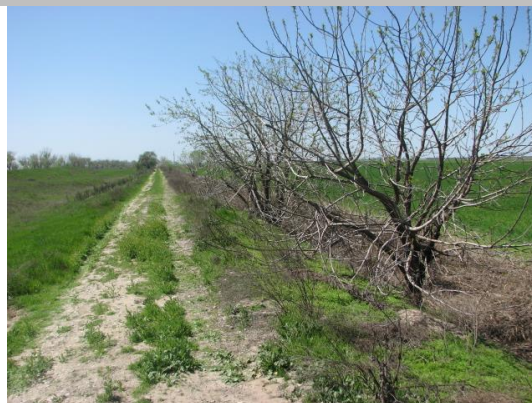
Photo 1 of 2 : FA_2018_NA0011_144_17_20180905_00018.jpg

Looking at cluster of walnut trees on landward slope. (Spring 2018)

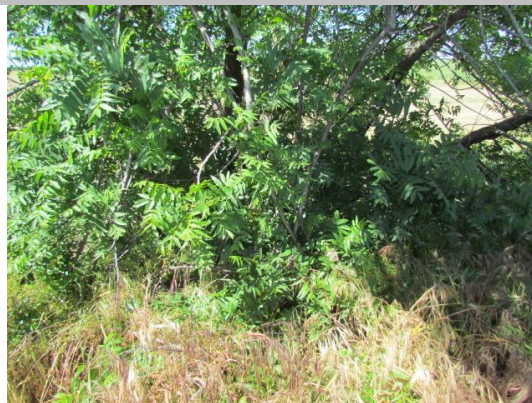
Photo 2 of 2 : FA_2018_NA0011_144_17_20180905_00019.jpg

Looking upstream from landside slope tree has blocked view of the slope and shoulder.

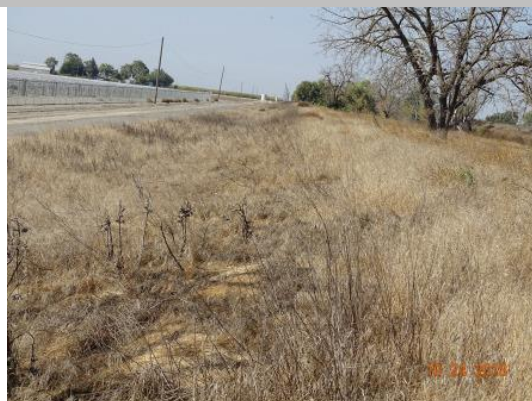
Photo 1 of 2 : FA_2018_NA0011_145_5_20181109_00028.jpg

View of wild growth on landside slope and shoulder. (Fall 2018)

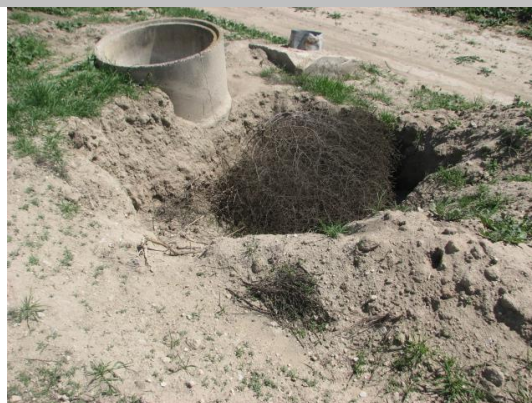
Photo 1 of 3 : FA_2018_NA0011_145_22_20180905_00018.jpg

Looking west at large hole next concrete riser (no pipe) on landward slope. (Spring 2018)

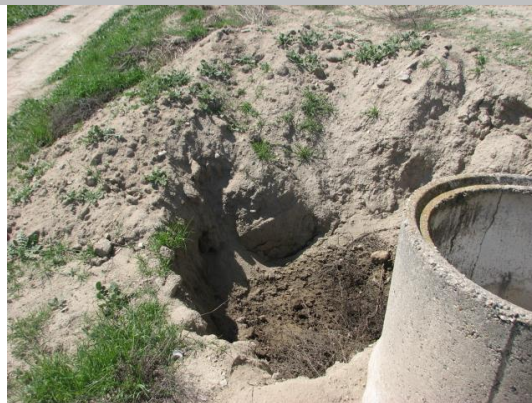
Photo 2 of 3 : FA_2018_NA0011_145_22_20180905_00019.jpg

Looking upstream at large hole on landward slope. (Spring 2018)

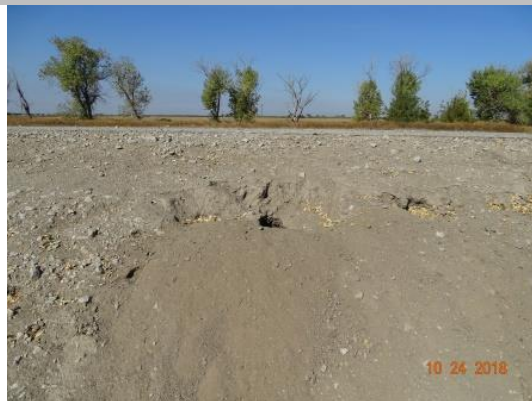
Photo 1 of 2 : FA_2018_NA0011_145_11_20181109_00033.jpg

Large rodent holes along this section. (Fall 2018)

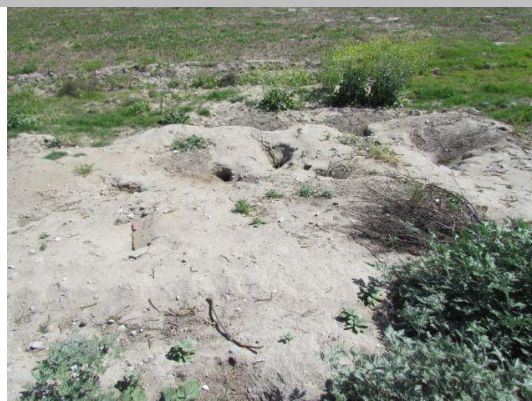
Photo 2 of 2 : FA_2018_NA0011_145_11_20180905_00007.jpg

Looking upstream at rodent activity on landward slope and toe.

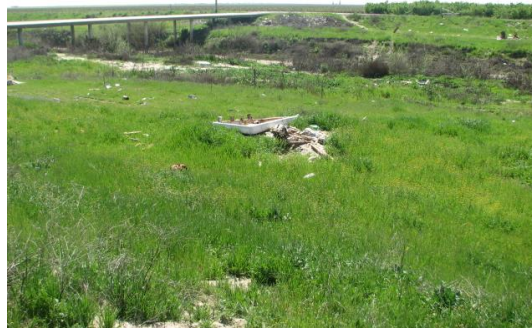
Photo 1 of 1 : FA_2018_NA0011_146_19_20180905_00006.jpg

Looking west at garage in channel. (Spring 2018)

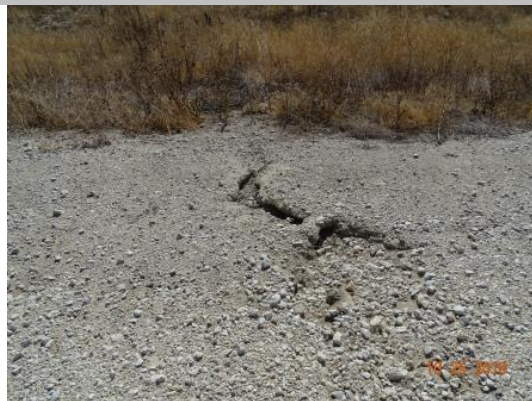
Photo 1 of 1 : FA_2018_NA0011_146_38_20181109_00028.jpg

Finger erosion on waterside slope. (Fall 2018)

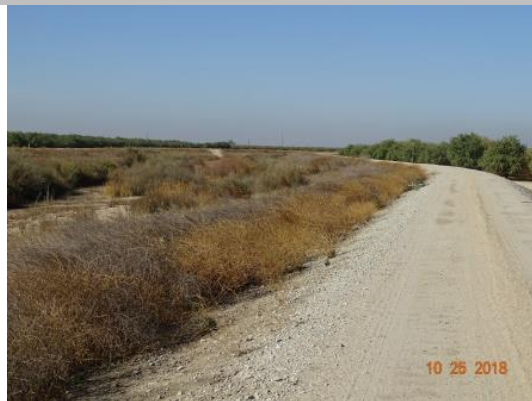
Photo 1 of 2 : FA_2018_NA0011_146_17_20181109_00031.jpg

Large brush along waterside slope. (Fall 2018)

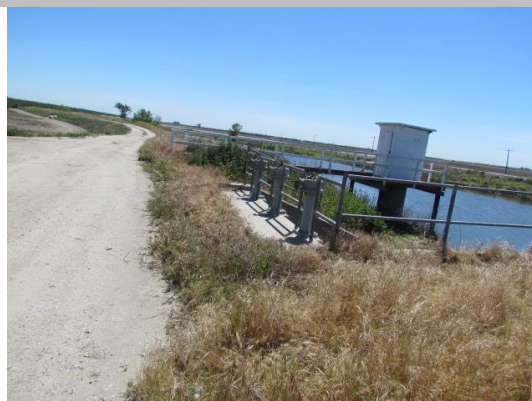
Photo 2 of 2 : FA_2018_NA0011_146_17_20180905_00004.jpg

Fresno River waterside looking upstream from levee mile 6.57, wild weed growth present on slope and shoulder.

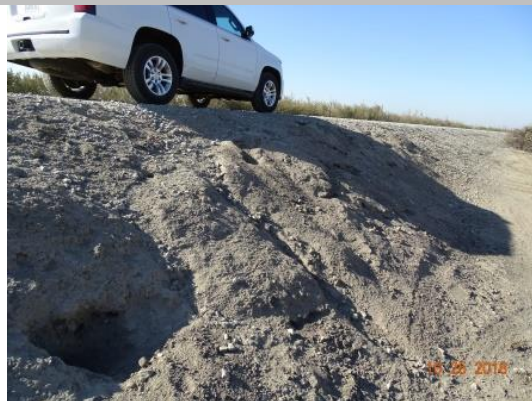
Photo 1 of 1 : FA_2018_NA0011_146_24_20181109_00033.jpg

Rodent activity on landside slope. (Fall 2018)

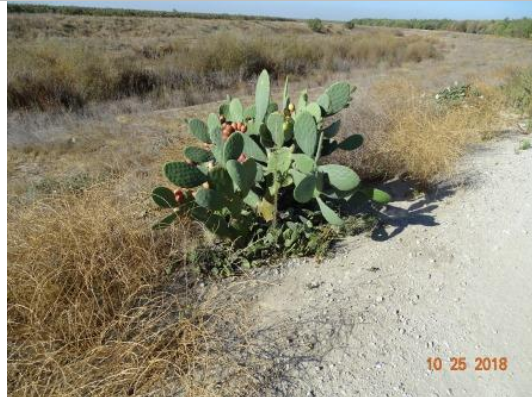
Photo 1 of 1 : FA_2018_NA0011_146_10_20181109_00036.jpg

Cactus on waterside slope. (Fall 2018)

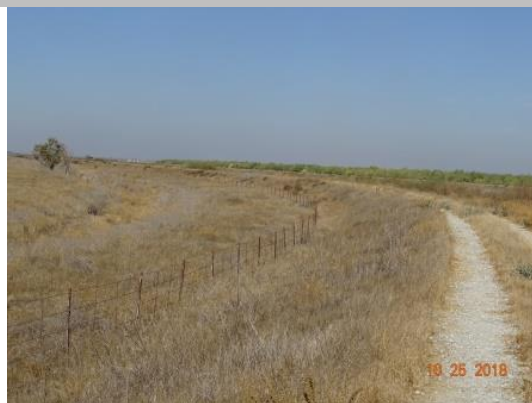
Photo 1 of 1 : FA_2018_NA0011_147_74_20181109_00043.jpg

heavy vegetation on landside slope and toe. (Fall 2018)

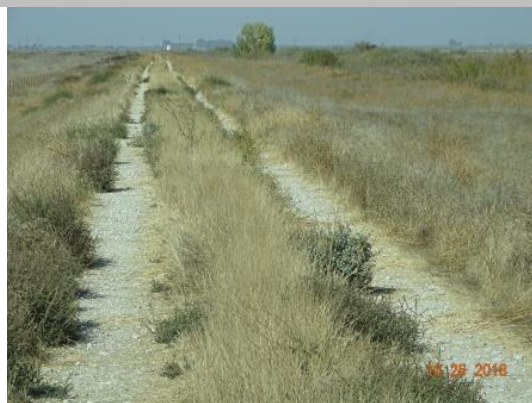
Photo 1 of 2 : FA_2018_NA0011_147_12_20181109_00044.jpg

tall dense vegetation on levee crown. (Fall 2018)

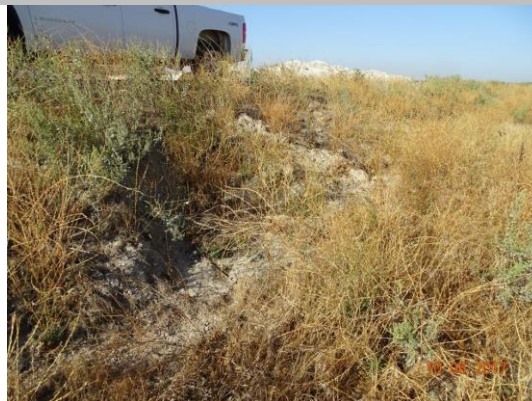
Photo 1 of 2 : FA_2018_NA0011_147_17_20180905_00004.jpg

Observed slump possibly exacerbated by rodent activity. 20' long x 8' high x 18" deep into levee slope.

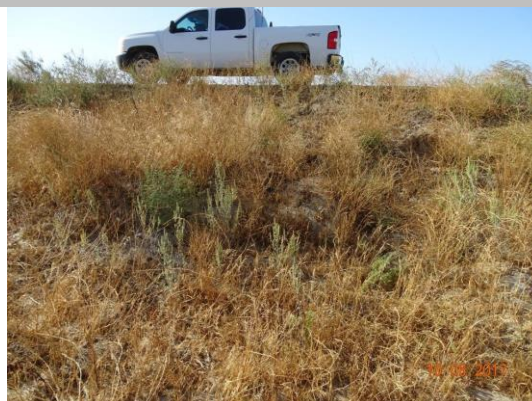
Photo 2 of 2 : FA_2018_NA0011_147_17_20180905_00005.jpg

Observed slump possibly exacerbated by rodent activity. 20' long x 8' high x 18" deep into levee slope.

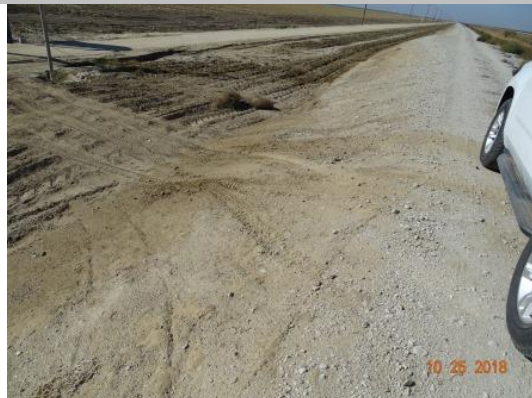
Photo 1 of 1 : FA_2018_NA0011_147_64_20181109_00048.jpg

Vehicle tracks on landside slope. (Fall 2018)

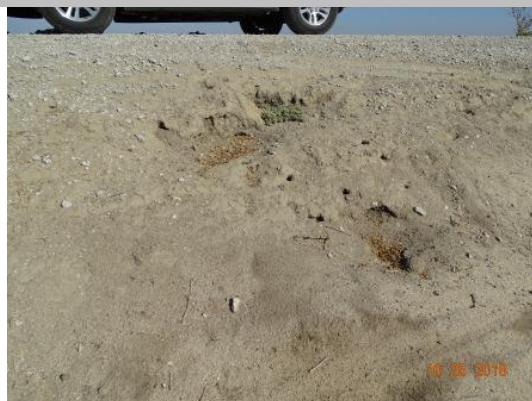
Photo 1 of 1 : FA_2018_NA0011_147_58_20181109_00051.jpg

minor erosion in landside slope. (Fall 2018)

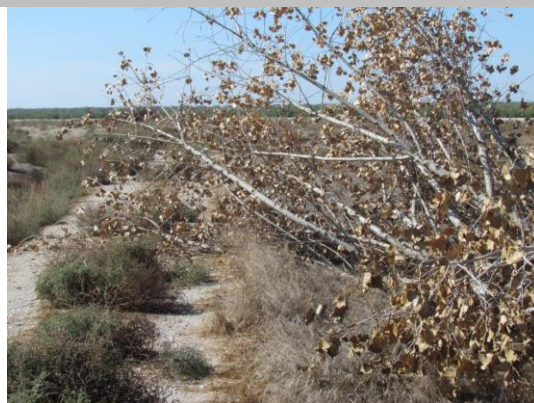
Photo 1 of 2 : FA_2018_NA0011_147_36_20180905_00013.jpg

Dead tree pushed upon the waterside slope and blocking the crown.

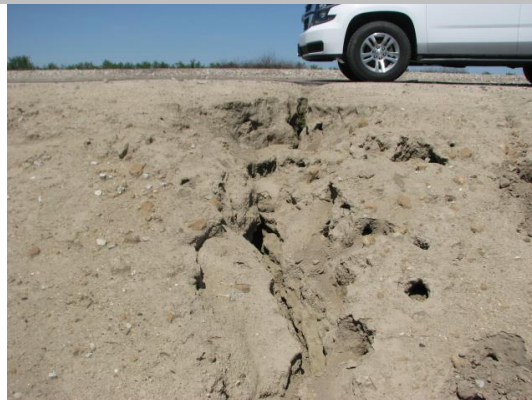
Photo 1 of 1 : FA_2018_NA0011_147_22_20180905_00007.jpg

Looking at finger erosion on landward slope. (Spring 2018)
