**Flood Control Project Maintenance
Levee Inspections**

Maintenance Issue Types Only, Levee Inspection Report By Mile - Fall 2019

Madera County FCWCA

Waterway	Bank	Unit Miles	Inspection Start/End	Inspector
Unit No. 01 Ash Slough	Right	2.37	10/02/2019 10/02/2019	Corey Fujitani

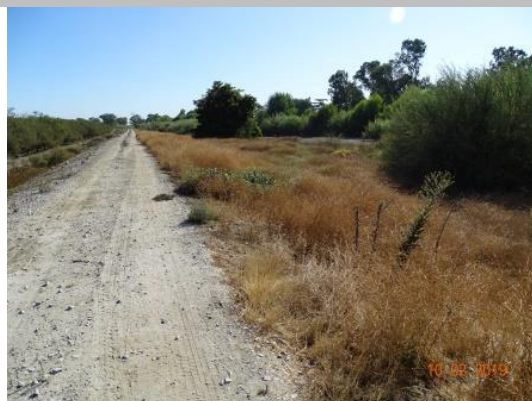
Photo 1 of 1 : FA_2019_NA0011_142_9_20191008_00030.jpg

LM Start	0.03	Rating **	U	Issue No.	9
LM End	2.14	Issue Type +	Ma	Location *	WS
Category	Earthen Levee			GPS Latitude/Longitude	
				Start	End
Item	Vegetation			37.046573 °	37.065960 °
				-120.427527 °	-120.400093 °
DWR ID	DWR_NA0011_01_f_2019_9				
Comment Code					
V1 : Control annual grass and weeds on the levee slopes and easements.					
Inspector Comment

View of vegetation on waterside slope looking upstream. (Fall 2019)

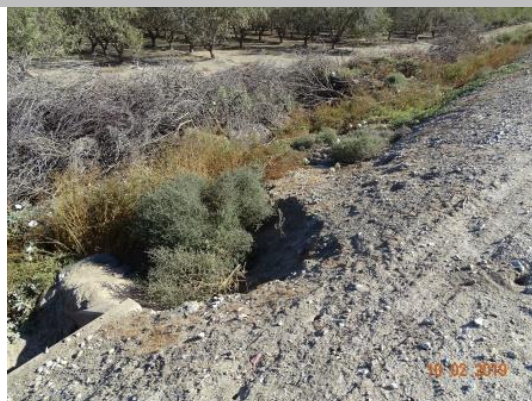
Photo 1 of 2 : FA_2019_NA0011_142_20_20191008_00031.jpg

LM Start	0.04	Rating **	U	Issue No.	20
LM End	0.04	Issue Type +	Ma	Location *	LS
Category	Earthen Levee			GPS Latitude/Longitude	
				Start	End
Item	Slope Stability			37.046624 °	37.046624 °
				-120.427317 °	-120.427317 °
DWR ID	DWR_NA0011_01_s_2014_20				
Comment Code					
S1 : Repair slope instability.					
Inspector Comment					
This is not a new erosion site, it should be repaired before the condition gets any worse.

View of damage to landside slope. (Fall 2019)

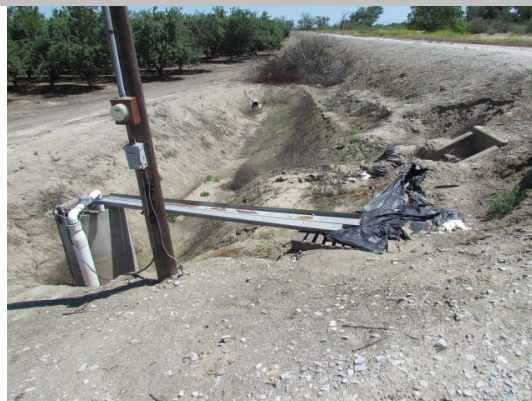
Photo 2 of 2 : FA_2019_NA0011_142_20_20190912_00008.jpg

There is damage to the landside levee slope next to the concrete inlet structure.

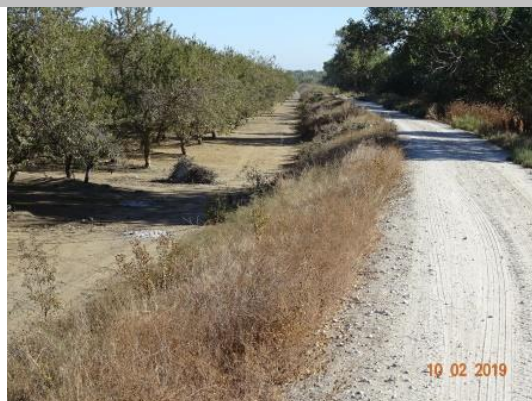
Photo 1 of 1 : FA_2019_NA0011_142_22_20191008_00032.jpg

Looking upstream along the landside slope. (Fall 2019)

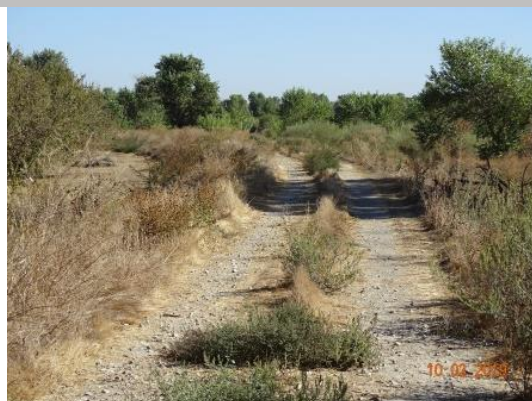
Photo 1 of 1 : FA_2019_NA0011_142_23_20191008_00033.jpg

View along the levee crown looking upstream. (Fall 2019)

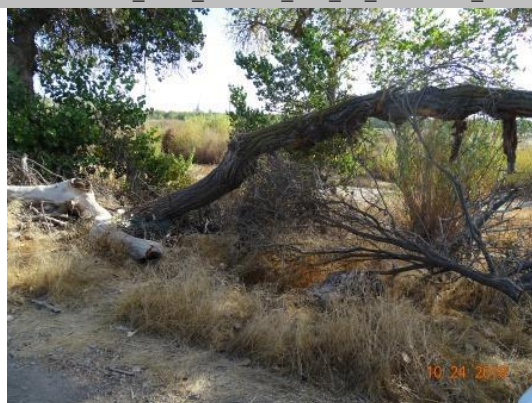
Photo 1 of 1 : FA_2019_NA0011_142_25_20190912_00010.jpg

LM Start	0.79	Rating **	U	Issue No.	25	
LM End	0.79	Issue Type +	Ma	Location *	WS	
Category	Earthen Levee			GPS Latitude/Longitude		
				Start		End
Item	Encroachments			37.053329 °		37.053329 °
				-120.417448 °		-120.417448 °
DWR ID	DWR_NA0011_01_f_2018_25					
Comment Code						
TR : Tree or limb						
Inspector Comment						
There is a fallen tree blocking the waterside slope.

tree limbs and trunks on waterside shoulder and slope. (Fall 2018)

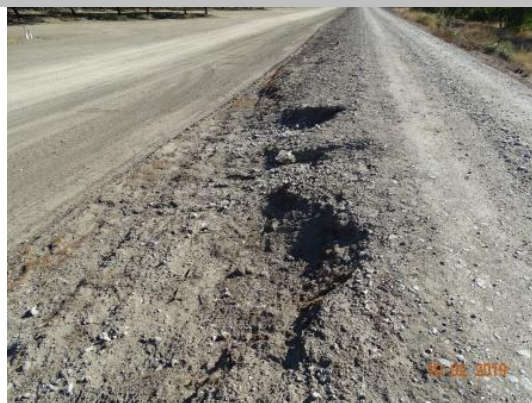
Photo 1 of 3 : FA_2019_NA0011_142_29_20191008_00037.jpg

LM Start	1.04	Rating **	M	Issue No.	29
LM End	1.04	Issue Type +	Ma	Location *	LS
Category	Earthen Levee			GPS Latitude/Longitude	
				Start	End
Item	Erosion / Bank Caving			37.055880 °	37.055880 °
				-120.414628 °	-120.414628 °
DWR ID	DWR_NA0011_01_f_2018_29				
Comment Code					
E2 : Schedule repair of erosion site prior to the next inspection.					
Inspector Comment

View of erosion looking upstream along the landside slope. (Fall 2019)

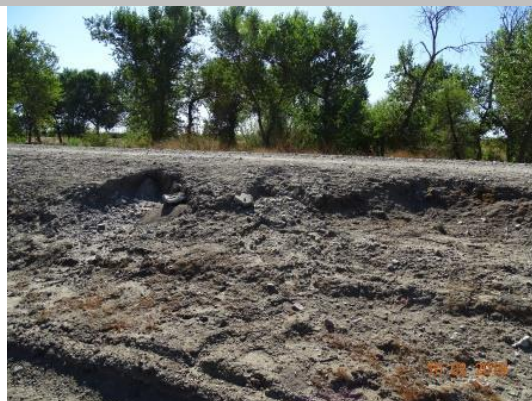
Photo 2 of 3 : FA_2019_NA0011_142_29_20191008_00036.jpg

View of erosion looking up the landside slope. (Fall 2019)

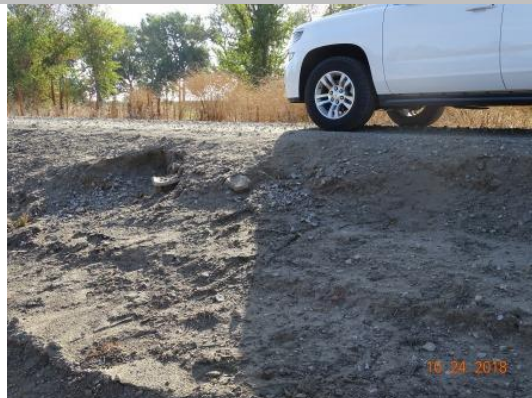
Photo 3 of 3 : FA_2019_NA0011_142_29_20190912_00012.jpg

LM Start	1.04	Rating **	M	Issue No.	29 (cont)	
LM End	1.04	Issue Type +	Ma	Location *	LS	
Category	Earthen Levee			GPS Latitude/Longitude		
				Start		End
Item	Erosion / Bank Caving			37.055880 °		37.055880 °
				-120.414628 °		-120.414628 °
DWR ID	DWR_NA0011_01_f_2018_29					
Comment Code						
E2 : Schedule repair of erosion site prior to the next inspection.						
Inspector Comment

Erosion on landside slope. (Fall 2018)

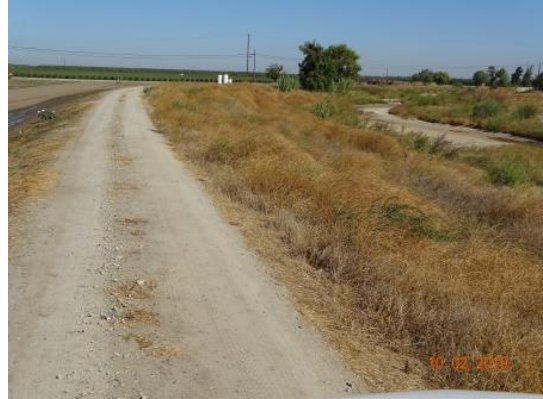
Photo 1 of 1 : FA_2019_NA0011_142_27_20191008_00035.jpg

View of vegetation on the waterside slope looking upstream. (Fall 2019)

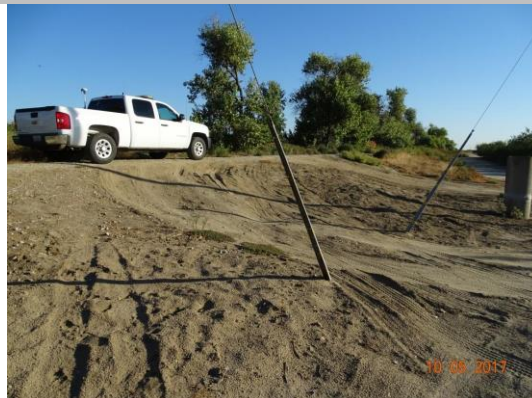
Photo 1 of 1 : FA_2019_NA0011_143_13_20190912_00009.jpg

LM Start	0.31	Rating **	M	Issue No.	13
LM End	0.31	Issue Type +	Ma	Location *	LS
Category	Earthen Levee			GPS Latitude/Longitude	
				Start	End
Item	Slope Stability			37.047266°	37.047266°
				-120.422393°	-120.422393°
DWR ID	DWR_NA0011_02_f_2017_13				
Comment Code					
S3 : Repair the levee slope damaged by vehicle traffic and prevent access where possible.					
Inspector Comment

Vehicle access to levee slope should be prevented and erosion repaired.

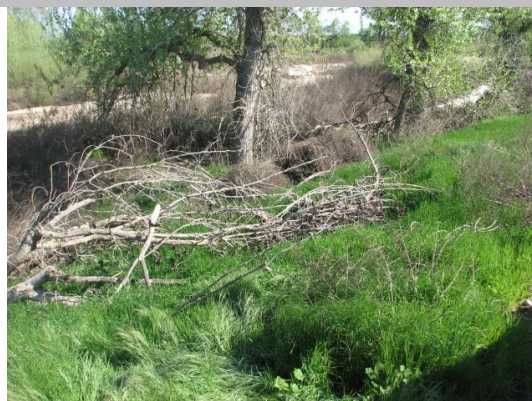
Photo 1 of 1 : FA_2019_NA0011_143_28_20190912_00020.jpg

LM Start	0.32	Rating **	M	Issue No.	28
LM End	0.32	Issue Type +	Ma	Location *	WS
Category	Earthen Levee			GPS Latitude/Longitude	
				Start	End
Item	Encroachments			37.047416 °	37.047416 °
				-120.422142 °	-120.422142 °
DWR ID	DWR_NA0011_02_f_2012_28				
Comment Code					
TR : Tree or limb					
Inspector Comment					
Remove the dead tree limbs from the waterside slope.

Looking downstream at tree limbs on waterward slope and toe. (Spring 2018)

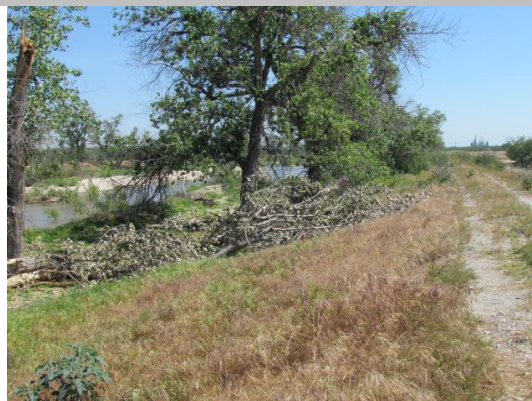
Photo 1 of 1 : FA_2019_NA0011_143_33_20190912_00024.jpg

Dead fallen trees on the waterside levee slope and shoulder.

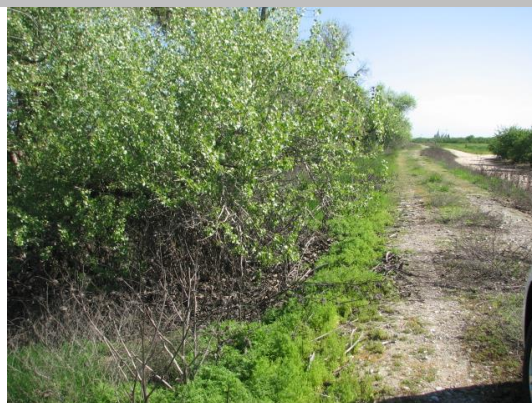
Photo 1 of 1 : FA_2019_NA0011_143_14_20190912_00010.jpg

Looking downstream at untrimmed trees on waterward shoulder and slope. (Spring 2018)

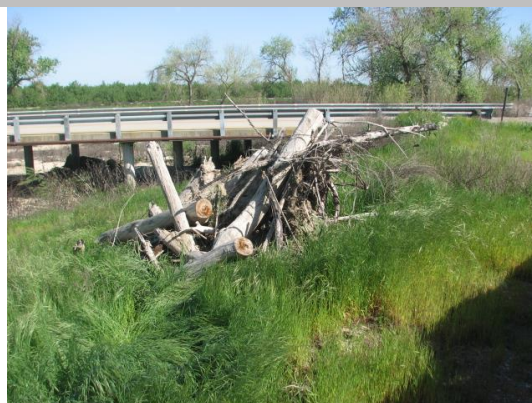
Photo 1 of 1 : FA_2019_NA0011_143_34_20190912_00025.jpg

Looking downstream at bush pile on waterward slope. (Spring 2018)

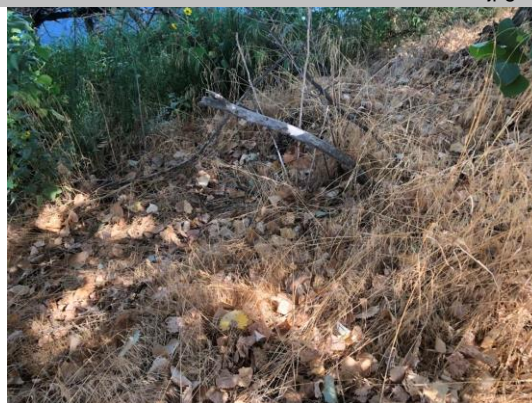
Photo 1 of 3 : SJR2019_NA0011U02RM2.57_2.jpg

Comment Code						
Inspector Comment						
Site ID: NA0011U02RM2.57						
09/10/2019: No significant change observed.						
09/20/2017: No significant change observed.						
07/22/2016: No significant change observed.						
09/08/2015: No significant change observed.						
07/22/2014: No significant change observed.						
08/30/2013: No significant change observed.						
07/31/2012: Site was visited on 07/24/2012. No significant change observed. Dense vegetation around the site						
08/09/2011: Site was inspected. No visible change was observed from the previous condition. A fallen tree was seen at the levee toe about 20 feet upstream, and tree root exposed. There has been no report from the district that this site was corrected.						
11/30/2010: Site was not inspected due to time constraints. There have been no reports from the district that the site was corrected. Continue to monitor site during flood events.

08/05/2010: Recommended for annual assessment and monitoring during flood events, per CLRO.						
2009: Site is recommended as a local maintenance issue, per Critical Levee Repair Office, Critical Erosion Sites Evaluation 2008 Report; site was previously rated "M"						
9/6/2007: Undercutting of the toe; several trees along the WS slope with roots exposed.

View of the erosion site from the levee crest.

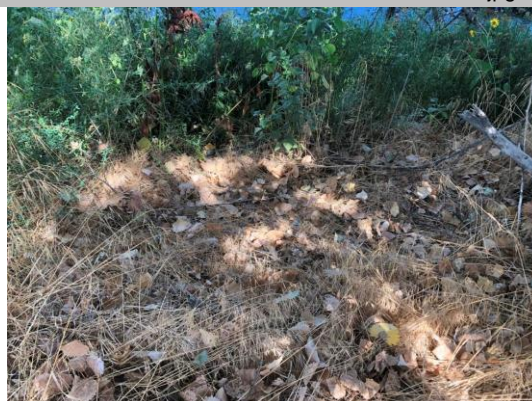
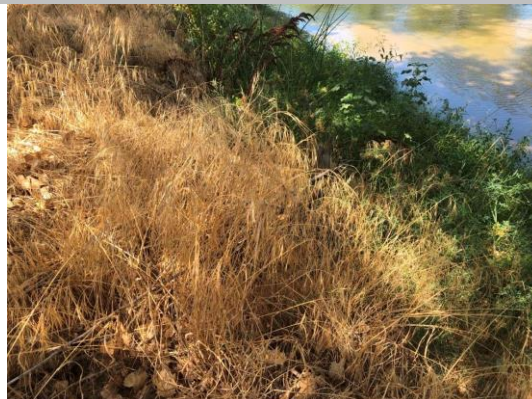
Comment Code						
Inspector Comment						
Site ID: NA0011U02RM2.57 09/10/2019: No significant change observed. 09/20/2017: No significant change observed. 07/22/2016: No significant change observed. 09/08/2015: No significant change observed. 07/22/2014: No significant change observed. 08/30/2013: No significant change observed. 07/31/2012: Site was visited on 07/24/2012. No significant change observed. Dense vegetation around the site 08/09/2011: Site was inspected. No visible change was observed from the previous condition. A fallen tree was seen at the levee toe about 20 feet upstream, and tree root exposed. There has been no report from the district that this site was corrected. 11/30/2010: Site was not inspected due to time constraints. There have been no reports from the district that the site was corrected. Continue to monitor site during flood events. 08/05/2010: Recommended for annual assessment and monitoring during flood events, per CLRO. 2009: Site is recommended as a local maintenance issue, per Critical Levee Repair Office, Critical Erosion Sites Evaluation 2008 Report; site was previously rated "M" 9/6/2007: Undercutting of the toe; several trees along the WS slope with roots exposed.

Close-up view of the site.

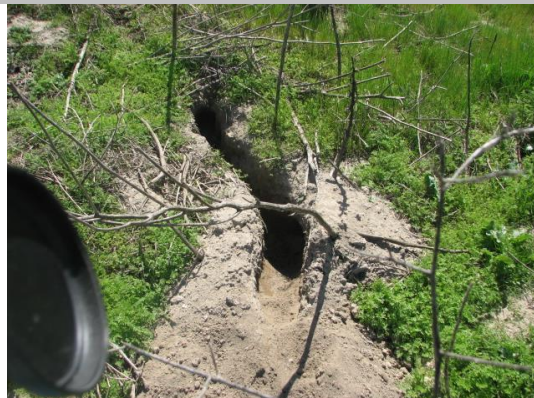
Photo 3 of 6 : FA_2019_NA0011_144_6_20190912_00005.jpg

Looking at rodent hole on landward slope. (Spring 2018)

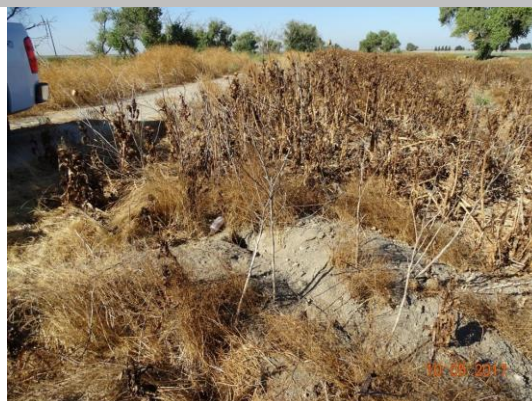
Photo 4 of 6 : FA_2019_NA0011_144_6_20190912_00006.jpg

Continued rodent activity.

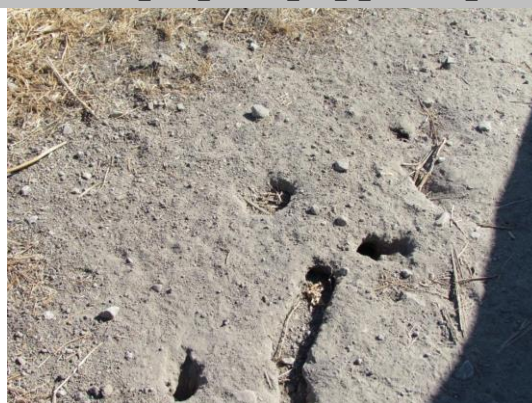
Photo 5 of 6 : FA_2019_NA0011_144_6_20190912_00007.jpg

More active rodent holes but no rodents observed at this specific location.

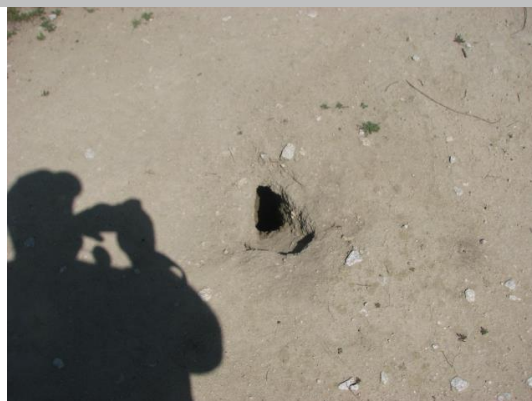
Photo 1 of 1 : FA_2019_NA0011_144_5_20190912_00002.jpg

Looking at rodent hole on levee crown. (Spring 2018)

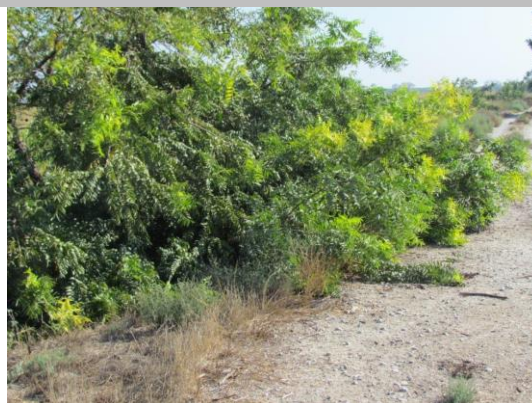
Photo 1 of 1 : FA_2019_NA0011_144_11_20190912_00011.jpg

Walnut trees blocking the view of the landside levee section.

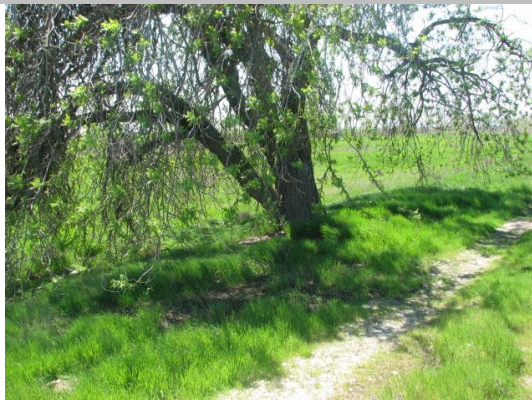
Photo 1 of 1 : FA_2019_NA0011_144_14_20190912_00012.jpg

Looking at untrimmed tree on waterward shoulder. (Spring 2018)

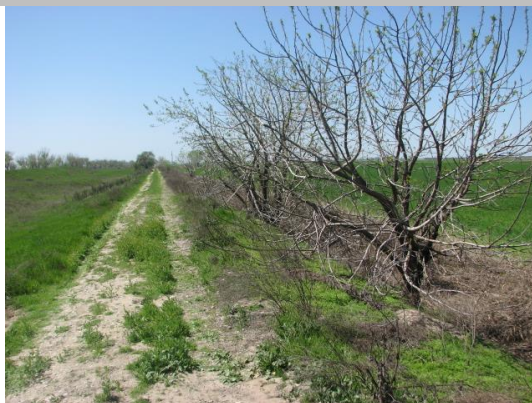
Photo 1 of 2 : FA_2019_NA0011_144_17_20190912_00013.jpg

Looking at cluster of walnut trees on landward slope. (Spring 2018)

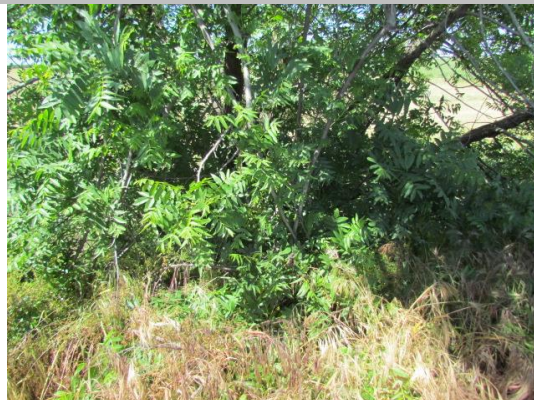
Photo 2 of 2 : FA_2019_NA0011_144_17_20190912_00014.jpg

Looking upstream from landside slope tree has blocked view of the slope and shoulder.

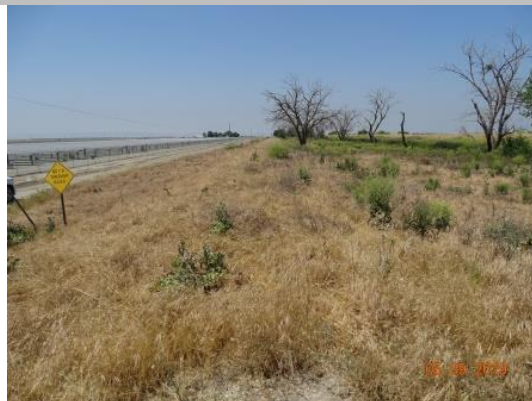
Photo 2 of 2 : FA_2019_NA0011_145_8_20190912_00007.jpg

Looking downstream from LM 1.49 at vegetation on levee crown. (Spring 2019)

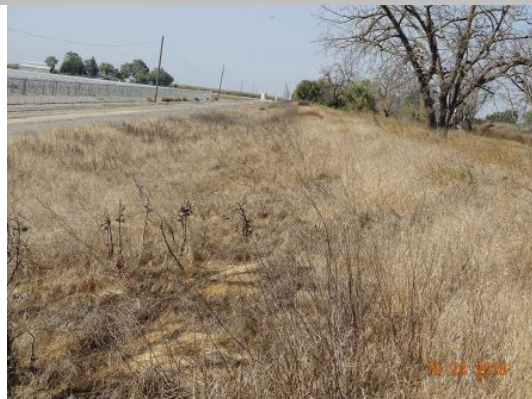
Photo 2 of 2 : FA_2019_NA0011_145_5_20190912_00005.jpg

View of wild growth on landside slope and shoulder. (Fall 2018)

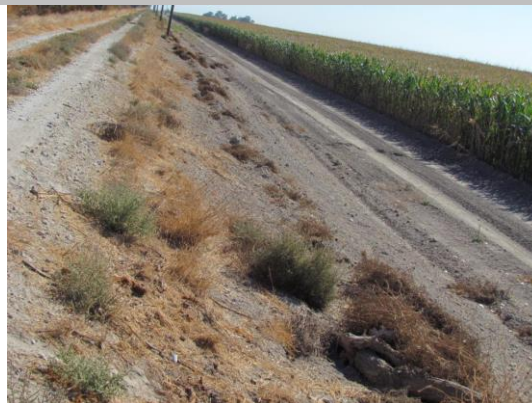
Photo 1 of 1 : FA_2019_NA0011_145_3_20190912_00001.jpg

LM Start	0.02	Rating **	U	Issue No.	3
LM End	0.97	Issue Type +	Ma	Location *	LS
Category	Earthen Levee			GPS Latitude/Longitude	
				Start	End
Item	Slope Stability			36.995506 °	36.995550 °
				-120.373233 °	-120.355935 °
DWR ID	DWR_NA0011_04_f_2016_3				
Comment Code					
S1 : Repair slope instability.					
Inspector Comment					
The slope in this area has been damaged by farm equipment.

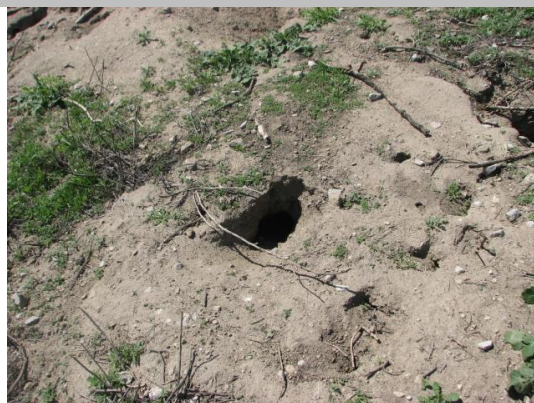
Photo 1 of 1 : FA_2019_NA0011_145_19_20190912_00020.jpg

Looking at large rodent hole on landward slope. (Spring 2018)

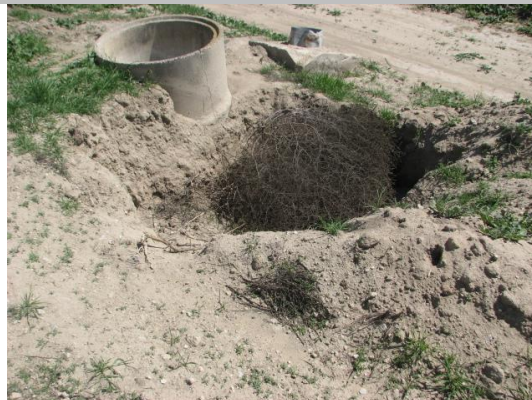
Photo 1 of 3 : FA_2019_NA0011_145_22_20190912_00021.jpg

LM Start	0.44	Rating **	U	Issue No.	22
LM End	0.44	Issue Type +	Ma	Location *	LS
Category	Earthen Levee			GPS Latitude/Longitude	
				Start	End
Item	Erosion / Bank Caving			36.995560 °	36.995560 °
				-120.365614 °	-120.365614 °
DWR ID	DWR_NA0011_04_s_2018_22				
Comment Code					
E2 : Schedule repair of erosion site prior to the next inspection.					
Inspector Comment					
Someone dug a large hole on the landward slope next to the concrete riser. There is no visible pipe at the site.

Looking west at large hole next concrete riser (no pipe) on landward slope. (Spring 2018)

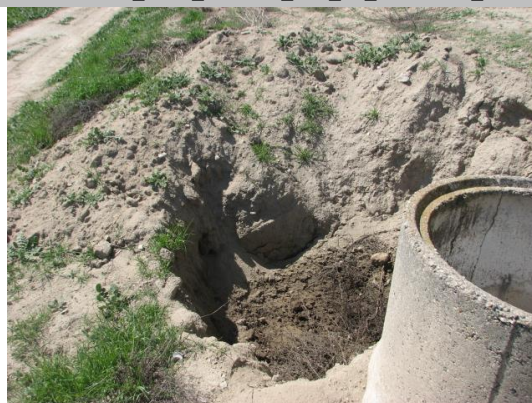
Photo 2 of 3 : FA_2019_NA0011_145_22_20190912_00022.jpg

Looking upstream at large hole on landward slope. (Spring 2018)

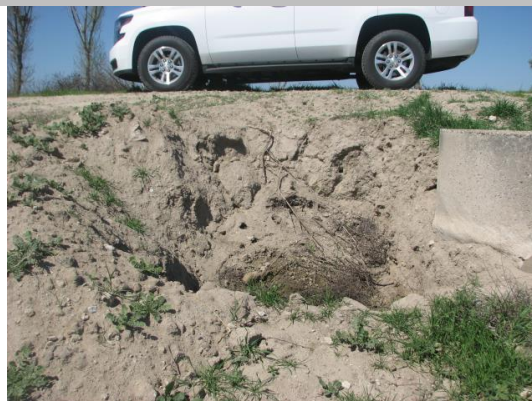
Photo 3 of 3 : FA_2019_NA0011_145_22_20190912_00023.jpg

Looking east at large hole next to riser (no pipe) on landward slope. (Spring 2018)

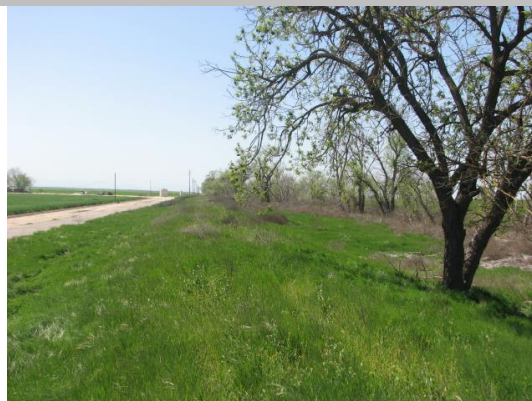
Photo 1 of 1 : FA_2019_NA0011_145_10_20190912_00009.jpg

Looking upstream at tree on waterward slope. (Spring 2018)

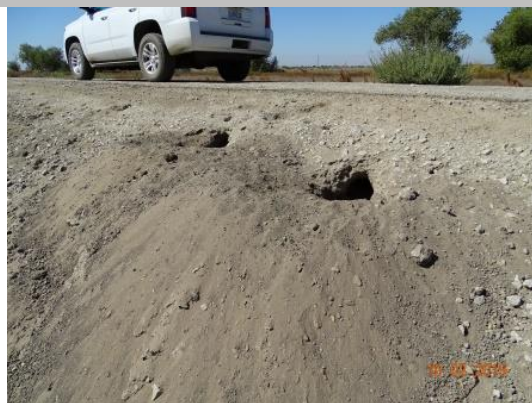
Photo 1 of 2 : FA_2019_NA0011_145_11_20191009_00037.jpg

Several large rodent holes along this section of levee. (Fall 2019)

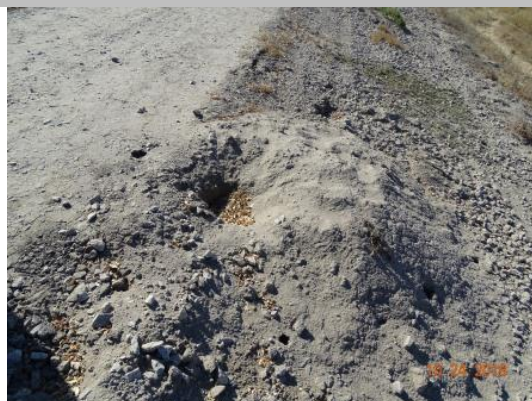
Photo 1 of 2 : FA_2019_NA0011_145_30_20190912_00025.jpg

Several large rodent holes on waterside slope. (Fall 2018)

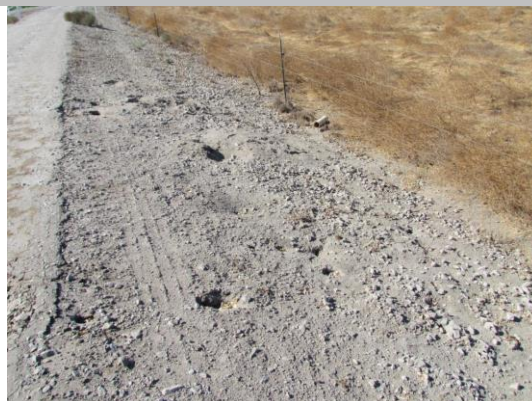
Photo 2 of 2 : FA_2019_NA0011_145_30_20190912_00026.jpg

View of rodent holes on the waterside slope.

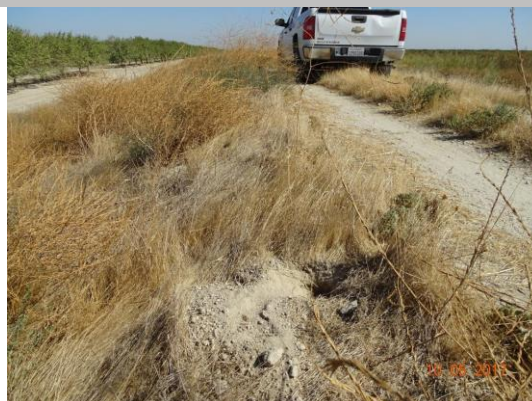
Photo 1 of 1 : FA_2019_NA0011_146_14_20190912_00006.jpg

Rodent activity on landside slope.

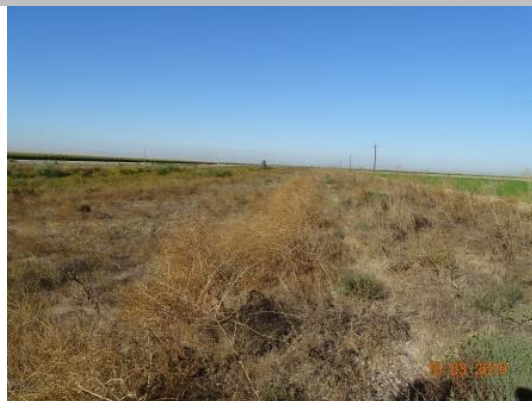
Photo 2 of 2 : FA_2019_NA0011_146_8_20191009_00033.jpg

View of vegetation on waterside slope. (Fall 2019)

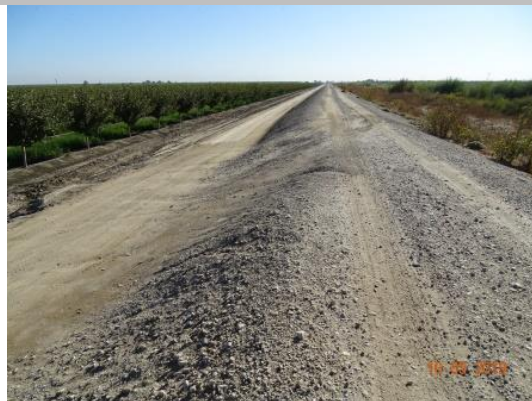
Photo 1 of 2 : FA_2019_NA0011_146_18_20191009_00039.jpg

Damage to landside shoulder and slope looking upstream. (Fall 2019)

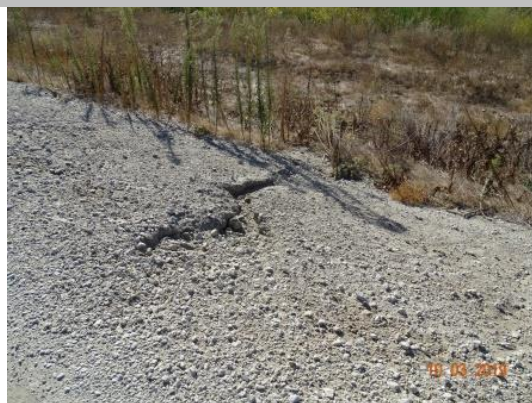
Photo 1 of 2 : FA_2019_NA0011_146_38_20191009_00040.jpg

Erosion on waterside slope. (Fall 2019)

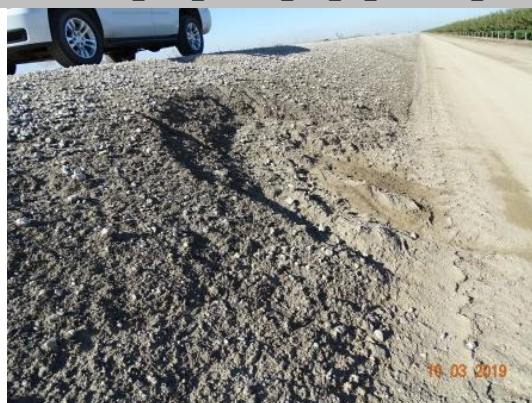
Photo 2 of 2 : FA_2019_NA0011_146_17_20191009_00042.jpg

View of erosion in landside slope. (Fall 2019)

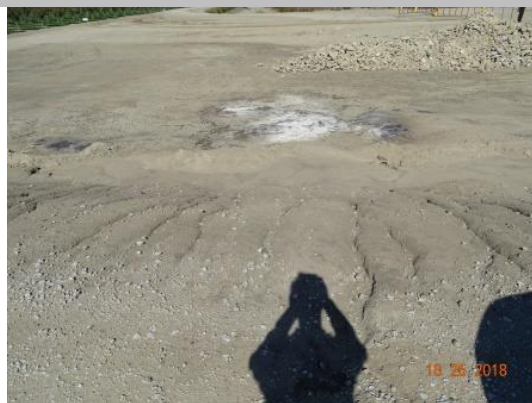
Photo 1 of 1 : FA_2019_NA0011_146_37_20190912_00017.jpg

Rill erosion on landside slope. (Fall 2018)

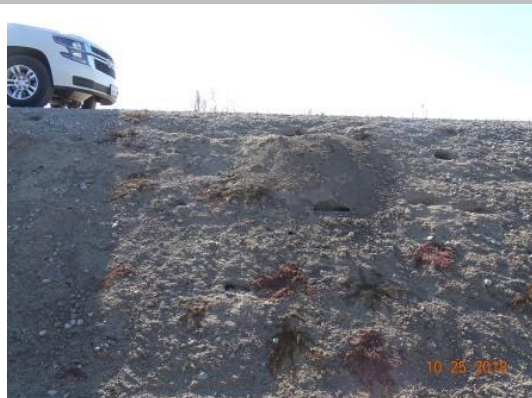
Photo 1 of 1 : FA_2019_NA0011_146_12_20190912_00004.jpg

Rodent activity on landside slope. (Fall 2018)

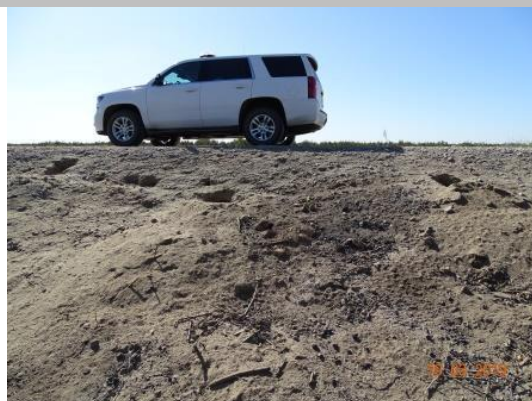
Photo 1 of 2 : FA_2019_NA0011_146_51_20191009_00046.jpg

Several rodent holes observed at this location. (Fall 2019)

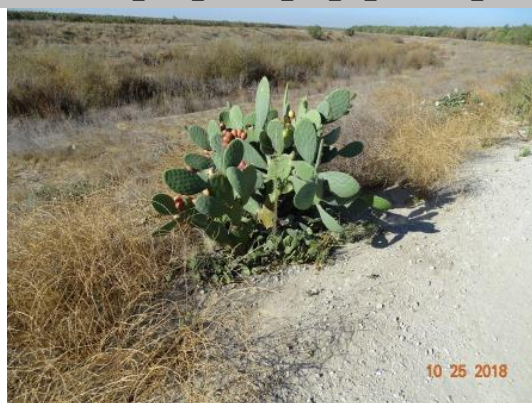
Photo 2 of 2 : FA_2019_NA0011_146_10_20190912_00002.jpg

Cactus on waterside slope. (Fall 2018)

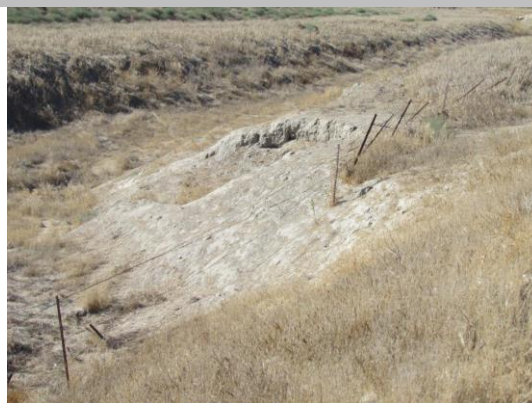
Photo 1 of 1 : FA_2019_NA0011_147_20_20190912_00005.jpg

Looking downstream at the old erosion site landside slope.

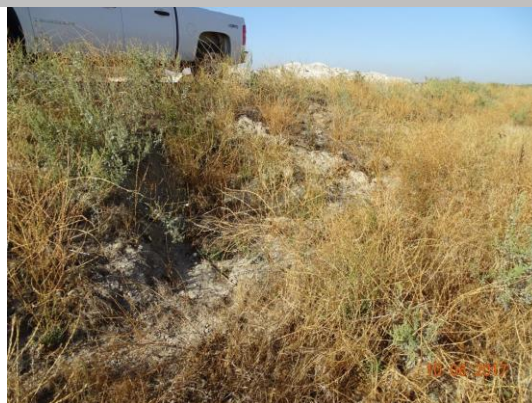
Photo 1 of 2 : FA_2019_NA0011_147_17_20190912_00003.jpg

Observed slump possibly exacerbated by rodent activity. 20' long x 8' high x 18" deep into levee slope.

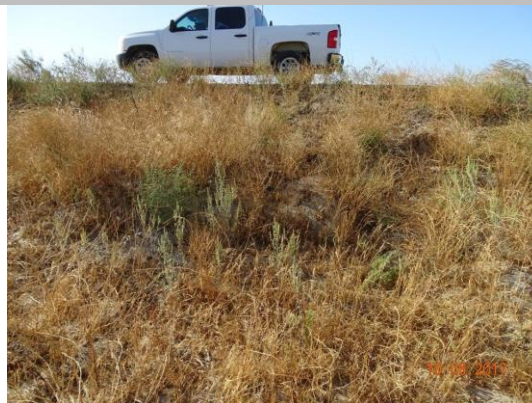
Photo 2 of 2 : FA_2019_NA0011_147_17_20190912_00004.jpg

Observed slump possibly exacerbated by rodent activity. 20' long x 8' high x 18" deep into levee slope.

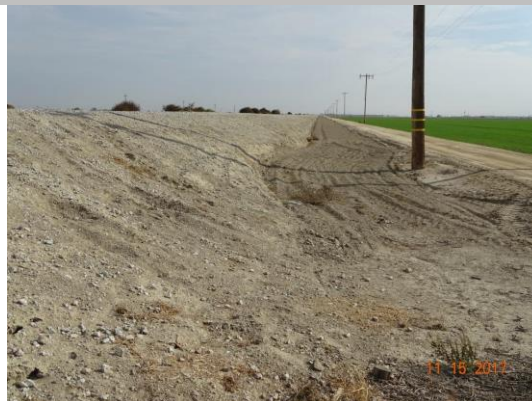
Photo 1 of 1 : FA_2019_NA0011_147_27_20190912_00008.jpg

Ag activity has cut into landside toe. Activity should be stopped and levee slope repaired.

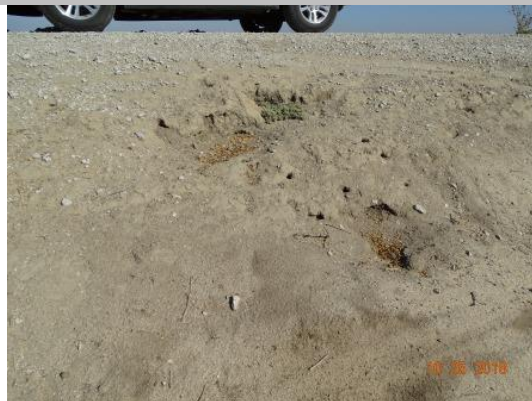
Photo 1 of 1 : FA_2019_NA0011_147_58_20190912_00024.jpg

Minor erosion on landside slope. (Fall 2018)

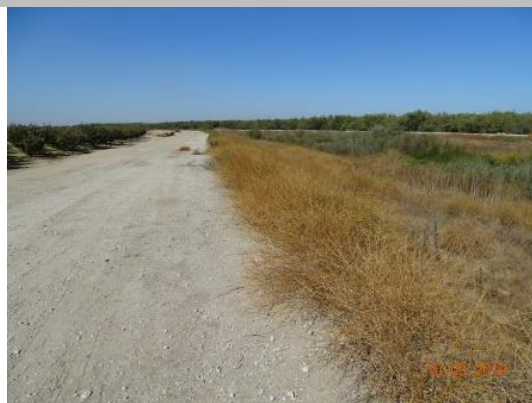
Photo 1 of 1 : FA_2019_NA0011_147_12_20191009_00051.jpg

Vegetation on waterside slope looking downstream. (Fall 2019)

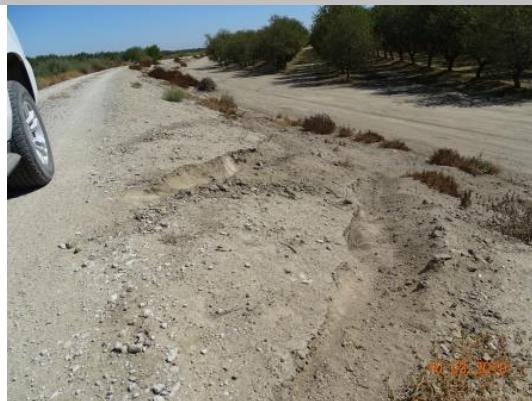
Photo 1 of 1 : FA_2019_NA0011_147_23_20191009_00052.jpg

Damage to landside slope from vehicle traffic. (Fall 2019)

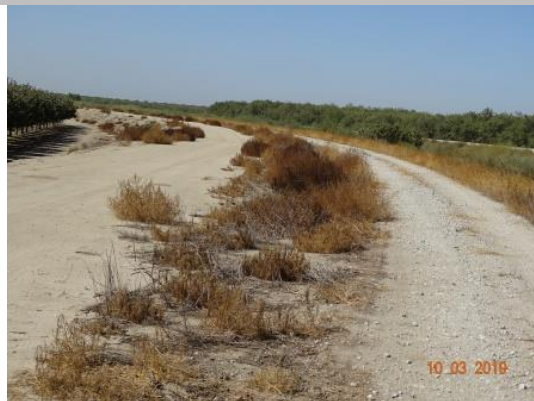
Photo 1 of 1 : FA_2019_NA0011_147_15_20191009_00053.jpg

Vegetation growing along levee crown. (Fall 2019)
