**Flood Control Project Maintenance
Levee Inspections**

Maintenance Issue Types Only, Levee Inspection Report By Mile - Fall 2020

Madera County FCWCA

Waterway	Bank	Unit Miles	Inspection Start/End	Inspector
Unit No. 01 Ash Slough	Right	2.37	09/24/2020 09/24/2020	Corey Fujitani

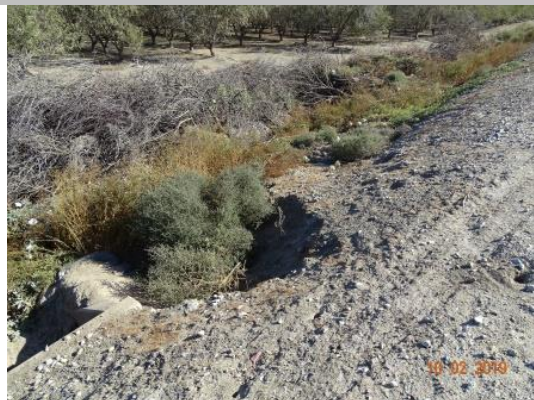
Photo 2 of 2 : FA_2020_NA0011_142_20_20200901_00010.jpg

View of damage to landside slope. (Fall 2019)

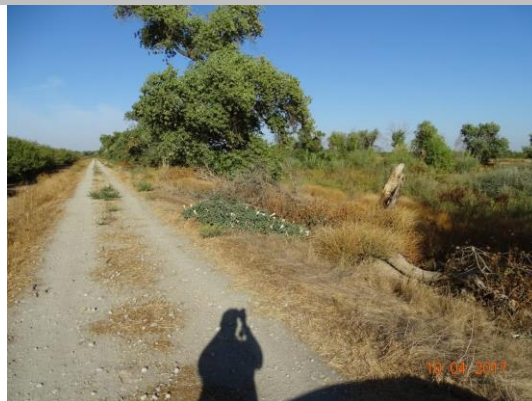
Photo 1 of 1 : FA_2020_NA0011_142_11_20200901_00001.jpg

Remove downed tree from waterside slope.

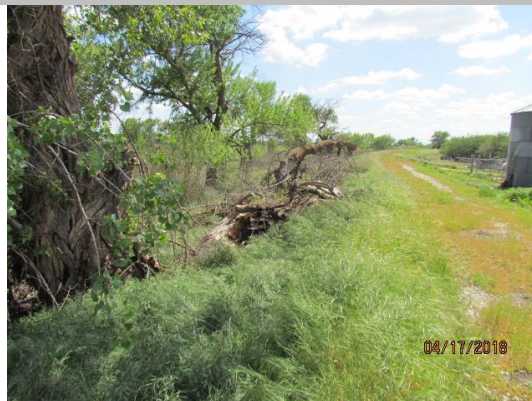
Photo 1 of 1 : FA_2020_NA0011_142_21_20200901_00011.jpg

Looking west at tree limbs and branches on waterward slope. (Spring 2018)

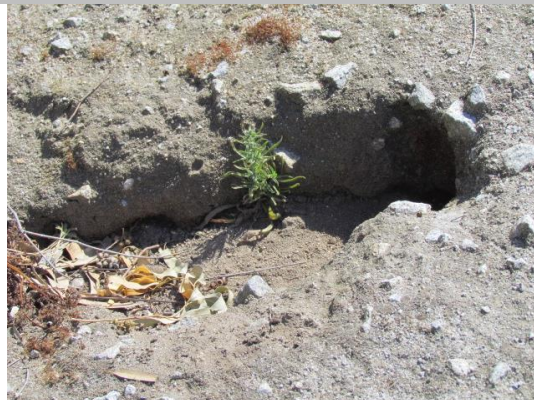
Photo 1 of 2 : FA_2020_NA0011_143_39_20200901_00018.jpg

Other rodent holes noted in the slope waterside levee section.

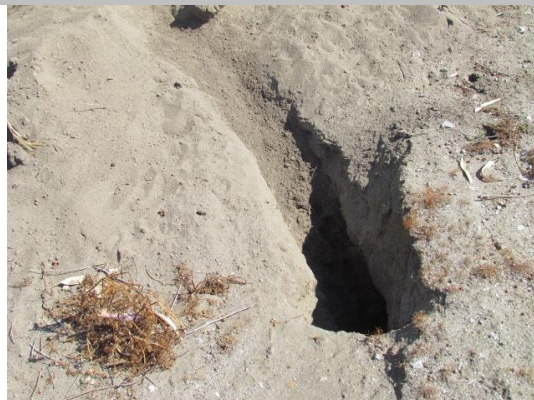
Photo 2 of 2 : FA_2020_NA0011_143_39_20200901_00019.jpg

Active rodents spotted in the area waterside slope levee mile 0.00- 1.67.

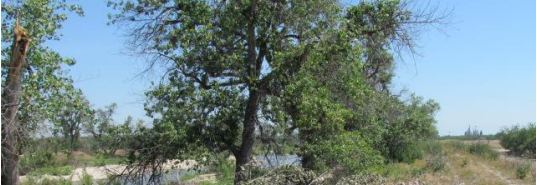
Photo 1 of 1 : FA_2020_NA0011_143_33_20200901_00016.jpg

Dead fallen trees on the waterside levee slope and shoulder.

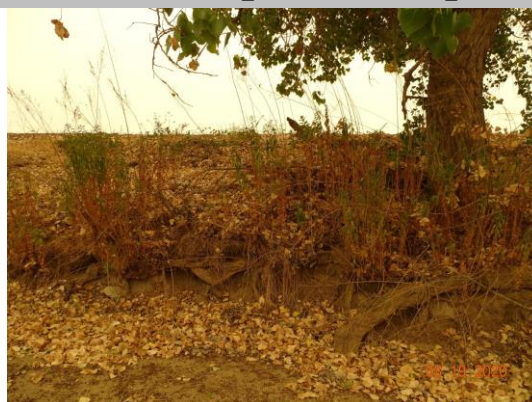
Photo 2 of 3 : SJR2019_NA0011U02RM2.57_04.JPG

8/19/2020: Eorsion visible on the levee toe.

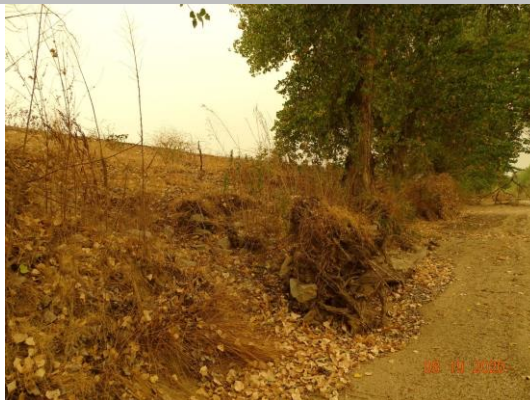
Photo 3 of 3 : SJR2019_NA0011U02RM2.57_07.JPG

8/19/2020: View of the levee slope looking downstream with erosion around a fallen tree root in the foreground.

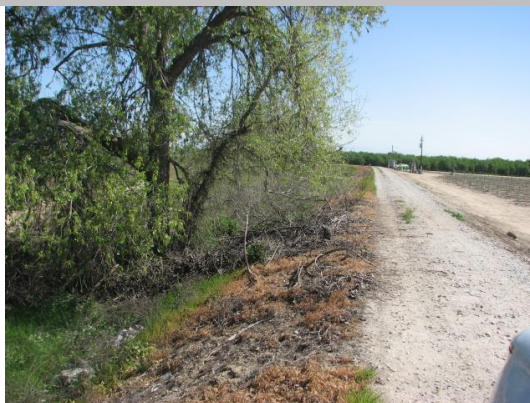
Photo 1 of 1 : FA_2020_NA0011_143_25_20200901_00010.jpg

LM Start	1.10	Rating **	M	Issue No.	17
LM End	1.13	Issue Type +	Ma	Location *	WS
Category	Earthen Levee			GPS Latitude/Longitude	
				Start	End
Item	Trim / Thin Trees			37.055437 °	37.055533 °
				-120.413392 °	-120.412863 °
DWR ID	DWR_NA0011_02_f_2017_17				
Comment Code					
T1 : Trim trees to at least five feet above ground level.					
Inspector Comment					
Trim branches from waterside tree hanging low over the crown inhibiting crown access.

Looking downstream at untrimmed tree on waterward slope. (Spring 2018)

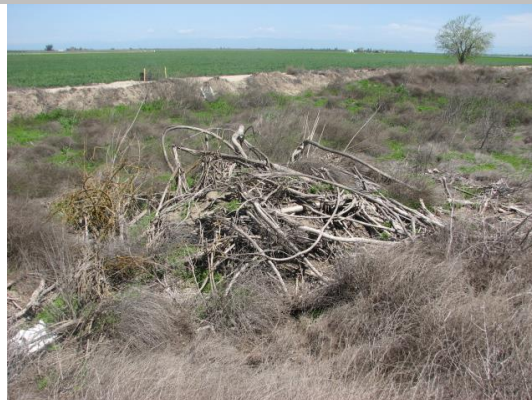
Photo 1 of 1 : FA_2020_NA0011_144_20_20200901_00010.jpg

Looking at prunings on landward slope. (Spring 2018)

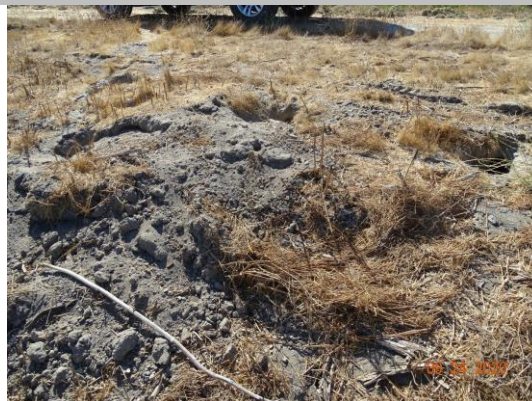
Photo 1 of 1 : FA_2020_NA0011_144_6_20201005_00018.jpg

LM Start	0.40	Rating **	U	Issue No.	6
LM End	1.51	Issue Type +	Ma	Location *	LS
Category	Earthen Levee			GPS Latitude/Longitude	
				Start	End
Item	Animal Control			36.996208 °	36.996607 °
				-120.366550 °	-120.346568 °
DWR ID	DWR_NA0011_03_f _ 2016_6				
Comment Code					
A1 : Exterminate rodents and backfill and compact or grout burrows.					
Inspector Comment					
LMA should install rodent bait stations placed along the landside slope and/or shoulder at from LM 0.40 to LM 1.51.

View of rodent burrows in the landside slope. (Fall 2020)

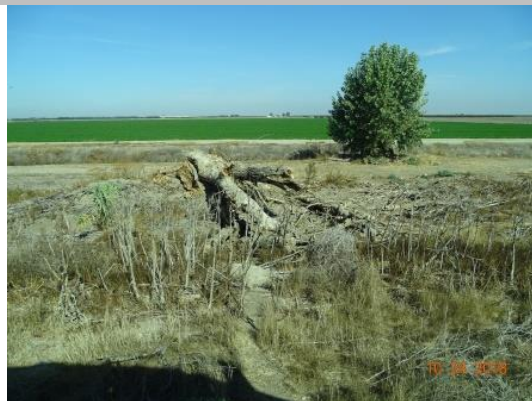
Photo 1 of 1 : FA_2020_NA0011_144_10_20200901_00005.jpg

LM Start	0.45	Rating **	U	Issue No.	10
LM End	0.45	Issue Type +	Ma	Location *	LS
Category	Earthen Levee			GPS Latitude/Longitude	
				Start	End
Item	Encroachments			36.996224 °	36.996224 °
				-120.365692 °	-120.365692 °
DWR ID	DWR_NA0011_03_f_2018_10				
Comment Code					
TR : Tree or limb					
Inspector Comment					
Remove the dead tree from the landside slope.

View of dead tree on the landside slope. (Fall 2018)

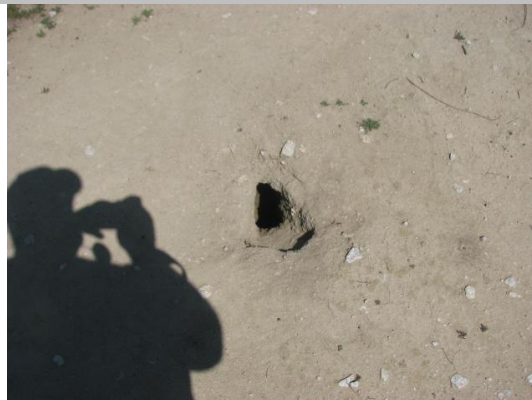
Photo 1 of 1 : FA_2020_NA0011_144_5_20200901_00002.jpg

Looking at rodent hole on levee crown. (Spring 2018)

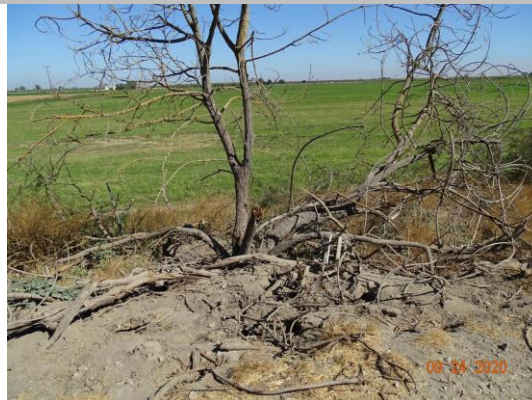
Photo 1 of 1 : FA_2020_NA0011_144_11_20201005_00019.jpg

Remove dead walnut tree on the landside slope. (Fall 2020)

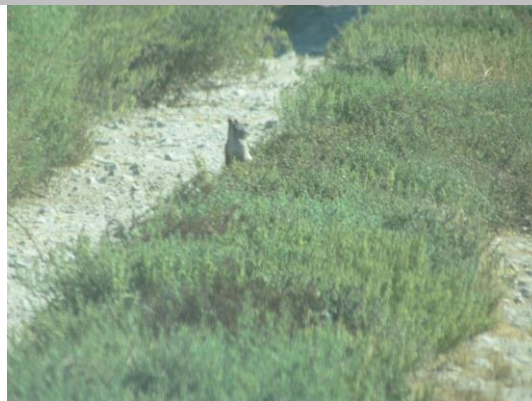
Photo 1 of 1 : FA_2020_NA0011_144_8_20200901_00004.jpg

LM Start	1.06	Rating **	M	Issue No.	8
LM End	1.51	Issue Type +	Ma	Location *	CR
Category	Earthen Levee			GPS Latitude/Longitude	
				Start	End
Item	Animal Control			36.996627 °	36.996607 °
				-120.354812 °	-120.346568 °
DWR ID	DWR_NA0011_03_f_2016_8				
Comment Code					
A1 : Exterminate rodents and backfill and compact or grout burrows.					
Inspector Comment					
Exterminate rodents from the roadway. Active rodents observed during inspection at this site.

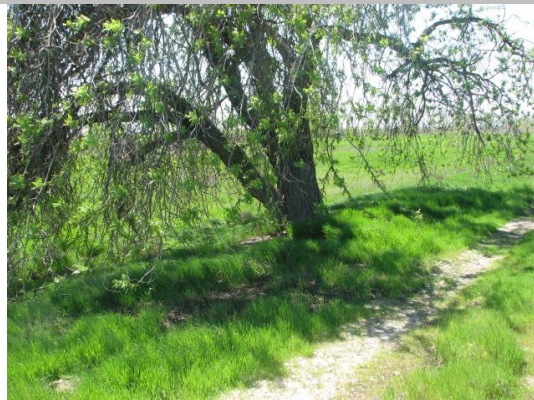
Photo 1 of 1 : FA_2020_NA0011_144_14_20200901_00007.jpg

Looking at untrimmed tree on waterward shoulder. (Spring 2018)

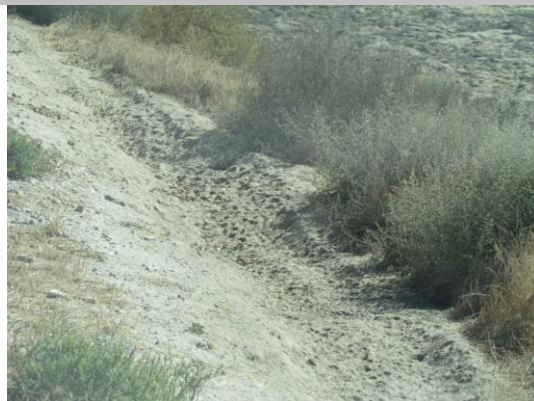
Photo 1 of 1 : FA_2020_NA0011_144_4_20200901_00001.jpg

LM Start	1.24	Rating **	M	Issue No.	4
LM End	1.25	Issue Type +	Ma	Location *	CR
Category	Earthen Levee			GPS Latitude/Longitude	
				Start	End
Item	Slope Stability			36.996582 °	36.996582 °
				-120.351482 °	-120.351258 °
DWR ID	DWR_NA0011_03_f_2016_4				
Comment Code					
S1 : Repair slope instability.					
Inspector Comment					
Repair the slope instability and damaged shoulder at this location.

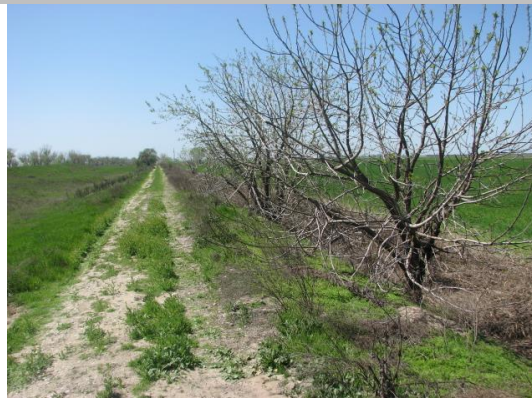
Photo 1 of 1 : FA_2020_NA0011_144_17_20200901_00008.jpg

Looking at cluster of walnut trees on landward slope. (Spring 2018)

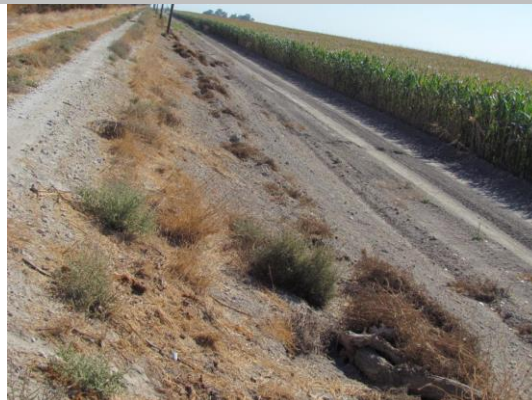
Photo 1 of 1 : FA_2020_NA0011_145_3_20200901_00001.jpg

LM Start	0.02	Rating **	U	Issue No.	3
LM End	0.97	Issue Type +	Ma	Location *	LS
Category	Earthen Levee			GPS Latitude/Longitude	
				Start	End
Item	Slope Stability			36.995506 °	36.995550 °
				-120.373233 °	-120.355935 °
DWR ID	DWR_NA0011_04_f_2016_3				
Comment Code					
S1 : Repair slope instability.					
Inspector Comment					
The slope in this area has been damaged by farm equipment.

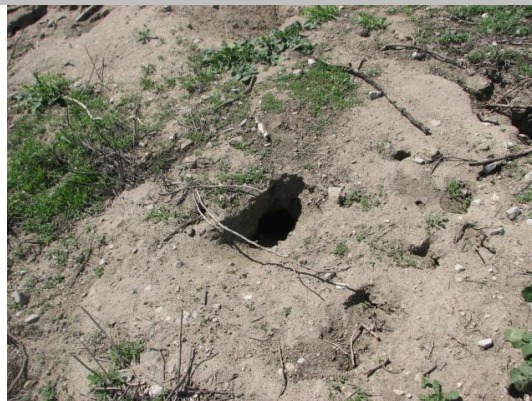
Photo 1 of 1 : FA_2020_NA0011_145_19_20200901_00011.jpg

Looking at large rodent hole on landward slope. (Spring 2018)

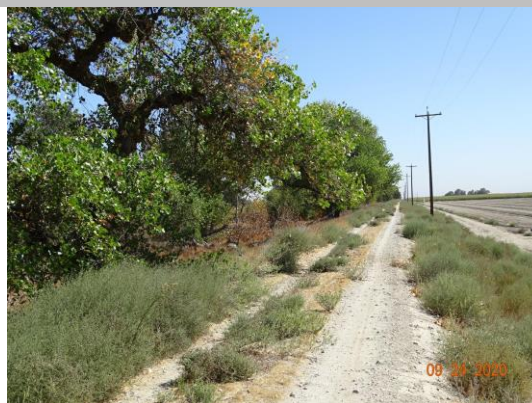
Photo 1 of 1 : FA_2020_NA0011_145_26_20201006_00027.jpg

LM Start	0.22	Rating **	M	Issue No.	26
LM End	0.22	Issue Type +	Ma	Location *	WS
Category	Earthen Levee			GPS Latitude/Longitude	
				Start	End
Item	Trim / Thin Trees			36.995533 °	36.995533 °
				-120.369593 °	-120.369593 °
DWR ID	DWR_NA0011_04_f_2019_26				
Comment Code					
T4 : Trim trees over roadway to at least 12 feet above ground level.					
Inspector Comment

Low hanging tree limb above the levee crown. (Fall 2020)

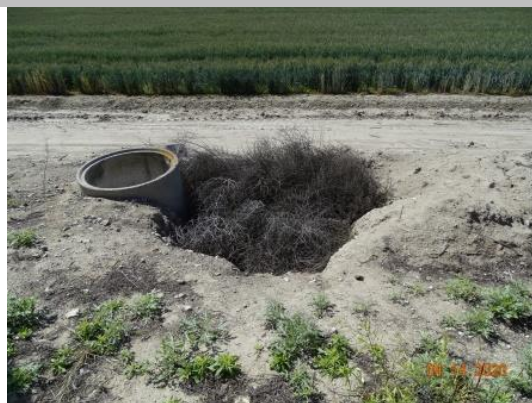
Photo 1 of 1 : FA_2020_NA0011_145_22_20200901_00012.jpg

LM Start	0.44	Rating **	U	Issue No.	22
LM End	0.44	Issue Type +	Ma	Location *	LS
Category	Earthen Levee			GPS Latitude/Longitude	
				Start	End
Item	Erosion / Bank Caving			36.995560 °	36.995560 °
				-120.365614 °	-120.365614 °
DWR ID	DWR_NA0011_04_s_2018_22				
Comment Code					
E2 : Schedule repair of erosion site prior to the next inspection.					
Inspector Comment					
A large hole was dug on the landward slope next to the concrete riser. There is no visible pipe at the site.

Looking west at large hole next concrete riser (no pipe) on landward slope. (Spring 2020)

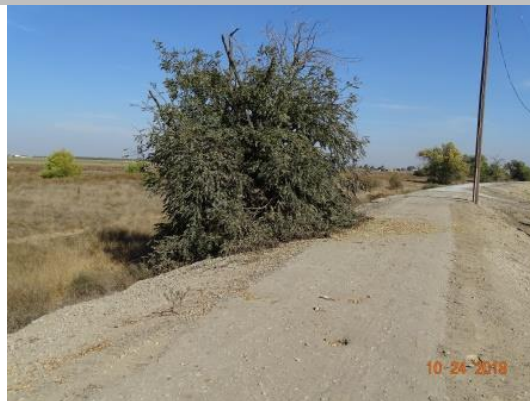
Photo 1 of 1 : FA_2020_NA0011_145_27_20200901_00013.jpg

Trim tree on waterside shoulder. (Fall 2018)

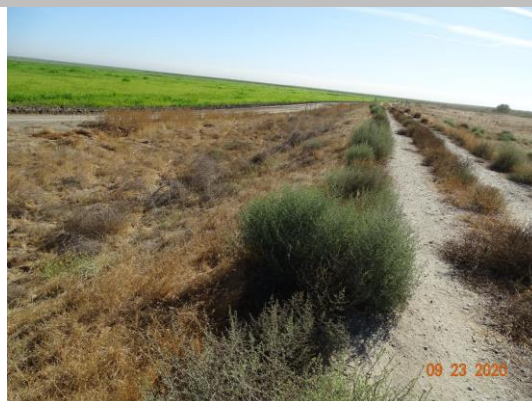
Photo 1 of 1 : FA_2020_NA0011_146_7_20201006_00032.jpg

Vegetation on the landside slope and toe. (Fall 2020)

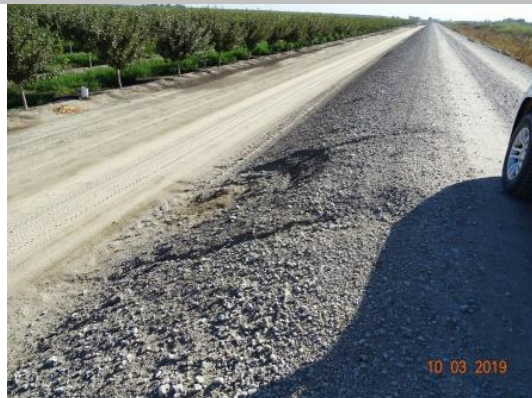
Photo 1 of 1 : FA_2020_NA0011_146_17_20200901_00006.jpg

LM Start	5.90	Rating **	M	Issue No.	17
LM End	5.90	Issue Type +	Ma	Location *	LS
Category	Earthen Levee			GPS Latitude/Longitude	
				Start	End
Item	Erosion / Bank Caving			36.968205 °	36.968205 °
				-120.267562 °	-120.267562 °
DWR ID	DWR_NA0011_05_f_2019_17				
Comment Code					
E2 : Schedule repair of erosion site prior to the next inspection.					
Inspector Comment

View of landside slope erosion looking upstream. (Fall 2019)

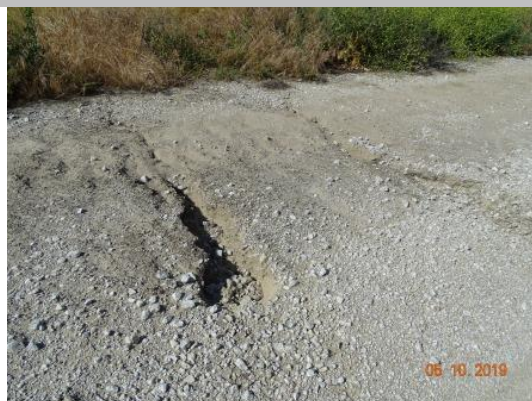
Photo 1 of 1 : FA_2020_NA0011_146_46_20200901_00019.jpg

LM Start	6.30	Rating **	M	Issue No.	46
LM End	6.30	Issue Type +	Ma	Location *	WS
Category	Earthen Levee			GPS Latitude/Longitude	
				Start	End
Item	Erosion / Bank Caving			36.968399 °	36.968399 °
				-120.260433 °	-120.260433 °
DWR ID	DWR_NA0011_05_s_2019_46				
Comment Code					
E2 : Schedule repair of erosion site prior to the next inspection.					
Inspector Comment					
Rills on waterside slope.

Rills observed on waterside slope. (Spring 2019)

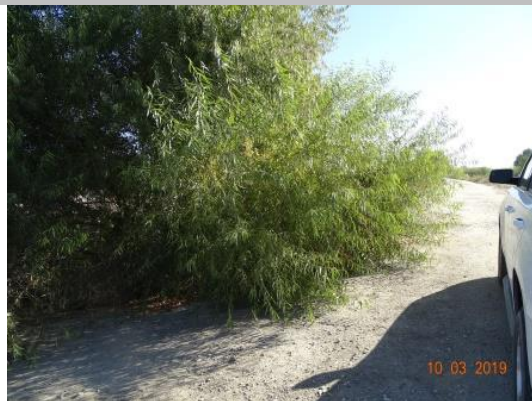
Photo 1 of 1 : FA_2020_NA0011_146_29_20200901_00013.jpg

View of tree growing on landside slope looking upstream. (Fall 2019)

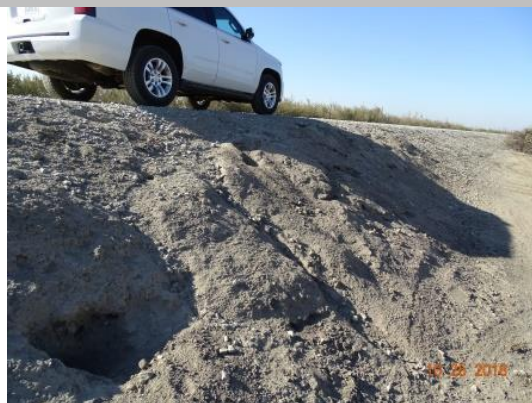
Photo 1 of 1 : FA_2020_NA0011_146_24_20200901_00009.jpg

Rodent activity on landside slope. (Fall 2018)

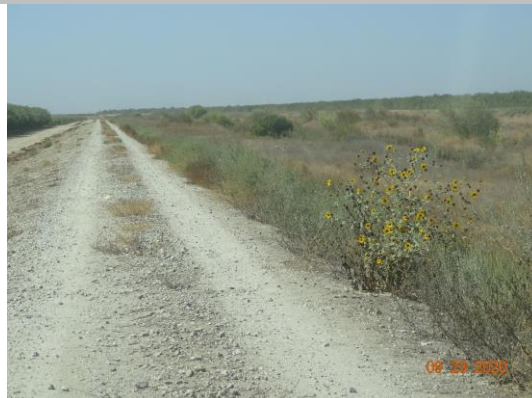
Photo 1 of 1 : FA_2020_NA0011_147_35_20201006_00047.jpg

Vegetation on the waterside slope. (Fall 2020)

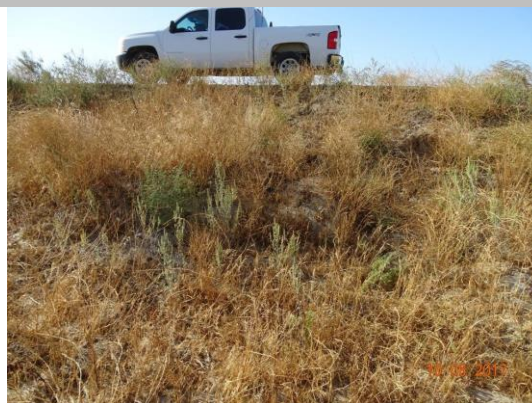
Photo 1 of 1 : FA_2020_NA0011_147_17_20200901_00003.jpg

LM Start	1.02	Rating **	U	Issue No.	17
LM End	1.15	Issue Type +	Ma	Location *	WS
Category	Earthen Levee			GPS Latitude/Longitude	
				Start	End
Item	Slope Stability			36.968520 °	36.967334 °
				-120.354012 °	-120.352154 °
DWR ID	DWR_NA0011_06_f_2017_17				
Comment Code					
S1 : Repair slope instability.					
Inspector Comment					
Observed slump possibly exacerbated by rodent activity. 20' long x 8' high x 18" deep into levee slope.

View of slump possibly the result of rodent activity.

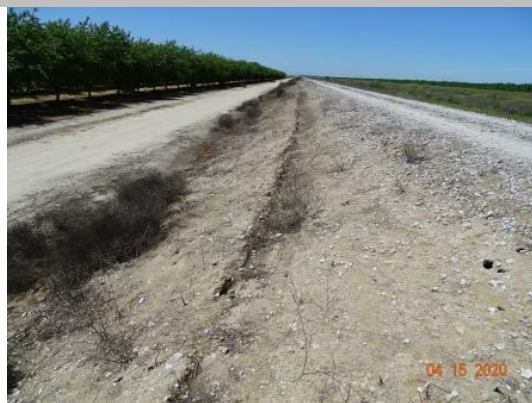
Photo 1 of 1 : FA_2020_NA0011_147_69_20200901_00024.jpg

Vehicle tracks in the landside slope. (Spring 2020)

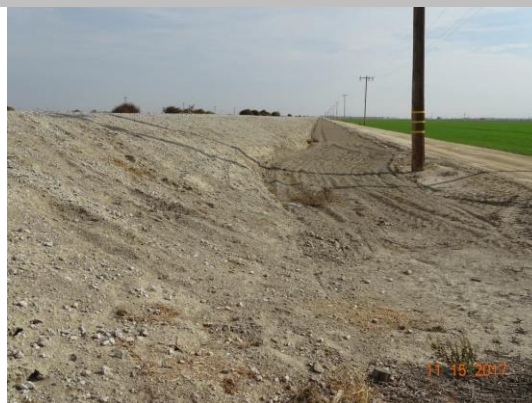
Photo 1 of 1 : FA_2020_NA0011_147_27_20200901_00008.jpg

Ag activity has cut into landside toe. Activity should be stopped and levee slope repaired.

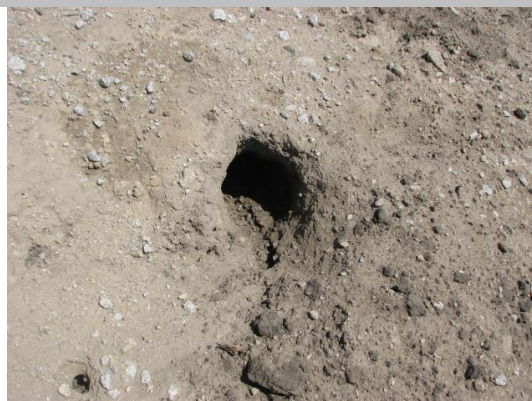
Photo 1 of 1 : FA_2020_NA0011_147_53_20200901_00019.jpg

Looking at typical rodent hole on landward slope. (Spring 2018)

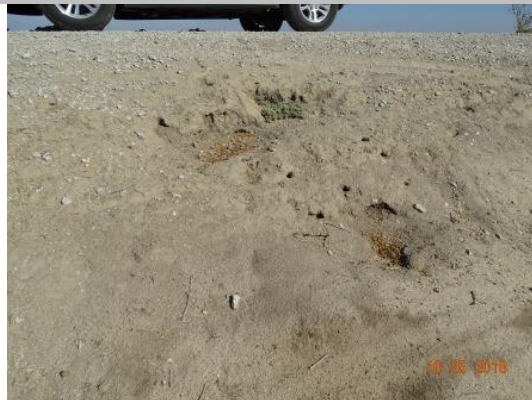
Photo 1 of 1 : FA_2020_NA0011_147_58_20200901_00021.jpg

Minor erosion on landside slope. (Fall 2018)

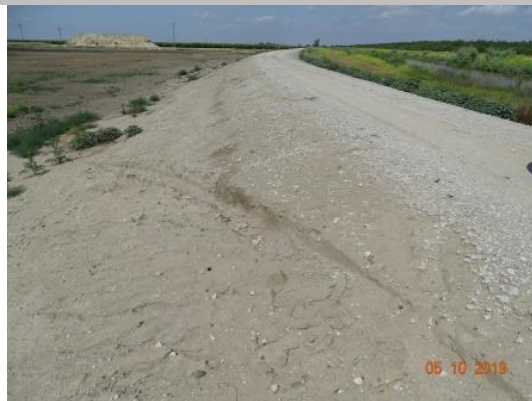
Photo 1 of 1 : FA_2020_NA0011_147_59_20200901_00022.jpg

View of vehicle tracks on landside slope. (Spring 2019)

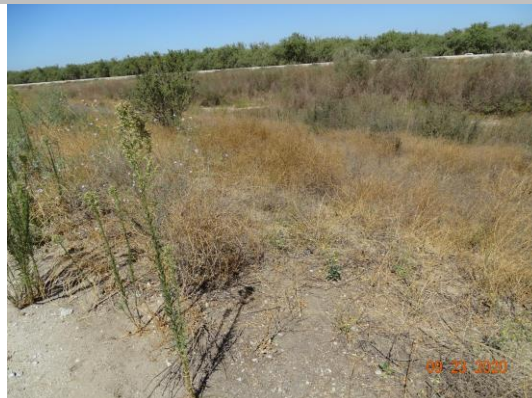
Photo 1 of 1 : FA_2020_NA0011_147_12_20201006_00051.jpg

View of vegetation on the waterside slope. (Fall 2020).

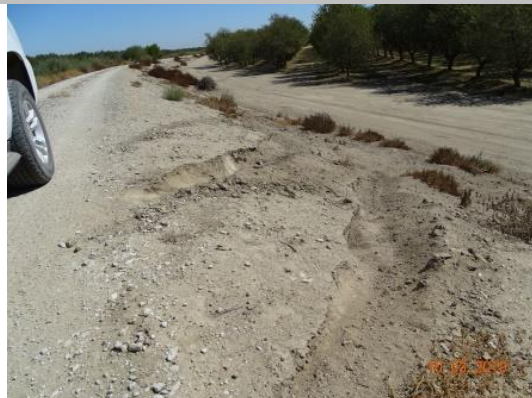
Photo 1 of 1 : FA_2020_NA0011_147_23_20200901_00006.jpg

Damage to landside slope from vehicle traffic. (Fall 2019)
